PRELIMINARY CONTAMINATED LAND ASSESSMENT

**Planning Proposal for a Dwelling
Entitlement
103 Yagers Lane, Skinners Shoot**

For:	M. Schreiber
Report no:	21421-CL.docx
Date:	May 2022

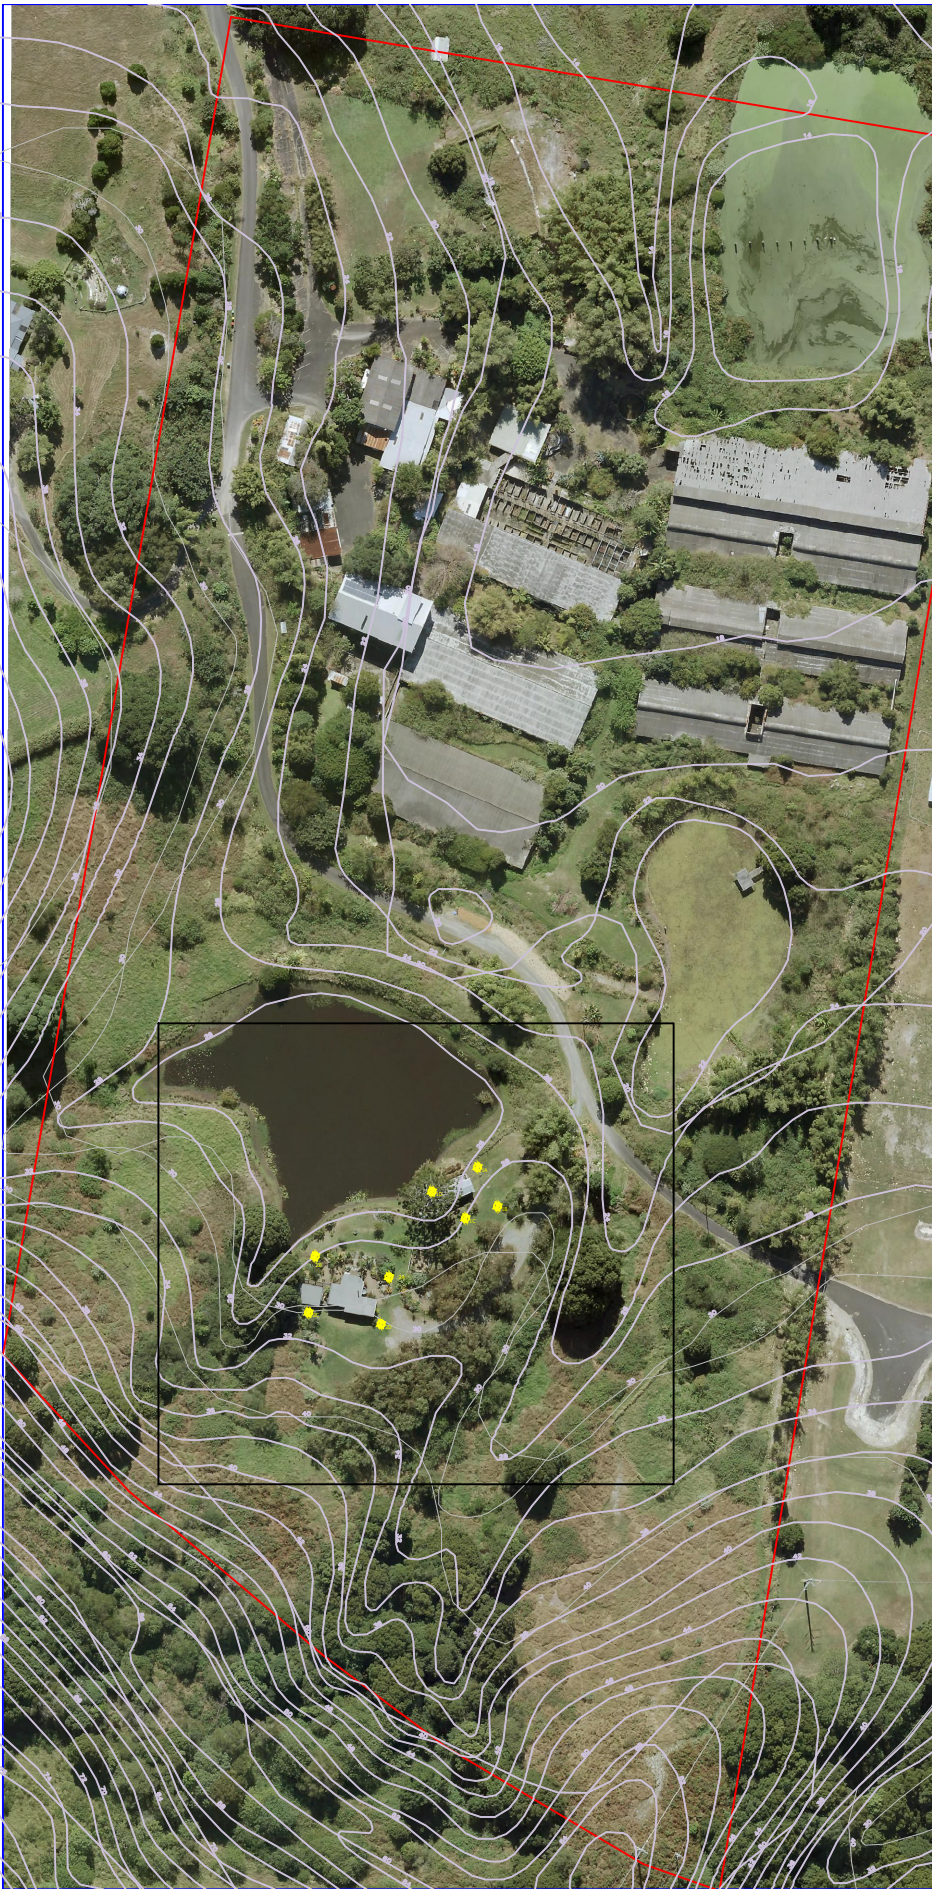
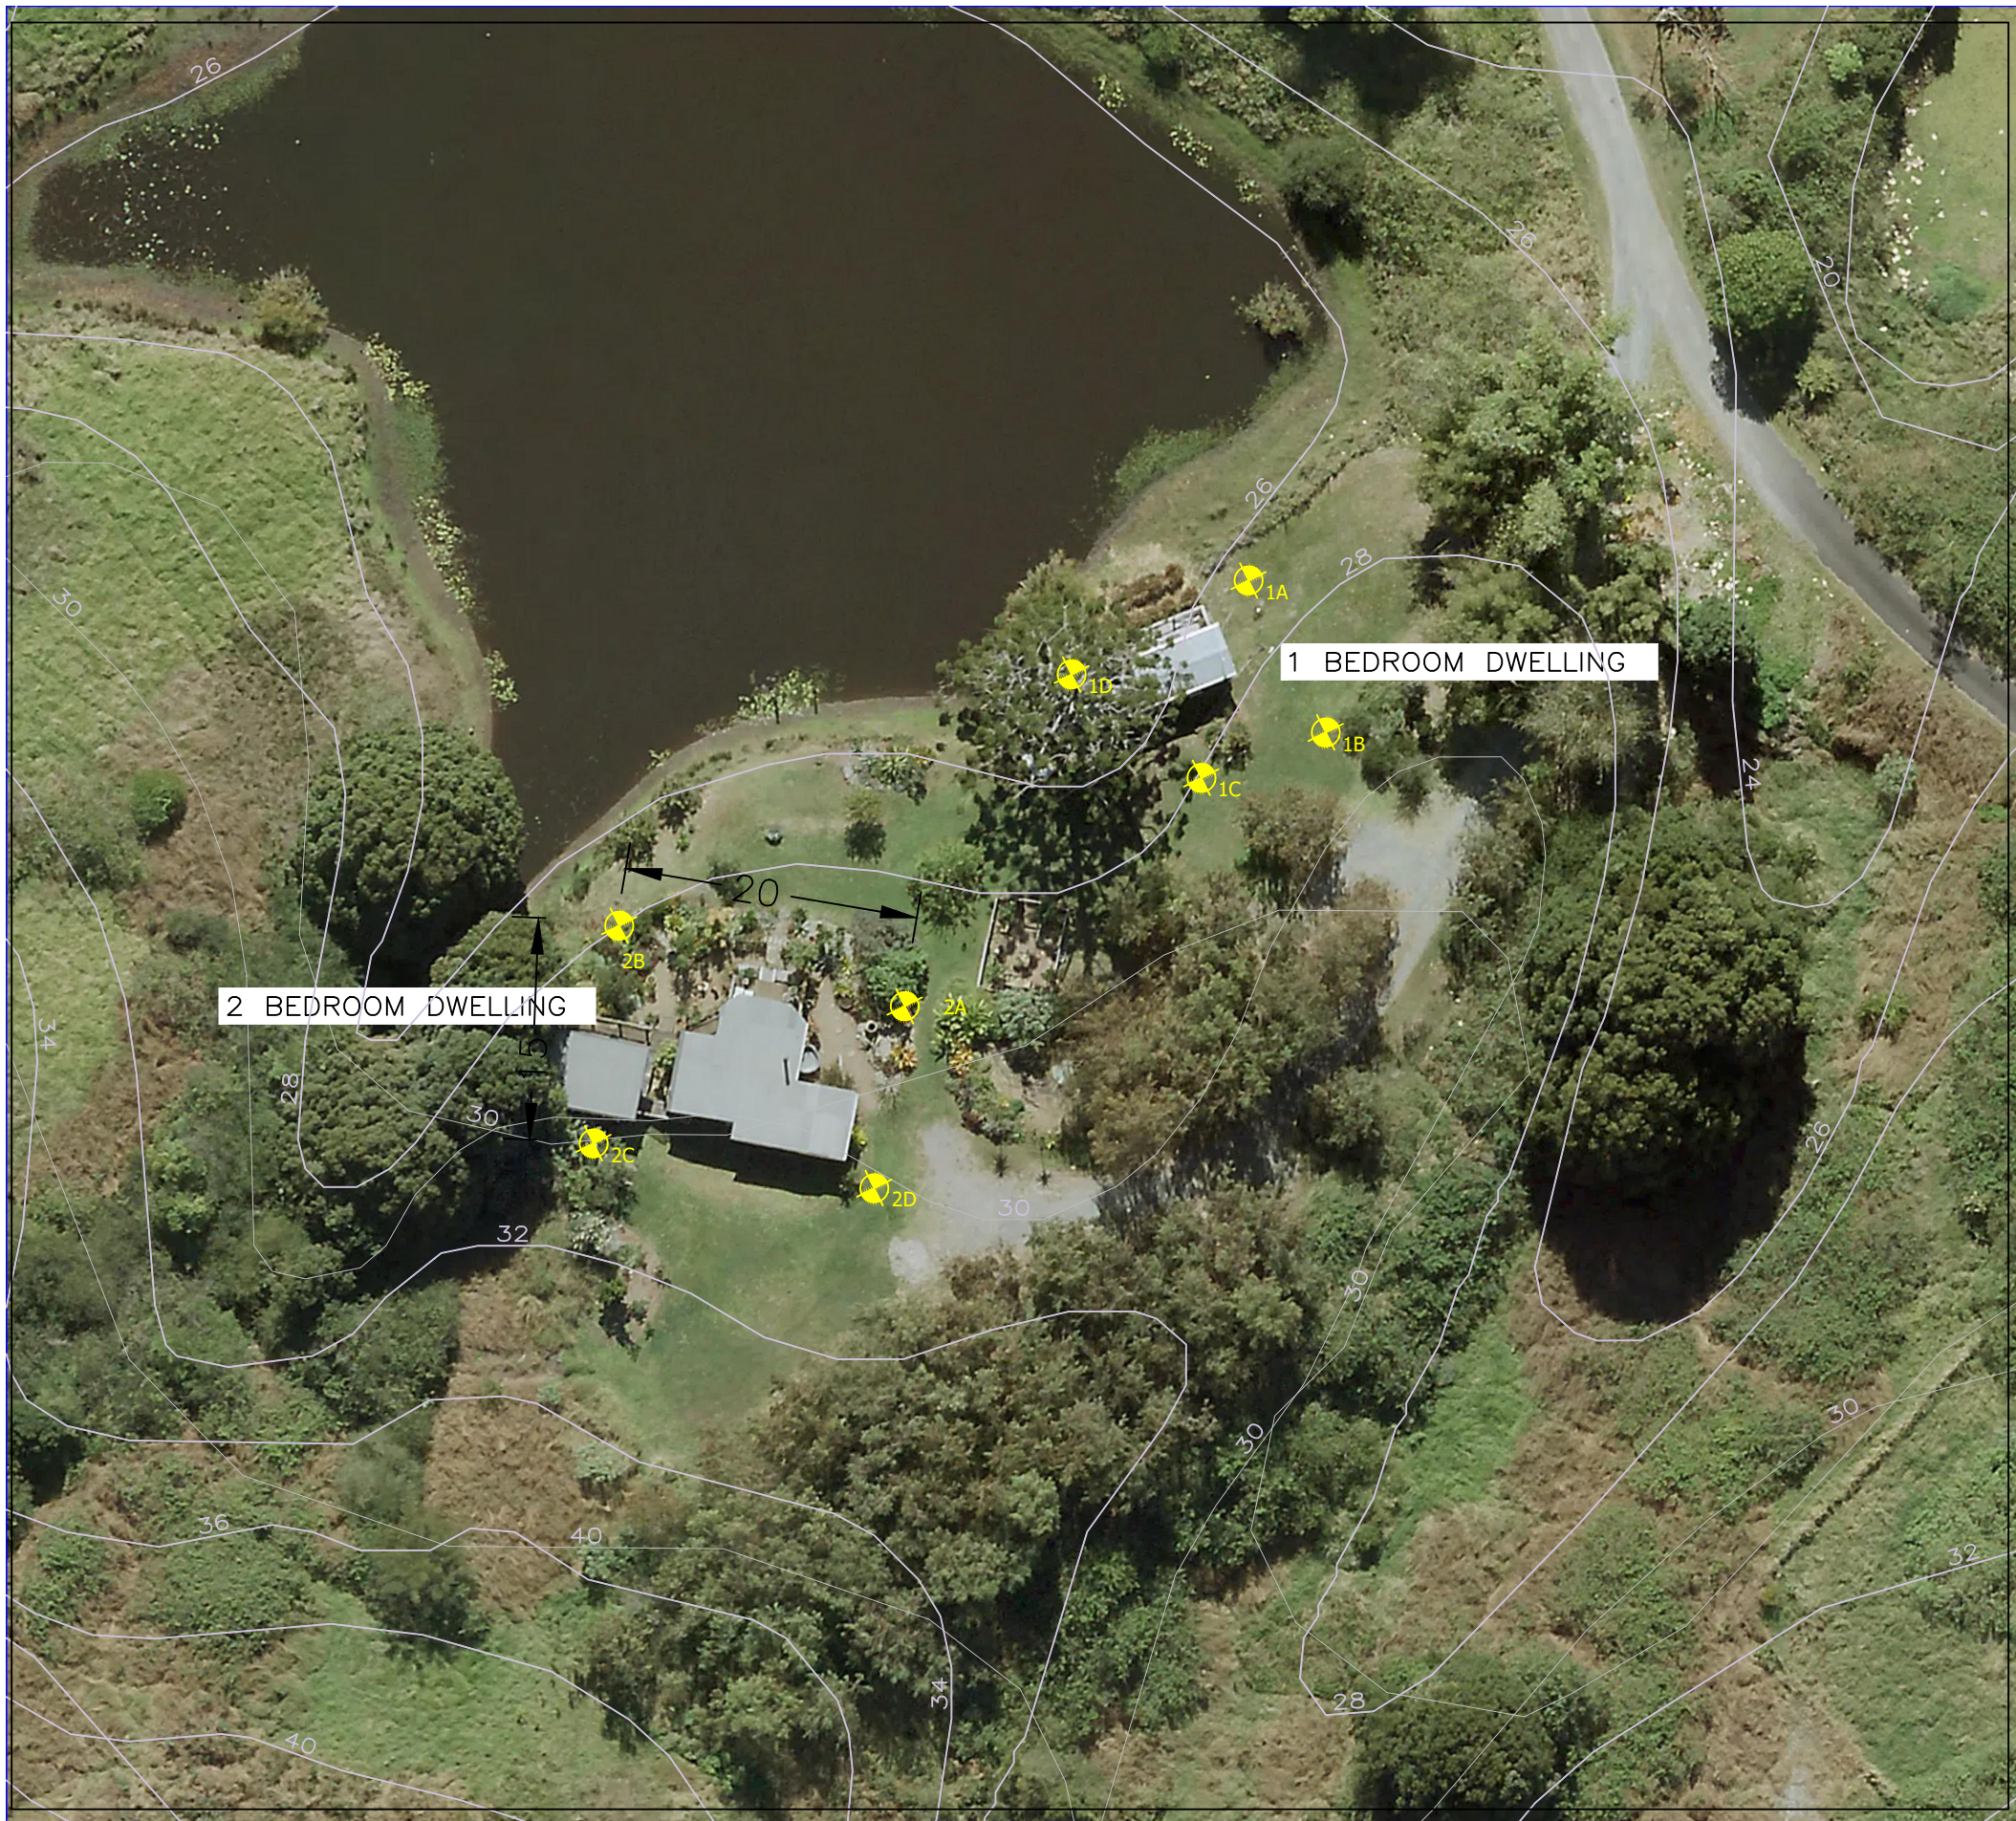
Composite 1 –Consisting of samples 1A, 1B, 1C and 1D. These samples were located around the northern dwelling and within the landscaping area to the south, up to 20 m apart.

Composite 2 – Consisting of sample points 2A, 2B, 2C and 2D. These samples were located around the southern dwelling and the landscaping area to the north of the dwelling, up to 20 m apart.

Exhibit No.2 presents the soil sample locations.
