Report on  
Preliminary Site Investigation (Contamination)

Tuggerah Gateway Site  
60 Wyong Road, Tuggerah

Prepared for  
Scentre Limited

Project 202794.01  
September 2021

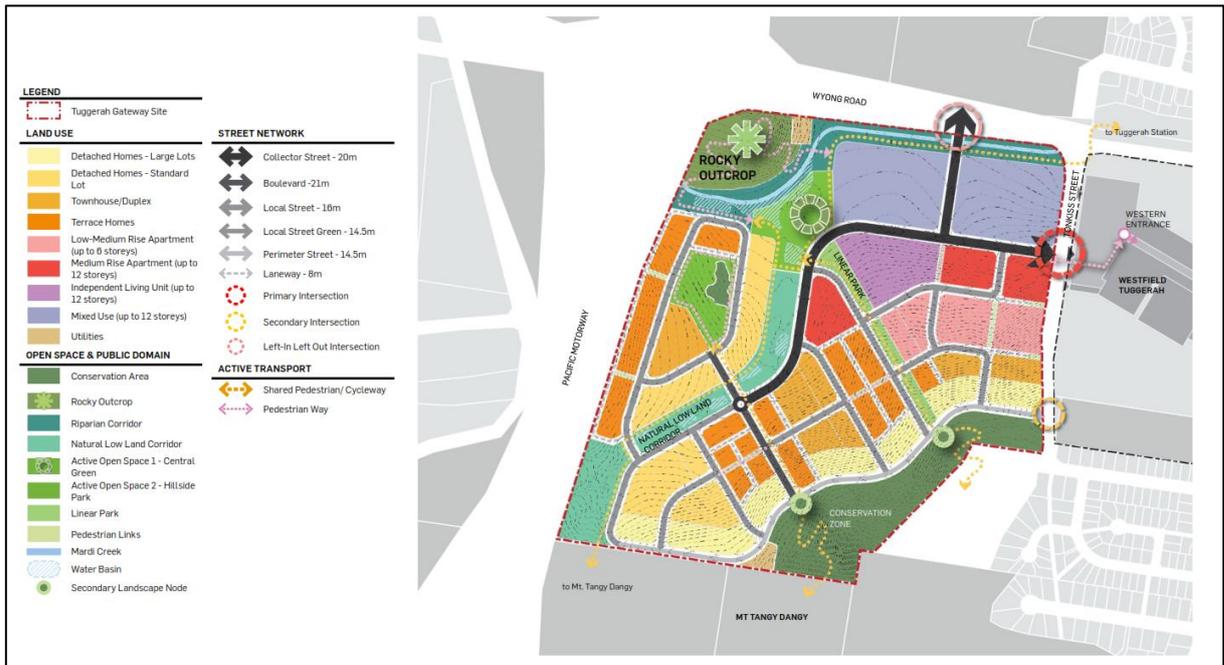
**Figure 1: Concept Plan**

The planning proposal seeks to rezone land comprising (part) Lot 2 in DP 1056960 and Lot 3 in DP 1084221 from RU6 Transition to R1 General Residential. The B4 Mixed Use zone in the north-east of the site and E2 Environmental Conservation zone in the south-east is to be retained. A number of internal roads and areas dedicated to open space / public domain are also proposed. The current concept plan for the proposed development is shown in Figure 1 below.

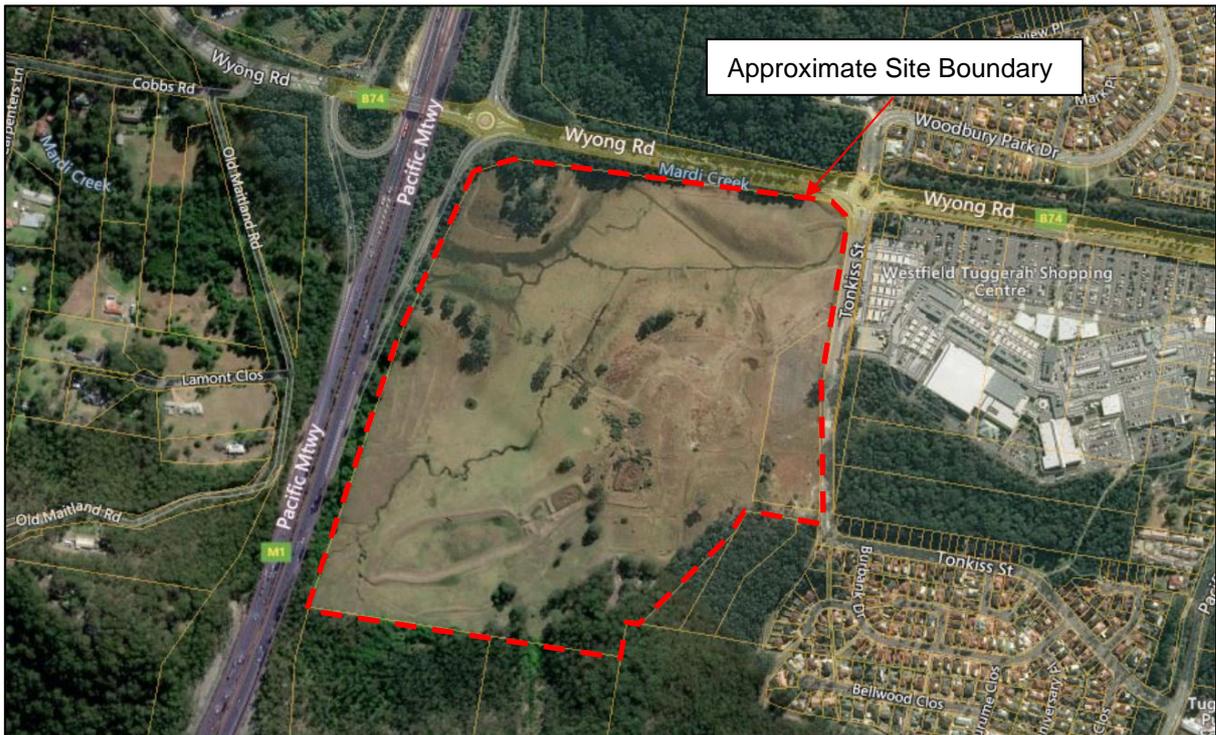
Figure 2: Aerial view of the site

An aerial view of the site is shown in Figure 2 below.

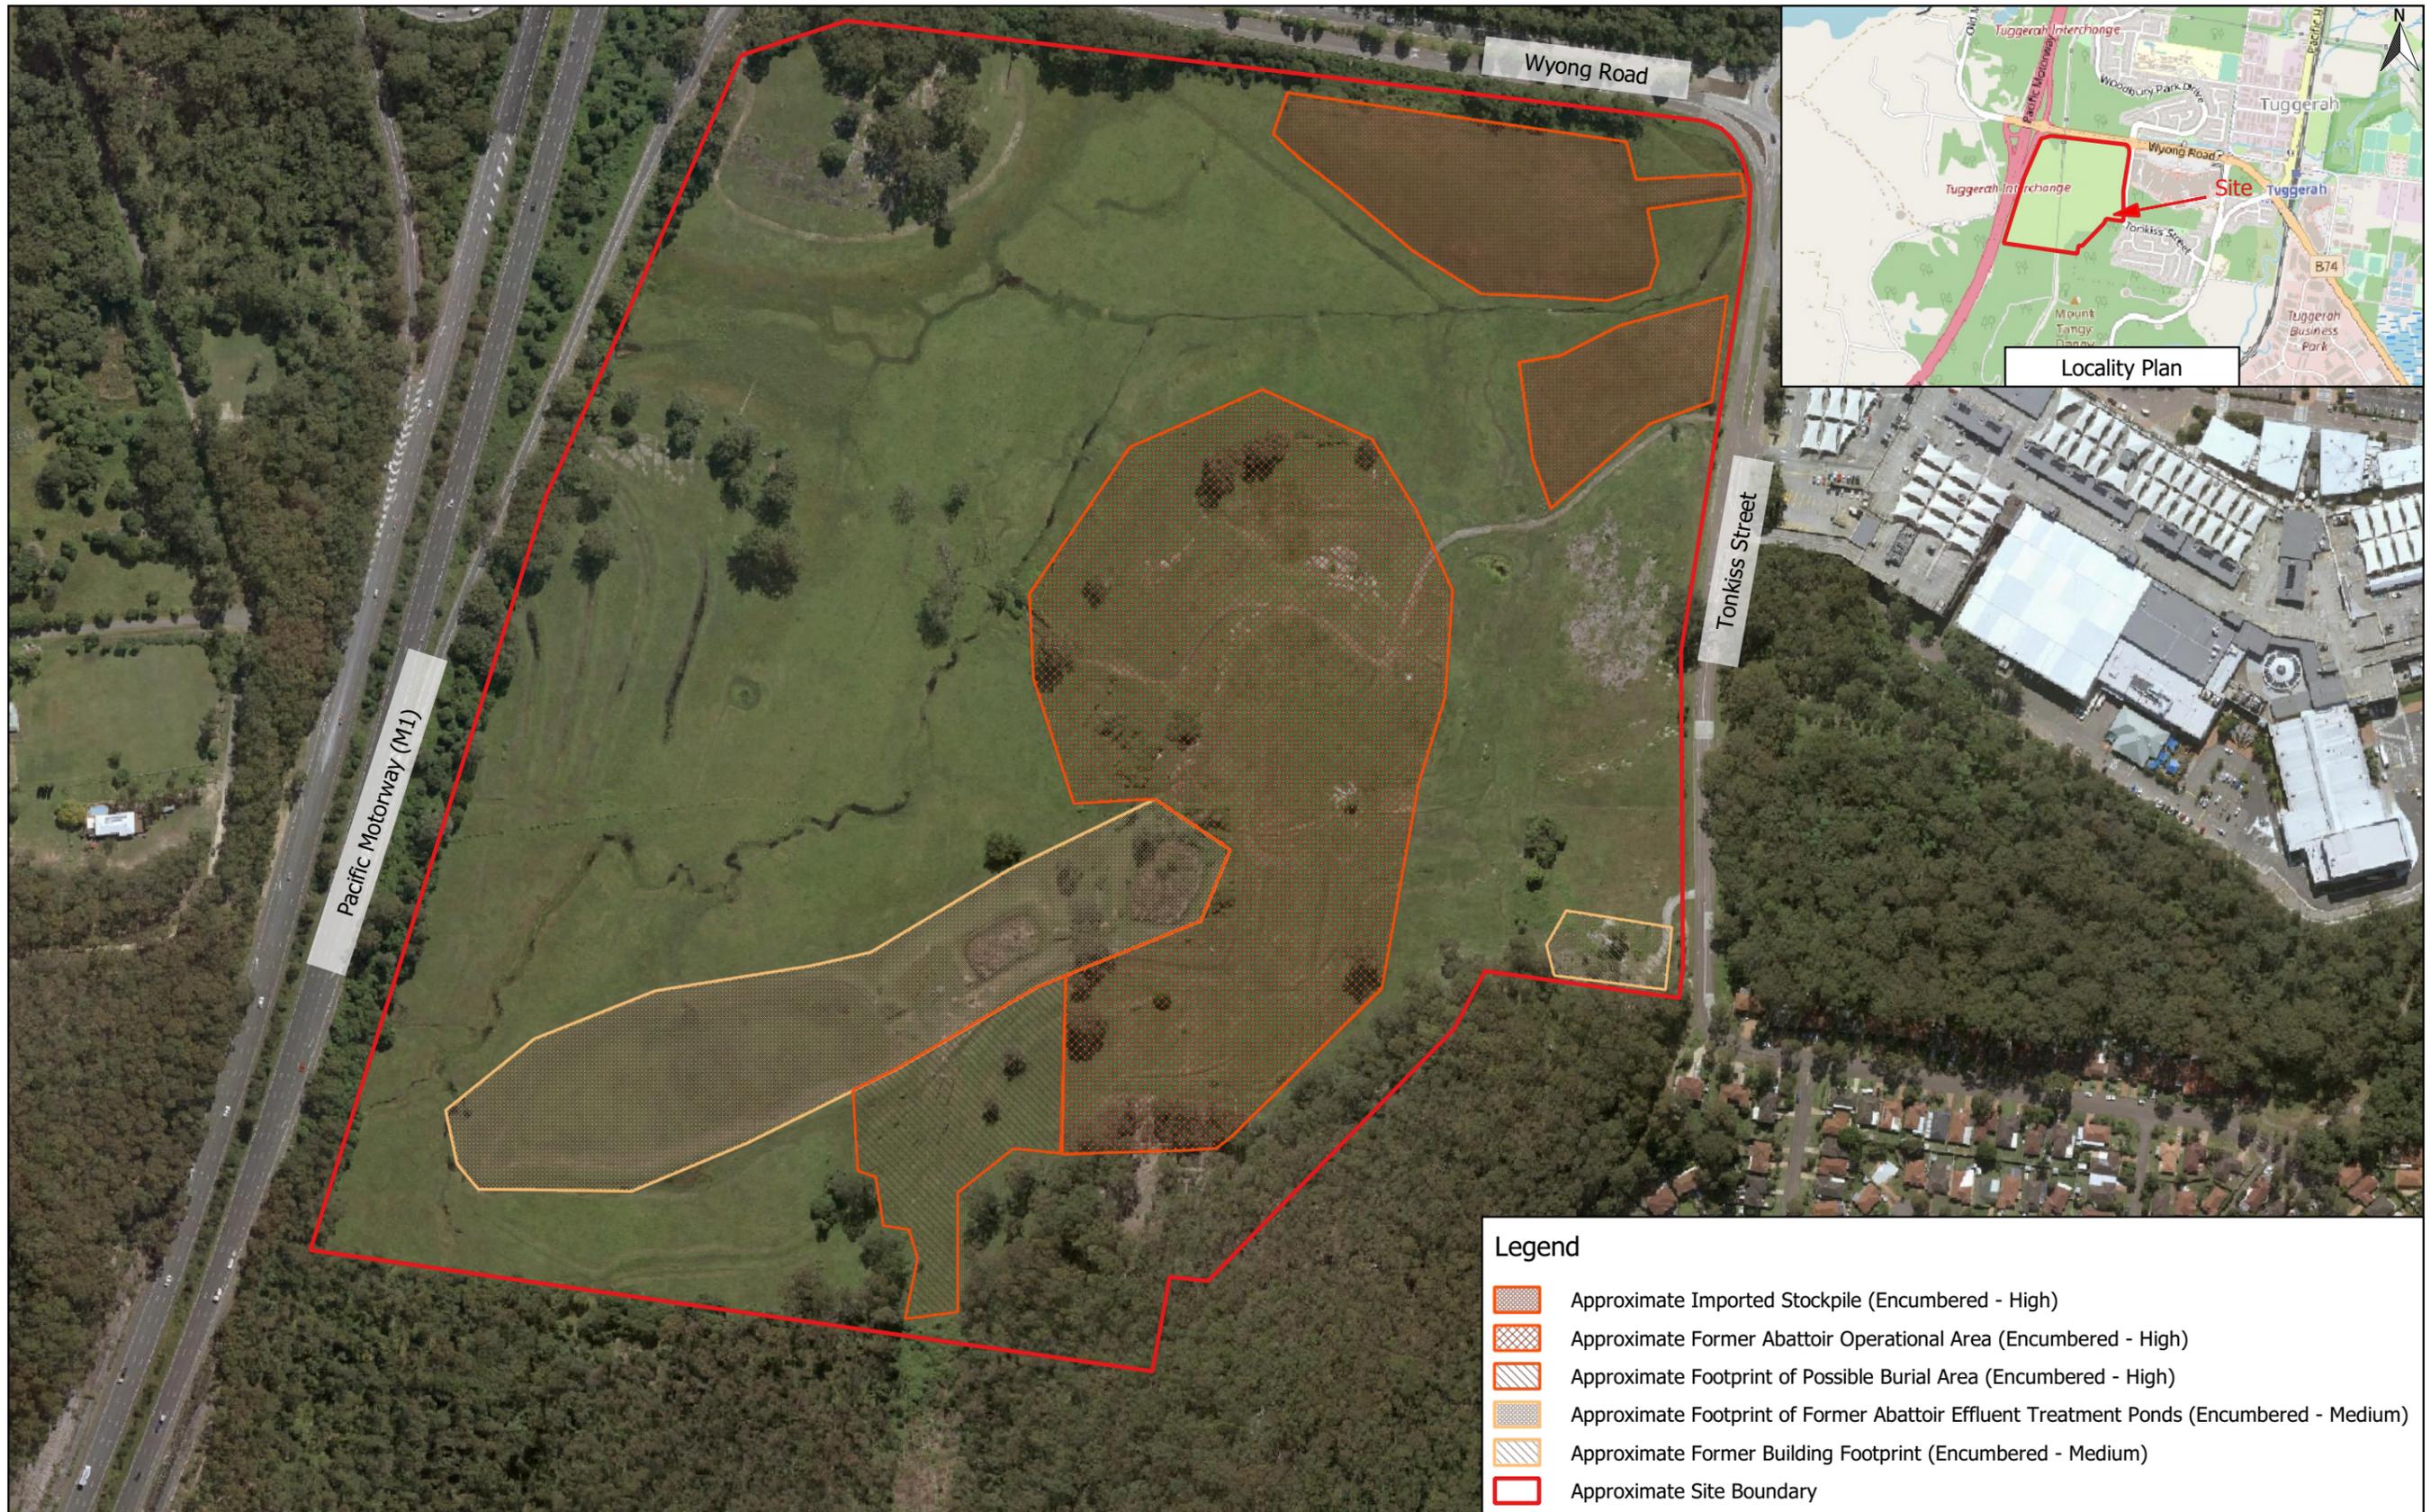
Douglas Partners Pty Ltd (DP) has been engaged by Scentre Limited (Scentre) to complete this preliminary site investigation (contamination) (PSI) for the Tuggerah Gateway Site at 60 Wyong Road, Tuggerah (the site). The site is shown on Drawing 1, Appendix A.

This PSI comprised a desktop review followed by a non-intrusive site walkover. DP considers that there is potential for contamination given the past site activities, past investigation results and the existing site conditions. Potential contamination sources were identified (refer to Table 6 – Section 8). The areas of environmental concern are identified in Drawing 1, Appendix A.

Based on the findings of the desktop review and site walkover, DP considers that there is potential for contamination given the past site activities, past investigation results and the existing site conditions. Potential contamination sources were identified (refer to Table 6 – Section 8). The areas of environmental concern are identified in Drawing 1, Appendix A.

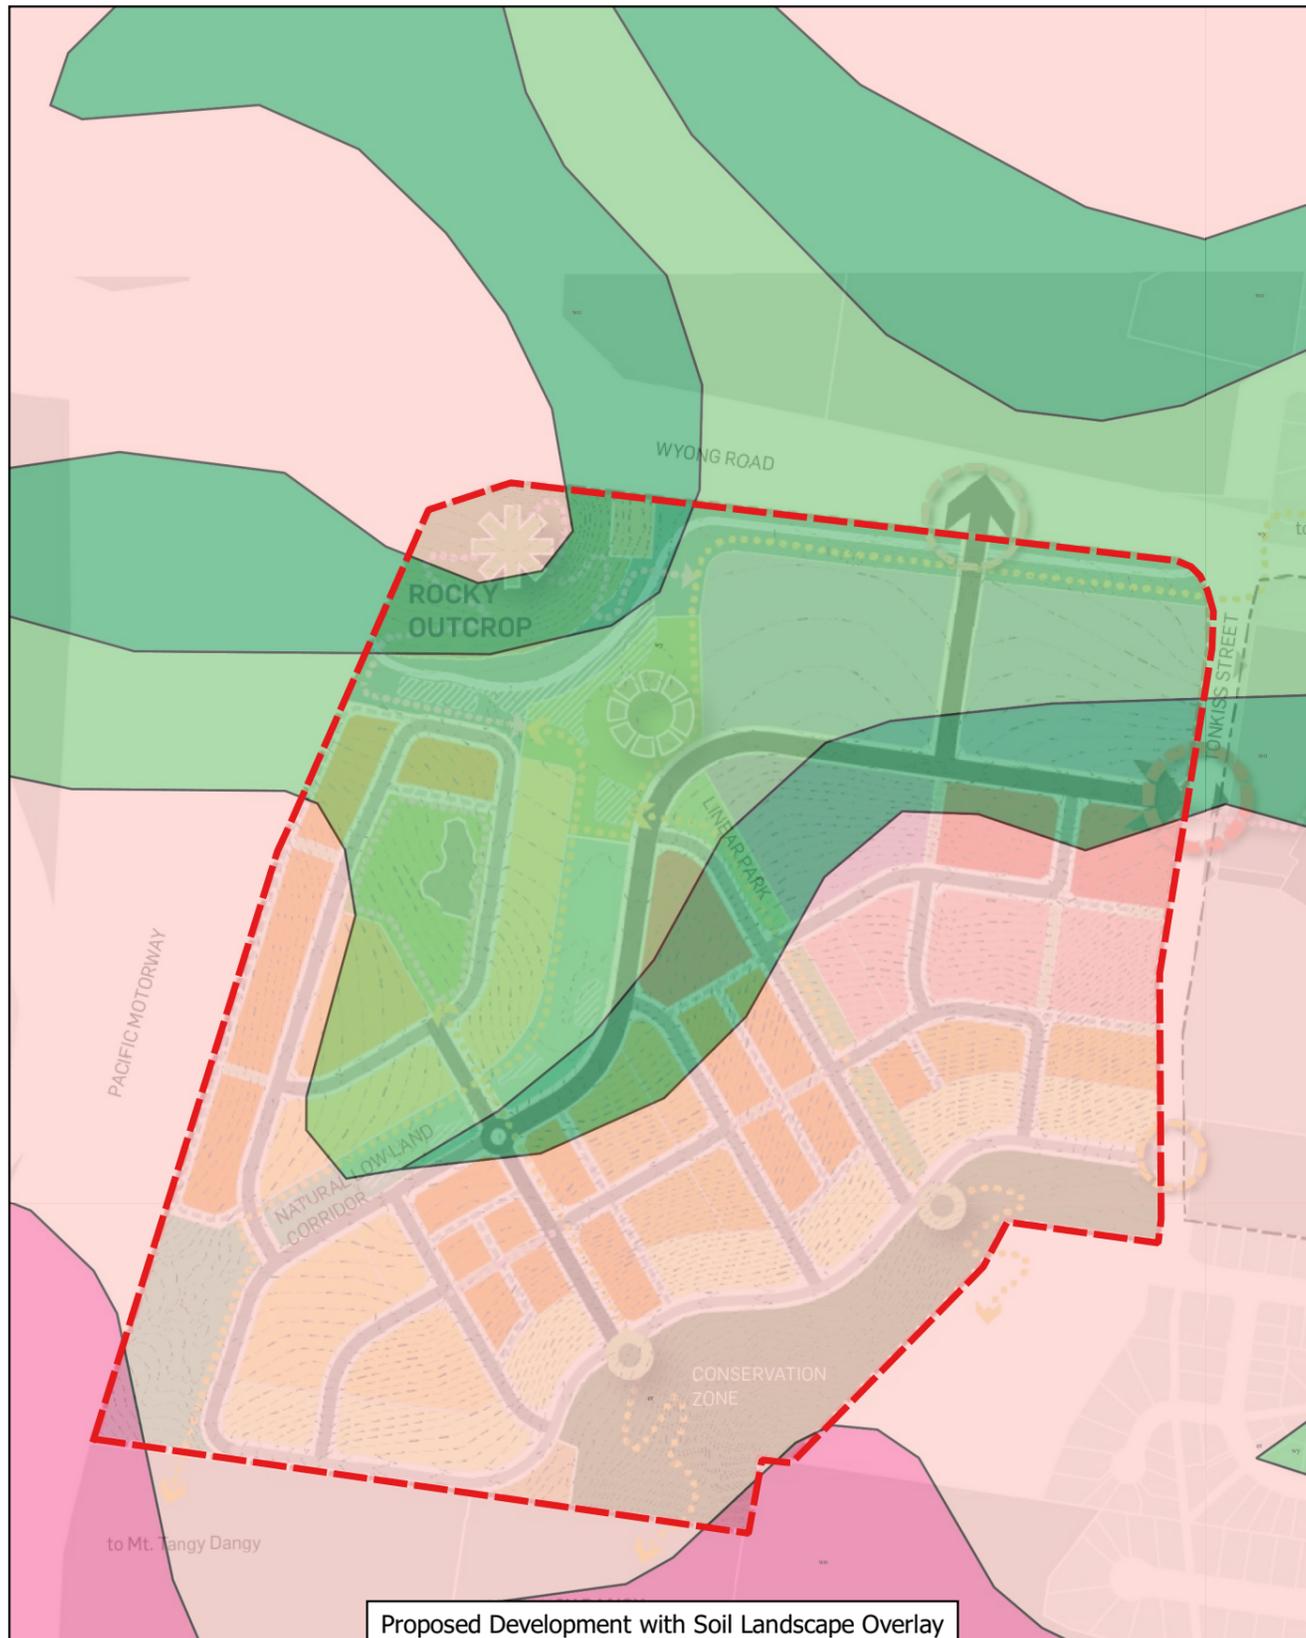
Proposed Development with Soil Landscape Overlay

Drawing adapted from RPT\_TGP\_Structure Plan-210830 and Gosford-Lake Macquarie 1:100,000 Soil Landscapes Sheet

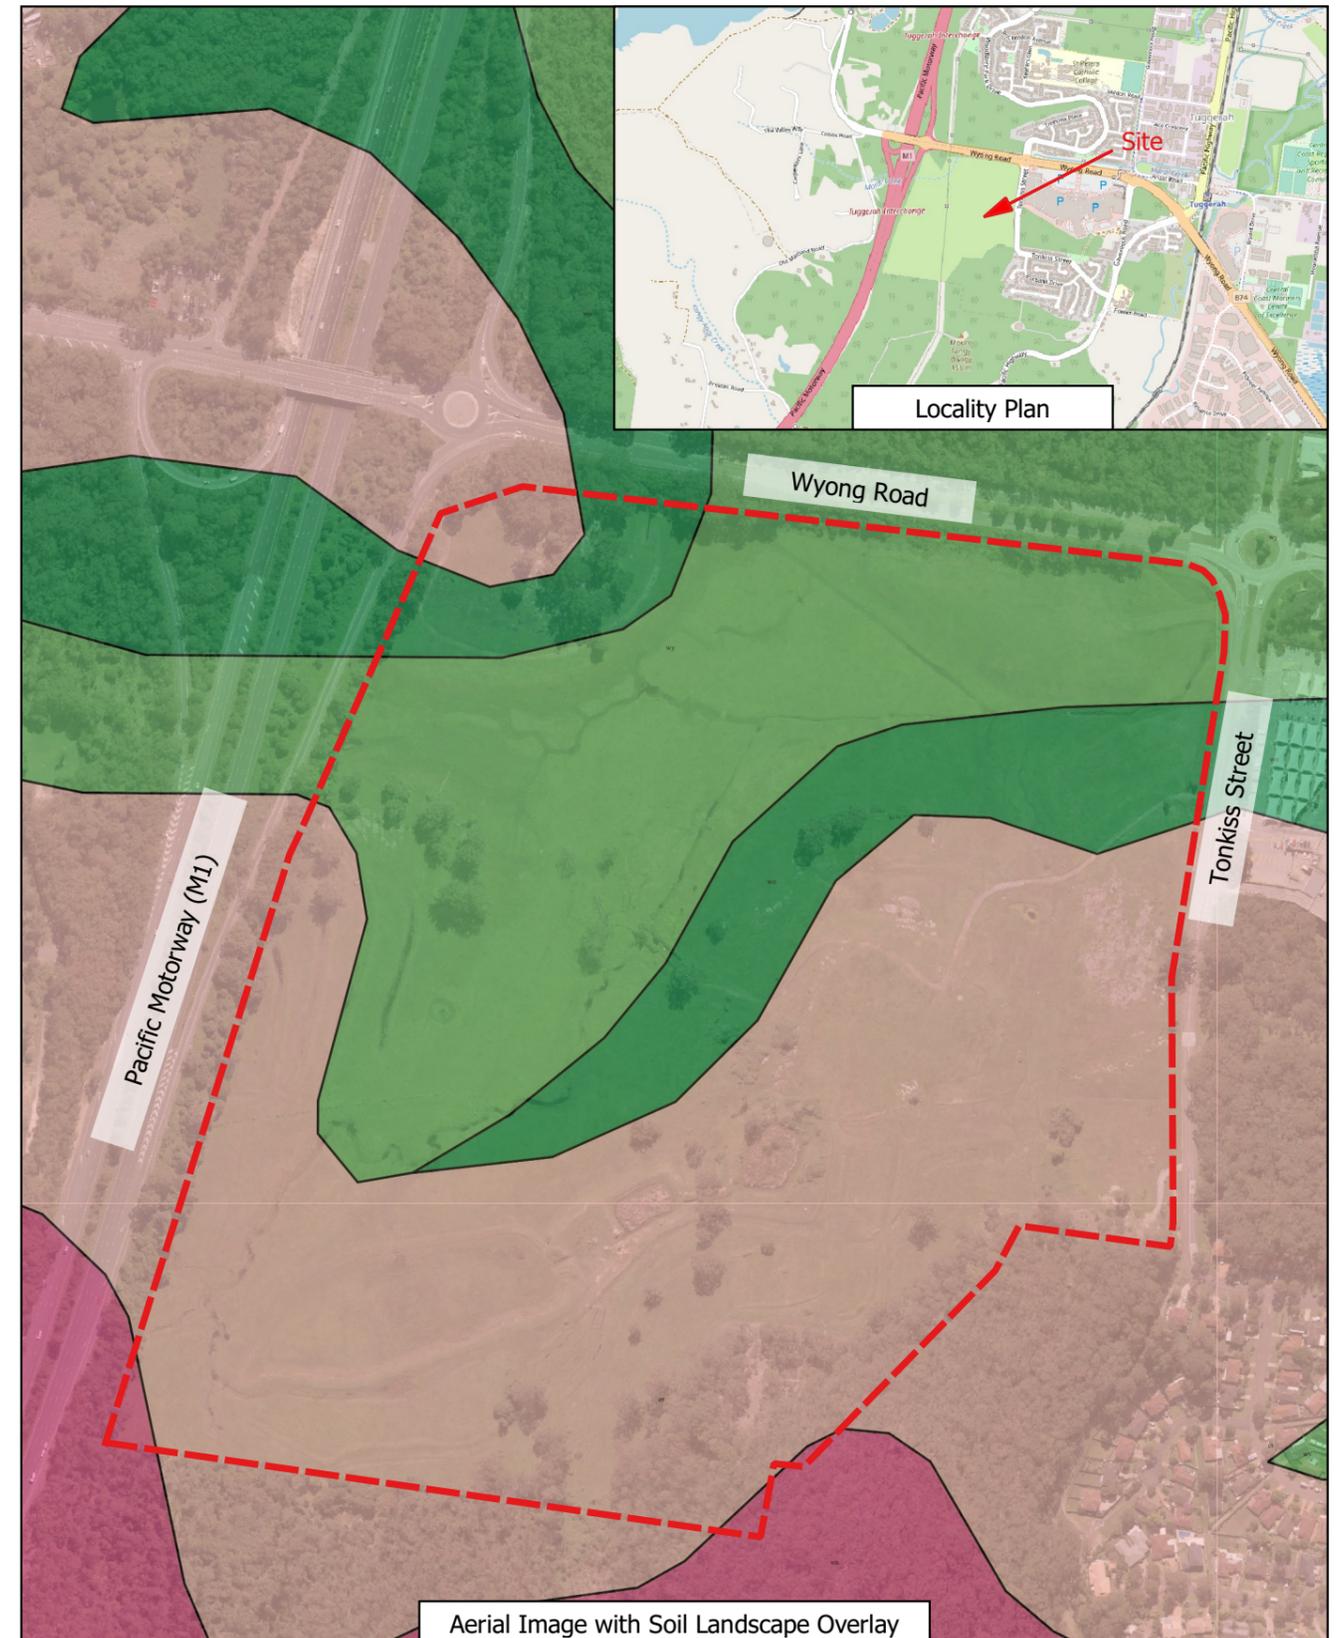
Aerial Image with Soil Landscape Overlay

Drawing adapted from Metromap Image and Gosford-Lake Macquarie 1:100,000 Soil Landscapes Sheet

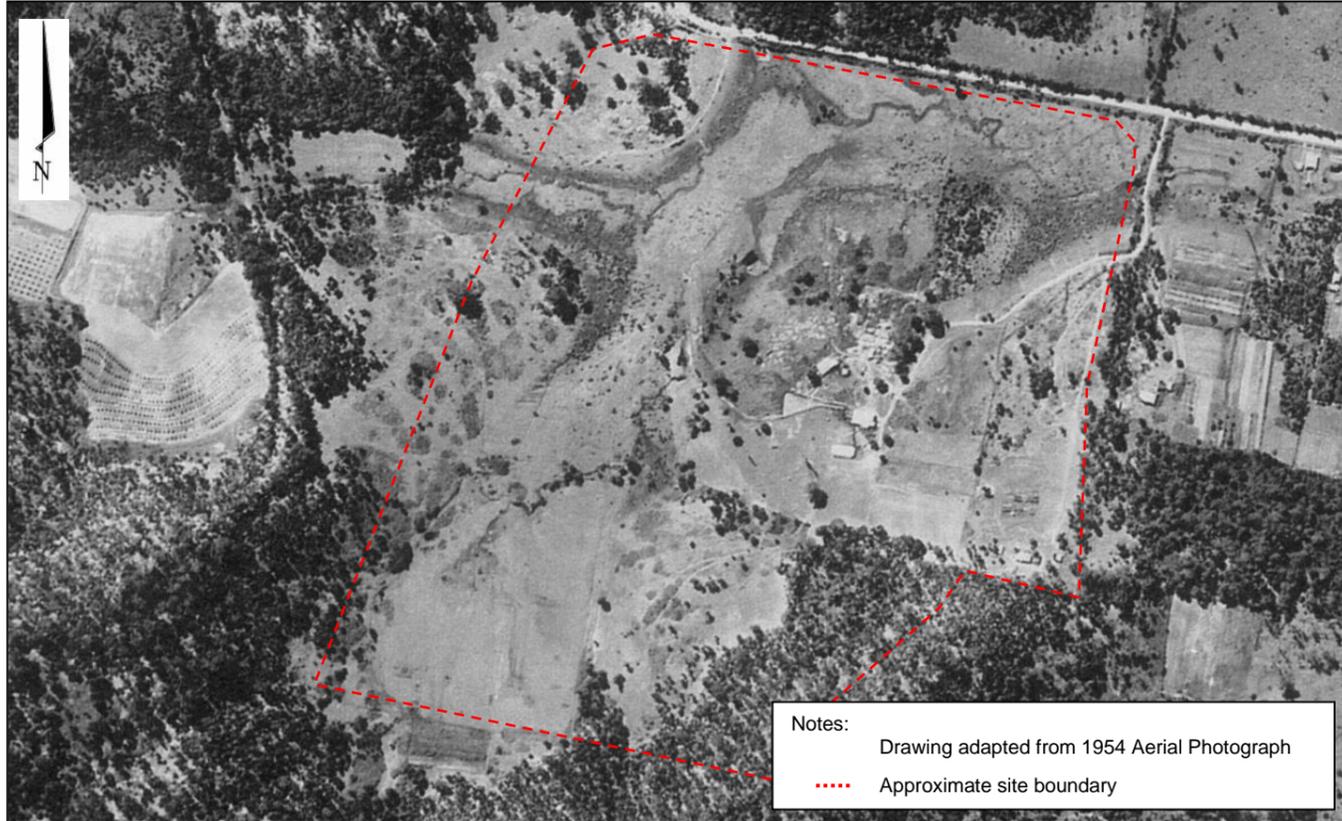
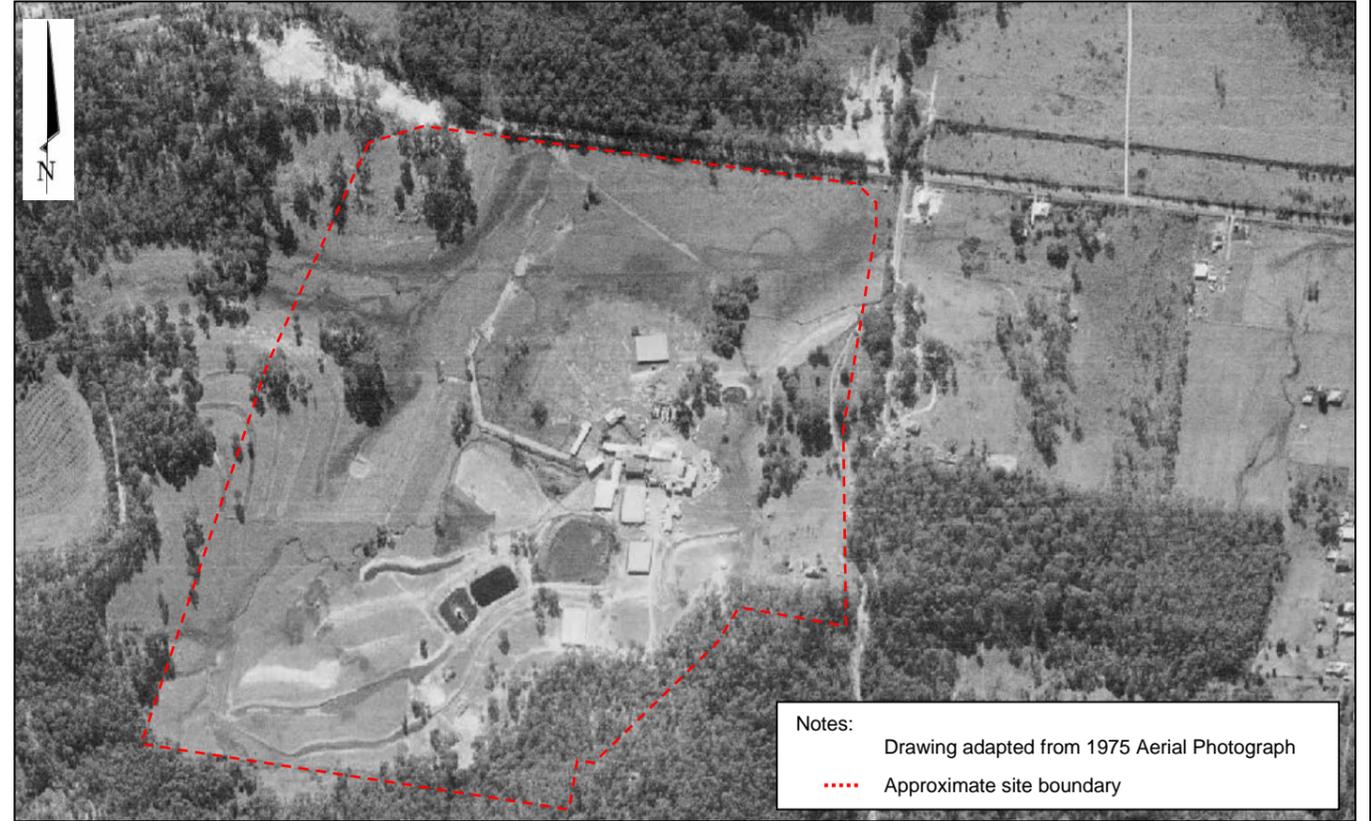
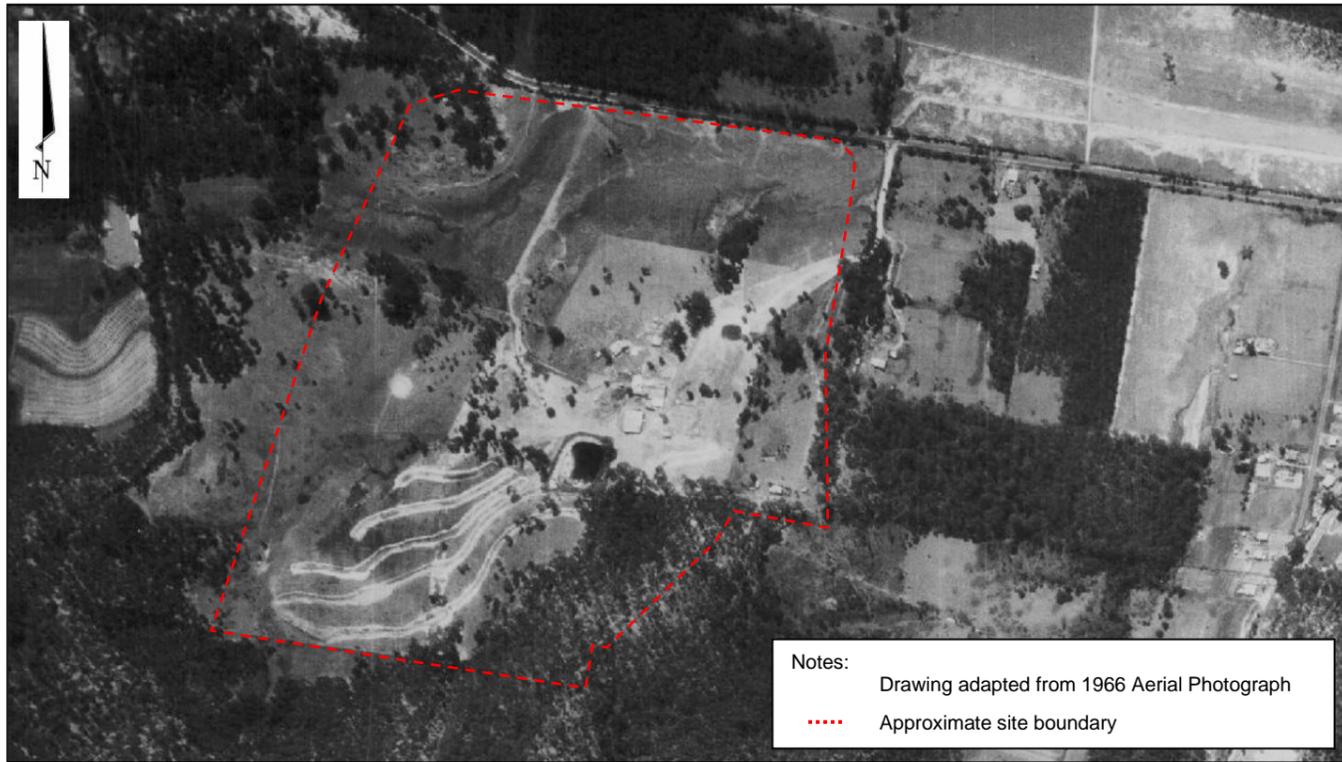
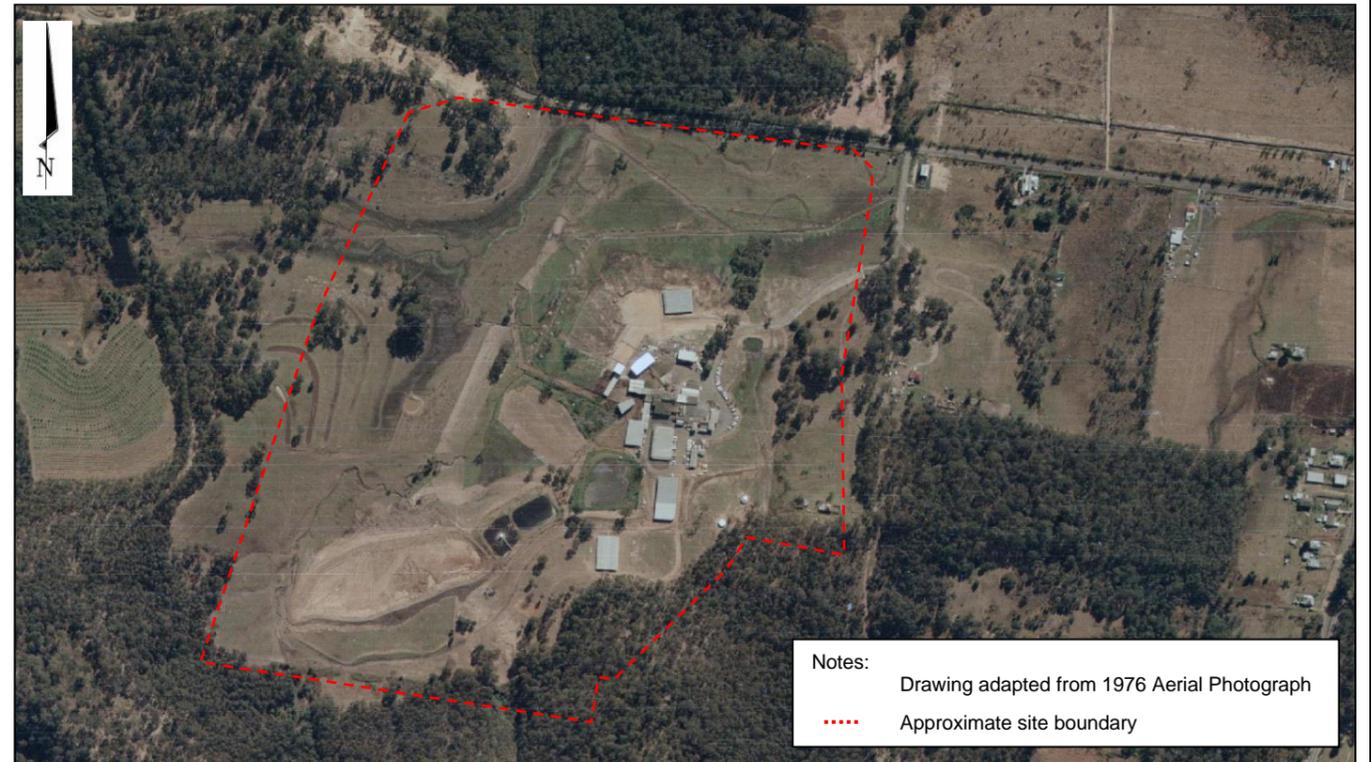
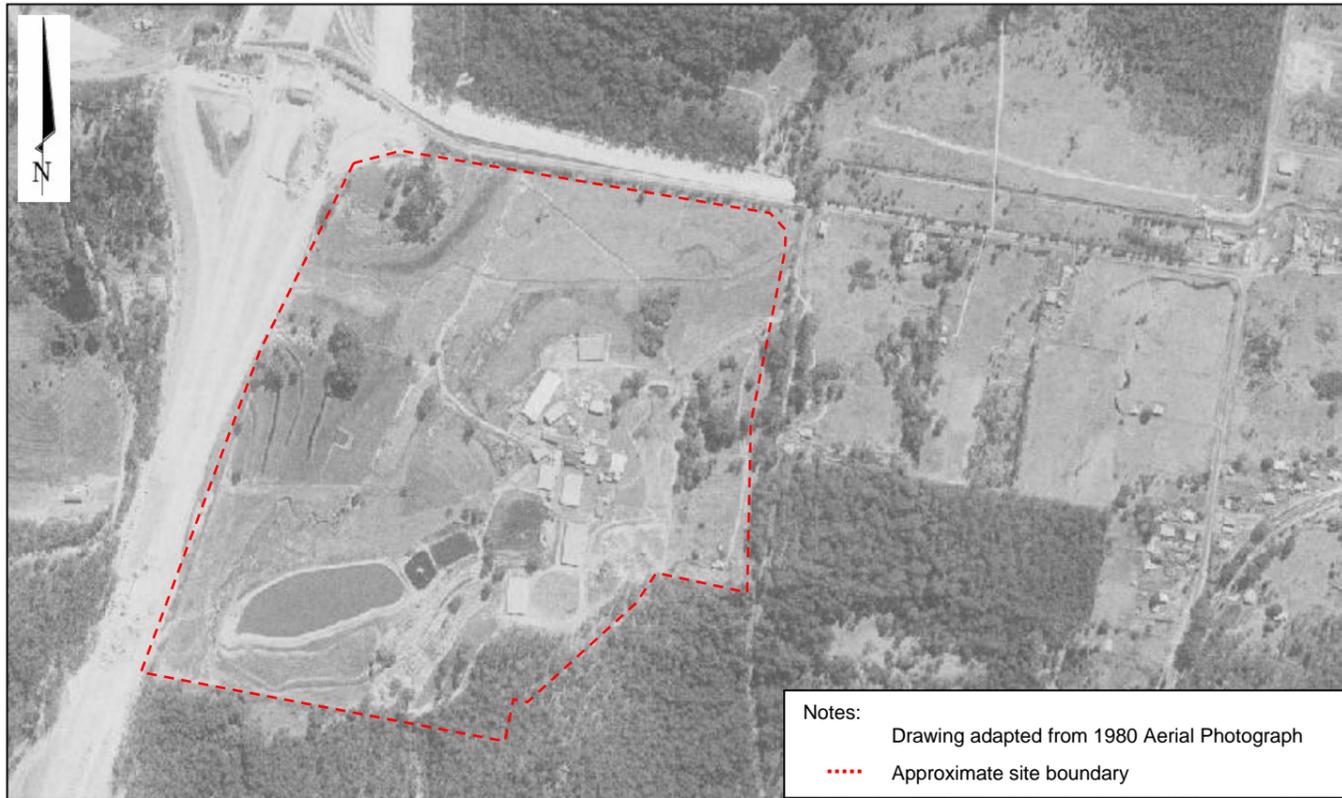
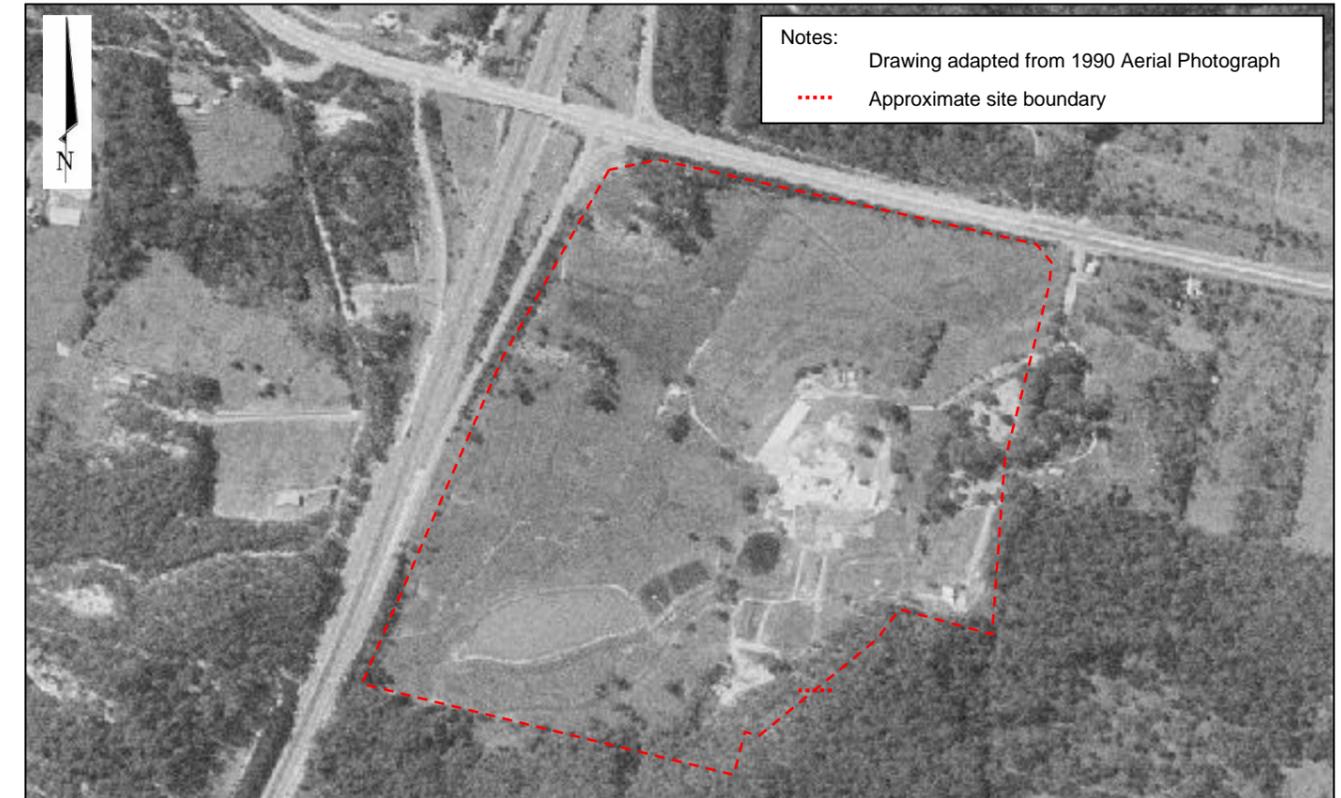
TITLE: **Historical Aerial Photographs**  
**Detailed Site Investigation (Contamination)**  
**Tuggerah Gateway Site**

Several historical aerial photographs were obtained from public databases and licenced sources (i.e. metromap.com.au). Extracts of the aerial photographs are included in Appendix C. A summary of key features observed for the site and surrounding land is presented in Table 4.

1966	<p>Abattoir operations appeared to have expanded, with some additional and larger buildings observed. Three dams were now visible, and the south-west portion of the site appeared to have been recontoured (possible series of trenches and mounds) to potentially control surface water runoff. No other significant changes were observed.</p>	<p>No significant changes were observed, other than a general decrease in intensive agricultural activities at nearby properties. Immediate surrounding properties appeared to comprise either bushland or a rural grazing usage.</p>
1975	<p>Abattoir operations appeared to have further expanded, with some additional and larger buildings observed. Some additional recontouring of surface levels in the southern and south-western areas were visible. Three new dams (suspected waste treatment ponds) were constructed or appeared to be under construction in the south-west portion of the site.</p>	<p>No significant changes were observed.</p>

1976	<p>No significant changes were observed, other than construction of the south-western most pond had continued. It is suspected that new construction works (i.e. a few new buildings/extensions) had resulted in excavated materials being regraded across the site (i.e. drainage depressions being infilled and some levelling of working areas) based on visible disturbance of surface vegetation.</p>	<p>No significant changes were observed.</p>
1980	<p>No significant changes were observed, other than some additional buildings associated with the abattoir had been constructed.</p>	<p>Pacific Motorway and Wyong Road appeared to be under construction or being upgraded.</p>

Year	Site	Surrounding Land Use
1985	No significant changes were observed, other than some additional buildings associated with the abattoir had been constructed.	Construction works associated with the Pacific Motorway and Wyong Road appeared to be completed. No intensive agricultural uses were evident on the surrounding properties.
1990	Abattoir operations appeared to have ceased and most/all of the buildings associated with the abattoir appeared to have been demolished. The building (suspected caretaker's house) located in the south-east corner was noted to have remained intact.	No significant changes were observed.
1994	All of the buildings associated with the abattoir had been demolished, and the area appeared to have a grass surface cover. The dams/ponds associated with the former abattoir appear to be largely intact. Suspected fill appears to have been imported to the north-east portion of the site most likely from the neighbouring Westfield Tuggerah Shopping Centre site (noted to be under construction at the time).	Westfield Tuggerah Shopping Centre and residential subdivisions appeared to be under construction to the east, north-east and south-east (respectively).

2004	No significant changes were observed. Close inspection of the aerial image identified a series of possible infilled trenches (darker strips) located centrally along the southern boundary. These features may suggest the presence of previous animal burial pits or other wastes.	No significant changes were observed.
2007	No significant changes were observed.	No significant changes were observed, other than Tonkiss Street had now been constructed adjacent to the eastern site boundary.
2016	No significant changes were observed, other than an area of trees positioned centrally along the eastern boundary had been removed and surface vegetation disturbed.	No significant changes were observed.
2019	No significant changes were observed, other than the suspected caretaker's house appeared to have been demolished, although some remnant materials or stockpiles were visible.	No significant changes were observed.

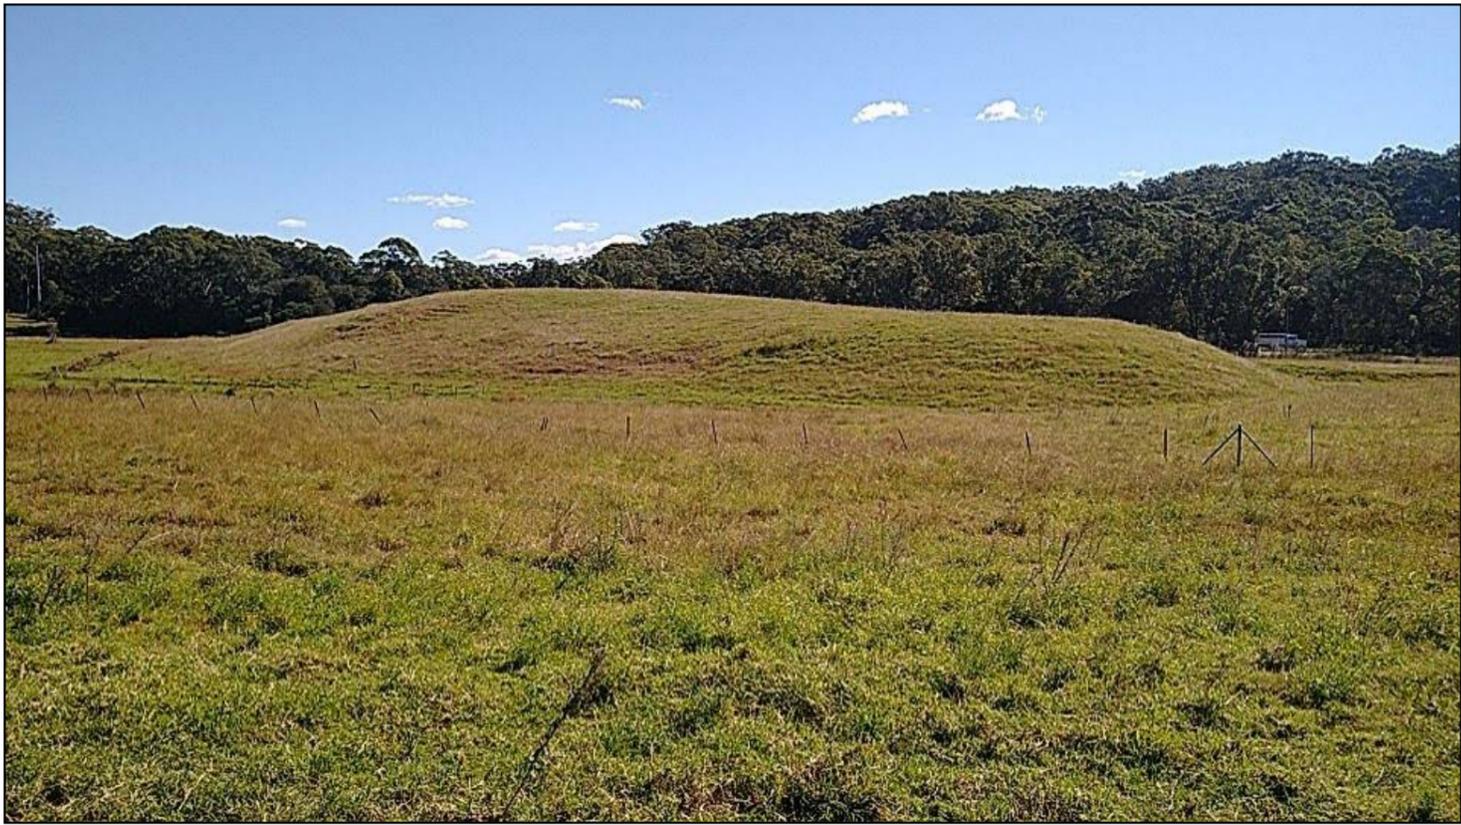
**Photo (1)**

Area / Issue	Location	Observations
Large Stockpiles	North-east portion of the site	<p>A large grass covered stockpile was observed within the north-east corner the site (refer to Photo 1). The stockpile was estimated to be up to 10 m high with dimensions of approximately 225 m by 70 m. Walkover did not identify any anthropogenic materials at the surface of the stockpile (noting that grass surface cover prevented adequate visual inspection). A second large stockpile was observed to the south of largest stockpile (refer to Photo 9). The stockpile was estimated to be up to 3 m high with dimensions of approximately 130 m by 50 m. Walkover identified concrete and steel at the surface of the stockpile (noting that the grass surface cover prevented adequate visual inspection).</p> <p>Several other smaller stockpiles/mounds of suspected soils were identified at the site. These piles had a grass surface cover that prevented adequate visual inspection.</p>
