## **Stormwater Assessment to Support Planning Proposal**

**148 Gaudrons Road Sapphire Beach, Lot 7 DP555490**

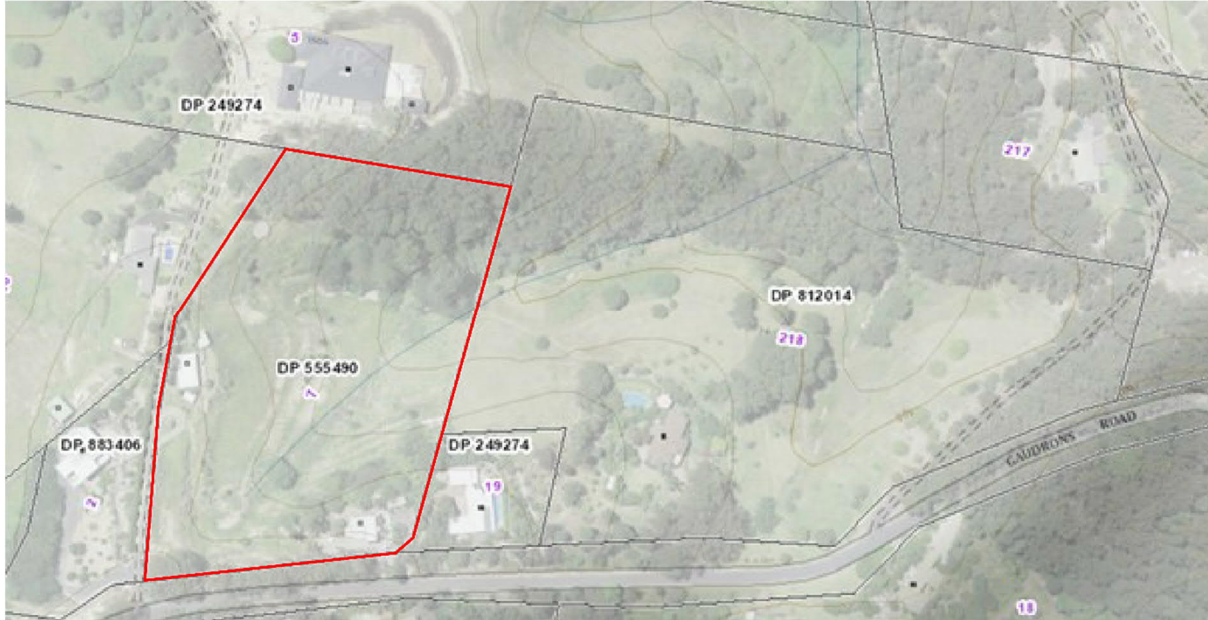
The site is located on the Northern side of Gaudrons road. The approximate site area is 2.05 hectares and is traversed by a natural drainage gully running in a North-East direction. The natural drainage gully continues through the adjoining property (Lot 218 DP812014) for approximately 180m before joining another natural watercourse. The drainage line is steeply graded and falls approximately 60m in level over 310m of length. Side slopes are in the order of 30% to 35%. The subject site and downstream lot are shown in figure 1.

Figure 1 – Subject site and adjoining lots (source Six Maps)

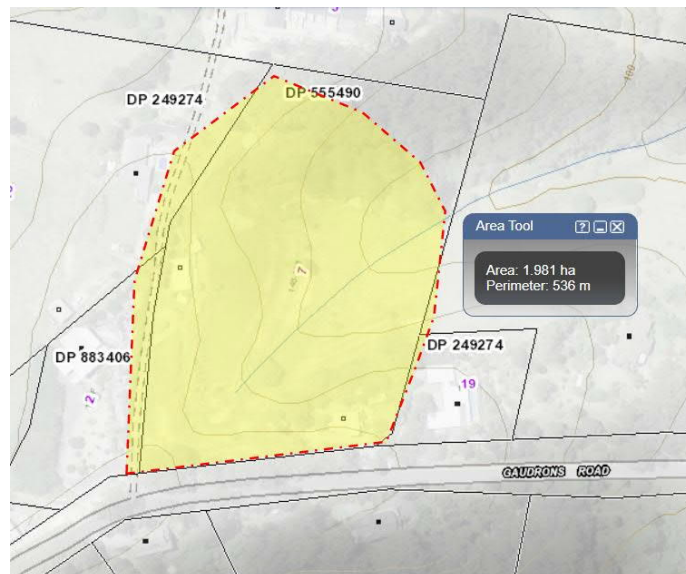
The catchment is primarily small lot Rural Residential landuse, and extends to Gaudrons Road to the South, and is confined by a ridge to the west on adjoining Lots. The catchment area was estimated using topographic maps, resulting in a measured approximate catchment area of 2 hectares. The catchment is shown below in figure 2.

Figure 2 – Estimated Catchment Area (source Six Maps)

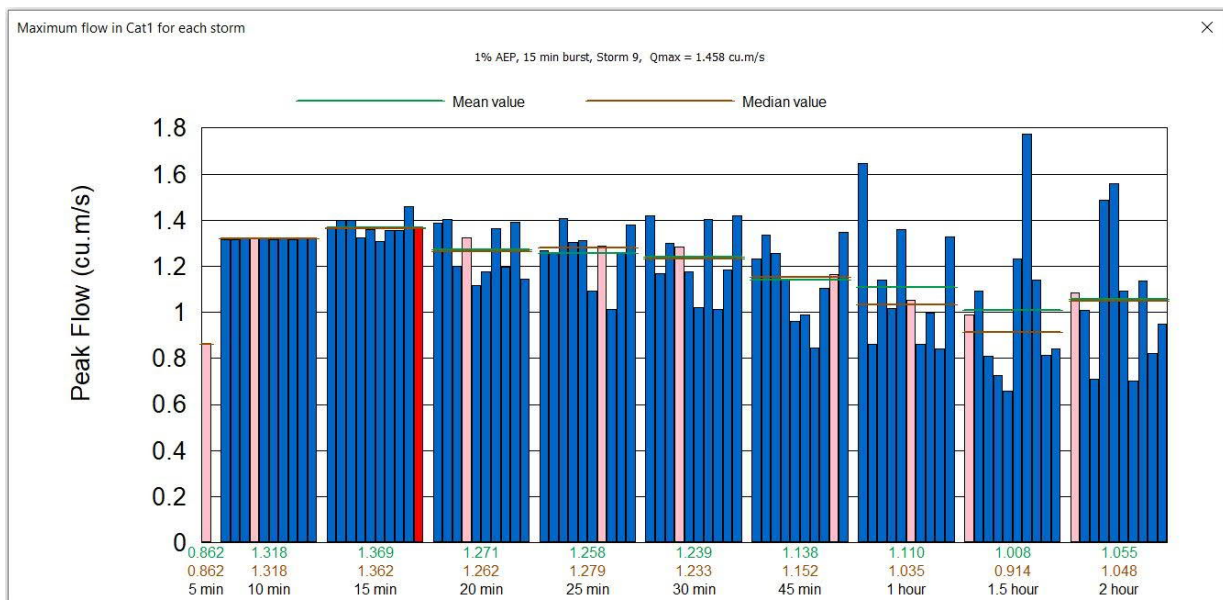
The peak mean flow of 1.369m<sup>3</sup>/s for the 1% AEP event at the catchment outlet occurs during the 15 minute storm burst. Results for the full ensemble of storms modelled is included in Figure 3.

Figure 3 – DRAINS results

ARR2019 specifies that an ensemble of 10 patterns are to be calculated for every duration, with the design peak flow taken as the average of the 10 patterns. ARR2019 data was accessed from the associated Datahub website including ARR2019 Storms, Rainfall Ensembles, and Preburst Rainfall. DRAINS software was used to simulate the catchment with an Initial Loss (IL) Continuing Loss (CL) Model. A summary of the adopted modelling parameters is provided below:

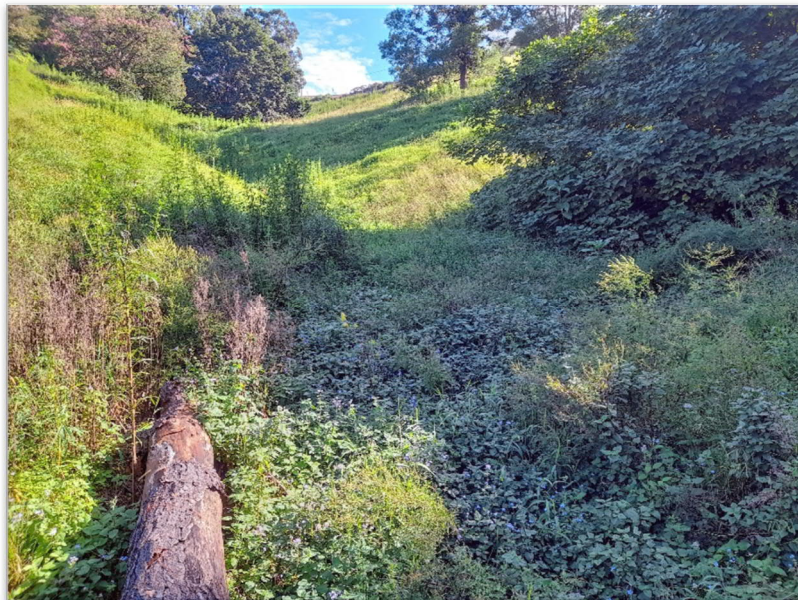
The site was inspected on 9th April 2021. A photo looking up the existing gully from the eastern side of the property is included in figure 3 below. The channel is well defined and widens as the gully flattens out towards the eastern boundary of the site. Any restrictions on future development due to flooding potential would be limited to the defined channel and banks.

*Figure 3 – Existing Gully (looking South-West from Eastern boundary)*

The natural drainage line that traverses the site does not significantly constrain the site for the proposed density of minimum 1 hectare lots.

- take into consideration the location of the existing drainage gully
- site any structures clear of the defined channel and banks
- be designed to limit the consequences for downstream properties.
