# Preliminary Acid Sulfate Soil Assessment - 9 Gaudrons Road, Sapphire Beach

26 November 2020

Ref	Ver	Date	Distribution
2021-71-03	A	26/11/20	Client

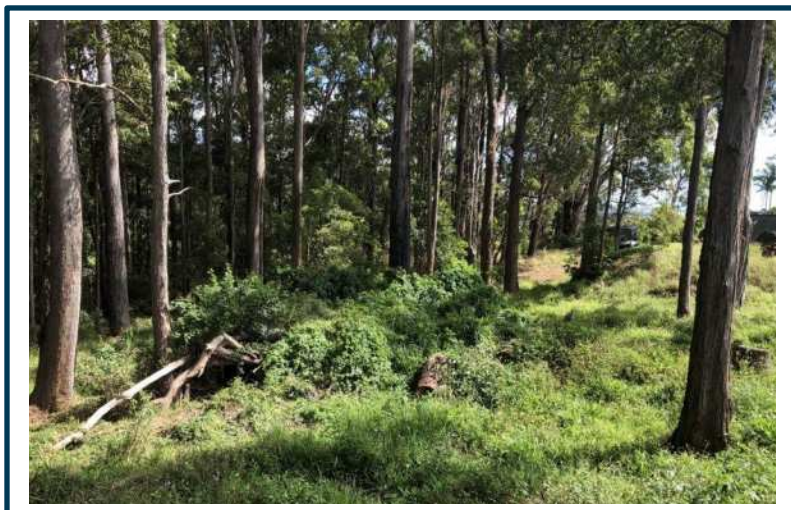
**Photograph 3.** Looking northwest across existing forest along western boundary.

The Site is mainly cleared and used for banana and fig tree production. Relic forest is present along the western boundary (Photographs 1-3).

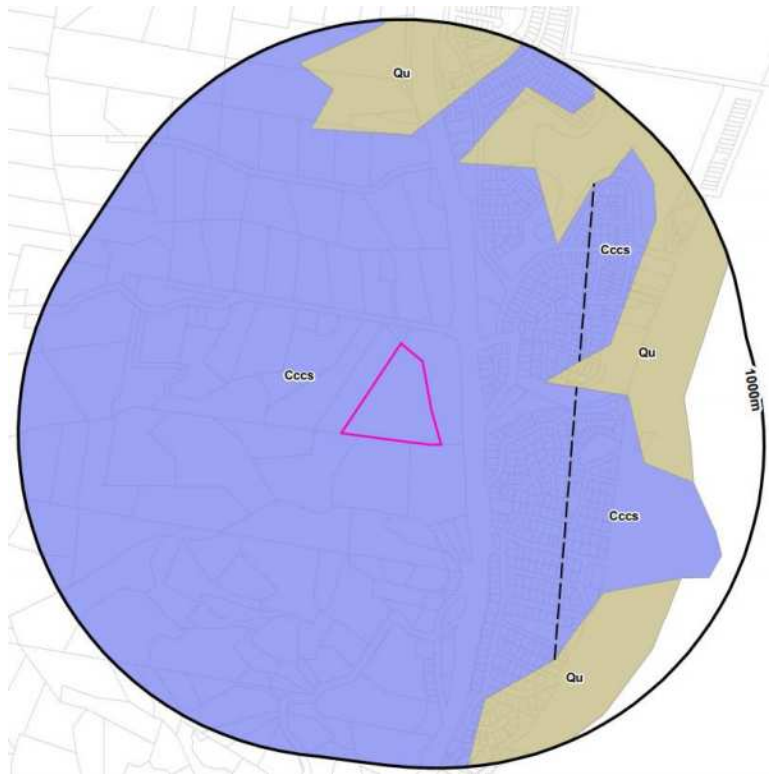
**Photograph 4.** Mapped geological formation and subject property location (magenta).

The Site is underlain by the Coramba beds (Cccs). These are comprised of lithofeldspathic wacke, minor siltstone, mudstone, metabasalt, jasper and rare calcareous siltstone (**Photograph 4**).

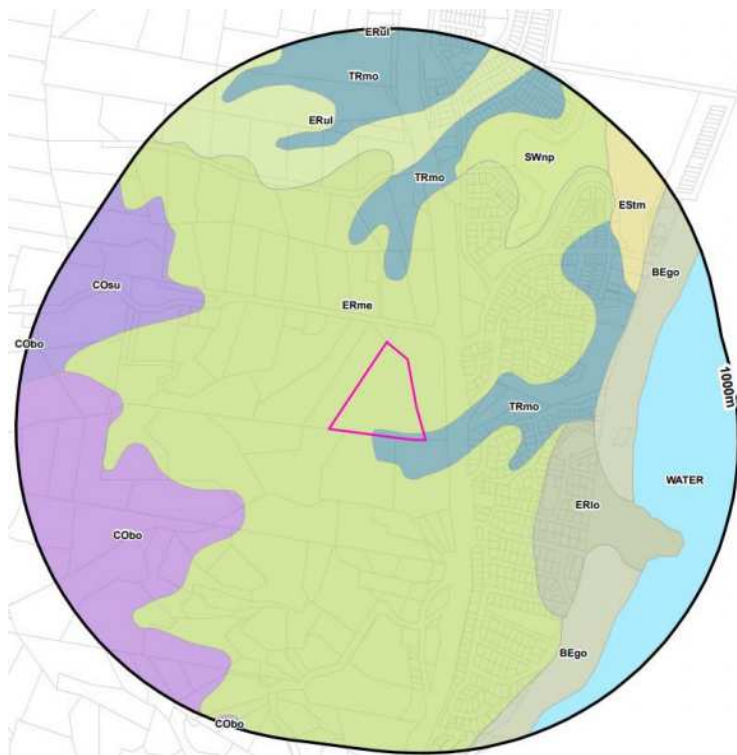
**Photograph 5.** Mapped soil landscape and subject property location (magenta).

We reviewed the Soil Landscapes of the Coffs Harbour 1:100,000 Sheet (Milford, 1999), and the Site is underlain by soils of the Megan soil landscape (ERme). The creek line along the southern boundary contains a narrow band of overlying Moonee Soil Landscape (TRmo) (**Photograph 5**).

The Megan soil landscape is an erosional soil type located on rolling low hills to hills on Late Carboniferous-aged metasediments with local relief up to 90mAHD and 200m AHD. Soils are moderately deep (>100cm), well drained structured red or yellow Earths and podsoles.

The Moonee soil landscape is a transferral soil type located on undulating rises, footslopes and drainage plains with local relief <30mAHD. Soils are moderately deep to deep poorly drained humic gleys.

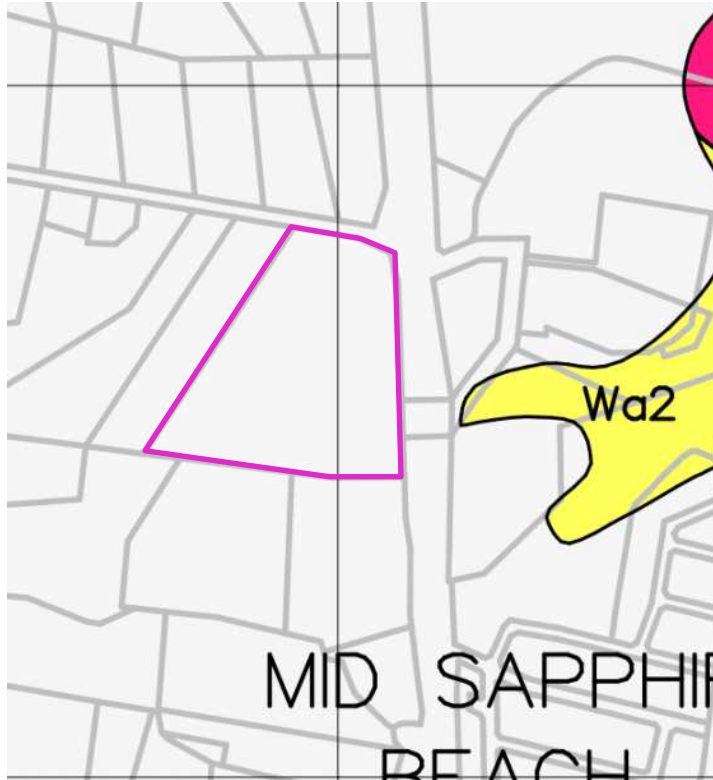
**Photograph 6.** Mapped ASS risk and subject property location (magenta).

The published Moonee Beach 1:25,000 ASS Risk Map indicates that the Site is not underlain by identified potential ASS (**Photograph 6**). The nearest mapped ASS risk is associated with the intermittent gully along the southern boundary and is of low probability (yellow), lacustrine swale and sandplain at 2-4mAHD.

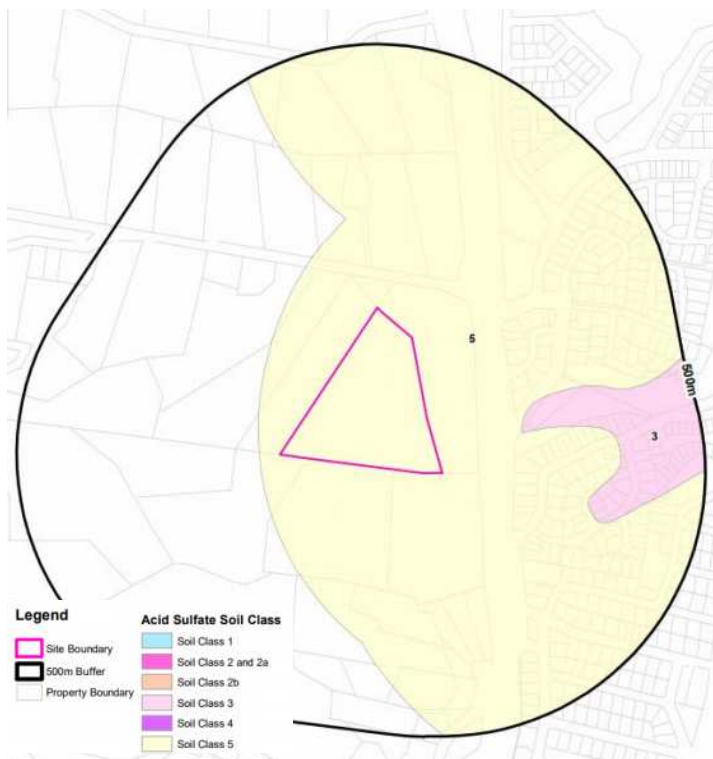
**Photograph 7.** CHCC LEP Mapped ASS classes.

Coffs Harbour City Council Local Environmental Plan (LEP, 2013) and Coffs Harbour City Council Planning and Environment Spatial Maps - ASS layers that are derived from the published ASS risk mapping, indicates that the Site is underlain by mapped “Class 5” ASS risk (**Photograph 6**). Class 5 is a 500m wide buffer zone created around mapped ASS risk soils (also yellow but not to be confused with the yellow of published ASS Risk Mapping). The LEP mapped ASS risk is Class 3.

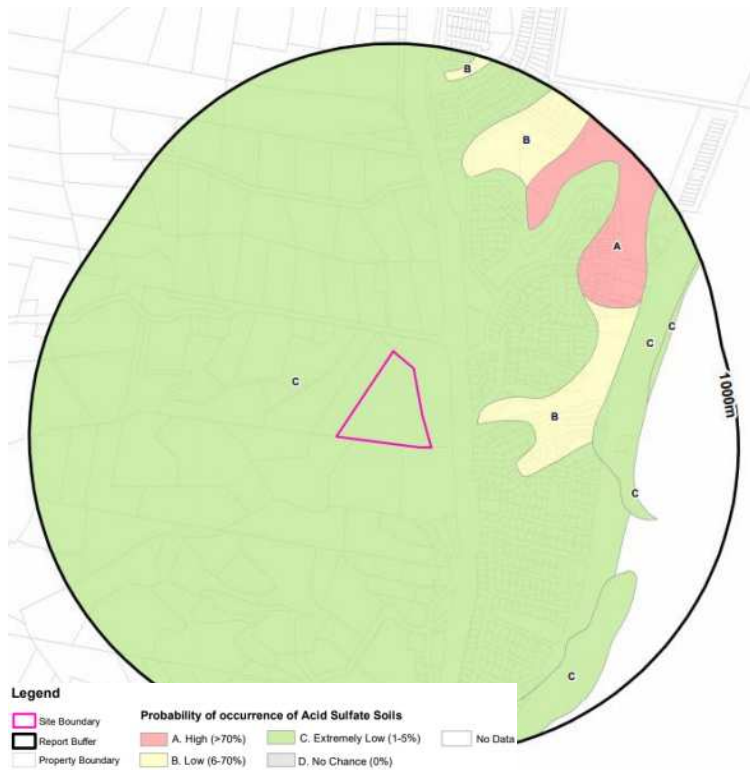
**Photograph 8.** Atlas of Australian Acid Sulfate Soils risk mapping.

The published Australian ASS Atlas lists the entire property and surrounds up to the ridgelines as extremely low risk (1-5%), a general rating for non ASS areas (**Photograph 8**).

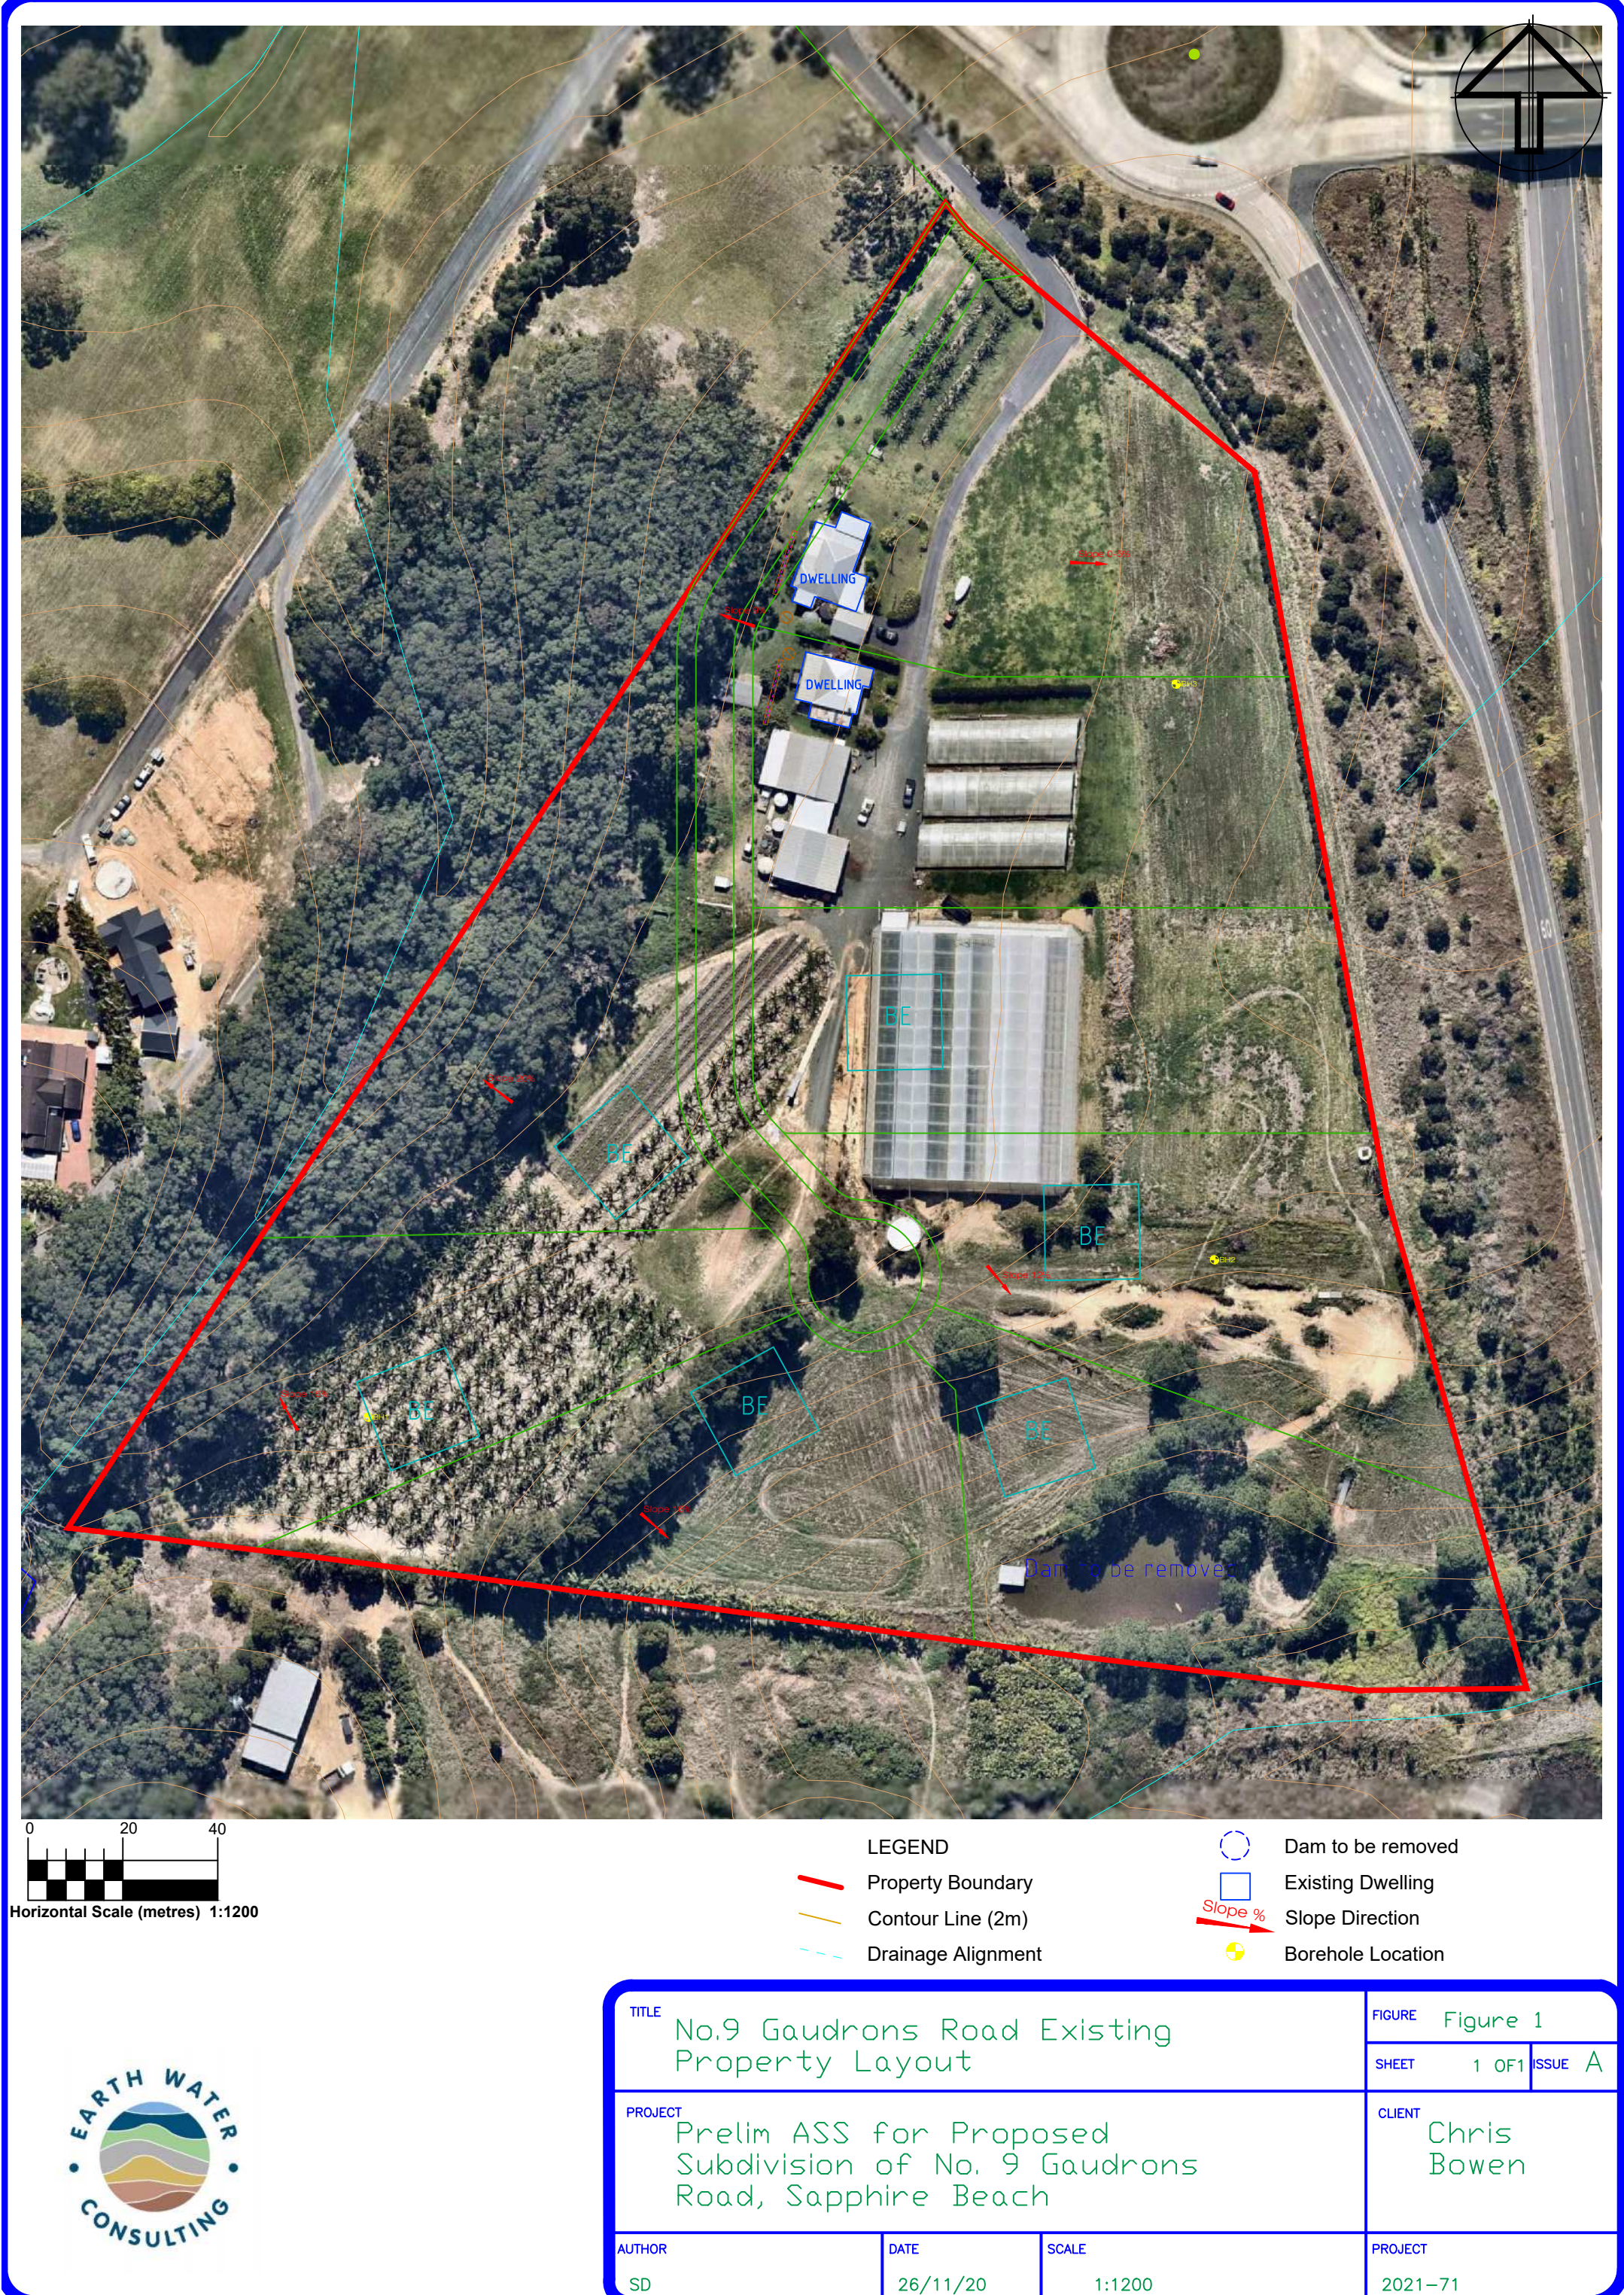
The Site is located at the beginning of Gaudrons Road, and comprises an elevated ridgeline at about 32mAHD that slopes down to the northwest and southeast to two unnamed intermittent gullies along the western and southern boundaries. An existing small farm dam is present in the southeastern corner that will be filled in during subdivision works. The groundsurface in the southeastern corner falls to about 10mAHD.

Site soils were observed by drilling three (3) boreholes (BH1-BH3) across the Site to a maximum depth of 1.2m using a hand auger. The location of the boreholes are shown in Figure 1 and a copy of the borehole logs are presented in Appendix A.

TITLE No.9 Gaudrons Road Existing Property Layout			FIGURE Figure 1	
PROJECT Prelim ASS for Proposed Subdivision of No. 9 Gaudrons Road, Sapphire Beach			SHEET 1 OF 1	ISSUE A
AUTHOR SD	DATE 26/11/20	SCALE 1:1200	CLIENT Chris Bowen	
			PROJECT 2021-71
