PRELIMINARY SITE INVESTIGATION

PROPOSED REZONING & SUBDIVISION

Lot 16 DP 856265
225 Terranora Road
Banora Point NSW

HMC2023.305

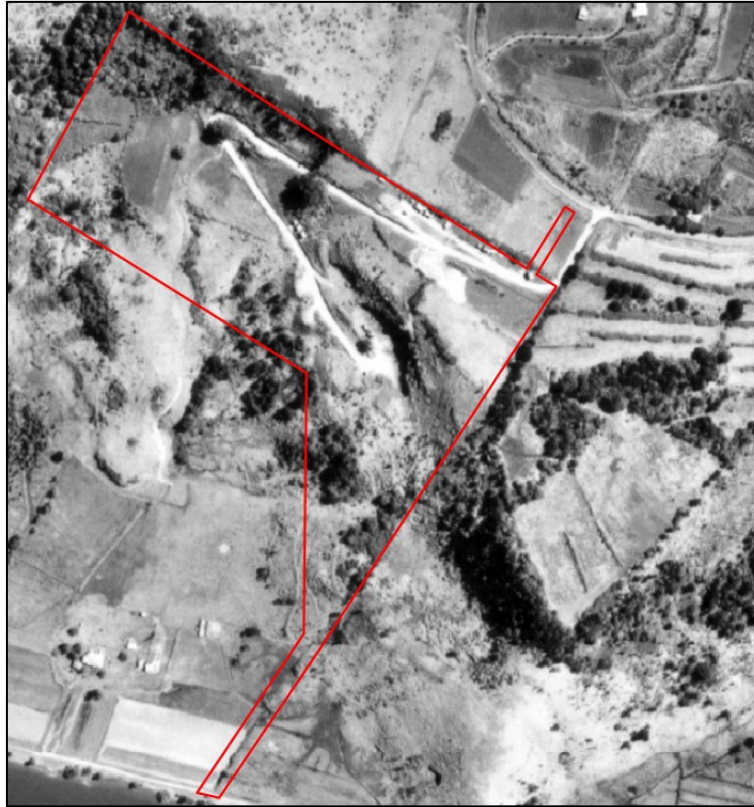
Figure 7 - Historical Aerial 1962 (TSC GIS)

Year	Source	Comments	Areas of Potential Concern Yes/No
1962	Tweed Shire Council GIS	Roads and excavation occurring majorly throughout northern portion of proposed site.	Yes
1970		Similar to 1962 with most of site excavated. No structures visible.	
1976		Similar to 1970, aerial not great quality.	
1987		Similar to 1976, quarry activities appear to be finished, vegetation present throughout northern portion of proposed site. Structures now visible to the north of proposed site	
1996		Site appears to have been filled with pasture grass established throughout disturbed site location.	
2003	Google Earth	Structure now visible to the north-eastern portion of proposed site.	
2009		Similar to 2003, heavily vegetated areas surrounding previously disturbed land in the northern portion of the proposed site.	
2012		Similar to 2009. Second structure now visible lying approximately 100m from the southern boundary.

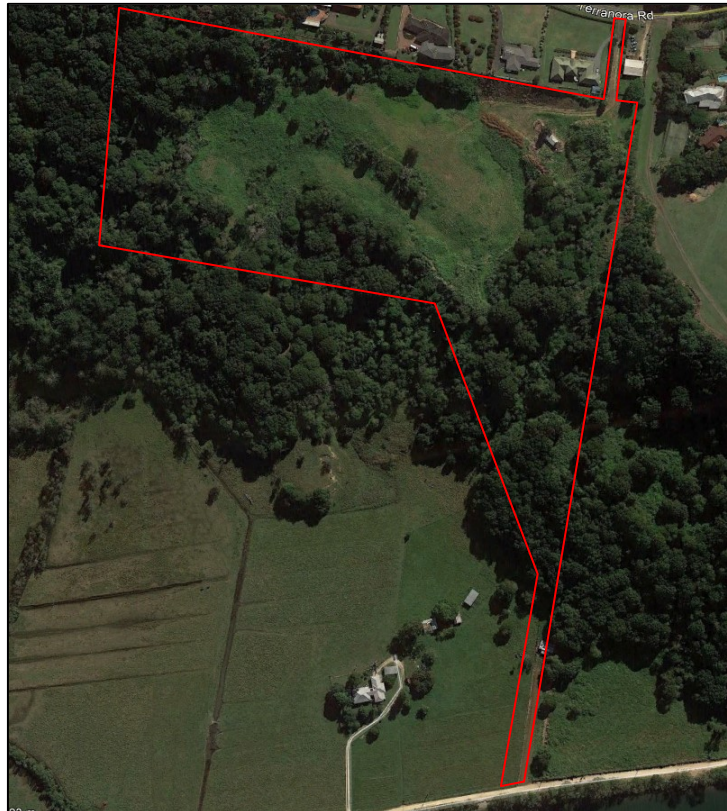
Figure 13 – Historic Aerial 2016 (TSC GIS)

2016-2017		Similar to 2012. Fill can be seen dumped in the north-eastern portion of the proposed site.	
2022	Nearmap	The property appears to be generally covered in grass with scattered vegetation. No intensive land uses noted.

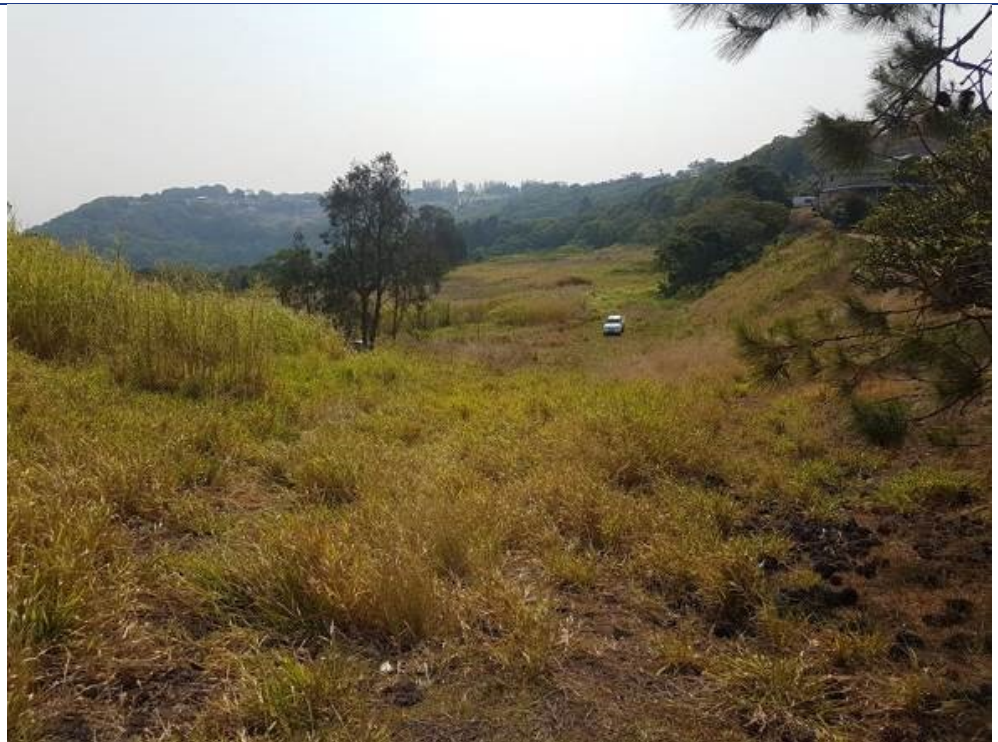
Description:

View west downslope across site.

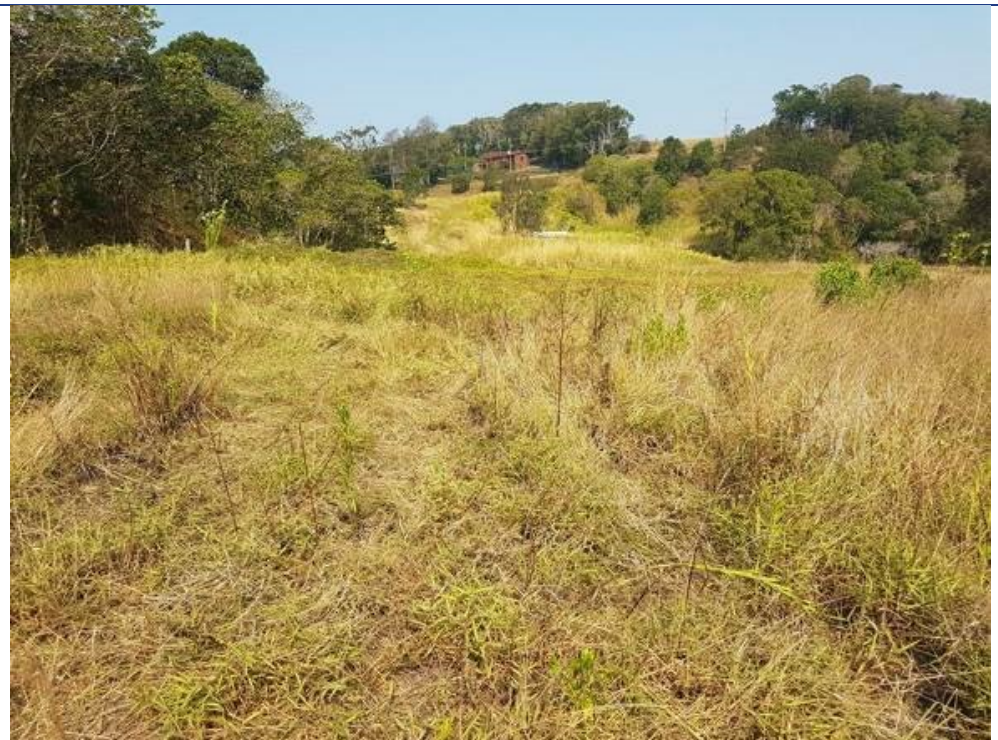
Photo No. 2	Date
	19.11.2019

Description:

View east and upslope across site.
