**GEOTECHNICAL CONSTRAINTS AND ENDORSEMENT
(CARDNO PTY LTD)**

GEOTECHNICAL ENDORSEMENT OF DRAWINGS
LOTS 2, 3, 4, 5, 7 & 8 D.P. 1240365,
LOT 3 D.P. 1090495
CENTRAL PRECINCT, NORTHERN SECTOR, WALLARAH PENINSULA

Central Precinct, Northern Sector -
Wallarah Peninsula

82218007

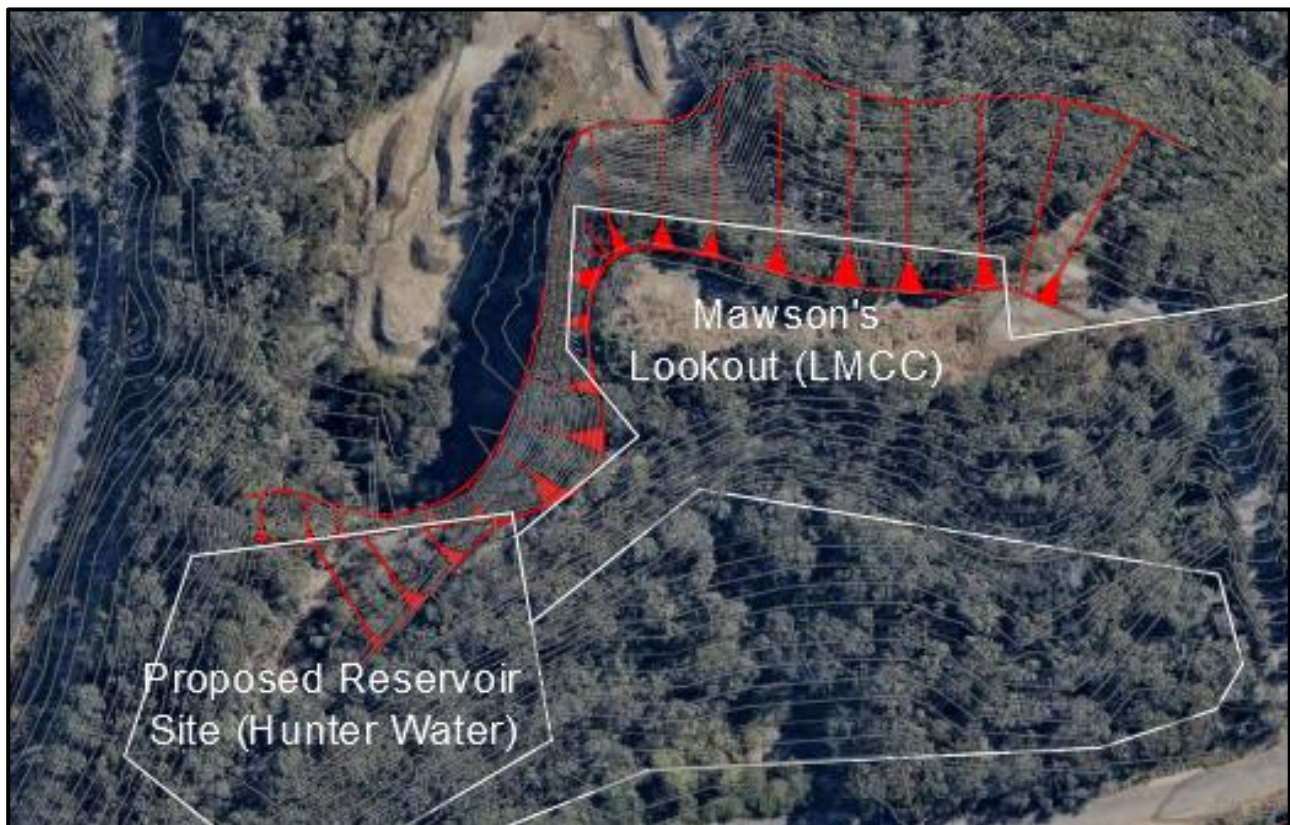
Figure 7-1 Area of High Stability Risk Crossing Common Boundary

- > Buttrressing portions of the high wall with spoil;
- > Selective face treatments;
- > Significant regrade of lower portions of the high wall; and/or
- > Construction of an earthen or mulch berm a minimum of 15m from the toe of the existing slope of at least 1.5m high.

As detailed above, it is expected that the sections of the high wall where heights are less than 10m, partial or complete removal will be undertaken during bulk earthworks. Partial or complete removal of the high wall throughout areas with similar wall heights is expected to reduce any minor stability issues associated with

these sections. Where partial or complete removal is not considered suitable, it is recommended to buttress exposed slopes with site won fill during site regrade.

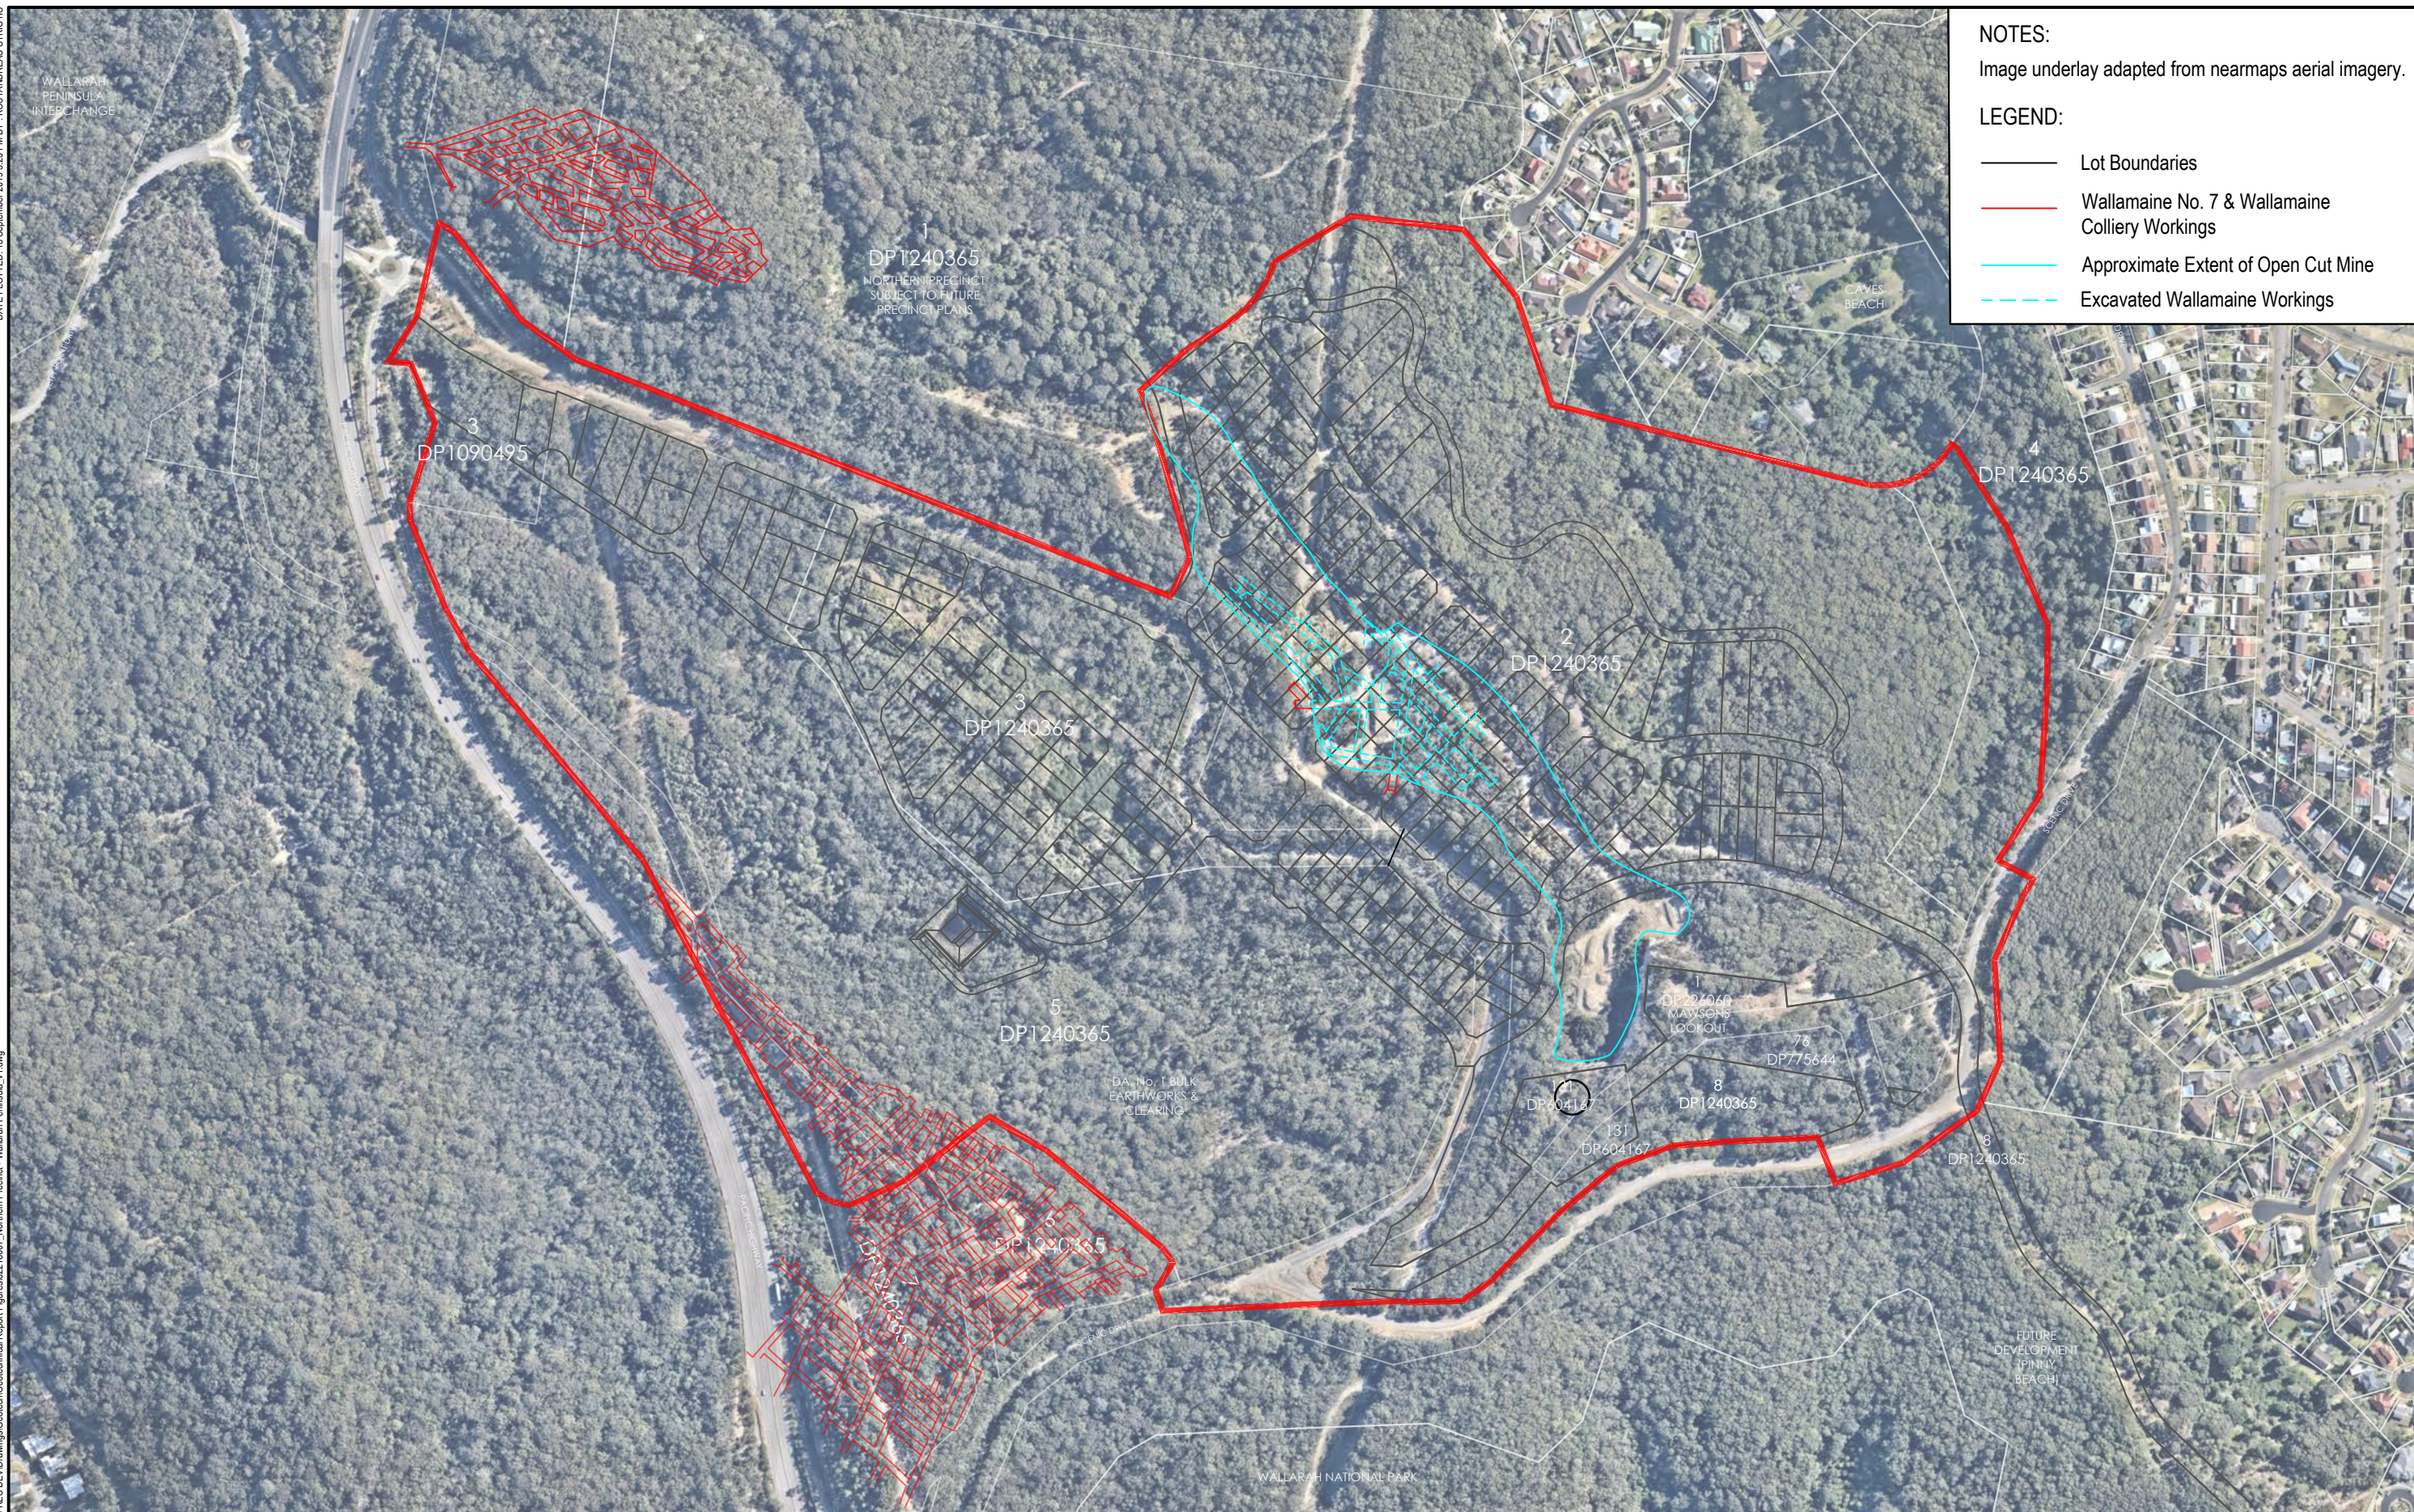
Further detail on the above geotechnical restraints and recommendations for future remediation of these areas can be seen detailed in Section 7 and areas identified can also be seen in Figures 2, 3 & 4 attached in Appendix A.

- Lot Boundaries
- Wallamaine No. 7 & Wallamaine Colliery Workings
- Approximate Extent of Open Cut Mine
- - - Excavated Wallamaine Workings
