**Bulahdelah Rezoning Project**

**Pacific Highway, Bulahdelah**

**Preliminary Site Contamination Assessment**

Report No. RGS00022.1-AB

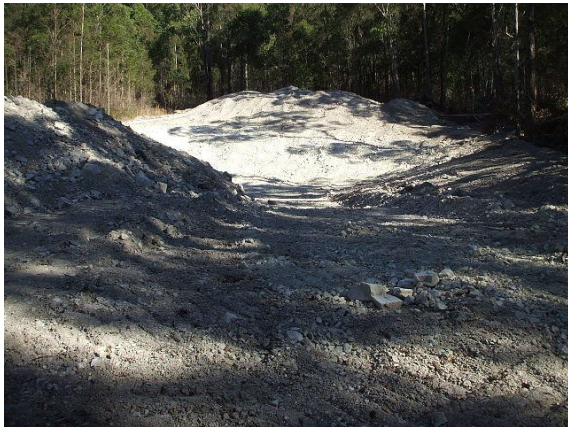
*Localised excavation for extraction of access track materials within proposed residential development area*

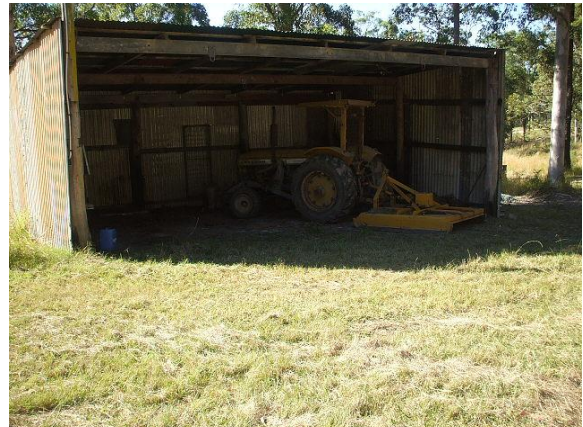
*Machinery shed near southern boundary of development area.*

| AREA OF CONCERN | SAMPLE & NUMBER |
|---|---|
| Machinery shed near southern boundary – possible leakage, spillage or dumping of fuels and oils. Use of pesticide sprays | Sample 3 obtained from base of open drain below shed, on southern boundary of property |

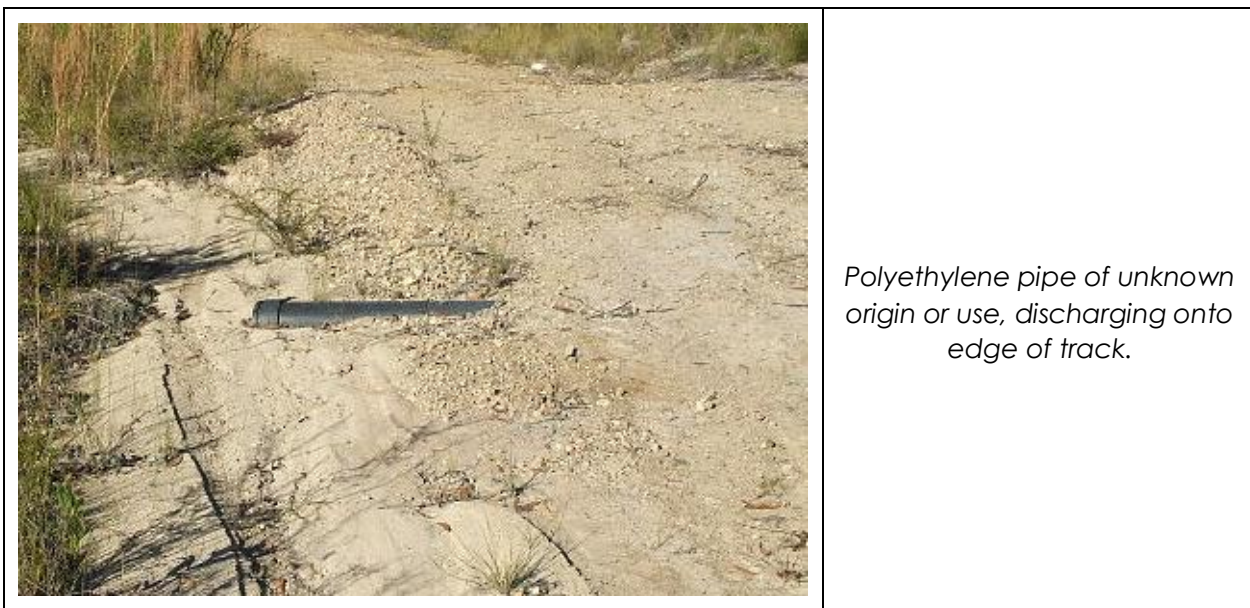
In an access track near the centre of the site, a polyethylene pipe was noted daylighting from the ground upslope of the track and discharging onto the edge of the track. The extent, source, and use of the pipe were not able to be determined from site observations
