Prepared for  
**Mirvac Residential (NSW) Developments Pty Ltd**

Prepared by  
**Ramboll Australia Pty Ltd**

Date  
**27 September 2022**

# **SITE AUDIT REPORT REMEDIATION ACTION PLAN, WESTERN SYDNEY UNIVERSITY CAMPUS, 2 AND 2A BULLECOURT AVENUE, MILPERRA**

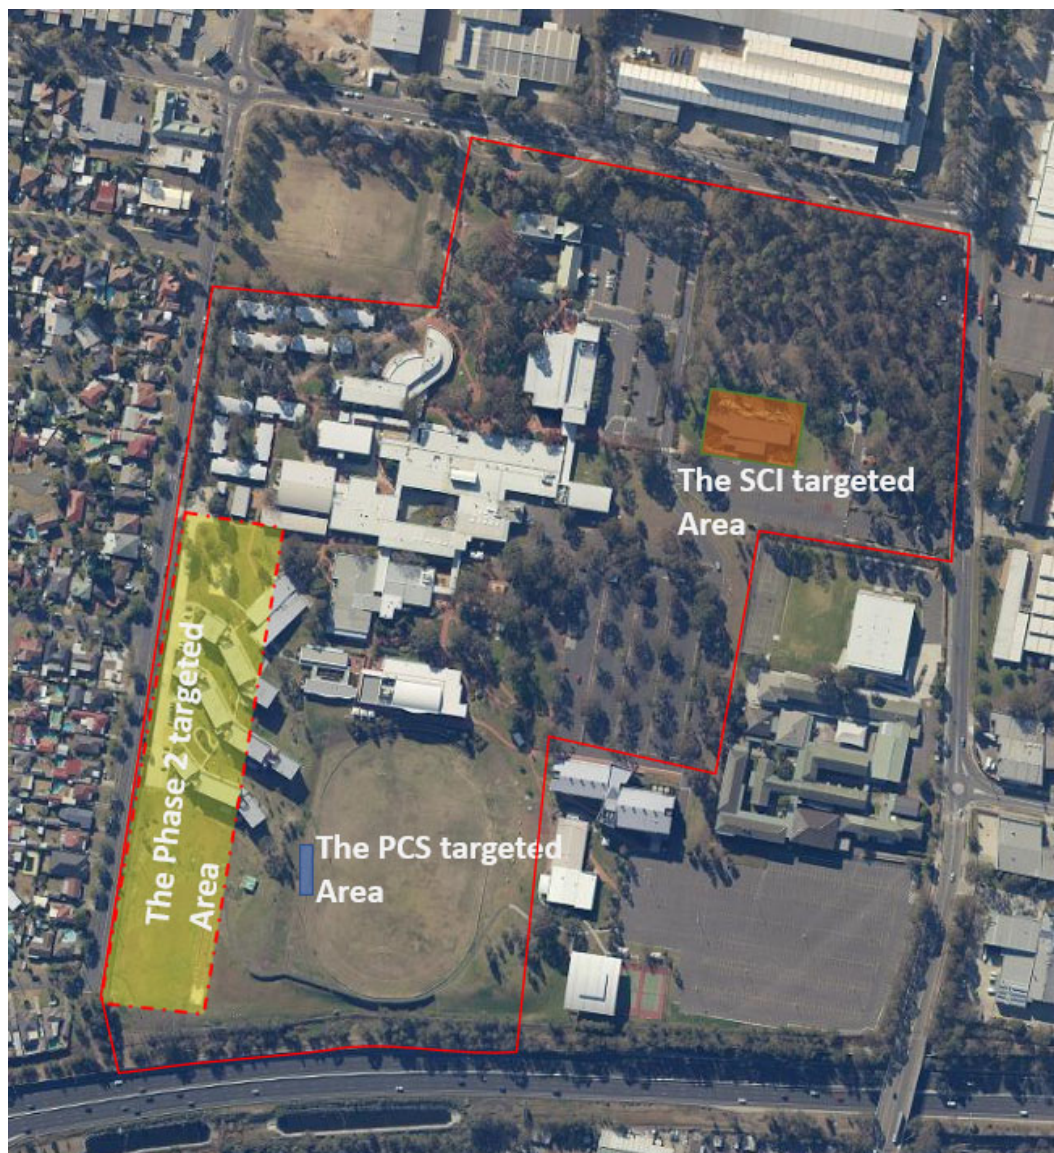
Figure 1: Areas targeted by the Phase 2, the PCS and the SCI. Red solid line represents site boundary

The Phase 2, the SCI and the PCS were limited to specific parts of the site, whilst the Phase 1, the DSI and the RAP were site-wide assessments. Indicative boundaries of the areas targeted in the Phase 2, the SCI and the PCS are shown in Figure 1.

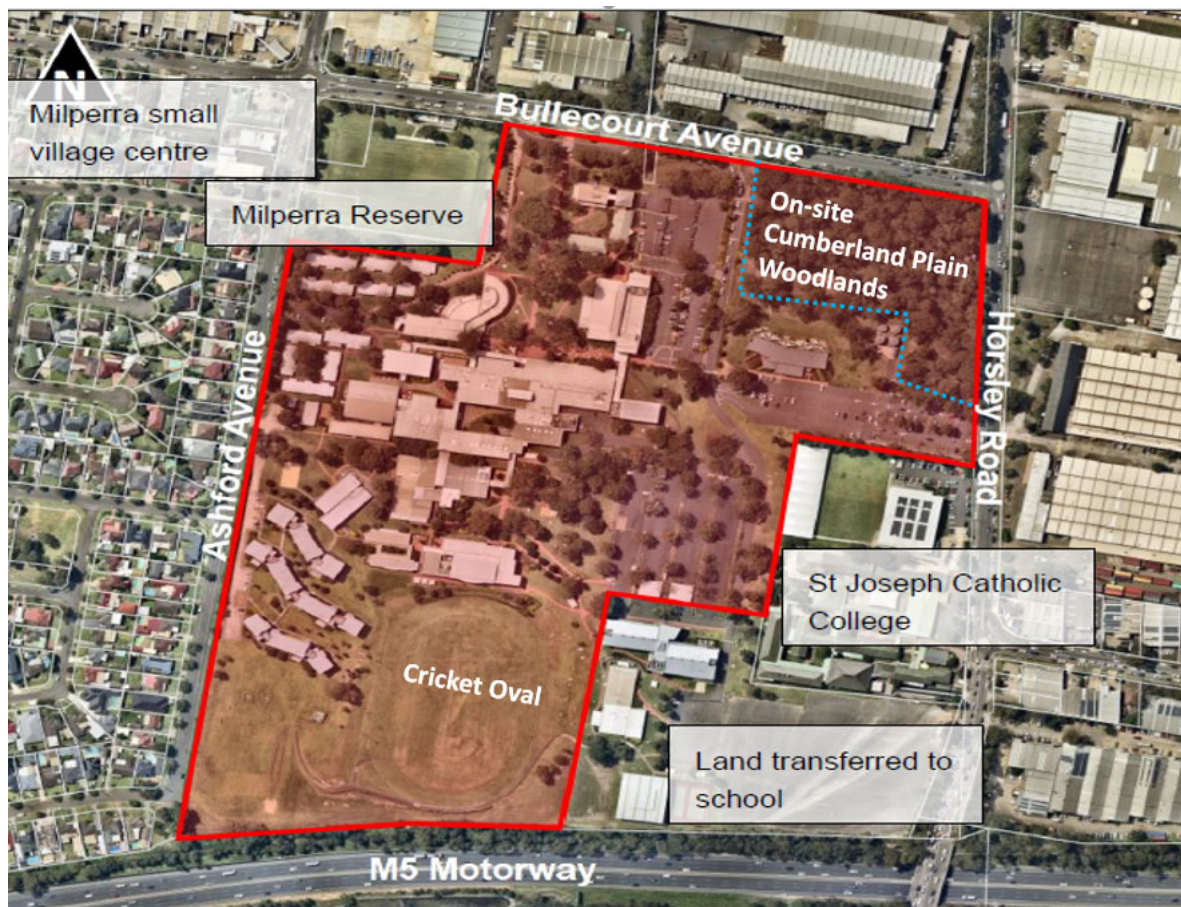
Figure 4: Surrounding land uses<sup>1</sup>

The adjacent land uses are shown in Figure 4 extracted from the NSW DPE Gateway determination report.

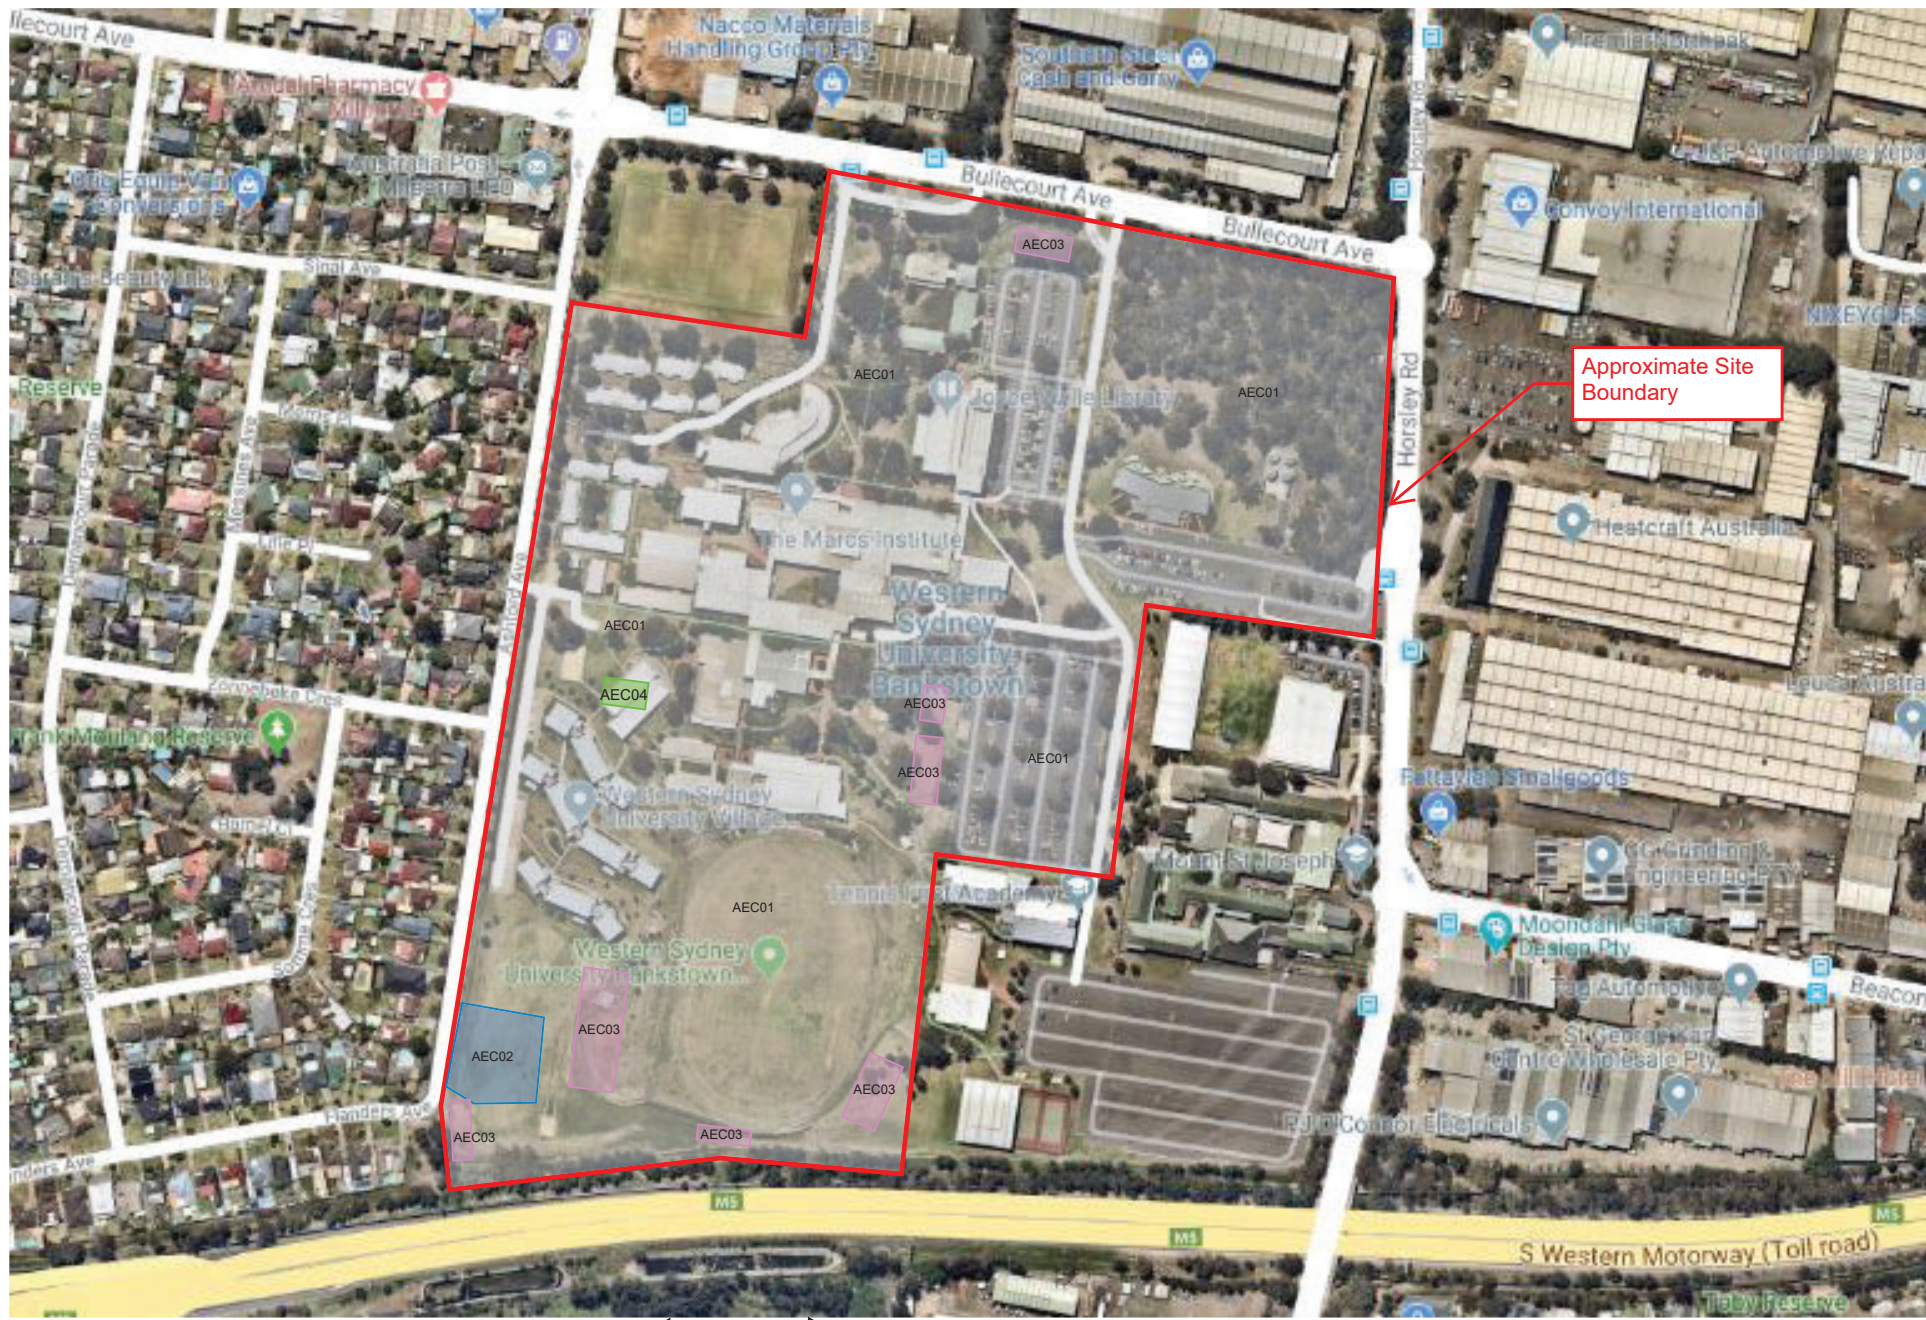
Figure Number:	3
	Figure Date:	10 December 2019
	Report Number:	9996-ER-1-1

Areas of Environmental Concern	
Client Name:	Mirvac Homes NSW PTY Ltd
Project Name:	Stage 2 Detailed Site Investigation
Project Location:	Western Sydney University – Milperra Campus – 2 Bullecourt Avenue, Milperra NSW

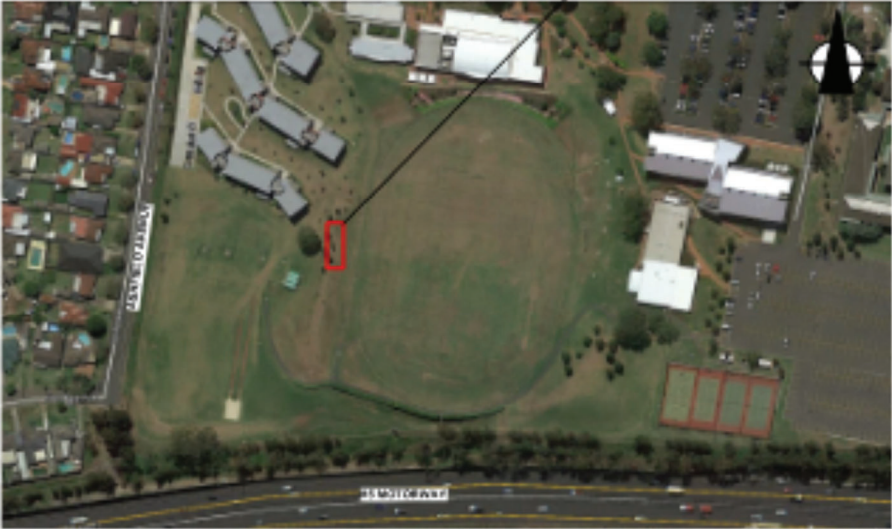
SITE LOCATION PLAN (Not to scale)

- - - - - Approximate site boundary
- BH (Fill Depth) Borehole location, number and depth of fill (m) (EIS 2016)

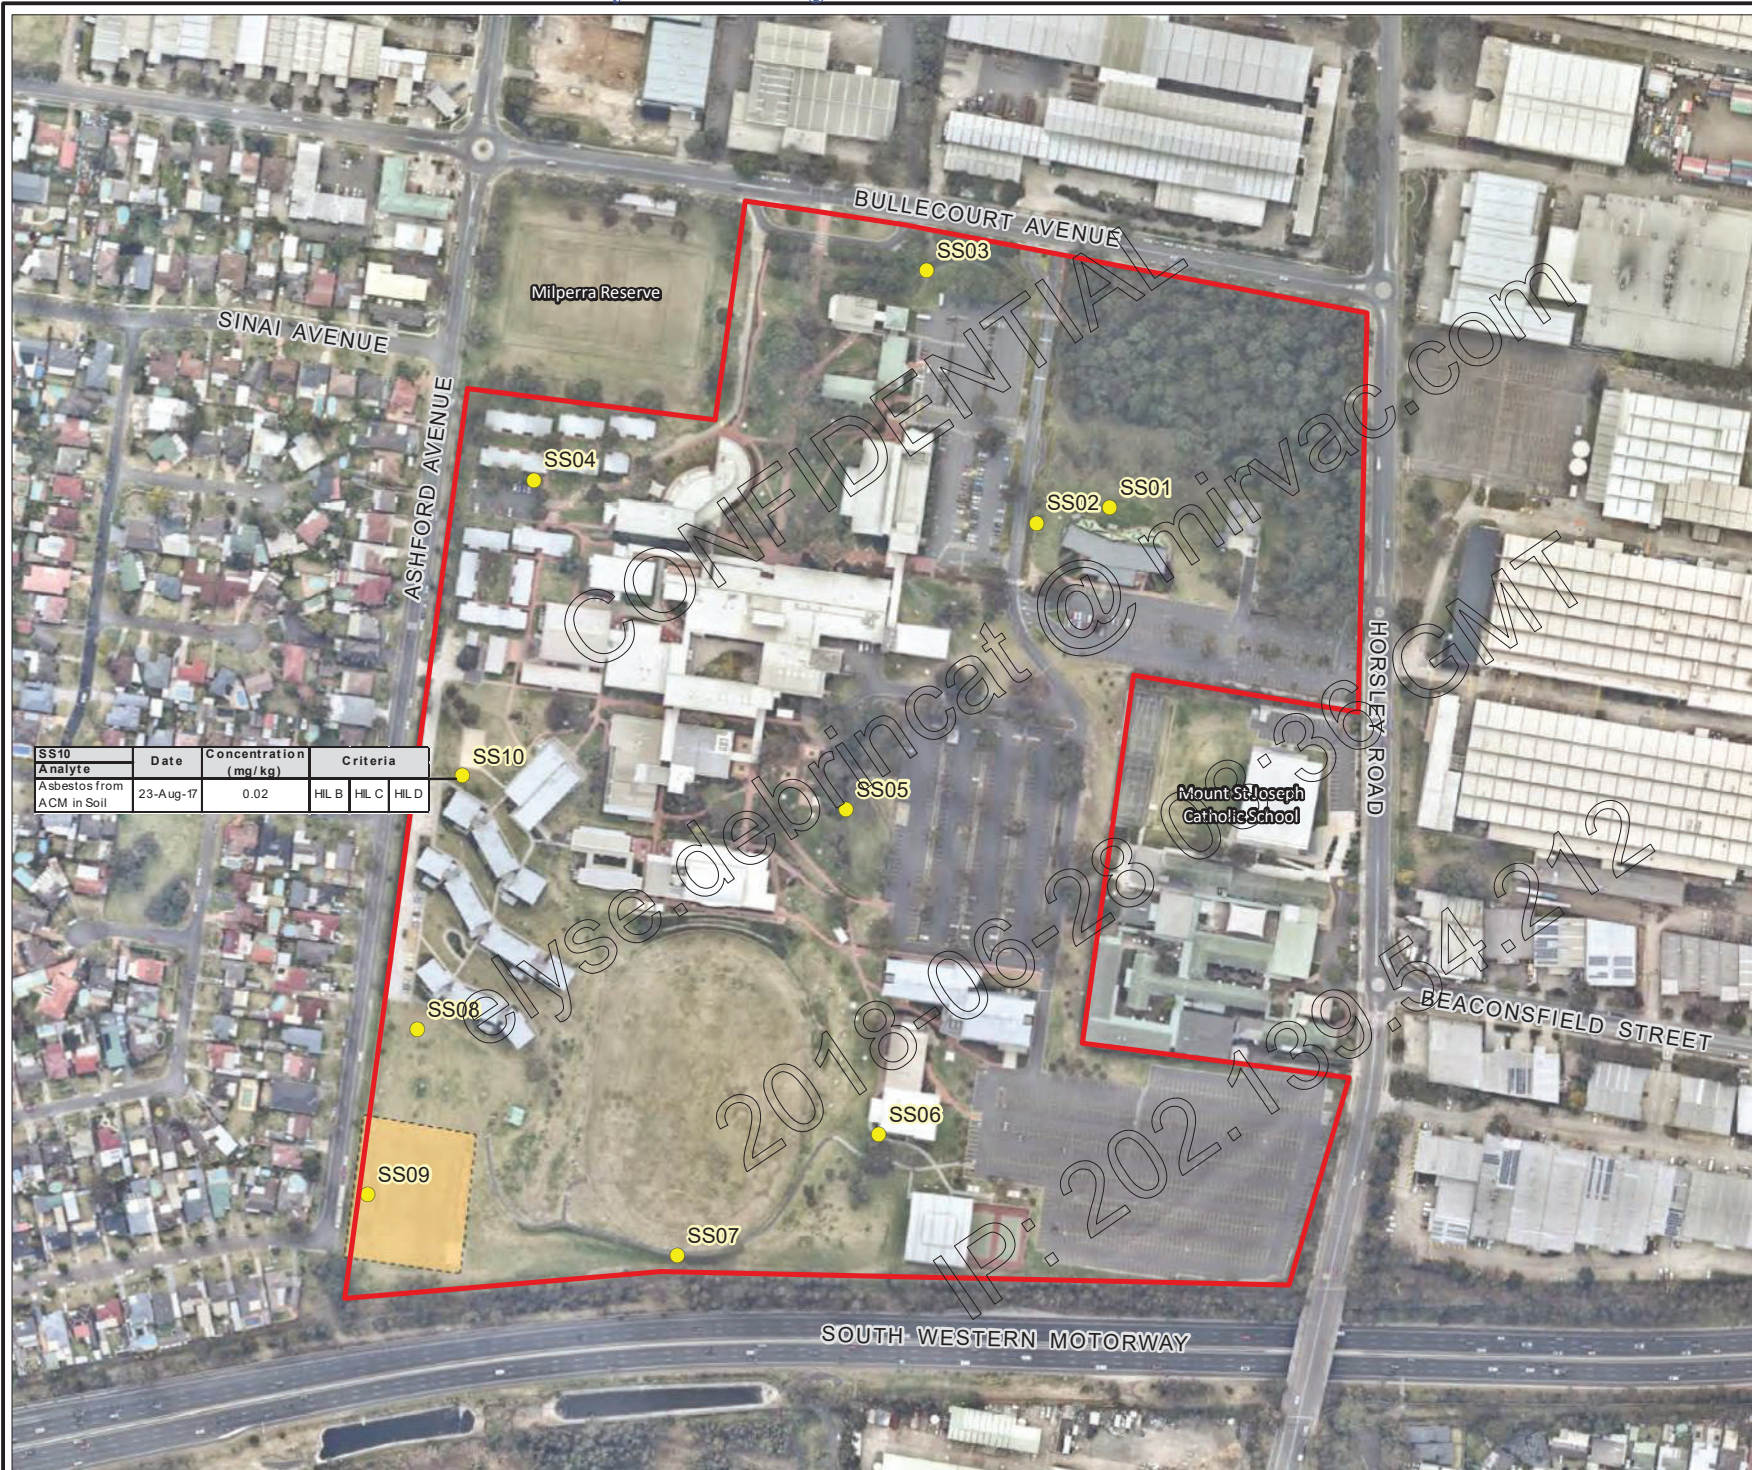
**FIGURE 3**

- Approximate Site Boundary
- Burial Area Containing Building Rubble (Coffey 2011)
- Sample Location

**SAMPLING LOCATIONS &  
 EXCEEDANCES**

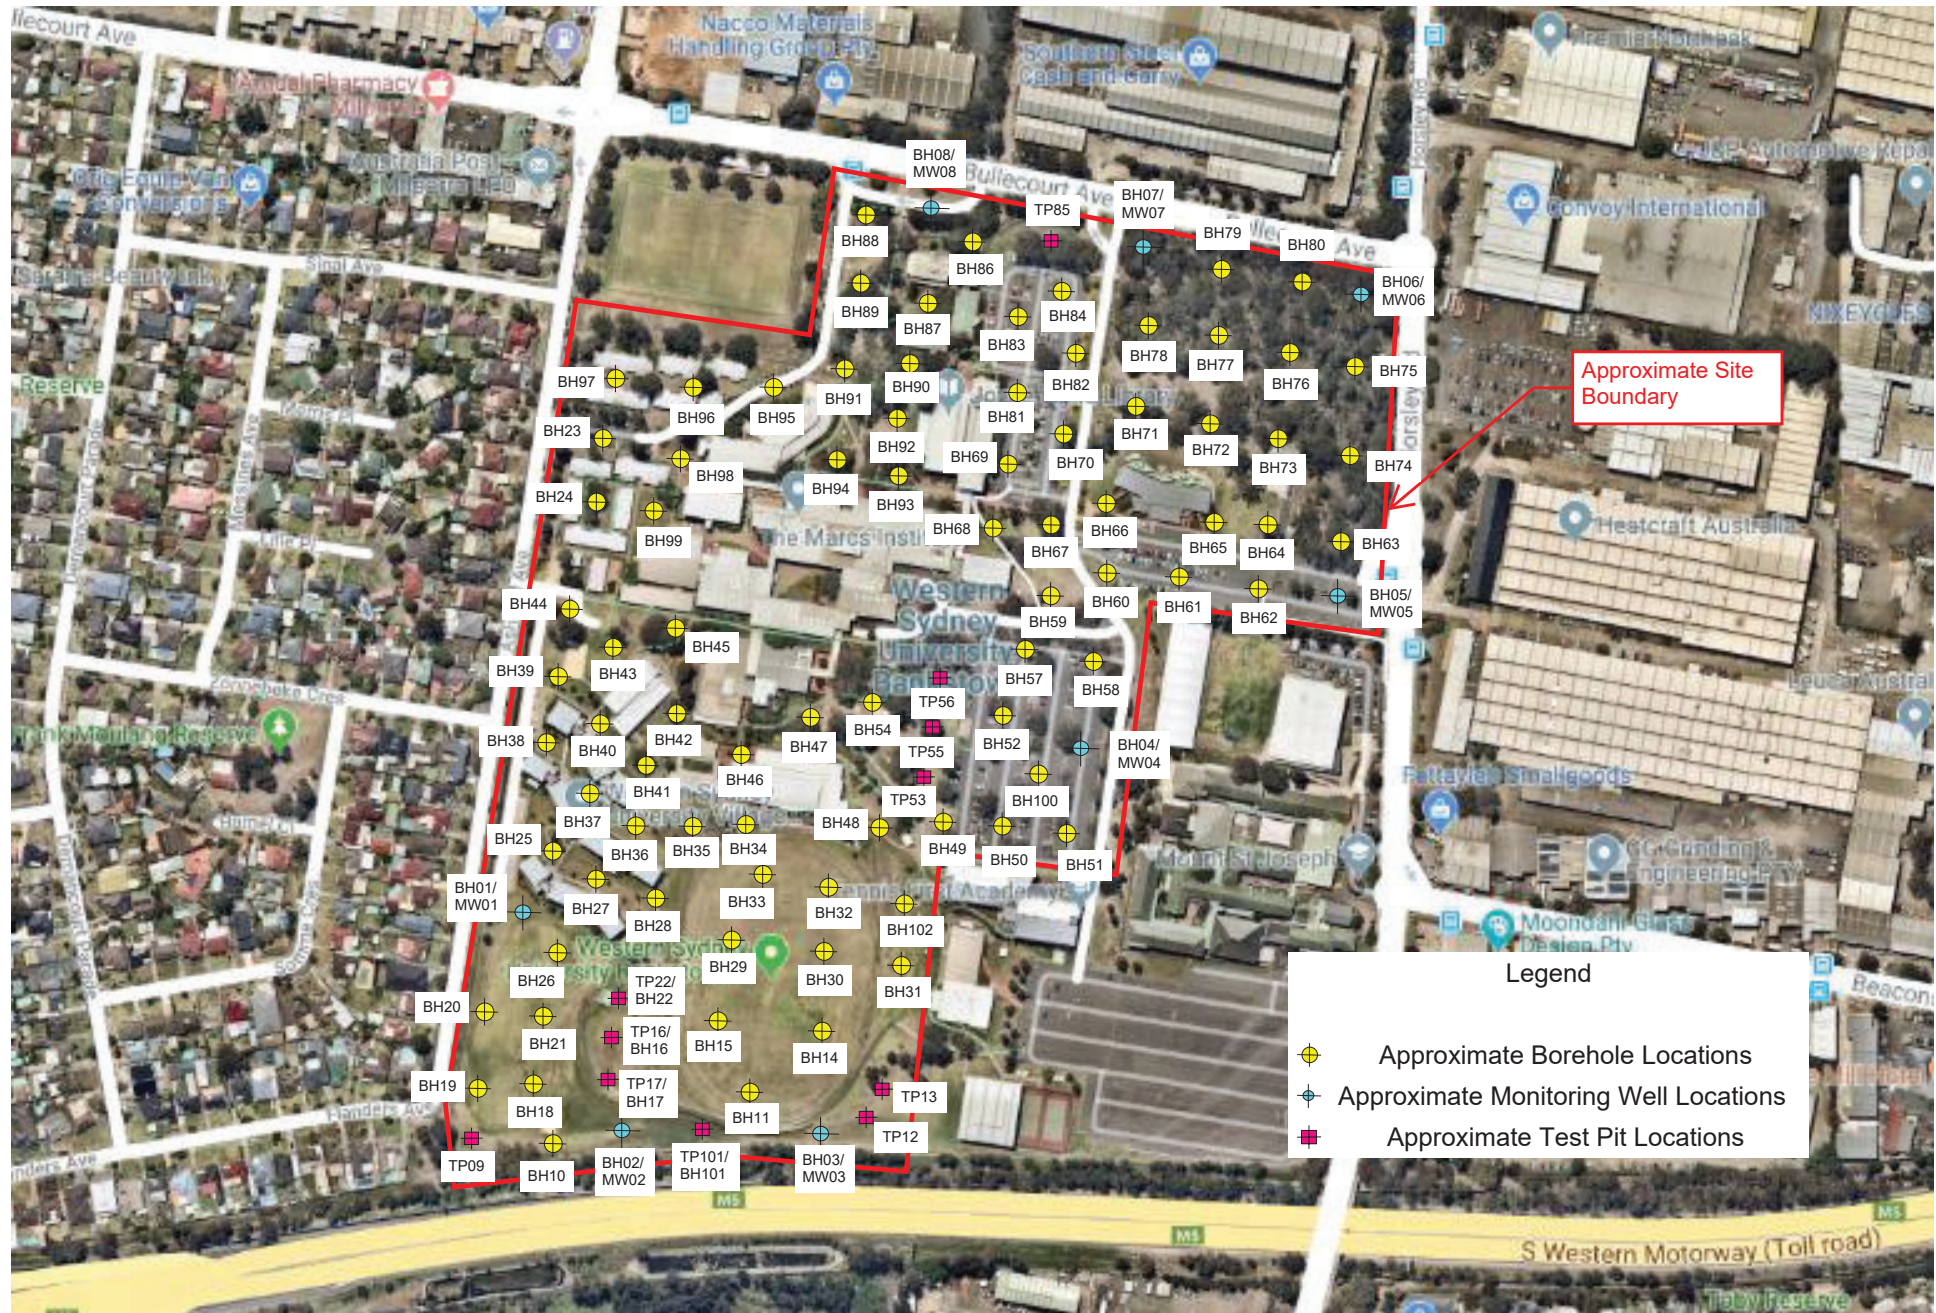
Sampling Point Layout Plan
