Planning Proposal

Highway Service Centre

Murrumbateman, NSW

March 2020

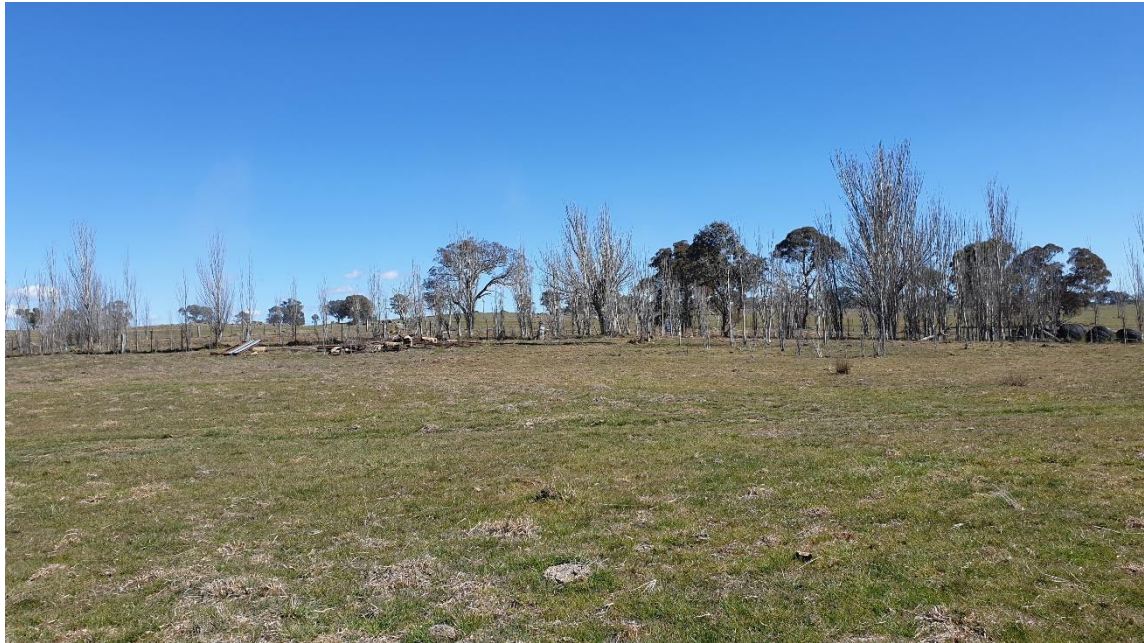
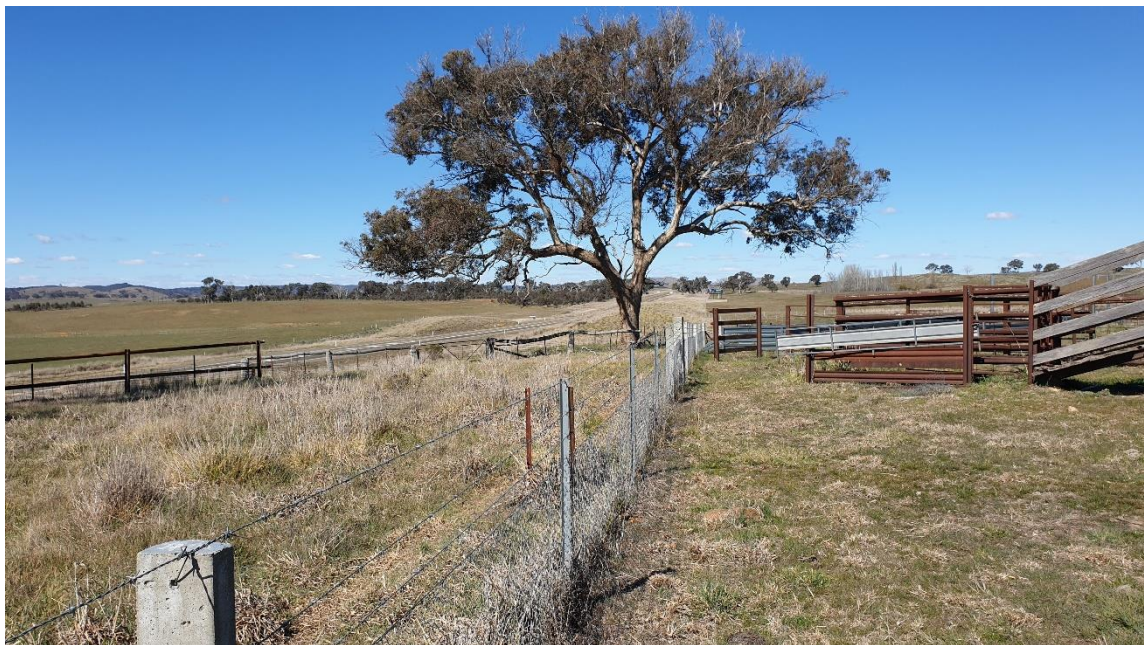
Above: Western view of the subject site; **Below:** Cattle Yards and adjoining vegetations.

The site comprises two paddocks and cattle yards with previous use primarily as intensive sheep and cattle grazing with a history of interspersed cropping. This has resulted in the development of an exotic grass and herbaceous pasture primarily comprised of Yorkshire Fog, African Lovegrass, *Briza* sp., *Avena* sp., Paspalum, Needle Grass and Couch with a lesser native component of *Themeda australis*, *Poa* sp. and Wheatgrass (refer to **Figure 2**). Exact composition was difficult to determine at the time of survey due to a lack of seed and the transitional season (i.e. grasses were frost affected, grazed and annual species transitioning between winter and summer).

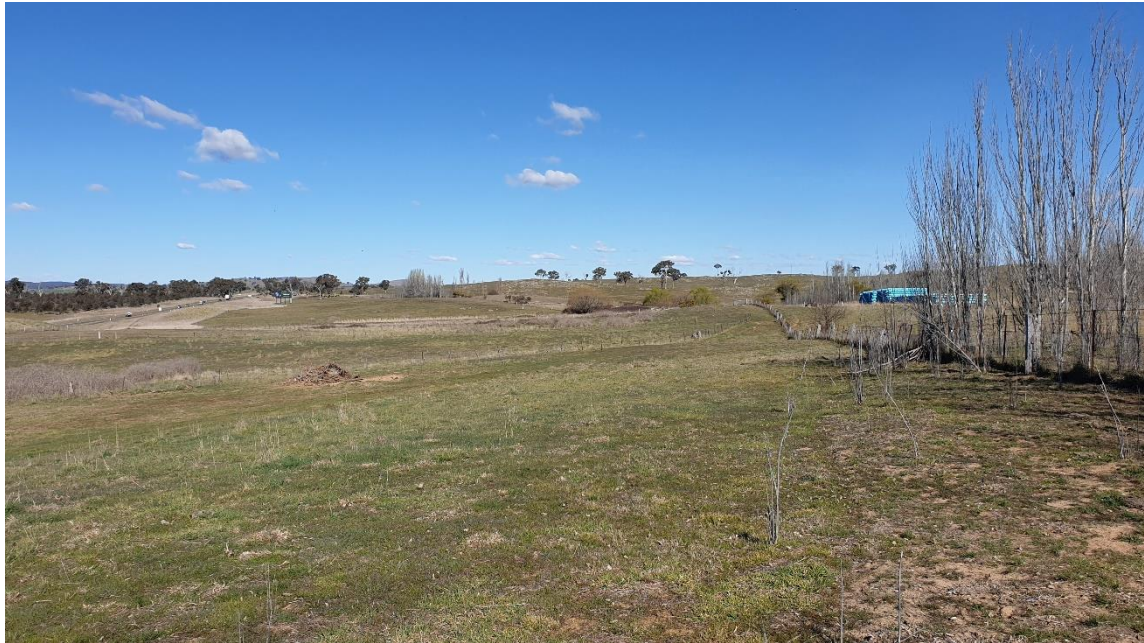
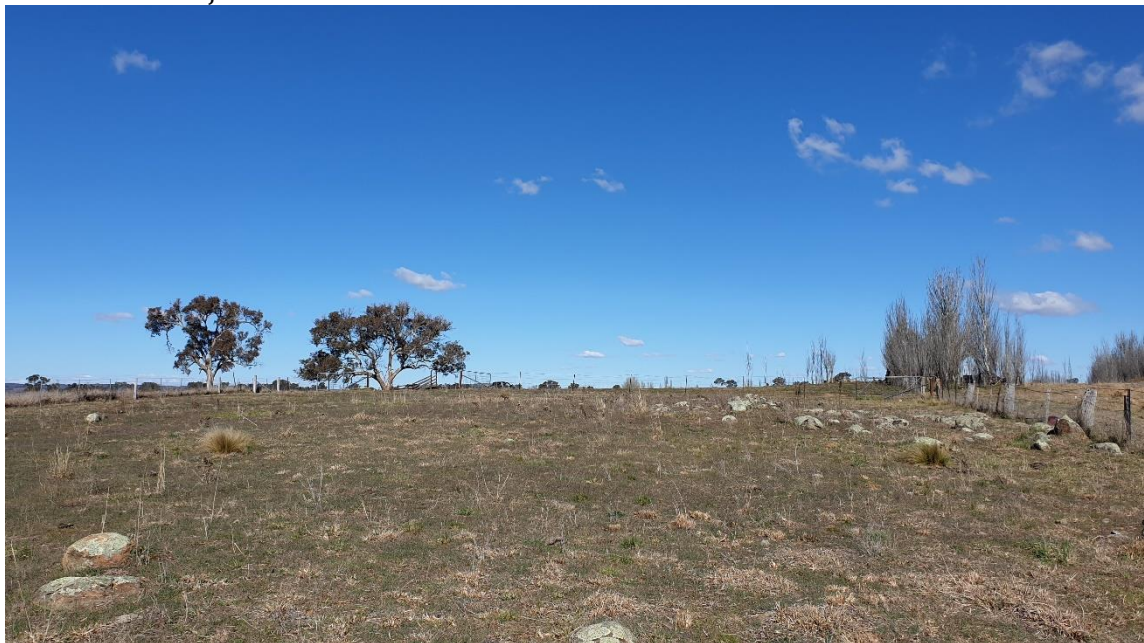
Above below: South view of the subject site showing the existing pasture, **Below:** South East view of subject site

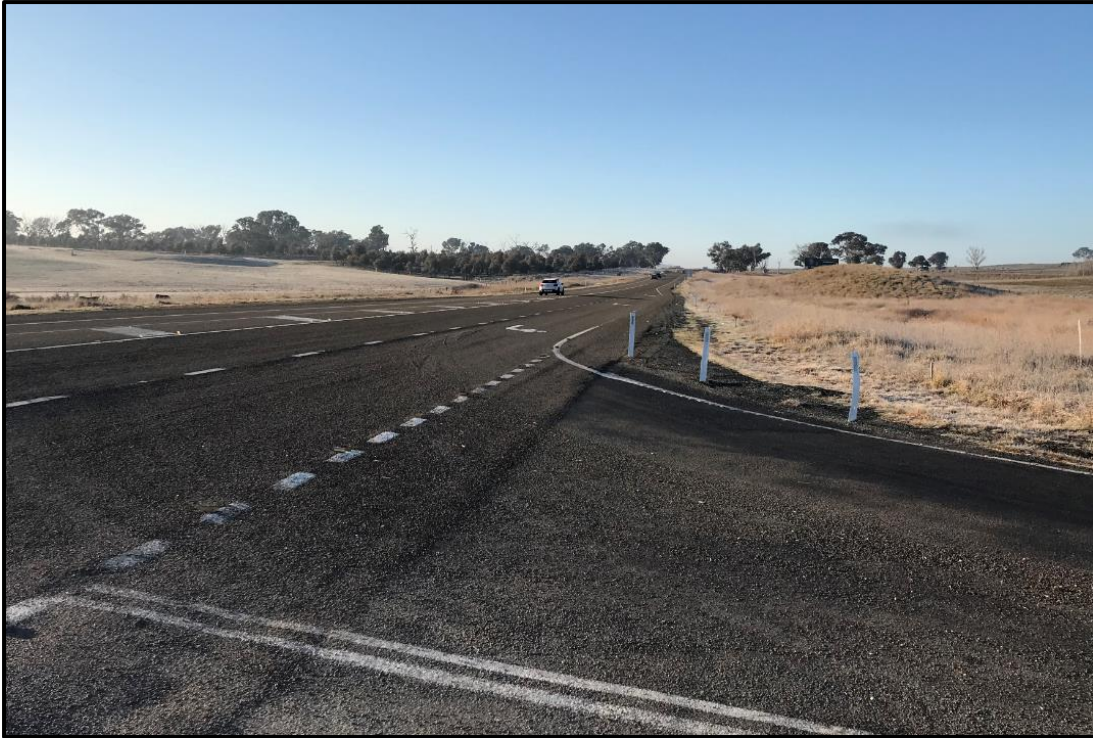
Photo 1 – View to right for driver exiting Longrail Gully Road

For the posted speed limit of 100 km/h, the sight distance required from Austroads Guidelines is 248 metres and for a limit of 110 km/h the sight distance requirement is 300 metres. The sight distance available at this intersection has been measured on site and exceeds 500 metres in both directions.

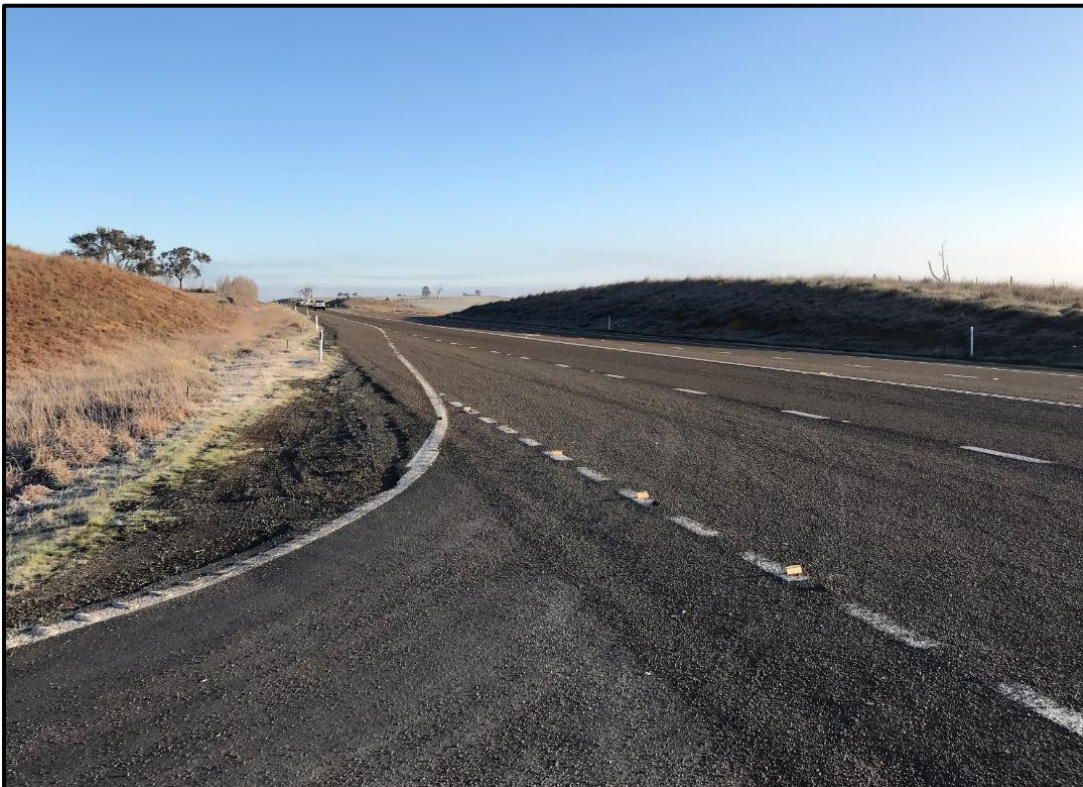
Photo 2 – View to left for driver exiting Longrail Gully Road

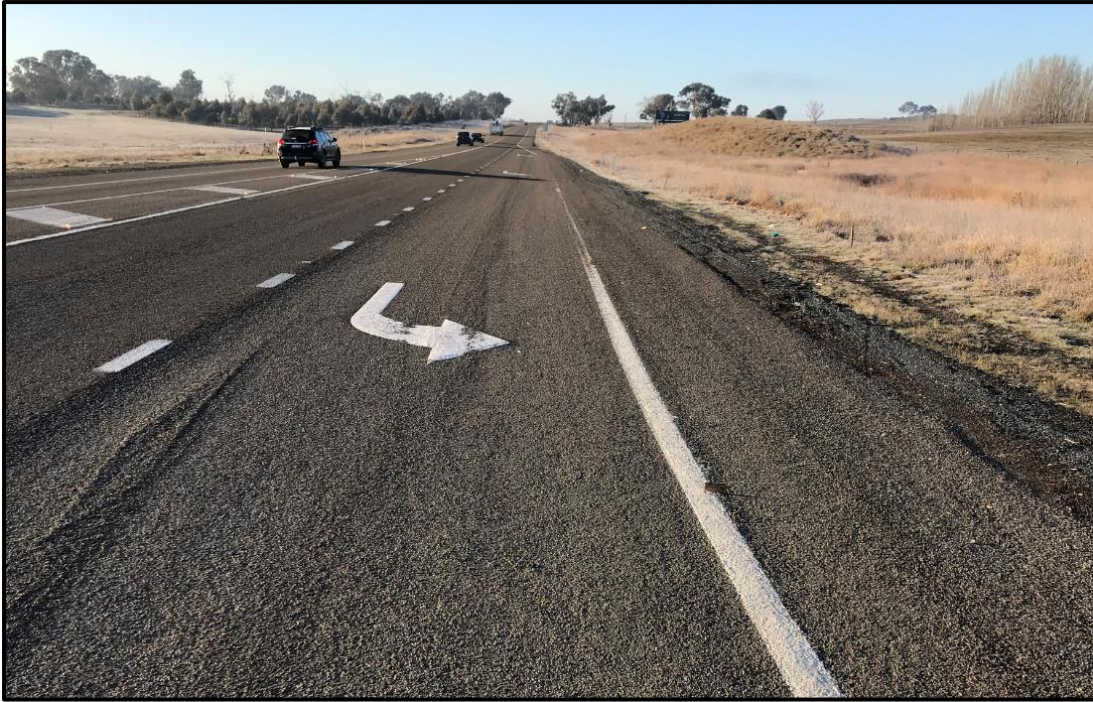
Photo 3 – Existing deceleration lane for vehicles turning left into Longrail Gully Road

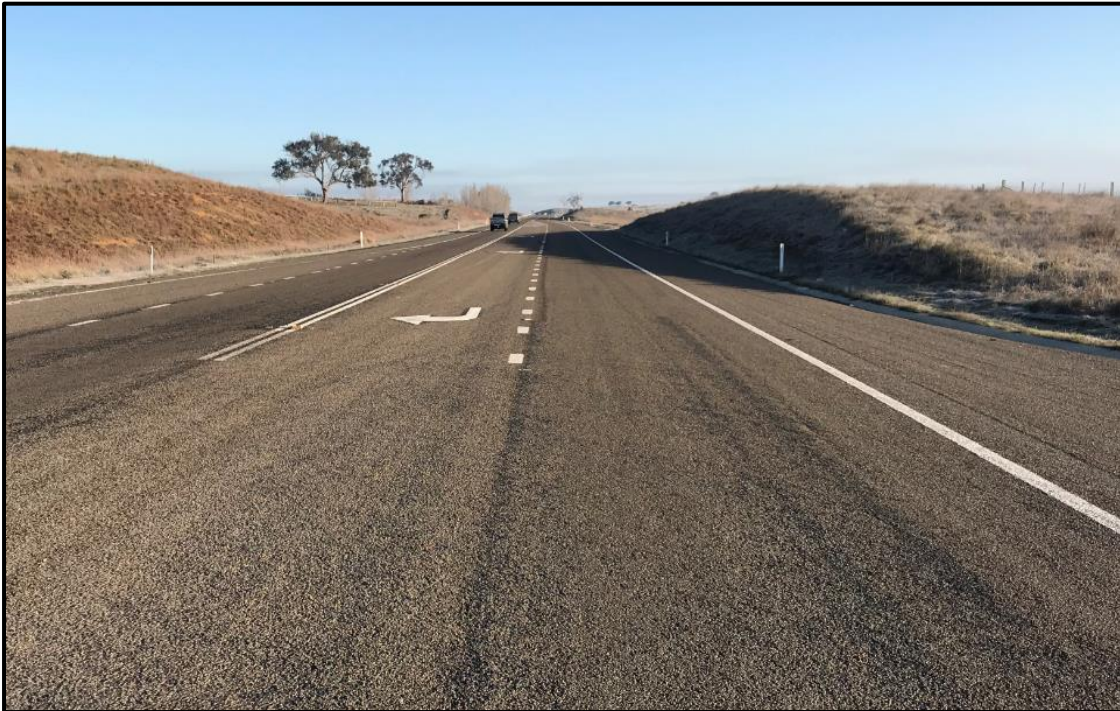
Photo 4 – Existing right turn lane for vehicles entering Longrail Gully Road

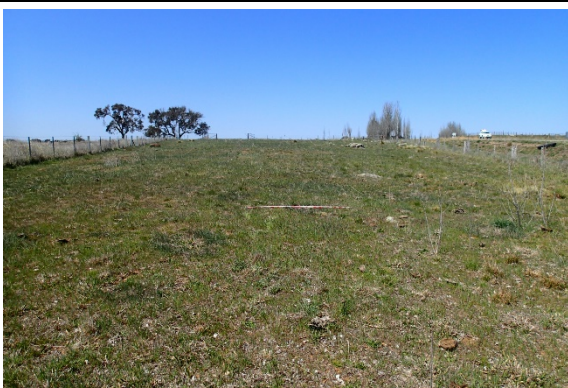
Plate 6-1. View south from northern extent of project area.

The norther block was surveyed with pedestrian transects traversing low gradient spur slopes at the extreme northern end of the lot. Visibility in this area was generally fair at about 20% but the area was considered to have relatively low archaeological potential (Plate 6-1).

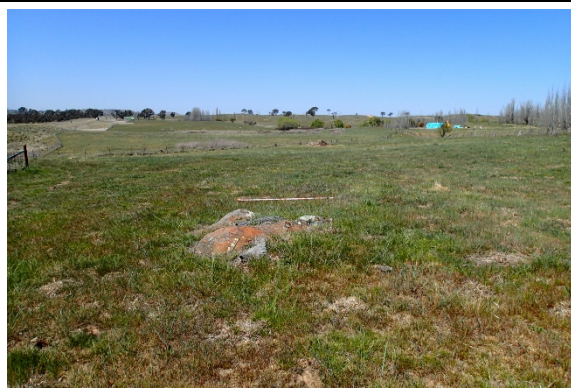
Plate 6-2. View north across crest of high spur showing outcropping bedrock.

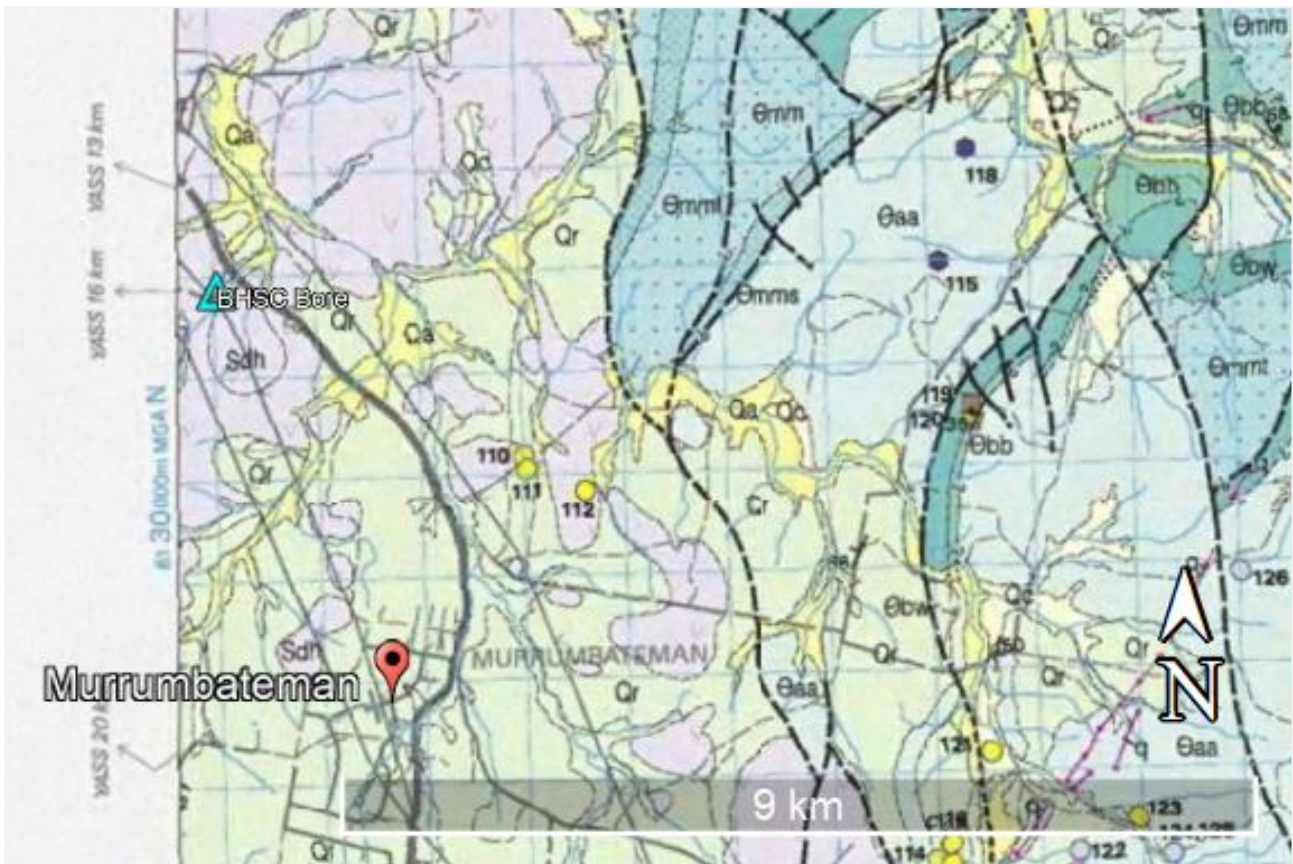
Figure 2: Geological Setting

Review of the geological setting was conducted with reference to the Gunning 1:100,000 geological series sheets. The site geology is provided in **Figure 2**. The assessment area is mapped as underlain by Hawkins Volcanics (Sdh). The stratigraphy is summarised in **Table 2** below:

Period	Stratigraphy / Formation	Symbol	Lithology
Quaternary	Quaternary	Qa	Alluvial gravel, sand silt and clay.
Quaternary	Quaternary	Qr	Residual deposits
Siluro-Devon	Hawkins Volcanics	Sdh	Blue-grey massive medium to coarse grained often welded porphyritic crystal vitric biotite cordierite-garnet rhyolitic to dacitic ignimbrite with occasional quartz and diorite xenoliths. Flow banded vesicular rhyodacitic to dactic lava, volcanic sandstone, minor rhyodacitic agglomerate and rhyolitic lapilli tuff are also present.

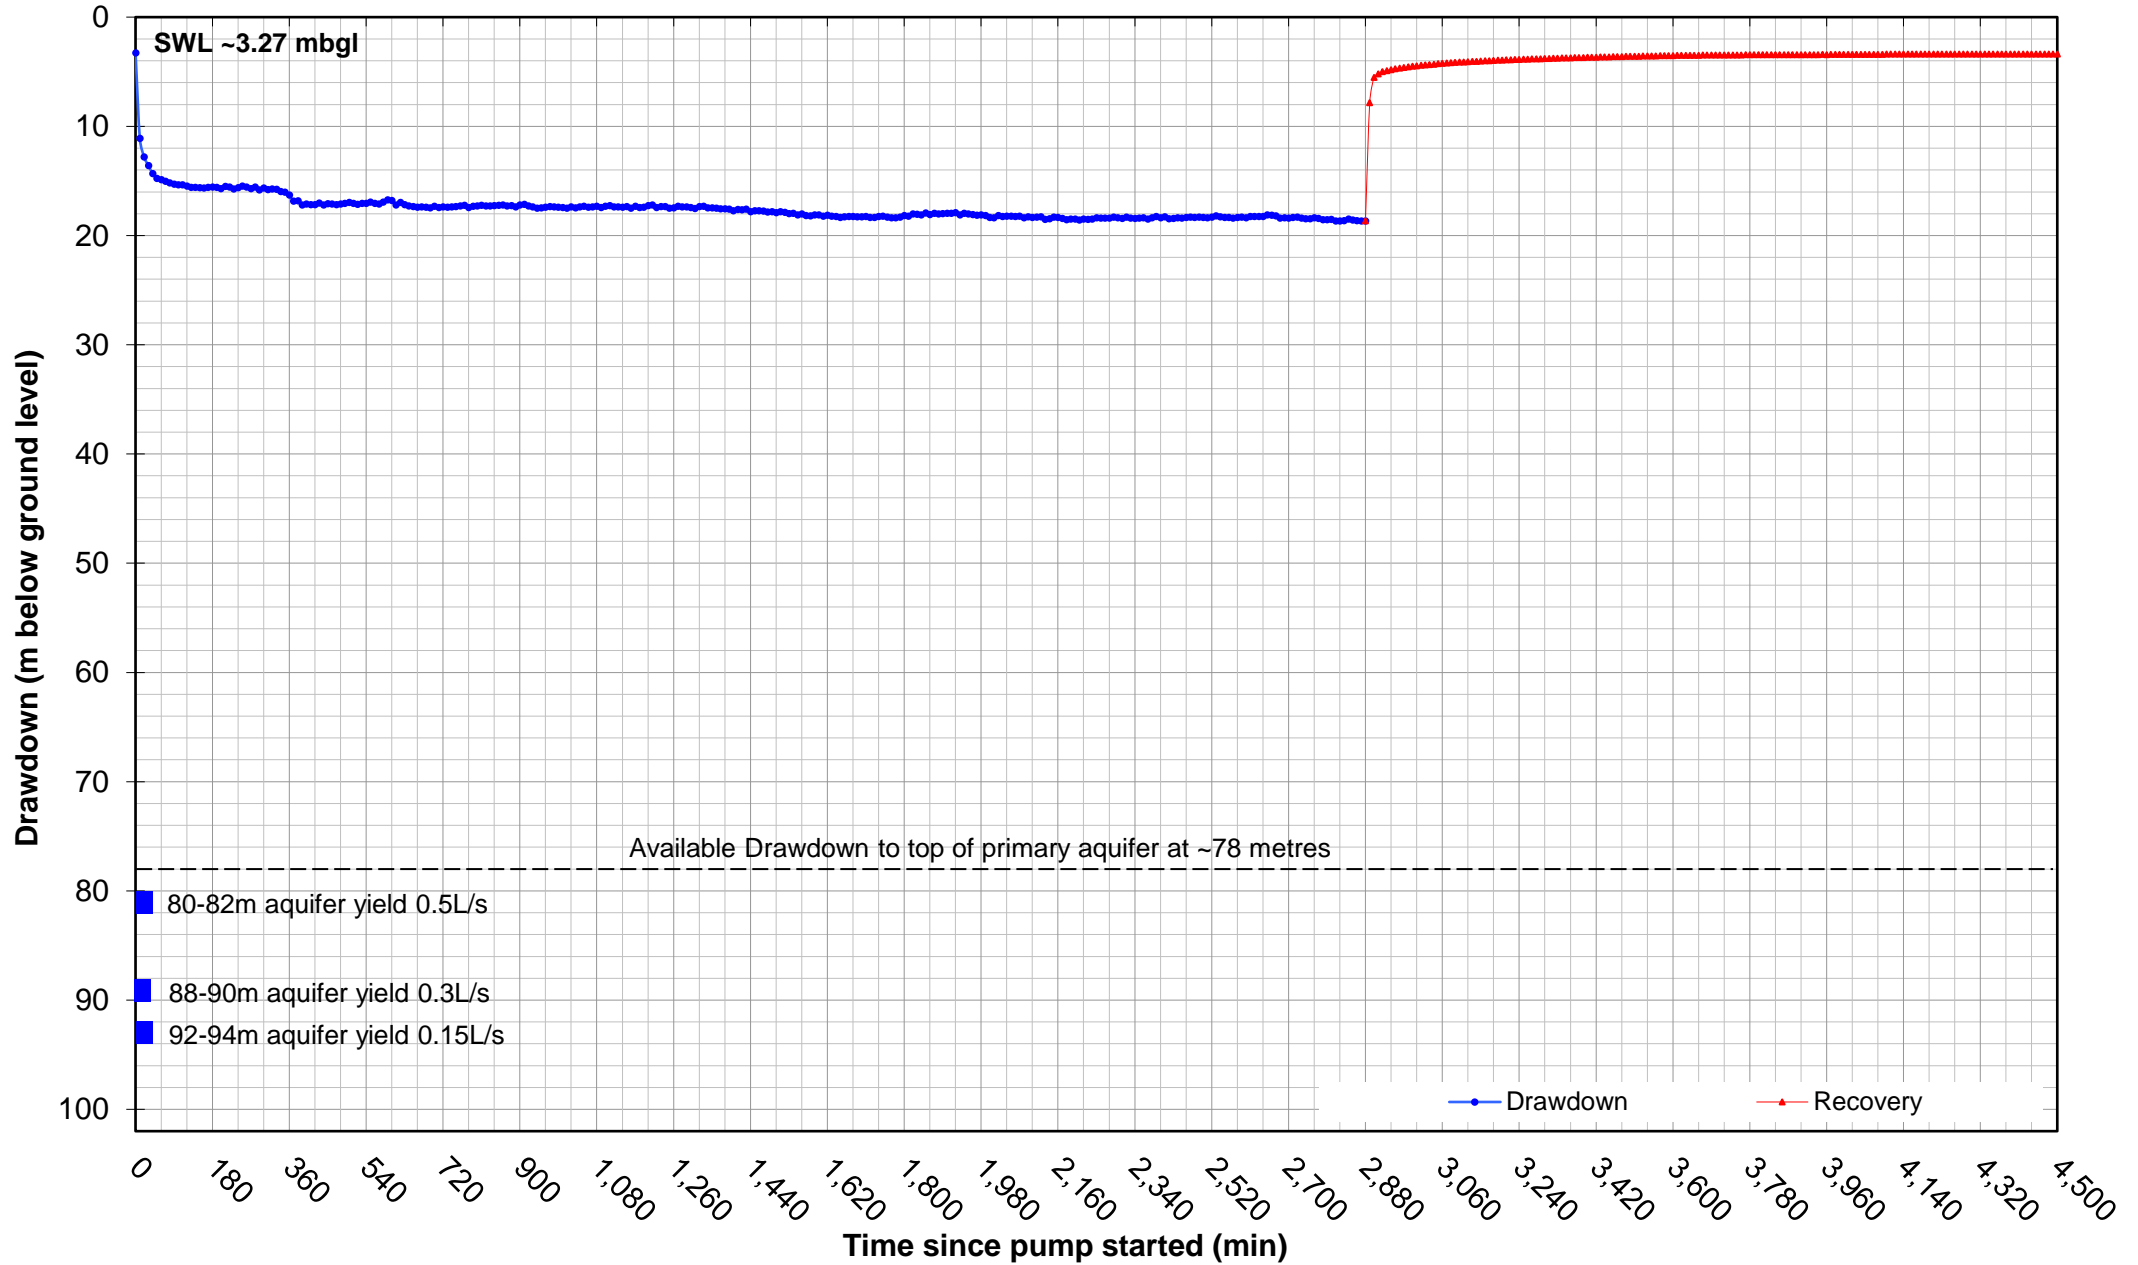
Time-Drawdown & Recovery - Bore 1 Pumping at 0.6 L/sec for 48 Hours
