# **Phase 1 Environmental Site Assessment**

Peat Island, Mooney Mooney, NSW

February 2013  
JBS 42532 – 553028 (Rev 0)

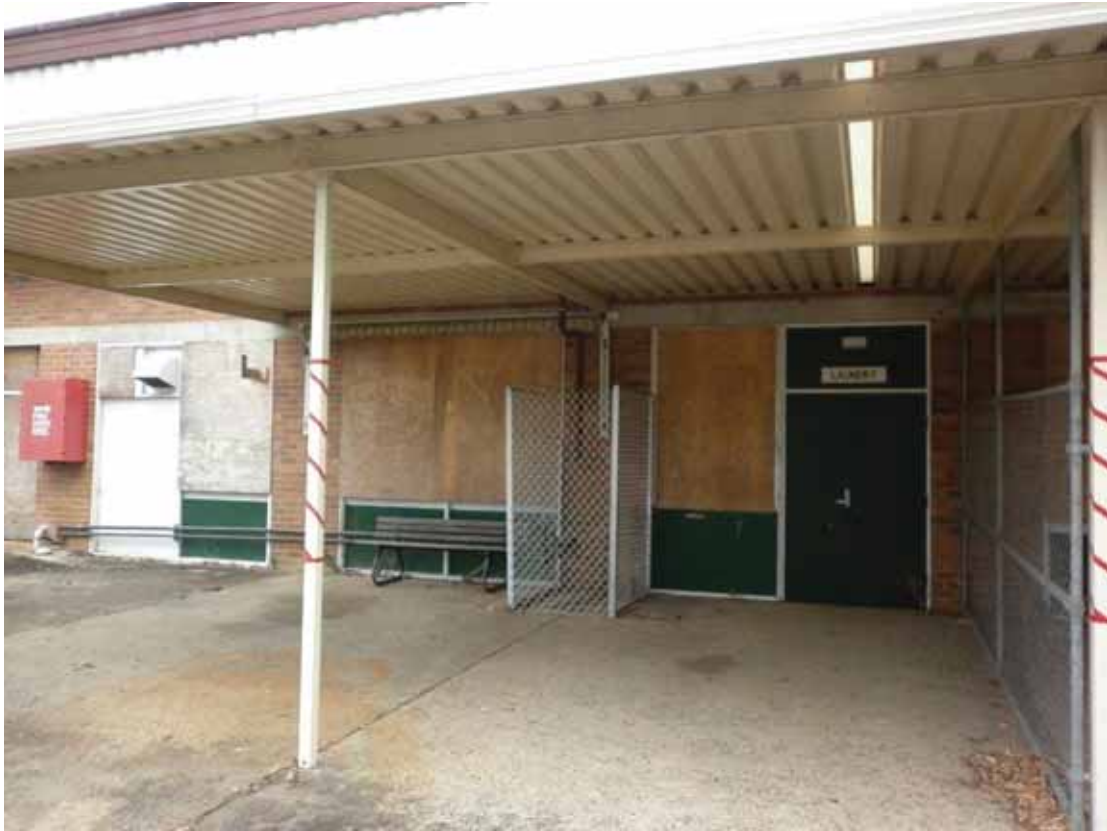
**Photograph 1** – Former Laundry building

During the site inspection the floor of the former laundry was observed to comprise a concrete slab, with chemical staining. Based on the possibility the laundry was used as part of the hospital there is potential for biohazard waste and chemical waste and therefore there is potential for microbiological contaminants associated with the former laundry to be present in soil at the site.

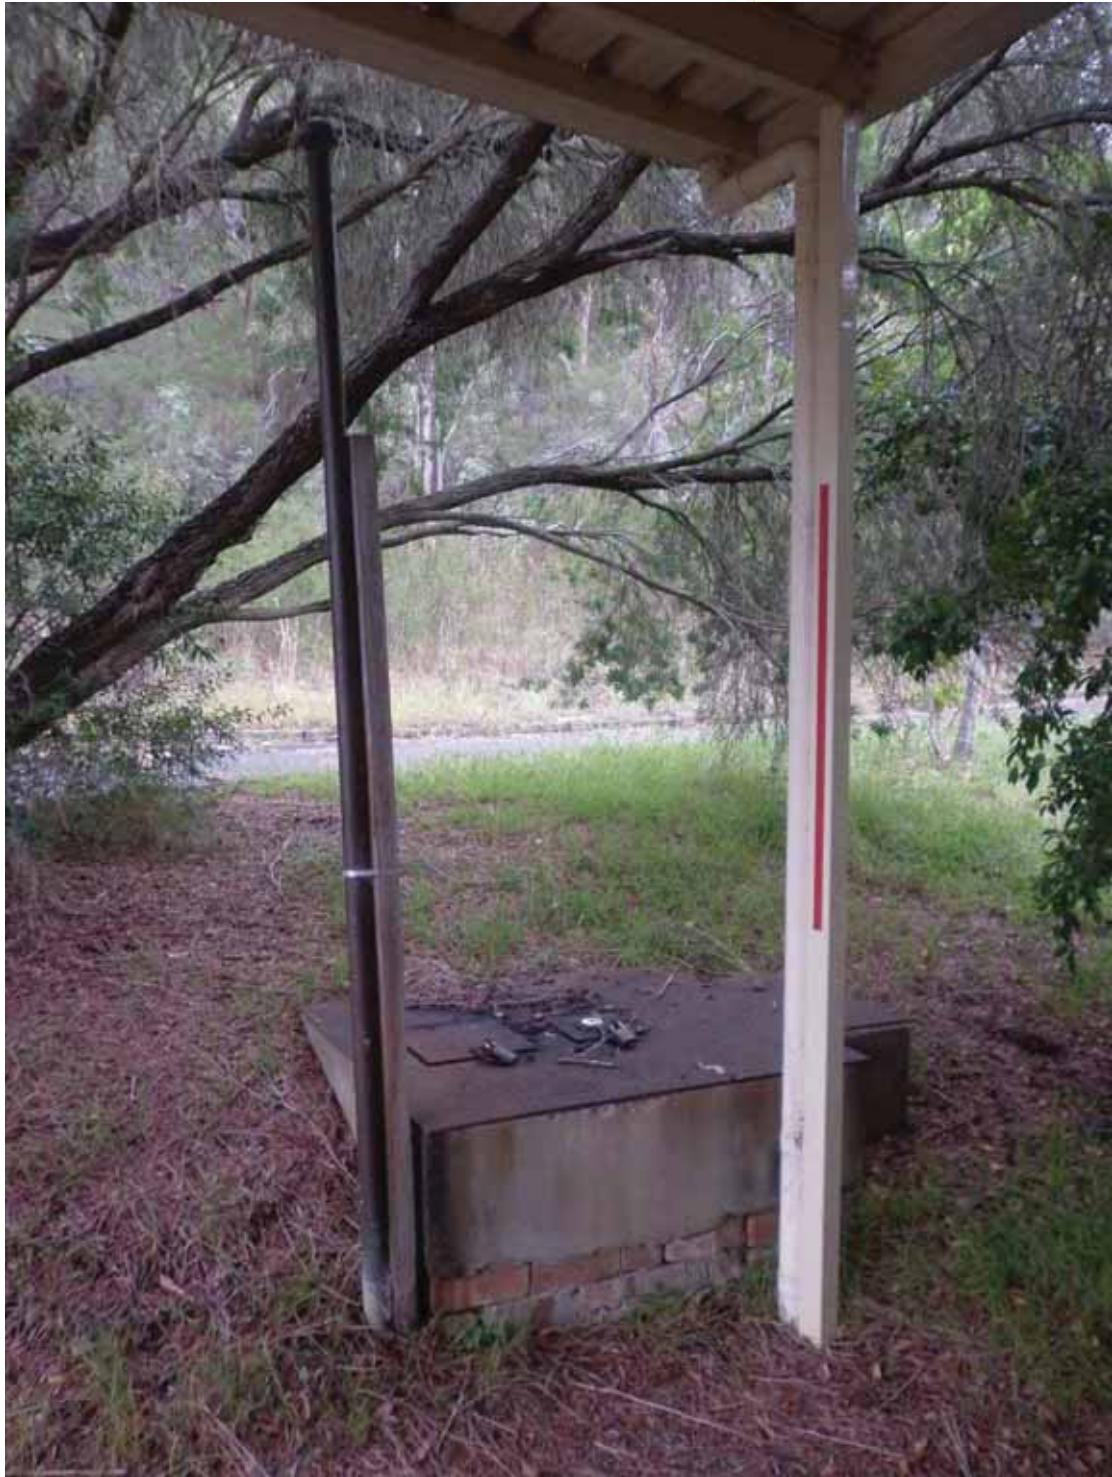
**Photograph 4** – Disused UST at rear of former laundry on mainland

A vent line and UST were observed at the rear of the former laundry. There is a potential for the laundry to have included dry cleaning practices. Therefore, there is a potential that inorganic and organic contaminants including potential volatile solvents, chlorinated solvents, volatile hydrocarbons (e.g. kerosene) and semi volatile hydrocarbons (e.g. naphthalene) to have been used at the site which can pose a potential risk to human health and the environment.

Additionally, it is recommend disused USTs at the site be decommissioned and validated in accordance with relevant regulations, standards and guidelines.

Additionally the presence of the USTs at the service station (Portion 7), Wharf (Portion 5), Peat Island (Portion 3), Church (Portion 6) and former laundry (Portion 1) will require management under the *Protection of the Environment Operations Act, 1997 (POEO Act)*<sup>9</sup> and *Underground Petroleum Storage Systems (UPSS) Regulation, 2008 (UPSS Regulation)*<sup>10</sup>. The UPSS Regulation indicates disused USTs must be decommissioned, preferably by removed where practicable. It is recommended the USTs be decommissioned in accordance with the UPSS Regulation and associated standards, guidelines and other regulatory requirements including appropriate work health and safety. It is recommended an appropriately experienced environmental consultant validate the decommissioning in accordance with the UPSS Regulation guidelines and other relevant guidelines.

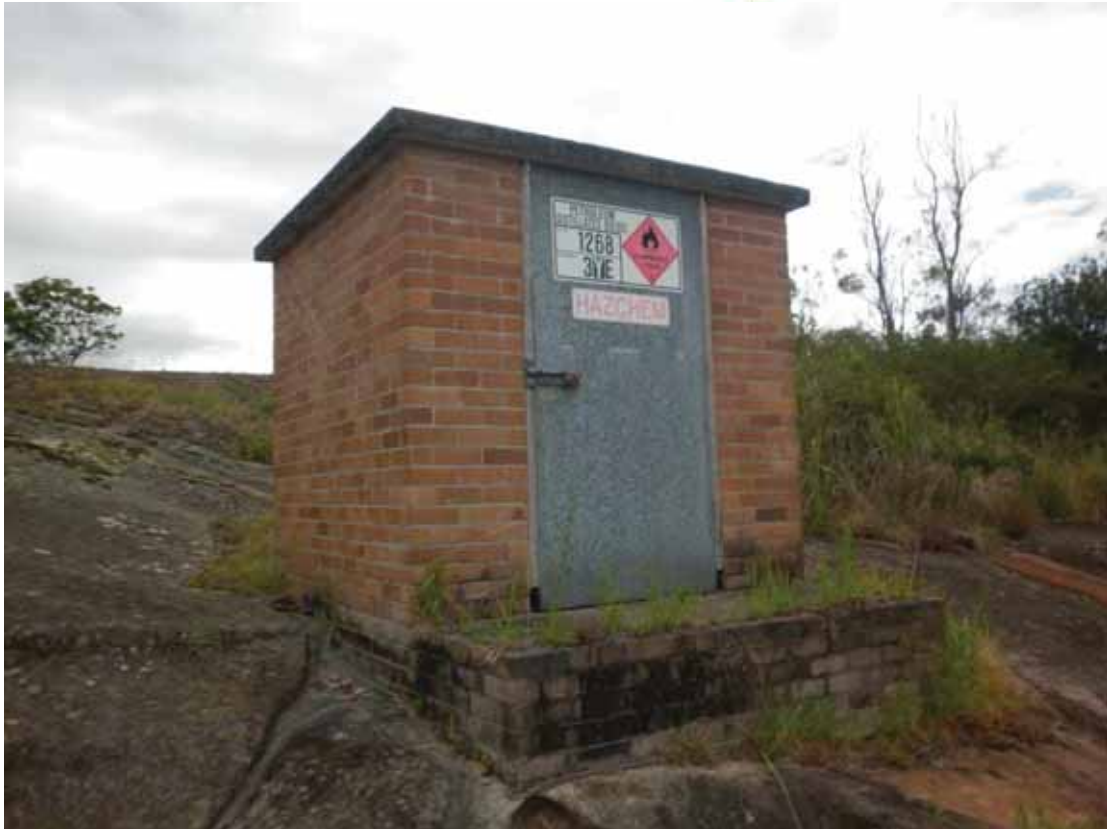
**Photograph 7** – Disused AST on mainland shed

| Areas 1 and 2 | Lot/DP | Description | Photographs |
|---|---|---|---|
| | | <p>was observed to the south of the administration building. The tank was rusted and in poor condition and was located within a storage shed on a slope approximately 25 m from the Hawkesbury River. The AST was located on a concrete slab but was not bunded.</p> <p>The land along the western boundary consists of flat, reclaimed land, with bitumen, concrete, bricks and plastic observed being used as reclamation materials.</p> | |

| Location | General Area | Goods |
|---|---|---|
| Portion 2 | Within a brick storage shed, a 1000 litre diesel above ground storage tank. | 1x 1000 L diesel AST, in poor condition |

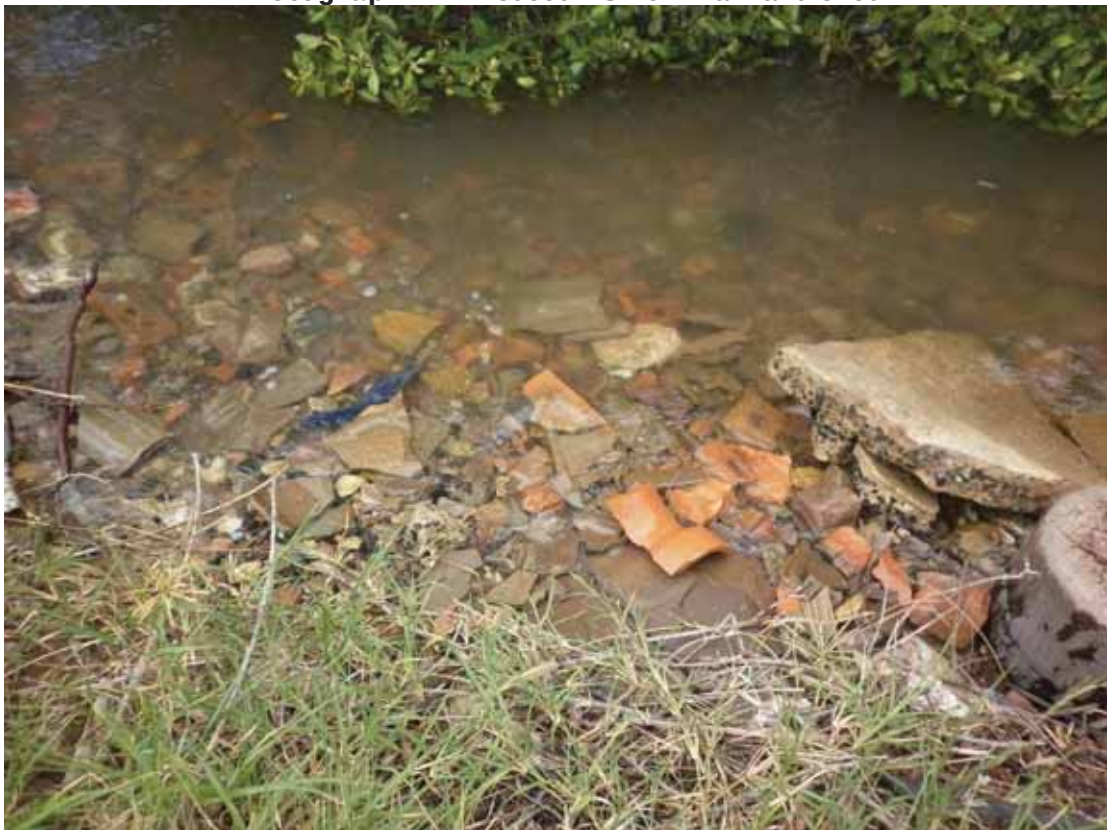
**Photograph 8** – Reclaimed Land along western foreshore of adjoining land

The site inspection indicated the presence of reclaimed land along the western foreshore and southern foreshore of Peat Island. Fill material of unknown origin could contain potential COPCs that are a risk to the environment or human health. Building rubble was observed within the reclaimed land and therefore there is potential for hazardous materials (e.g. asbestos) in the fill material.

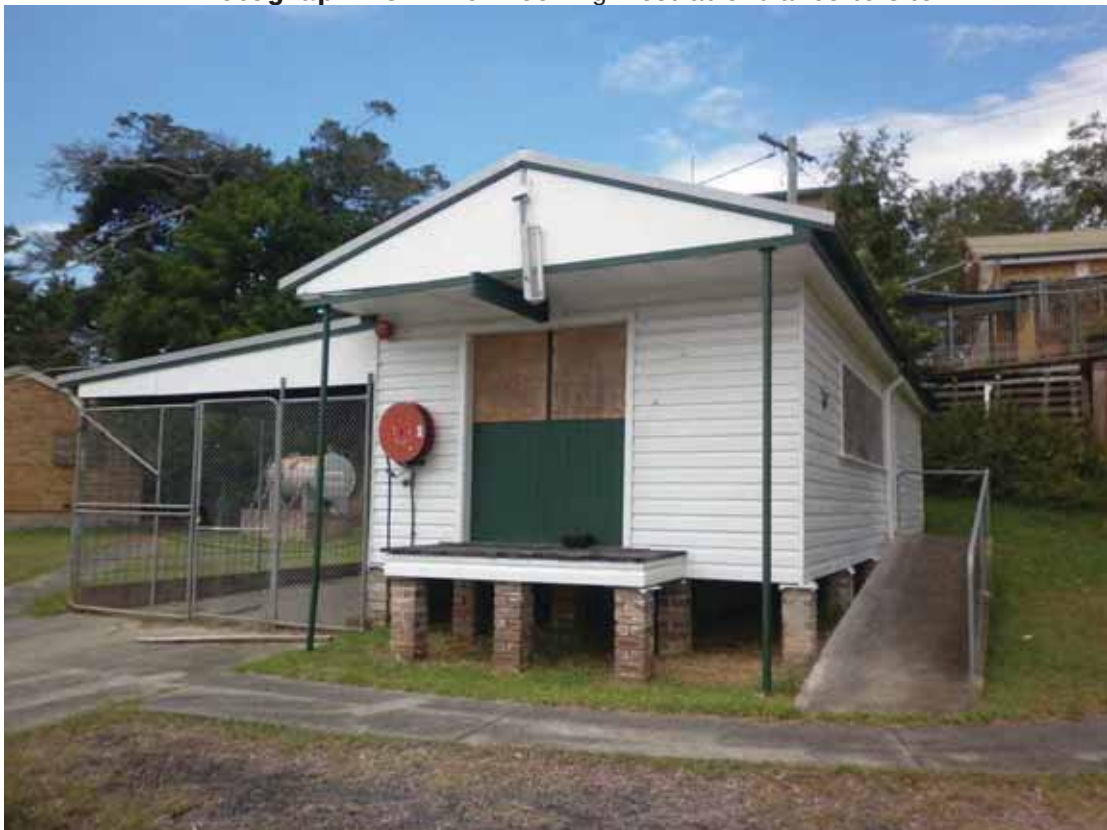
**Photograph 16** – Cleaners property

A cleaner's shed was located on Peat Island, along the eastern boundary of the island. The shed was a rectangular, wooden building, which was in moderate condition. Chemical signs were present on and in the building including corrosive signage. It is unknown what chemicals were stored within the shed or used at the site, however hydrogen peroxide was observed within a plastic bottle. Potential chemicals used at the site include lead paint, various solvent based chemicals such as degreasers and acid and/or alkaline based chemicals used to attack rust or clean the swimming pools located at the site.

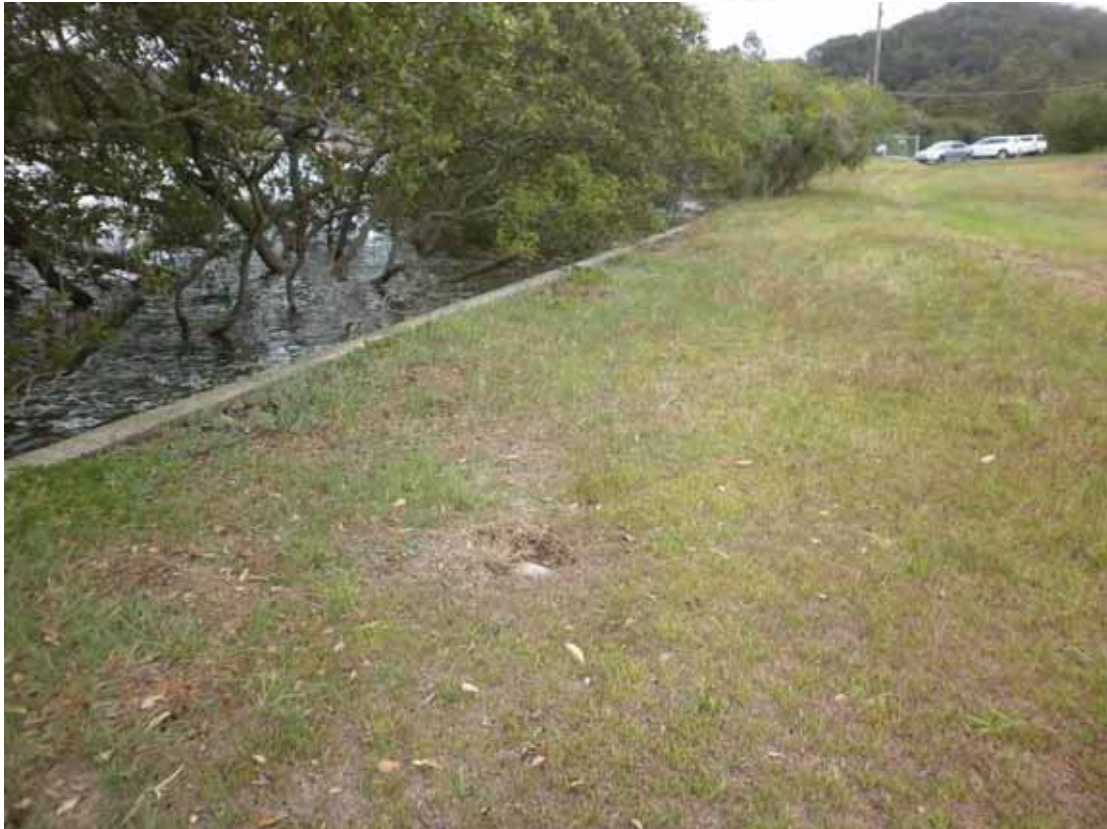
**Photograph 17 – Reclaimed Land**

| Areas 1 and 2 | Lot/DP | Description | Photographs |
|---|---|---|---|
| Area 1 Portion 4 - Adjoining Land to Peat Island | Lot 11 DP1157280 | <p>Vacant, vegetated area which consisted of flat, reclaimed land, with bitumen, concrete, bricks and plastic observed being used as reclamation materials.</p> | Photographs 17 |

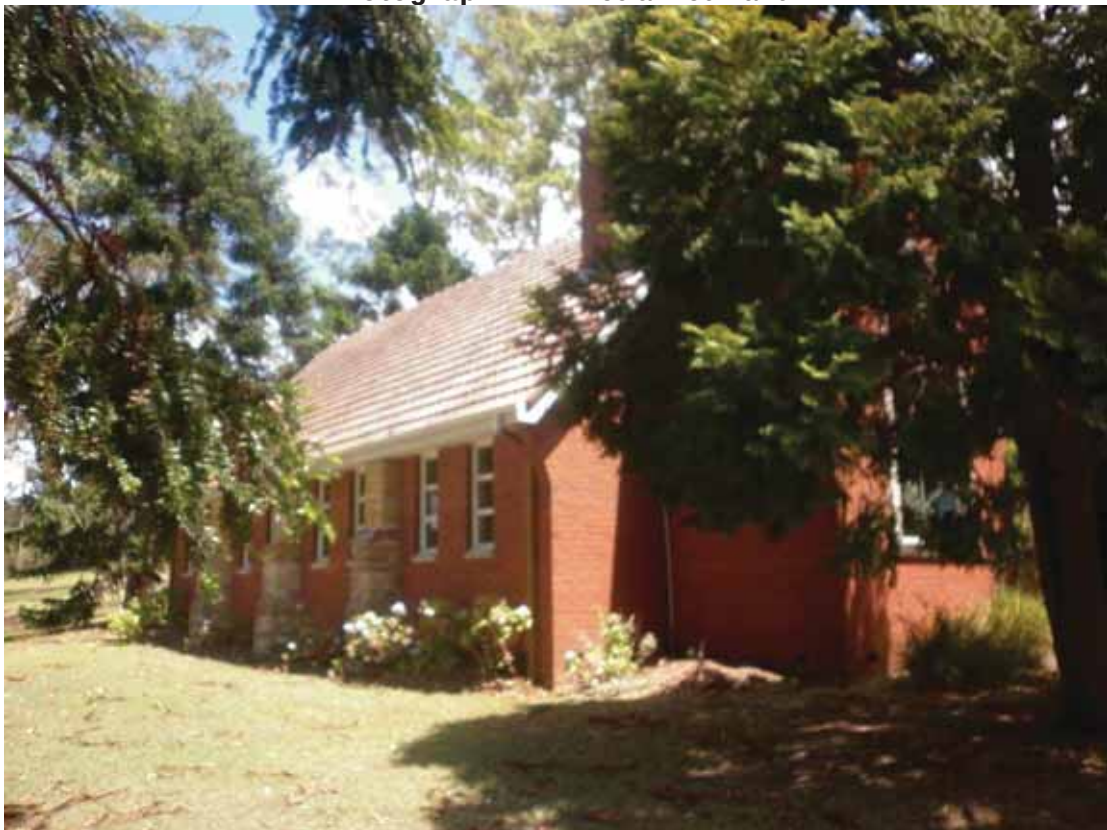
**Photograph 18– The Church**

| Areas 1 and 2 | Lot/DP | Description | Photographs |
|---|---|---|---|
| Area 1 Portion 6 – Hillside | Lot 6 DP597504 & Lot 1 DP 107391 | <p>Bushland, with a water tower located at the summit of the hill. The water tower was in good condition but is not part of the proposed development area.</p> <p>Adjacent to the Pacific Highway was a brick church. The church was in good condition. Adjacent to the church to the north west was a vacant accommodation building, which was in poor condition. A LPG Gas tank was observed adjacent to the building. A disused tennis court was present to the south of the accommodation.</p> | Photographs 18 - 22 |

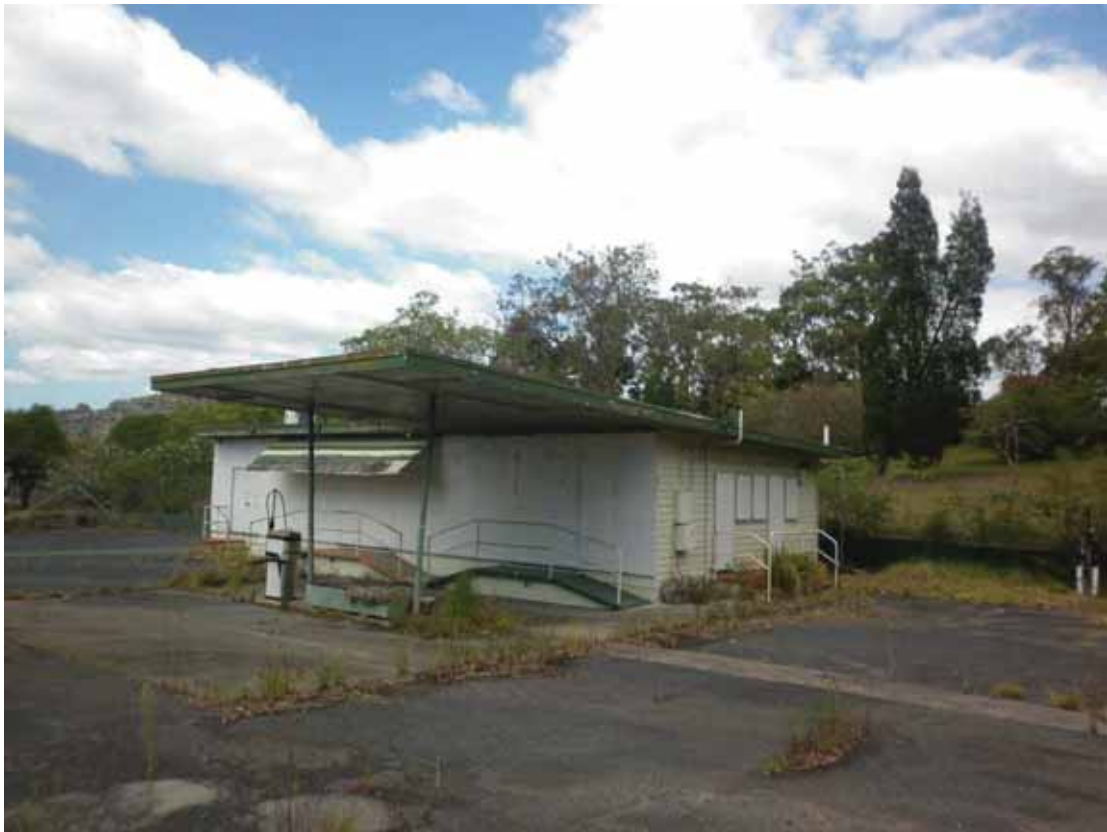
**Photograph 23** – View looking west at the Former Service Station

The service station was observed to contain at least three USTs, with the contents and size of the USTs being unknown (however, potentially unleaded and diesel due to colouring on bowsers present). The current contents and status of the USTs is not known.

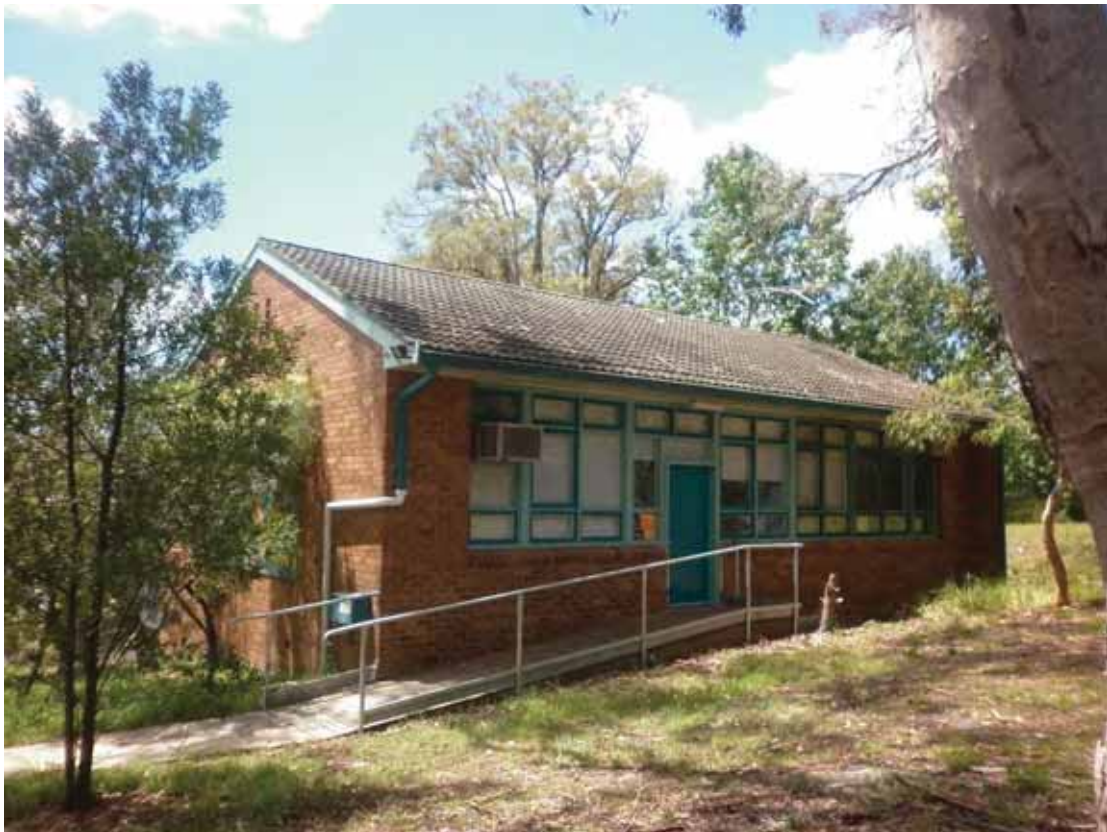
**Photograph 26** – View looking south at the Former School

| Areas 1 and 2 | Lot / DP | Description | Photographs |
|---|---|---|---|
| Area 2 Portion 9 DEC and Fire station | Lot 1 DP 431780 | A single storey, brick fire station was located along Point Road, with two concrete underground water tanks located at the back of the property.<br><br>Further to the south was located four wooden and brick school cabins. A playground was located within the central portion of school. A concrete toilet block was located at the southern boundary of the school, with a single, concrete septic tank located to the south east of the toilet block.<br><br>To the east of the school the topography sloped down to the east approximately 2 m, with a sports field located adjacent to the school. | Photographs 26 - 29 |

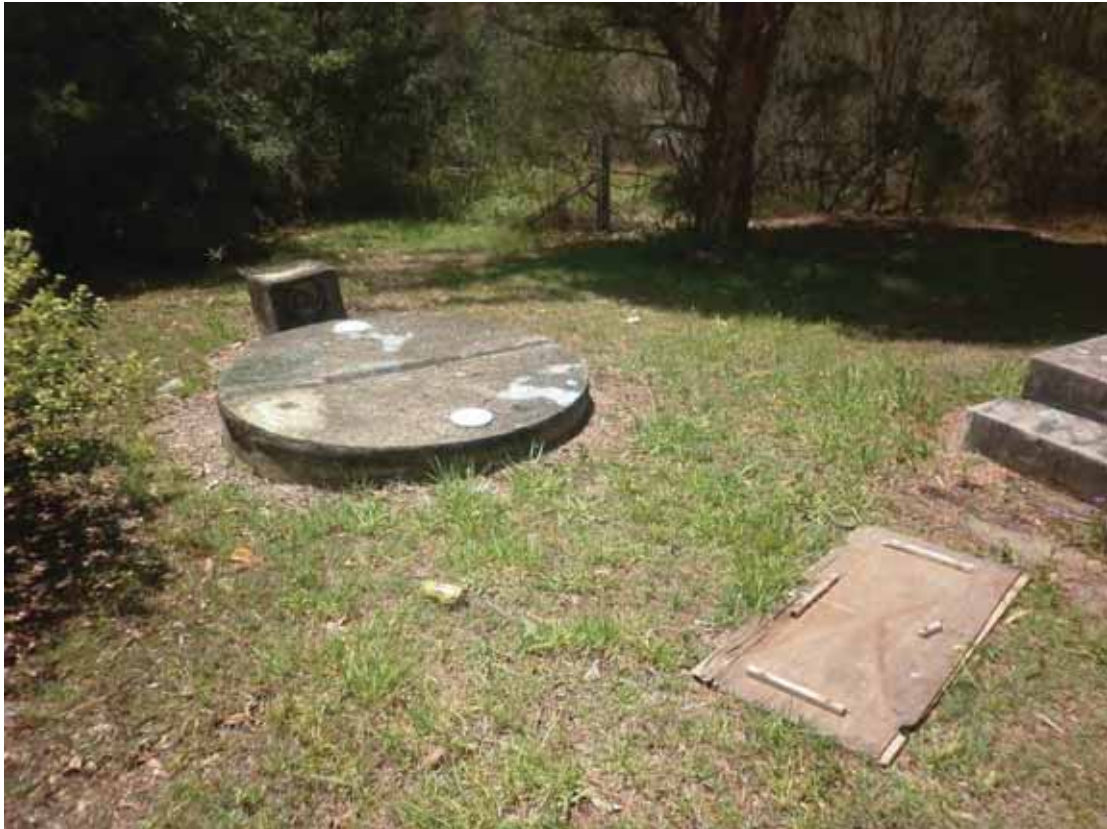
**Photograph 28** – View looking south at the septic tank

Area 2 containing the former school was observed to have a septic tank and associated fill material.
