**Preliminary Site  
Contamination  
Report**

For proposed  
Rezoning Application

502 Bridgman Rd, Wattle Ponds  
**SINGLETON**

## **PRELIMINARY SITE CONTAMINATION REPORT**

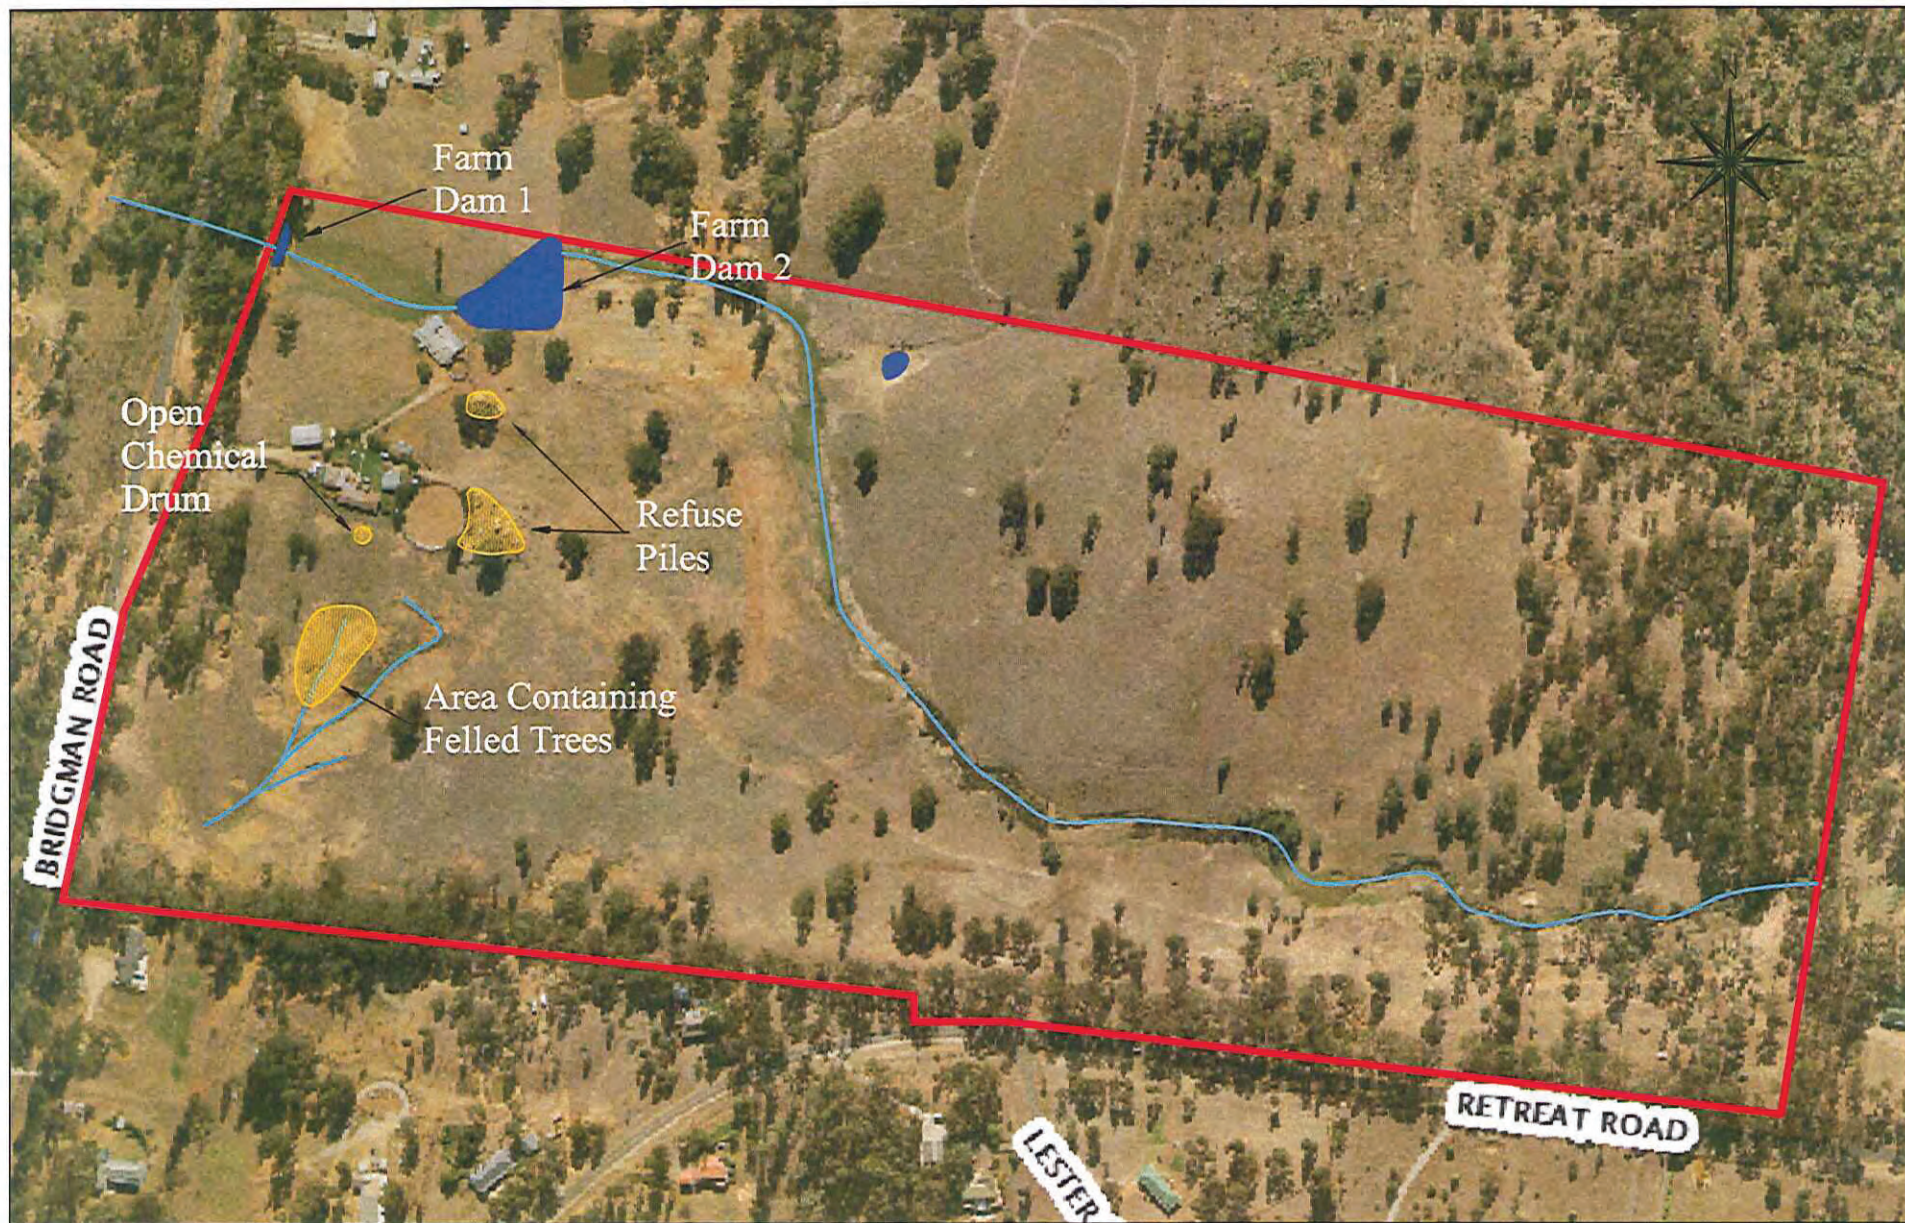
- No visible signs of spills or leaks outside the brick dwellings;
- No obvious odours outside the structures or within the site boundaries;
- Several large areas of scrap material (empty pressed metal drums, concrete stormwater pipes, scrap metal etc), derelict vehicles and machinery (car bodies, motorbikes, trailers, lawnmowers etc), fencing material (strainer posts etc) and refuse piles containing house hold waste etc [Refer to Figure 5 (p13) and Plates 8, 9 and 10 (p16 – 17)].

- Several felled trees located in the south western creek line (the current owner has utilised these to try and reduce stormwater velocity and limit erosion within the creek line) [Refer to Figure 5 (p13) and Plate 13, p20].

- No visible on-site losses of dangerous goods or discarding of explosive materials;
- Established vegetation (trees and shrubs) appeared healthy
- A large open liquid container containing a dry black lining of material which has the odour of road tar emulsion. The container is located to the south west of the 'show ring' [Refer to Figure 5 (p13) and Plate 7 (p16)].

It was noted during the site inspection that the site contained several areas of refuse material. These areas were located to the north west of the existing dwellings and to the west of the dressage/show ring [Refer to Figure 5 (p13)]. The areas contained a large amount of material that could not be identified as it was inaccessible due to the quantity of material present. From what was visible and accessible, the refuse piles appeared to contain:

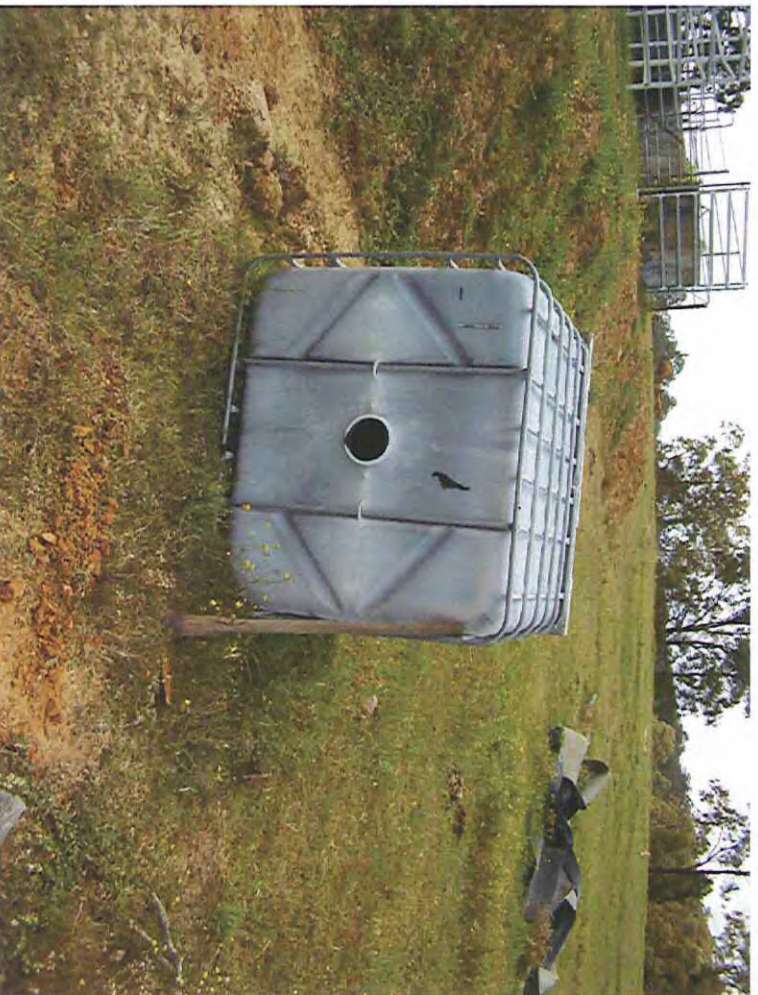
**PLATE 7: VIEW LARGE OPEN CHEMICAL CONTAINER**

During the site inspection it was noted that the grazing paddock (approximately 80 acres) contained several empty pressed metal oil drums and a large plastic chemical drum, the area surrounding these drums was inspected and no obvious signs of leaks and/or spills were observed.

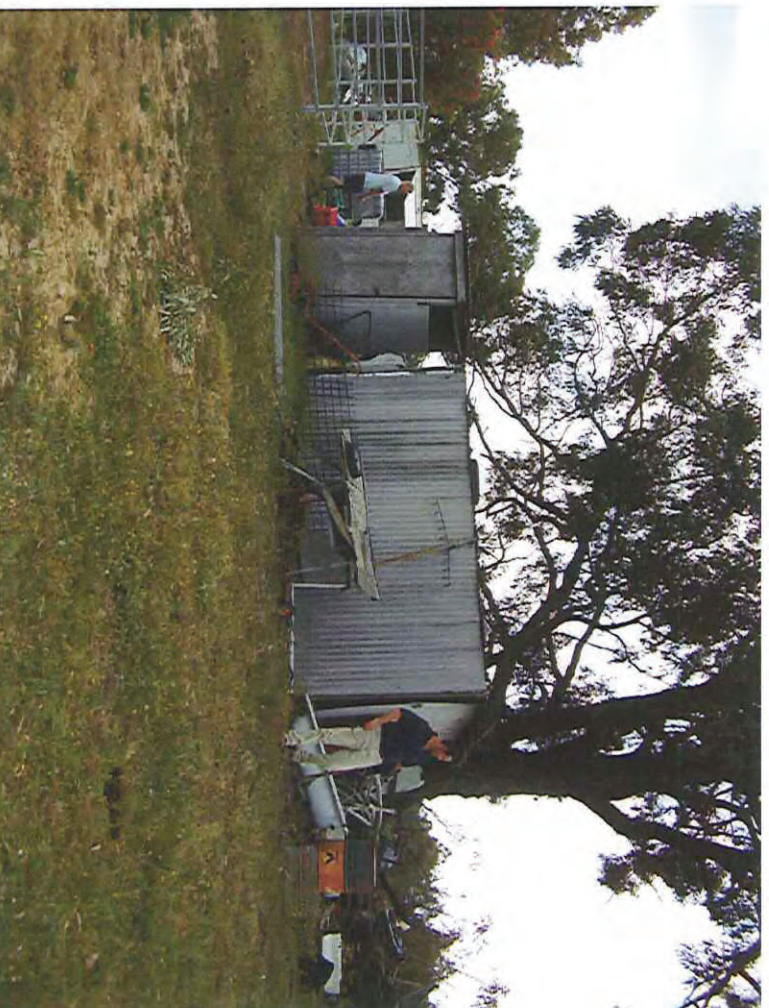
**PLATE 8: VIEW OF AREA CONTAINING REFUSE MATERIAL**

- Scrap metal;
- Vehicle (car and truck) bodies;
- Derelict (inoperable) vehicles and lawn care equipment
- Fencing material;
- Agricultural Machinery, parts and equipment; and
- Domestic household waste.

It has been determined that these areas pose a moderate contamination risk, as the areas could not be fully explored. These areas of concern are located entirely within the front 8.1 hectares of the site and are therefore not expected to impact upon the remaining development area.

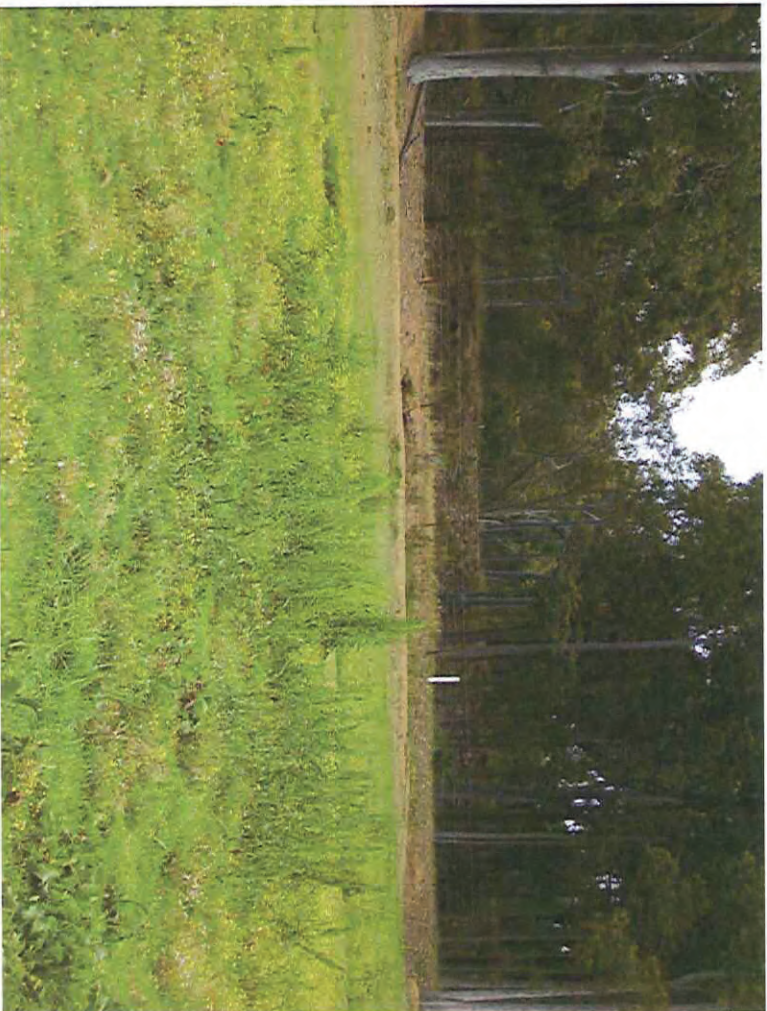
PLATE 11: VIEW OF TOWARDS OBANVALE WTP AND FARM DAM 1

The Obanvale Water Treatment Plant (WTP) is located to the north west of the site [Refer to Plate 11 (p18)]. Topographic mapping indicates ephemeral drainage flows adjacent to the WTP effluent ponds. The drainage line continues through the WTP site, under Bridgman Road, through two (2) small farm dams (Farm Dams 1 & 2) before traversing the development site, [Refer to Plate 12 (p18)].

After discussions with the current owners and surrounding land owners, it has been determined that the only time the drainage line contains water is during the WTP ‘flushing’ process as well as periods of heavy rainfall.

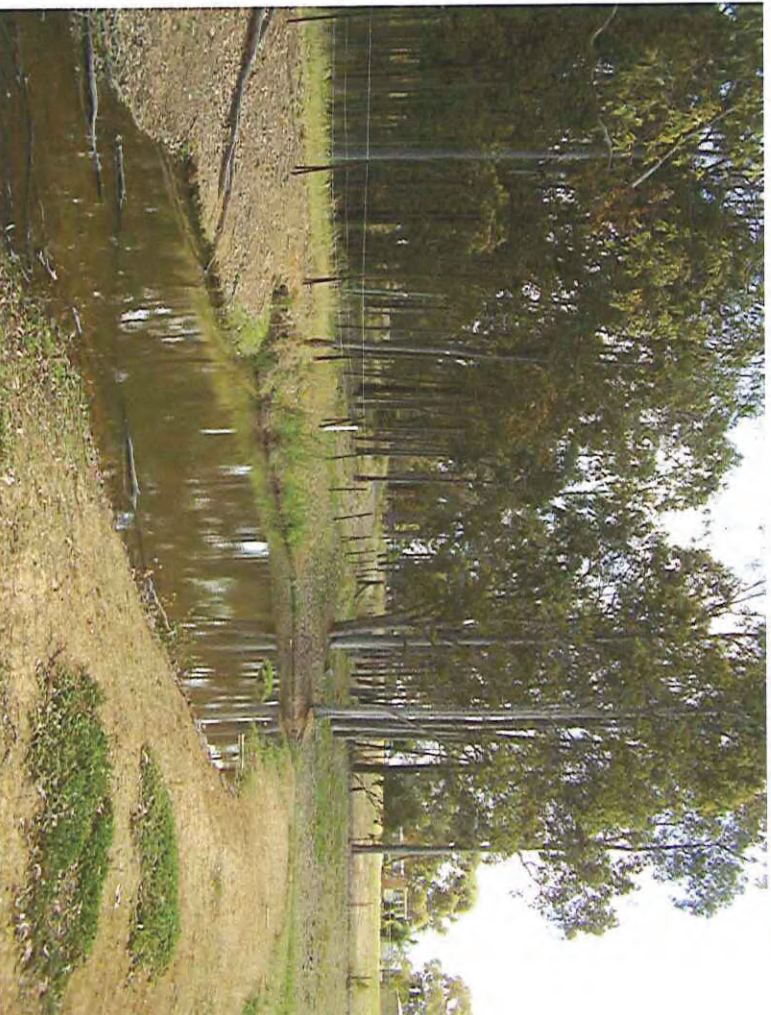
PLATE 12: VIEW OF FARM DAM 1 LOCATED IN THE NORTH WESTERN CORNER OF THE SITE

Mr Geelan and Mr Badior have informed us that when the WTP is ‘flushed’ excess filter water migrates onto the subject site. This excess water is captured by a small dam (Farm Dam 1) located in the north western corner of the site [Refer to Figure 3 (p10)].
