ELOURA HOLDINGS PTY LTD

SEPTEMBER 2018

GEOTECHNICAL INVESTIGATION REPORT

176-184 GEORGE
STREET, CONCORD
WEST NSW

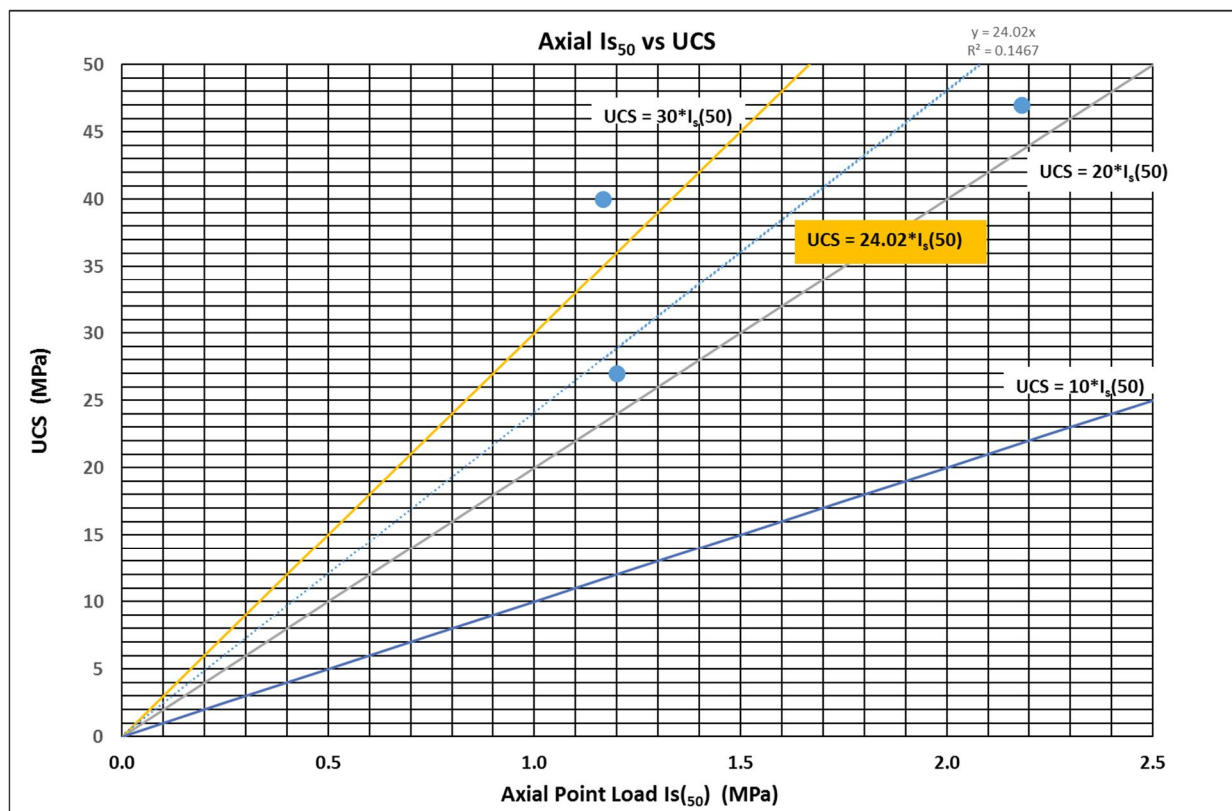
Figure 5-1 Correlation between point load index and uniaxial compressive strength

To determine the strength of the rock, a total of 27 point load index (PLI) tests were carried out (axial and diametrical) and 3 uniaxial compressive strength (UCS) tests were performed on the rock cores retrieved from the boreholes. Assessment was performed to correlate the PLI and UCS; the plot is presented in Figure 5-1. A multiplier of 20 has been adopted for the rock strength classifications for the shale of medium strength or better encountered at the site, which is at the lower bound of expected variability.

Given the presence of relatively shallow rock, likely footing systems would comprise strip or pad footings founded on medium strength rock or better. Footings founded on this material using the recommended allowable capacities should have load induced settlements of no greater than 1.0% of the footing width.

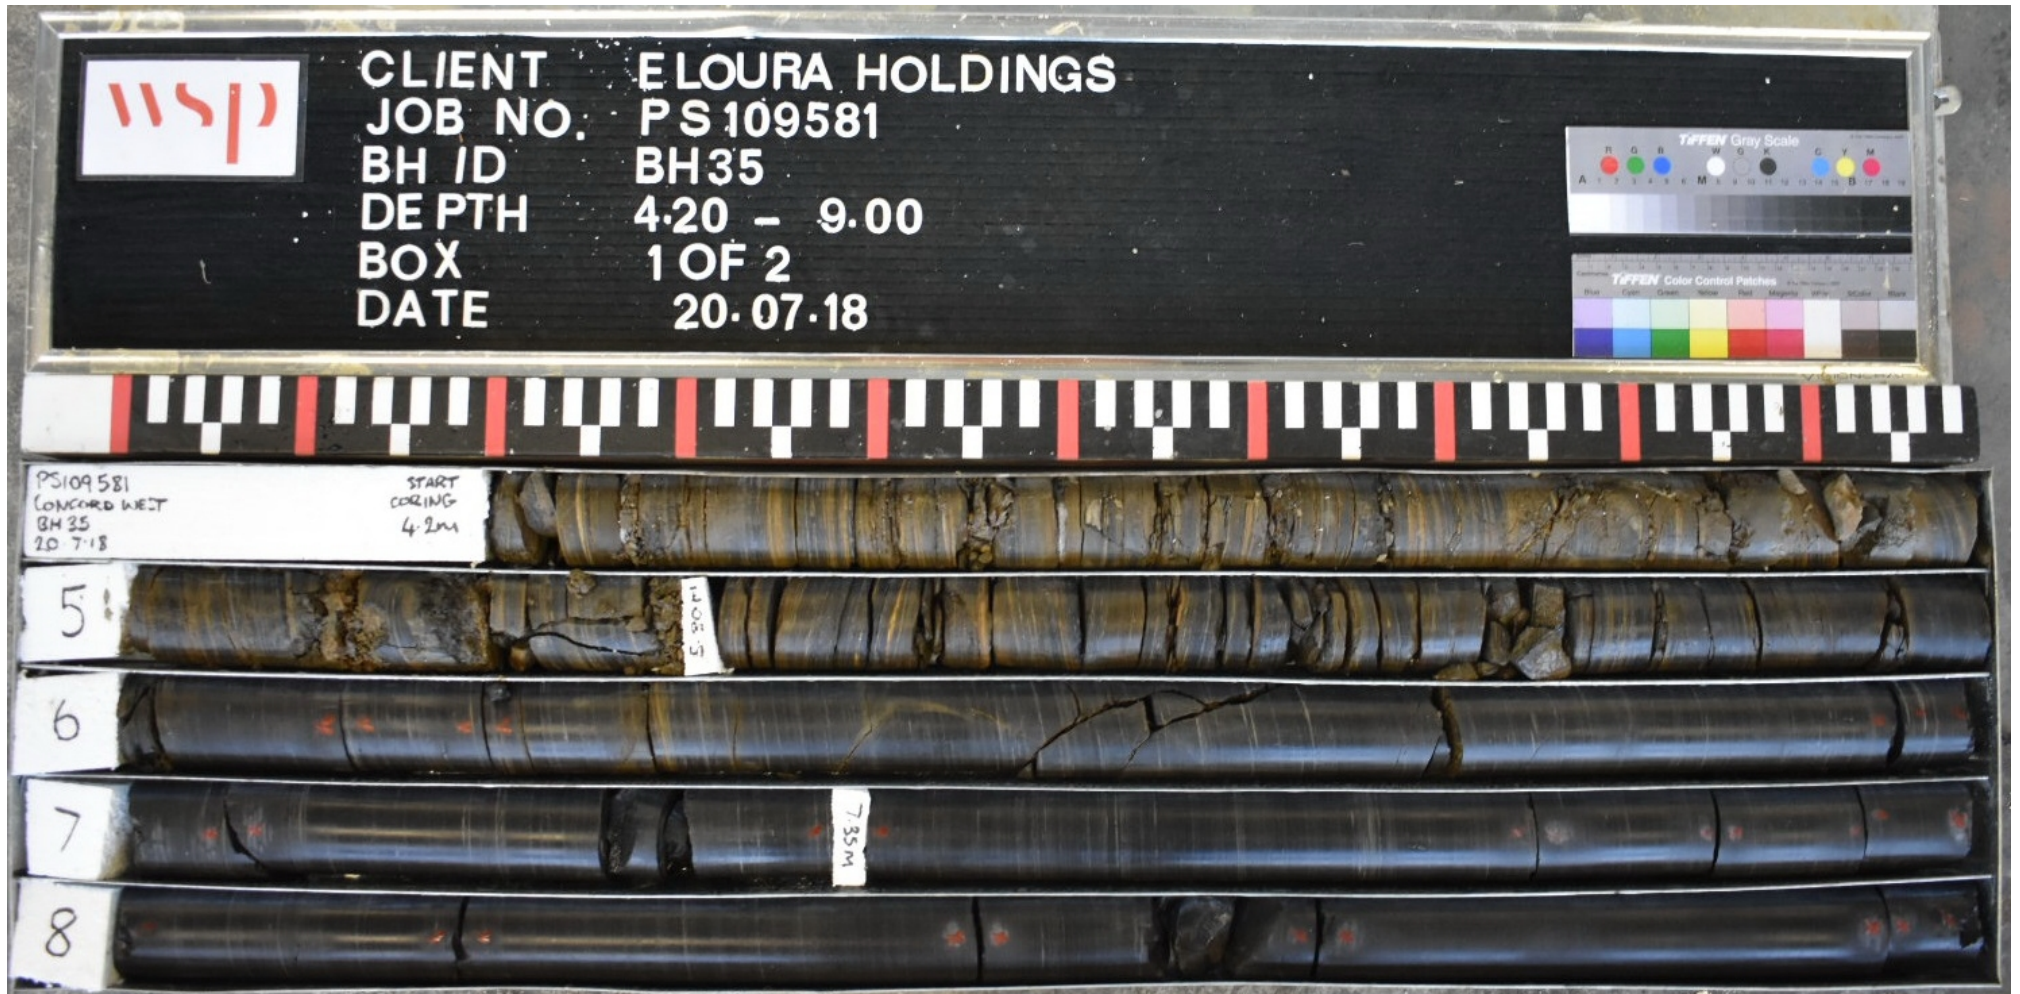
PointID : BH35 Depth Range: 4.20 - 9.00 m

TITLE Eloura Holdings Concord West 176-184 George Street Core Photo - BH35	DRAWN GW	DATE 27/07/2018
		CHECKED DW	DATE 27/07/2018
		SCALE Not To Scale	A4
		PROJECT No PS109581	FIGURE No 1/2

START CORING AT 4.20m SHALE; fine grained, dark grey and brown, layered, bedding 0-5deg, iron staining throughout	MW to HW

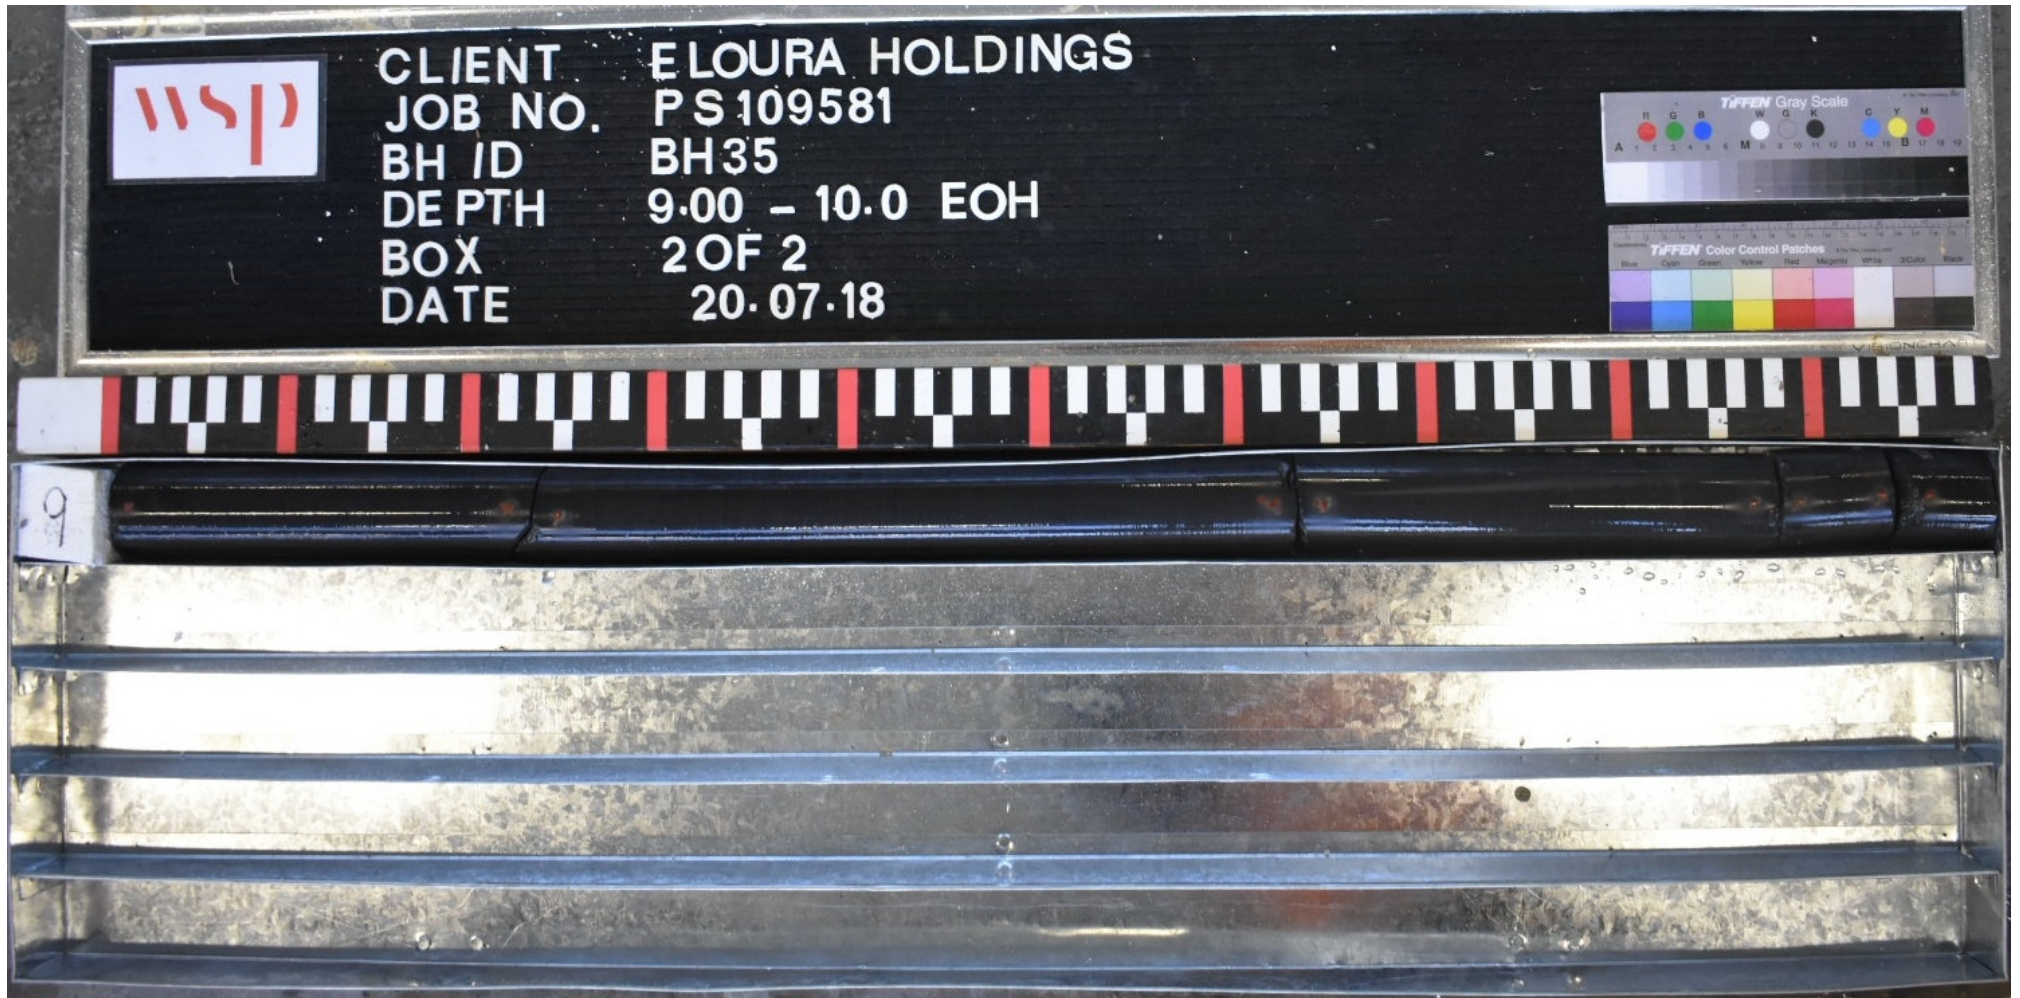
PointID : BH35 Depth Range: 9.00 - 10.00 m

TITLE Eloura Holdings Concord West 176-184 George Street Core Photo - BH35	DRAWN GW		DATE 27/07/2018		
		CHECKED DW		DATE 27/07/2018		
		SCALE Not To Scale				A4
		PROJECT No PS109581		FIGURE No 2/2

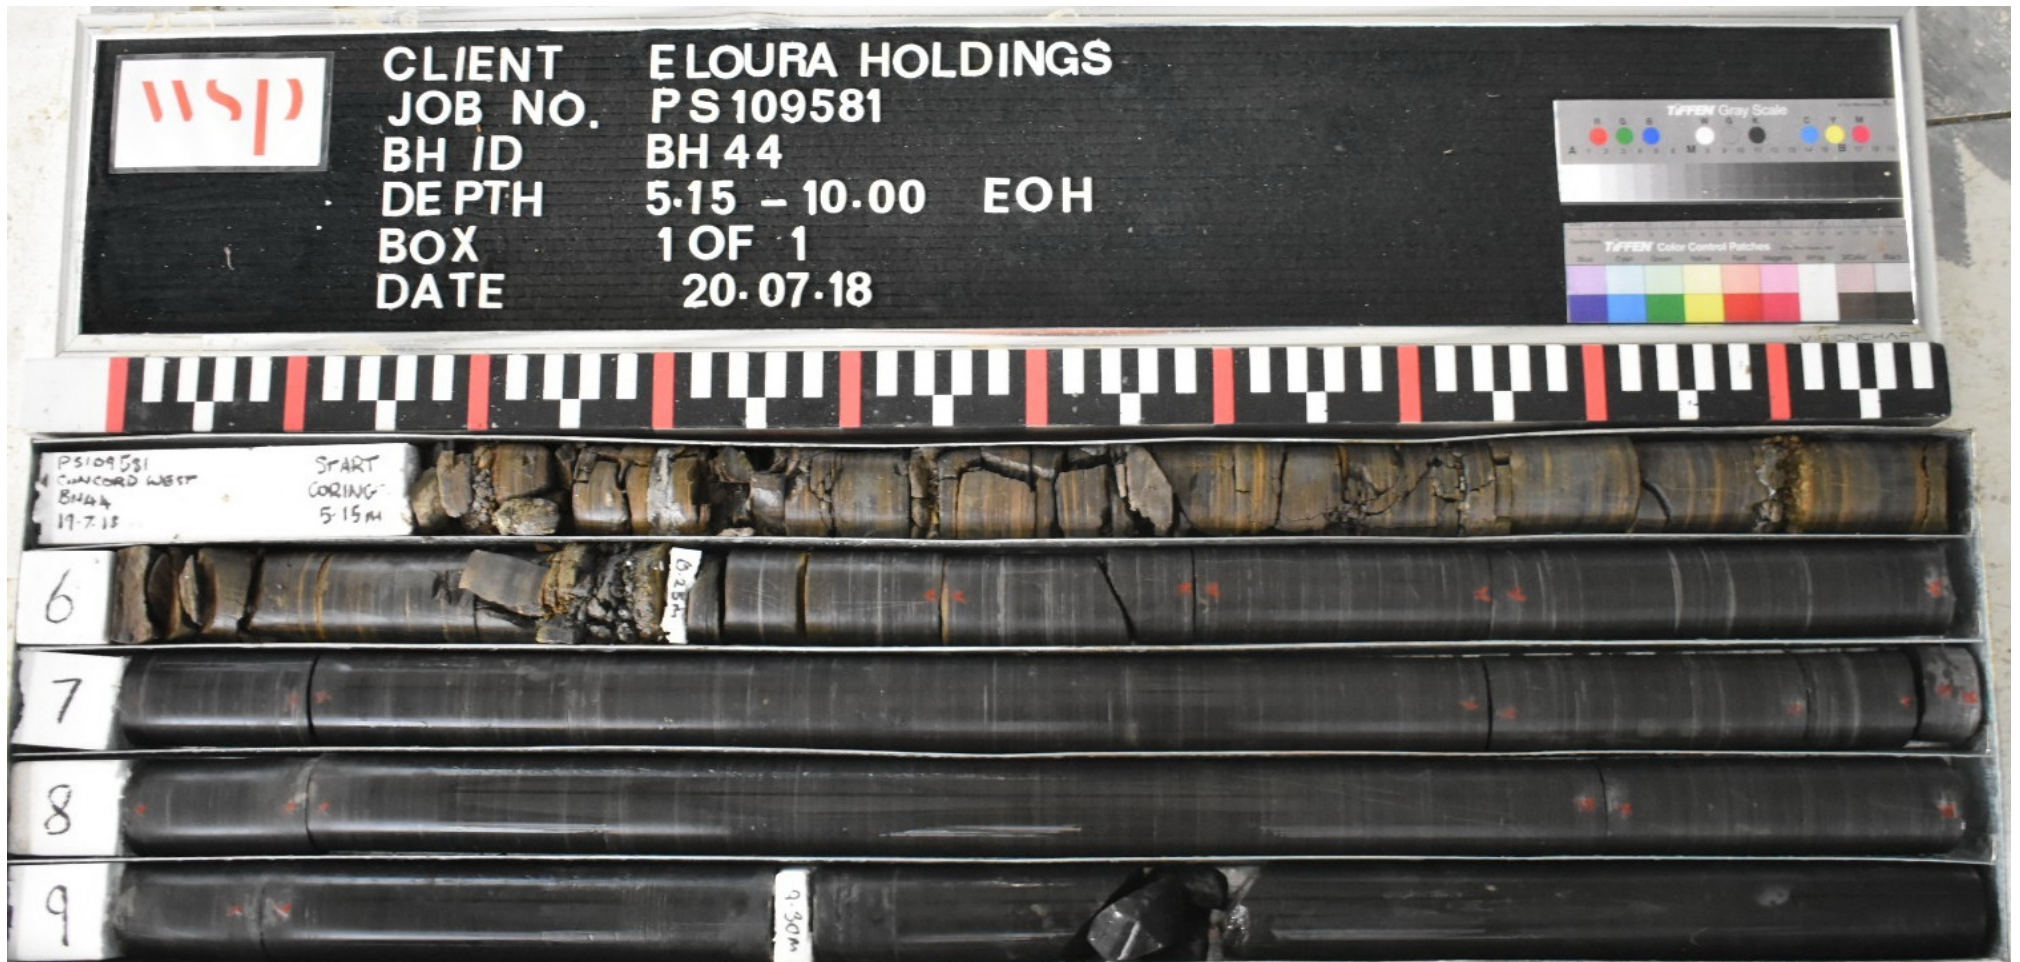
PointID : BH44 Depth Range: 5.15 - 10.00 m

TITLE Eloura Holdings Concord West 176-184 George Street Core Photo - BH44	DRAWN GW		DATE 30/07/2018		
		CHECKED DW		DATE 30/07/2018		
		SCALE Not To Scale				A4
		PROJECT No PS109581		FIGURE No 1/1

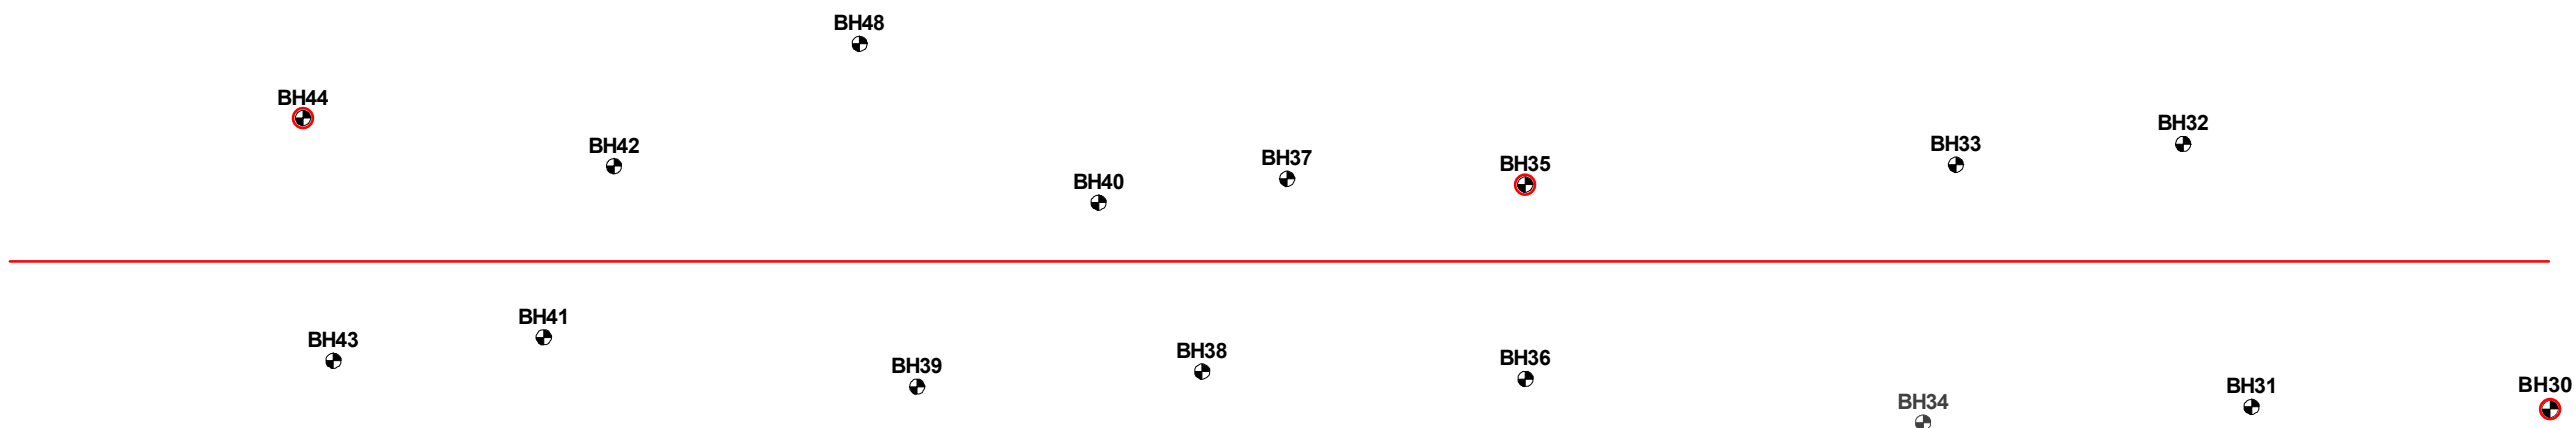
GEOTECHNICAL LONG SECTION

Note: All elevation data is indicative due to inaccuracies in handheld GPS

A geotechnical long section outlining inferred subsurface conditions across the project site based on lithological information from three geotechnical boreholes and contamination boreholes is presented in Appendix D. Detailed geotechnical and contamination borehole logs can be found in Appendix C, and Contamination investigation report, WSP (2018), respectively. Interpretation of geological units are in accordance with the geological descriptions summarised in Section 4.2.

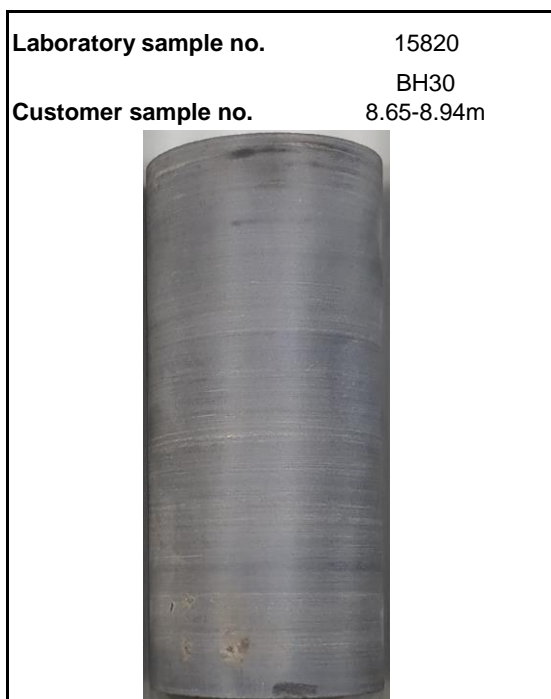
Specimen prior to testing

Uniaxial Compressive Strength of Rock Core
