**DRAFT**  
**DEVELOPMENT CONTROL PLAN**  
**No.**

**PARKSIDE AT TERRIGAL**

Adopted by Gosford City Council  
X xxxx 2009

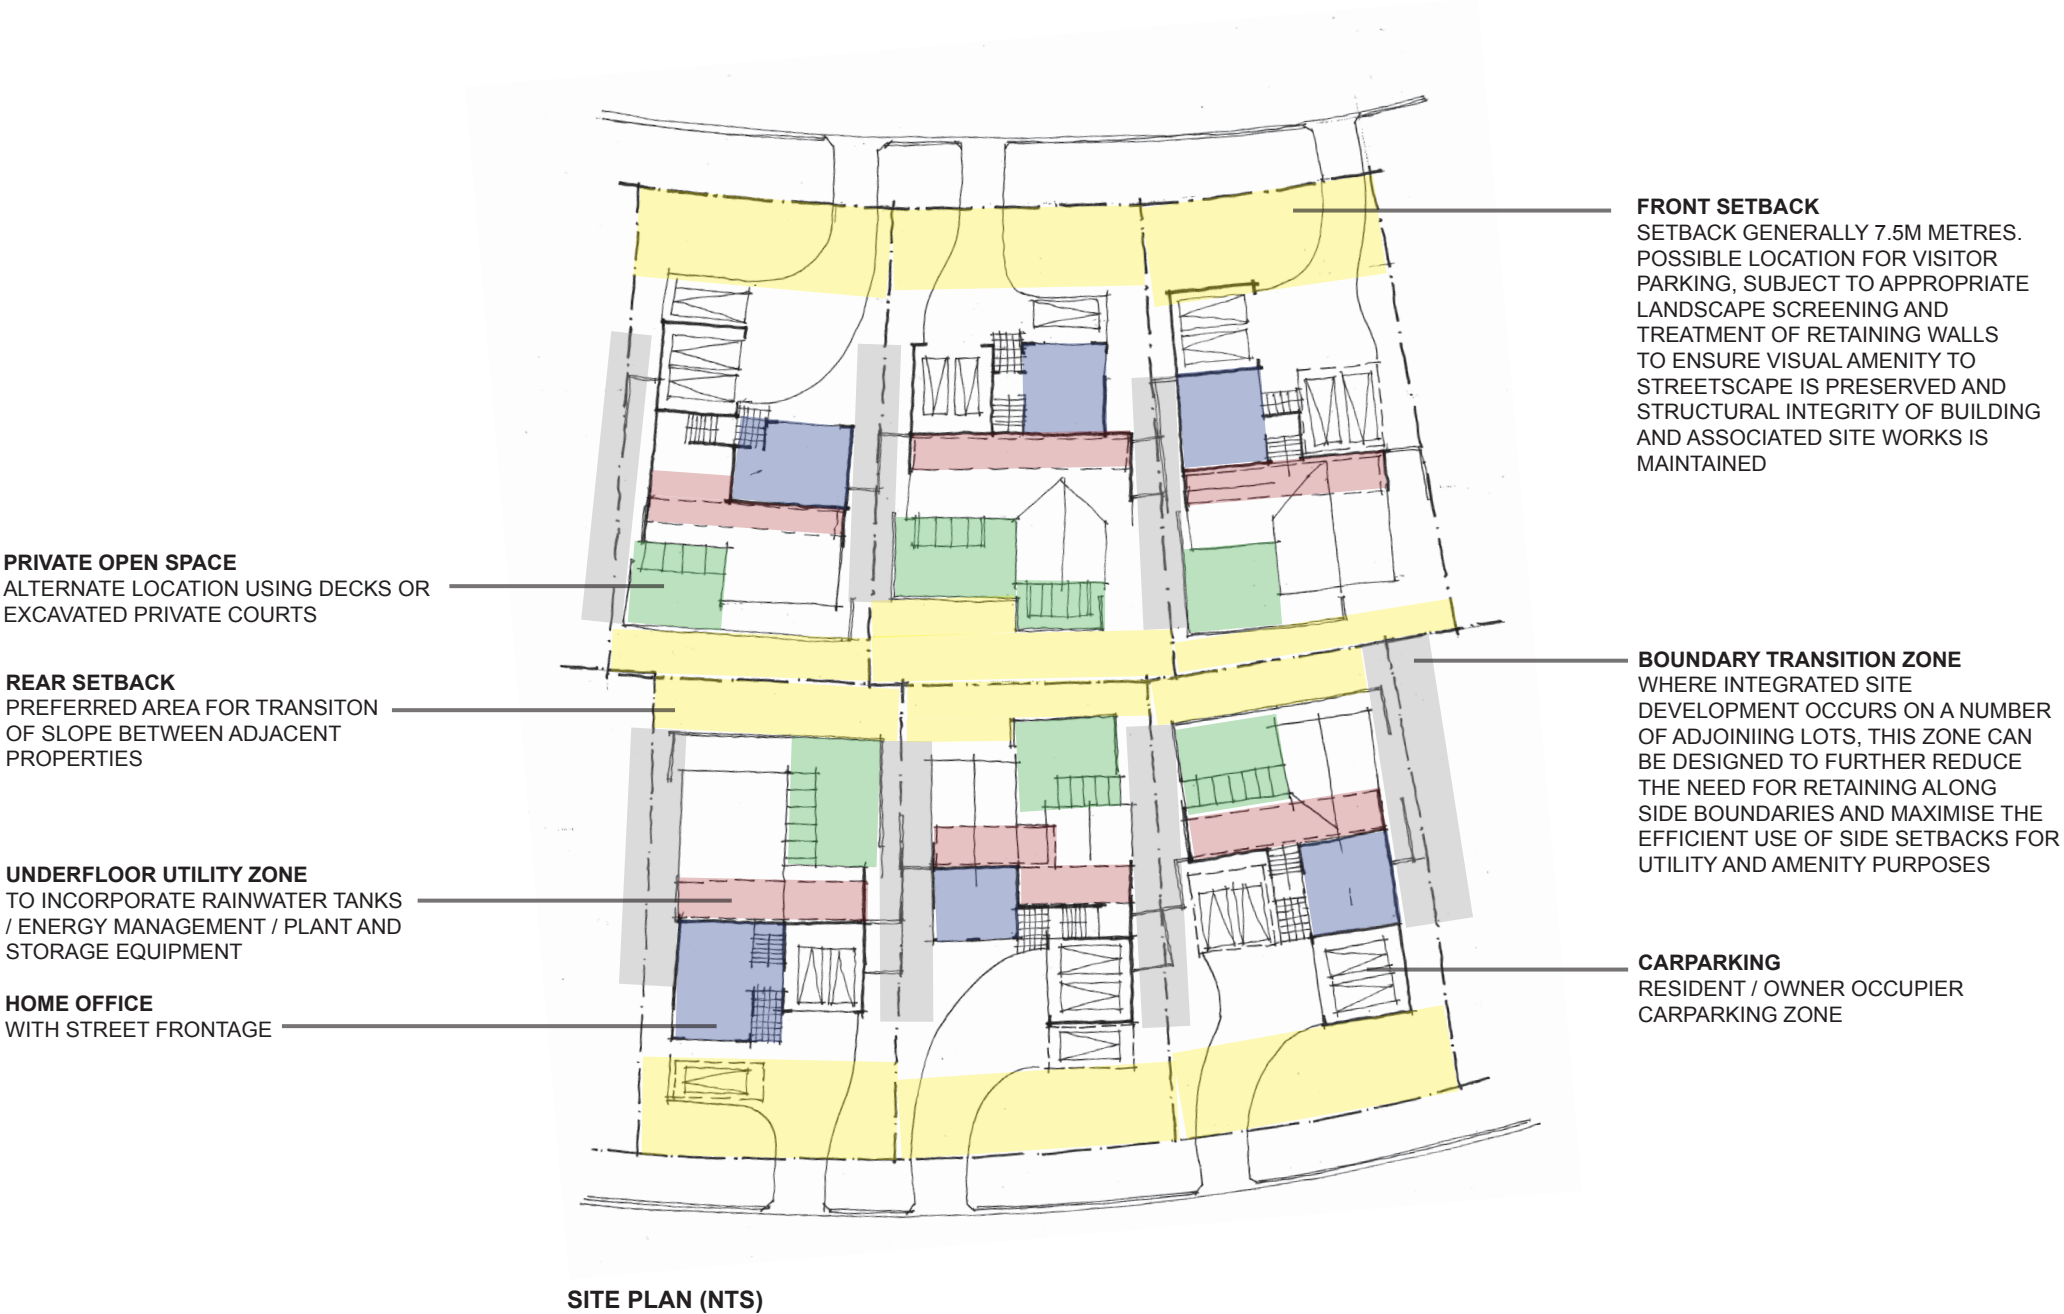
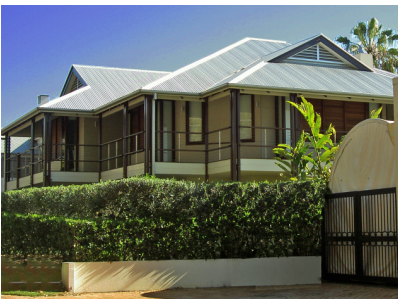
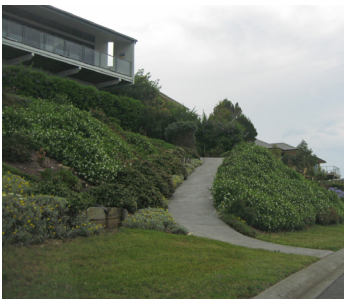
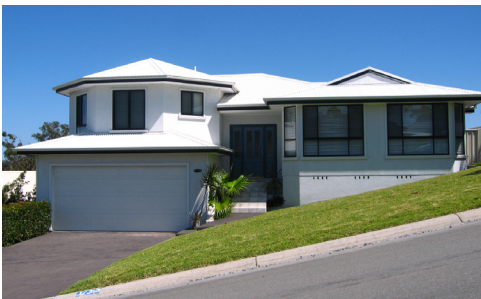
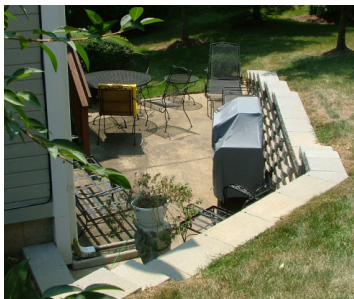
# option A - house design requirements

WHEN USED:
  - TO ADDRESS CHANGES IN SITE LEVEL
  - TO PROVIDE CONTAINED SINGLE LEVEL SPACES FOR INDIVIDUAL FUNCTIONS, SUCH AS PRIVATE OPEN SPACE OR HOME OFFICE
  - SCREENING TO UNDERCROFT SPACES, TO MAINTAIN VISUAL AMENITY TO STREETScape
- 4. CUT AND FILL -**  
TO BE USED PRUDENTLY TO ADJUST EXISTING SITE LEVELS TO ACHIEVE OPTIMAL DWELLING DESIGN OUTCOME

WHEN USED:
  - WHERE ADJUSTMENT TO SURFACE LEVELS AND RETAINING WALLS IS REQUIRED, RETAINING WALLS OVER 1 METRE IN HEIGHT SHOULD BE TERRACED WITH APPROPRIATE LANDSCAPE

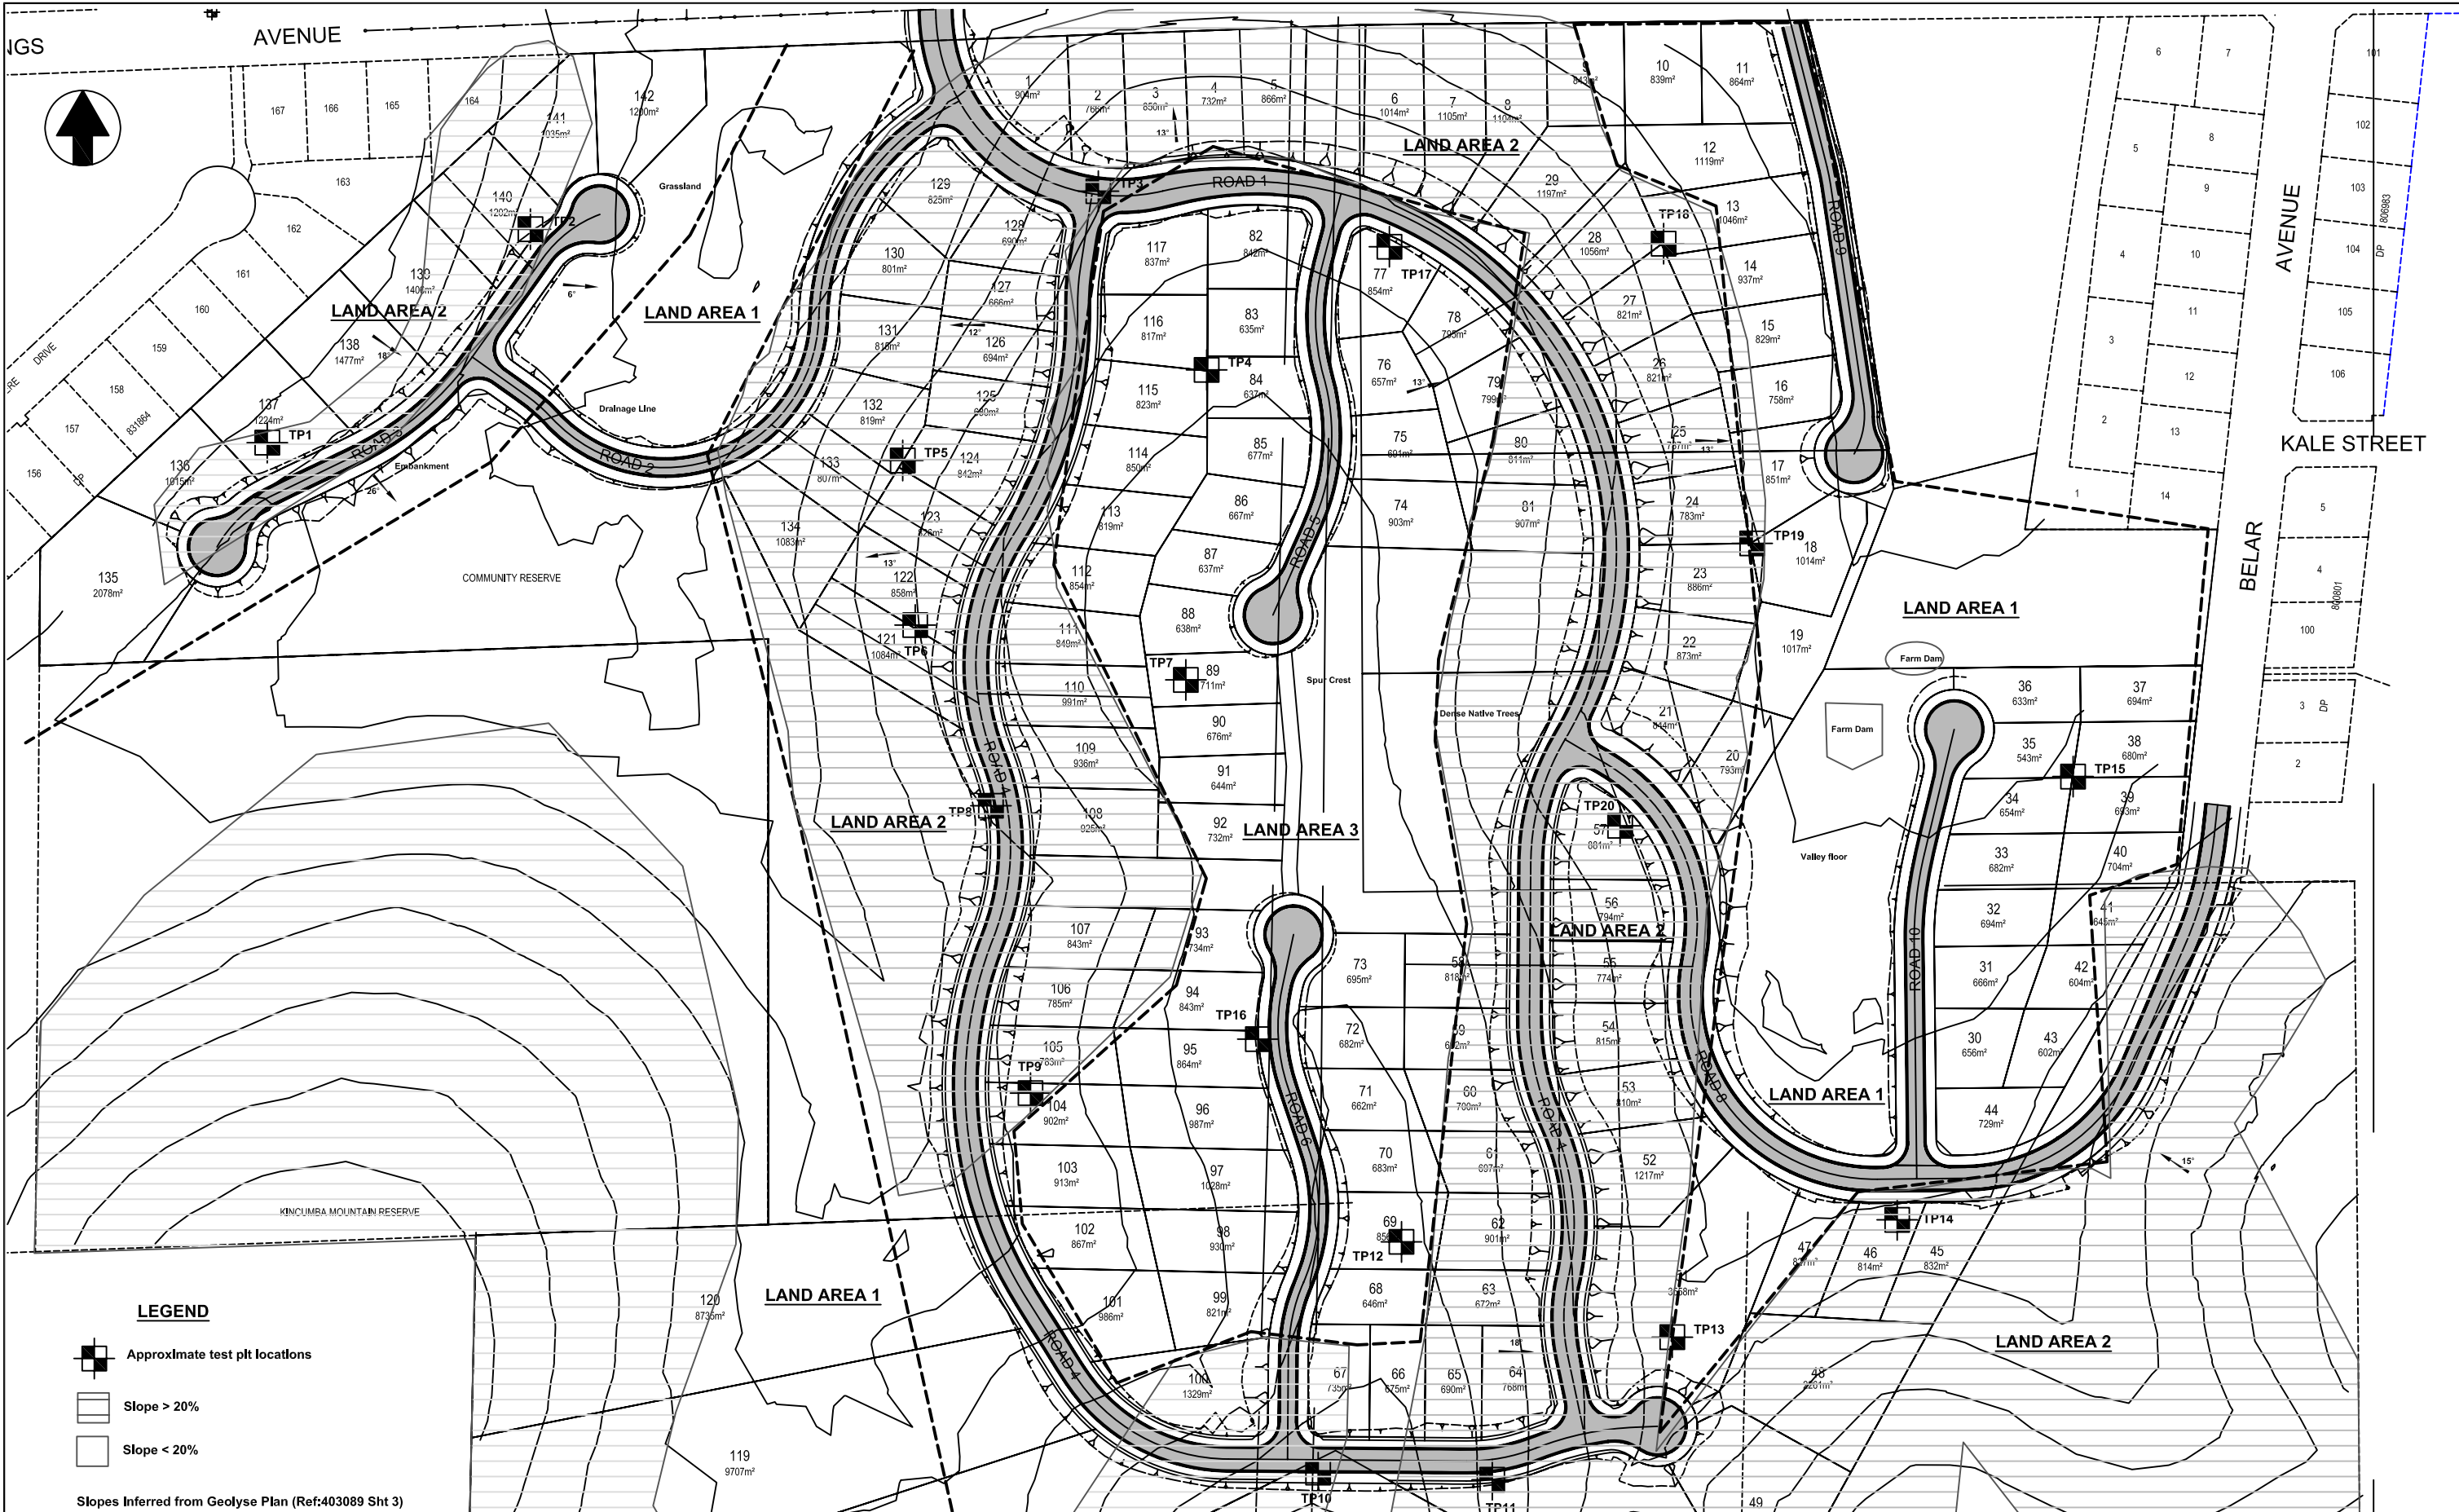
| project no: | GEOTKARI02083AA | drawing no./figure no:<br>FIGURE 2 |

| title: | SITE PLAN AND INVESTIGATION LOCATIONS | |
