## Visual Analysis & Impact Assessment

December 2010

[Parkside@Terrigal](mailto:Parkside@Terrigal)  
Kings Avenue, Terrigal

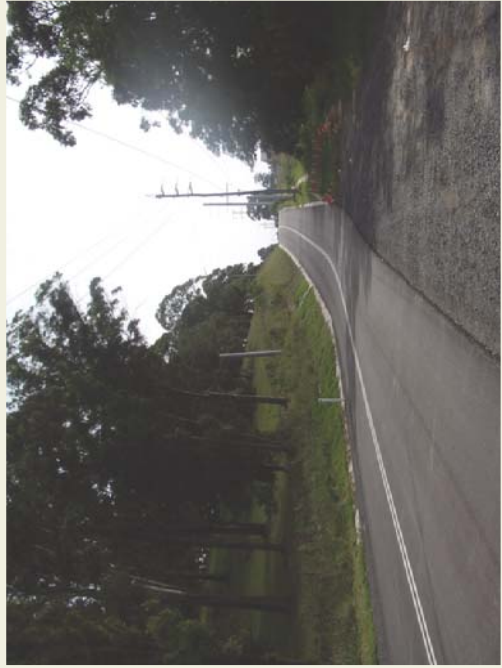
1. View looking west along Kings Avenue. The site is to the left of the road and a steep 'cut' batter limits views along the ridgeline from the road.

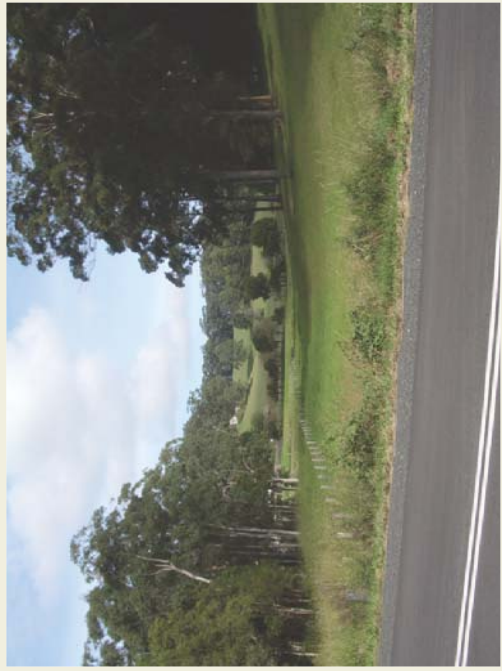
2. View looking south towards the cleared eastern valley. Existing stands of vegetation & rural residential lots create a pleasant character amidst the surrounding dense, residential development.

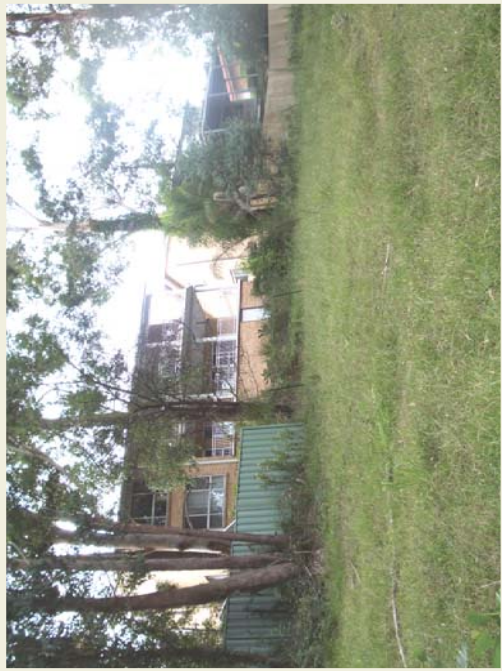
3. Adjoining properties on western boundary, are designed to take advantage of views into the site.

These slopes differ from the first zone in that the gully vegetation to the west of the slopes inhibits distant views. Where views are possible they are into the rear yards of large brick and tile homes located along Windermere Road. The views from these slopes are also limited to the south by the rising topography. (Refer photo 3, page 5)

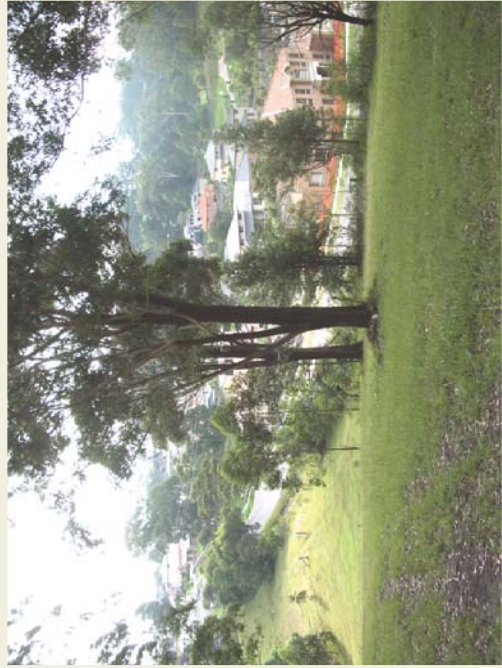
4. View looking north west to surrounding residential area. The back drop of vegetation along the Terrigal Drive ridgeline maintains the sense of "the valley".

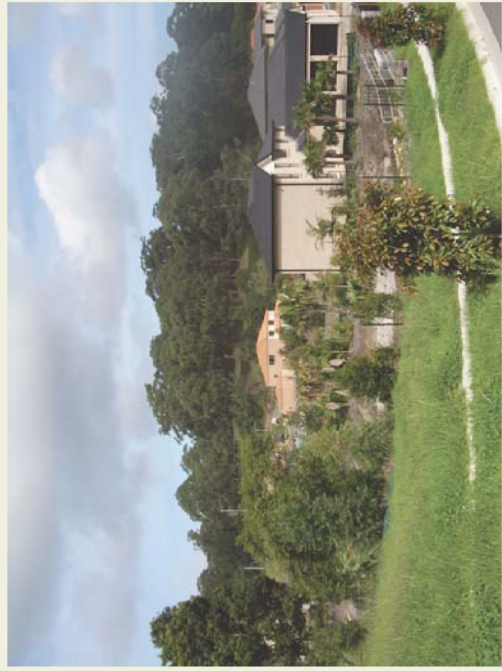
5. View looking south towards the central, vegetated ridgeline. The existing site vegetation provides a backdrop to residential areas on the northern side of Kings Avenue.

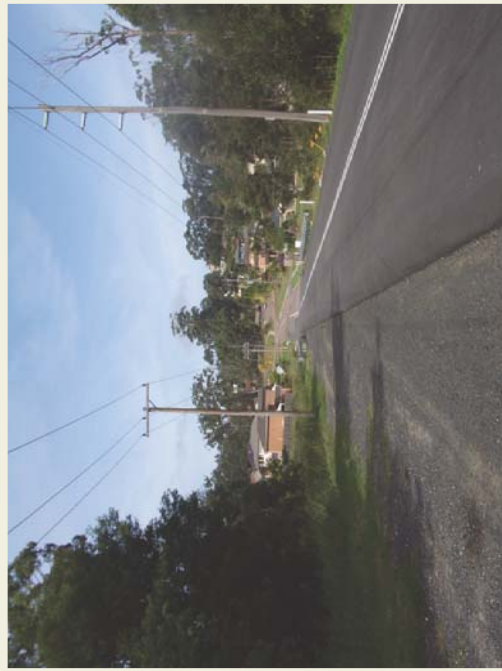
6. View looking east along Kings Avenue. Existing vegetation & informal road verges evoke a sense of semi-rural living.

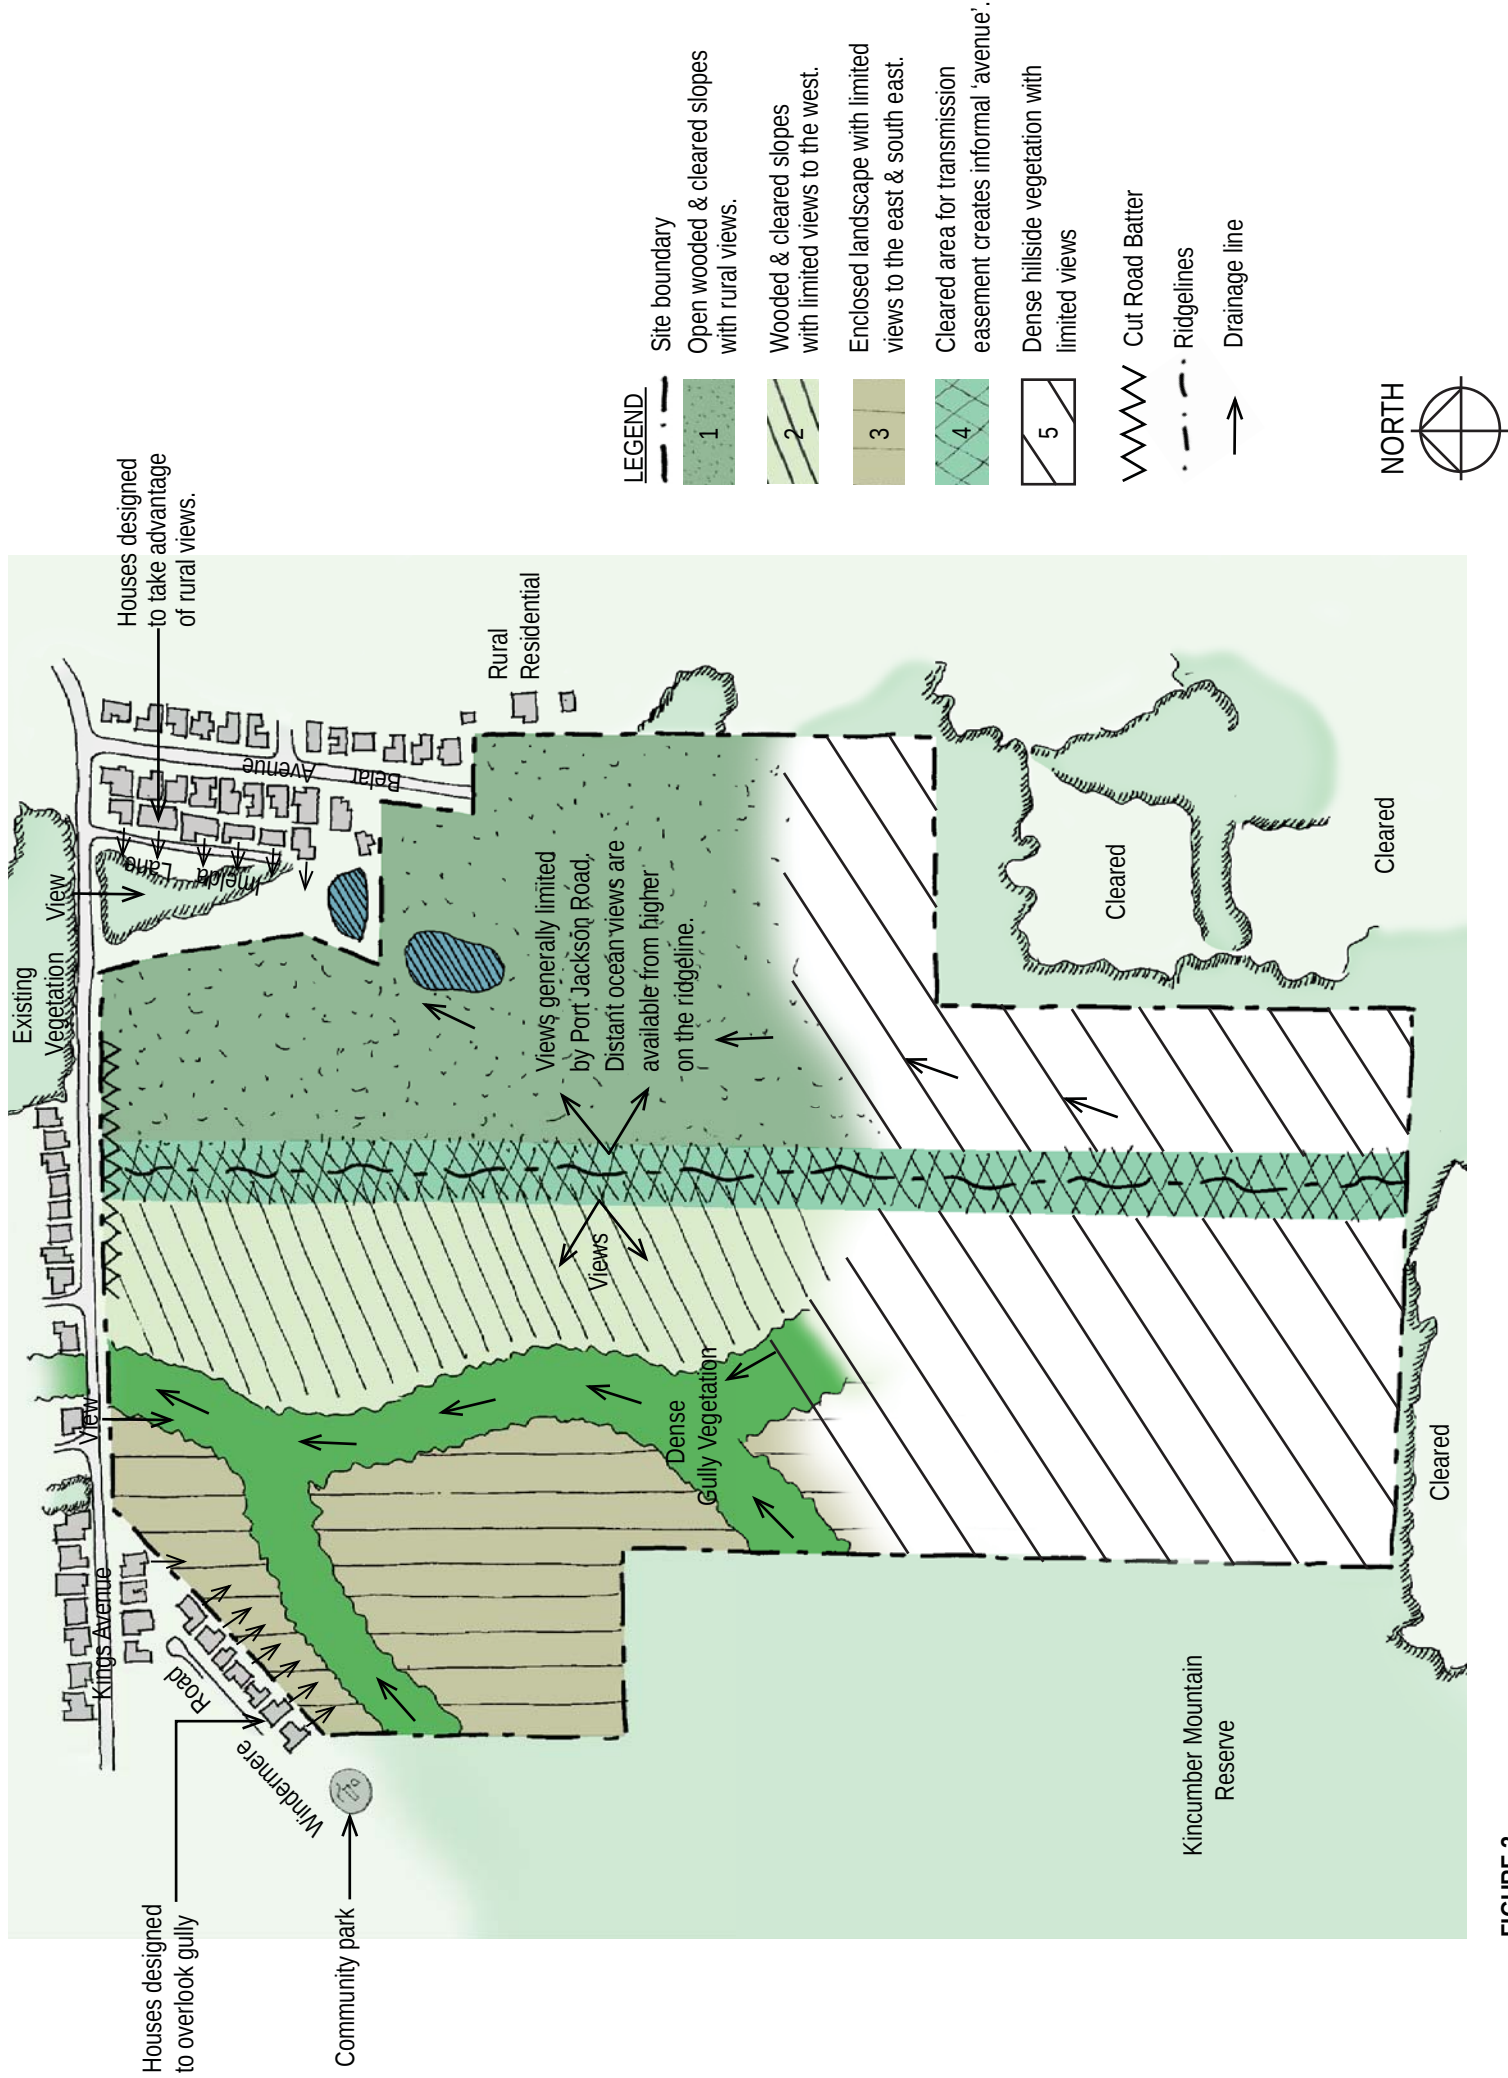
FIGURE 3

**1. Open wooded and cleared slopes with rural views to the east and south.**  
These areas generally have an easterly aspect with moderate slopes and a native tree canopy cover of up to 50%. The grassy cover of Kikuyu and limited shrub layer permit filtered views to the east towards of rural properties located off Belar Avenue.

## 2. Wooded and cleared slopes with limited views to the west.

## 3. Transmission easement

## 4. Enclosed landscape character

## GENERAL DESCRIPTION - Refer to Figure 3

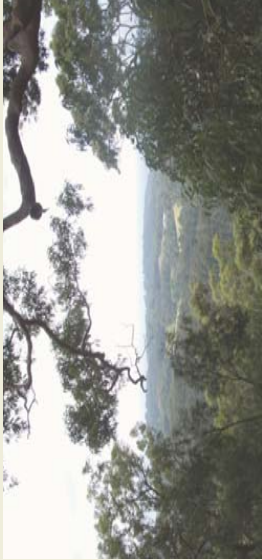
1. Easterly Views from the top of Kincumber Mountain, extends to the scenic highway ridgeline.

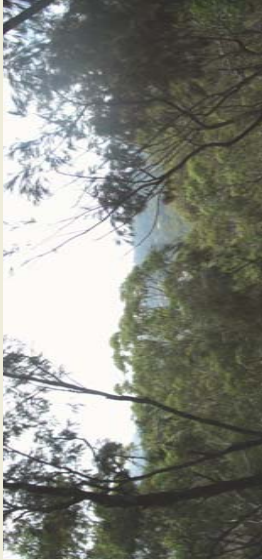
2. Views looking northeast from Kincumber Mountain are obscured by vegetation however the central ridgeline of the site can be identified (see view shed analysis Map 1).

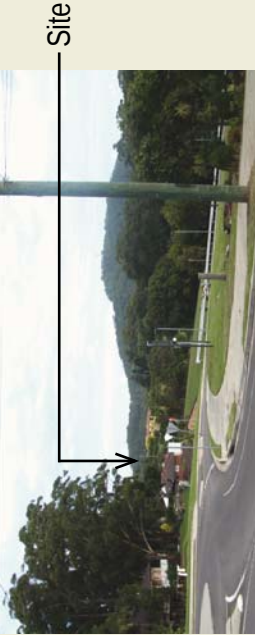
3. Ridgeline in front of Kincumber Mountain

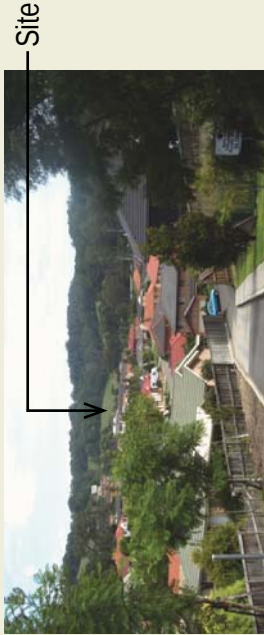
4. Views to South East gully from Terrigal United Church.

Views along the eastern, cleared valley are available from the Terrigal United Church on Terrigal Drive. Views from this point take in the densely developed areas immediately south of the church and extend to Kincumber Mountain in the background. Views of the site are in the middleground and the proposed development along the ridgeline will be visible, however, the dark form of the Kincumber Mountain vegetation will remain the dominant visual feature. The view from Serpentine Road includes a small section of the lower part of the ridgeline, this is not a significant viewpoint as the dominant visual feature from this location is Kincumber Mountain and the residential areas off Mobbs Road are visible in the foreground refer photo 3, page 6.

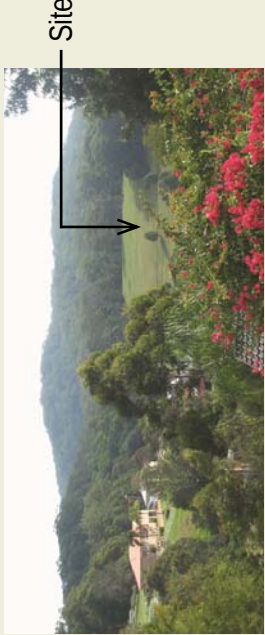
5. Eastern slopes are visible from Port Jackson Road.

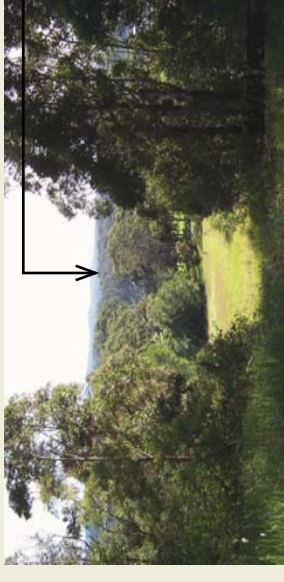
1. View looking north east near high point of site.

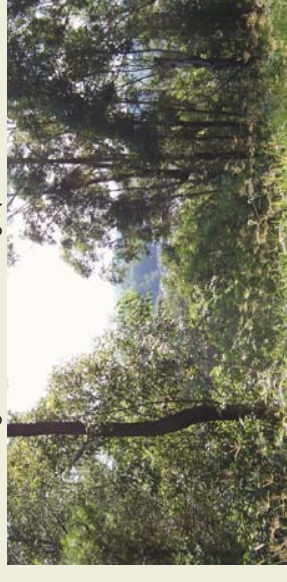
2. View to west filtered by existing vegetation.

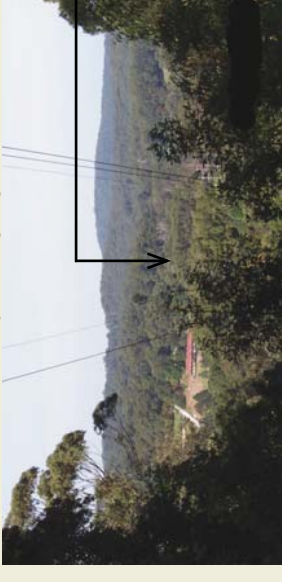
3. Views from the top of Site, overlooking Picketts Valley.

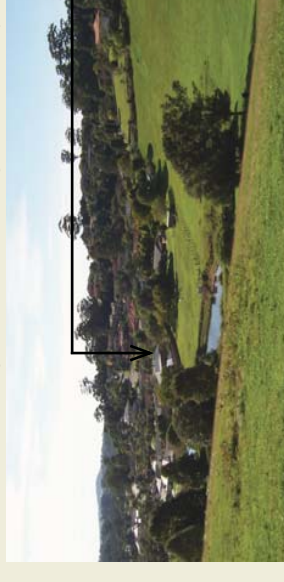
4. Views to east looking over rural residential.

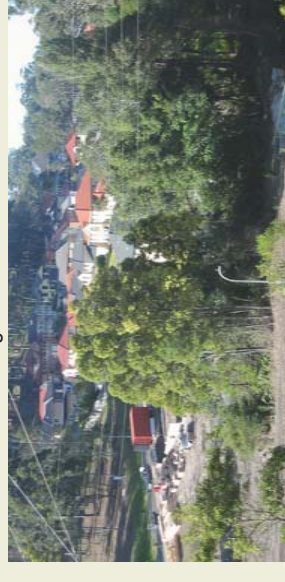
5. View from lower ridge looking north to recent residential development.

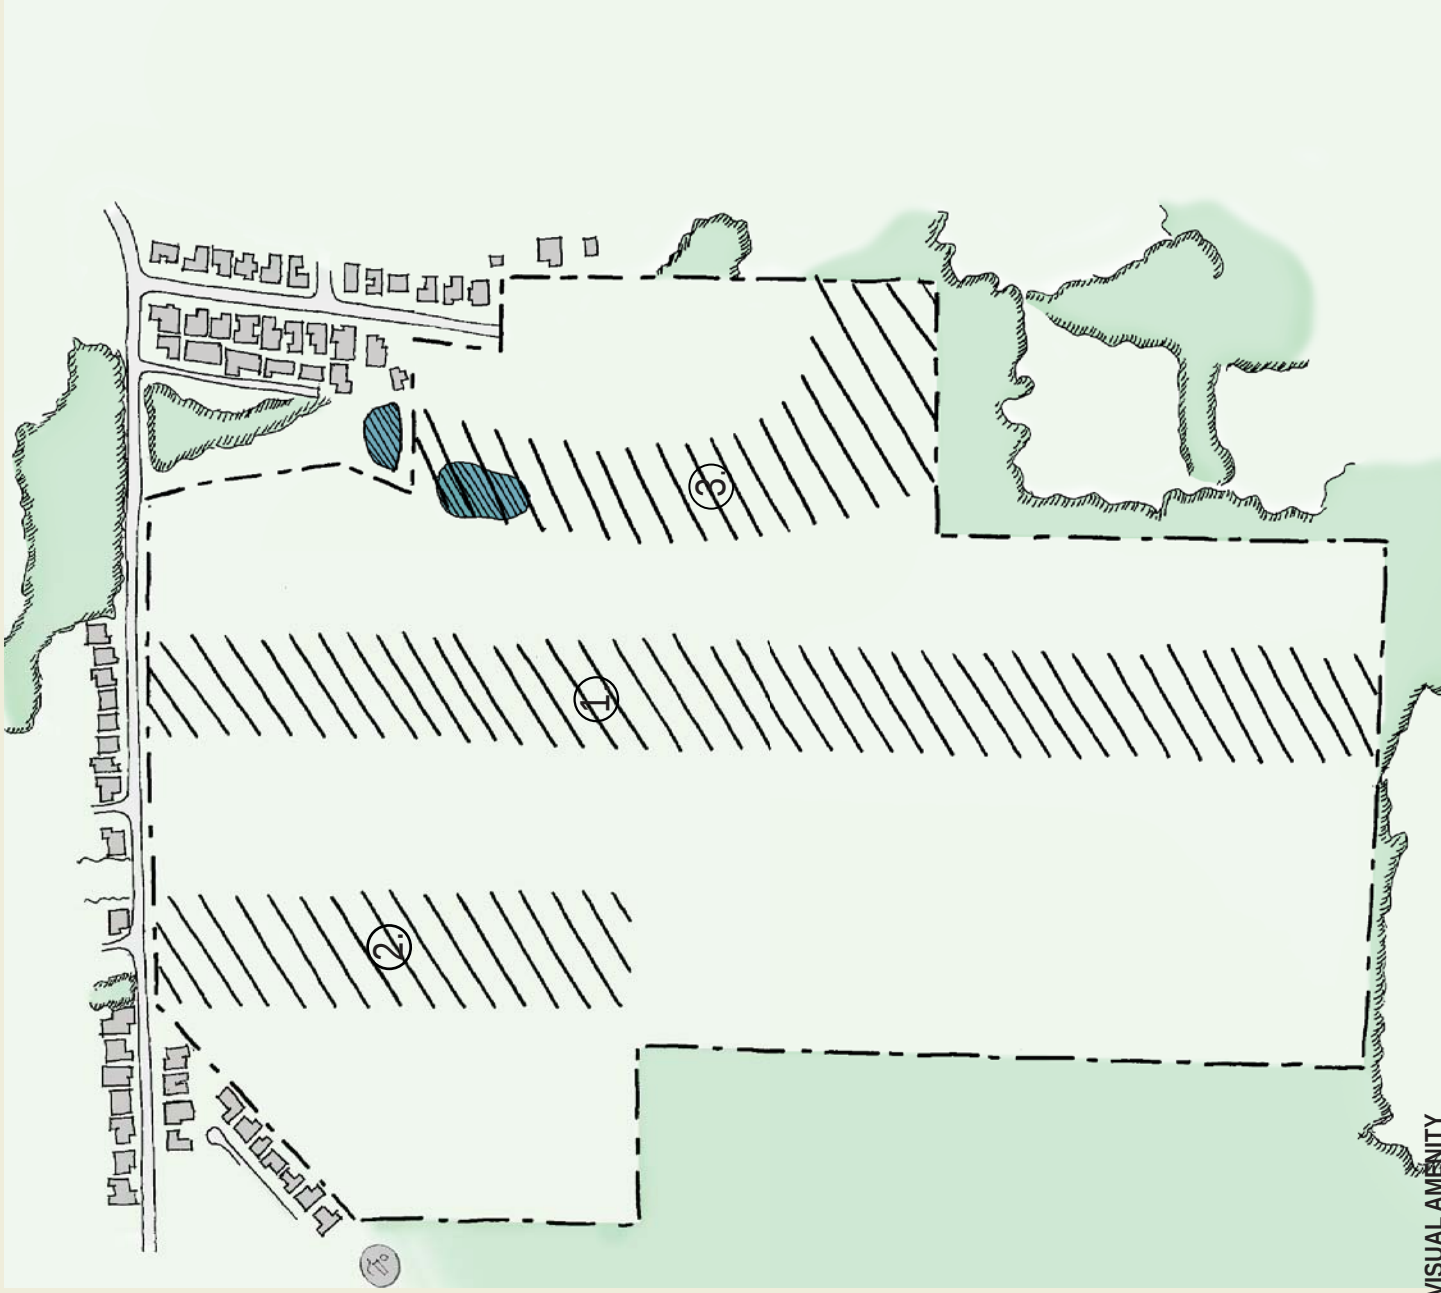
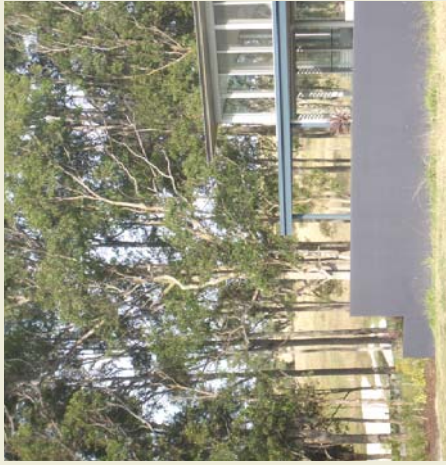
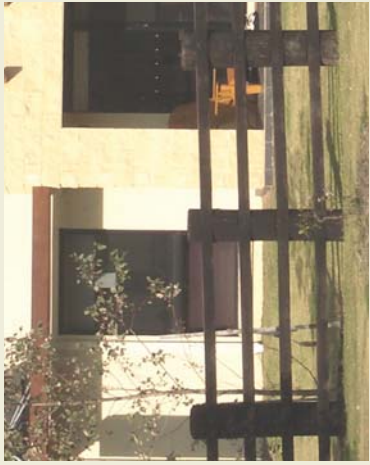
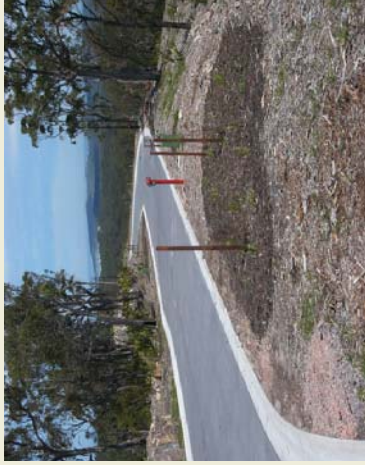
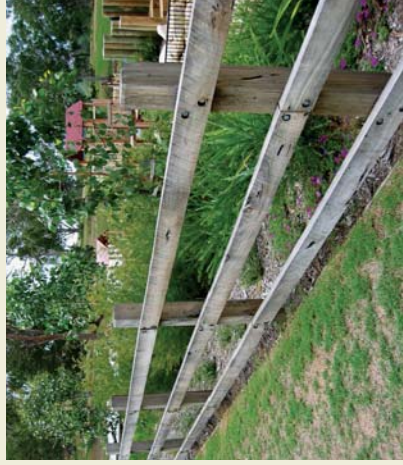
FIGURE 4

SIGNIFICANT VISUAL AMENITY

1. The Ridgeline is significant to the broader site context as it is visible from Terrigal Drive, from Terrigal Drive, Kincumber Mountain & within the adjoining valley. Although the ridge is partially cleared, due to the presence of an established electricity easement, Most views to the site are from an angle & screened by the ridgeline vegetation.
2. Views into the gullies from Kings Avenue extend the sense of the rural landscape.
3. Area 3 has a highly scenic character & provides amenity to residents on higher ground to the east of the site.

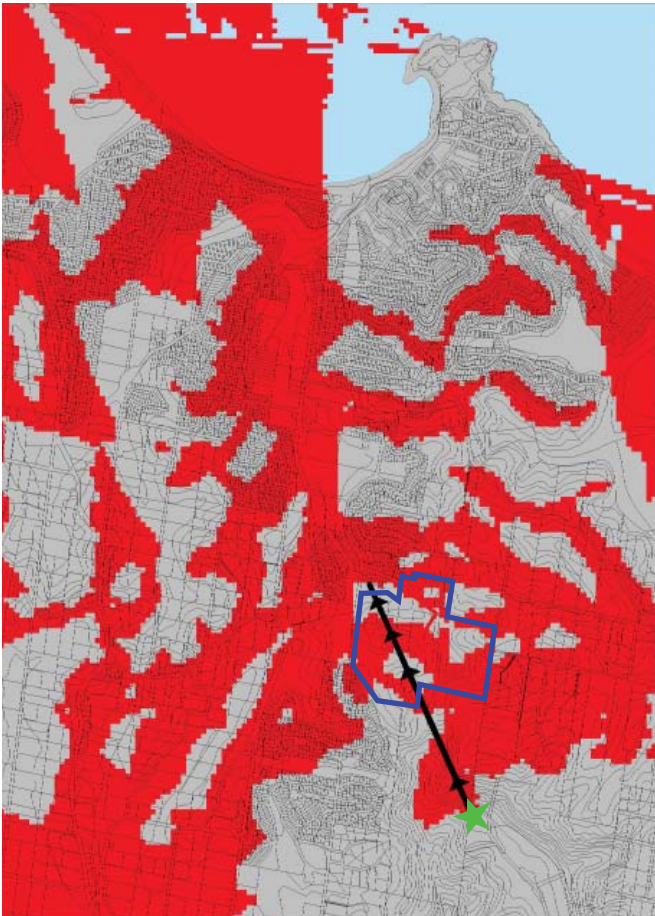
**Map 1 - Kincumber Mountain (Colin Watters Lookout)**  
Central ridgeline is visible however it is obscured by vegetation up to 20m high.

From Kincumber Mountain, the site can be seen from Collin Watters Lookout which is a 20minute walk from the parking and facilities area of the reserve. Map 4 on page 7 indicates that views to the east and north east over the site are available from the lookout. Views of the site are limited by the vegetation cover on the site and are also filtered by existing vegetation at the lookout, refer to photographs 1 - 6. From the lookout, the rural residential area of Picketts Valley provides an attractive outlook and a transition between the densely developed valley of Kings Avenue and the bushland reserve of Kincumber Mountain.

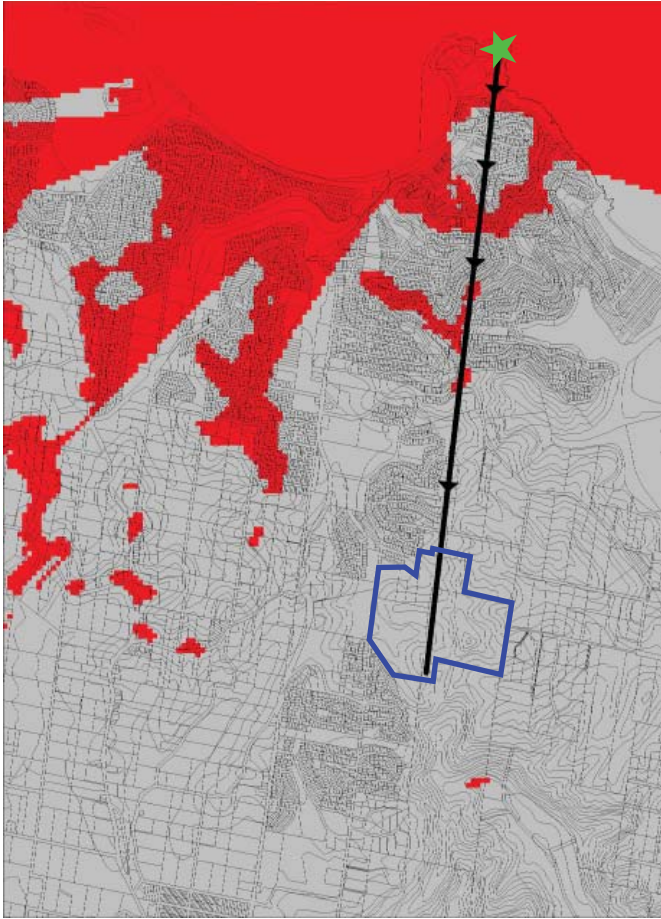
**Map 6 - The Skillion, Terrigal**  
The site is not visible however Kincumber Mountain is.

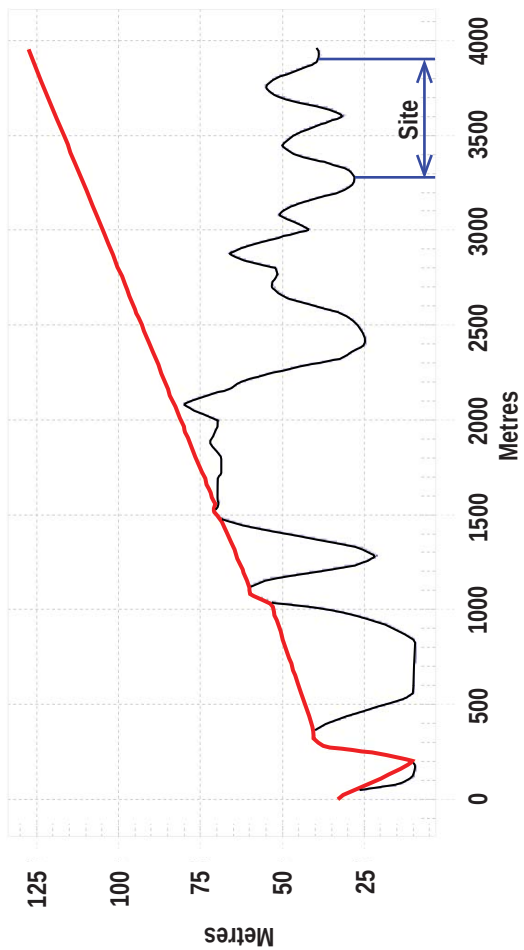
**Cross Section 6 - The Skillion, Terrigal**  
Vertical Exaggeration = 32
