# Planning Proposal

## Proposed Rezoning Sutton Road and Faithfull Street, Gundaroo

Prepared for HRC & MR Meischke  
March 2013

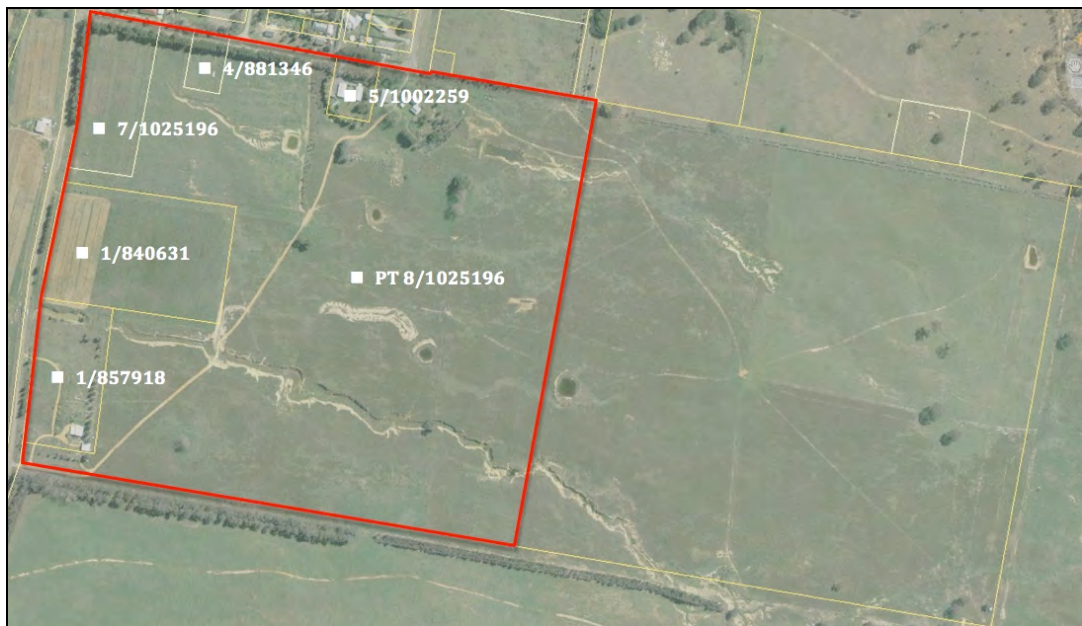
Figure 3: Investigation area and subject allotments (Source: NSW Land and Property Information)

The investigation area comprises holdings with an area of approximately 40 hectares, as indicated in Table 1. An aerial image indicating subject allotments is provided in Figure 3.

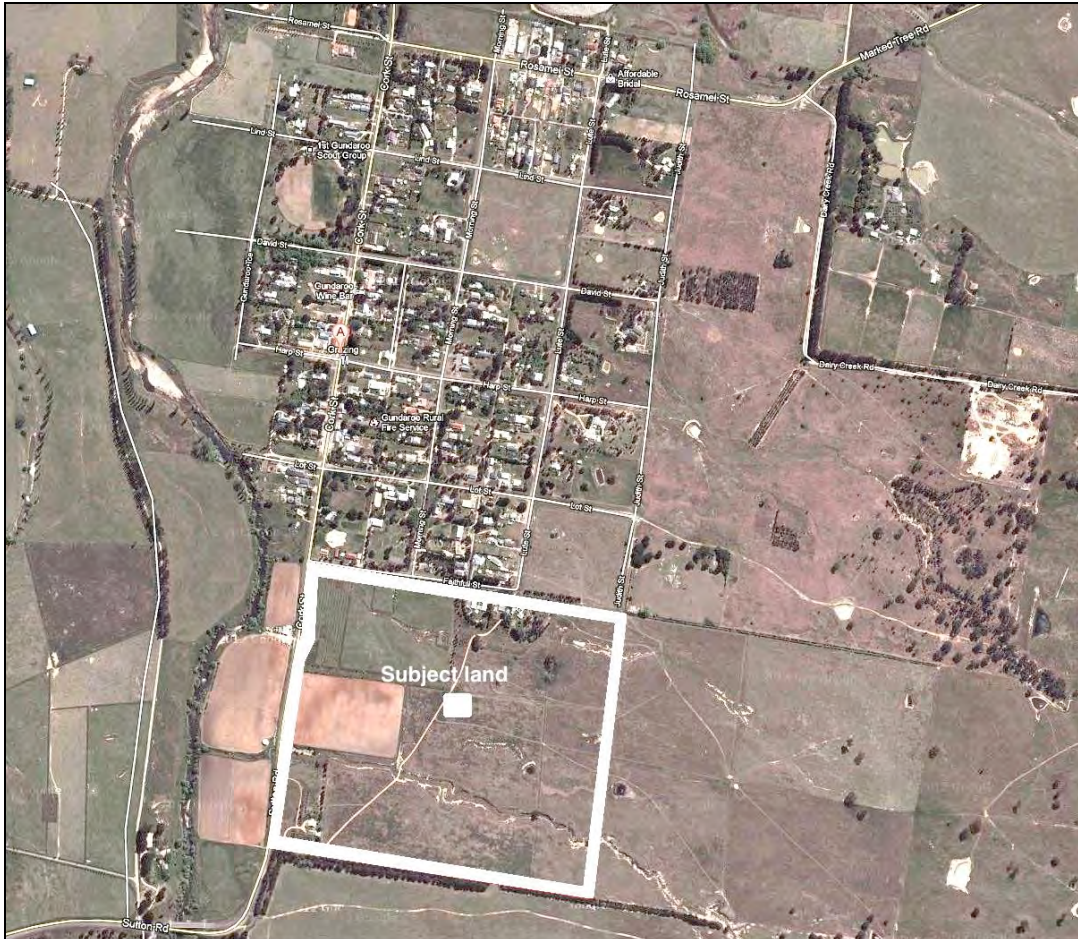
Figure 6: Location of subject land (Source: Google Maps)

The subject land adjoins the village of Gundaroo at its southern boundary, as indicated below in Figure 6.

The land is bound by Faithfull Street and the village to the north, to the east and south by agricultural land, and to the west by Sutton Road (Cork Street).

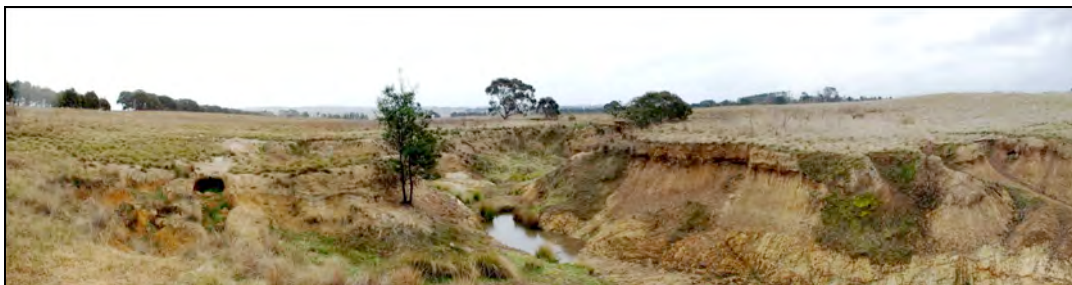
Photo 6: View of intermittent gully (Source: Salvestro Planning)

The land contains four (4) farm dams constructed across drainage depressions, and an erosion gully containing an intermittent watercourse traverses the site in an east – west direction.

*The existing erosion gully that extends from east to west across the site, should be stabilized as part any proposed development of the site. The stabilization will require the eroded cut batters to be reshaped and flattened to provide batters that may be effectively vegetated and managed. Slopes of less than 1:4 would be anticipated. Some local protection works, including gabion blankets and cages, may be required to protect the reshaped batters from high velocity water flows that could re-initiate erosion.*

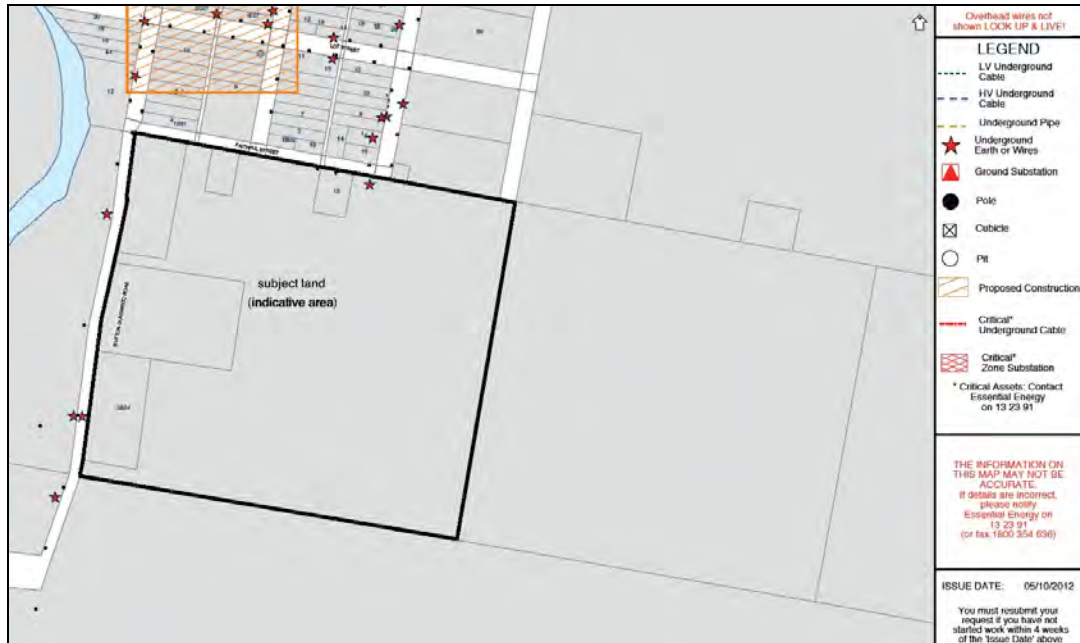
Electrical infrastructure is located along Sutton Road and Faithfull Street, as indicated below in Figure 15.

Figure 15: Electrical Services (Source: DBYD – Essential Energy)

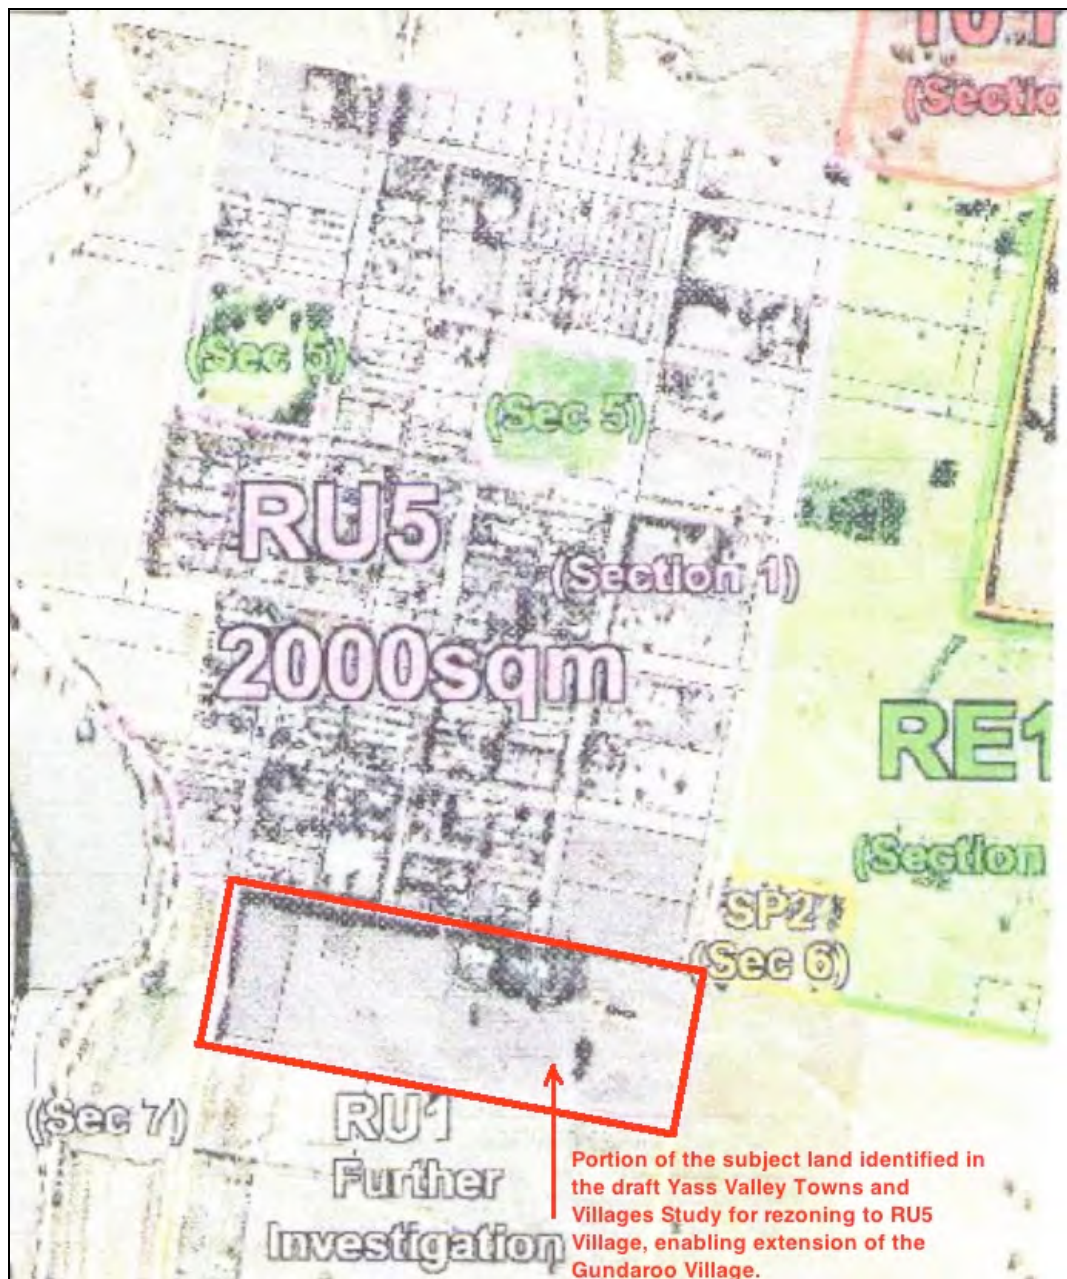
Figure 16: Subject land proposed for village zone in draft study (Source: Draft Yass Valley Town and Villages Study 2010)

A portion of the subject land was proposed for rezoning to RU5 Village, indicated below in Figure 16, under the (draft) Yass Valley Town and Villages Study as it was identified, and generally supported as the logical extension of the village.

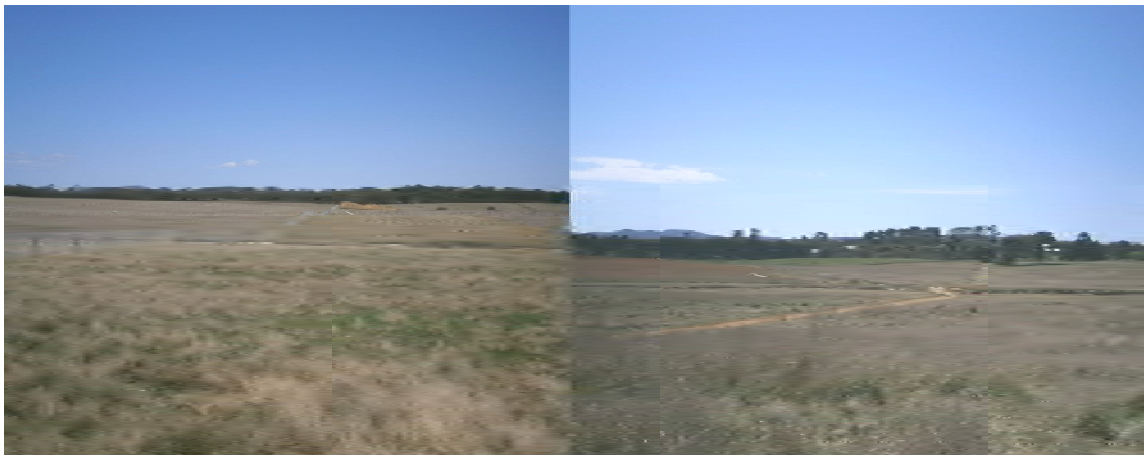
P1 - Looking south at from NE corner

P2 - Looking north from centre of southern boundary

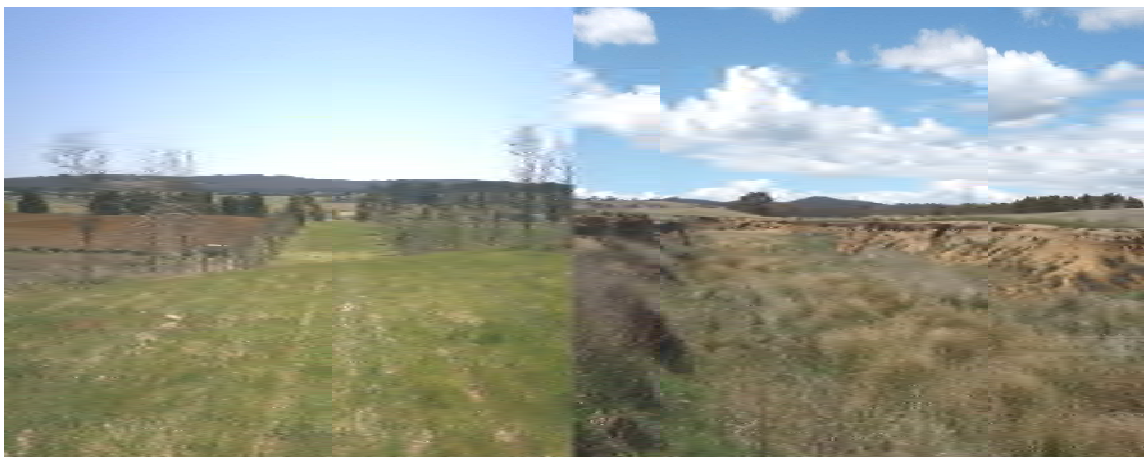
P3 – Looking west from centre of site

P4 – Erosion gully looking east from causeway

At the time of the investigation the farm dams were full and there was water flowing in the intermittent creek within the erosion gully. The banks of the erosion gully were typically sub-vertical with scree slopes transitioning to a terraced base.

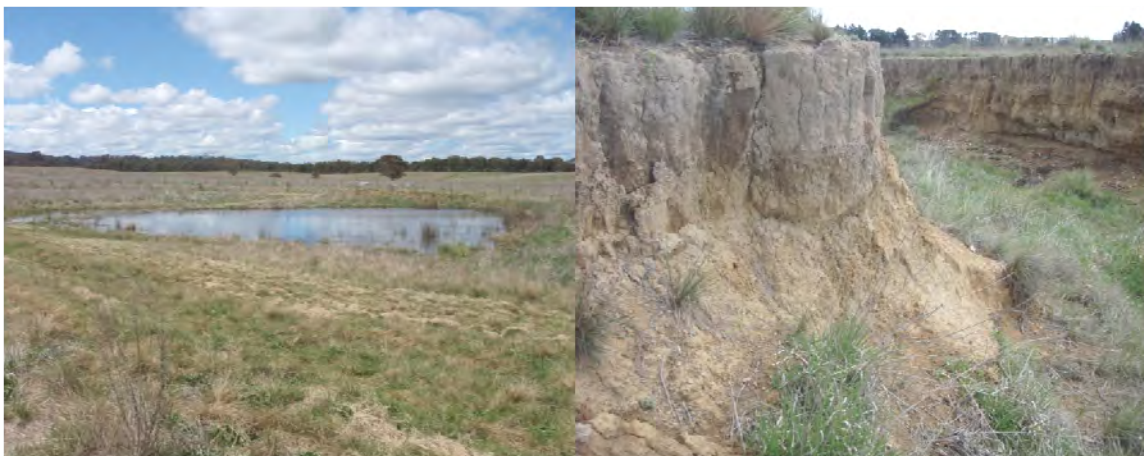
P5 – Dam to the south of Lute Street

P6 – Erosion gully bank to west of causeway

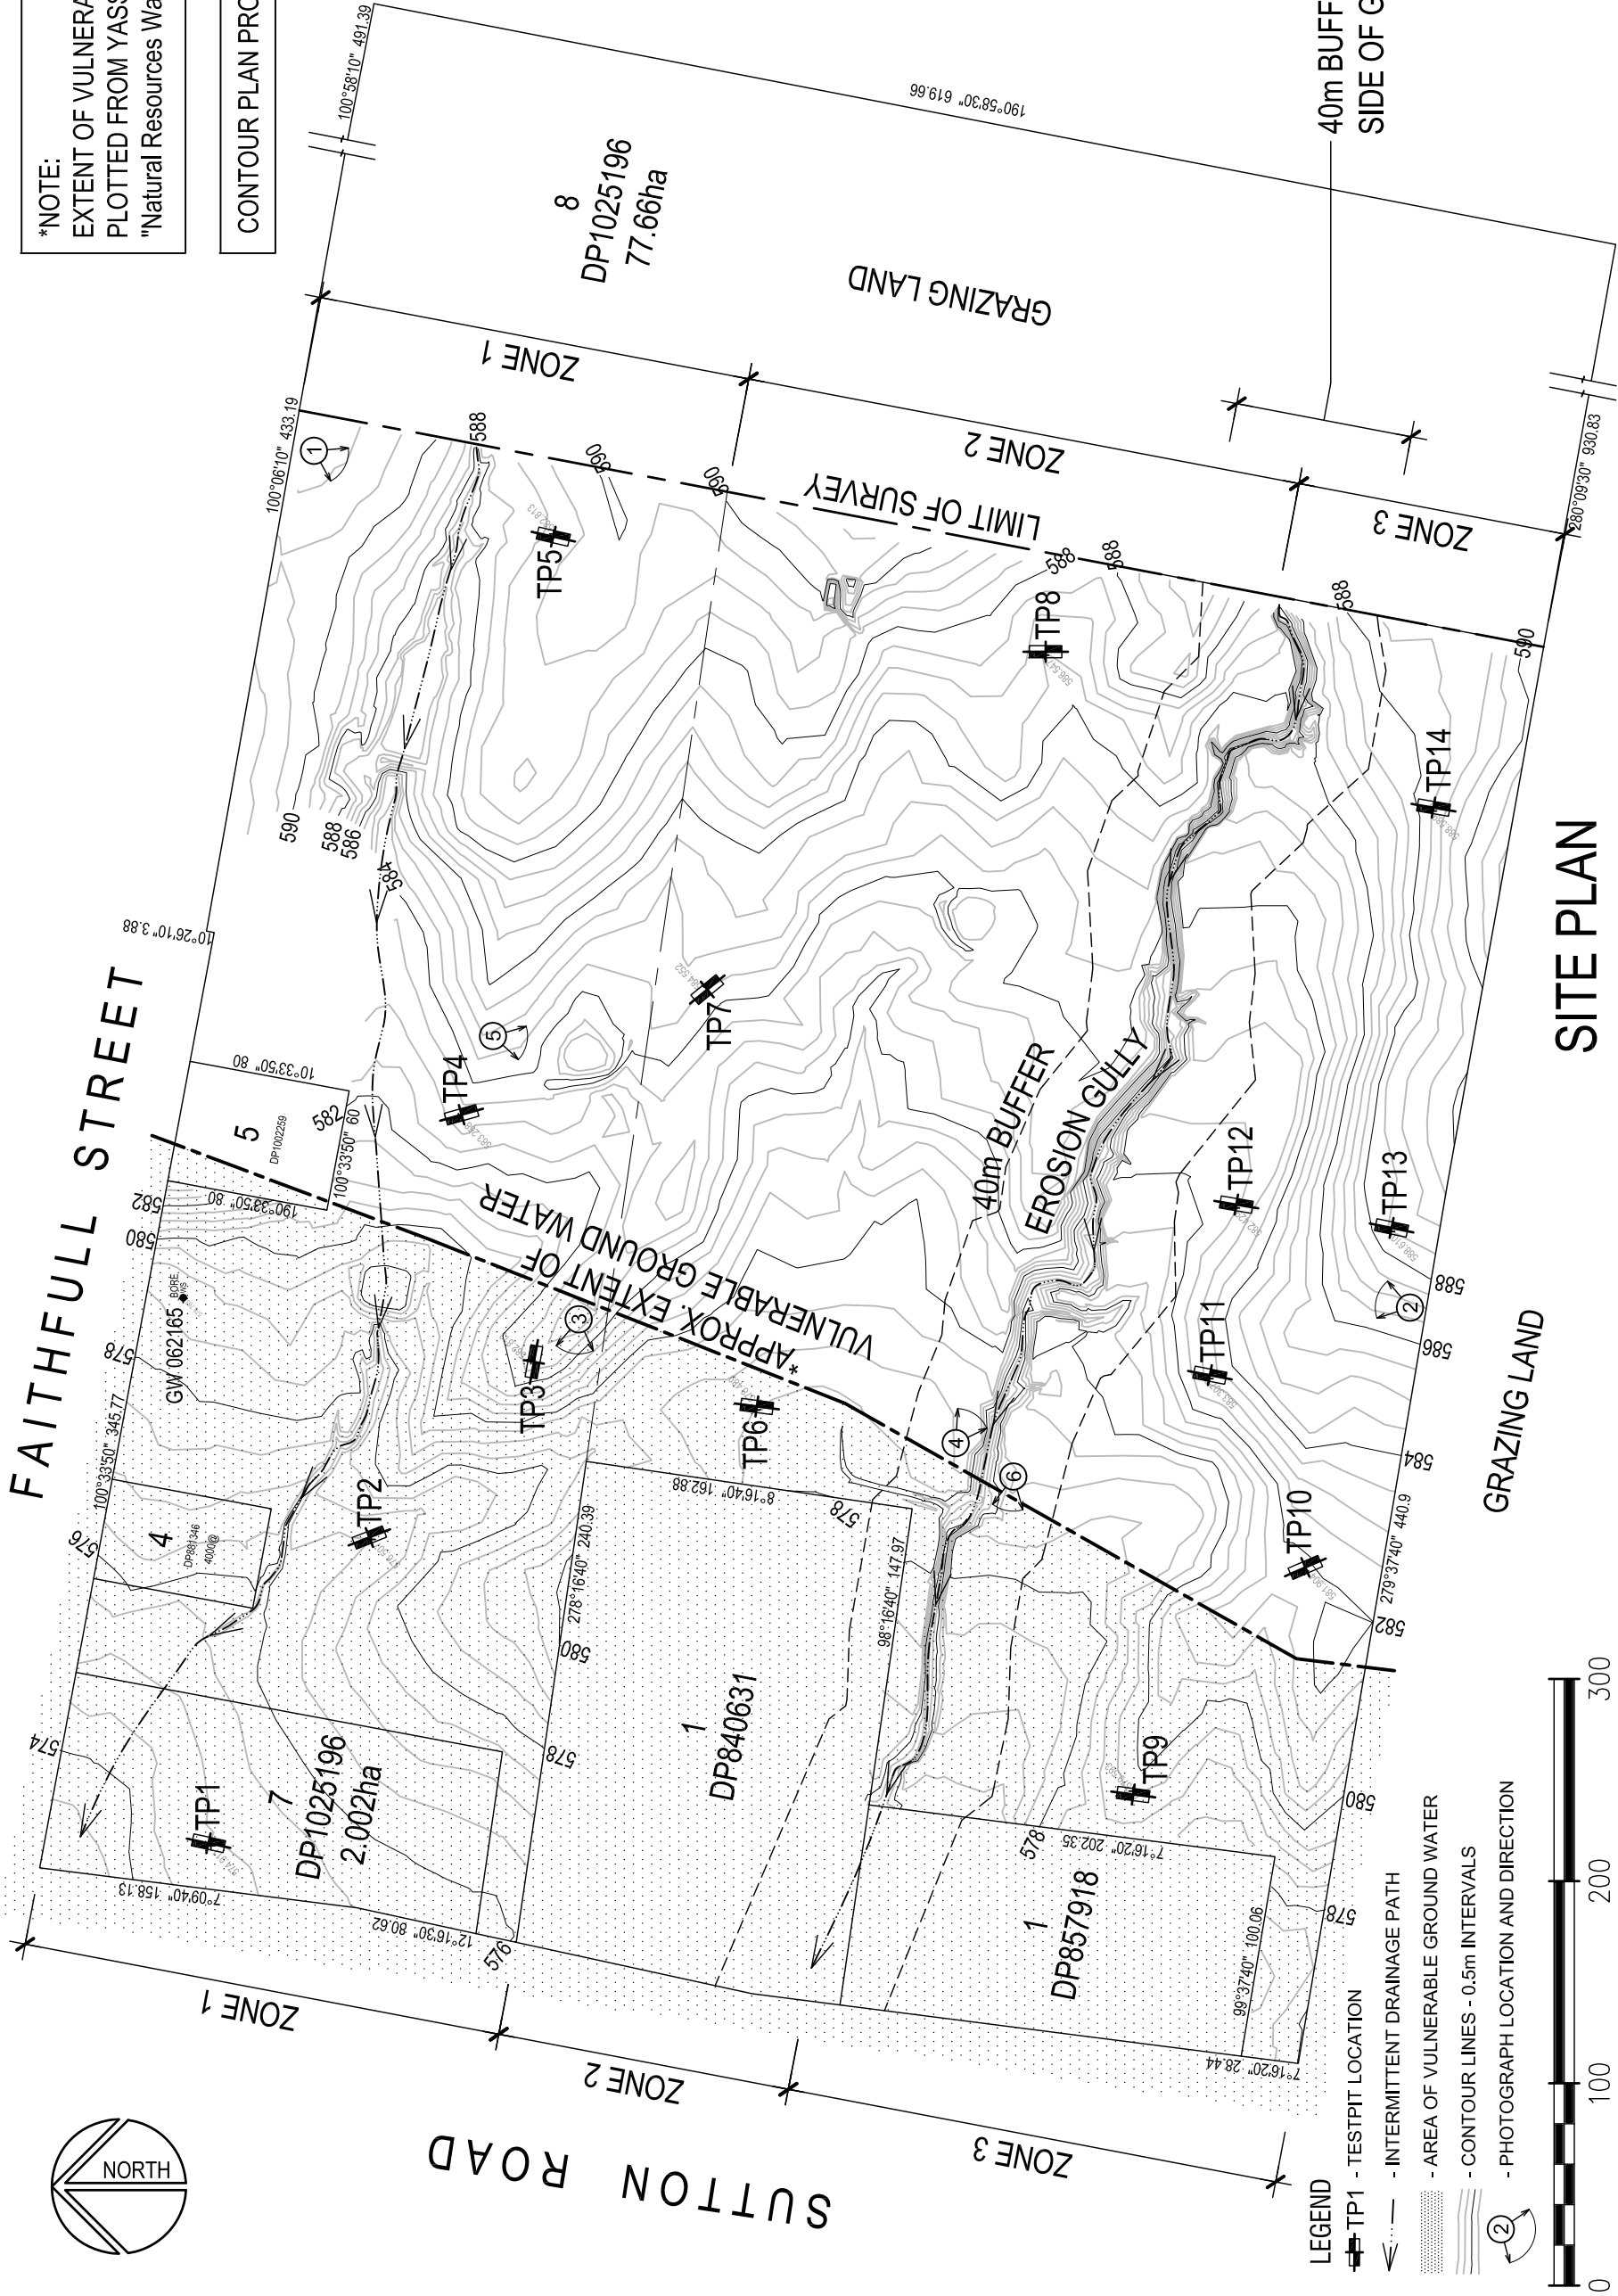
- LEGEND
- TP1 - TESTPIT LOCATION
  - INTERMITTENT DRAINAGE PATH
  - AREA OF VULNERABLE GROUND WATER
  - CONTOUR LINES - 0.5m INTERVALS
  - PHOTOGRAPH LOCATION AND DIRECTION

SITE PLAN  
PROPOSED RE-ZONING  
Cnr SUTTON RD & FAITHFULL ST, GUNDAROO  
DR R. & MRS M. MEISCHKE
