Preliminary contamination investigation

Lot 2 DP568837, Lot 11 DP1160748, Lot 17 DP584625, Lot 20 DP549764, Lot 71 DP579908, Lots A and B DP163425 Howick Street, Bathurst NSW

Summary report

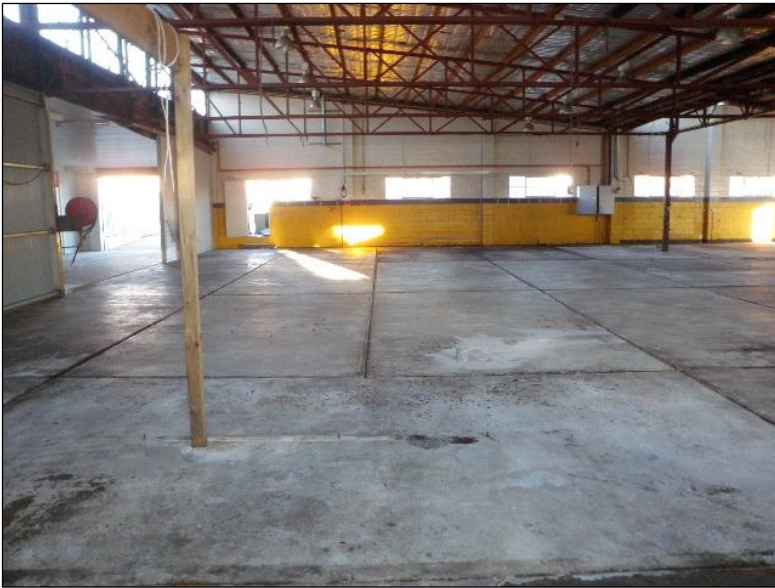
In the workshop on Lot B

A large waste oil tank was previously located within in the service department area of the large building in Lot B. The waste oil tank was emptied and rinsed with an EN2000 solution. The sump will be removed at the time of development. A car wash bay with sump was present in a shed on Lot 2.

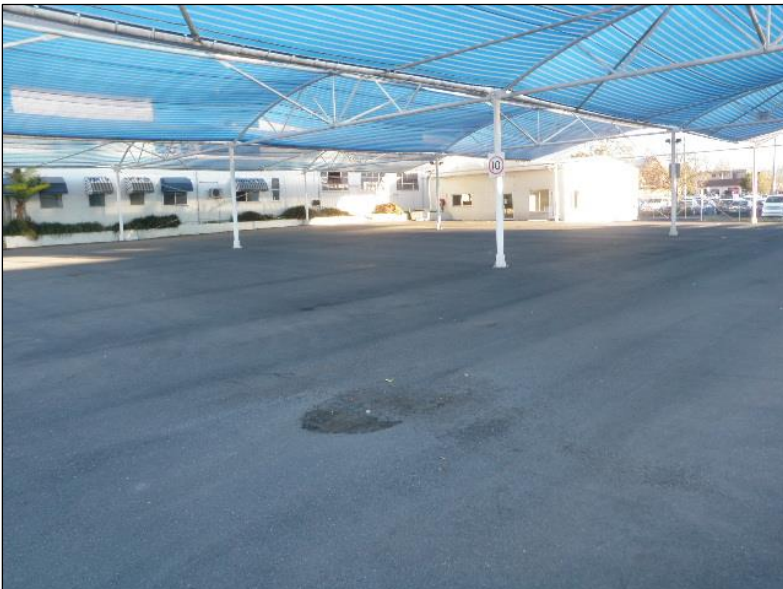
Lot 2 former outdoor car sales area

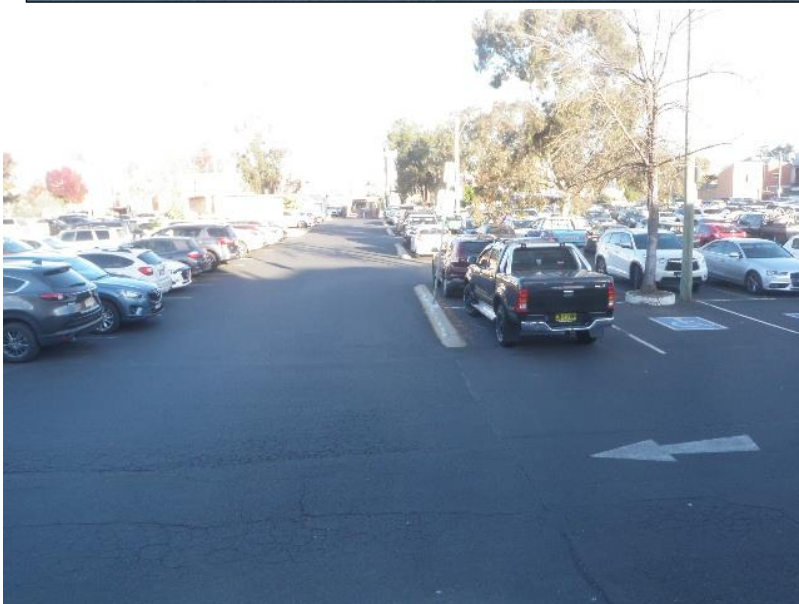
Lot 11 Public Car park

An intrusive investigation should be undertaken in the public car park Lot 11. The investigation should include soil sampling and analysis on a grid pattern.

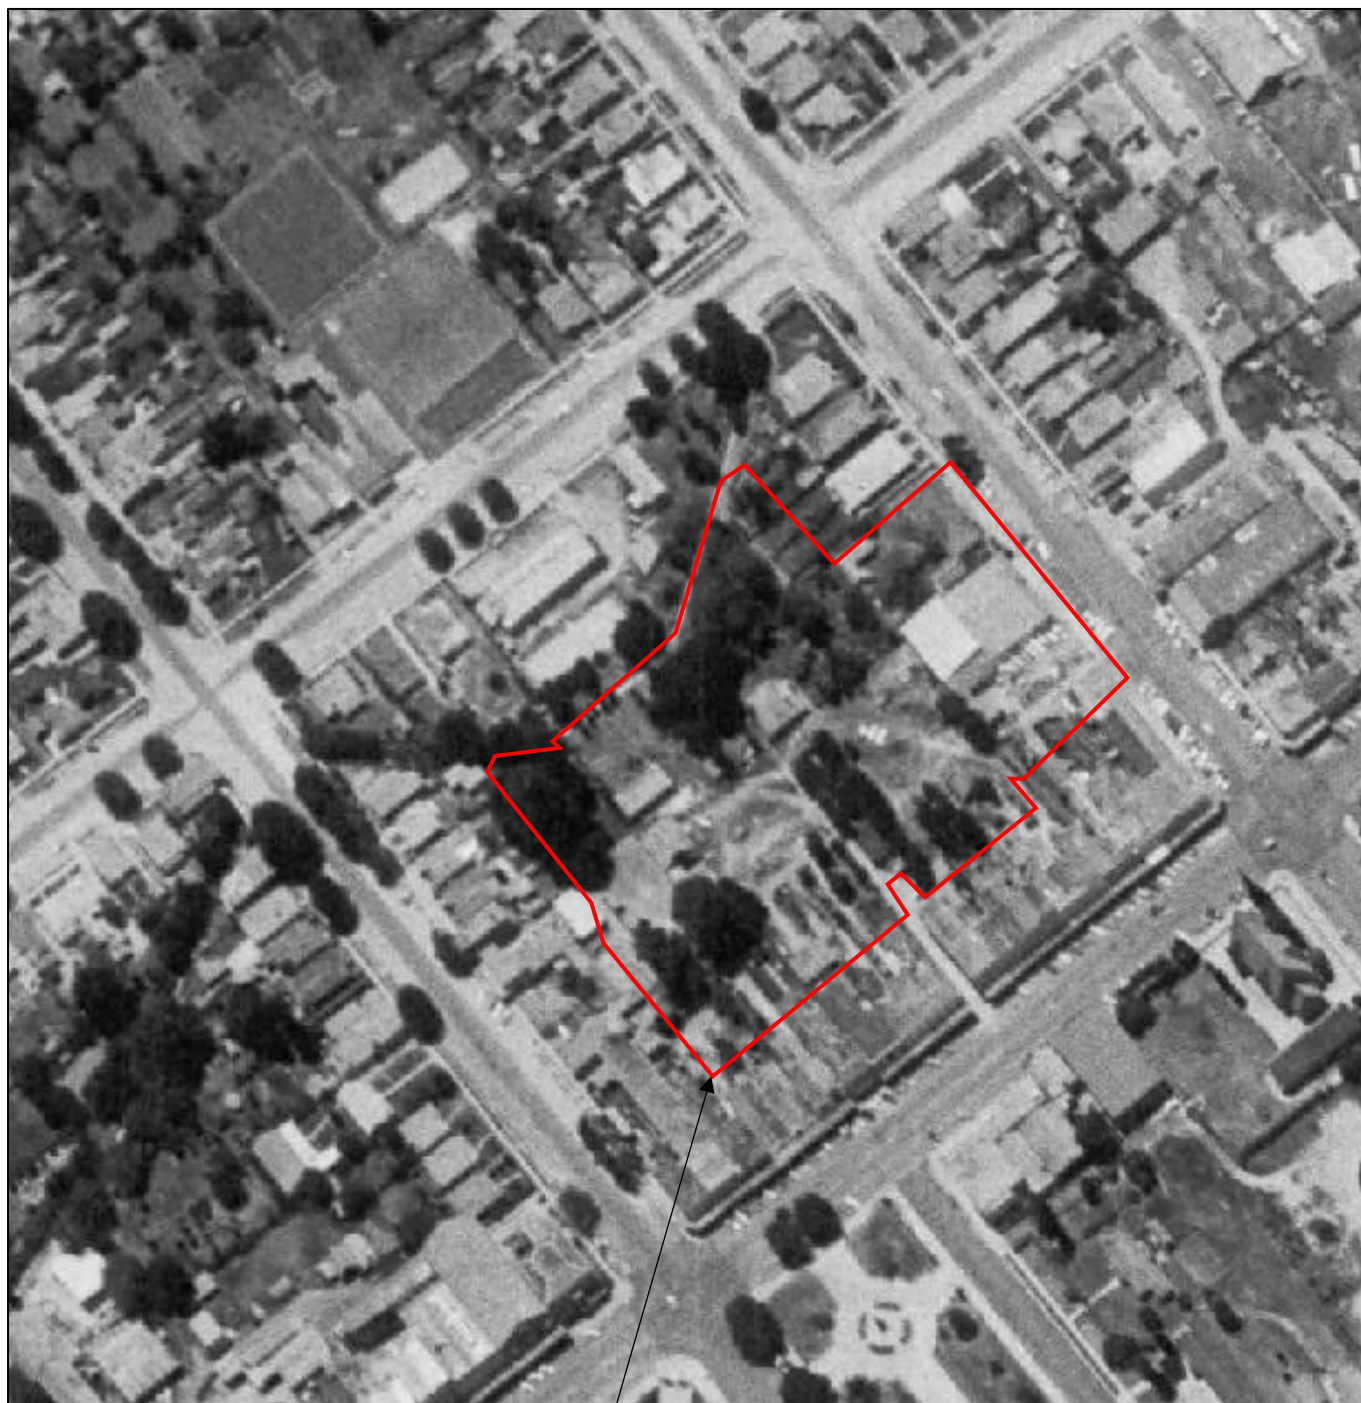
Appendix 2b. 1964 Aerial photograph		
Lot 2 DP568837, Lot 11 DP1160748, Lot 17 DP584625, Lot 20 DP549764, Lot 71 DP579908, Lots A and B DP163425 Howick Street Bathurst NSW

Investigation area

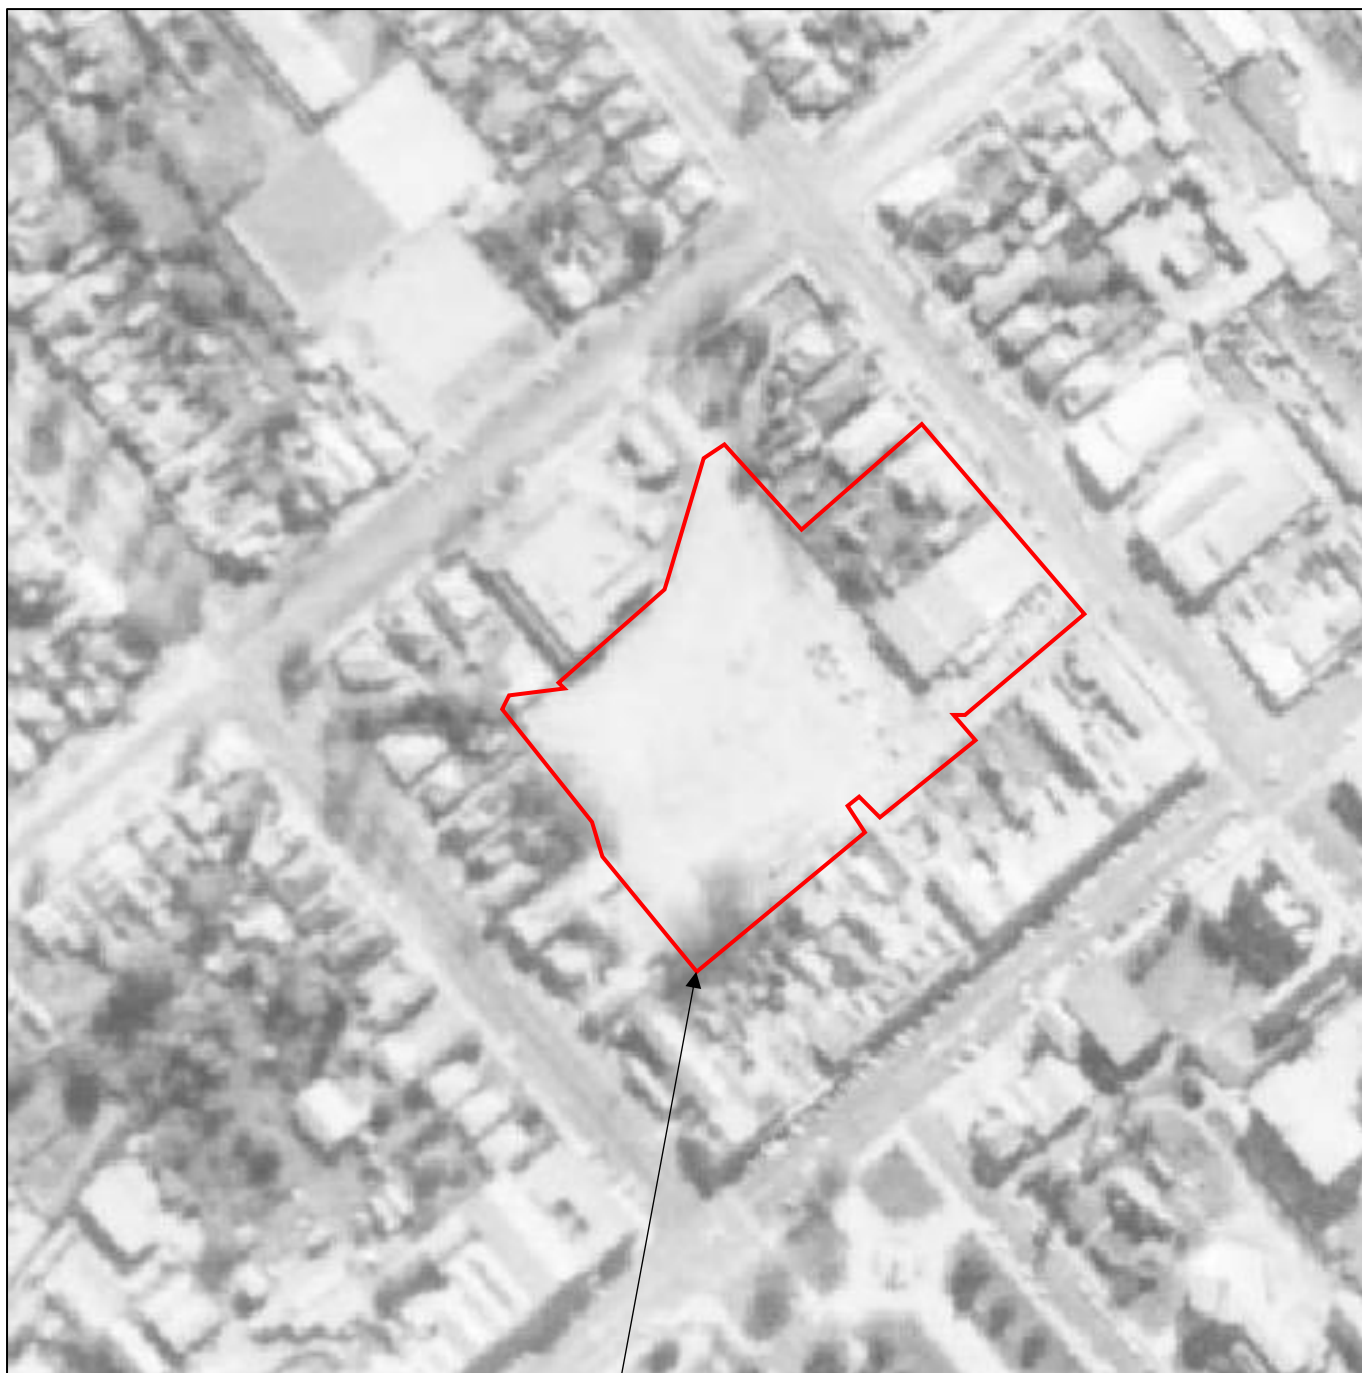
Appendix 2c. 1973 Aerial photograph		
Lot 2 DP568837, Lot 11 DP1160748, Lot 17 DP584625, Lot 20 DP549764, Lot 71 DP579908, Lots A and B DP163425 Howick Street Bathurst NSW

Investigation area

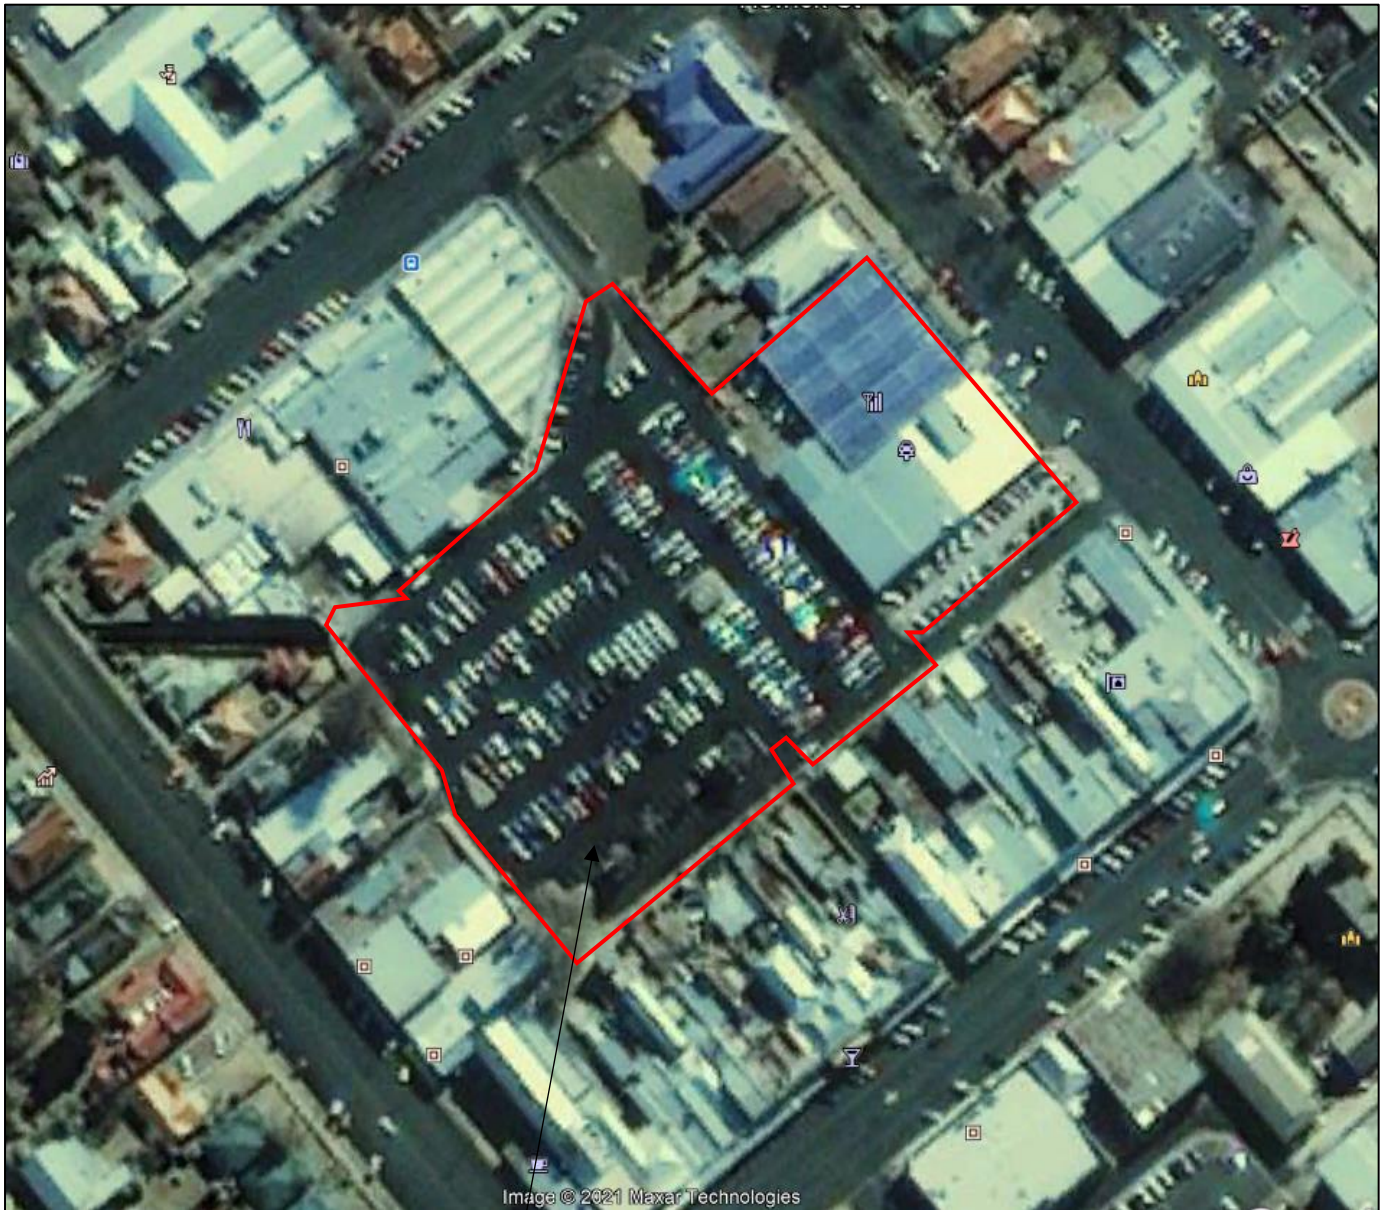
Appendix 2d. 2012 Aerial photograph		
Lot 2 DP568837, Lot 11 DP1160748, Lot 17 DP584625, Lot 20 DP549764, Lot 71 DP579908, Lots A and B DP163425 Howick Street Bathurst NSW

Investigation area
