# Oran Park (SHR 1695)

## Conservation Management Plan

prepared for  
Hixson Pty Ltd

May 2019  
REF: 1655: CMP  
Issue 23

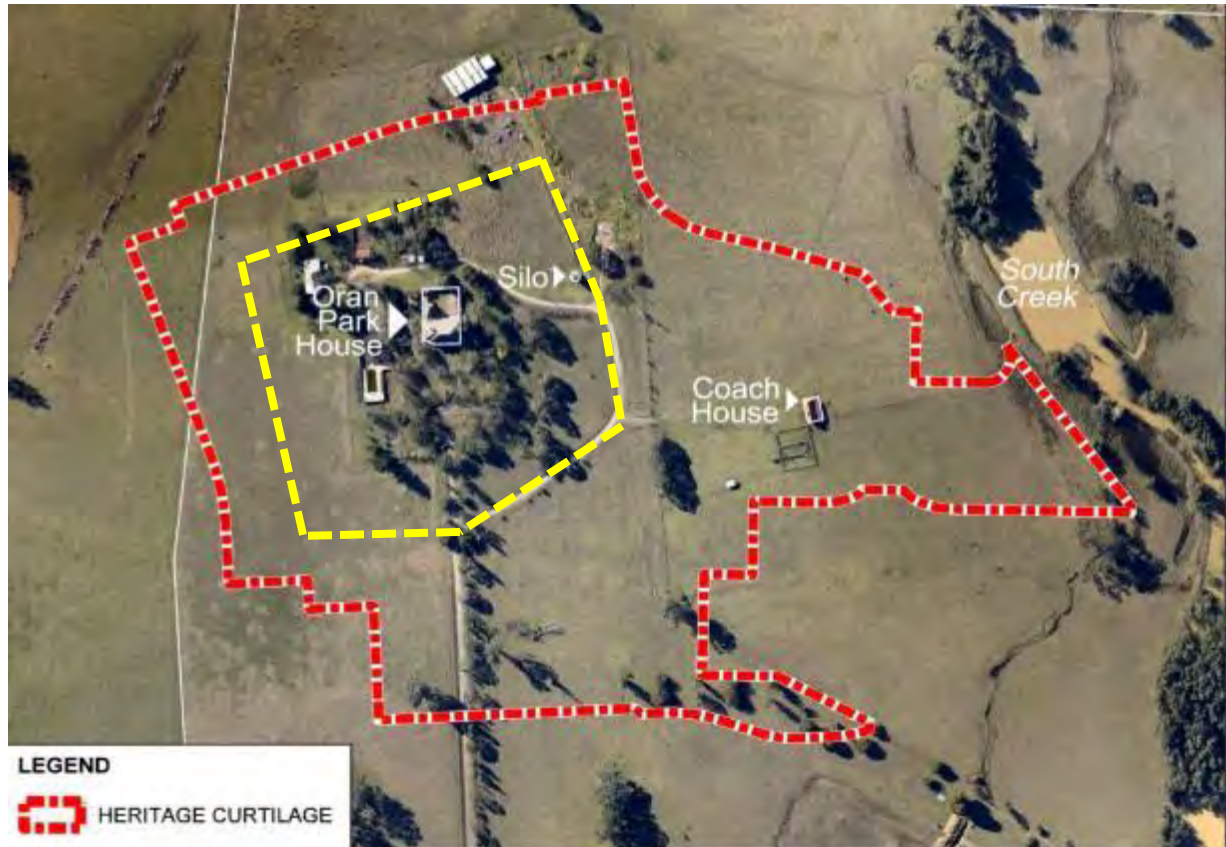
Figure 1: Outlines the SHR curtilage overlaid onto a c2013 aerial photograph showing extent of the subject site. The Homestead Lot is outlined in yellow. Source: Oculus Public Domain Strategy March 2017 pg.4. N↑. Not to scale.

Note: The Oran Park Estate residential subdivision has already been approved and works have been underway for some time, including within the SHR curtilage zone. Refer to the Figure 1.

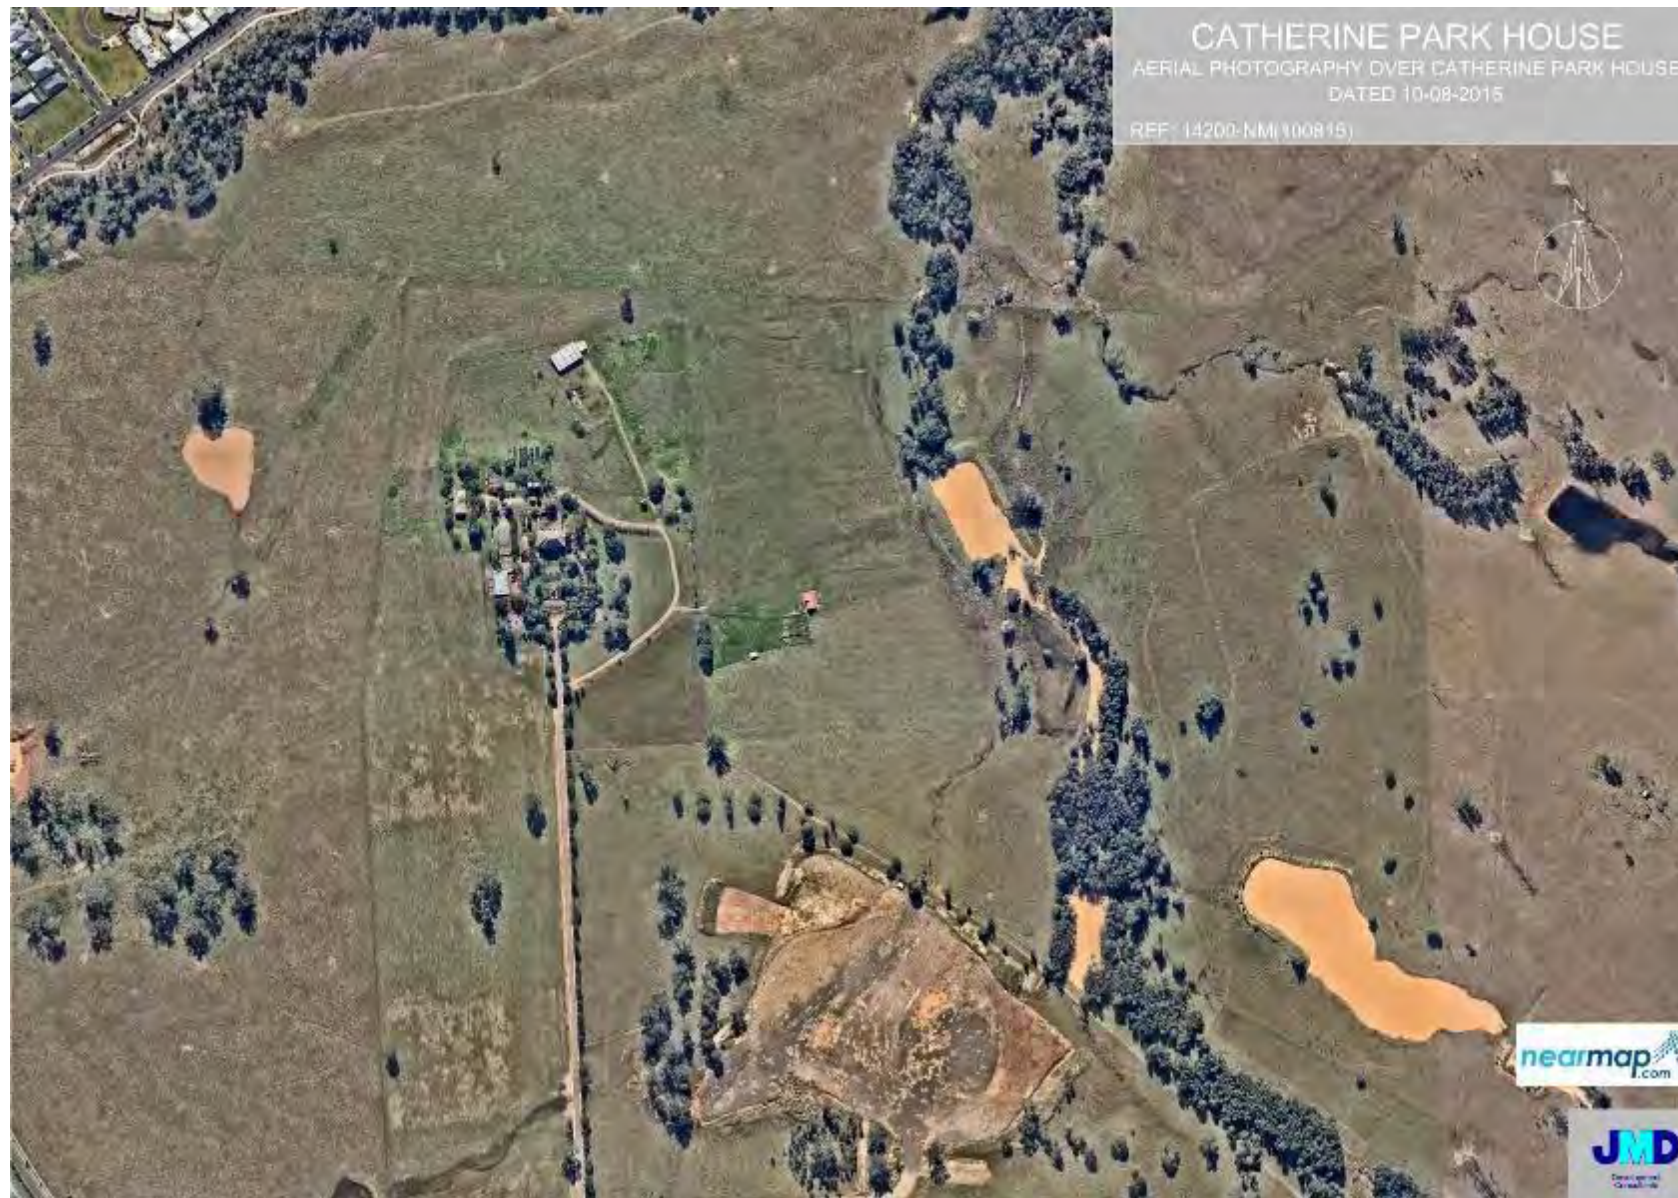
Addendum Figure 2:  
Aerial image dated  
10 August 2015  
showing the Oran  
Park Estate before  
major residential  
subdivision works  
had commenced at  
the site.  
Source: JMD  
Development  
Consultants,  
nearmap.com

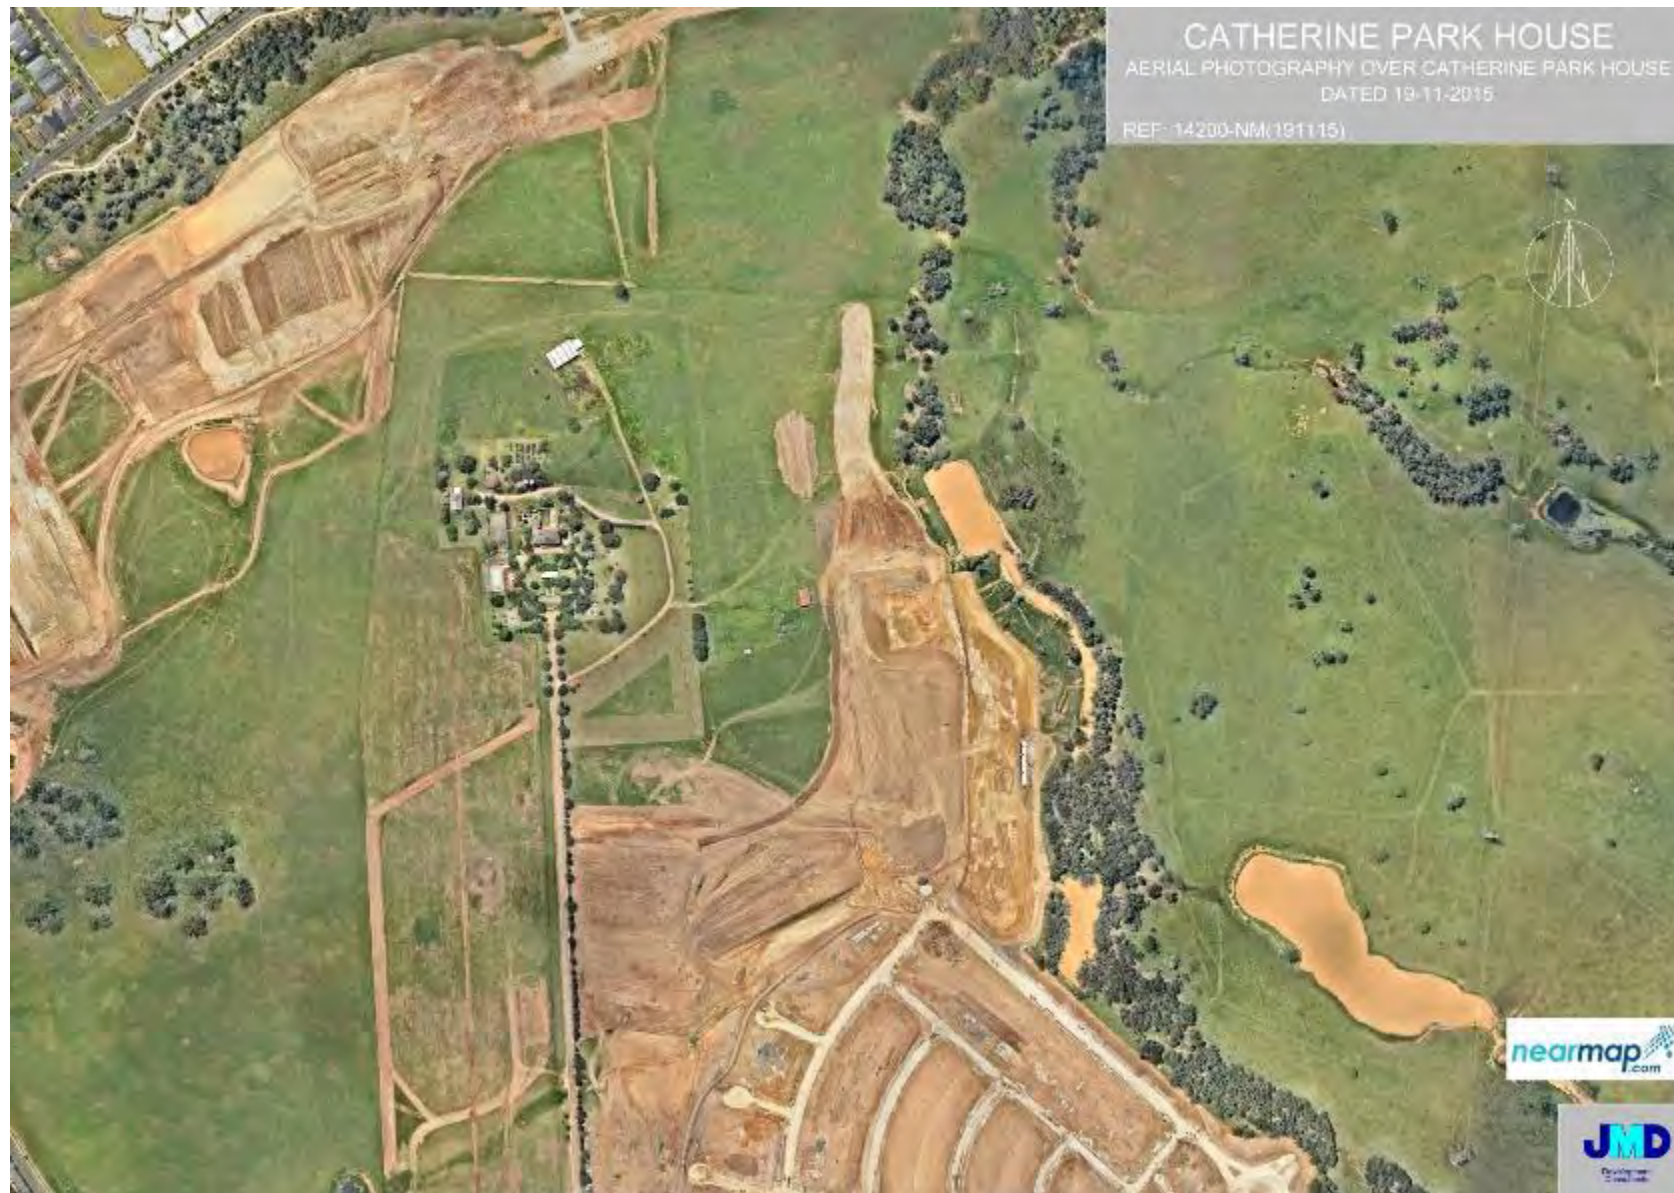
Addendum Figure 3:  
Aerial image dated  
19 November 2015  
showing the Oran  
Park Estate. Clearly  
visible are grading  
works to the site as  
well as the  
commencement of  
residential streets  
and roadways.  
Source: JMD  
Development  
Consultants,  
nearmap.com

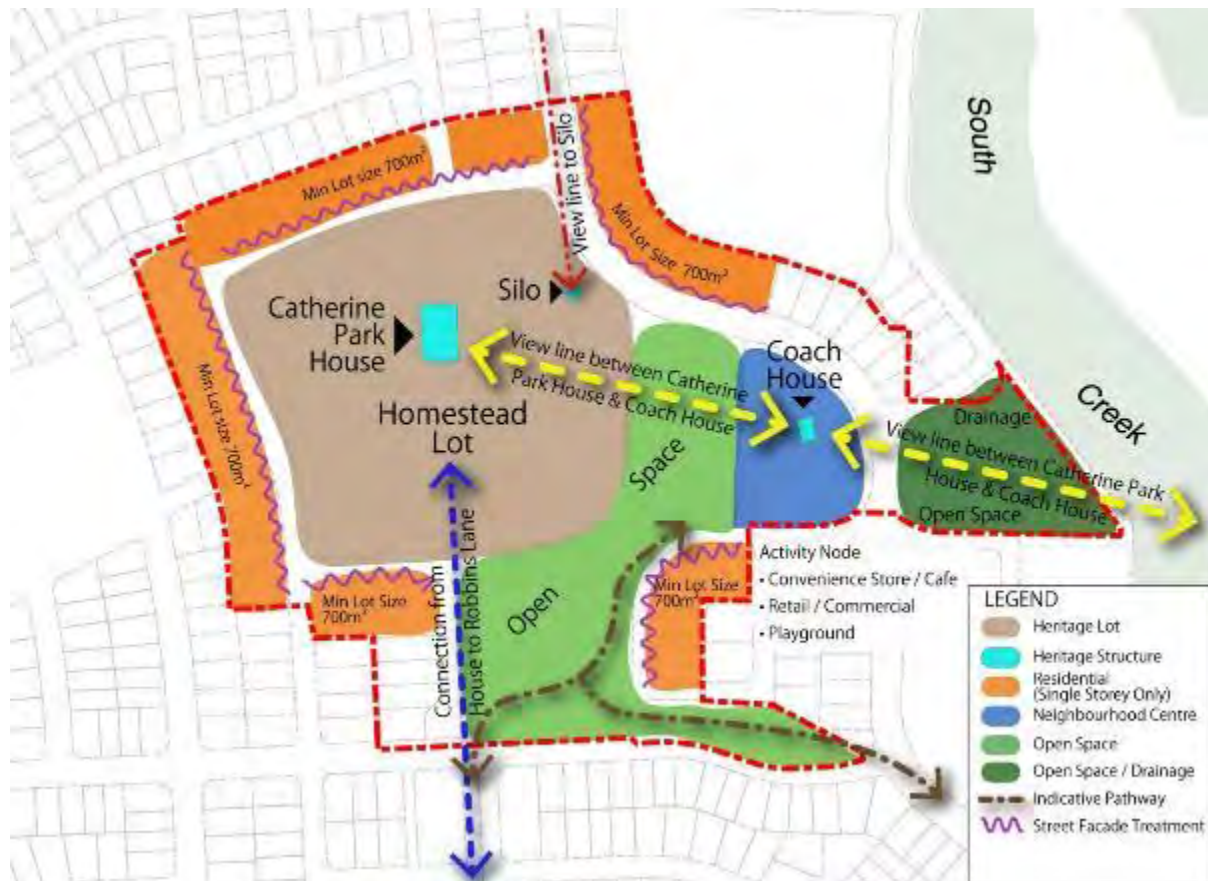
Figure 9: Oran Park outer Heritage Principles plan showing the important view lines and proposed and approved controls surrounding the house lot in the current residential subdivision of the property. This figure was prepared to inform the Heritage Exemption Guidelines and does not preclude other forms of development.

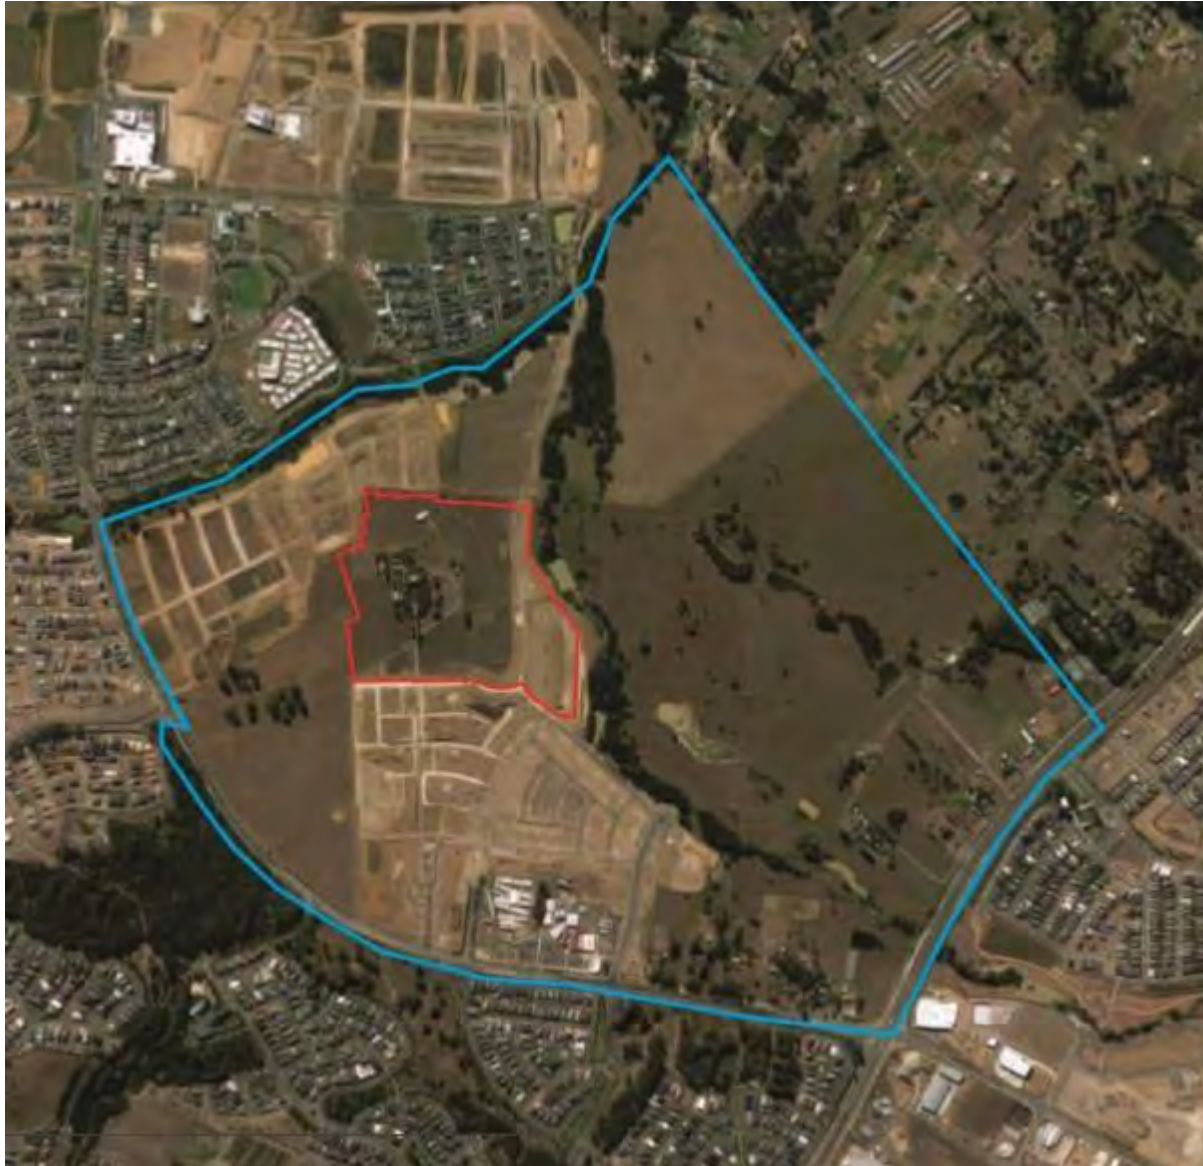
Figure 10: 2017 aerial photograph with the boundary of the Indicative Layout Plan for the Oran Park Estate shown in blue, and the boundary of the Stage 6 subdivision (incorporating Oran Park homestead lot and the SHR curtilage of the property) shown in red. Source: Casey & Lowe: 2017:pg.1 – base image Google 2017.

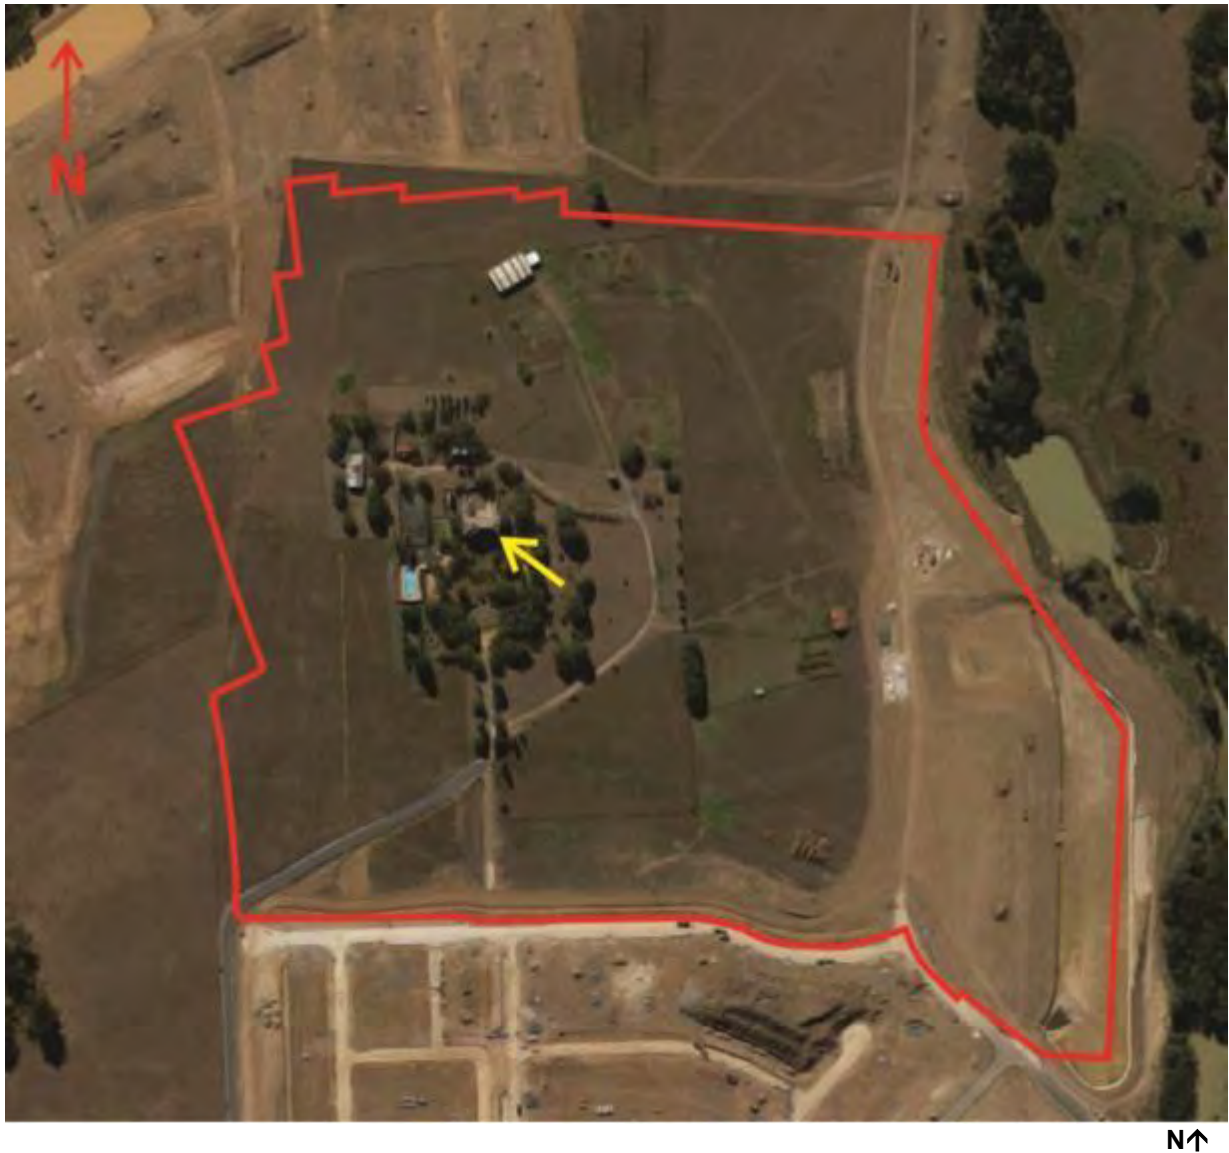
Figure 11: The red line indicates the boundary of the approved Stage 6 subdivision of the Oran Park Estate. The yellow arrow is pointing to Oran Park House. Source: Casey & Lowe: 2017: pg.2 – base image: Google 2017.

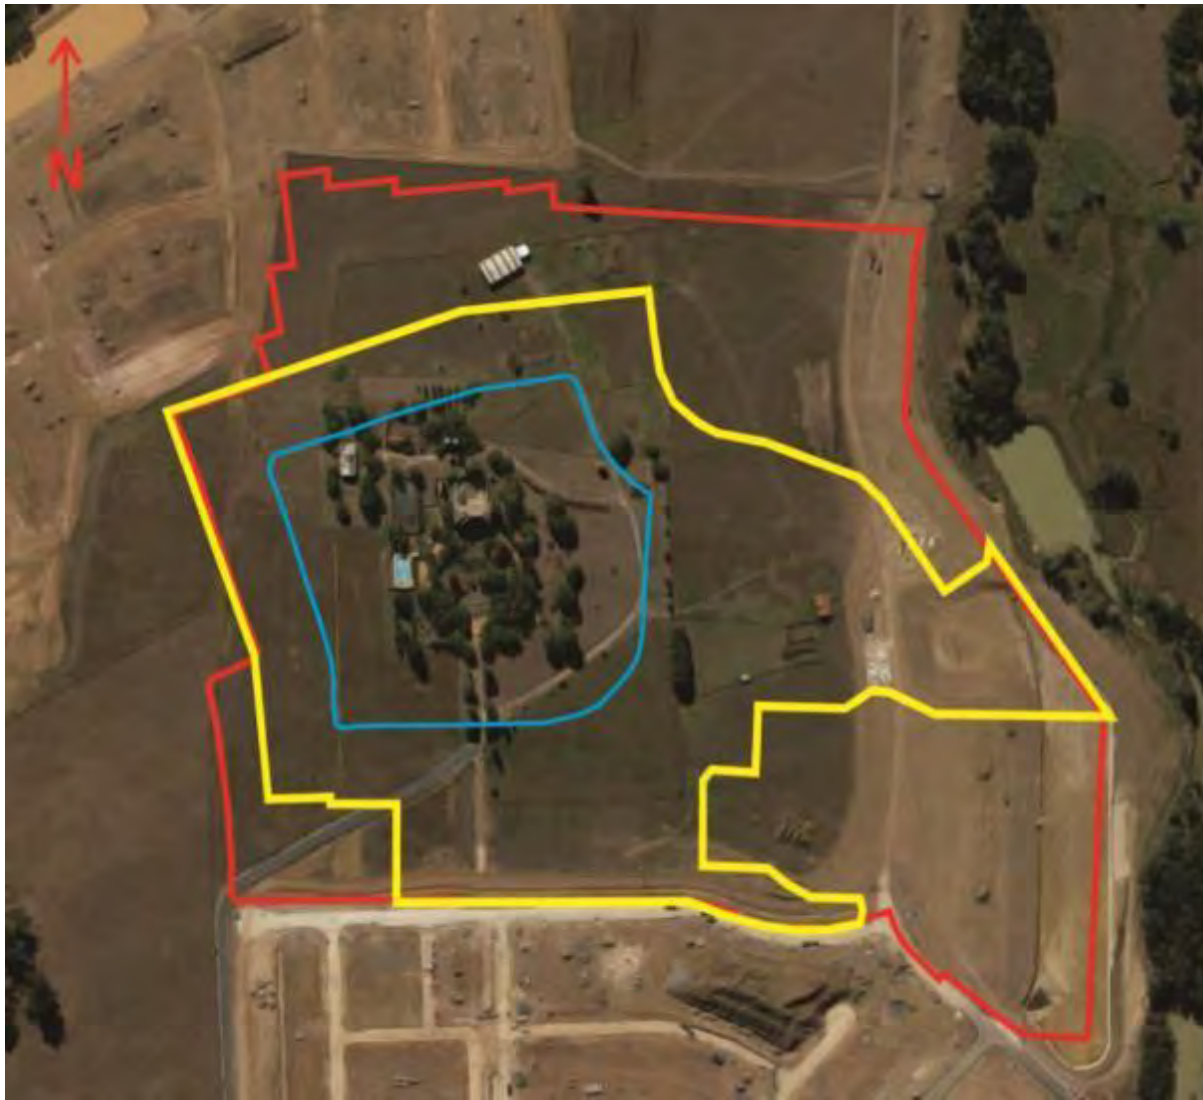
Figure 12: Overlay on 2017 aerial showing the approved Stage 6 subdivision boundary in RED, the SHR heritage curtilage in YELLOW and a proposed fence line around the homestead area in BLUE. Source: Casey & Lowe: 2017:pg.4 – base image Google 2017. N↑

On 5<sup>th</sup> March 2015 the State Heritage Register Listing Number 01695 was gazetted. This established the curtilage of approximately 14 hectares and included the House lot, part of the south-east driveway, the Coach House, the Silo and a pasture paddock linking to South Creek and residential development adjacent to the House Lot. Refer to Figures 8 and 12.

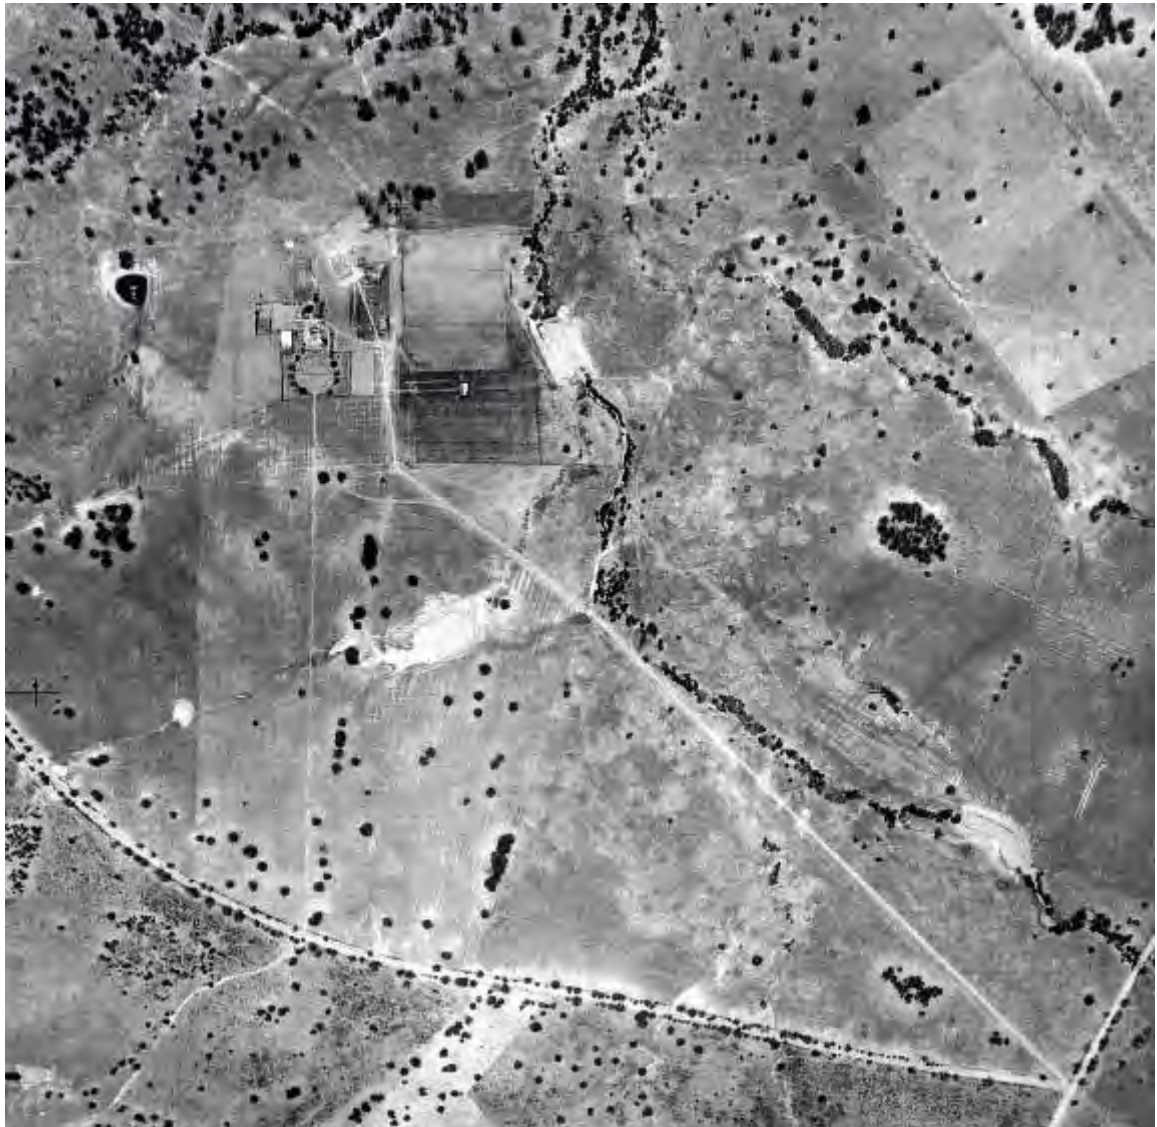
Figure 24: This 1947 aerial photograph shows Oran Park House and its immediate grounds. Two access roads can be seen – one travelling diagonally into the property from the intersection of the Hume Highway and Cobbitty Road in the lower right and another fainter track travelling in a straight line from Cobbitty Road to the tree-lined circular drive in front of the house. *Lands Department*

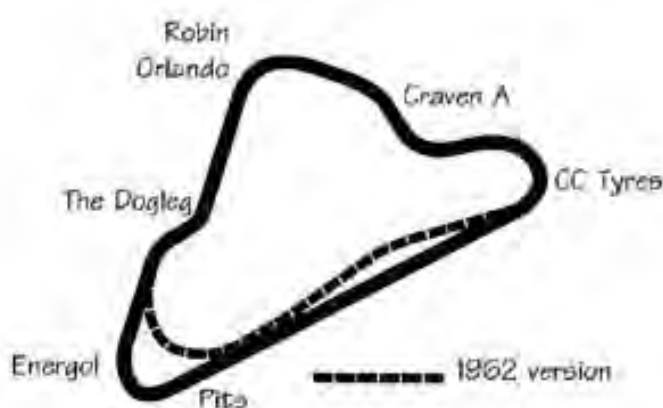
Figure 26: The dotted lines show the 1962 layout of Oran Park Racetrack within a later 1.21-mile version. This plan shows the corner names used in 1965. Terry Walker, *Fast Tracks*, p 120

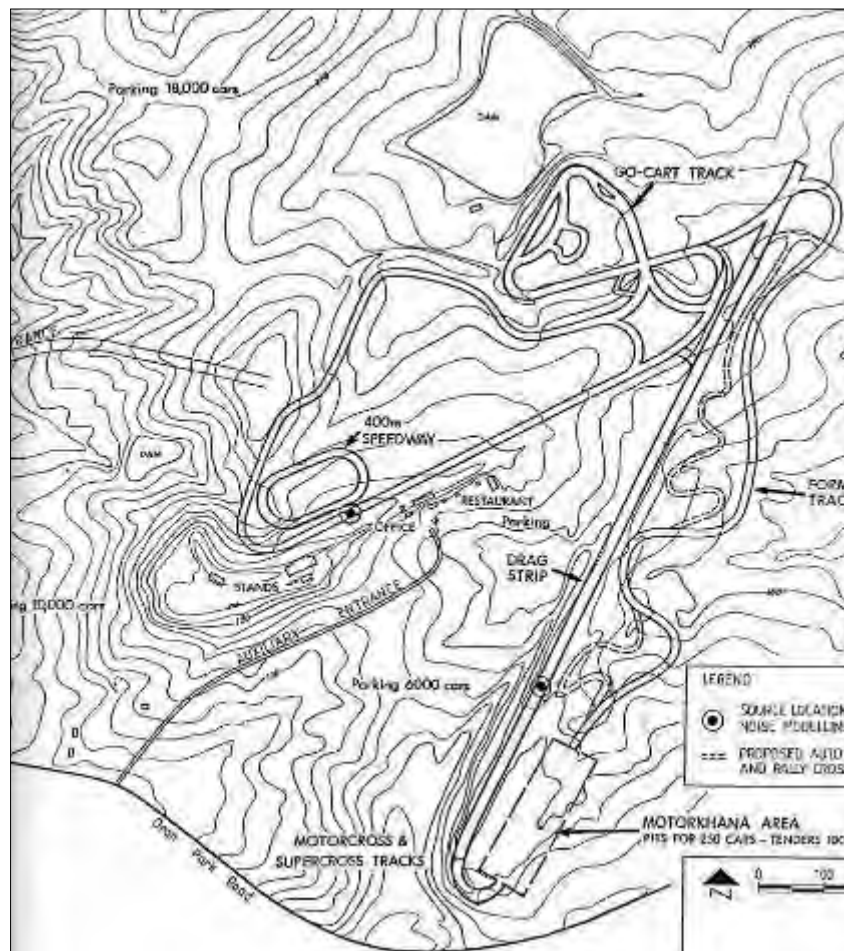
Figure 30: This plan showed the level of additional development proposed for the Oran Park Raceway in 1985. *Oran Park Environmental Study 1985*

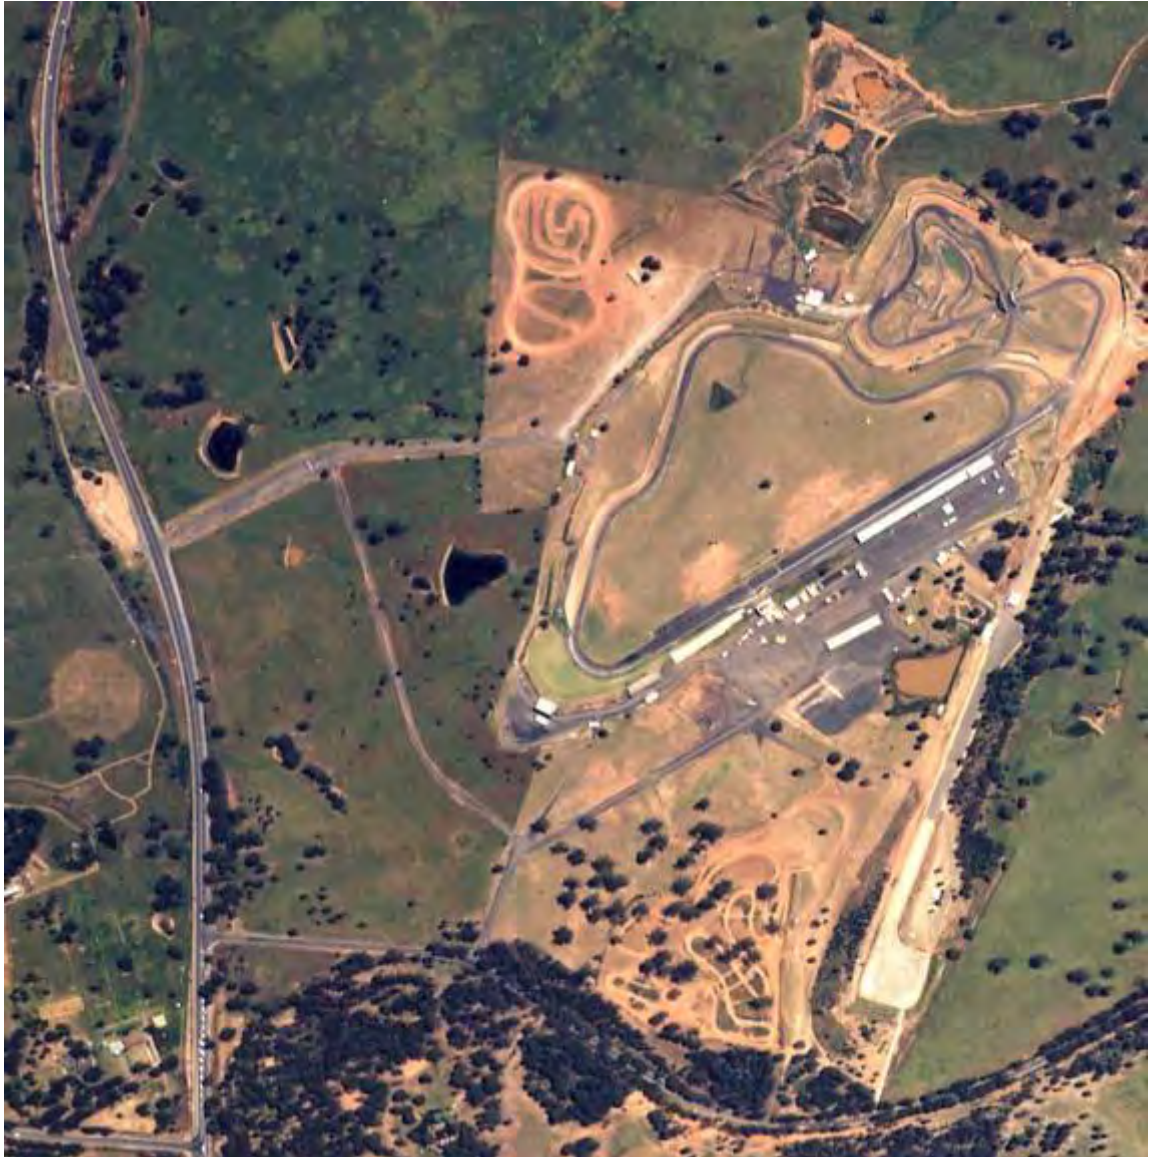
Figure 32: The aerial photograph dated 20 December 2005 shows the facilities at the Oran Park Raceway before its closure in 2008. *Lands Department*

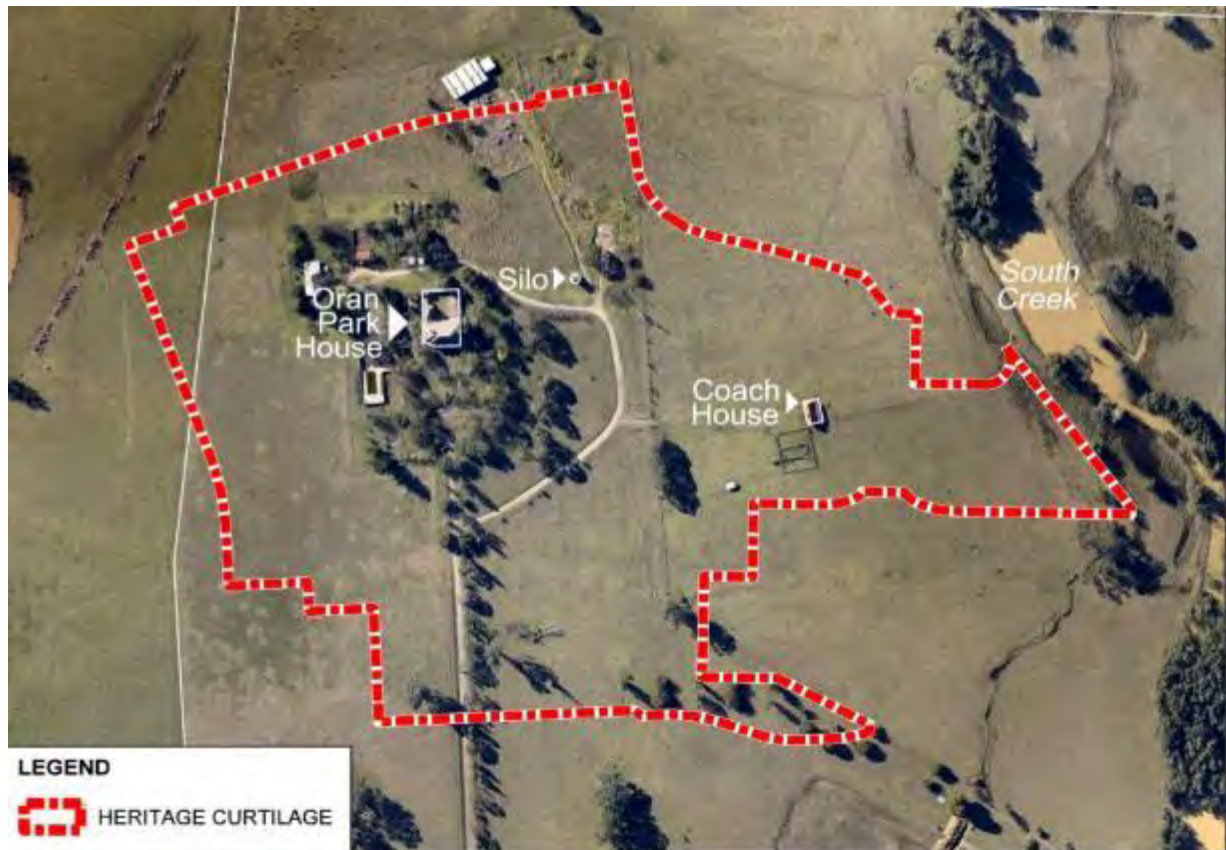
Figure 44: SHR curtilage overlaid onto a c2013 aerial photograph showing extent of the subject site. Source: Oculus Public Domain Strategy March 2017 pg.4. N↑. Not to scale.

Refer to Figures 44 and 45 overpage for the Subject Site area.

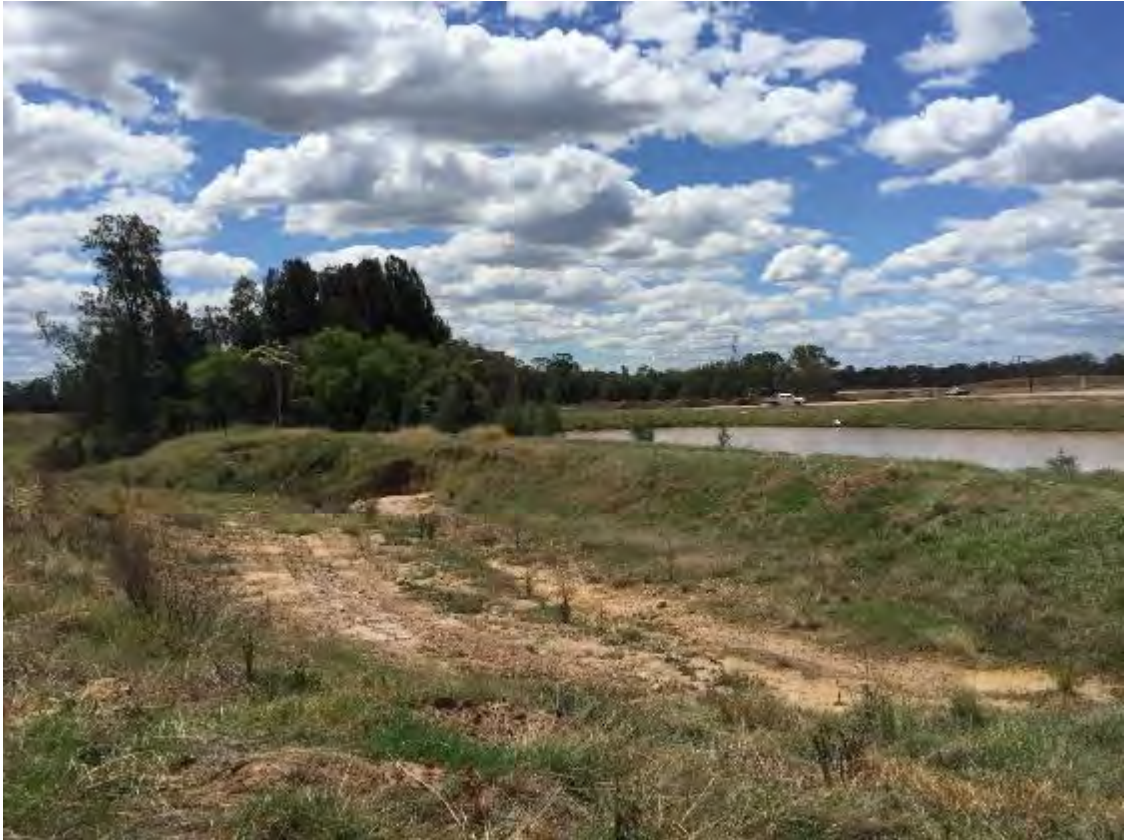
Figure 56: South Creek environs showing probably former weir location. TTA 2013

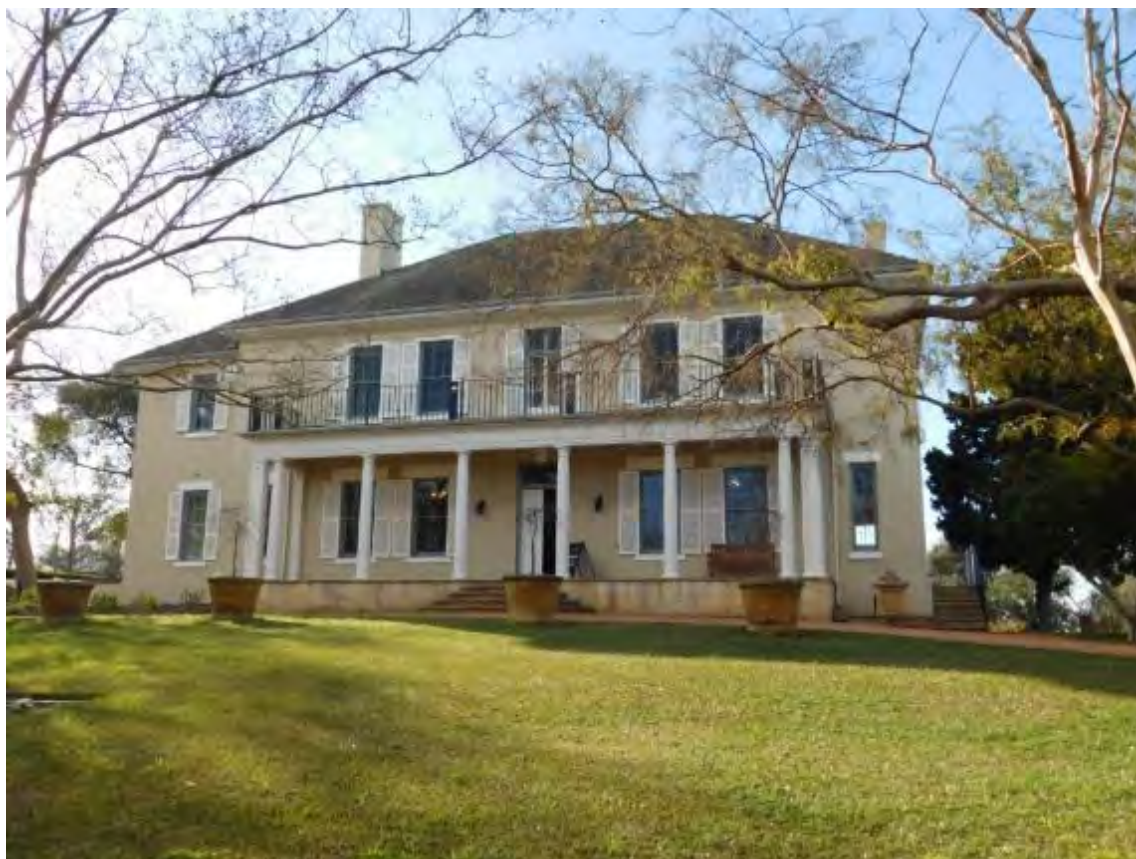
Figure 62: Front (south) elevation of the house showing the west wing. TTA 2013

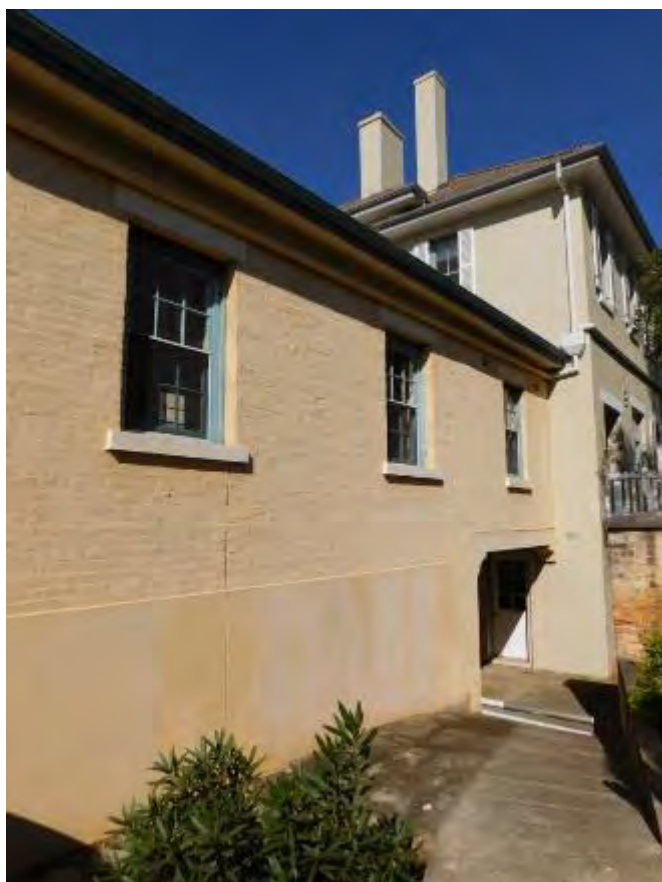
Figure 63: West elevations of the house showing the c1865 annex with the 3-storey West Wing that was added by Robbins. TTA 2013

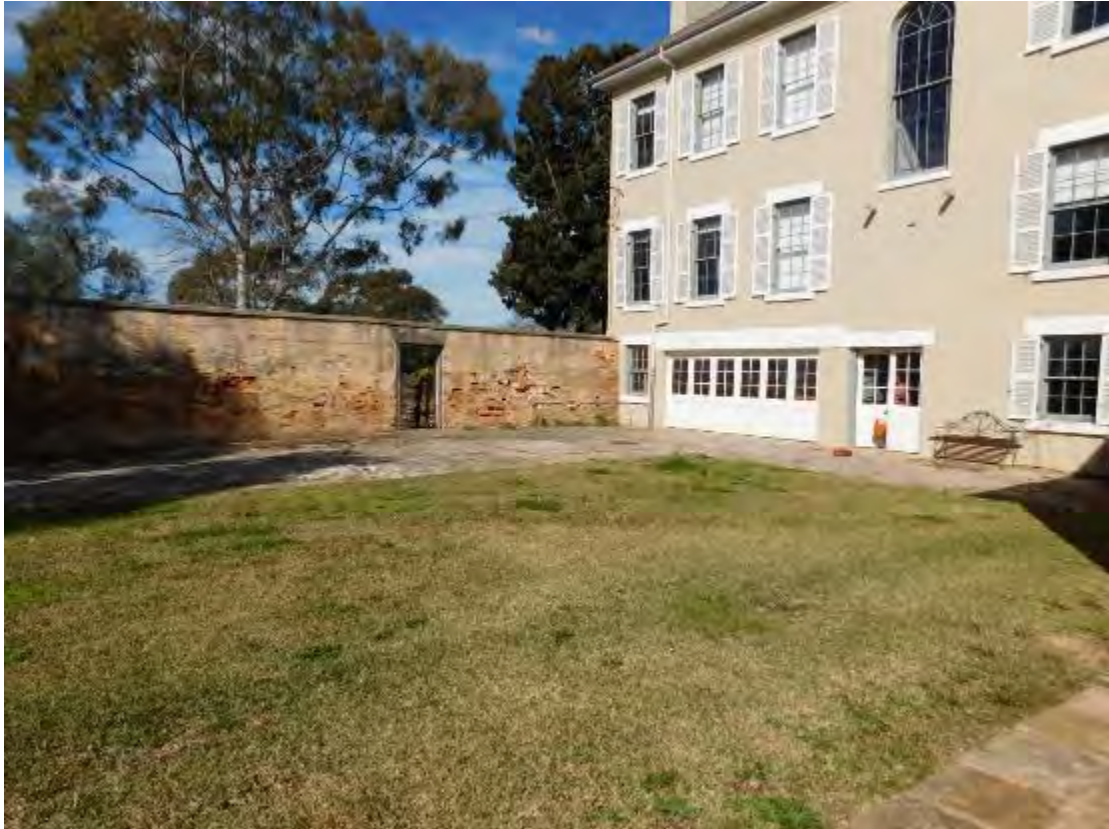
Figure 64: Rear (north) elevation of the house showing the generally symmetrical ground and first floors and the basement level. TTA 2013

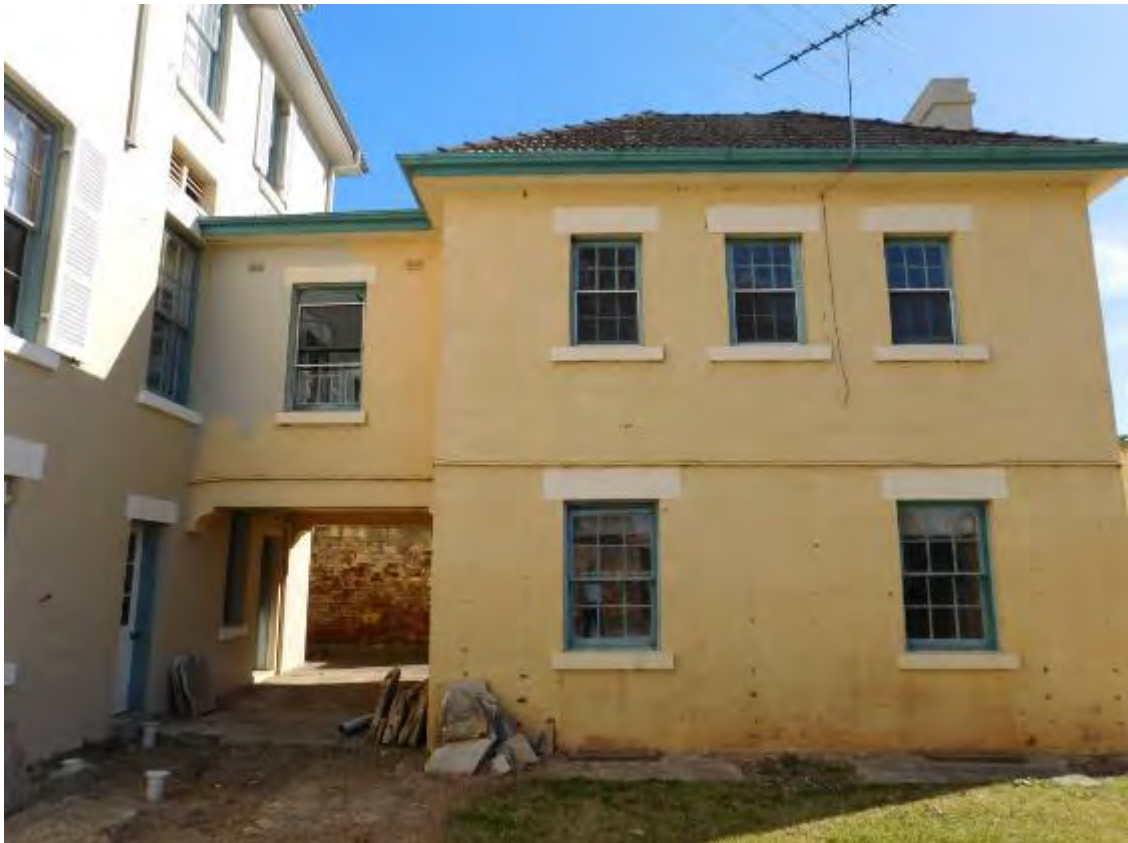
Figure 65: East elevation of the c1865 annex showing the link to the house built by Robbins. TTA 2013

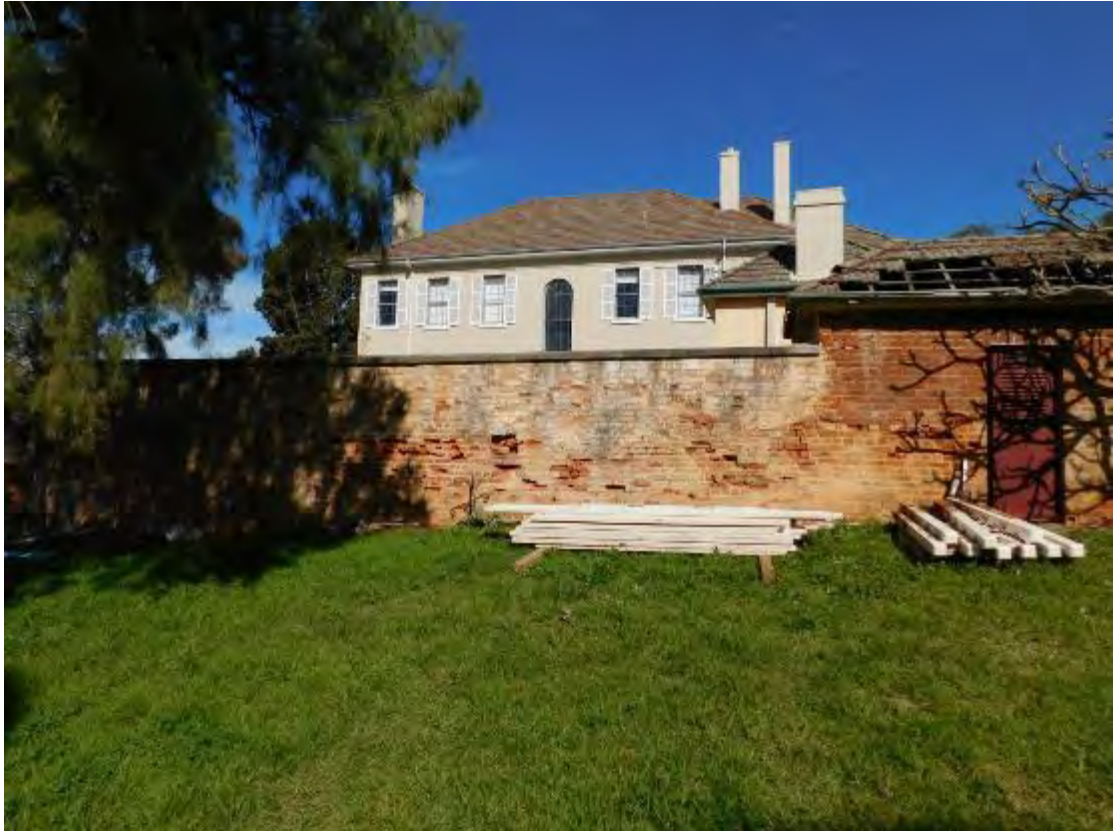
Figure 68: The rear brick wall surrounding Oran Park House showing its poor condition. TTA 2013

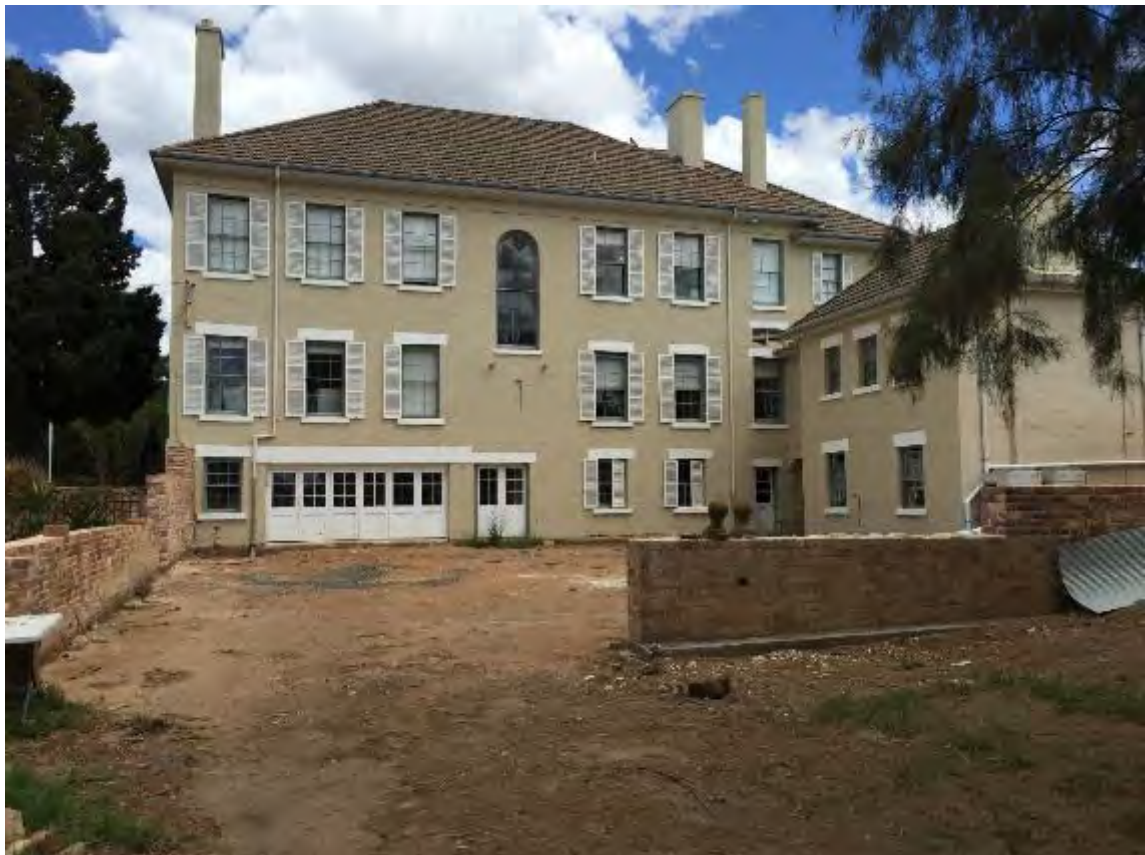
Figure 69: Current Oct 2017 view of the rear (north elevation) of the property. Note the rear courtyard brick wall had gone past the safe lean point and had been assessed by a structural engineer as unsafe and had to be carefully dismantled for safety reasons. TTA Oct 2017
