# Oran Park (SHR 1695)

## Conservation Management Plan

prepared for  
Hixson Pty Ltd

May 2019  
REF: 1655: CMP  
Issue 23

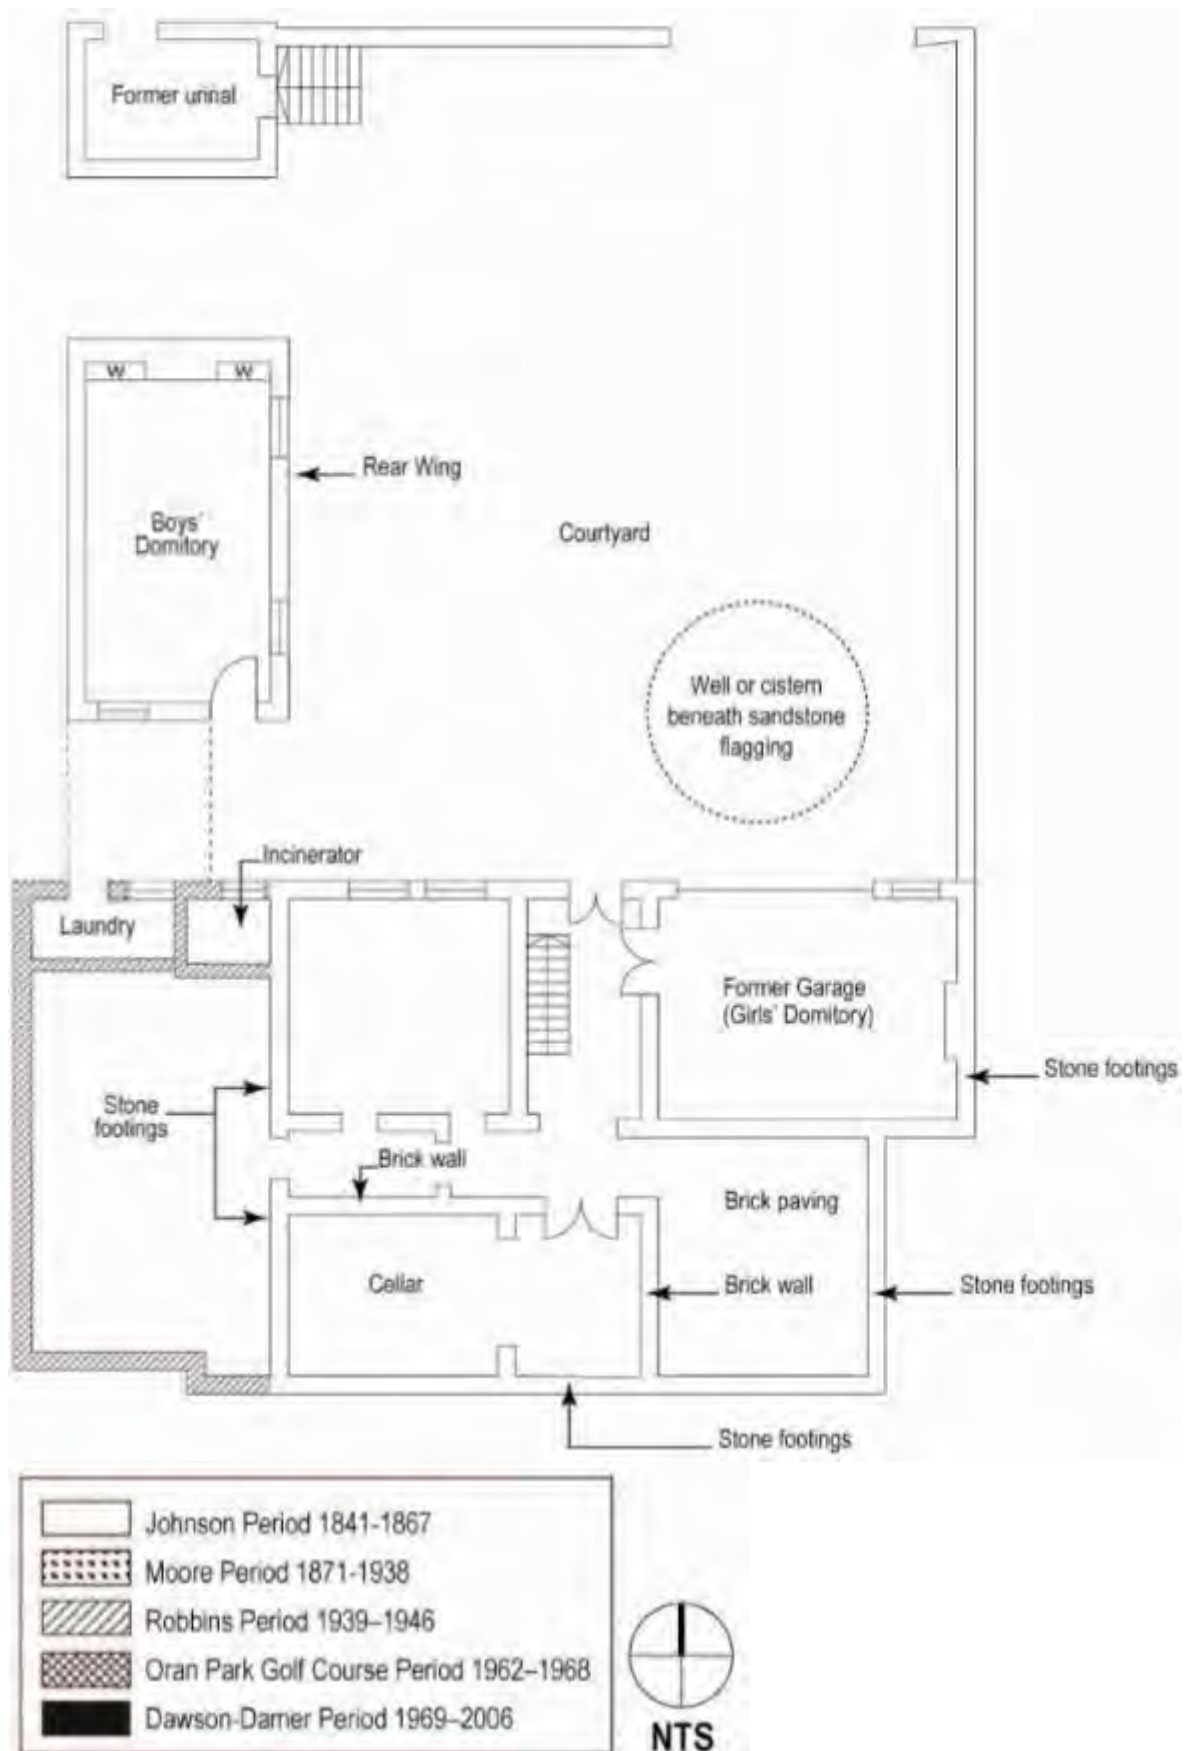
Figure 80: Basement Sketch Plan not to scale. Source: GML 2010 CMP pg. 60.

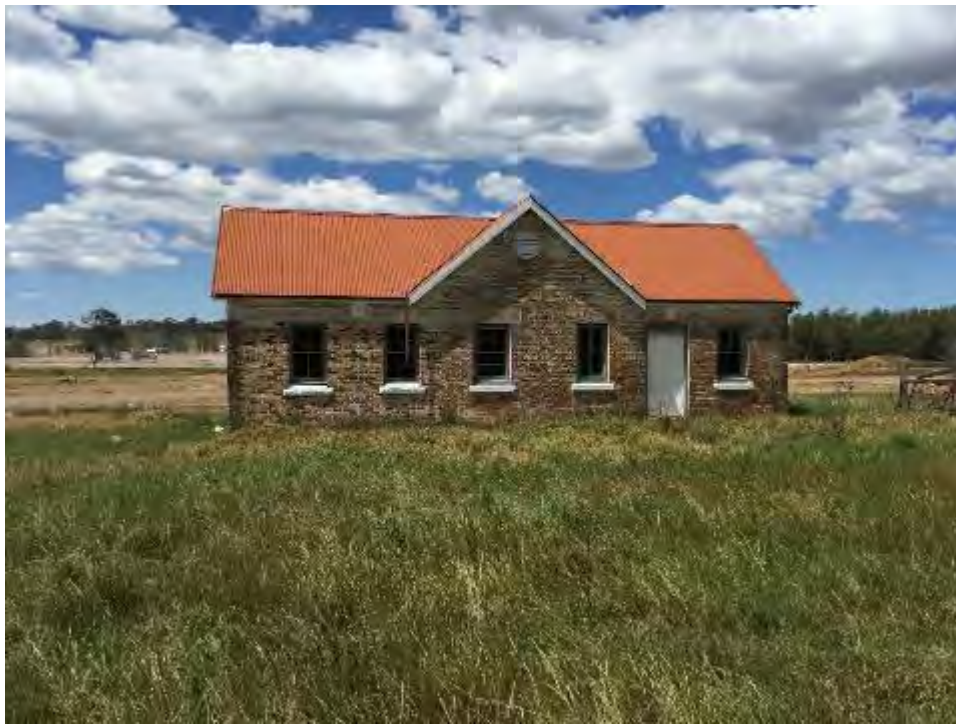
Figure 81: Coach House, west elevation. TTA Oct 2017

The Coach House is located a fair distance to the east of the house. The Coach House was originally constructed in c1837 as a two-storey building (refer Figure 113) with a single storey timber stable on the northern side. It is likely this was the original cottage on the property as noted in the Land Titles dealings. As it stands today, the Coach House is only partly original and has been partly modified with the second storey section pulled down and openings reworked. (Refer to section 4.0).

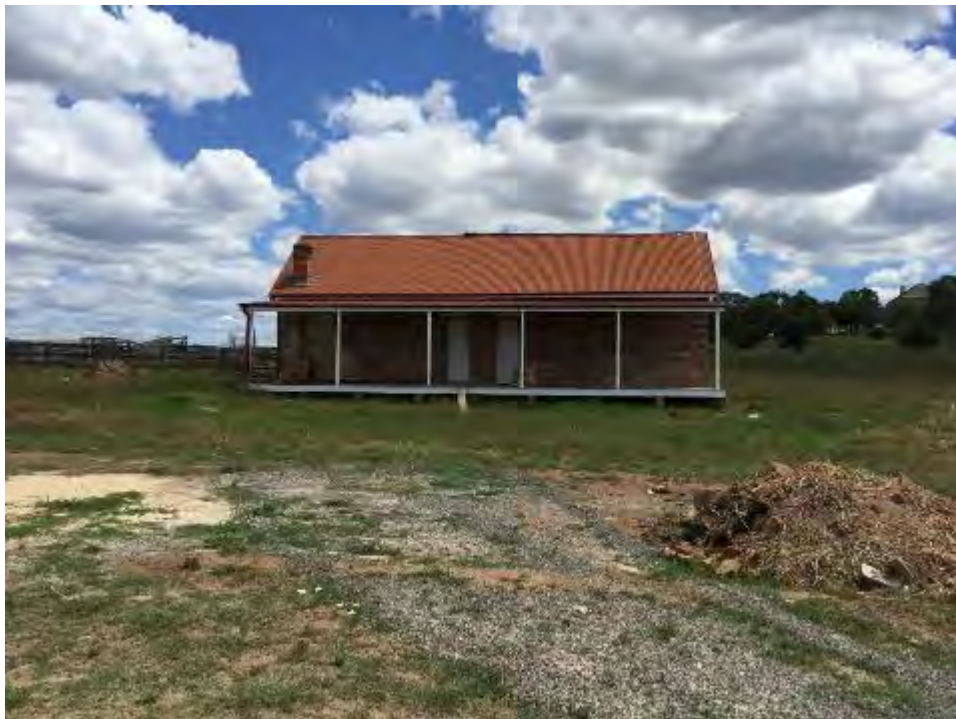
Figure 82: Coach House east elevation. Note Oran Park House to the right of frame. TTA Oct 2017

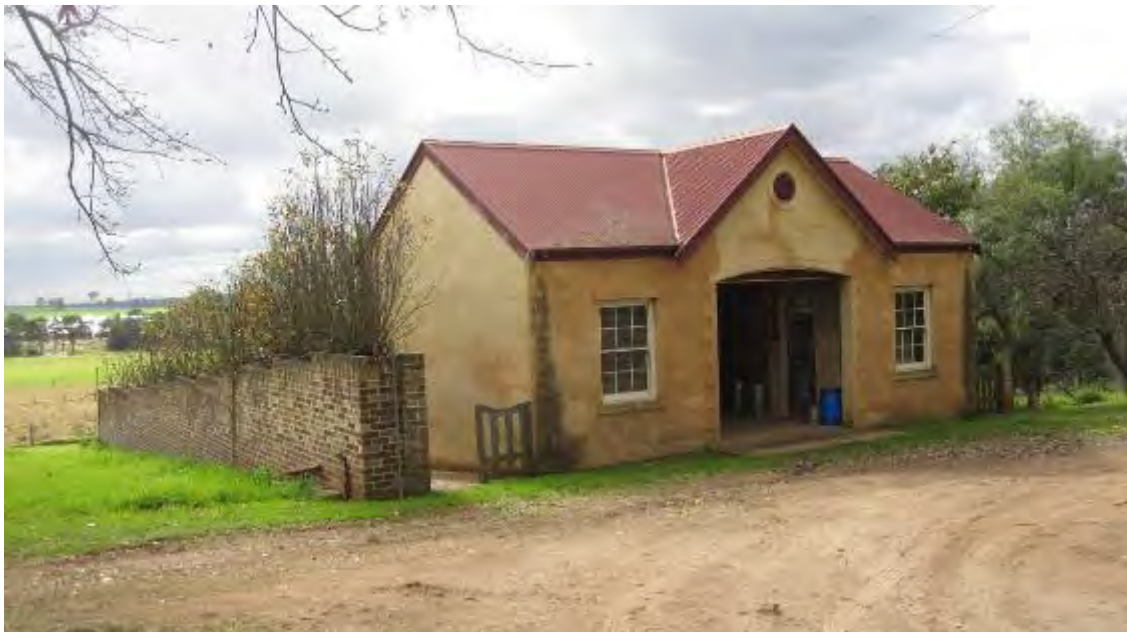
Figure 84: Garden Equipment Store, south and west elevations. TTA 2013

The Garden Equipment Store is a small single storey building located to the north-west of the house built in c1990 and is similar in style to the modified coach house.

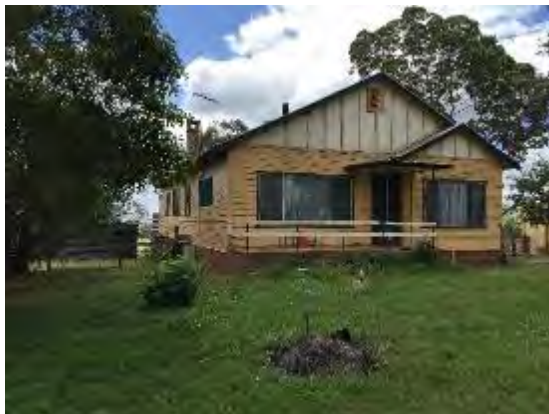
Figure 85: Caretaker's House, south and west elevations. TTA Nov 2017

- Roof Corrugated galvanized mild steel sheeting and exposed rafter eaves.
- Walls Timber frame and clad with painted timber weatherboards
- Windows Aluminium to new additions and timber to remnant original cottage elevations
- Sub Floor Large common face brick piers (note: these piers are tilting and failing especially to the west elevation)

The appearance of the Caretaker's Residence is an ordinary building following some interwar details. The additions and adaptations have extended the cottage without modulating or stepping the long east and west facades and this has resulted in the additions overwhelming the original scale and design of the cottage. The former cottage is now a large structure and is in poor condition. Refer to Appendix F for further information.

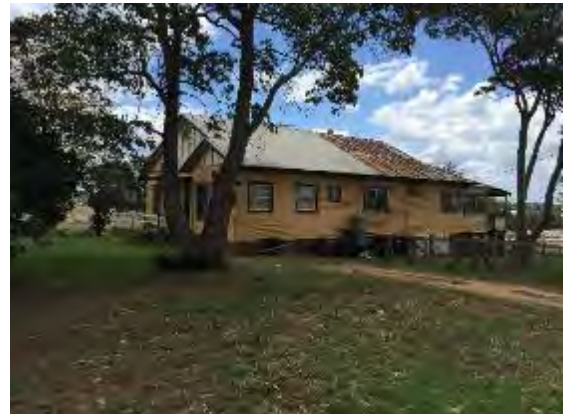
Figure 86: Caretaker's House, south and east elevations. TTA Nov 2017

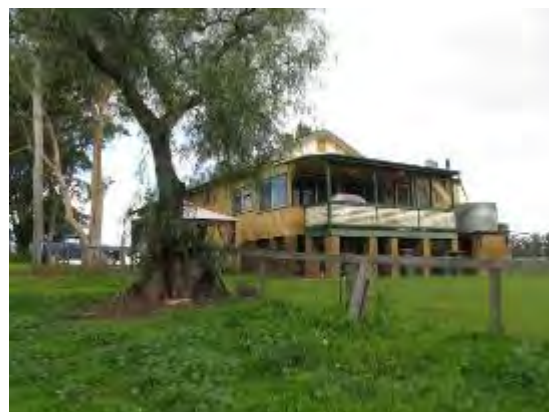
Figure 87: Caretaker's House, north and east elevations. TTA 2013

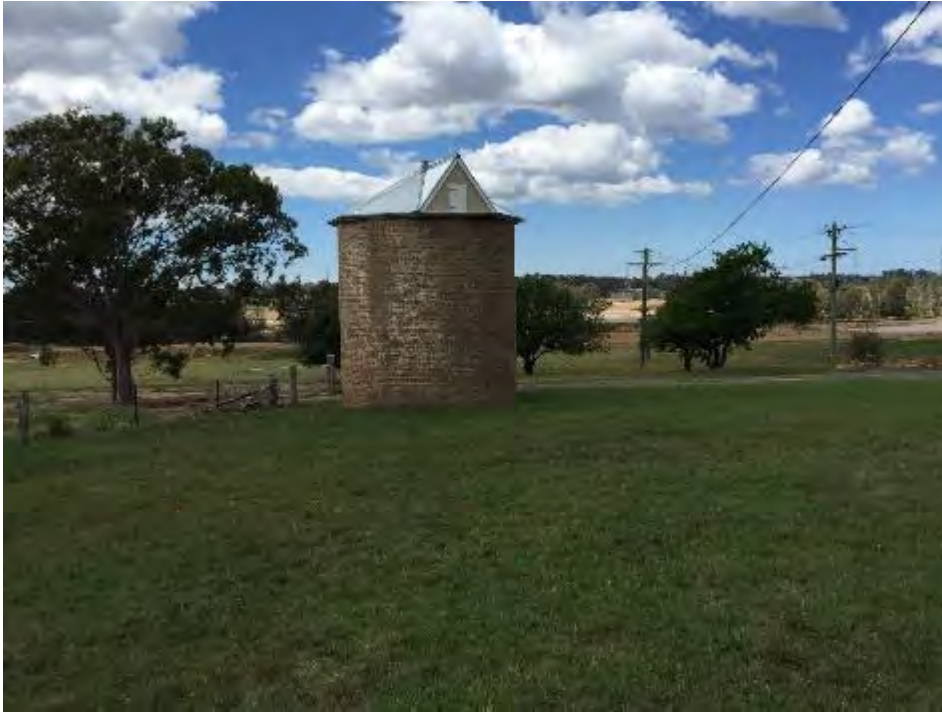
The silo is a round, brick structure with corrugated iron roof located to the north-east of the house. It was likely constructed in c1920 for silage as the base is buried into the ground. This building is evidence of the clay industry at Oran Park.

Figure 92: Silo looking east. TTA Oct 2017

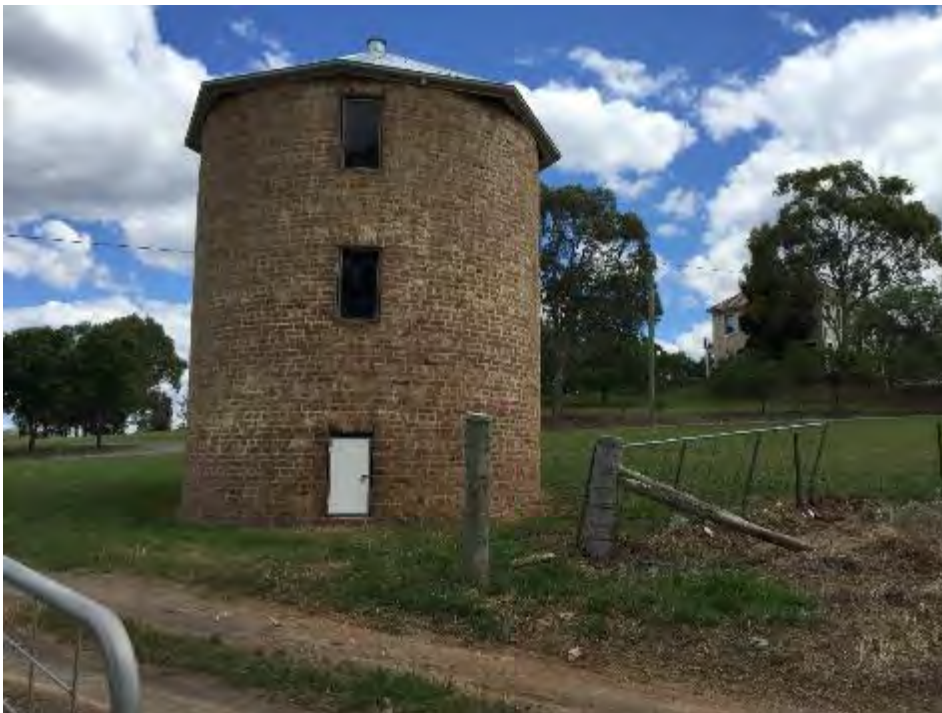
Figure 93: Silo looking west back to the house (visible to the right of frame). TTA Oct 2017.

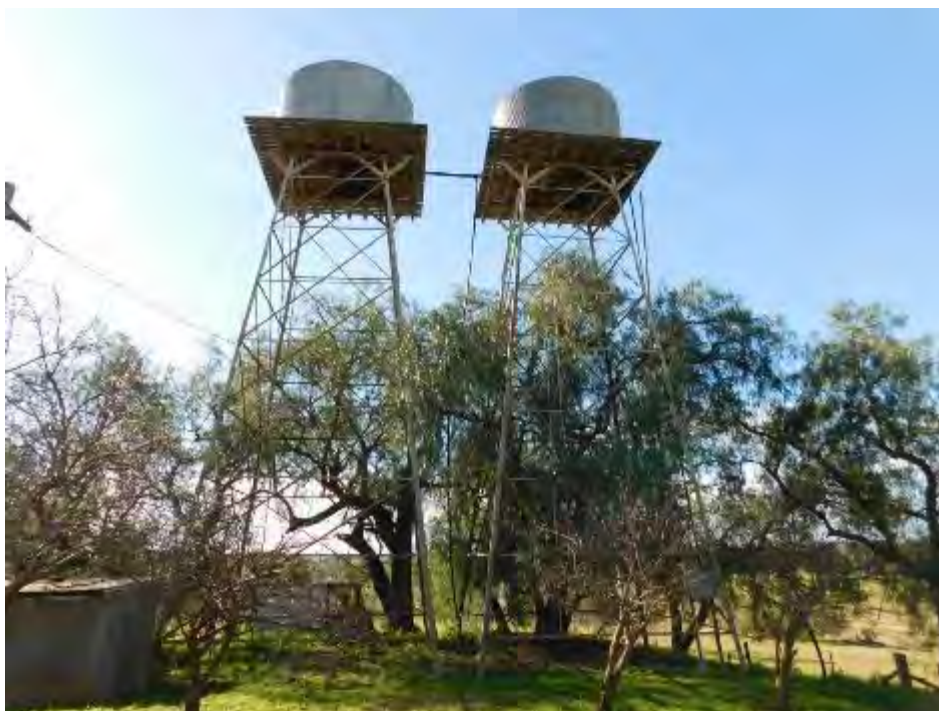
Constructed in c1980, the pair of corrugated metal elevated water header tanks is located to the north of the house. They form a striking landmark in the landscape with the house. The Estate had a reliance on rain and South Creek for water.

Figure 94: Water tanks looking north. TTA 2013

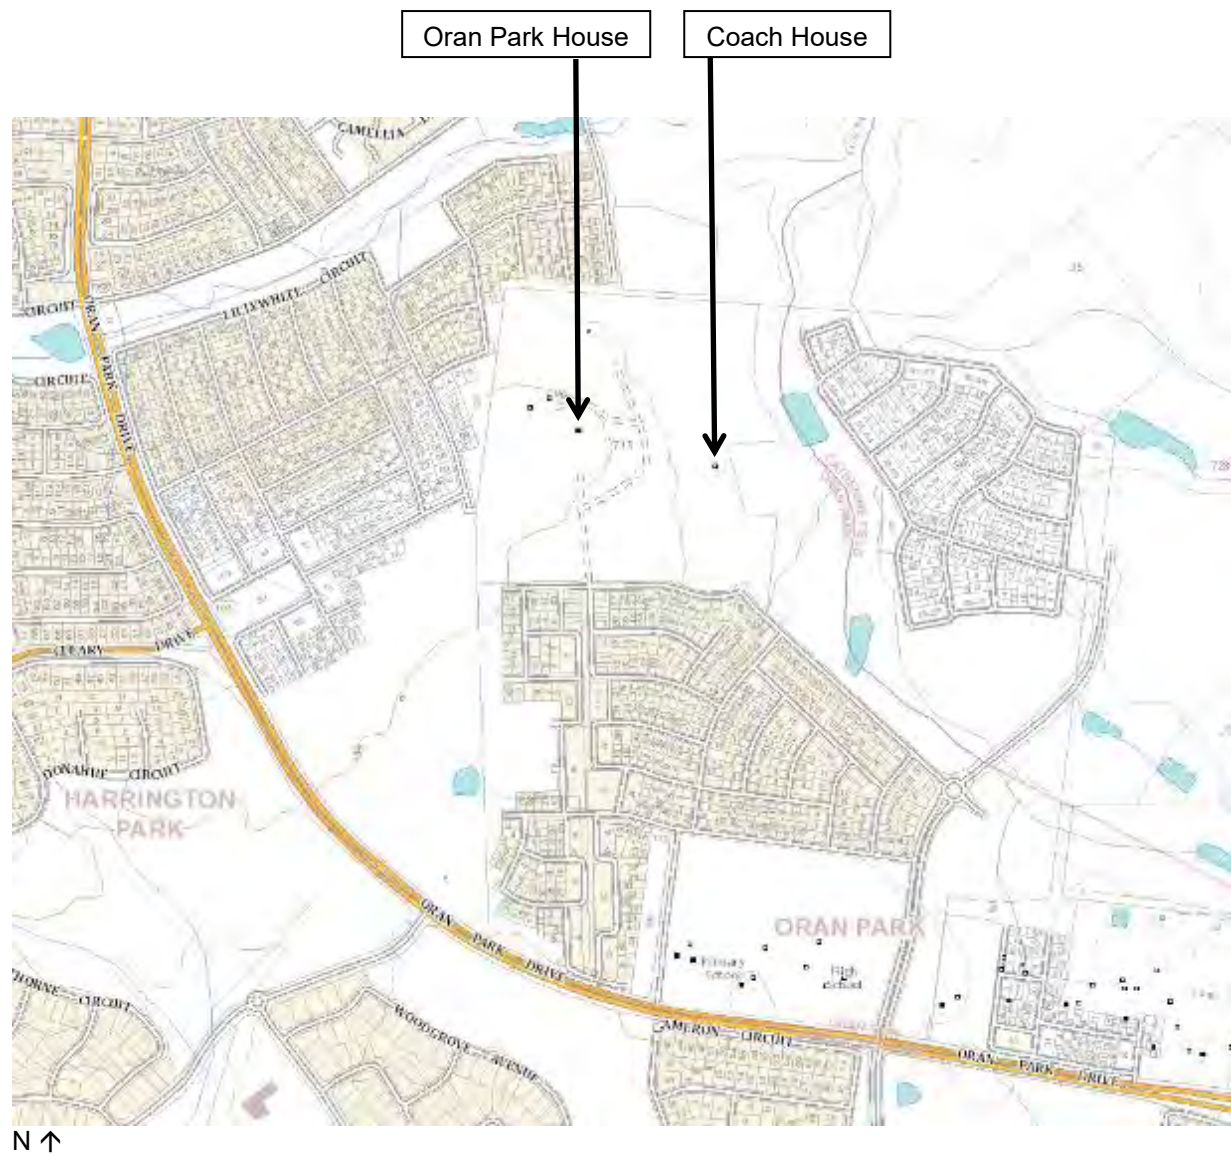
Figure 95: Cadastral plan of the Oran Park Estate showing the extent of recent and ongoing residential subdivision.  
Source: Sixmaps

Refer to the Addendum November 2017 at the front of this report and Figures 4-13 and 95 over page.

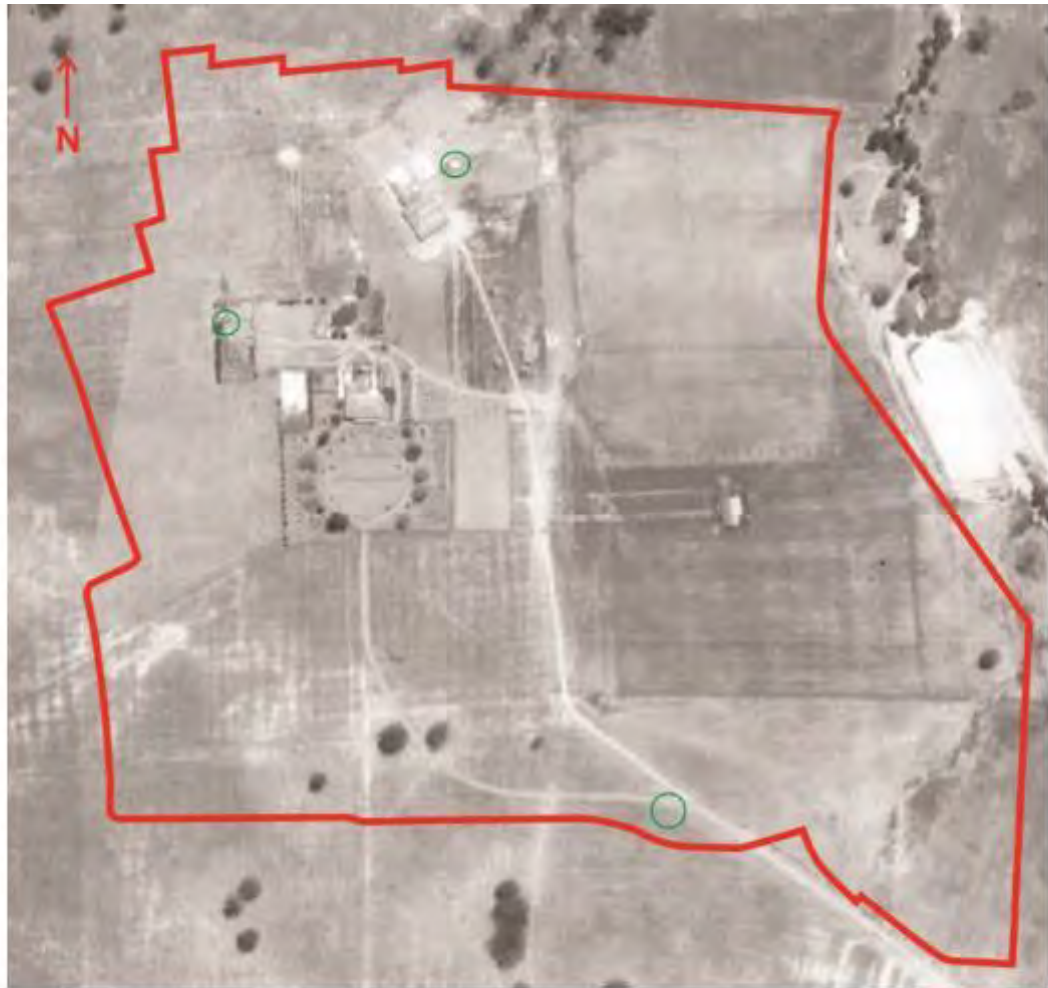
Figure 3.1: An aerial photograph dating to 1947 shows a driveway leading from Cobbity Road (south west of the study area) up toward the sheds to the north of Catherine Park House. The Stage 6 boundary is indicated in red. The green circles indicate possible features investigated during the site visit.

Figure 102: Casey & Lowe areas of investigation. (Casey & Lowe: 2017:pg.11).

*During the site visit particular attention was paid to four (sic) possible structures identified on the 1947 aerial photograph (Figure 3.1 [TTA figure 98]) which were no longer apparent on the 2017 Google satellite photo. No trace of the three possible structures was found, although their remains may be present beneath the overgrown grass or below ground. It is also possible that the shapes in the 1947 photograph were not structures but items which would be unlikely to leave an archaeological signature, such as water troughs, trucks, farm equipment or temporary sheds.<sup>70</sup>*

*A group of demolished sheds to the north of the main house, shown on the 1947 aerial photograph, are unlikely to have archaeological potential (Figure 3.1 [TTA Figure 102]). Items within the sheds suggest they were built in the 1930s or later, and are therefore of little archaeological interest.<sup>73</sup>*

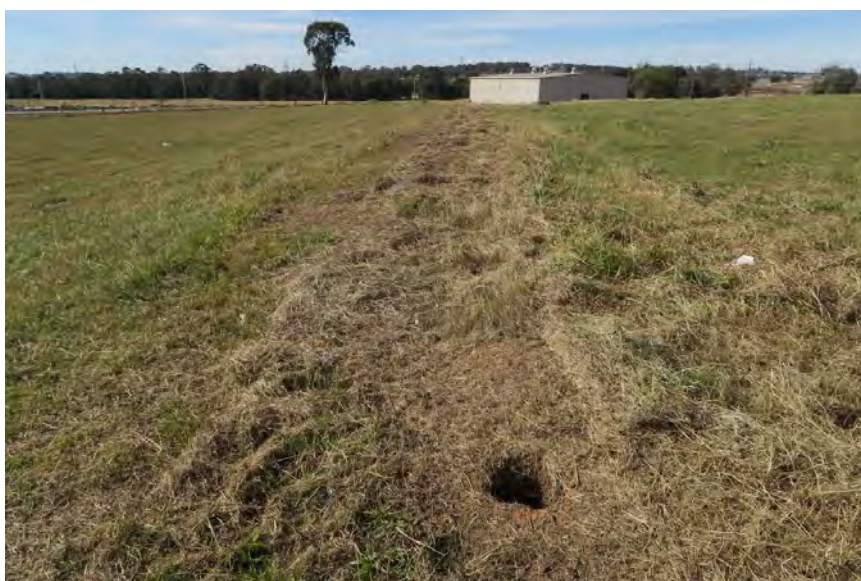
Figure 103: Evidence of recently removed fenceline in the paddock north of Oran Park House. Source: Casey & Lowe: 2017:pg.12, Figure 3.2.

- Beyond the house environs no evidence of past structures was found in the open grassed paddocks except for evidence of a recently removed fenceline (refer Figure 75). "Development had already begun on some of the land in the south and east of the study area. Substantial areas of land within this area had been buried below imported soil used to build up and level the land. Some of these mounds were quite overgrown and had been there for some time, while others appeared to be quite fresh and recent. Based on historical analysis, these areas are unlikely to have contained archaeological material however, the soil has completely obscured any remains that might have been present...Large areas of land in the south and east of the study area also appeared to have been recently graded in preparation for construction." (Casey & Lowe:2017:pg.12).

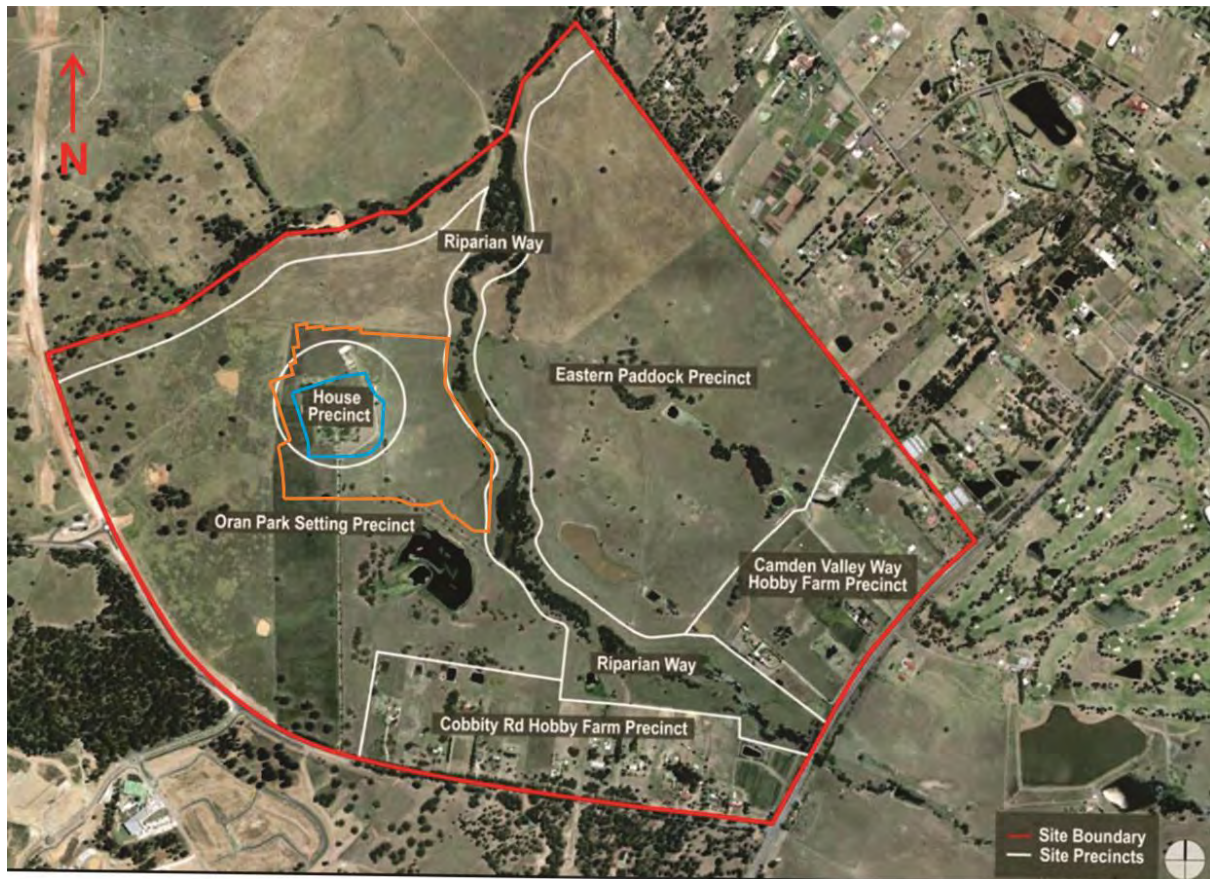
Figure 106: (Casey & Lowe: 2017: Figure 4.1) "Overlay showing the site precincts as defined by GML (outlined in white). The Catherine Fields (Part) Precinct site is outlined in red, the Stage 6 Subdivision is outlines in Orange, and the proposed boundary around the homestead is outlined in blue. Base plan from GML 2012, with annotations by C&L."

*On the basis of this assessment, three key areas of historical archaeological potential have been identified, as described in Table 4.1 and Figure 4.1.*

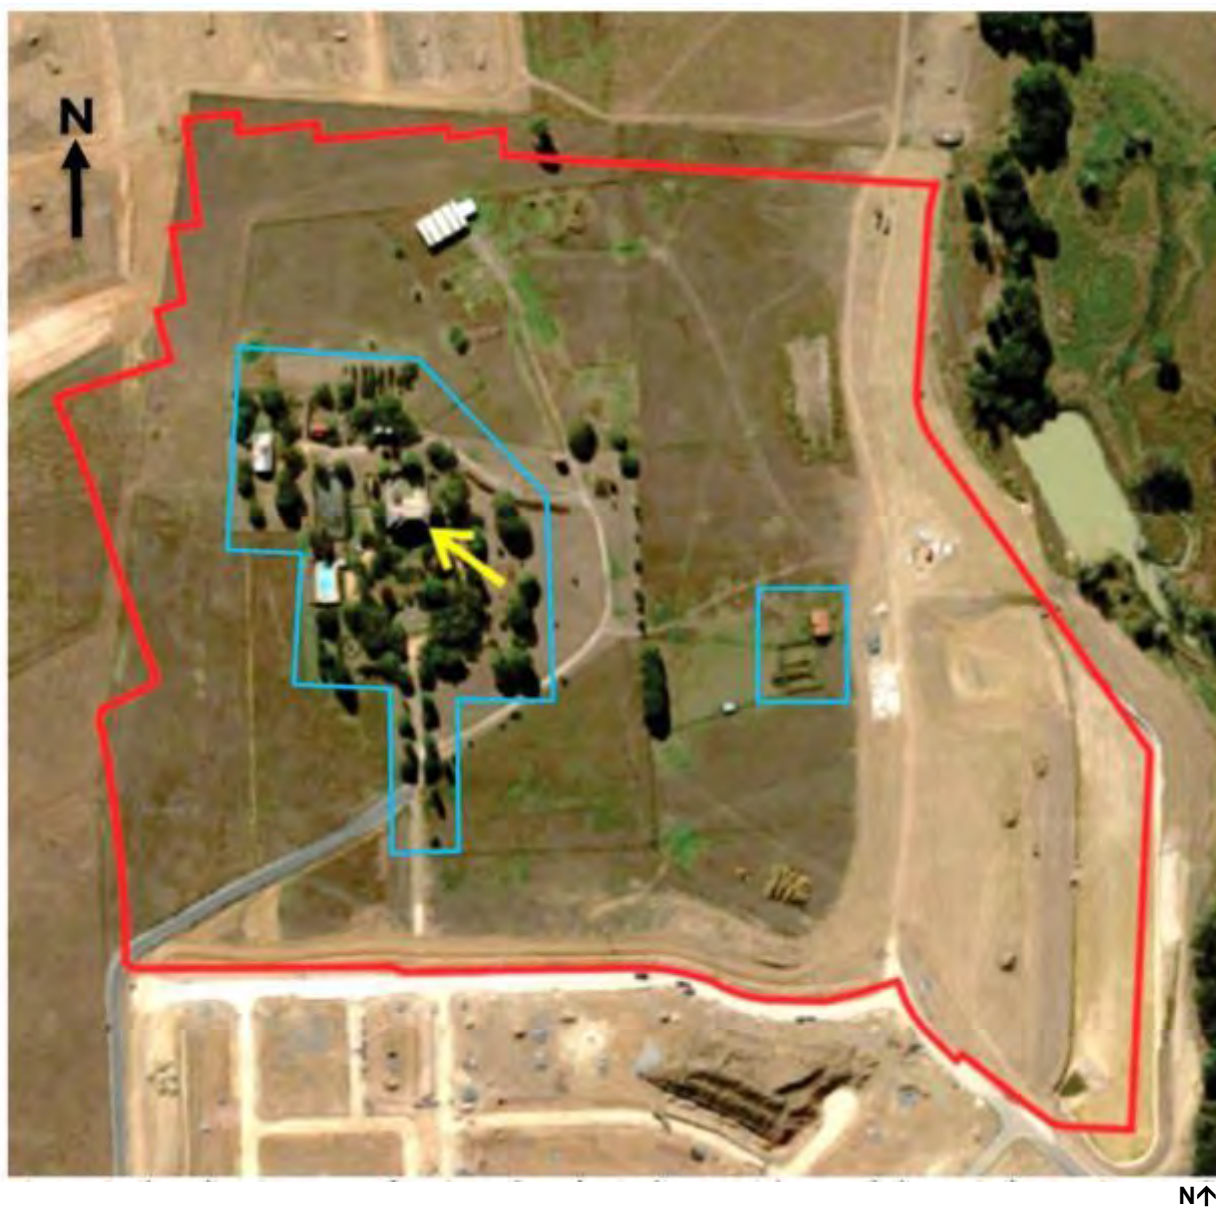
Figure 107: Main areas of European archaeological potential outlined in blue. Source: Casey & Lowe.

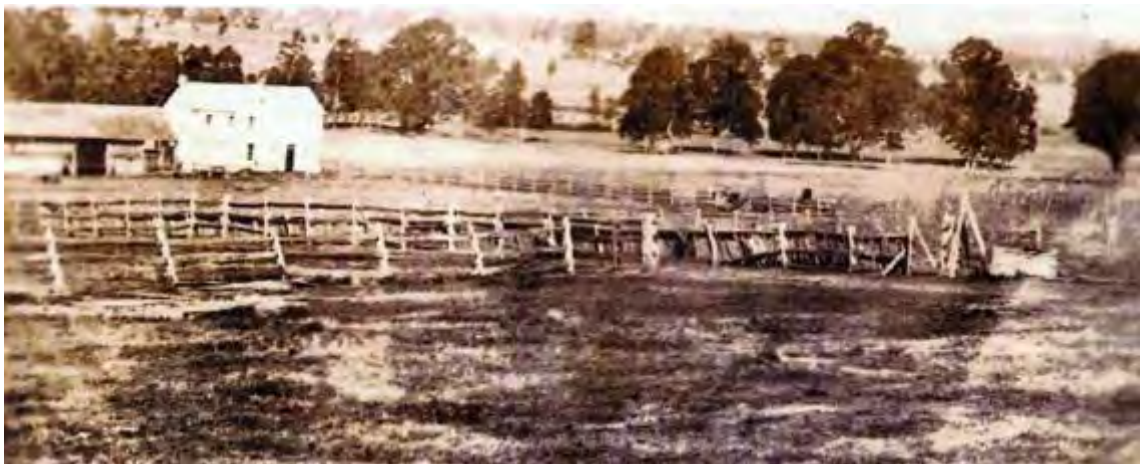
Figure 113: Original Homestead Coach House looking east during the Moore Period (1871-1938) showing the two storey structure of the coach house and single storey stables on the northern elevation. Moore Family Archives.

An early image of the Coach House taken some time during the Moore period shows the building. It is much more the design of a cottage than a coach house. We believe the coach house use came much later, after the house at its current location was built around c1865. Siting of the house would have also been crucial in c1837. The siting of what is now known as the Coach House was close to the property's water supply of South Creek.

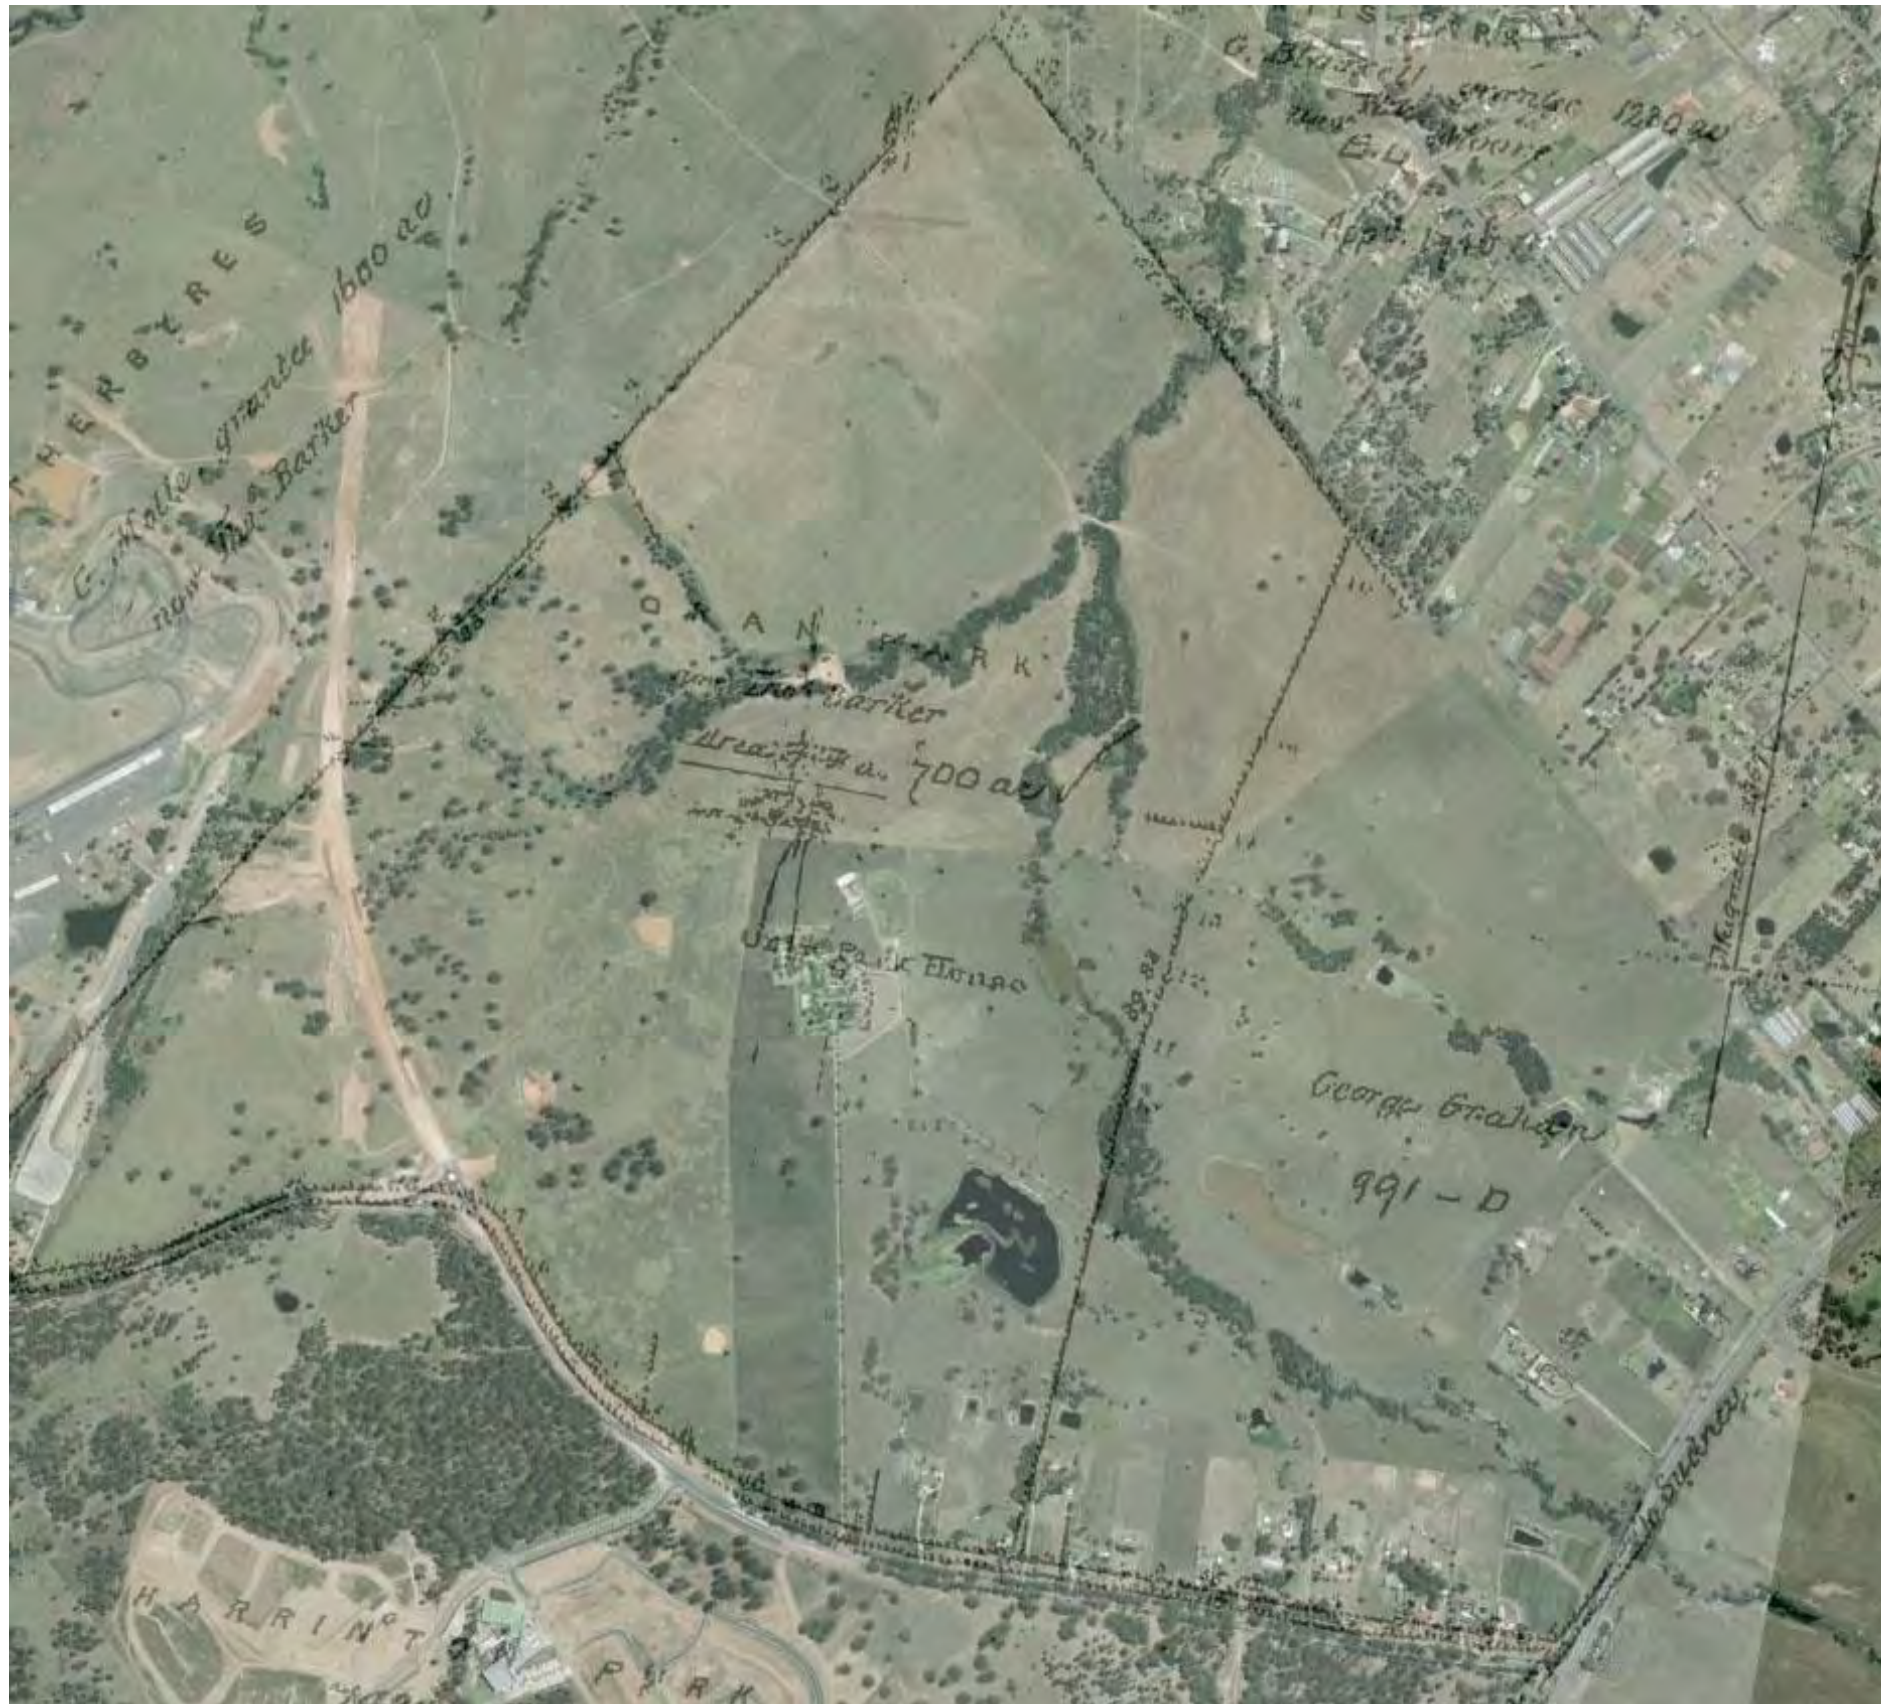
Figure 119: Current aerial photograph of the Oran Park property overlaid with the 1867 survey showing that the location of Oran Park House as depicted on the survey is the location of the house as it stands today. The north-east and north-west grant lines are still clearly visible in the landscape.

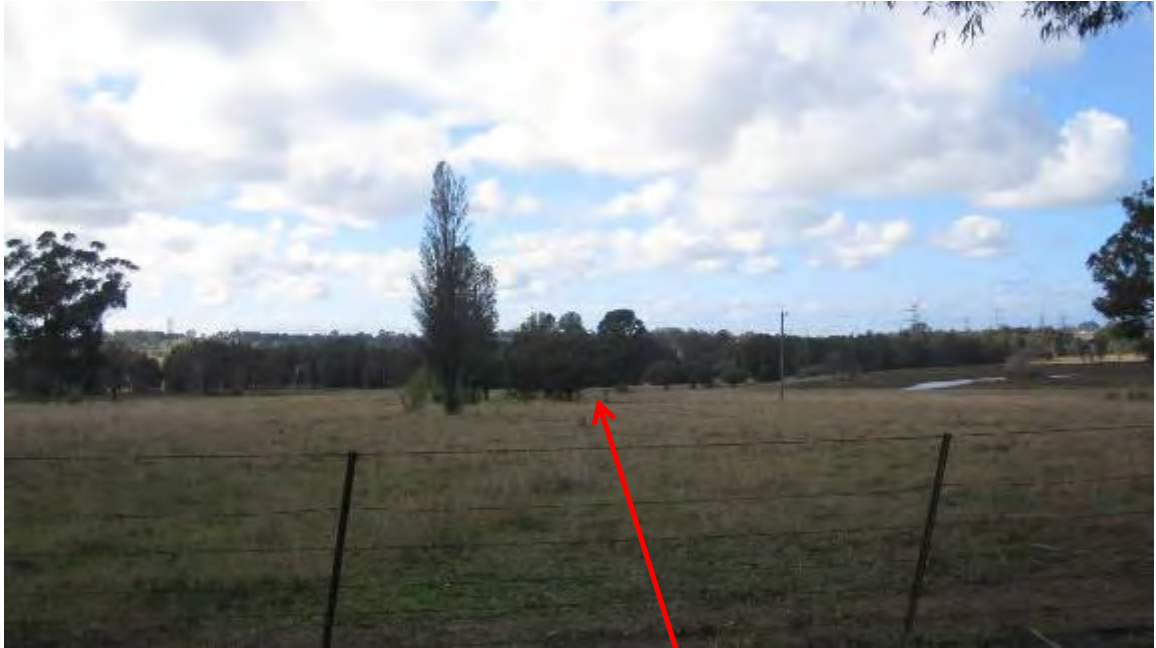
Figure 138: Avenue of trees in the south-east paddock that formerly lined the original driveway from Camden Valley Way & Oran Park Drive (formerly Cobbitty Road) leading up to the carriage loop in front of the house. TTA 2013

The avenue of trees planted in the late 1940s to the early 1950s along the former original driveway leading from the corner of Camden Valley Way and Oran Park Drive up to the carriage loop still exists in part on the site. Refer to Figures 138 and 139 below.

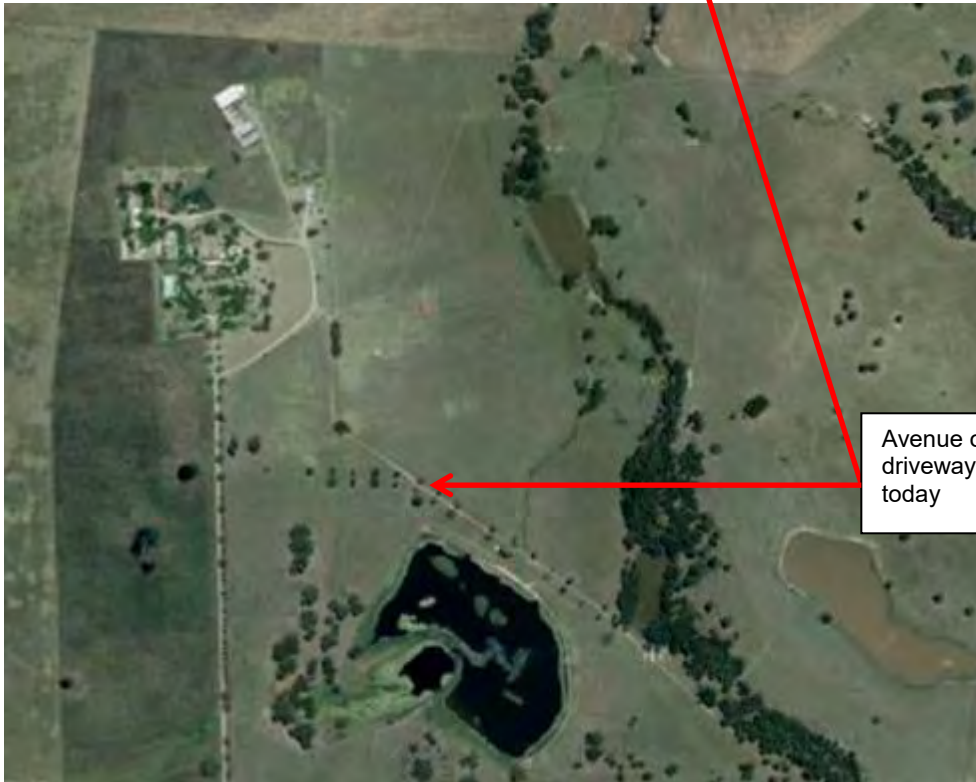
Figure 139: 2011 aerial of the subject site showing the avenue of trees still existing along the path of the original driveway. Refer to aerial figures in section 4.1 for further detail. Google maps.

Avenue of trees along original driveway still exist on site today

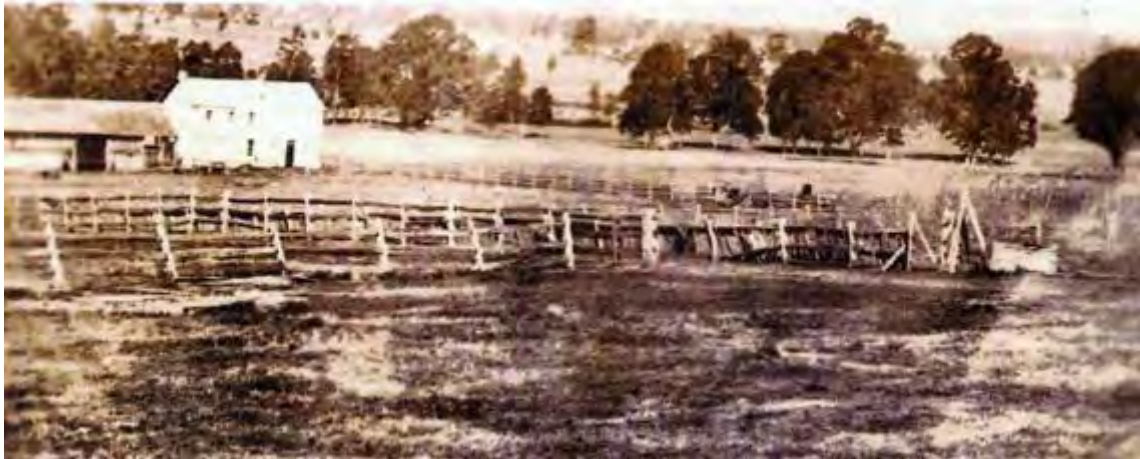
Figure 140: Coach House looking east during the Moore Period (1871-1938) showing the two storey structure of the coach house and single storey stables on the northern elevation. Moore Family Archives.

Dawson-Damer removed this section of the Coach House and reworked the building to how it looks today

Physical and documentary evidence has also confirmed that the Coach House is only partly original and has been substantially modified with the second storey section pulled down. Originally a two-storey structure with a single storey stable on the northern side, the Coach House is now single storey with reworked openings. Part of the west wall, and the south wall, are the only remaining original fabric of the Coach House which we suggest was the first residence/house.

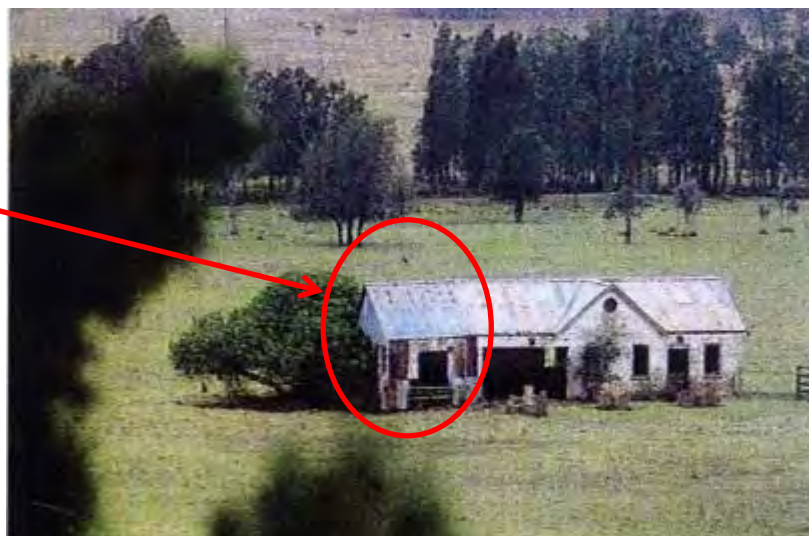
Figure 141: Coach House in 1992 showing the building was altered to a single storey structure with large openings and the stables are no longer extant. Belle – Design & Decoration, June/July 1992, pg.44.

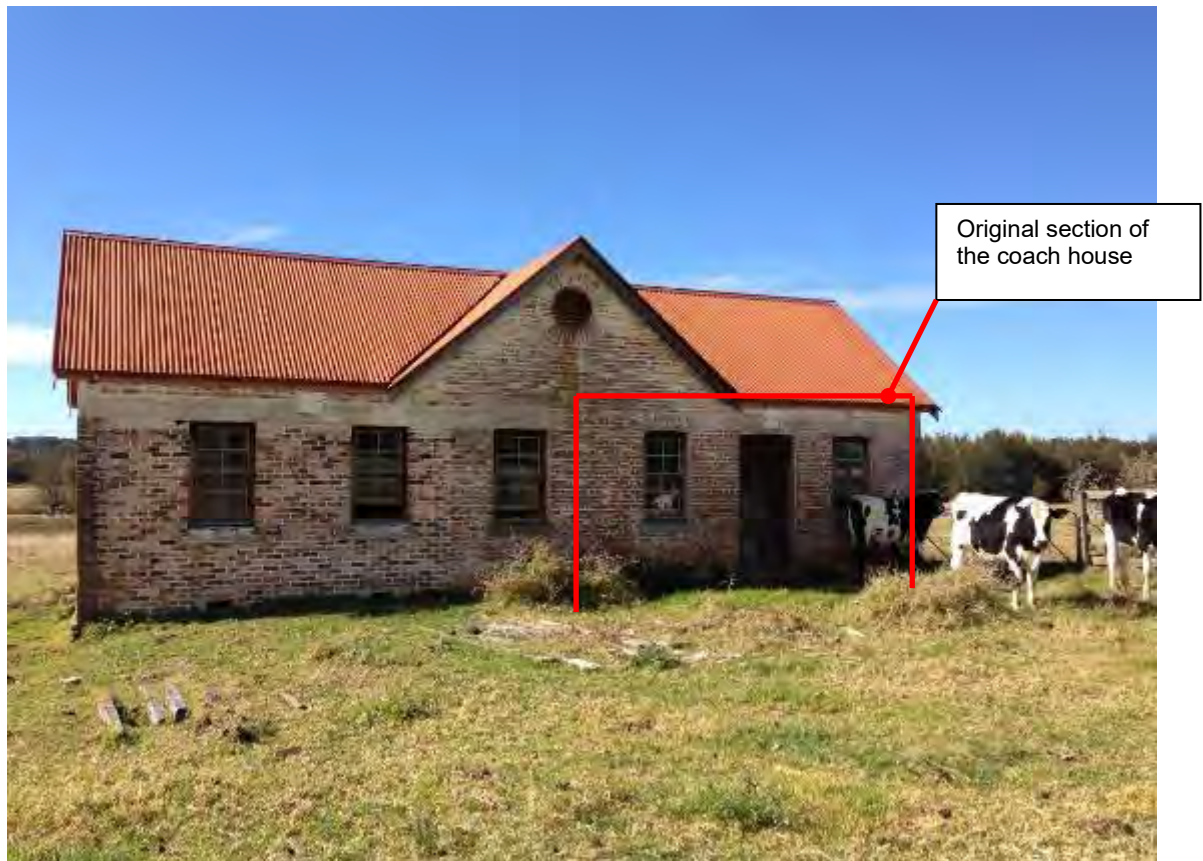
Figure 143: This images shows the original section on the west elevation of the coach house. Other openings have been reworked and the north end of the building demolished. TTA 2013

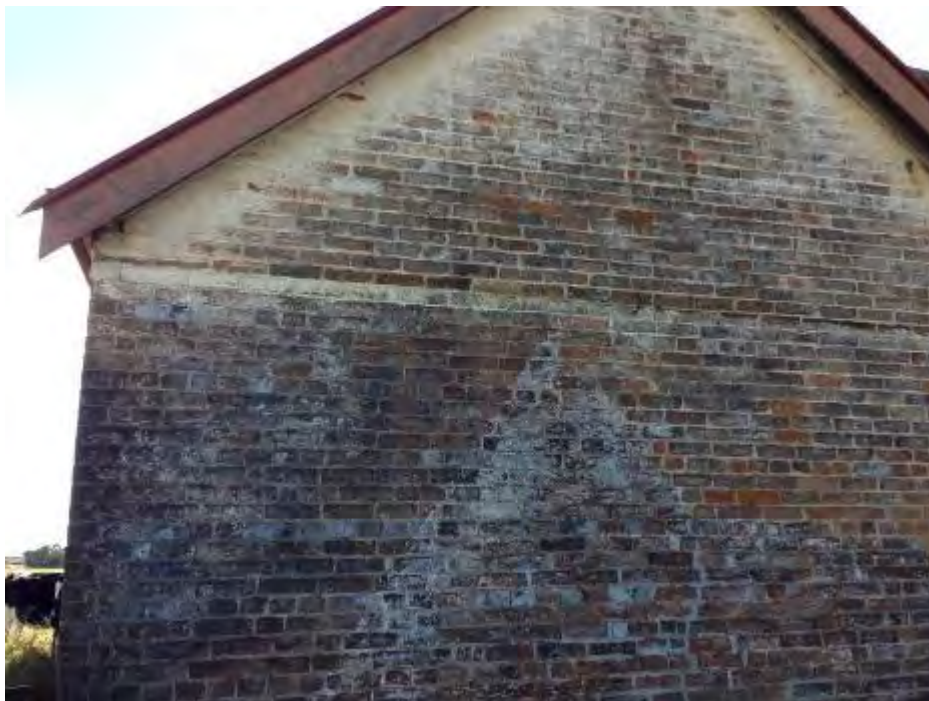
Figure 144: Original south wall of the coach house. It is suggested this is the original house c1837. TTA 2013
