# Oran Park (SHR 1695)

## Conservation Management Plan

prepared for  
Hixson Pty Ltd

May 2019  
REF: 1655: CMP  
Issue 23

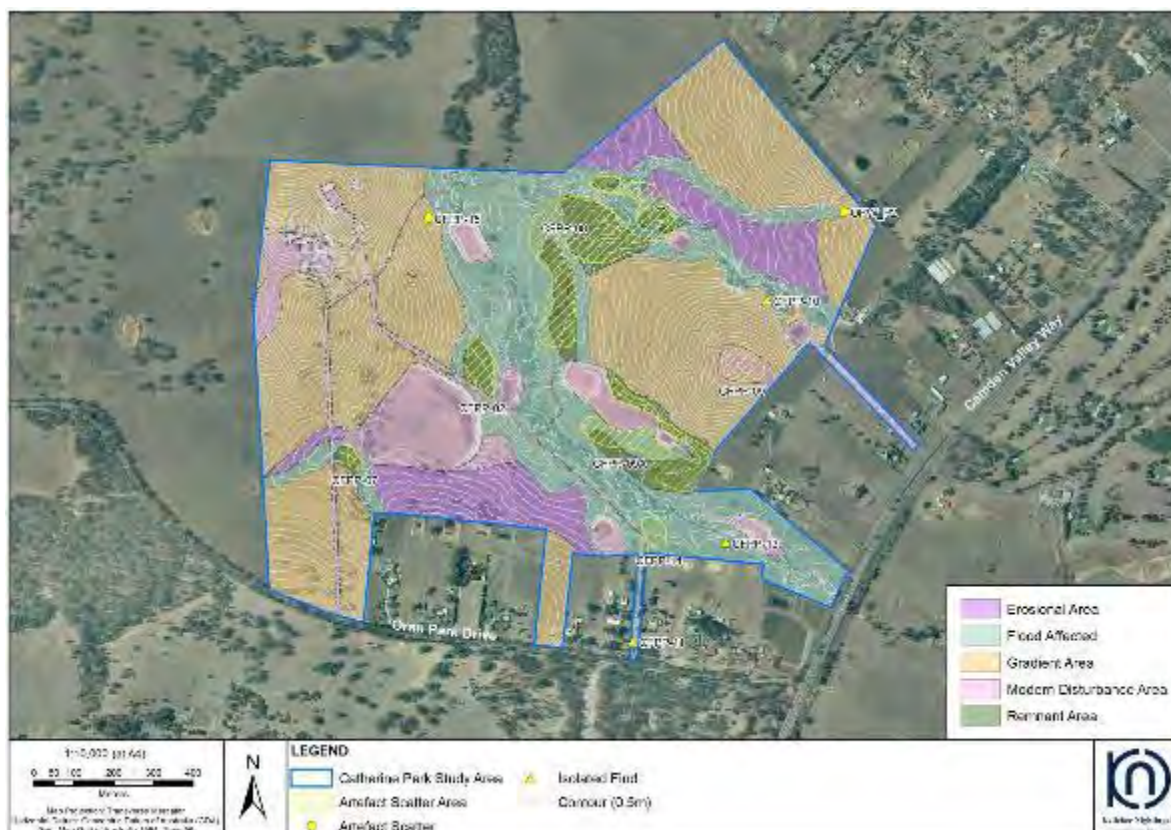
Figure 151: Disturbance mapping and location of archaeological sites within Catherine Park. KNC: CHAR June 2014:pg.12 Figure 7.

- Archaeological remains related to the initial use of the property and 1830s original residence (coach house) and c1865 House would be of State significance.
- Later 19<sup>th</sup> and early 20<sup>th</sup> century archaeological remains would be of local significance.
- The area around the Oran Park House and Coach House building complex has the potential to reveal past building layouts, uses and roadways. Refer to section 3.6 of this CMP.
- For a detailed study and understanding of the Aboriginal Archaeology refer to Appendix I Catherine Park Cultural Heritage Assessment Report, Kelleher Nightingale Consulting Pty Ltd dated June 2014, pg.18. Additionally refer to Figures 151 and 152.

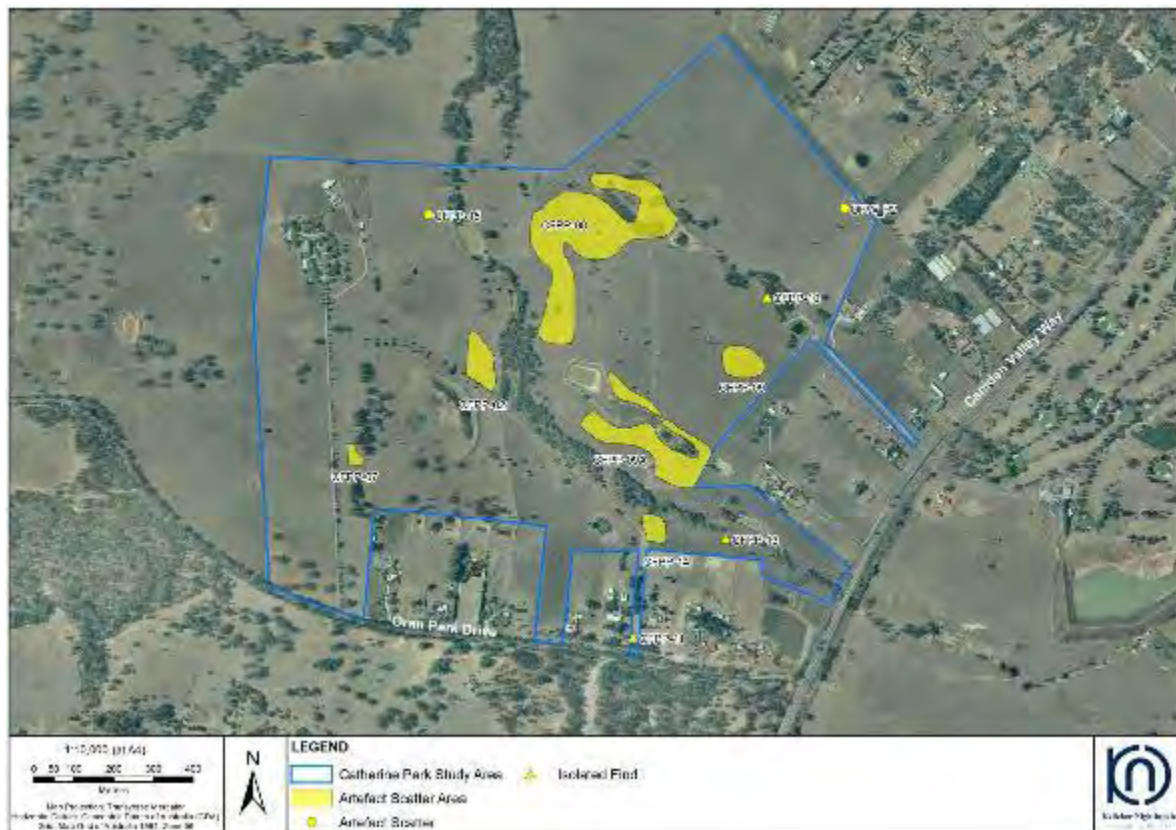
Figure 152: Identified Aboriginal sites within the study area. KNC: CHAR June 2014:pg.16

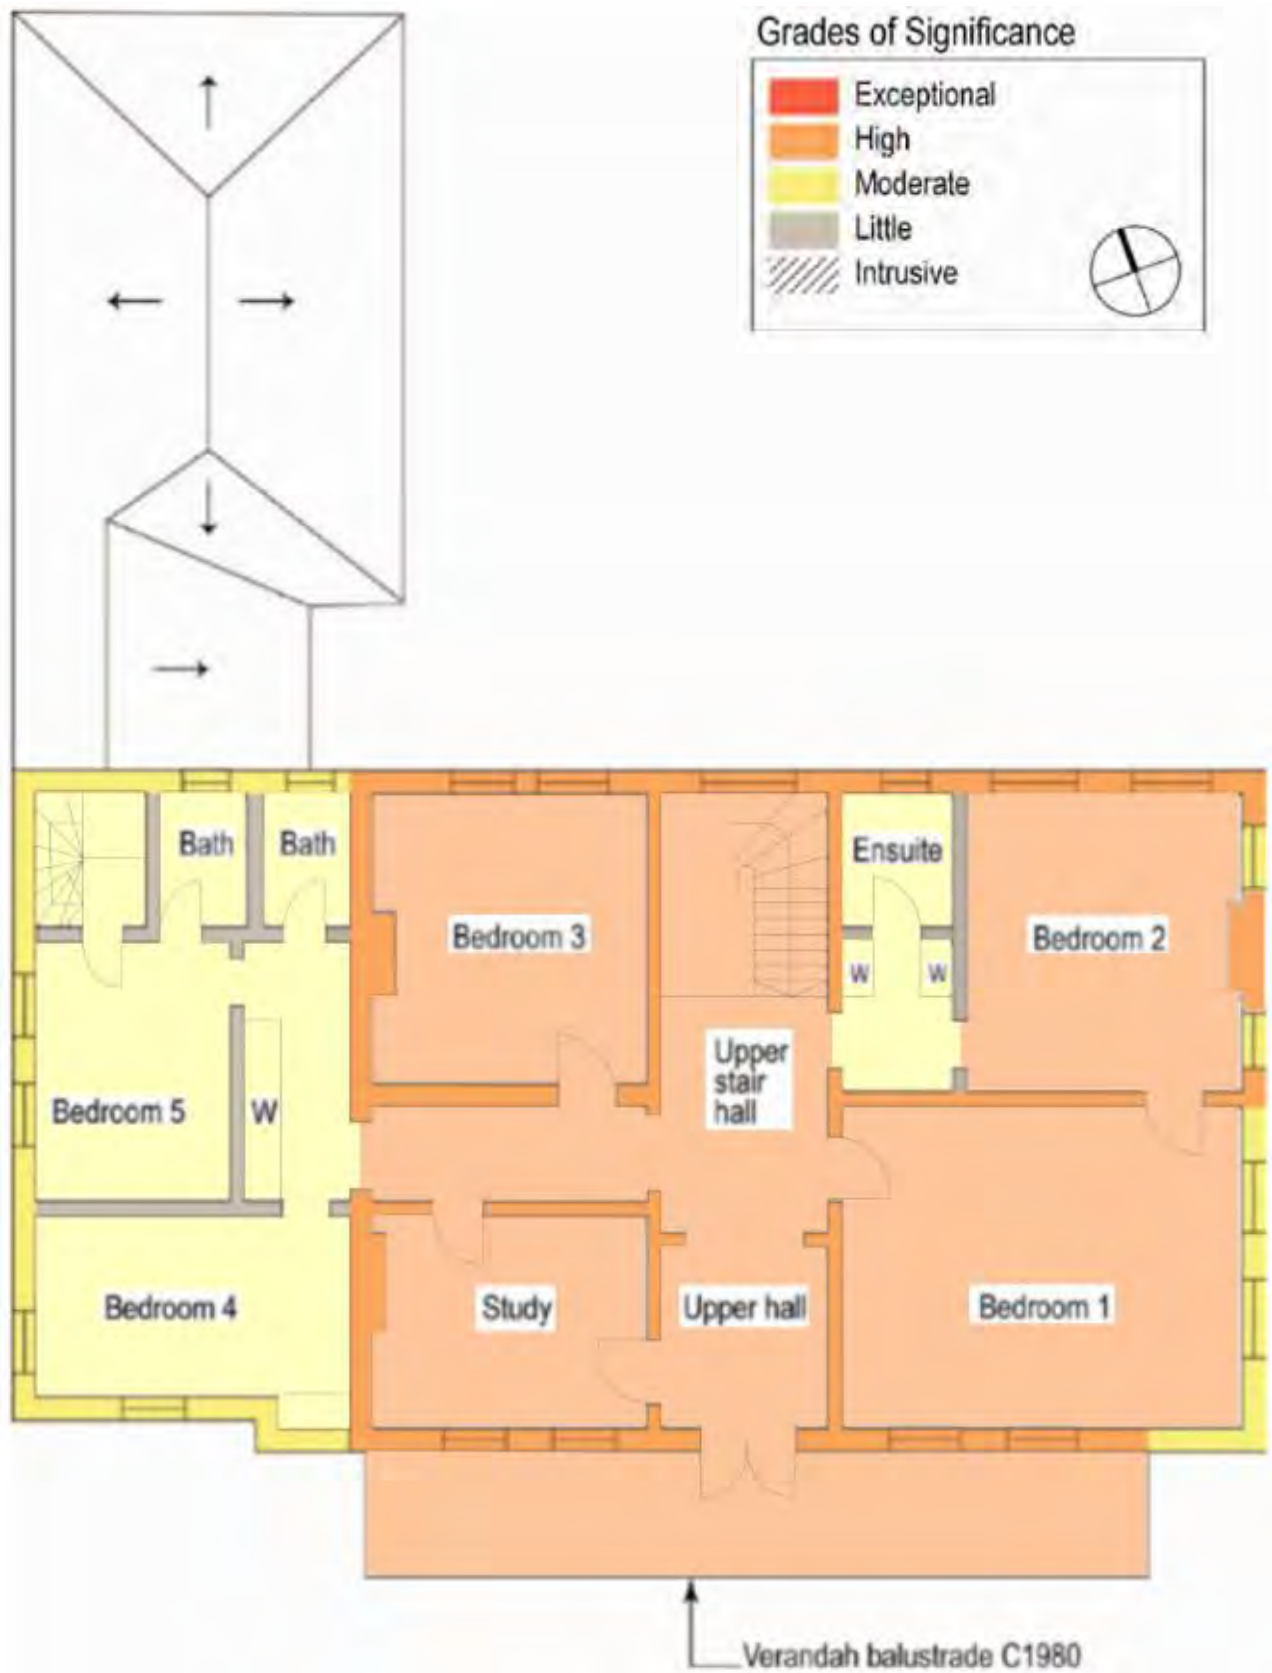
Figure 155: Grading of significance of the First Floor of Oran Park House, as sourced from GML: 2010:pg.91.

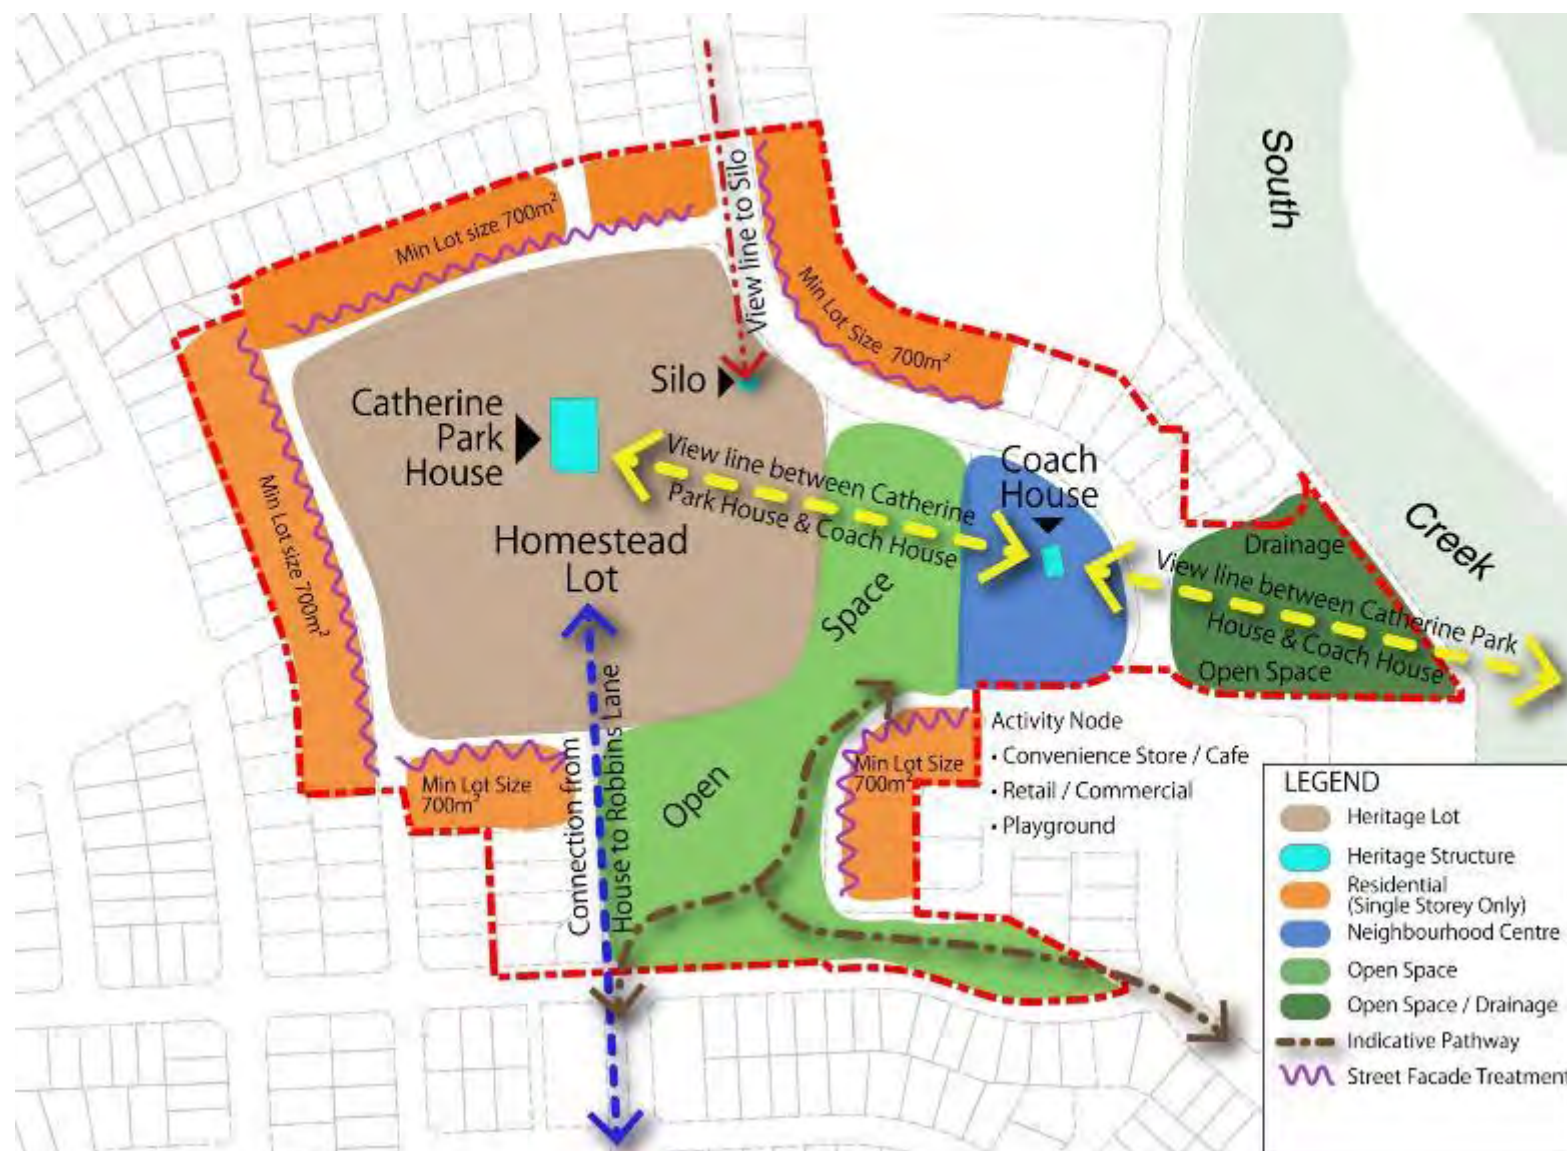
Figure 157:  
 Oran Park outer Heritage Principles plan showing the important view lines and proposed and approved controls surrounding the Homestead Lot in the current residential subdivision of the property. This figure was prepared to inform the Heritage Exemption Guidelines and does not preclude other forms of development.

- Development approval has been granted to construct new residences around the Homestead Lot (refer to Figure 157).
- Development approval has been granted for subdivision of the greater estate and residential development beyond the Homestead Lot.

- Policy 9.9 In developing plans for the future use of the Homestead Lot, the significant external and internal fabric of the subject building and its views and vistas must be conserved to maintain the significance of the site. Refer to Figure 157.

Policy 9.10 The Heritage Exemption Guidelines prepared for inclusion in the gazettal on the State Heritage Register should apply to development within the curtilage but excluding the Homestead Lot. These developments are exempt from NSW Heritage Council Section 60 approvals. Refer to Figure 157, Appendix C and Appendix D.

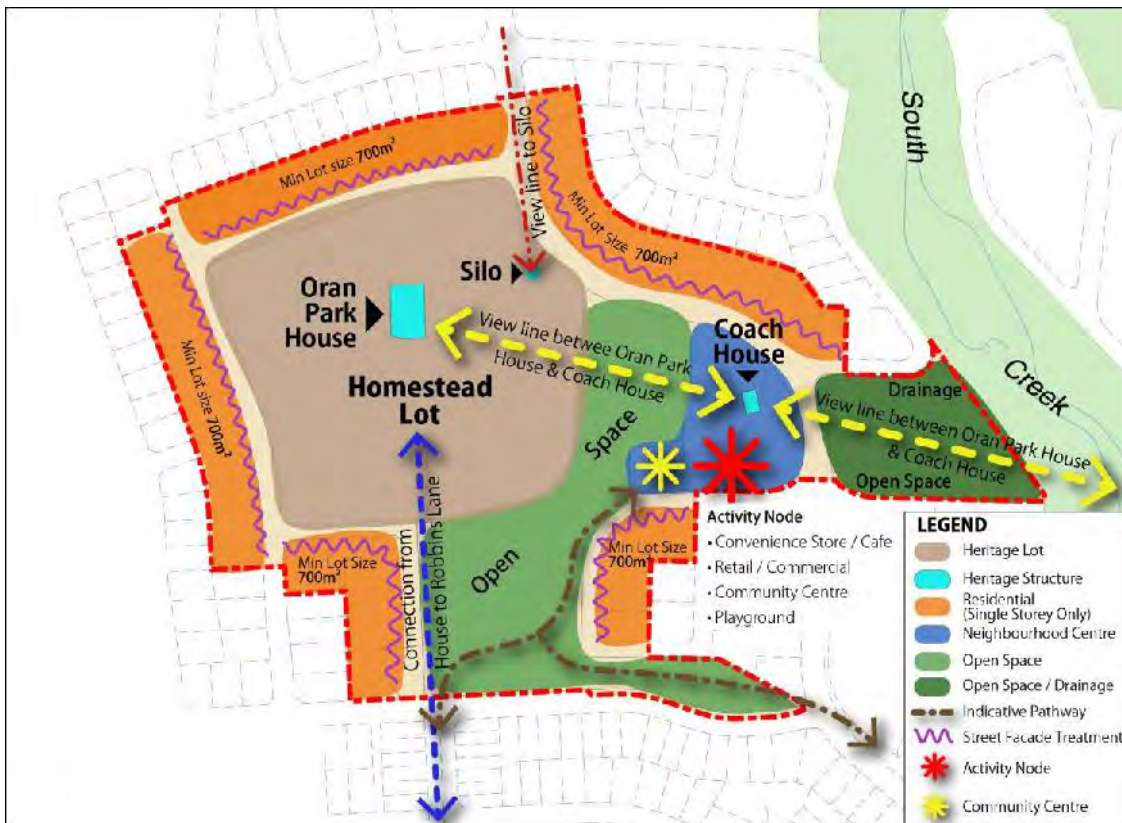
Figure 3 – Oran Park House Outer Heritage Curtilage Principles

- 1) All development outside the Oran Park House allotment and within the heritage curtilage is to be designed to achieve the principles in Figure 3.

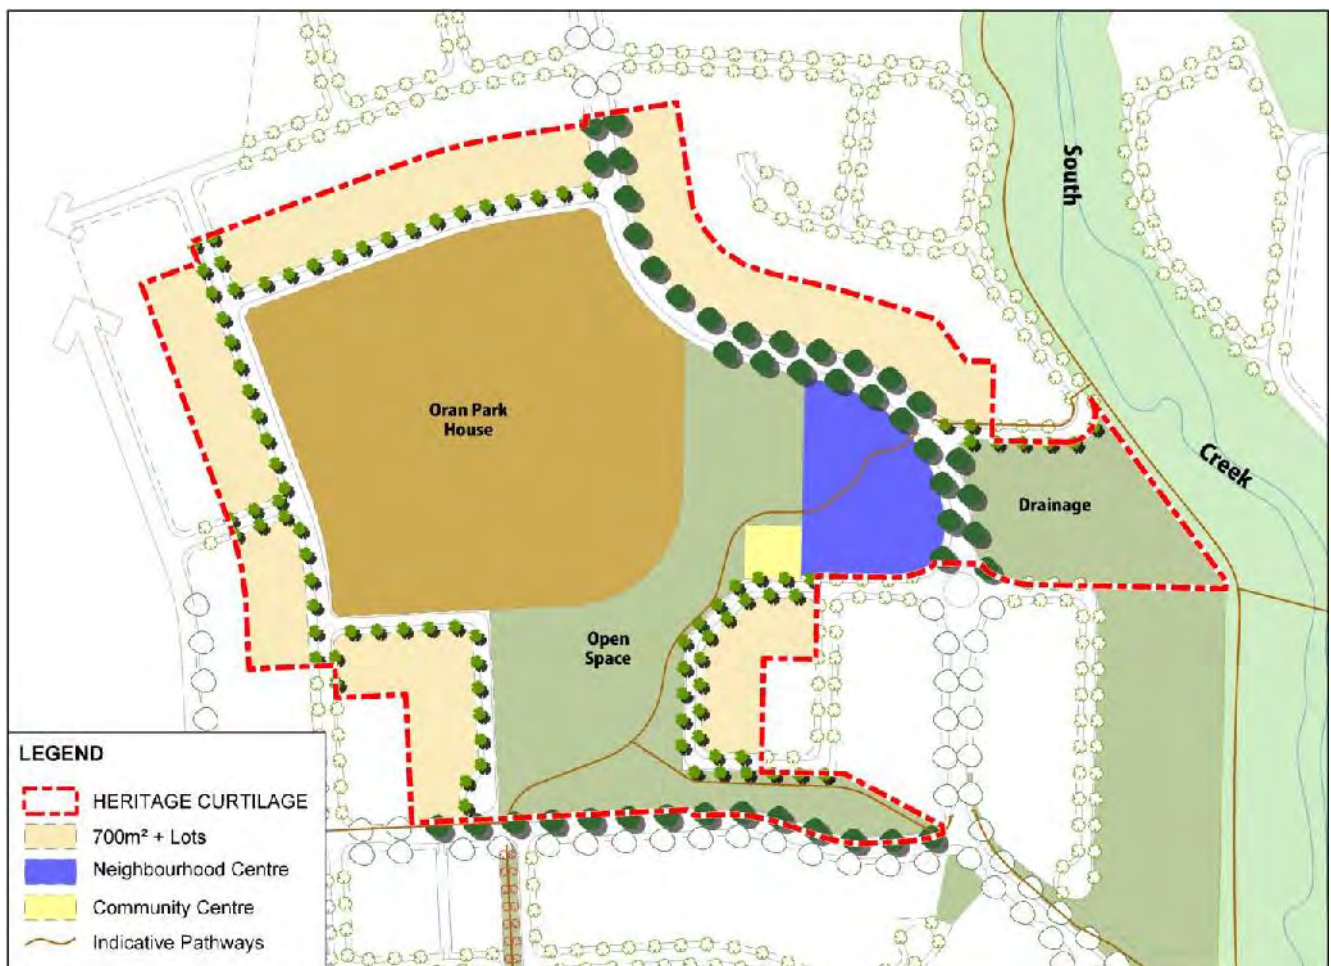
Figure 5 – Subdivision within the Oran Park House Outer Heritage

- 1) All subdivision outside the Oran Park House allotment and within the heritage curtilage is to be designed to be generally in accordance with Figure 5.

- 2) The subdivision design is to ensure that:
  - a. Building platforms are created that facilitate minimal changes in height.

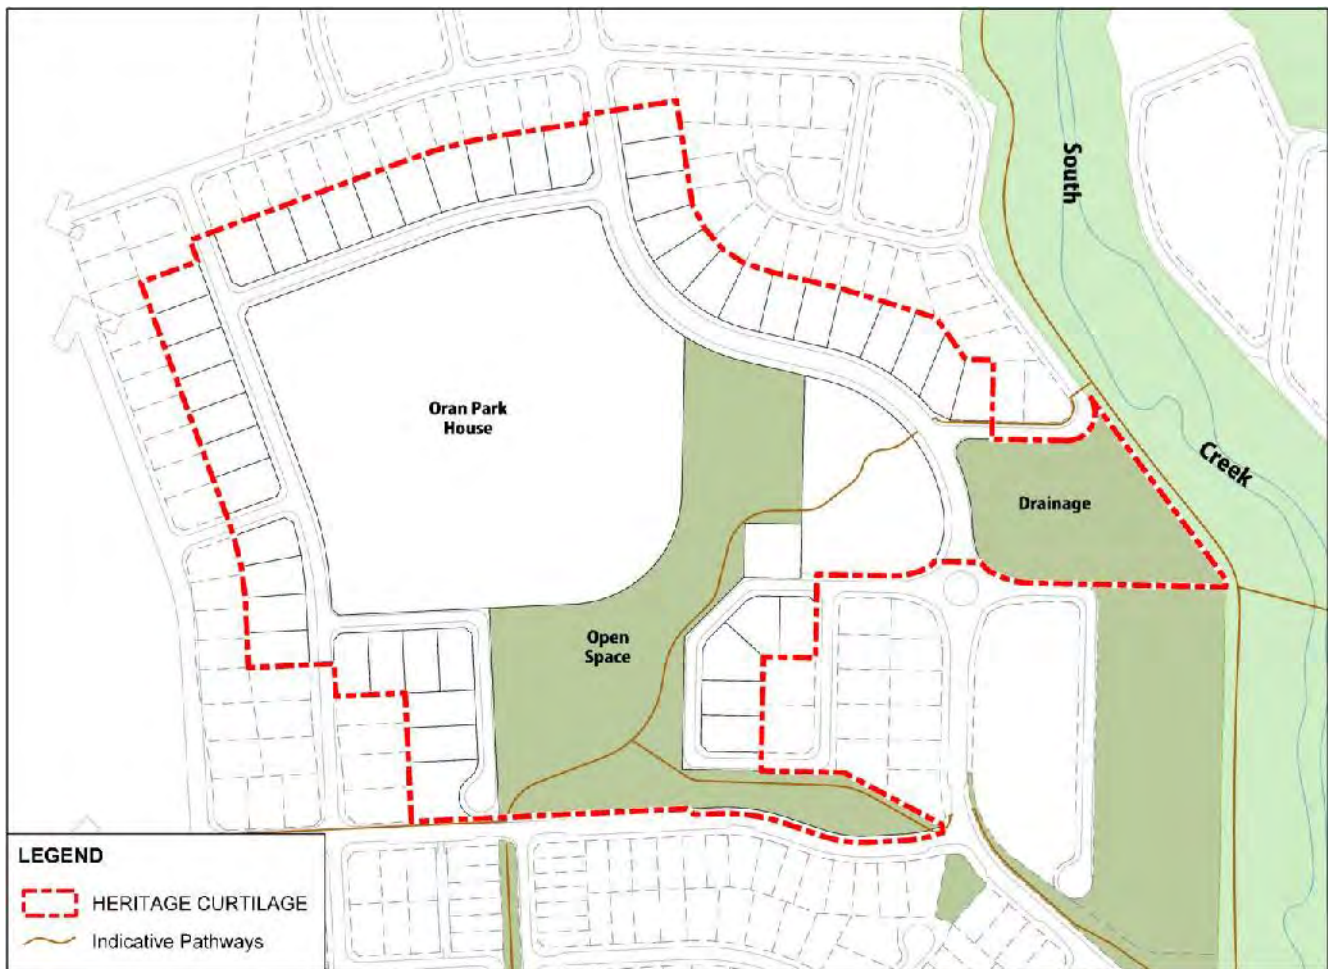
**Figure 6 – Public Open Space and Pathways**

- 1) Public open space and pathways within these areas are to be provided generally in accordance with Figure 6.

- 2) Public open spaces are to be designed for trees, shrubs, pathways, furniture and playgrounds.
- 3) Large green open spaces are to be grassed with expansive open spaces.
- 4) Pathways aligned with former driveways are to be planted with trees on both sides.
- 5) Pathways are not to be provided in the verge of streets abutting the Oran Park House allotment.
- 6) Pathways are to be provided on the same side of the street as the residential buildings.

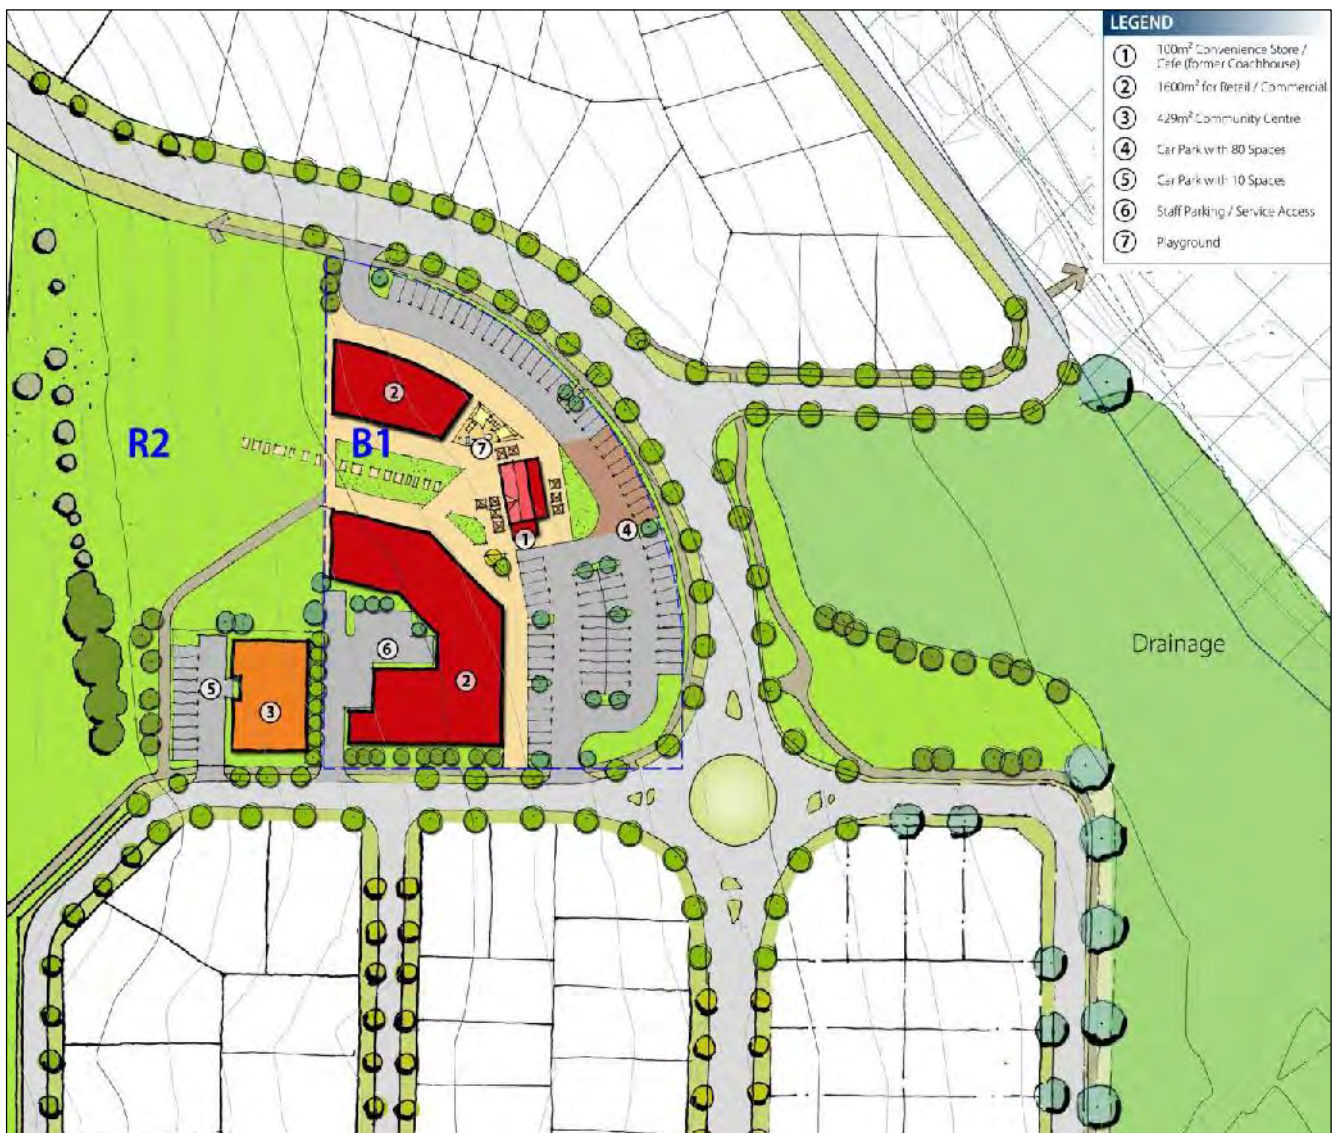
Figure 7 – Local Neighbourhood Centre

- 1) All development within the Local Neighbourhood Centre is to generally be in accordance with the layout and land uses shown in Figure 7.
- 2) Commercial/Retail development within the Local Neighbourhood Centre is to ensure appropriate activation of the central plaza and playground.
- 3) Building facades are to be visually interesting and complement the Coach House.
- 4) A central plaza is required to be provided in accordance with Figure 7, which provides opportunity for alfresco dining, serves as a community gathering space and protects views and vistas between the Coach House and Oran Park house.
- 5) Structures which could potentially impact the views/vistas between the Coach House and Oran Park House are not permitted within the central plaza.

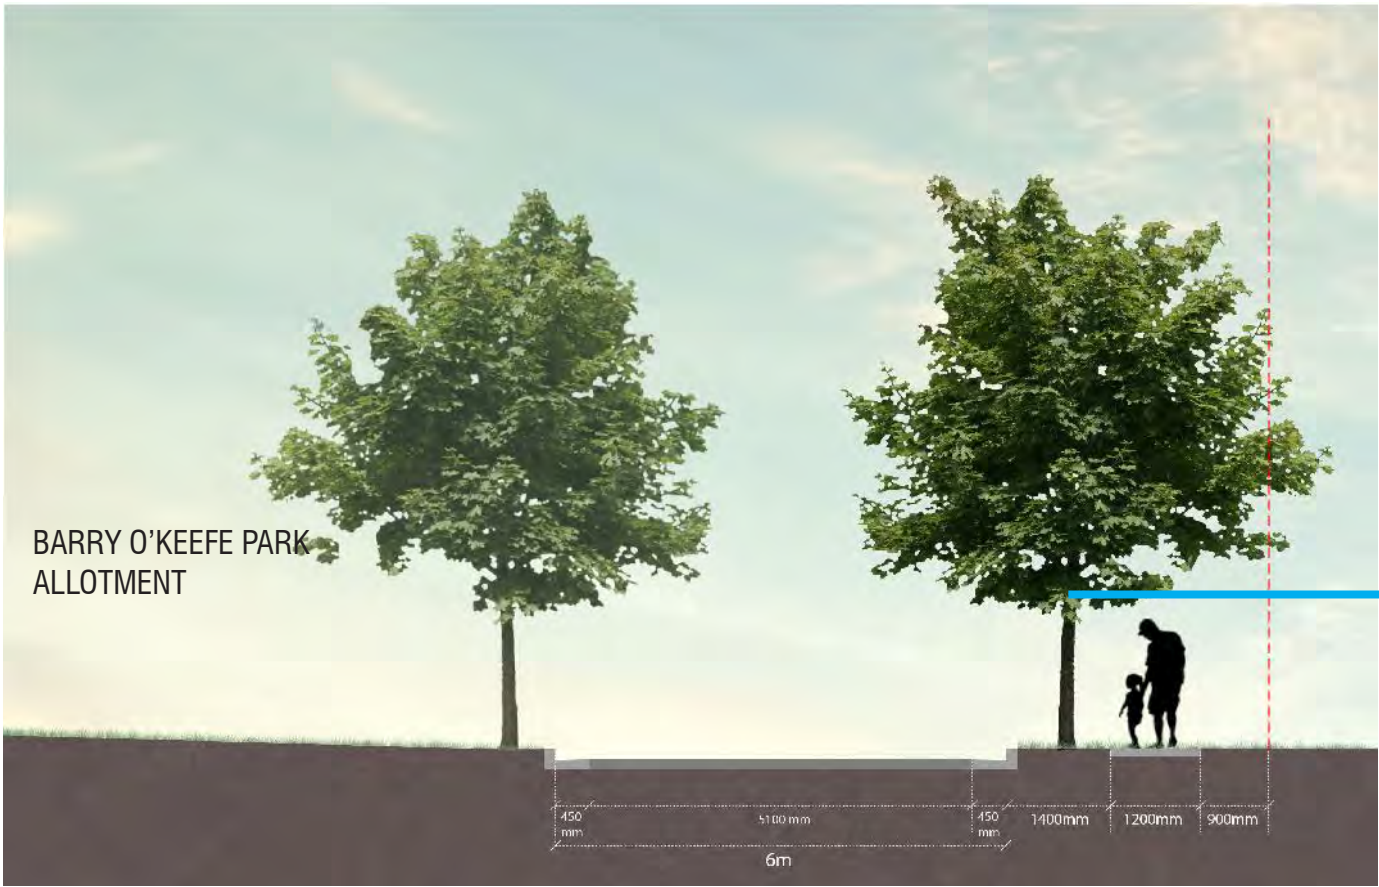
SECTION 01

The street and verge design incorporates street trees at regular spacing with footpath, kerbs and gutters and on street parking. The street tree planting utilises trees with varying heights and canopy widths to suit the scale of the streetscape.

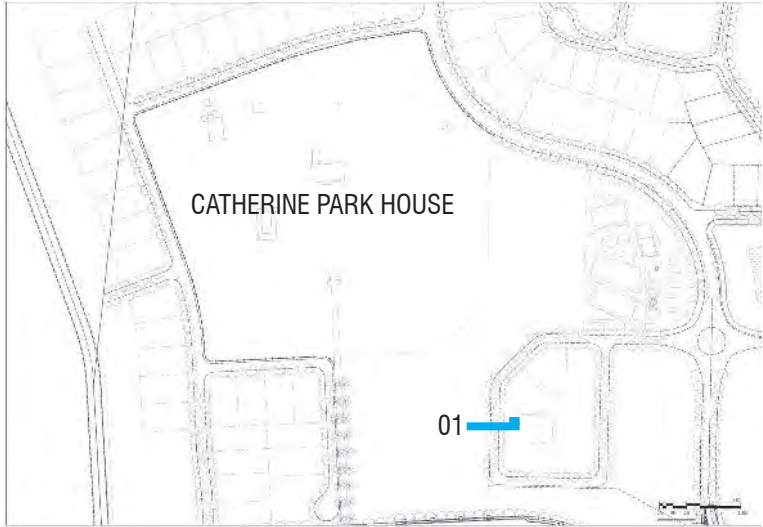
RESIDENTIAL VERGE WITH STREET TREES AND FOOTPATH

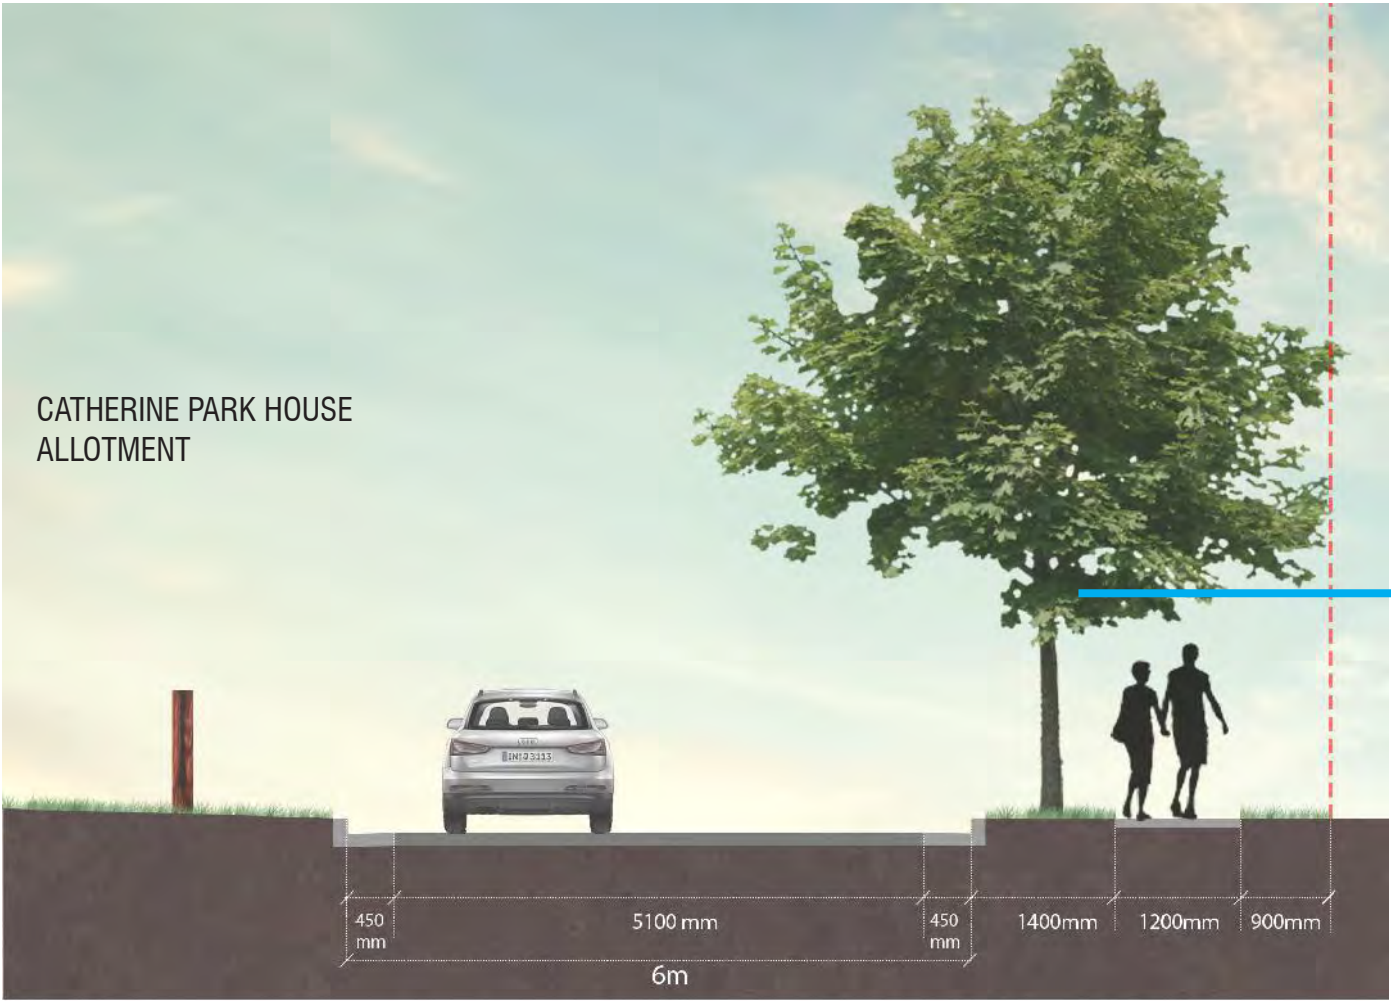
SECTION 02

As per the Conservation Management Plan where the street verges interface with the Catherine Park House allotment the trees are omitted on the allotment side to maintain view corridors to Catherine Park House.

Post and rail fencing will be installed adjacent the kerbs on the curtilage allotment and parks to discourage vehicles from being able to mount the kerbs and drive into the open space and house curtilage and will further reinforce the rural character of the site.

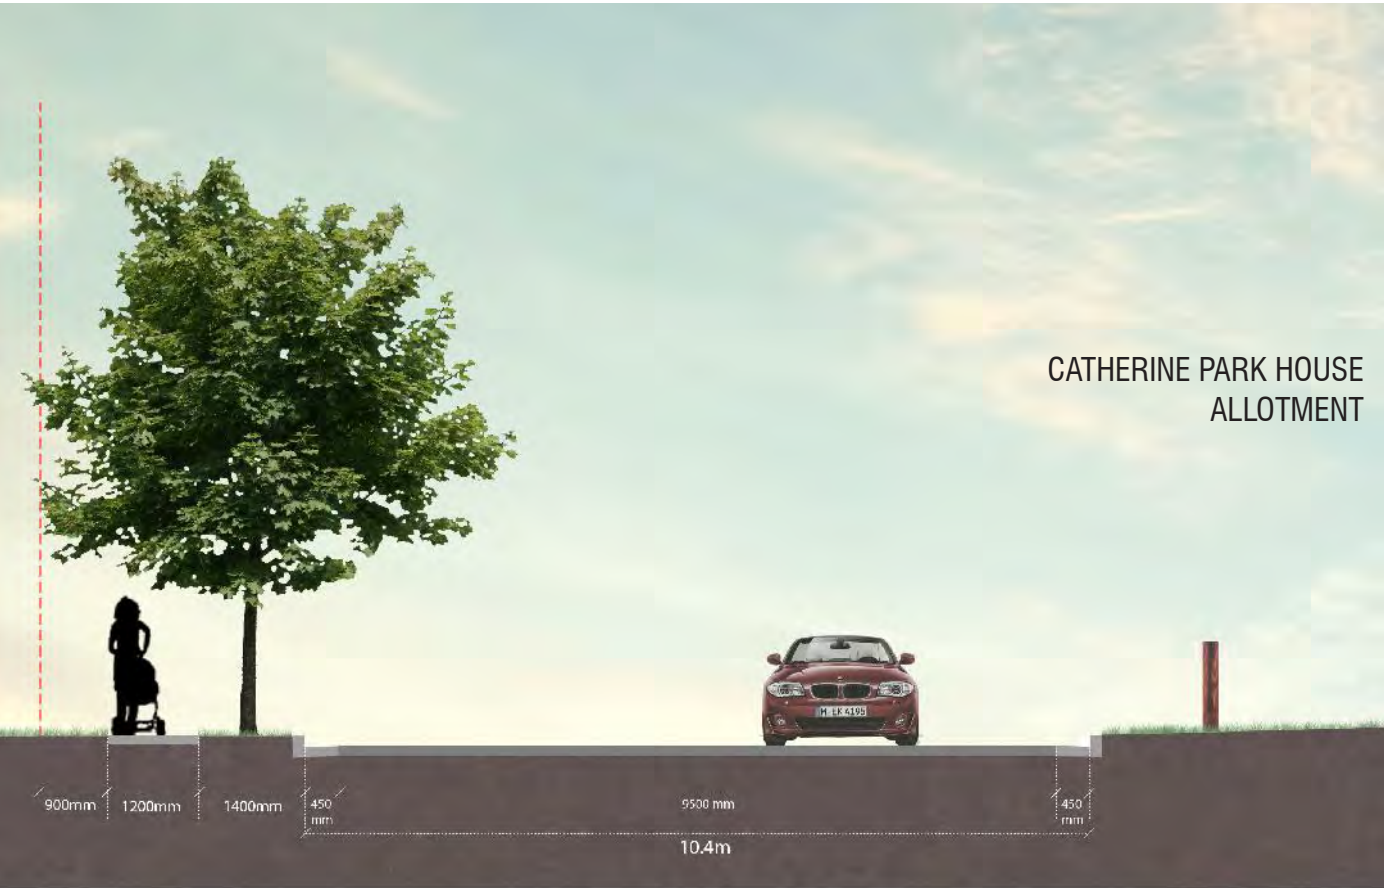
SECTION 03

# Verge Treatments on Street Interfaces with CPH

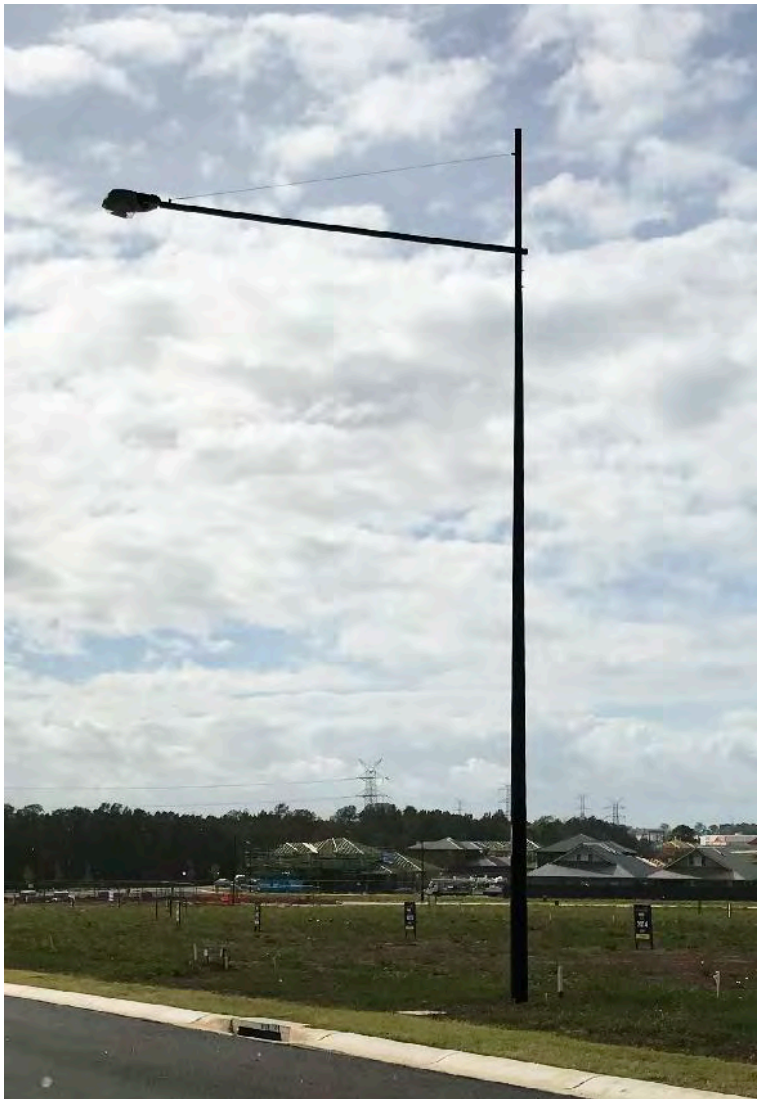
Main Streets

Single Pole-Top Luminaire on long outreach  
Aeroscreen  
Product Code: MK11 14W  
Lamp: LED  
Supplier: Sylvania Lighting

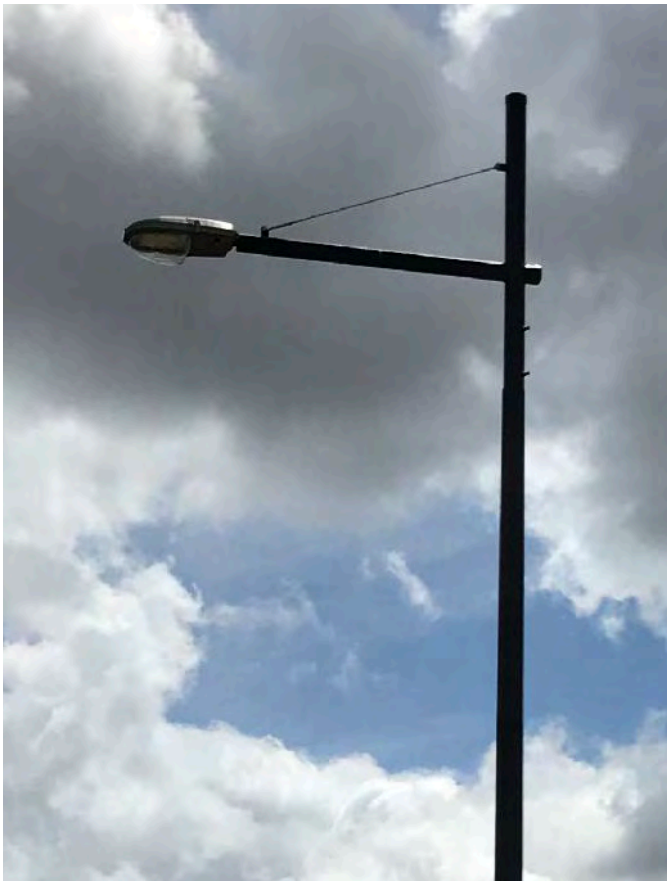
Local Streets

Single Pole-Top Luminaire on short outreach  
Aeroscreen  
Product Code: MK11 14W  
Lamp: LED  
Supplier: Sylvania Lighting

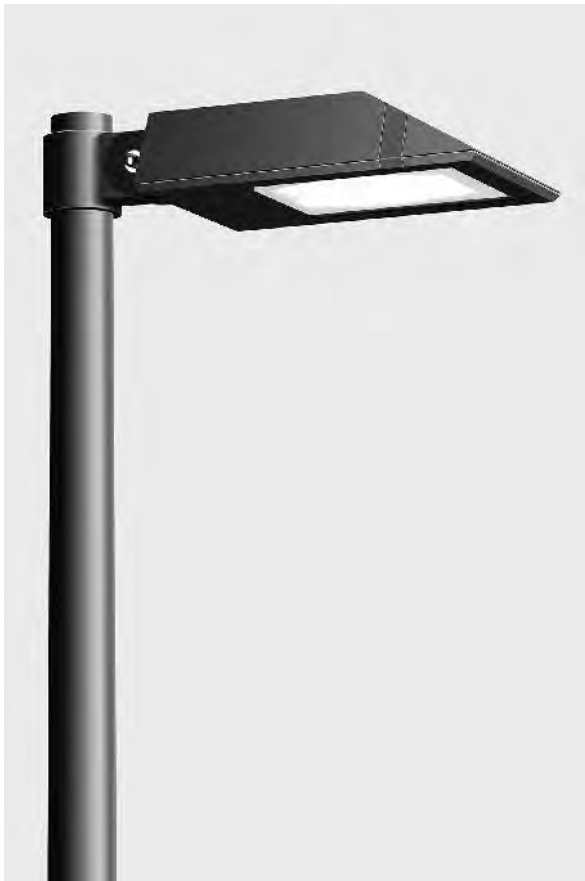
Parks and Open Space

Single Pole-Top Luminaire  
Asymmetrical Flat Beam  
Product Code: 77 939  
Lamp: LED  
Supplier: BEGA

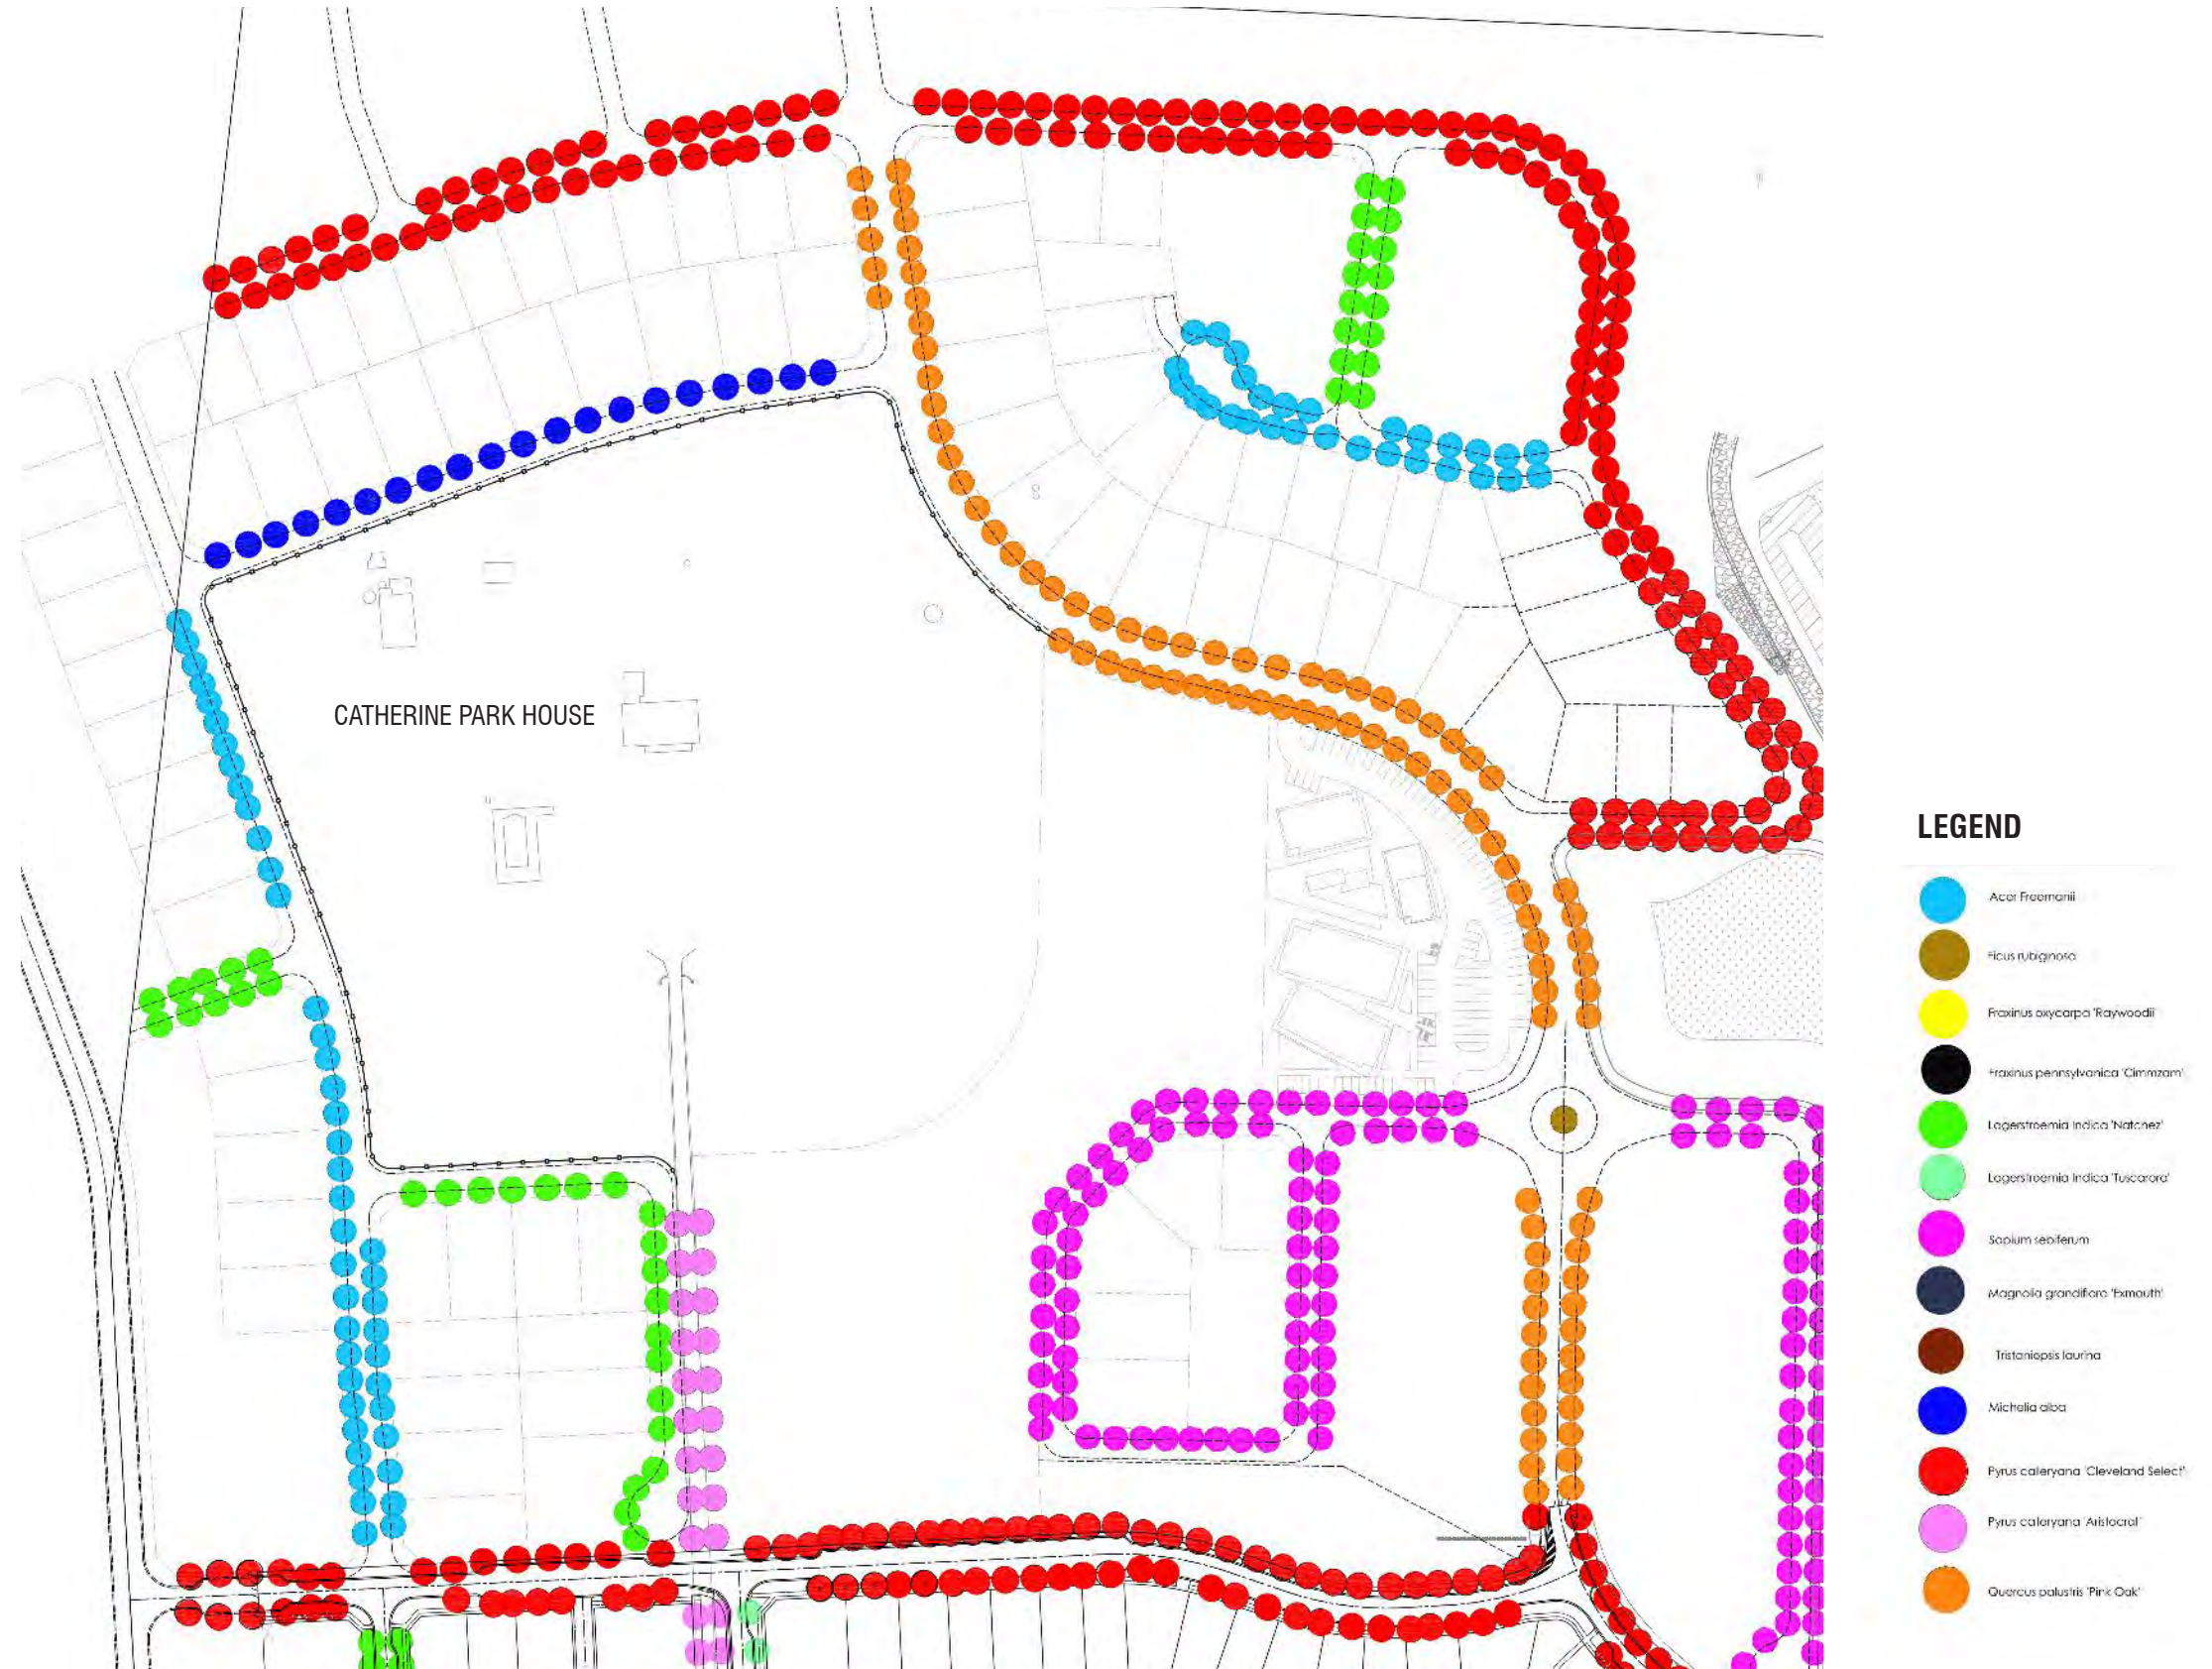
**STREET TREE LANDSCAPE PLAN**

- Establish a hierarchy to the streets through the careful use of different street trees;
- Encourage walkable, shaded streetscapes as diverse 'green' spaces;
- Provide diversity in plant selection that will increase biodiversity;
- Use landscape elegantly to create identity and maximise amenity for residents and visitors; and
- Be robust, suited to the available aspect and ambient wind levels and minimise water use.
