# Oran Park (SHR 1695)

## Conservation Management Plan

prepared for  
Hixson Pty Ltd

May 2019  
REF: 1655: CMP  
Issue 23

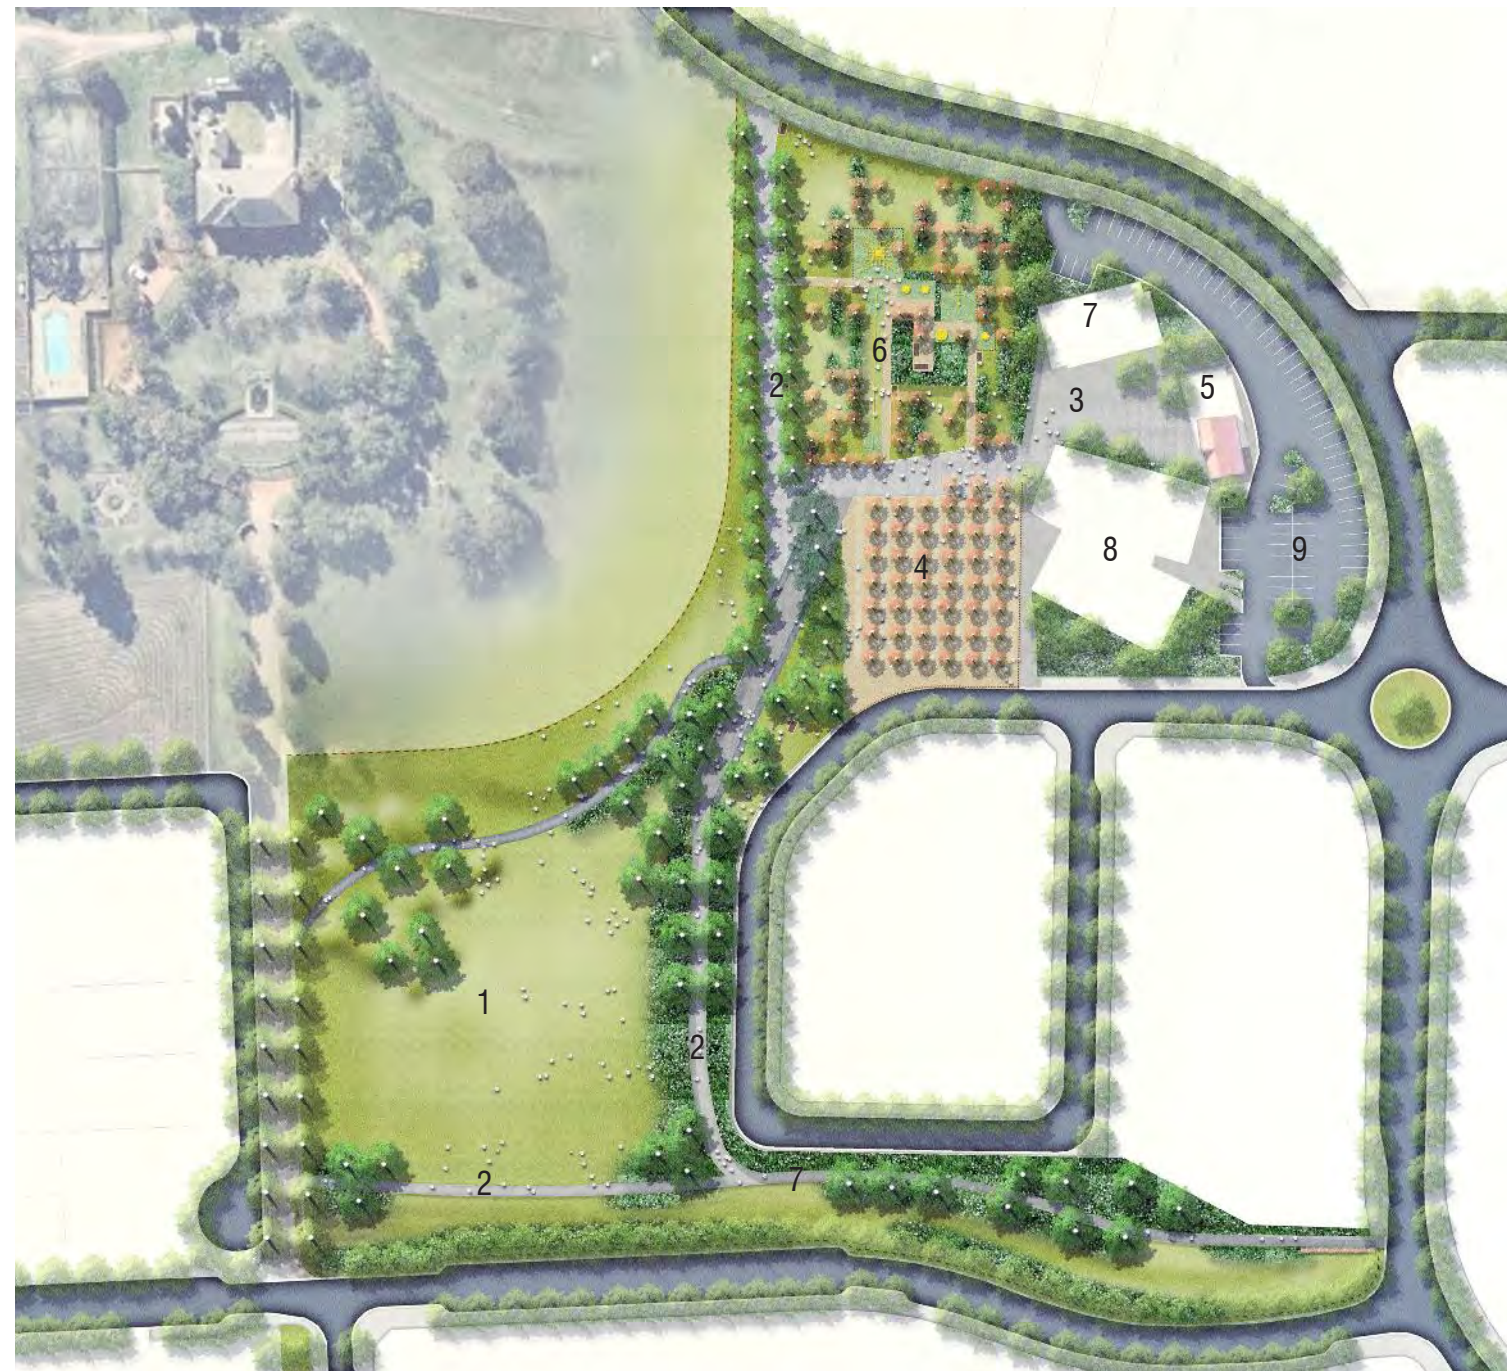
BARRY O'KEEFE PARK\_NTS

The main open space within the heritage curtilage is Barry O'Keefe Park which will be located between the future community facilities and Catherine Park House.

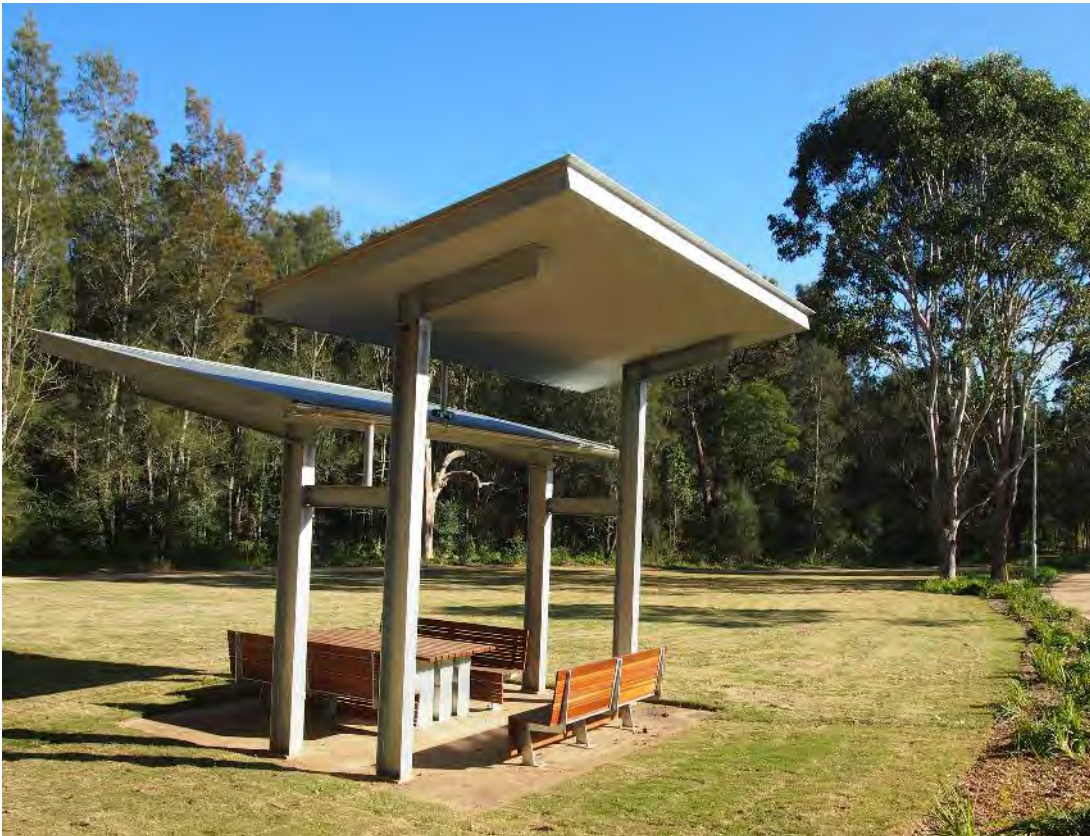
*Bespoke Park Shelter*  
OCULUS

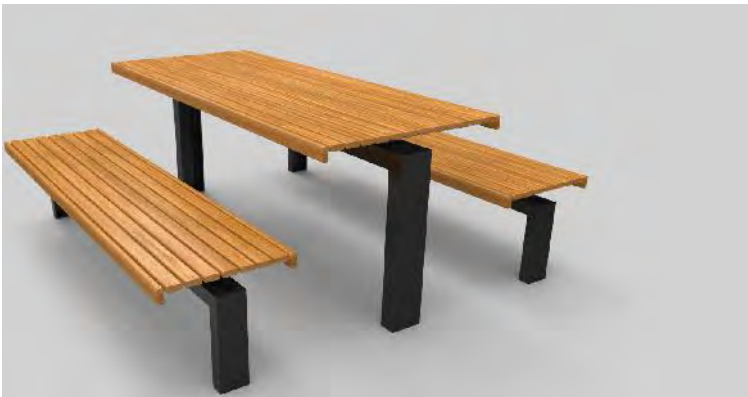
*Supplier*  
MosUrban - Sturt Picnic Set

- Materials*
- Powder coated steel leg,with powder coated aluminum frame
  - Slats: Select stained hardwood or aluminium

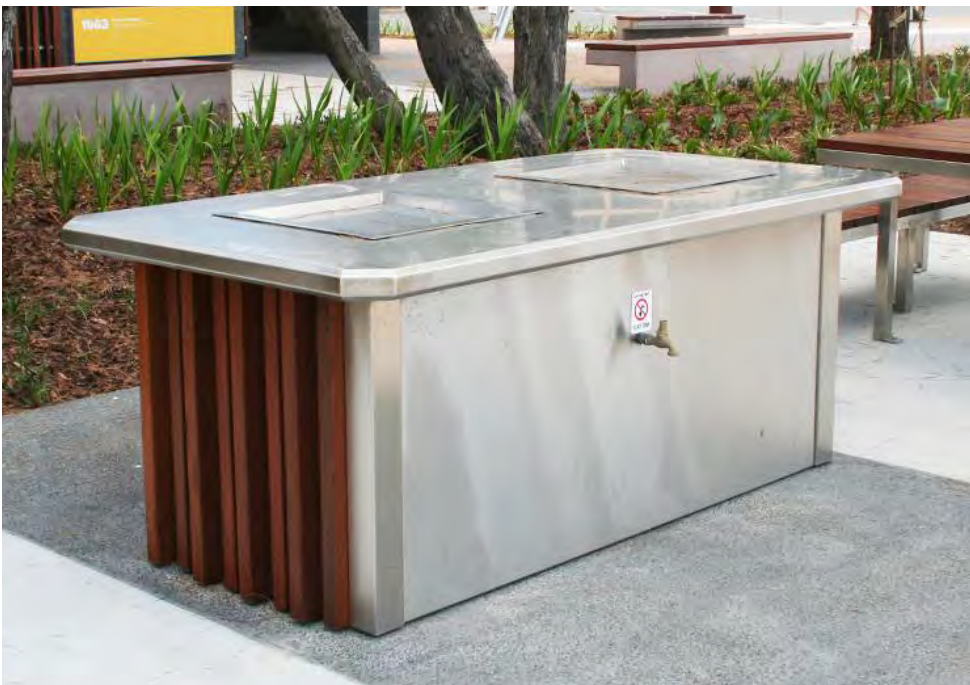
*Supplier*  
Landmark Pro - Eco Double plate

- Materials*
- Frame: 304 grade stainless steel
  - Bench top: 1.5mm thick, 304 grade stainless steel bench top
  - External cladding: 1.2mm thick, 316 grade stainless steel hotplate
  - Hotplate:3.4mm thick, 316 grade hotplate

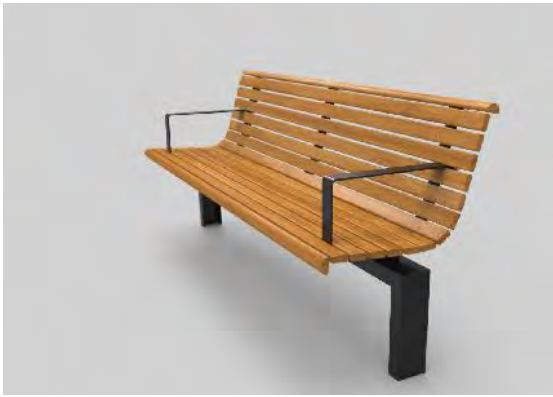
*Supplier*  
MossUrban - Sturt Seats with Arm Rests

- Materials*
- Powder coated steel leg,with powder coated aluminium frame
  - Slats: Select stained hardwood or aluminium

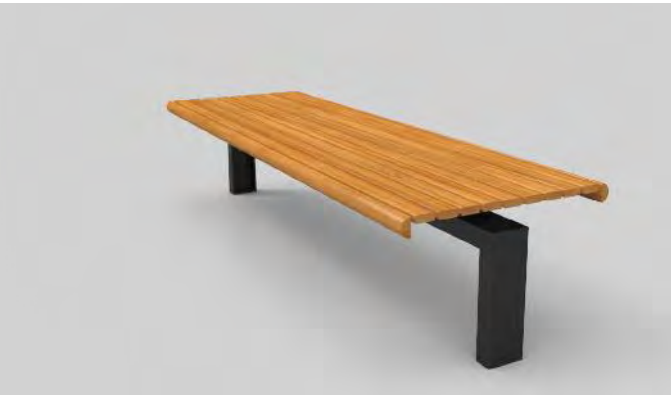
*Supplier*  
MossUrban - Sturt Bench

- Materials*
- Powder coated steel leg,with powder coated aluminium frame
  - Slats: Select stained hardwood or aluminium

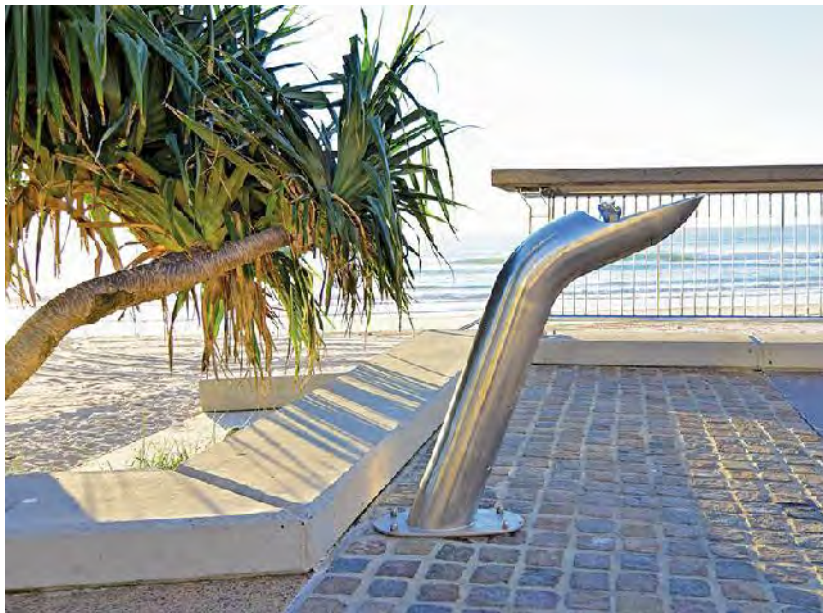
*Drinking Fountain*  
*Supplier*  
Landmark Pro- Foreshore Drinking Fountain (No Accessories)

- Materials*
- Bubbler: Stainless Steel
  - Body: Stainless Steel
  - Finish: Electric Polished

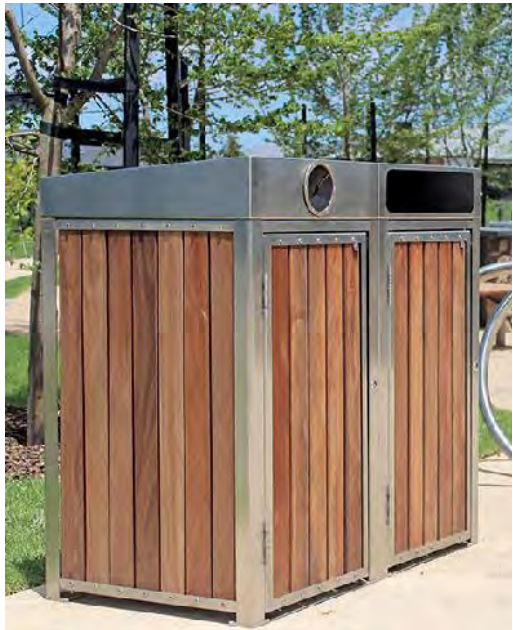
*Supplier*  
Landmark Pro- Daintree Bin Surround (120L)

- Materials*
- Frame: HDG ST / PC
  - Panels: WPC
  - Opening: Standard and circular

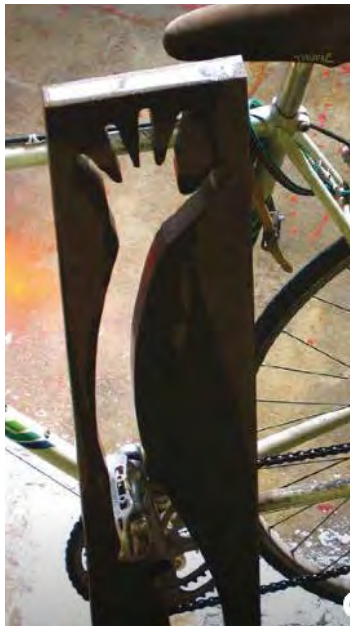
*Supplier*  
Landmark Pro - Tactil Stand

- Materials*
- Cor ten ST / HDG ST / PC
  - In-ground Fixing

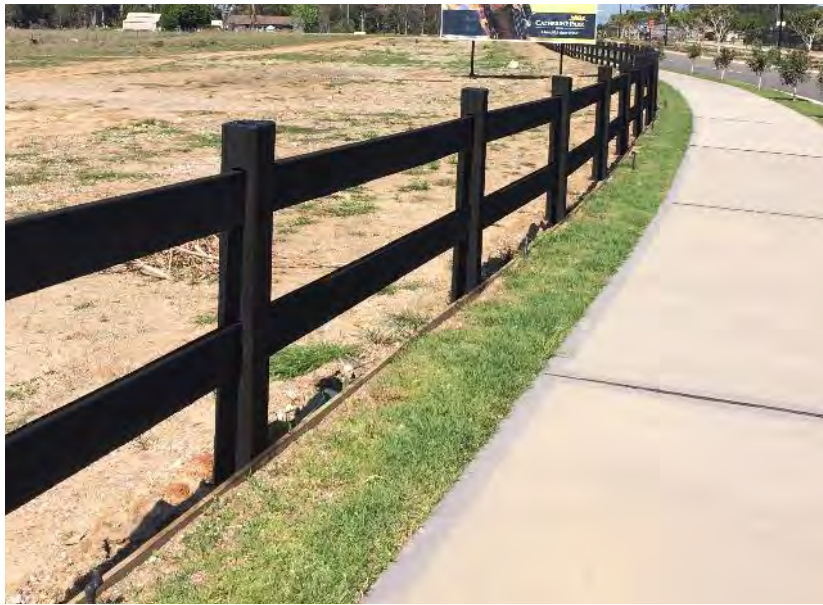
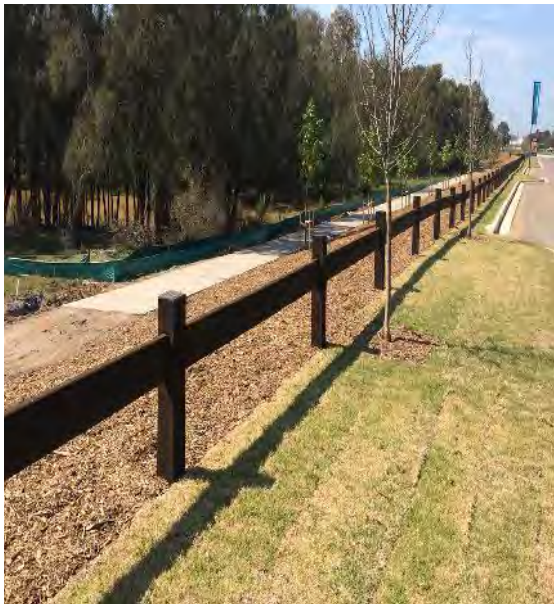
Single and Double Rail  
Post and rail Fences

- Materials*
- Hardwood Timber
  - Oiled

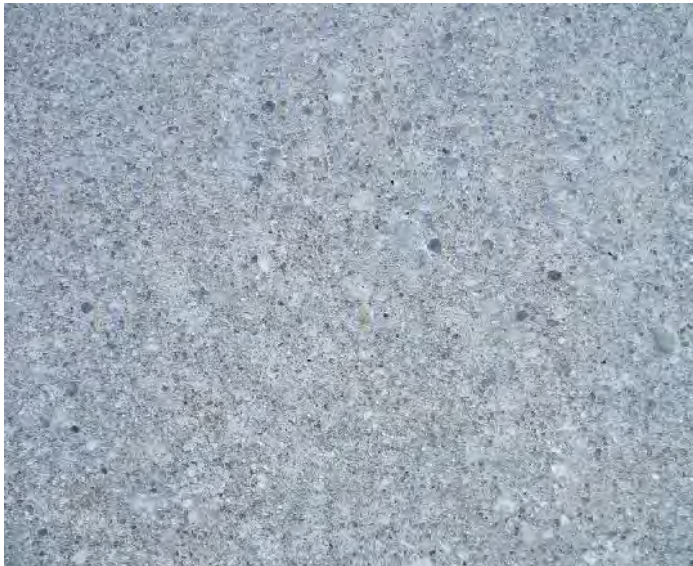
Insitu Concrete  
Broom Finish Grey Cement

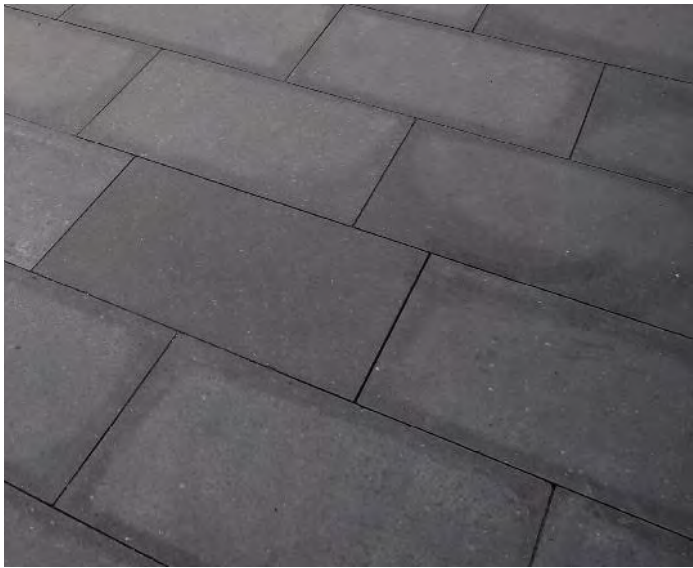
Concrete Unit Paver  
Honed and Scratch Finish Pavers

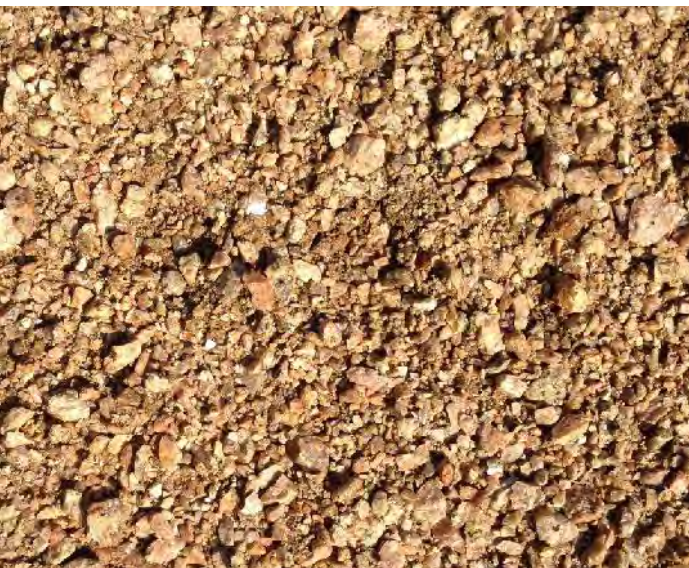
Decomposed Granite Gravel  
ANL Brown Decomposed Granite Gravel

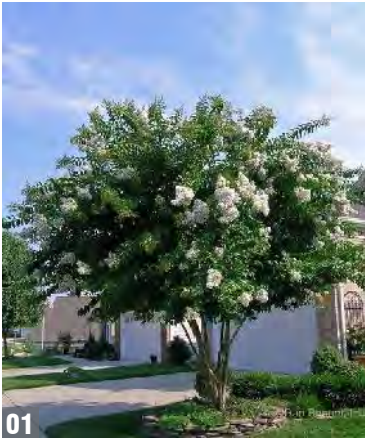
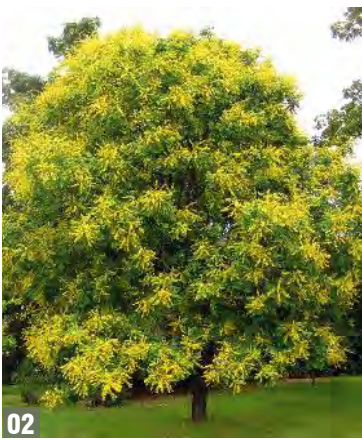
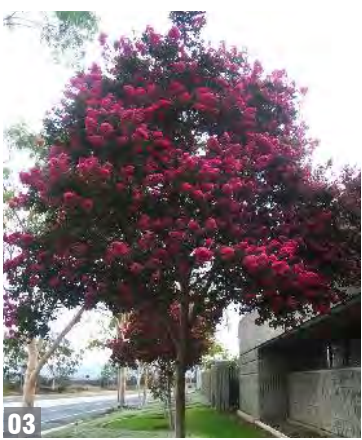
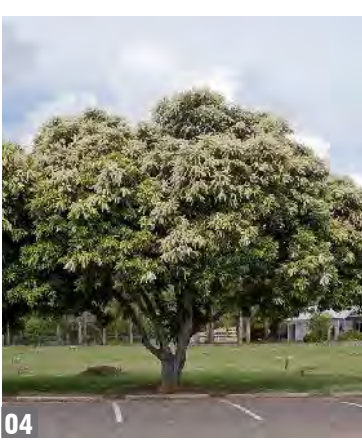
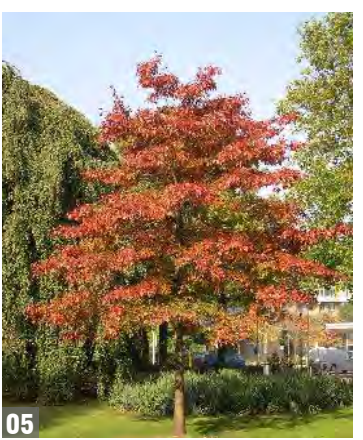
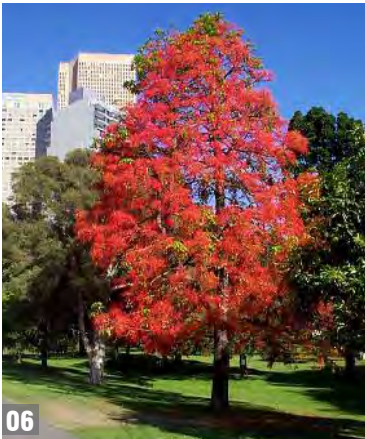
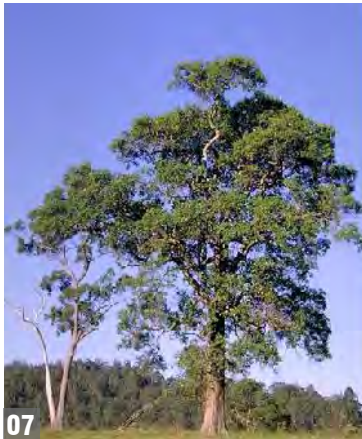
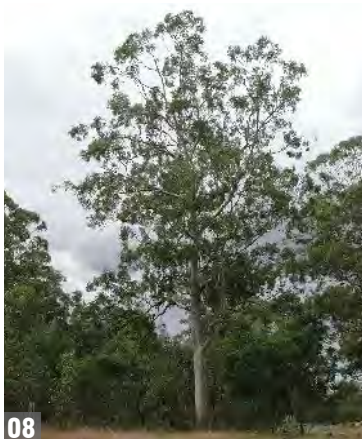
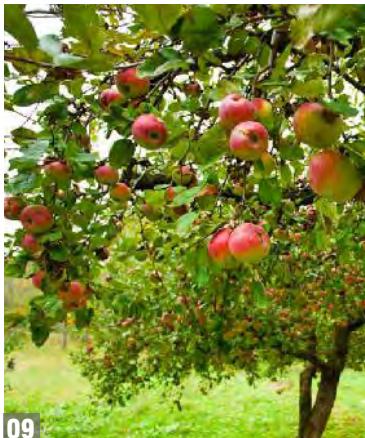
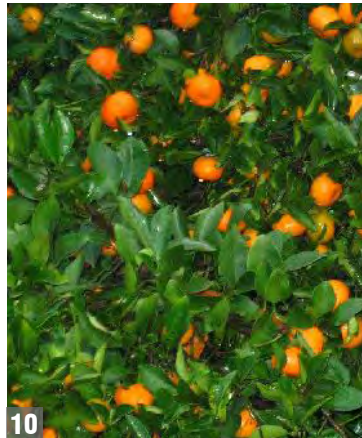
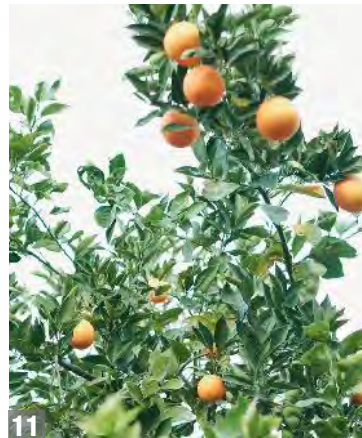
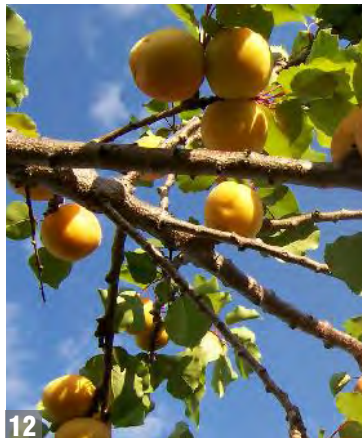
Species	Common Name
1 <i>Lagerstroemia indica</i> 'Natchez'	Natchez Crape Myrtle
2 <i>Koelreuteria paniculata</i>	Golden Rain Tree
3 <i>Lagerstroemia indica</i> 'Tuscadora'	Crape Myrtle
4 <i>Buckinghamia cellissima</i>	Ivory Curl Flower
5 <i>Quercus palustris</i> 'Freefall'	Pink Oak
6 <i>Brachychiton acerifolius</i>	Illawarra Flame Tree
7 <i>Angophora subvelutina</i>	Broad Leaved Apple
8 <i>Eucalyptus tereticornis</i>	Forest Red Gum
9 <i>Malus floribunda</i>	Crab Apple
10 <i>Citrus tangerina</i>	Tangerine
11 <i>Citrus sinensis</i>	Naval Orange
12 <i>Prunus armeniaca</i>	Apricot

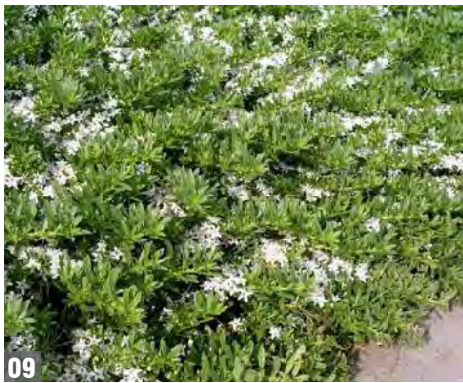
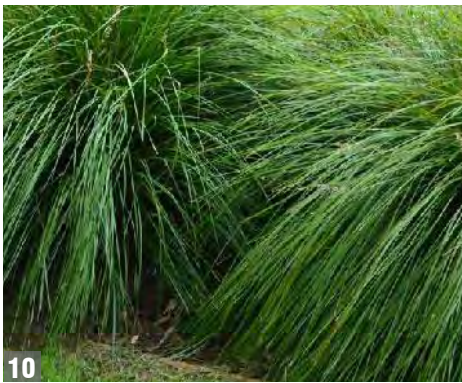
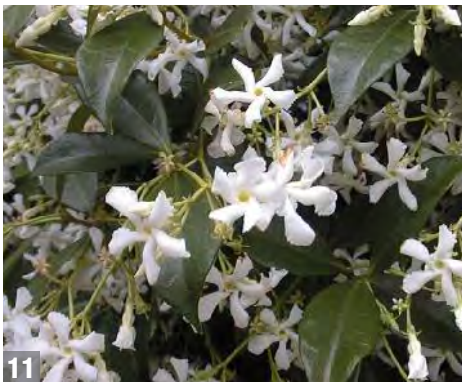
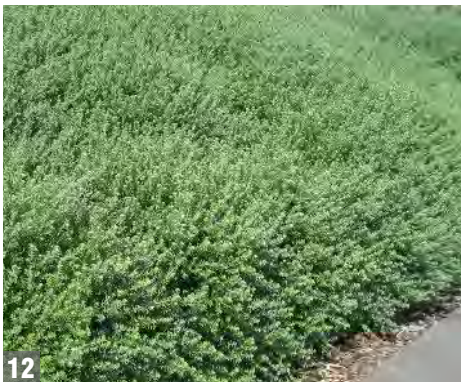
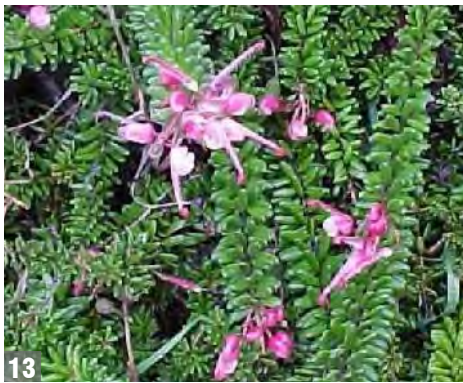
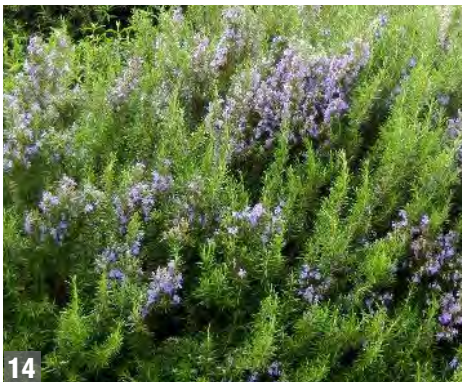
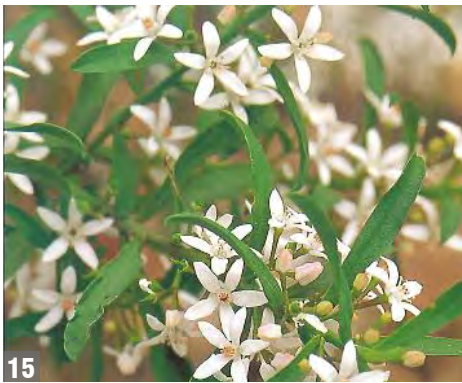
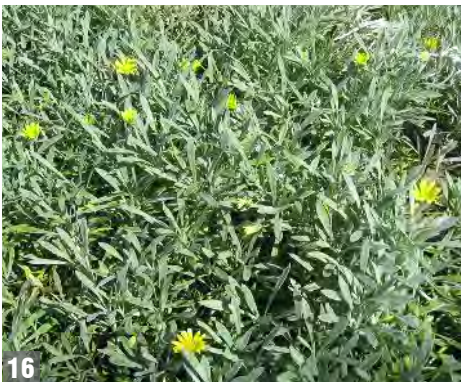
## Indicative Schedule

Image	Species	Common Name	Height	Spread
01	<i>Camellia sasanqua</i> Plantation Pink	LSasanqua	1.8m	1.0m
02	<i>Coleonema pulchrum</i>	Pink Diosma	0.6m	0.3m
03	<i>Dianella caerulea</i>	Blue Flax Lily	0.6m	0.6m
04	<i>Raphiolepis</i> 'Springtime'	Indian Hawthorn	1.5m	1.2m
05	<i>Buddleia davidii</i> 'Purple Butterfly'	Butterfly Bush	1.8m	1.2m
06	<i>Diets bicolor</i>	Yeloow Dietes	0.5m	0.4m
07	<i>Eremophila nivea</i>	Silky Eremophila	1.5m	1.5m
08	<i>Loropetalum capense</i>	Fringe Flower	1.6m	1.0m
09	<i>Myoporum parvifolium</i>	Creeping Boobialla	0.3m	0.4m
10	<i>Lomandra longifolia</i> 'Lime Wave'	Lomandra Lime Wave	0.6m	0.6m
11	<i>Trachelospermum jasminoides</i>	Star Jasmine	0.5m	1.2m
12	<i>Westringa mundii</i>	Coastal Rosemary	0.6m	1.0m
13	<i>Grevillea lanigera prostrate</i>	Prostrate Grevillea	0.5m	0.8m
14	<i>Rosmarinus officinalis</i>	Rosemary	0.6m	0.8m
15	<i>Philotheca myoporoides</i>	Waxflower	1.2m	0.8m
16	<i>Gazania tomentosa</i>	Gazania	0.3m	1.0m

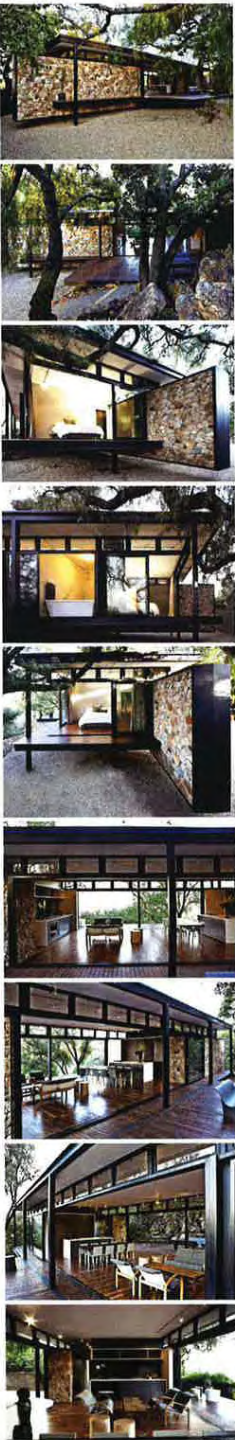
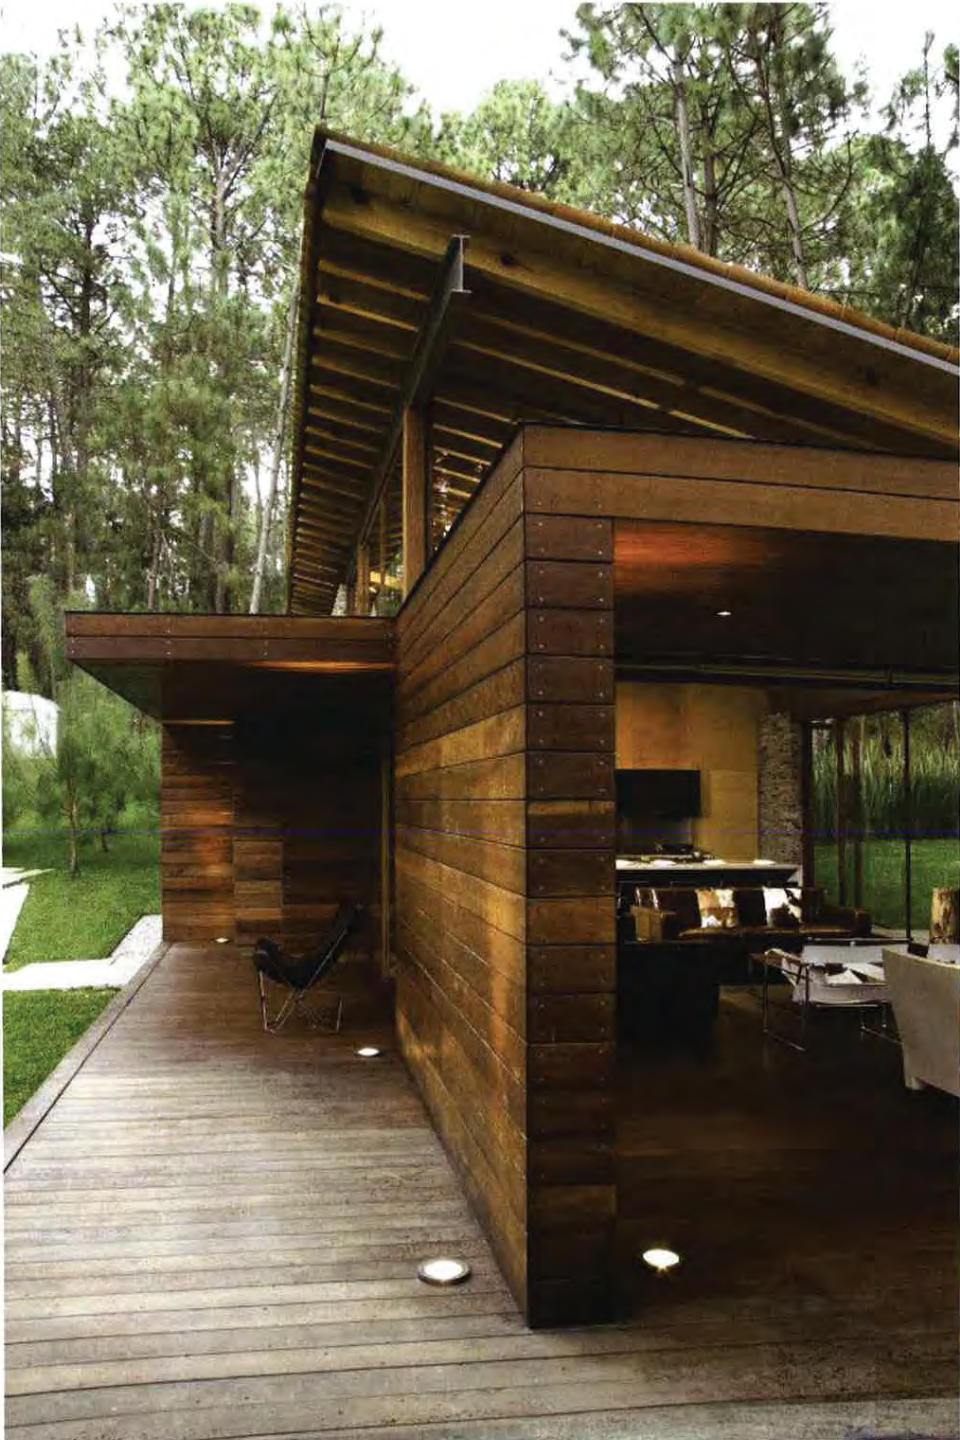
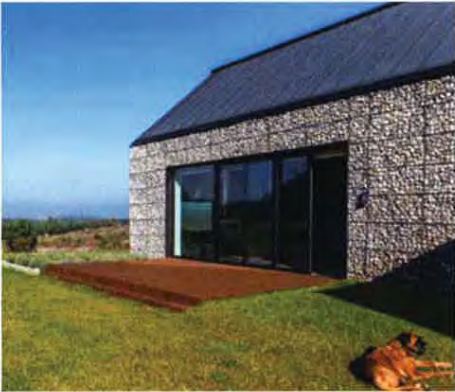
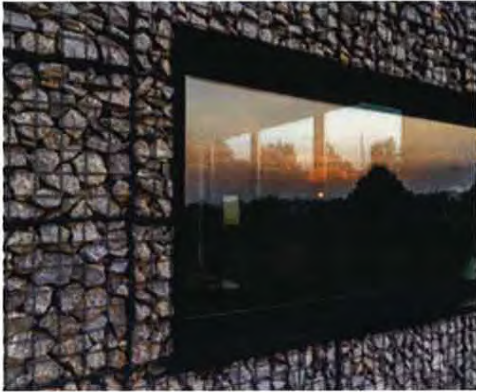
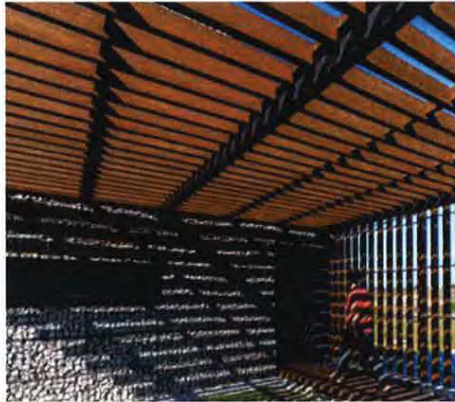
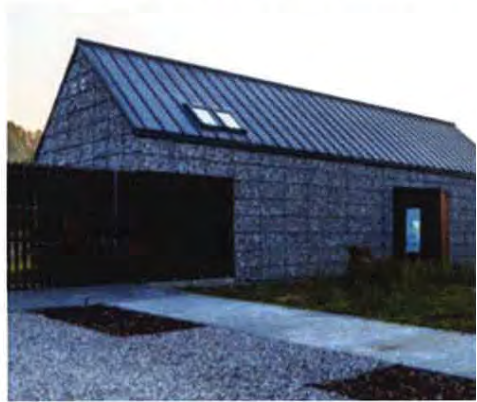
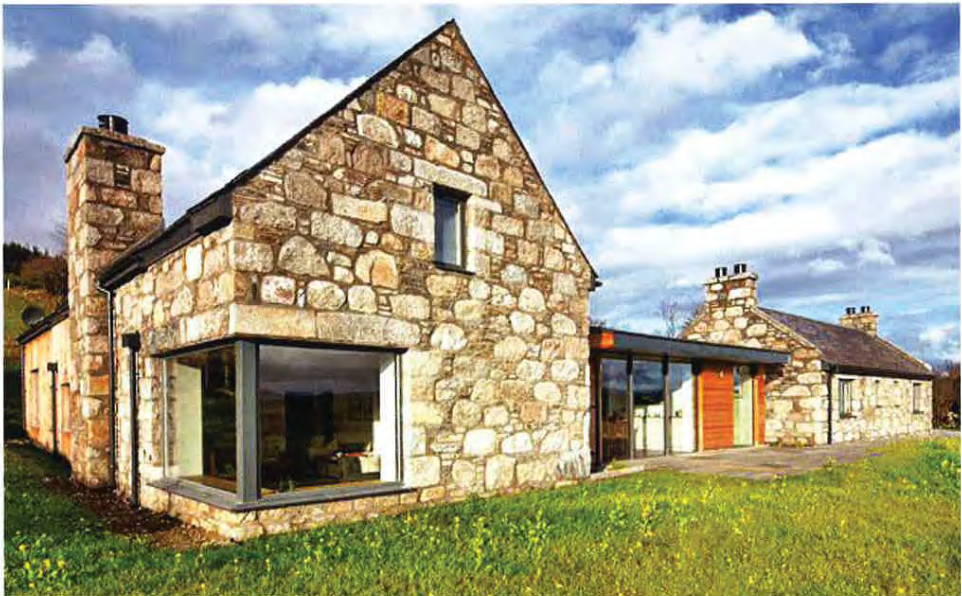
# Materials Palette

The materials palette will include primarily natural materials such as stone, brick and timber to reflect a contemporary rural character.

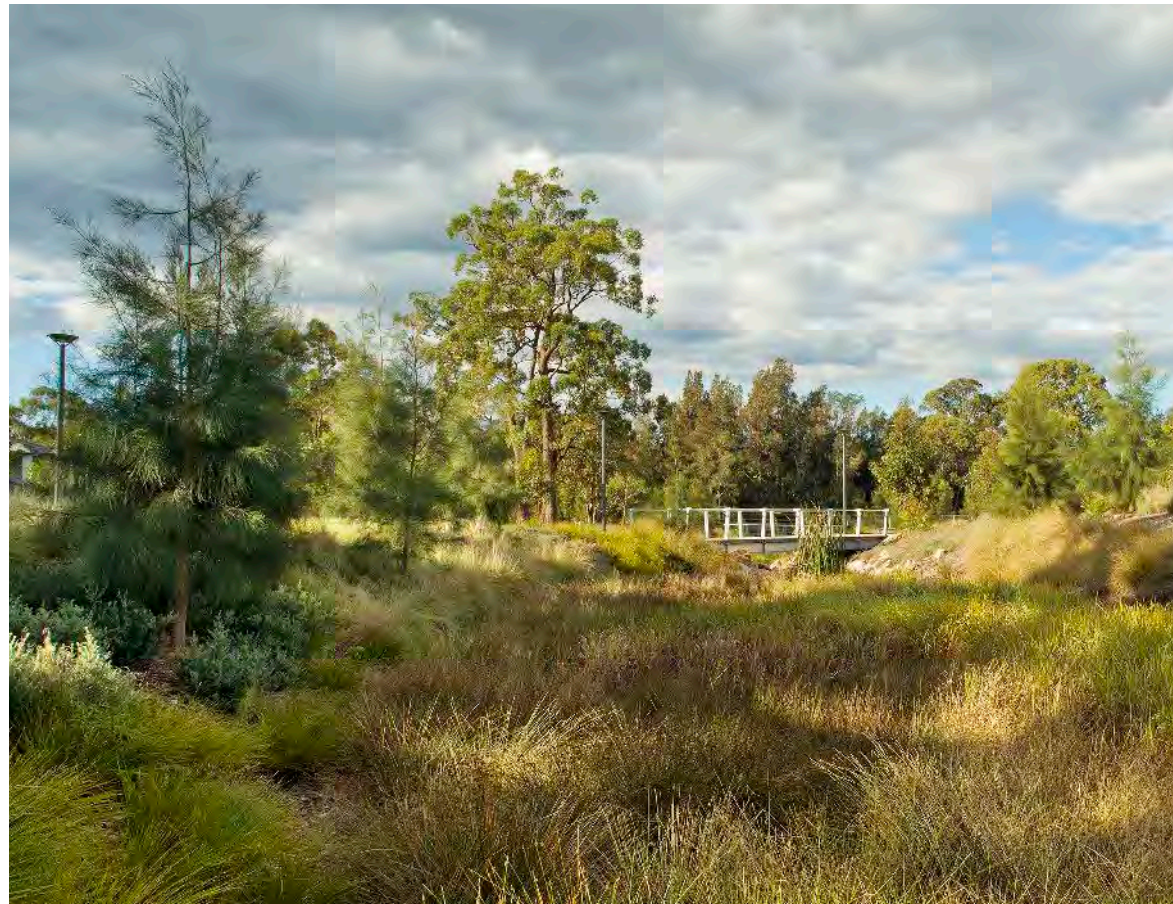
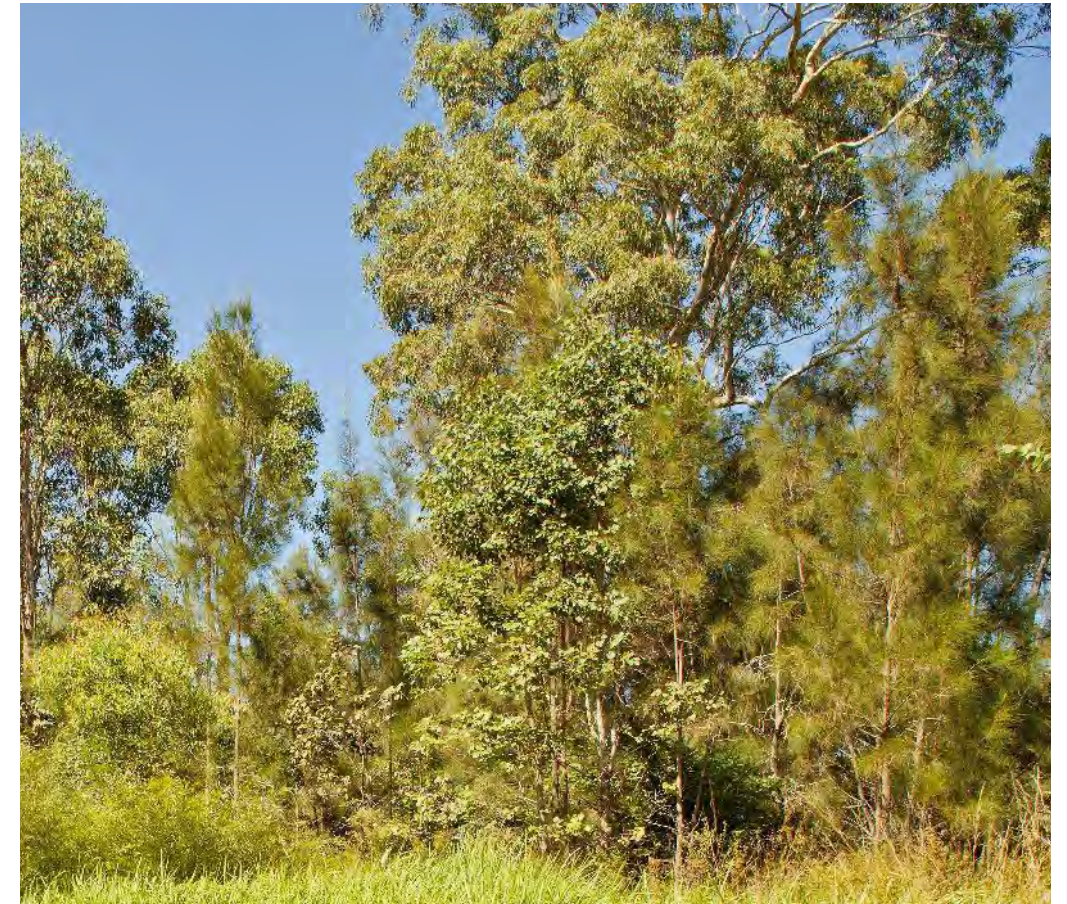
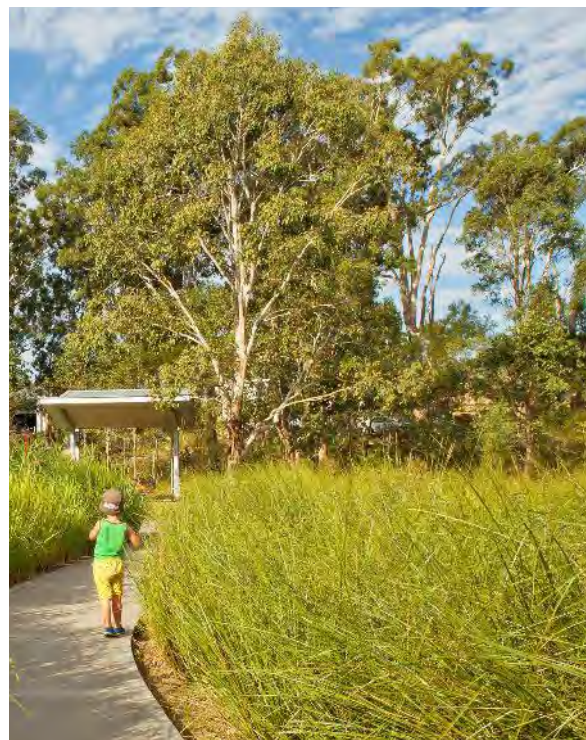
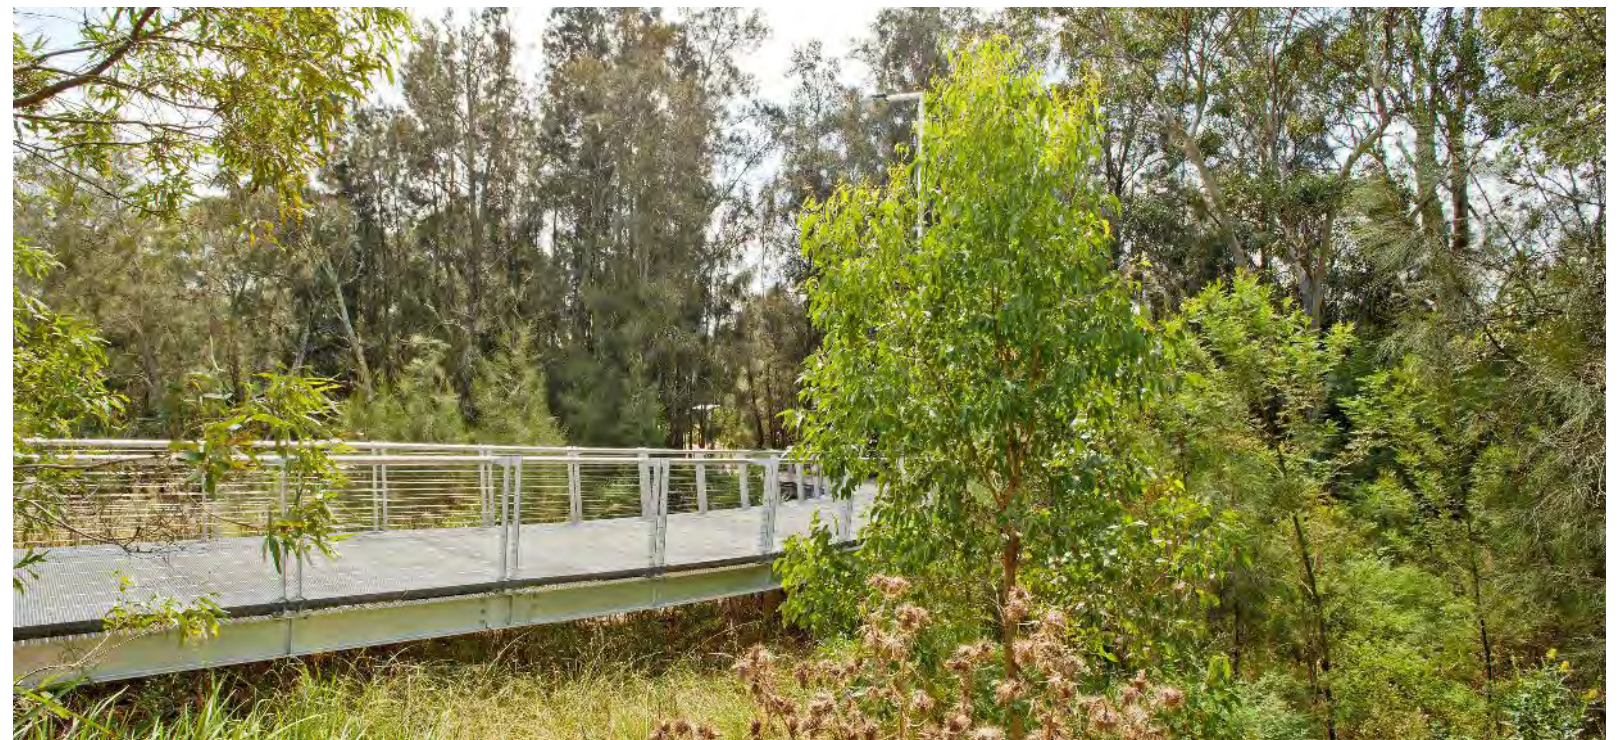
The stormwater management facilities will consist of a series of collection, detention and treatment devices including vegetated swales, detention ponds and grass overland flow paths.

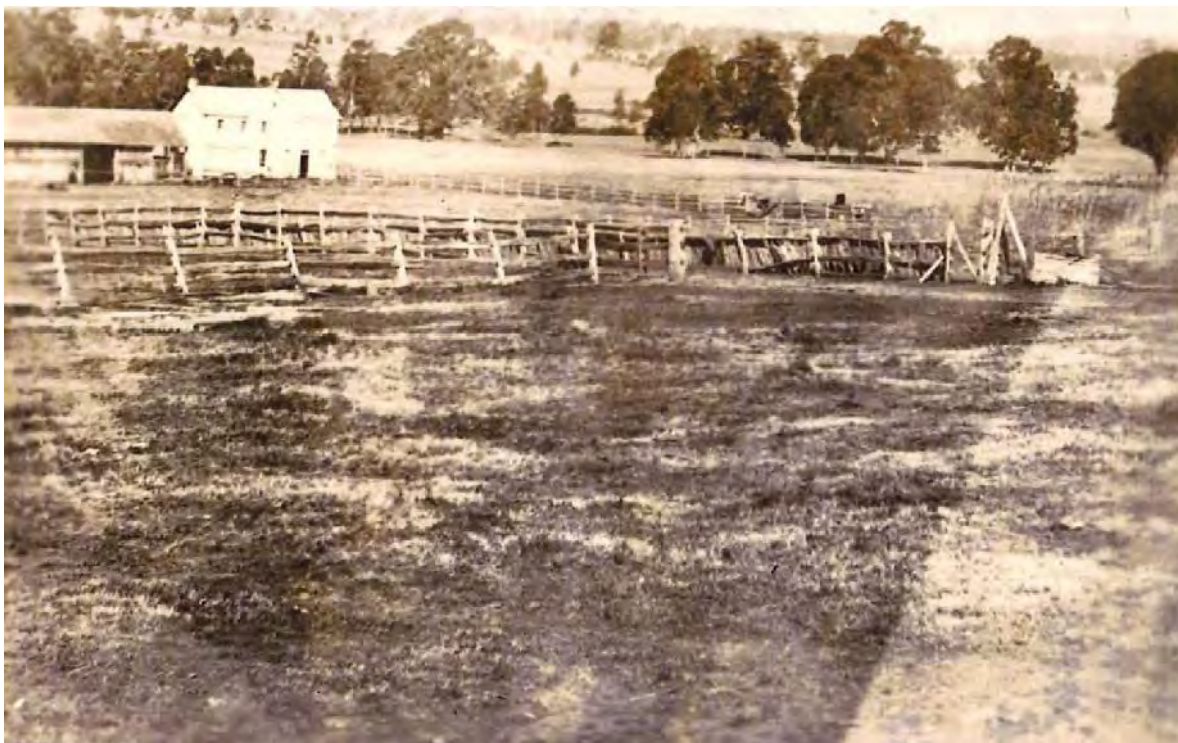
View toward the coach house taken during the Moore family's ownership (1871-1938). Moore Family Archives, cf Tropman & Tropman 2017.

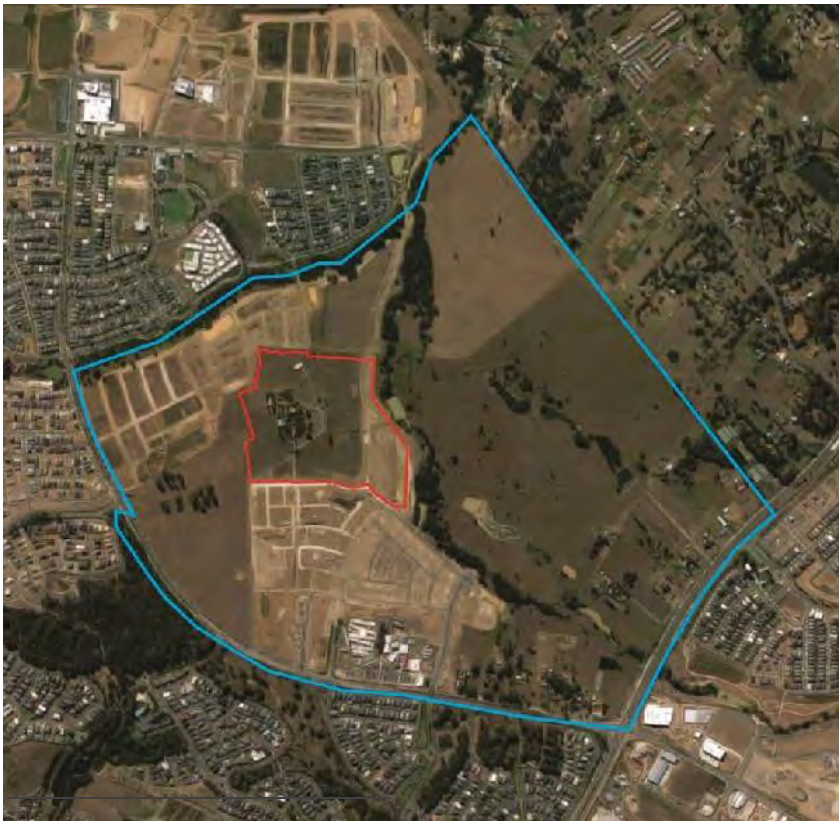
Figure 1.1: Location plan showing the position of the study area. The proposed boundary of the Stage 6 subdivision is outlined in red and the overall Catherine Park property is outlined in blue. Base map Google 2017; north is at the top of the image.

The study area once formed part of a large parcel of land surrounding Catherine Park House (Figure 1.1). This was known as Catherine Fields (Part) Precinct and was 322.7 hectares in size. A large portion of this land was released by the NSW government for urban development in 2011. This development has already begun, creating the new suburb of Catherine Park.

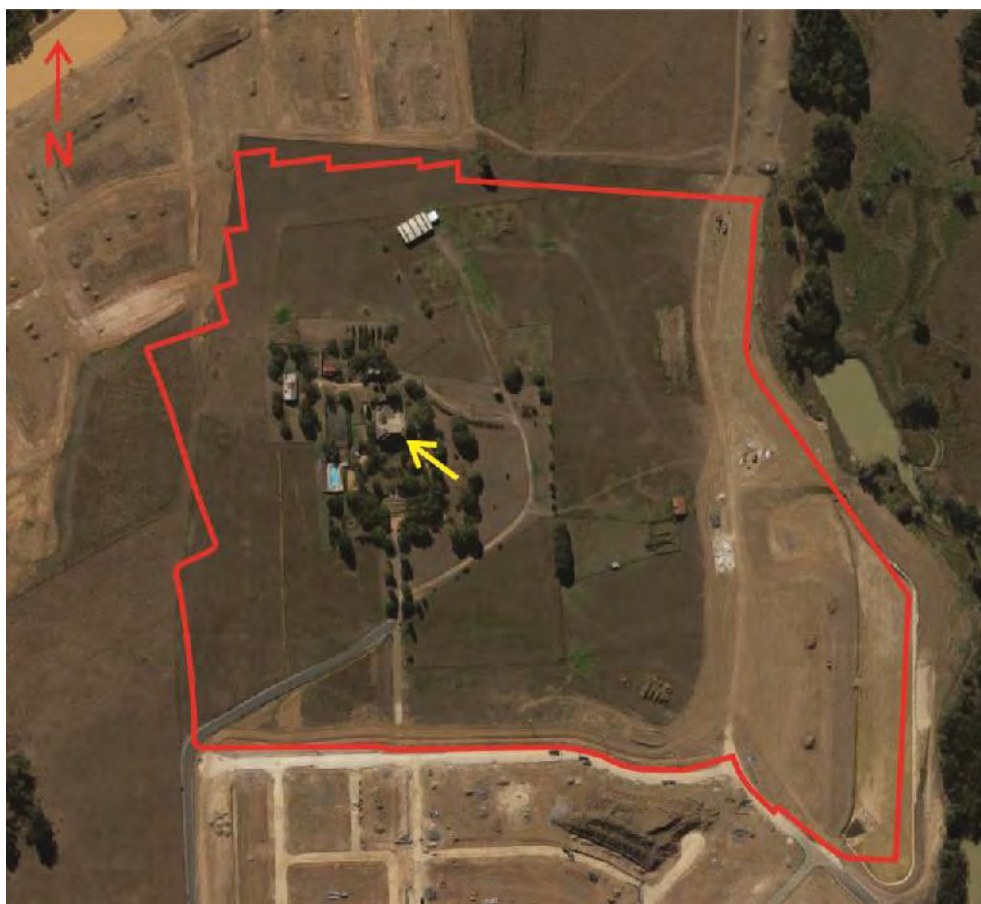
Figure 1.2:  
The Catherine park  
Homestead within the  
proposed  
Stage 6  
boundary  
(outlined in  
red). The  
yellow arrow  
points to the  
principal  
structure,  
Catherine Park  
House. Base  
map Google  
2017.

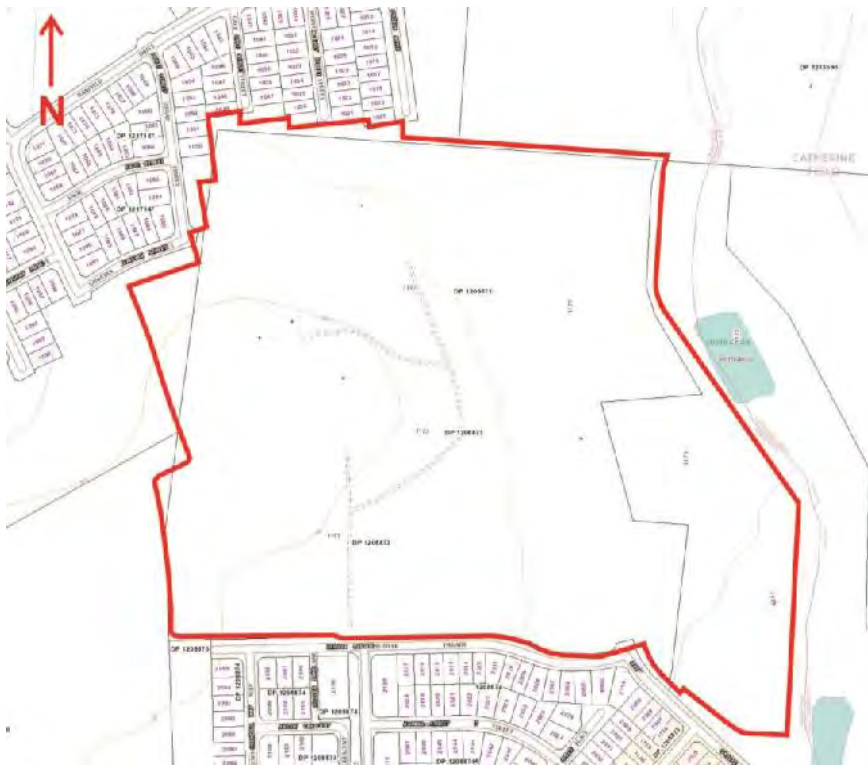
Figure 1.3: The proposed Stage 6 subdivision area (outlined in red) overlaid on cadastral plan with lot boundaries. Six Maps 2017.

The site is located on Oran Park Drive, Oran Park, northeast of Camden and north of Narellan. It is within the local government area of Camden and is situated to the east of Oran Park Drive and Dugay Street, south of Dunstan Street and at the end of four streets of Banfield Drive, north of Seidler Parade and west of South Creek. The proposed subdivision relates to Lot 1177 DP 1208873, Lot 1175 DP 1208873, Lot 1000 DP 1217147 and Lot 2 DP 1213590 (Figure 1.3).

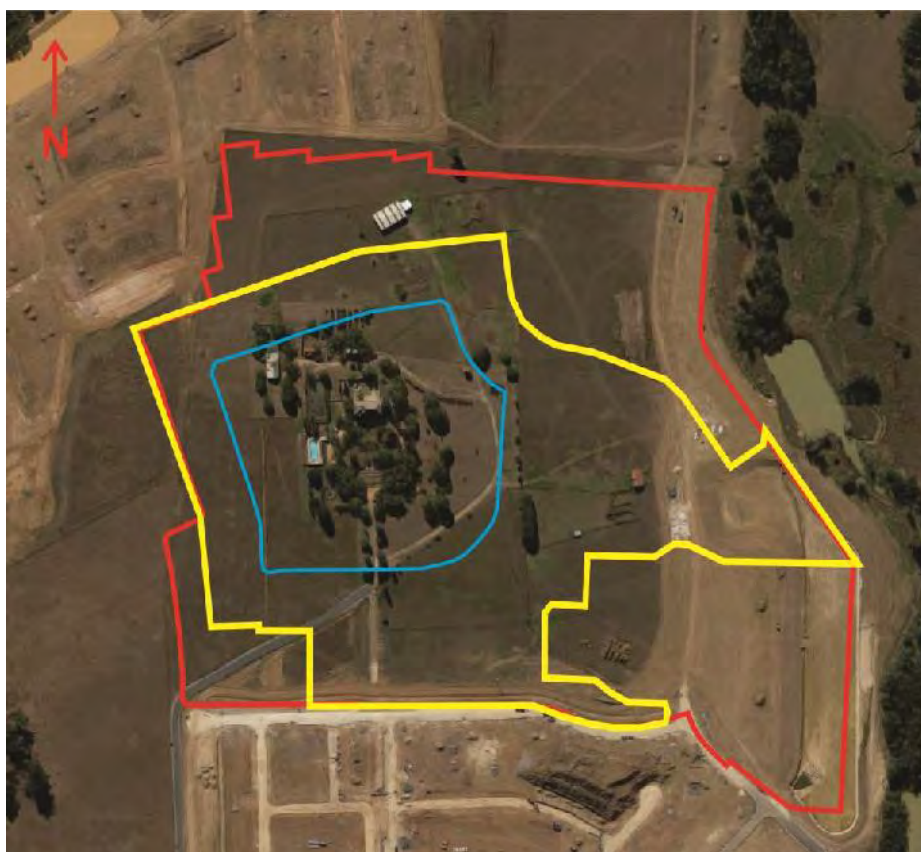
Figure 1.5: Overlay showing the Stage 6 subdivision study area (outlined in red), current heritage curtilage area (outlined in yellow) and a proposed fenceline surrounding the homestead (outlined in blue). Base map Google 2017.

Catherine Park House itself is a State Heritage-listed item (SHR No. 1695) and a heritage curtilage has been maintained around the house, associated landscape and built features (Figure 1.4). This curtilage is located entirely within the proposed Stage 6 subdivision. The subdivision for housing within the curtilage is part of the proposal (Figure 1.5).

Catherine Park House is listed as a heritage item of State significance on the State Heritage Register (SHR No. 1695). The proposed subdivision entirely encompasses the SHR curtilage and proposes residential subdivision within the curtilage of the heritage item (Figure 1.5). The SHR listing for Catherine Park House states:
