# Oran Park (SHR 1695)

## Conservation Management Plan

prepared for  
Hixson Pty Ltd

May 2019  
REF: 1655: CMP  
Issue 23

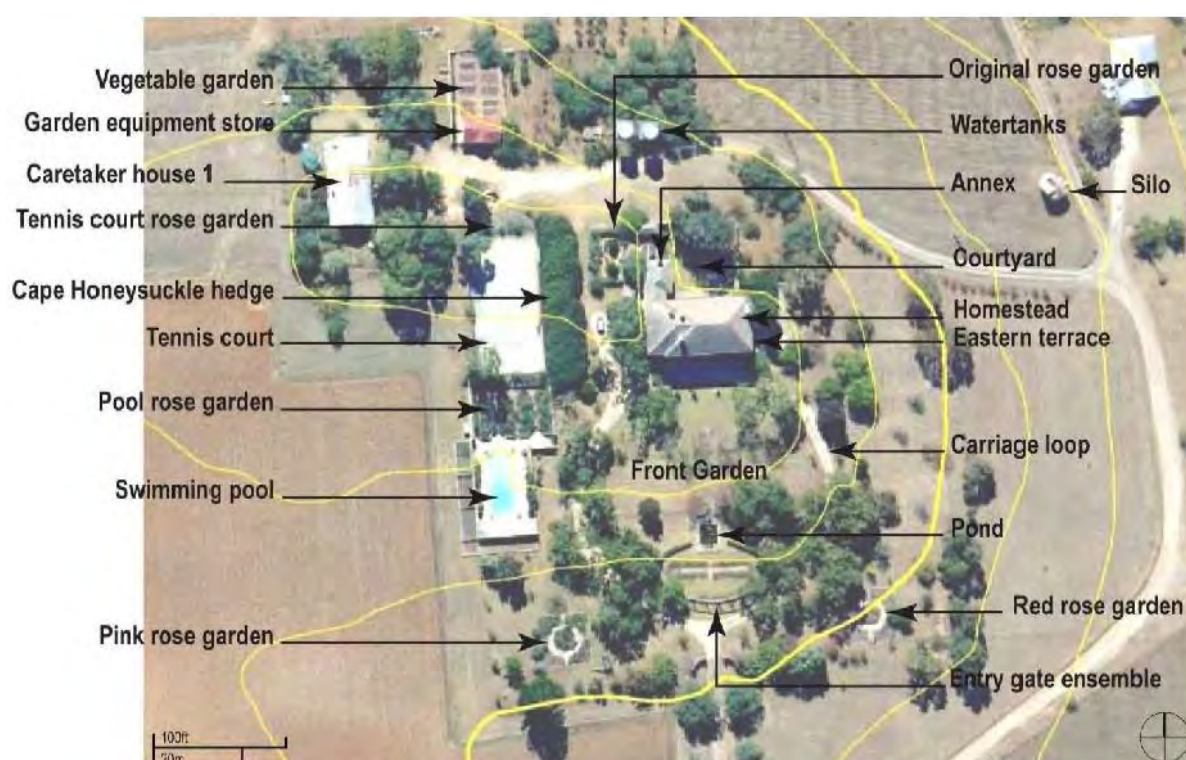
Figure 1.6: Layout of the buildings at Catherine Park House. Extracted from GML 2012, p.31. North is at the top of the image.

The land forming the Stage 6 Subdivision area largely consists of open, grassy fields. Catherine Park itself sits on a knoll and overlooks the surrounding landscape. Structures mostly consist of Catherine Park House and its associated buildings, which are generally concentrated around the house itself (Figure 1.6). Other buildings include a group of modern sheds to the north, a silo dating to the 1920s in the east, and the former coach house to the southeast, which dates to the late 1830s.

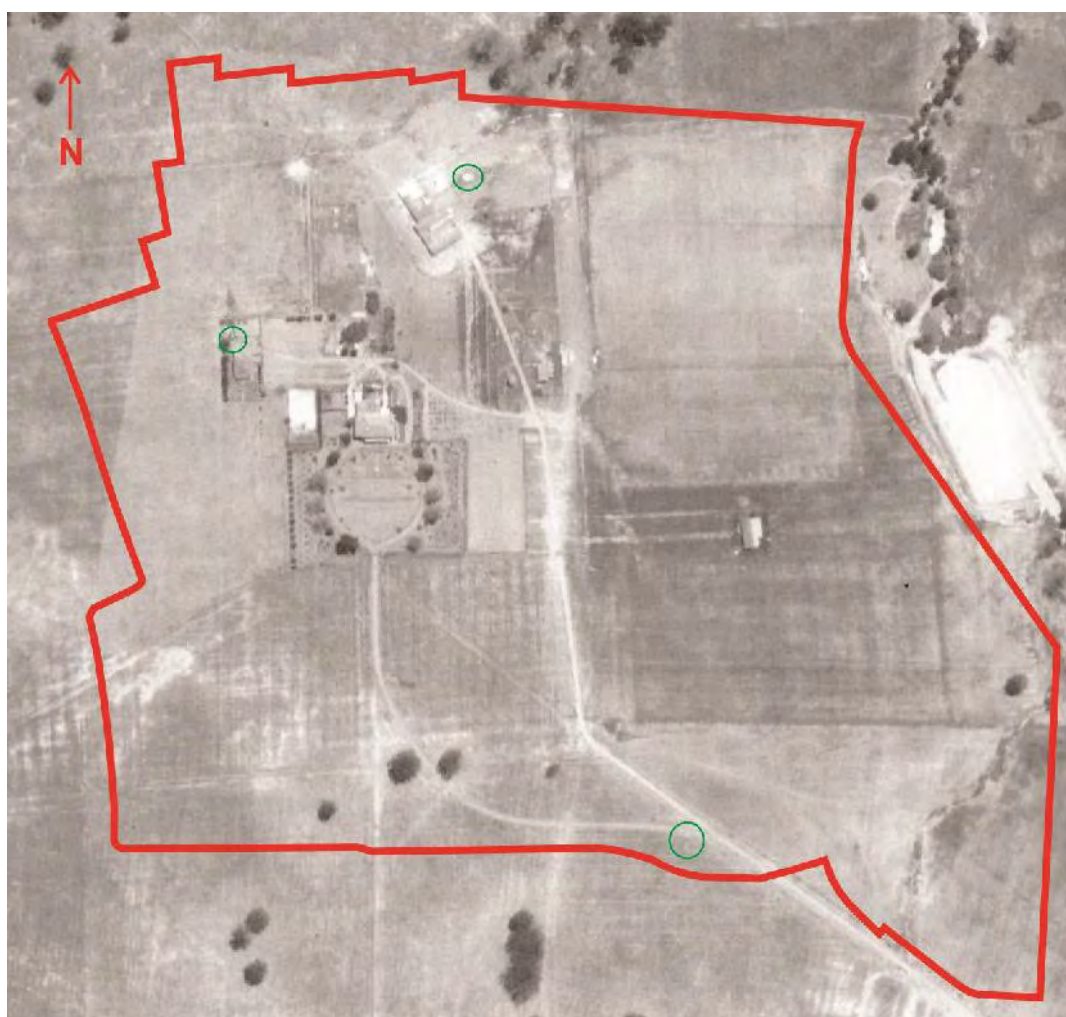
Figure 3.1: An aerial photograph dating to 1947 shows a driveway leading from Cobbitty Road (south west of the study area) up toward the sheds to the north of Catherine Park House. The Stage 6 boundary is indicated in red. The green circles indicate possible features investigated during the site visit.

During the site visit, particular attention was paid to four possible structures identified on the 1947 aerial photograph (Figure 3.1) which were no longer apparent on the 2017 Google satellite photo. No trace of the three possible structures was found, although their remains may be present beneath the overgrown grass or below ground. It is also possible that the shapes in the 1947 photograph were not structures but items which would be unlikely to leave an archaeological signature, such as water troughs, trucks, farm equipment, or temporary sheds.

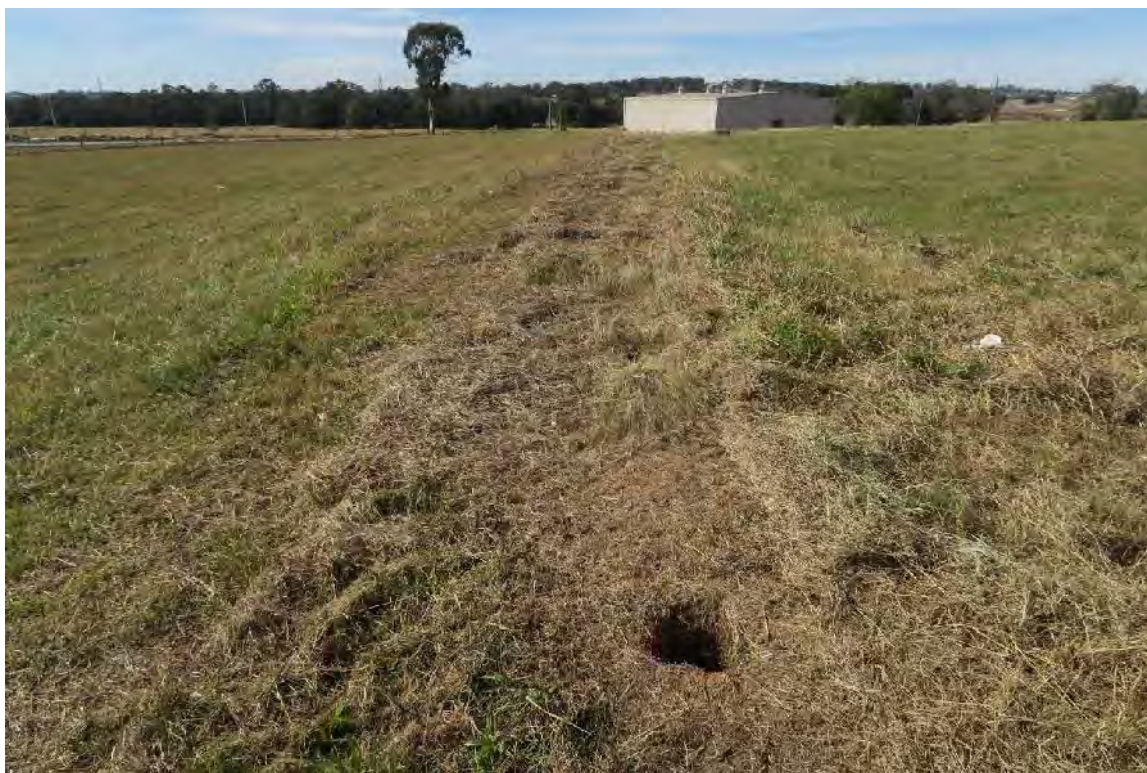
Figure 3.2: A recently removed fenceline in the paddock to the north of the main house. View to the east.

Beyond the immediate vicinity of the house, the land generally consisted of open, grassy paddocks with a gradual slope toward South Creek in the east. In the north of the study area a mown paddock showed no evidence for earlier structures, although a recently removed fence line was clearly visible (Figure 3.2). Development had already begun on some of the land in the south and east of the study area. Substantial areas of land within this area had been buried below imported soil used to build up and level the land. Some of these mounds were quite overgrown and had been there for some time, while others appeared to be quite fresh and recent. Based on historical analysis, these areas are unlikely to have contained archaeological material, however, the soil has completely obscured any remains that might have been present (Figure 3.3). Large areas of land in the south and east of the study area also appeared to have been recently graded in preparation for construction (Figure 3.4).

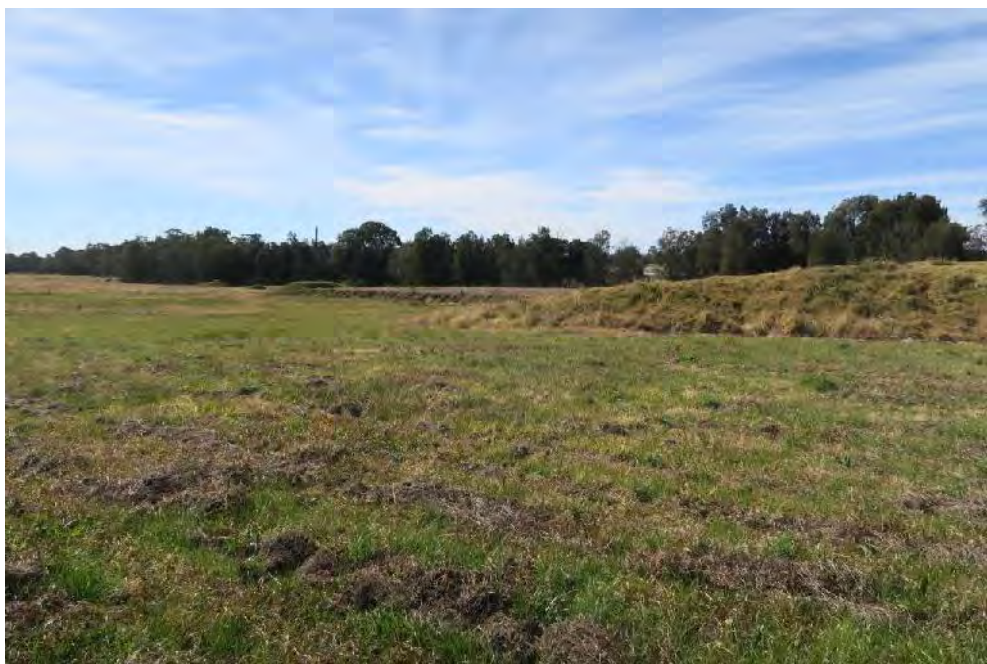
Figure 3.3:  
Large mounds  
of soil in the  
northeast  
corner of the  
site. View to  
the northeast.

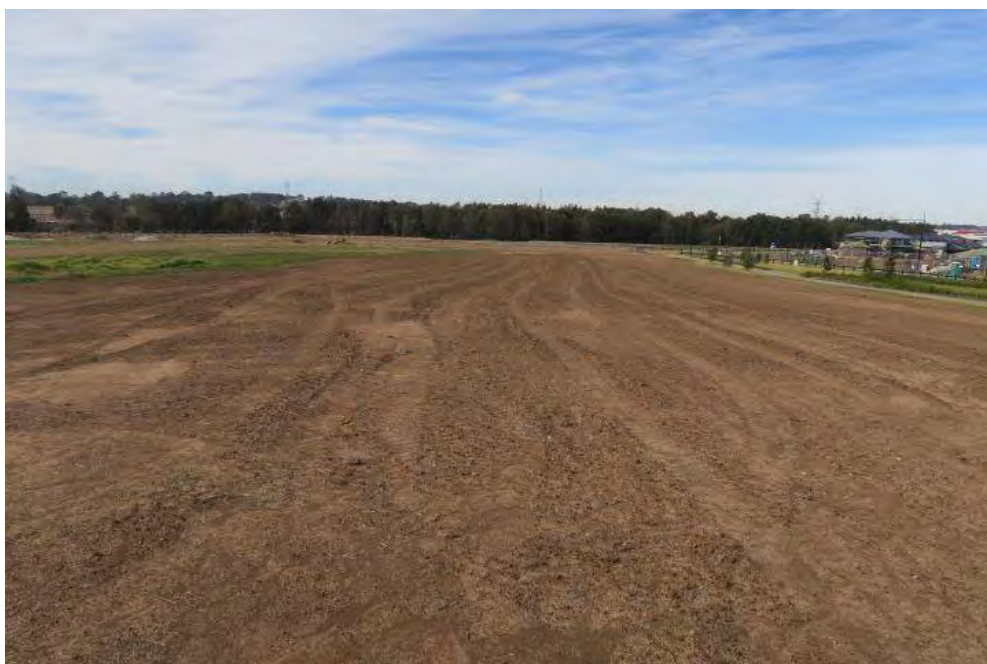
Figure 3.4:  
Grading in the  
southern  
portion of the  
site. View to  
the east.

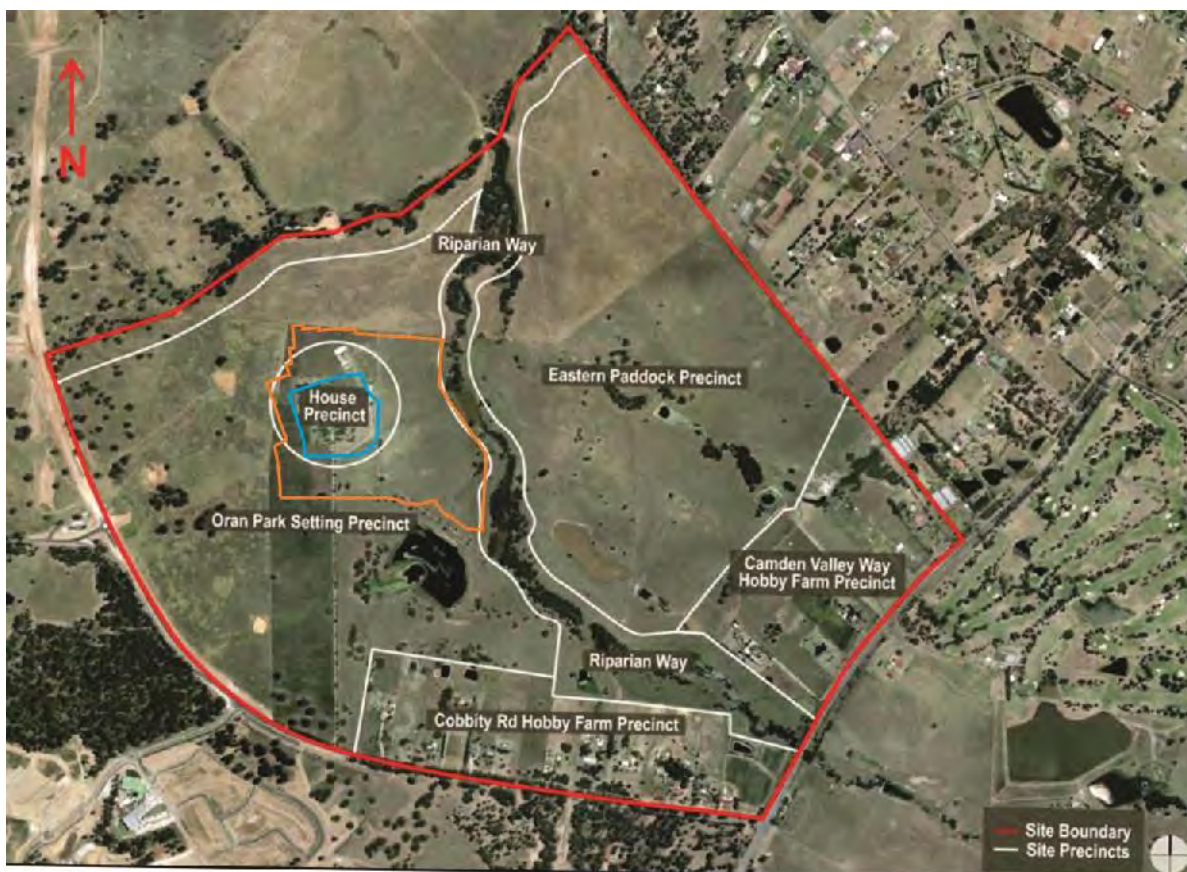
Figure 4.1: Overlay showing the site precincts as defined by GML (outlined in white). The Catherine Fields (Part) Precinct site is outlined in red, the Stage 6 Subdivision is outlined in orange, and the proposed boundary around the homestead is outlined in blue. Base plan from GML 2012, with annotations by C&L.

This Archaeological Impact Assessment generally agrees with GML's assessment of archaeological potential, however, Tropman & Tropman argue that the original c.1830s dwelling house is likely to be the same as the coach house which is still standing to the east of Catherine Park House.<sup>10</sup> This Impact Assessment agrees with Tropman & Tropman's interpretation of this structure, and notes that a number of archaeological remains are likely to be concentrated in the vicinity of this building, including those associated with its original use as a domestic dwelling, its later use as a coach house, and possible other uses. A photograph which probably dates to the late 19th century shows a stables to the north of the coach house, remains of which may survive below the ground (Figure 4.2).

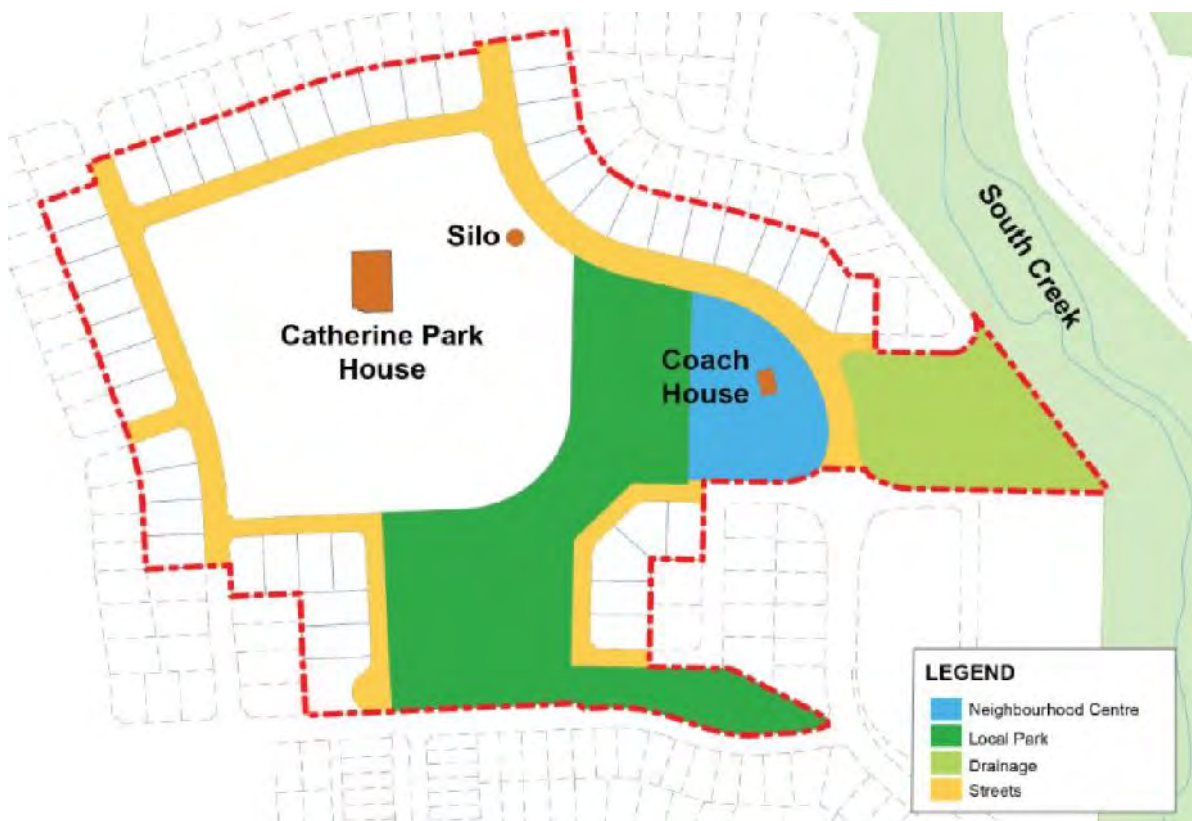
Figure 6.2: Proposed land use within the SHR curtilage (dashed in red). Tropman & Tropman, April 2017, p. 16.

It is proposed to divide the heritage curtilage into several new land uses (Figure 6.2):

- Neighbourhood Centre: planned and zoned around the existing coach house, to be refurbished (Figure 6.3).
- Local Park: approximately 2.6 hectares in size to the southeast of Catherine Park House, containing the former historic driveway between Oran Park Drive and the main house.
- Drainage: area adjacent to South Creek, located to maintain visual connection between Catherine Park House and the creek.

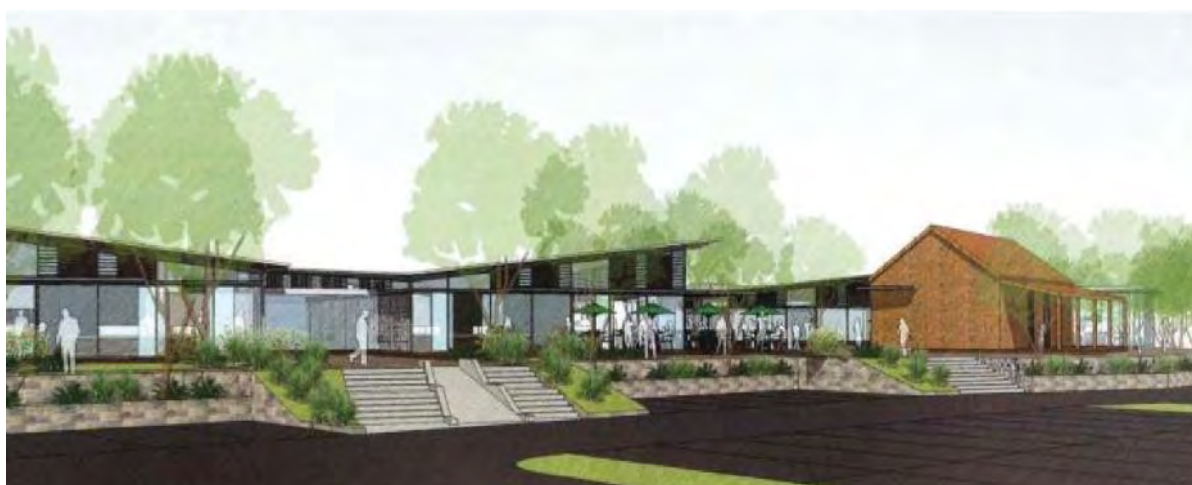
Figure 6.3: Concept design of the refurbished coach house. Renders shown are indicative only and are included as character precedent images only. Tropman & Tropman, April 2017, p. 16.

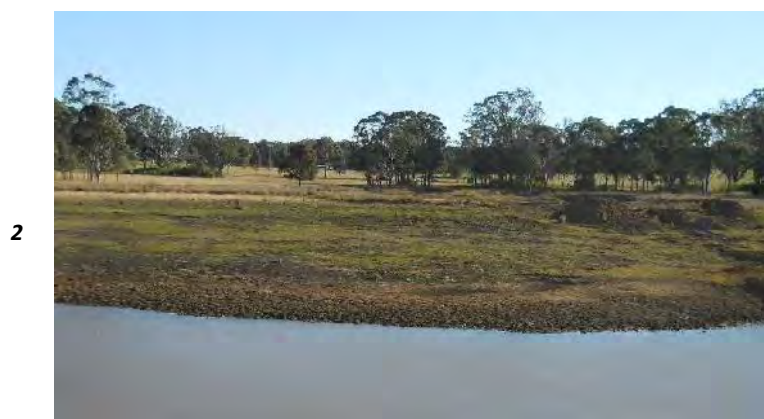
CFPP-02, former dam. Looking west toward CFPP-07 behind trees at right.

Between CFPP-07 and CFPP-02 was a large former dam. The majority had been drained but the eastern margin retained water. Dam construction, use and eventual drainage in this portion of the transect precluded the excavation of any test units, as the sediments could be expected to offer little archaeological integrity or intact soil profiles. The previously submerged portion of the dam (now grassed) appeared moderately-highly disturbed.

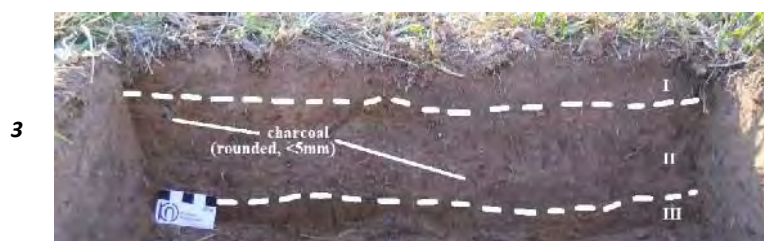
CFPP-02 447E 091N South Facing Section

Located on a level-very gentle slope landform c. 100m west of South Creek, this unit displayed a brown silty loam humic layer (I), underlain by a grey-brown silty clay with rounded charcoal fragments <5mm diameter (II). Charcoal scatters increased with depth. Fine sub-rounded ironstone and shale gravels were <5mm in (I) and (II). Grey/yellow clay B horizon (III) with no visible inclusions was the limit of excavation.

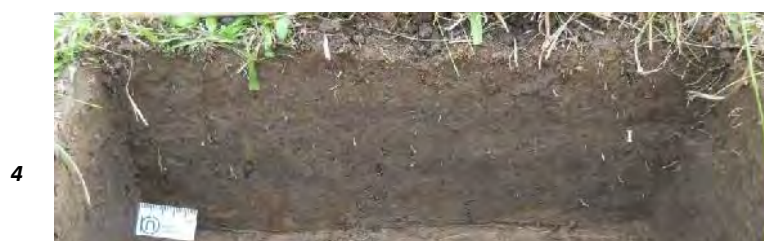
Area A 614E 091N North Facing Section

This excavation unit was located on the flat floodplain immediately east of South Creek. The sediment profile was of a relatively homogenous grey brown silty clay loam (I) above a yellow-brown and grey mottled clay B horizon. Rounded ironstone gravels <10mm were present from 5cm depth. Infrequent charcoal scatter (<2%) and baked clay nodules <10mm formed the only visible inclusions.

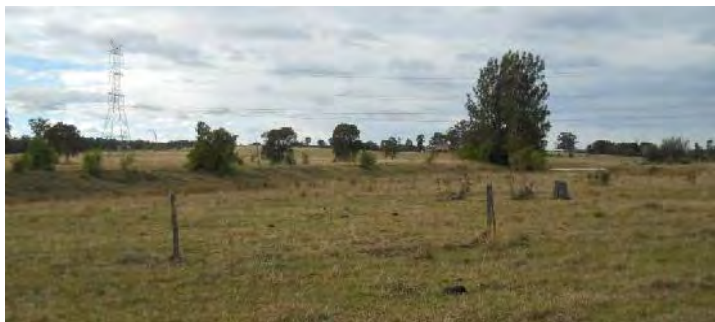
Area A, former dam. Looking east to high point of CFPP-09

Between the northern portion of Area A and site CFPP-09 was a former dam, now drained. Construction of the dam has disturbed the soils along the base of the slope leading up from the South Creek floodplain to the crest and elevated portion of CFPP-09.

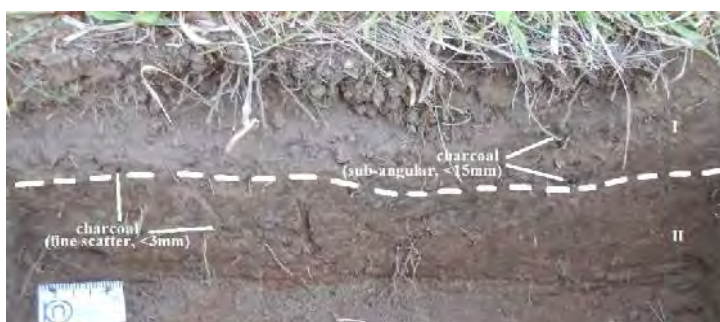
CFPP-09 892E 030N North Facing Section

This test excavation unit was located on the gentle lower slope immediately east of the dam. The unit section demonstrated a brown silty clay loam (I) with clustered sub-angular charcoal fragments <5mm. A slight colour change to a red-brown silty clay loam (II) occurred above a B horizon of red and grey mottled clay. Fine shale gravels <10mm and charcoal scatter <3mm occurred throughout units (I) and (II).

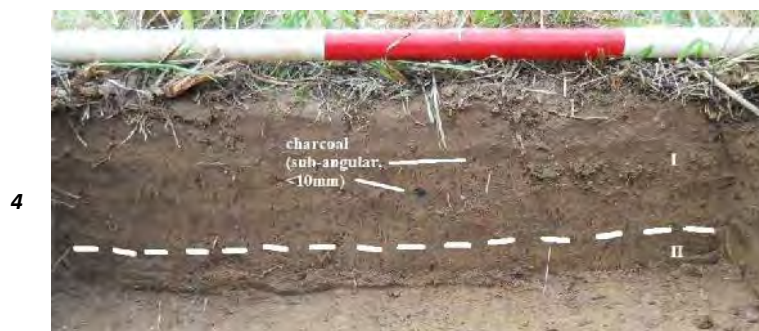
**CFPP-08 860N 540E South Facing Section**

Located on the very gentle slope between two drainage channels, this test excavation unit demonstrated a brown light clay (I) of weak strength and granular structure, with scattered red and dark soft segregations <3mm. Sub-angular charcoal <10mm occurred from 5cm depth. A clear and even boundary introduced a pale light clay with similar inclusions. Infilled biopores occurred at the basal interface between (II) and the B horizon of yellow medium clay.

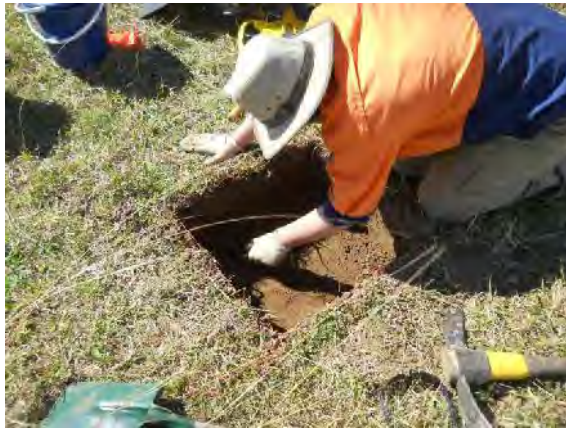
Plate 1. Excavation at CFPP-02

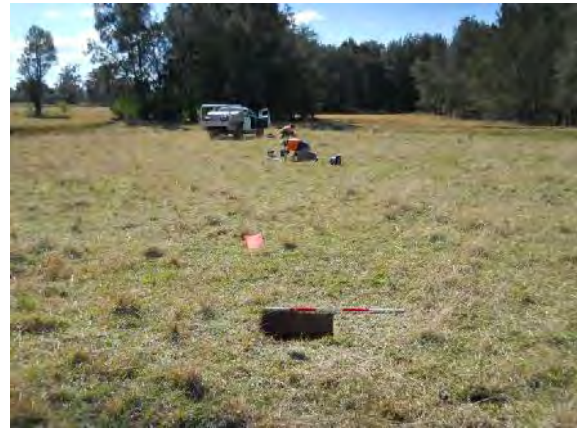
Plate 2. Test transect at CFPP-02

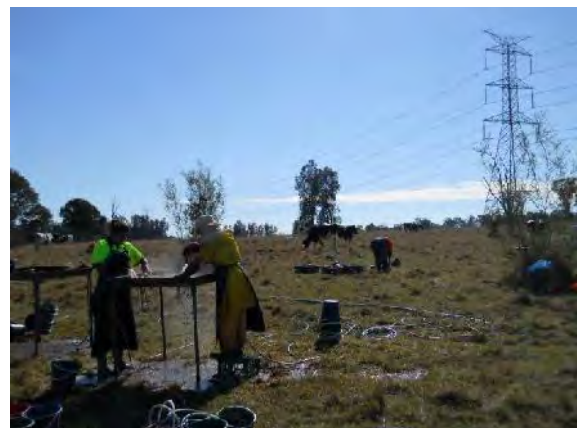
Plate 8. Sieving and excavation at CFPP-09

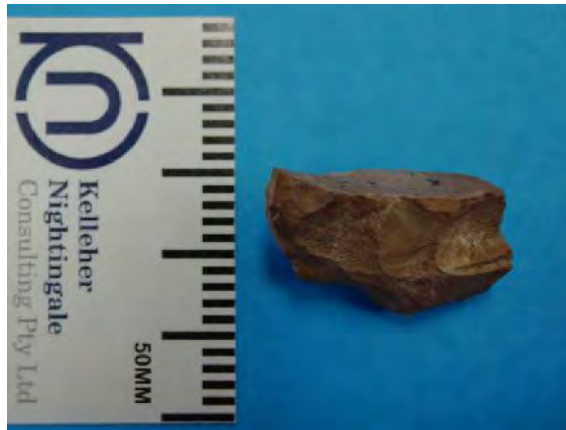
Plate 9. Silcrete core fragment/core tool (artefact ID 1)

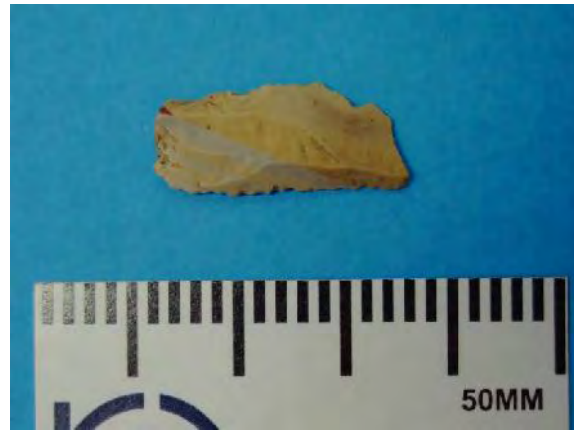
Plate 10. Chert proximal flake fragment with usewear on lateral margin (artefact ID 60)

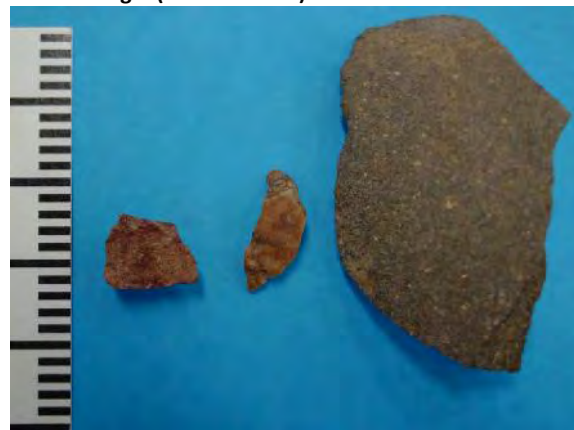
Plate 12. L-R: silcrete flake, silcrete angular fragment and basalt/rhyolite cobble fragment from 865E 525N, CFPP-08 (artefact IDs 50-52)

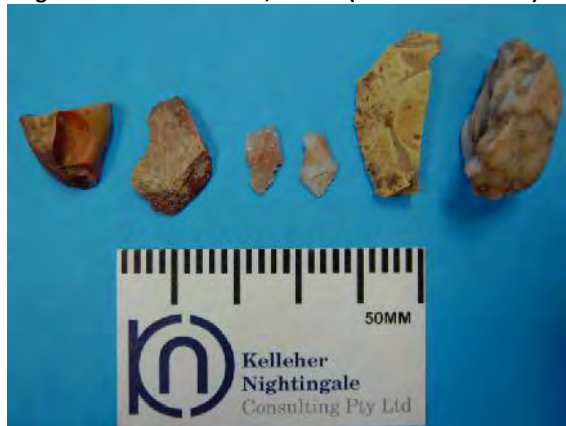
Plate 13. Artefacts from 441E 131N, CFPP-02 (artefact IDs 19-24)

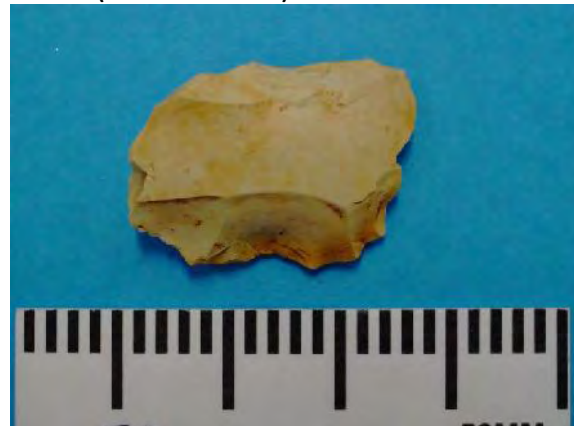
Plate 14. Tuff flake from 902E 010N, CFPP-09 (artefact ID 59)

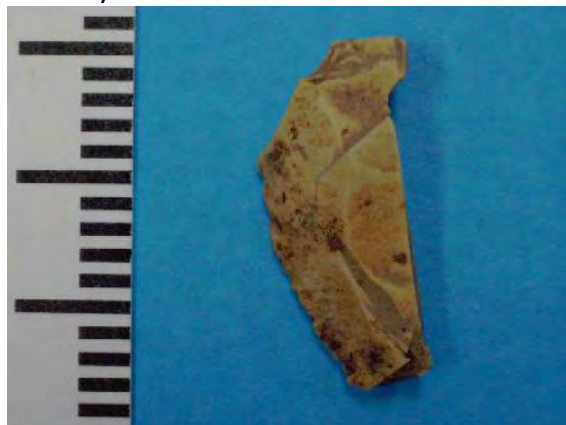
Plate 15. Tuff proximal flake fragment with usewear on lateral margin, 441E 131N CFPP-02 (artefact ID 23)

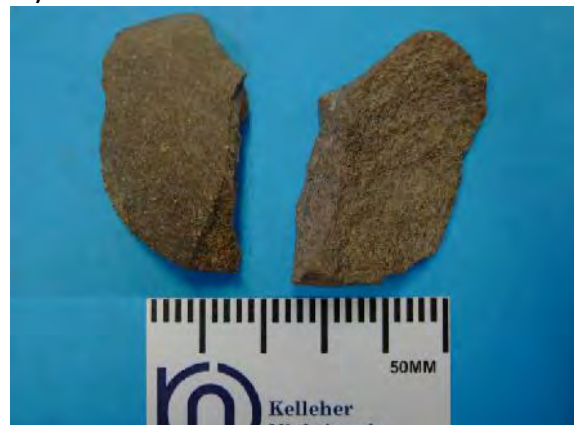
Plate 16. Dorsal and ventral views of basalt/rhyolite cobble fragment (artefact ID 52)
