PLANNING PROPOSAL

THE HUB

MOUNTAIN ASH ROAD, GOULBURN

ENGINEERING SERVICES REPORT

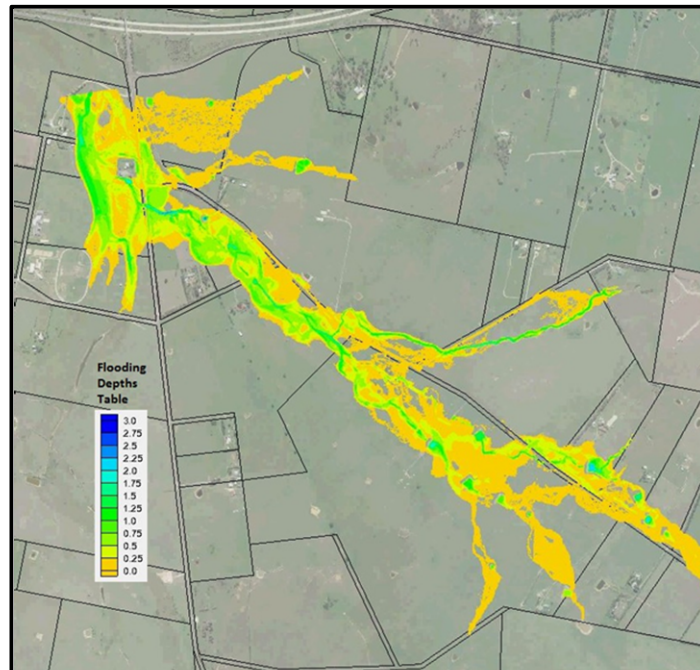
Below is an extract from the modelling showing the extent and depth of the 100yr ARI inundation. A significant extent of the area subject to flooding during the 100yr ARI is between 0 and 250mm.

A sensitivity analysis was also undertaken for the 50yr ARI which determined that the extent of inundation was largely similar to that determined for the 100yr ARI. The attached plans include the 100yr ARI flooding extents. The plans also show the centerlines of the drainage paths and setbacks of either 40m or, where the drainage path has caused an incision into the ground surfaces, 100m.

The analysis determined that the rising waters from the Gundry Creek system have little impact on the Planning Proposal site nor the potential future layout.

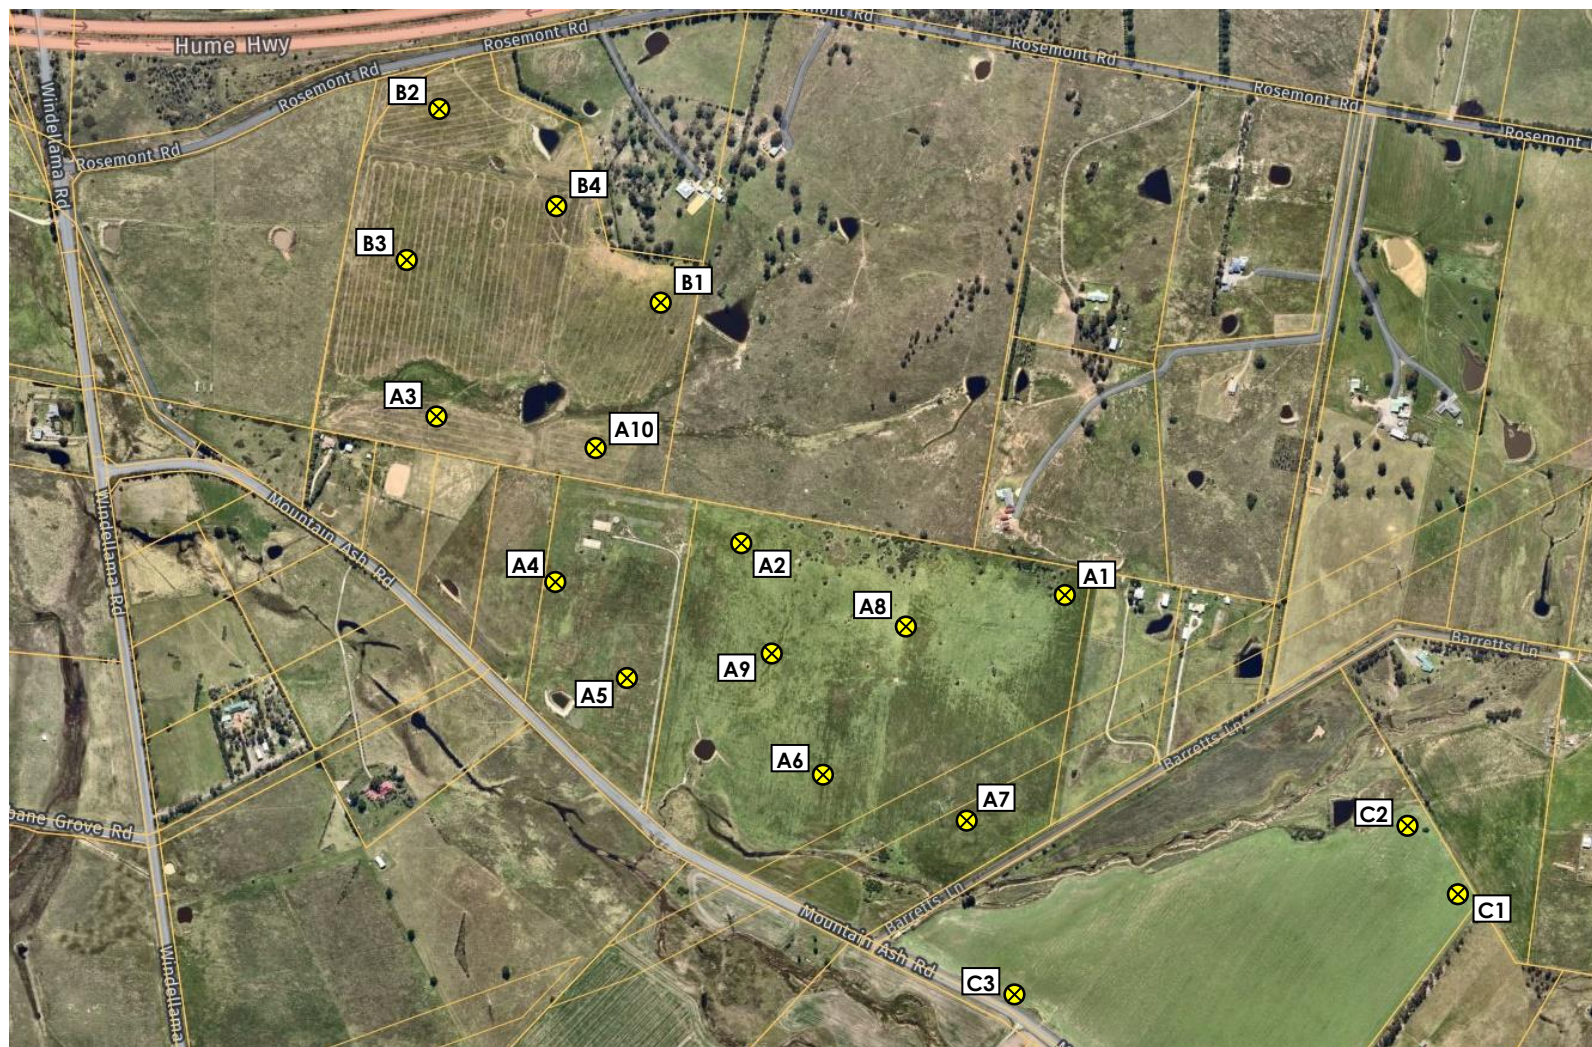
**SOUTHERN REGION LAND ENGINEERING
BRISBANE GROVE RURAL SUBDIVISION
AERIAL PHOTOGRAPH AND BOREHOLE LOCATIONS**

To establish the subsurface conditions, thirty-one (31) test holes were drilled at client-provided locations around the proposed subdivision. Figure 1 shows the site locality, while Figures 2 and 3 are aerial photographs showing the location of the investigation boreholes. The subsurface profiles were logged in terms of the Unified Soil Classification System (USCS). The borehole logs can be found in Appendix B.

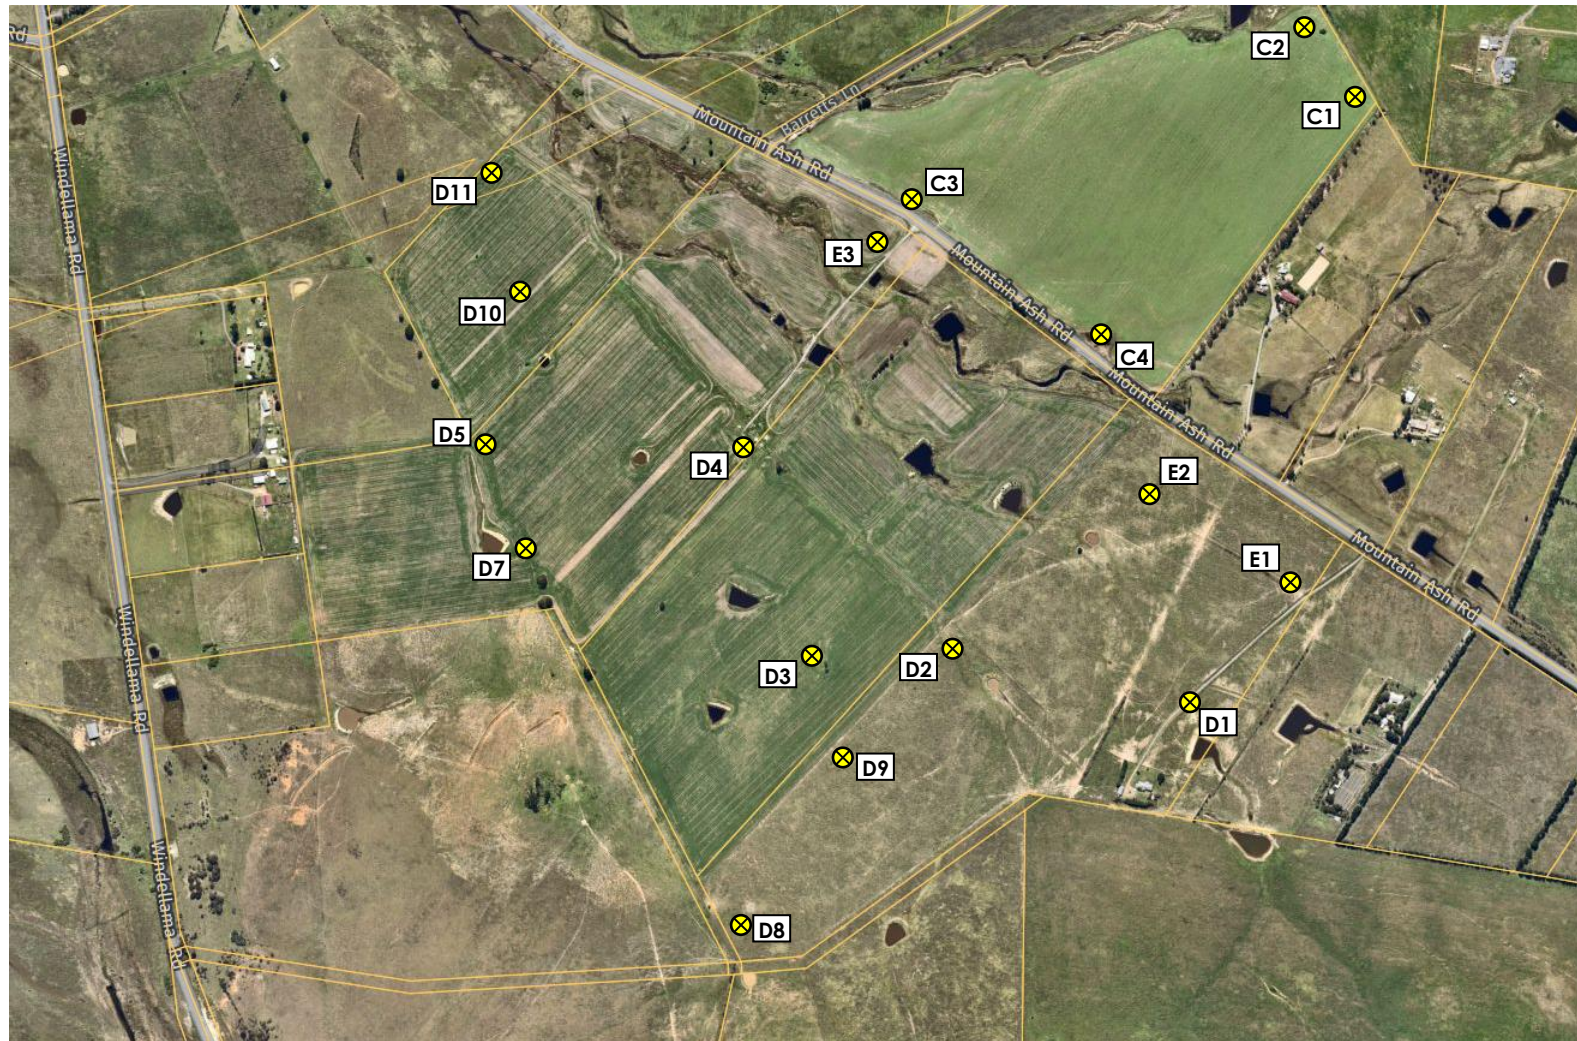
**SOUTHERN REGION LAND ENGINEERING
BRISBANE GROVE RURAL SUBDIVISION
AERIAL PHOTOGRAPH AND BOREHOLE LOCATIONS**

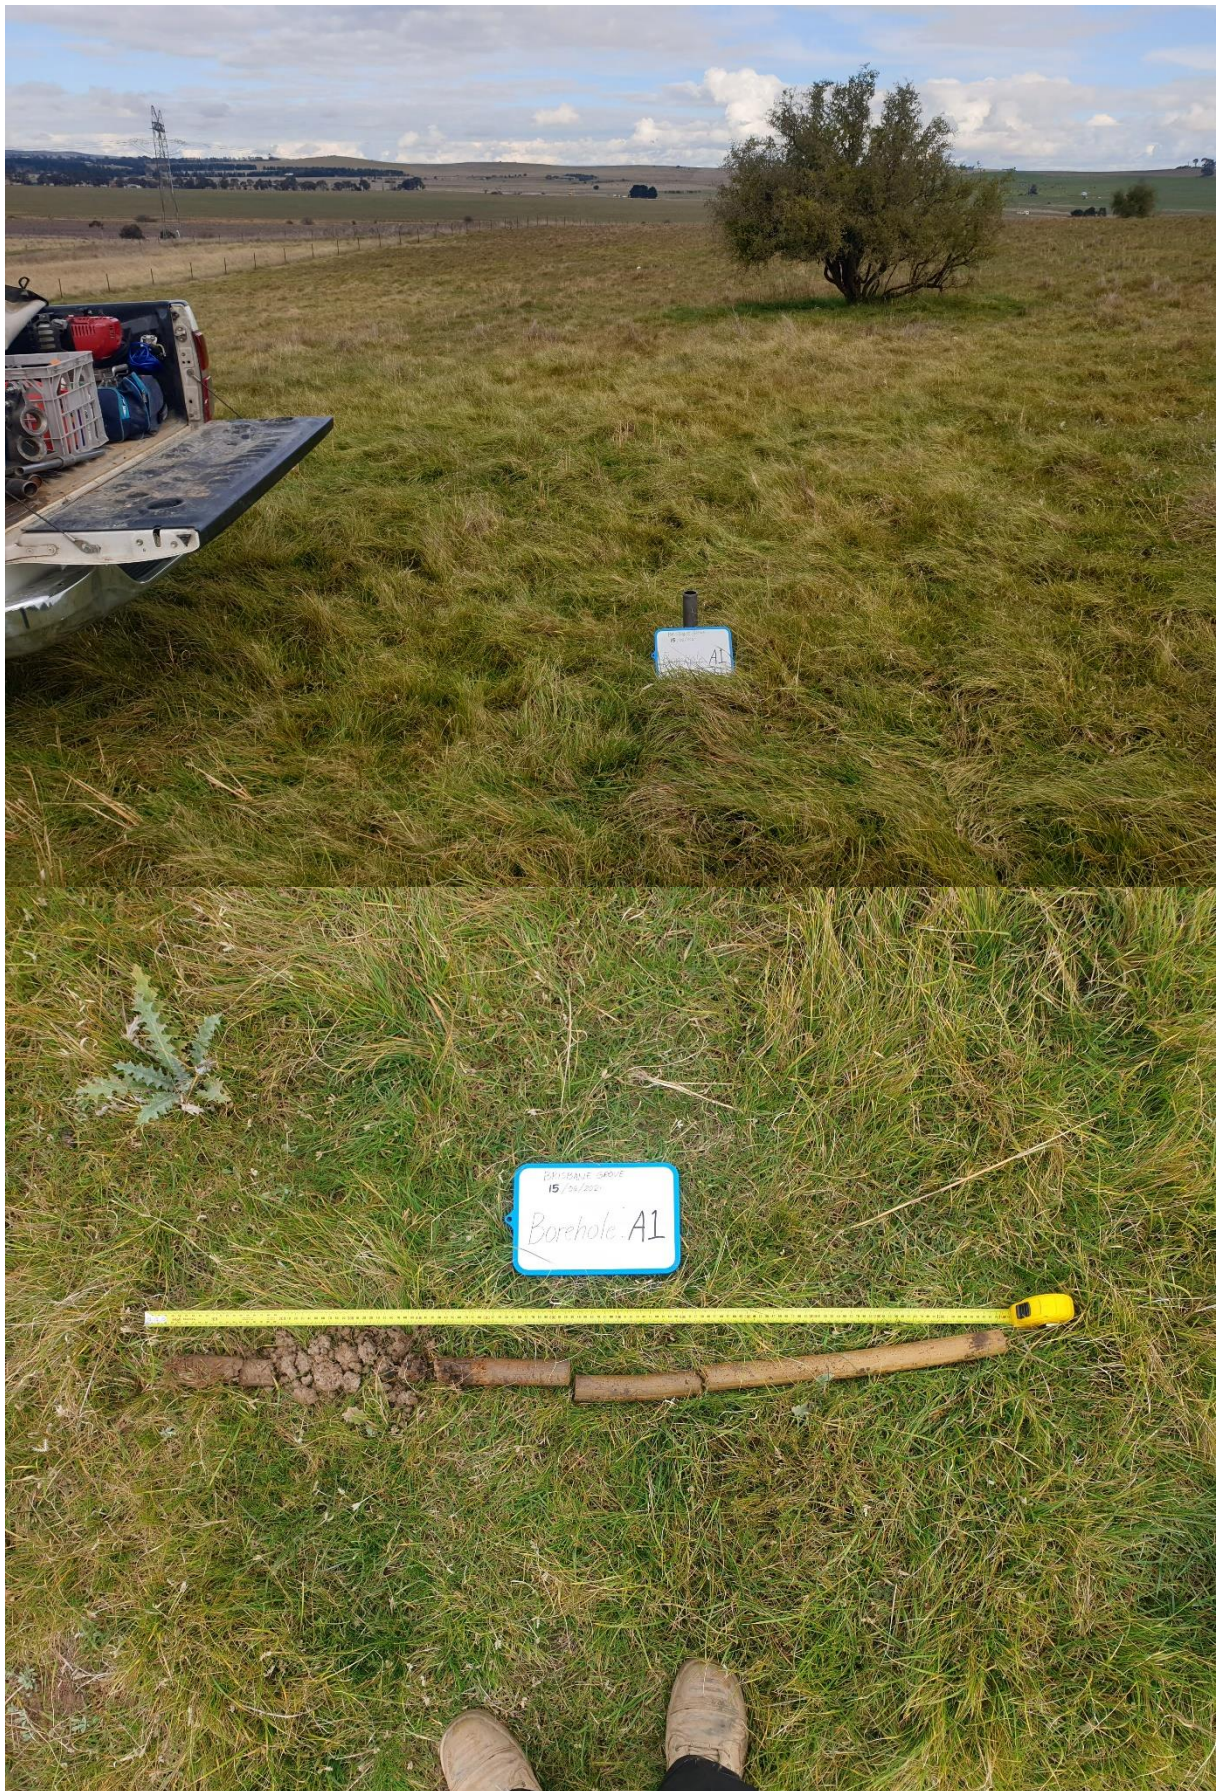
**SOUTHERN REGION LAND ENGINEERING
BRISBANE GROVE RURAL SUBDIVISION
LOCATION AND SOIL CORE PHOTOS (A1)**

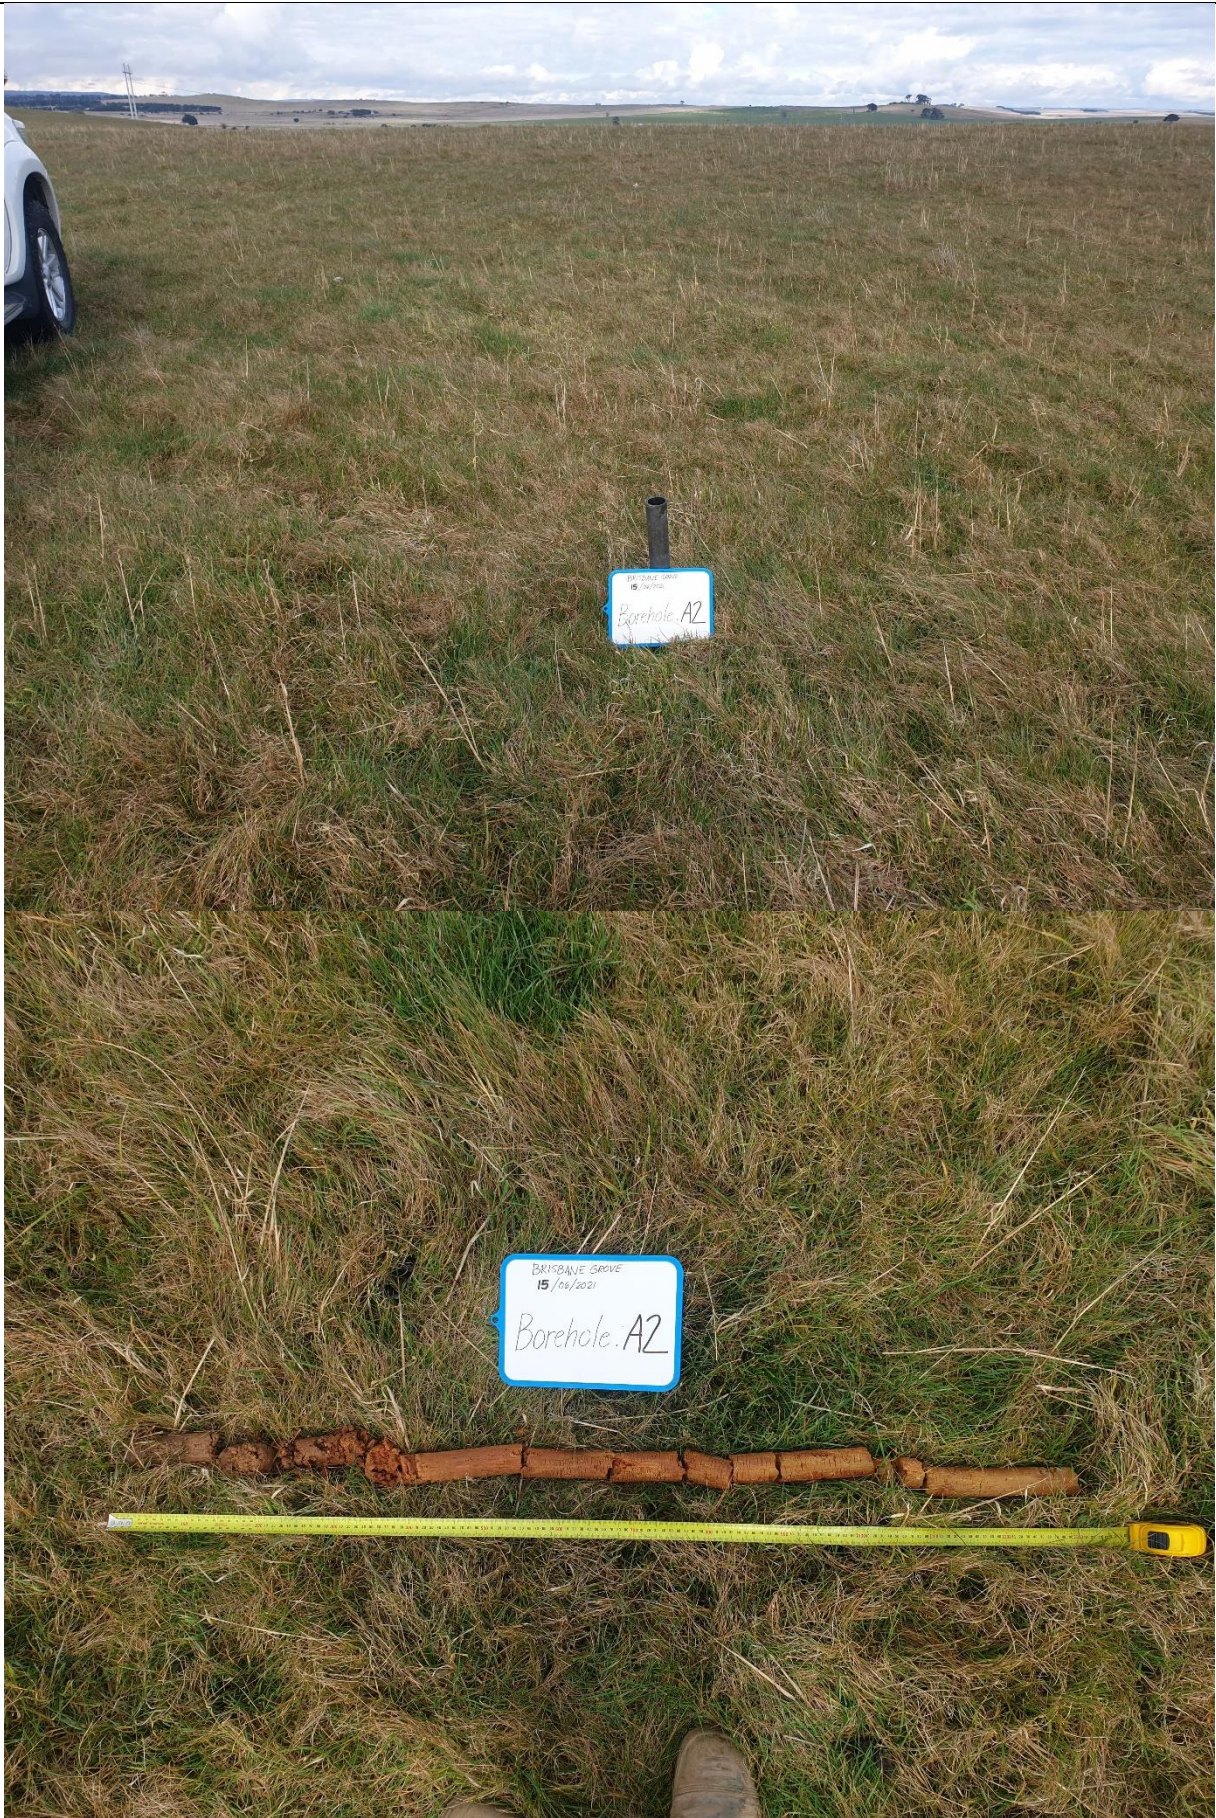
**SOUTHERN REGION LAND ENGINEERING
BRISBANE GROVE RURAL SUBDIVISION
LOCATION AND SOIL CORE PHOTOS (A2)**

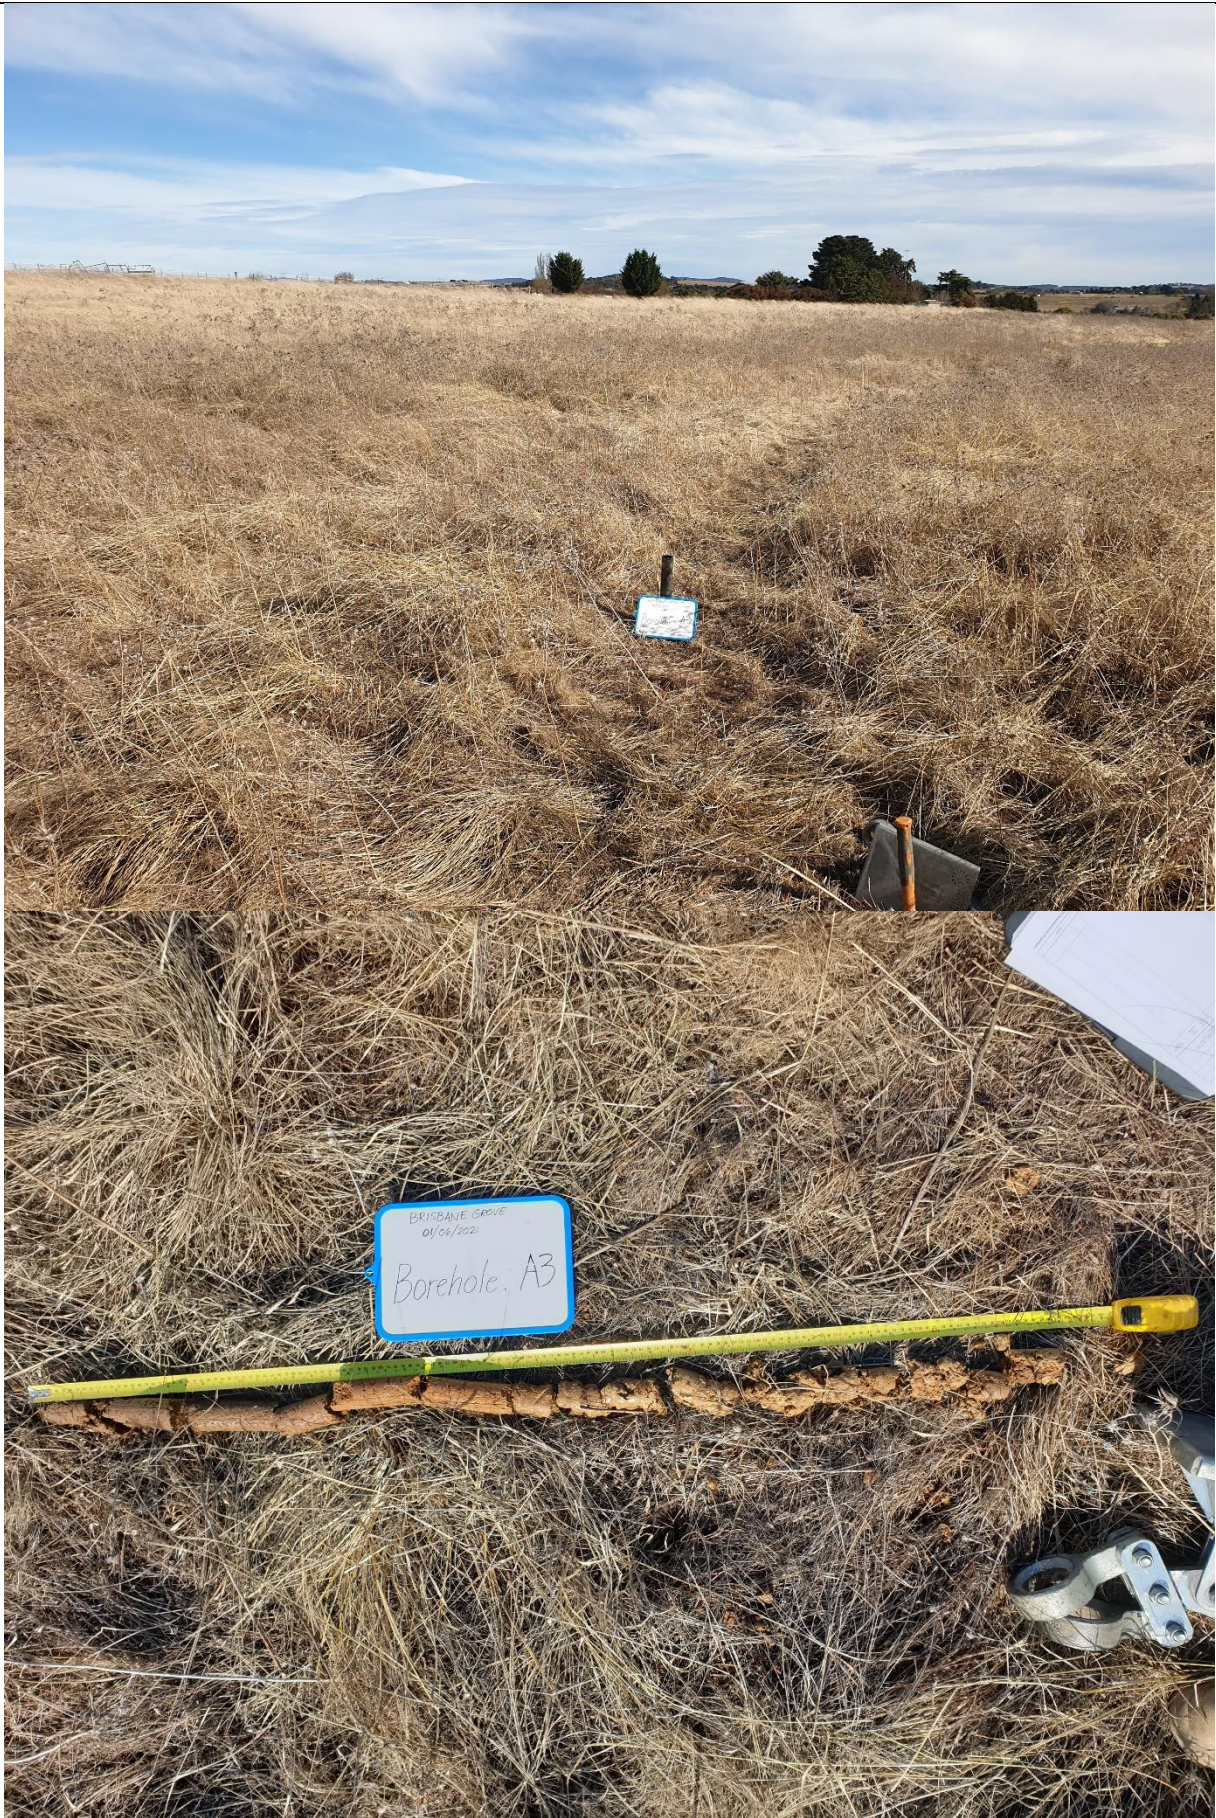
**SOUTHERN REGION LAND ENGINEERING
BRISBANE GROVE RURAL SUBDIVISION
LOCATION AND SOIL CORE PHOTOS (A3)**

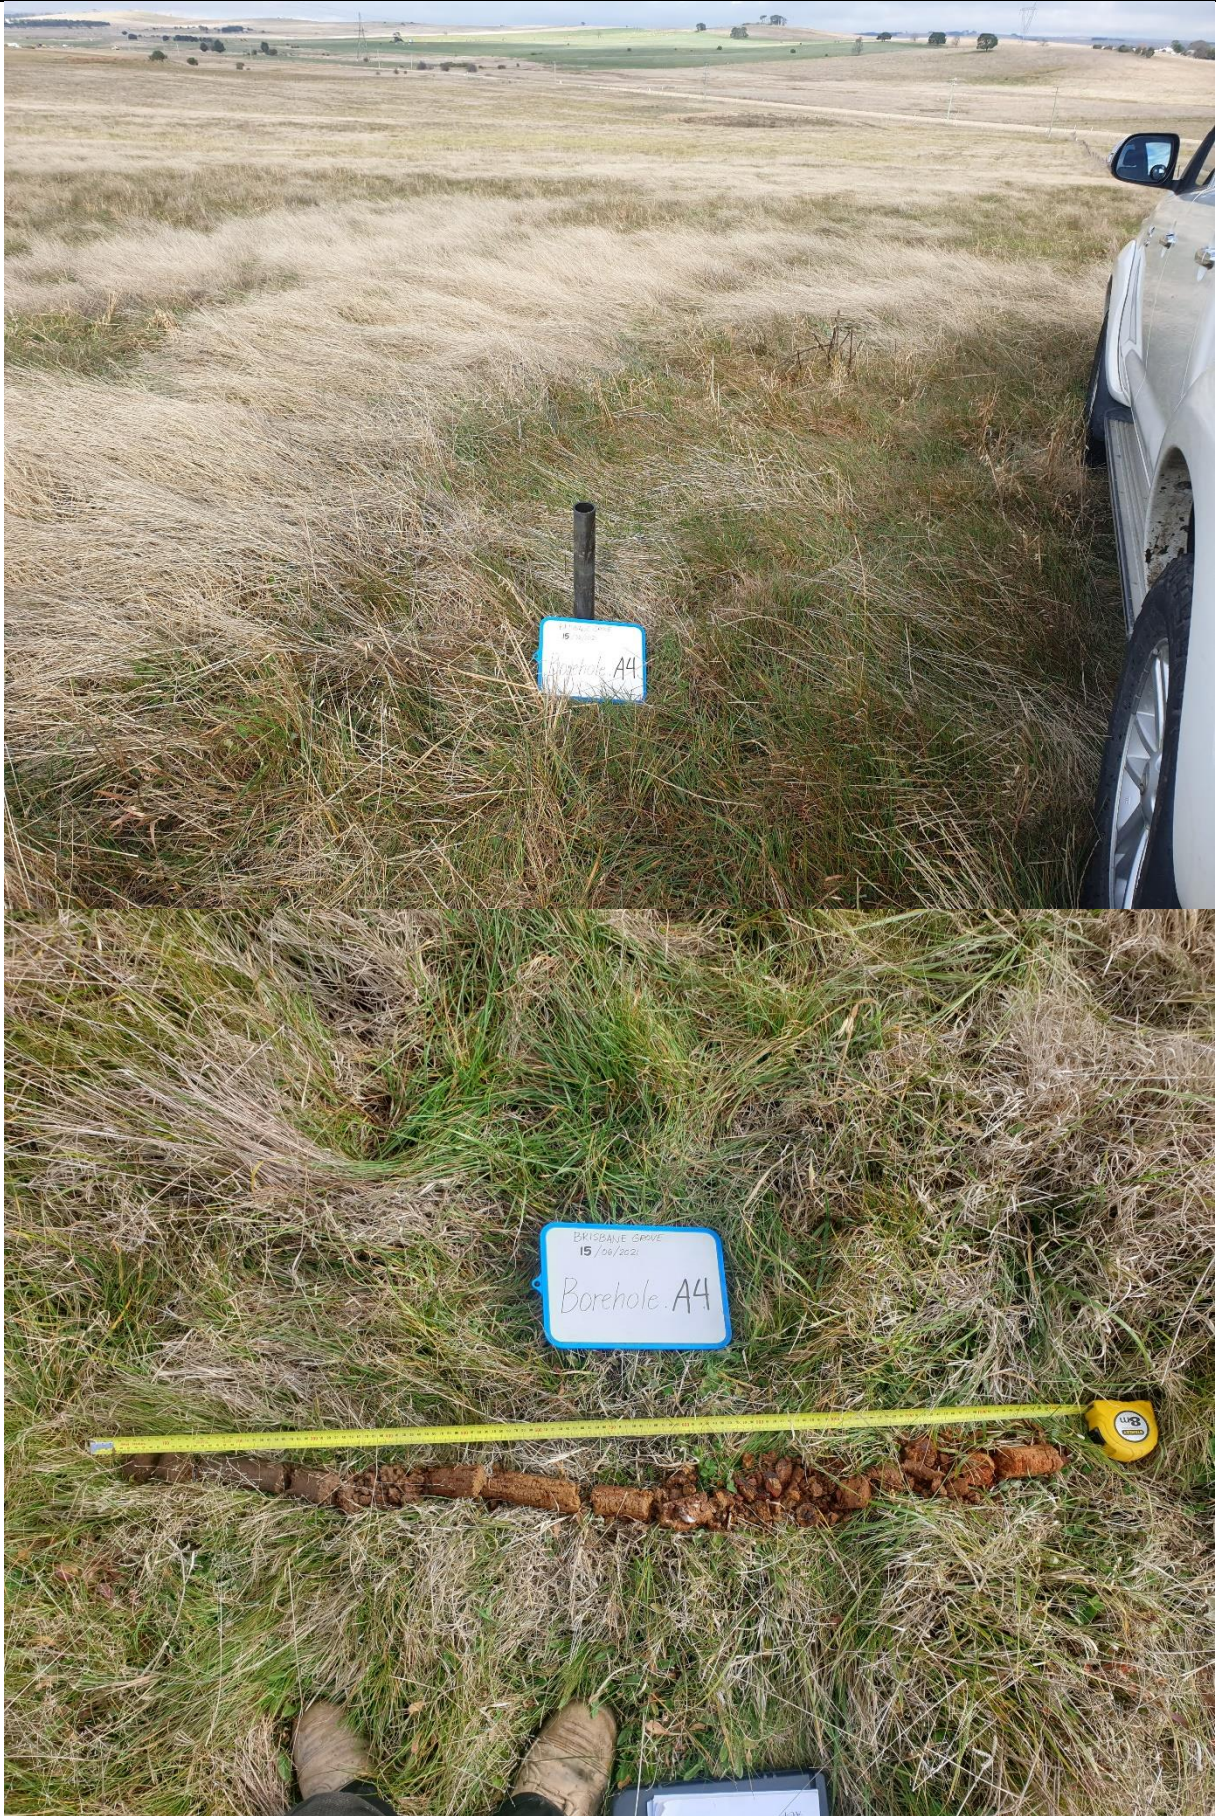
**SOUTHERN REGION LAND ENGINEERING
BRISBANE GROVE RURAL SUBDIVISION
LOCATION AND SOIL CORE PHOTOS (A4)**

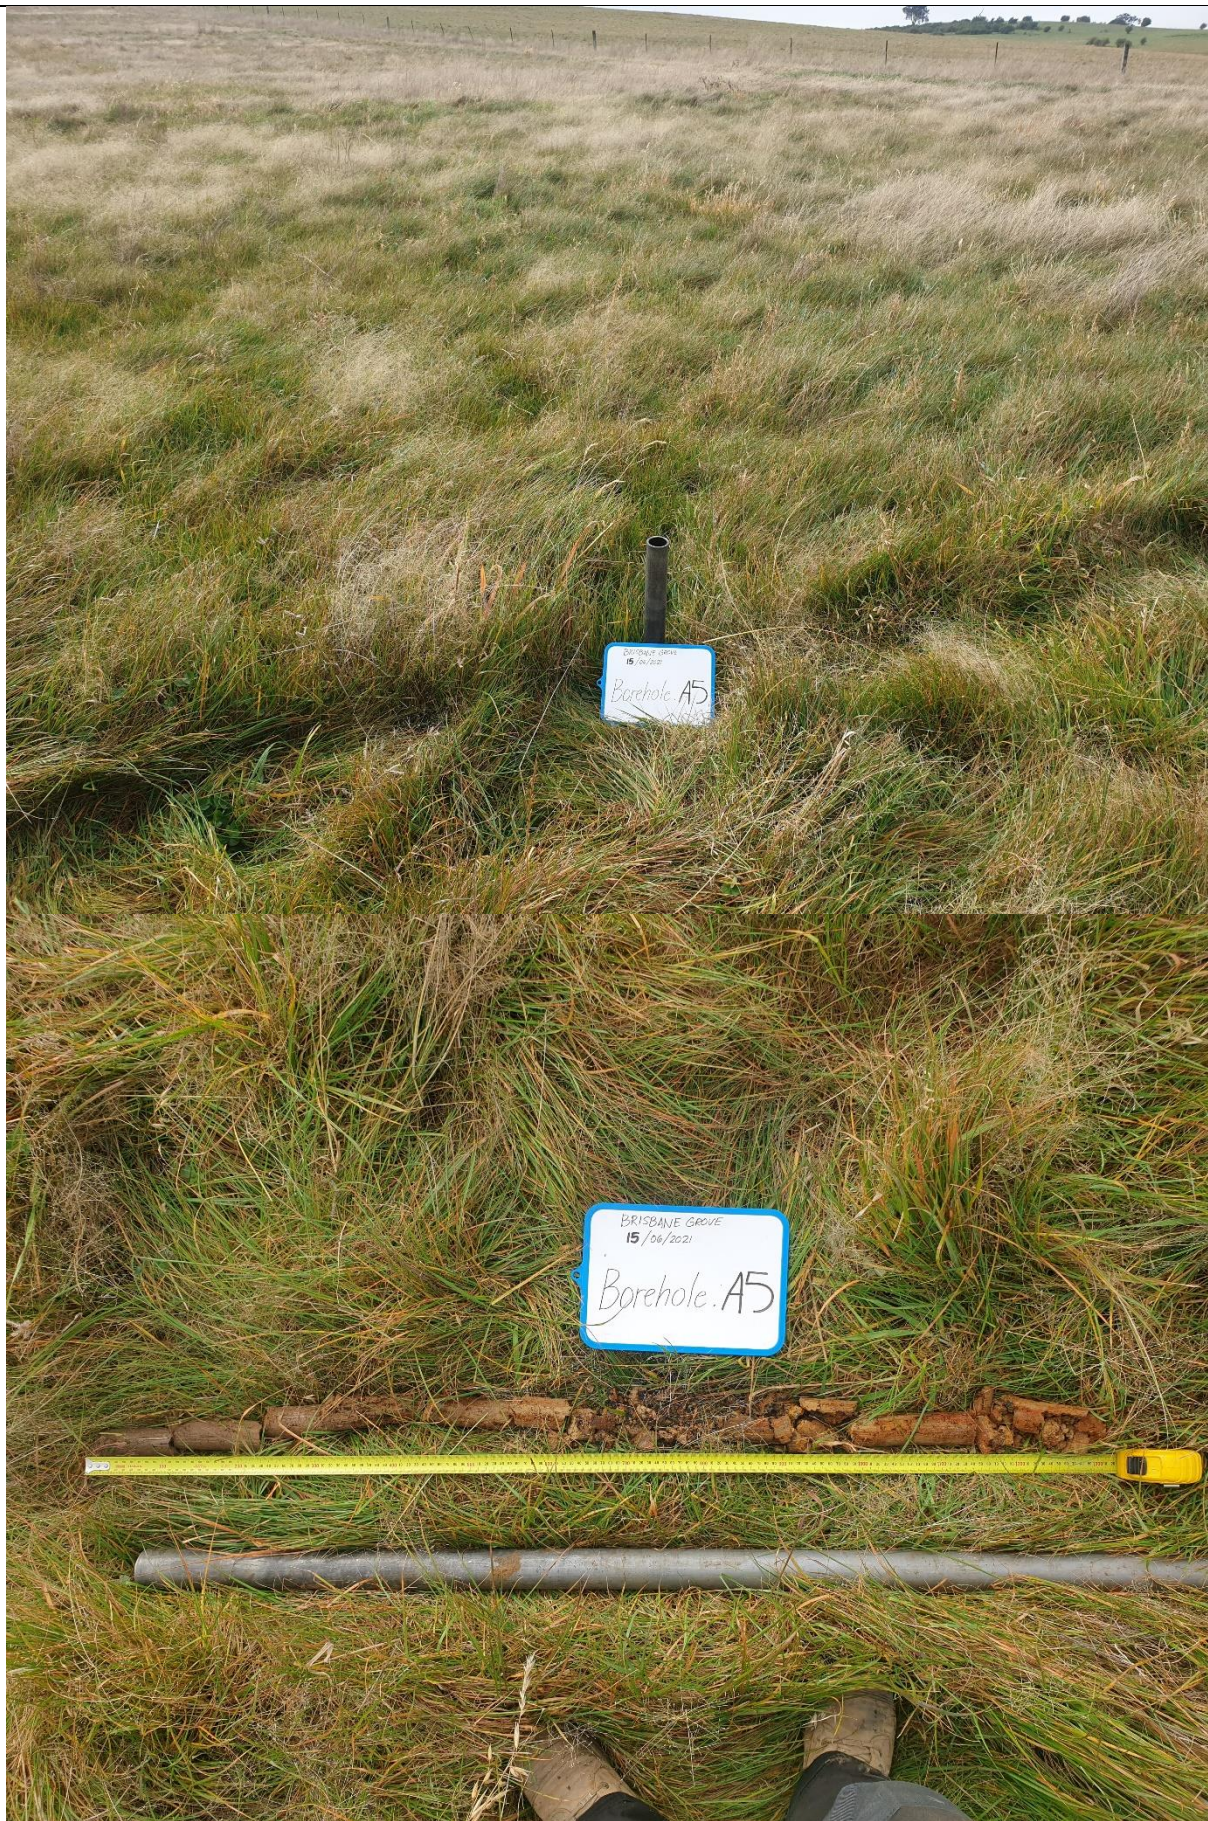
**SOUTHERN REGION LAND ENGINEERING
BRISBANE GROVE RURAL SUBDIVISION
LOCATION AND SOIL CORE PHOTOS (A5)**

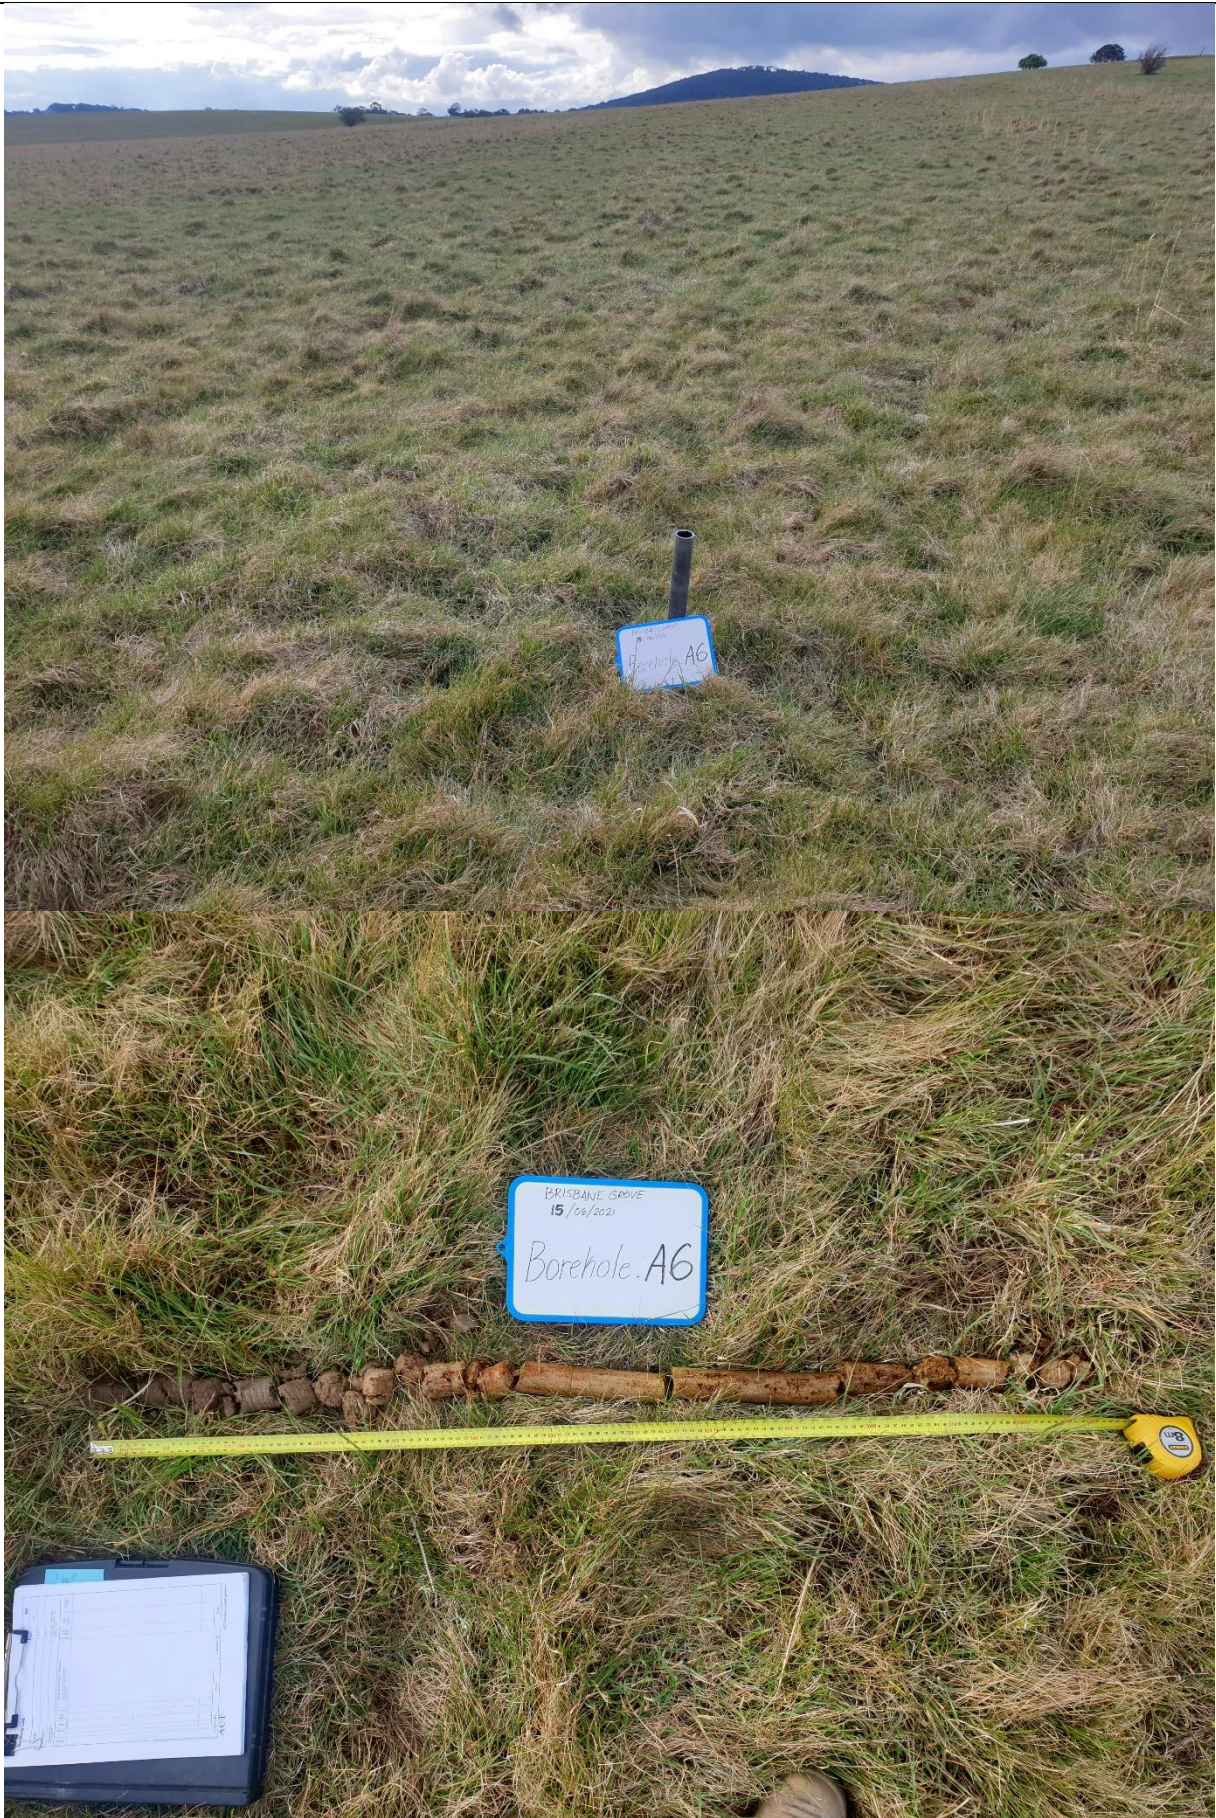
**SOUTHERN REGION LAND ENGINEERING
BRISBANE GROVE RURAL SUBDIVISION
LOCATION AND SOIL CORE PHOTOS (A6)**

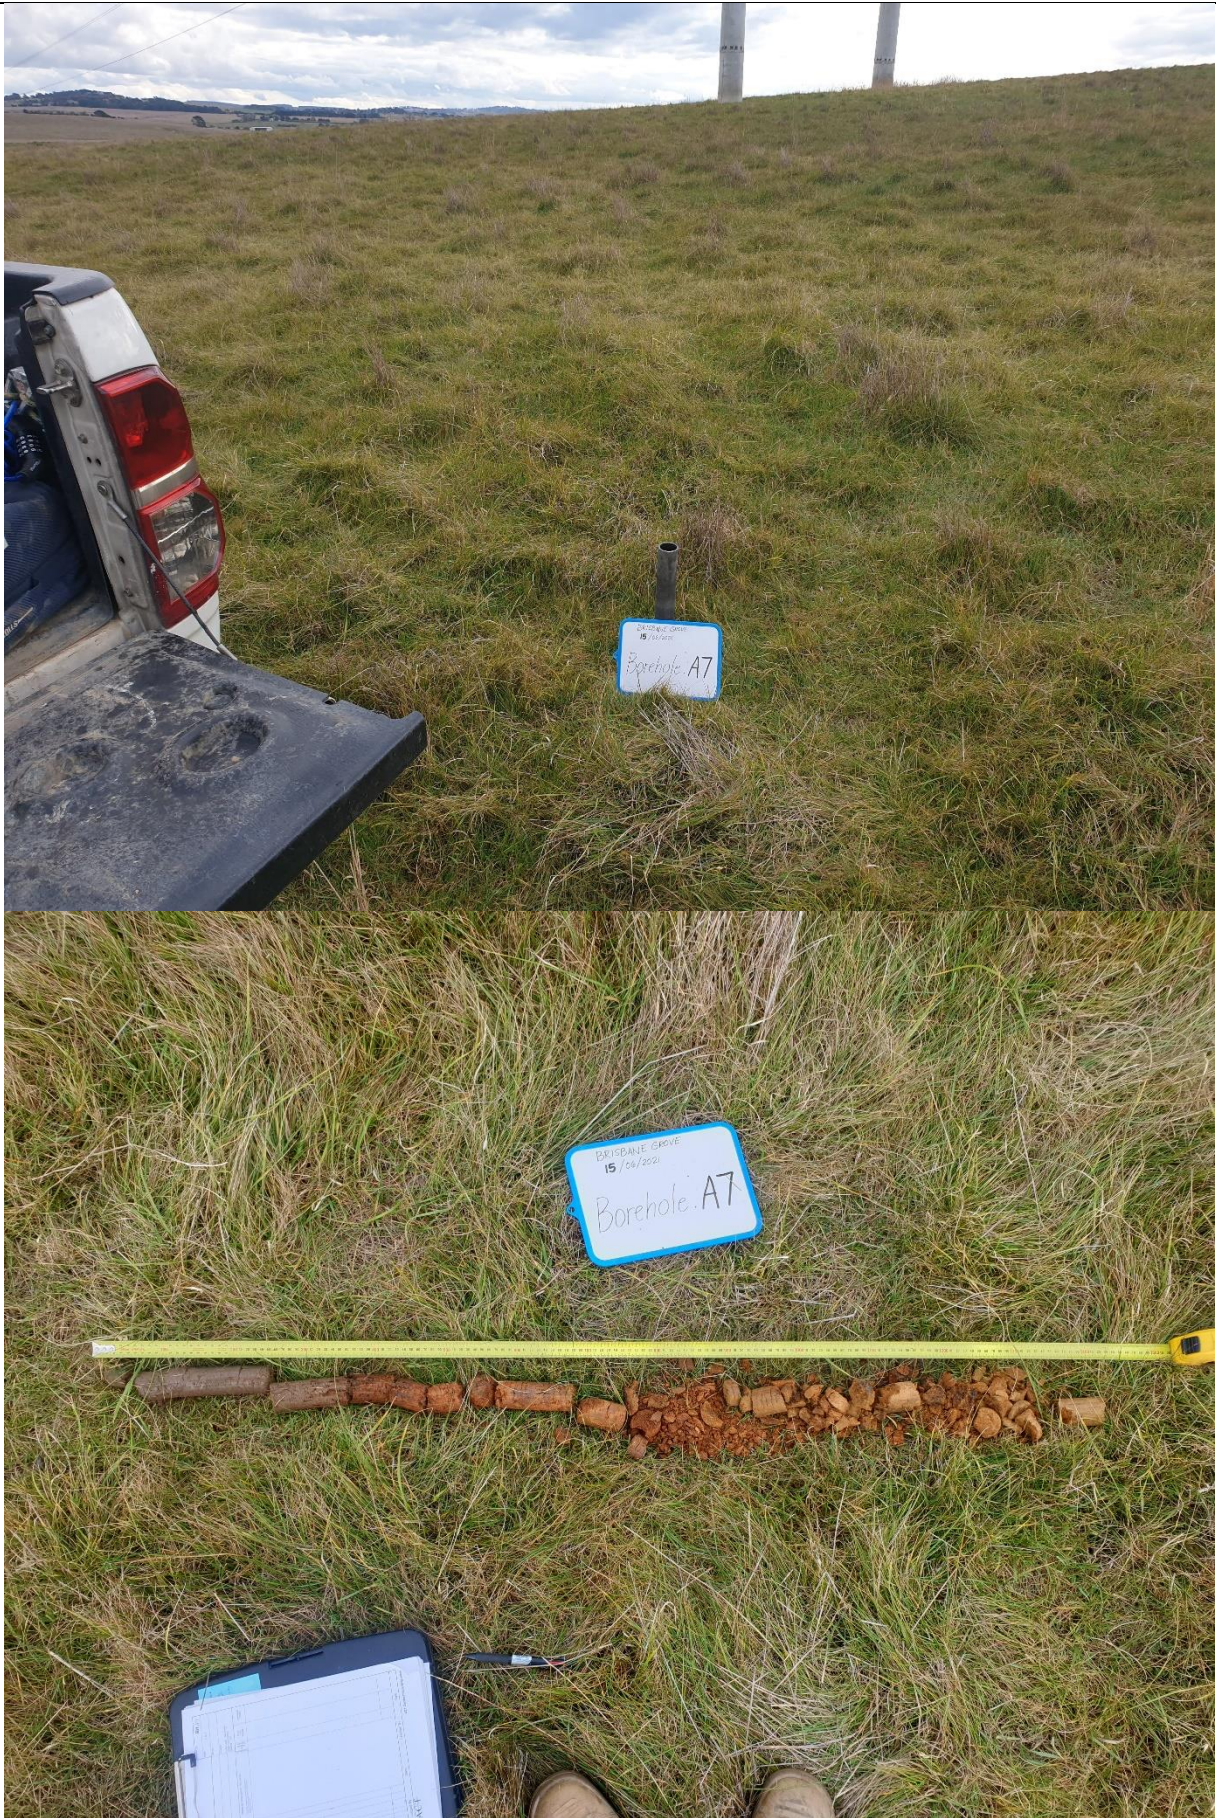
**SOUTHERN REGION LAND ENGINEERING
BRISBANE GROVE RURAL SUBDIVISION
LOCATION AND SOIL CORE PHOTOS (A7)**

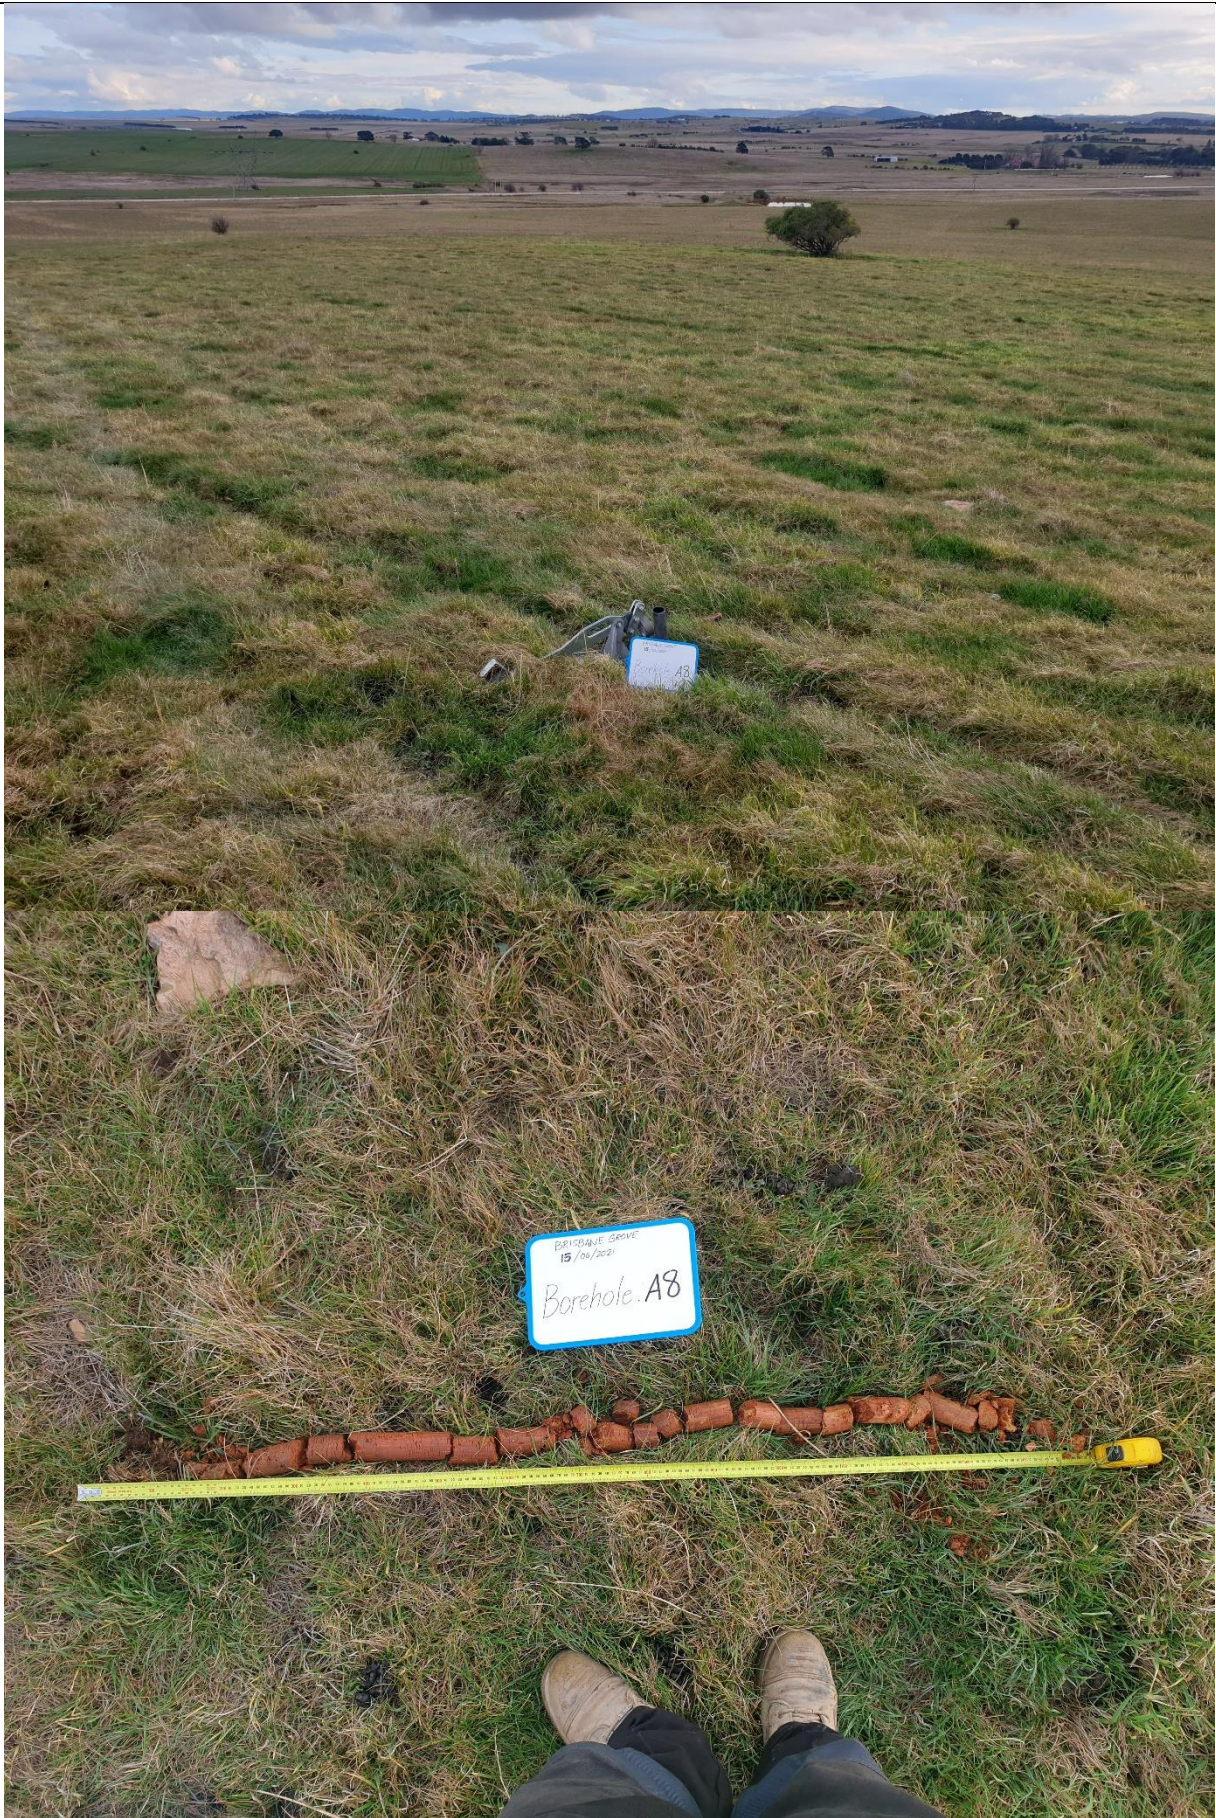
**SOUTHERN REGION LAND ENGINEERING
BRISBANE GROVE RURAL SUBDIVISION
LOCATION AND SOIL CORE PHOTOS (A8)**
