PLANNING PROPOSAL

THE HUB

MOUNTAIN ASH ROAD, GOULBURN

ENGINEERING SERVICES REPORT

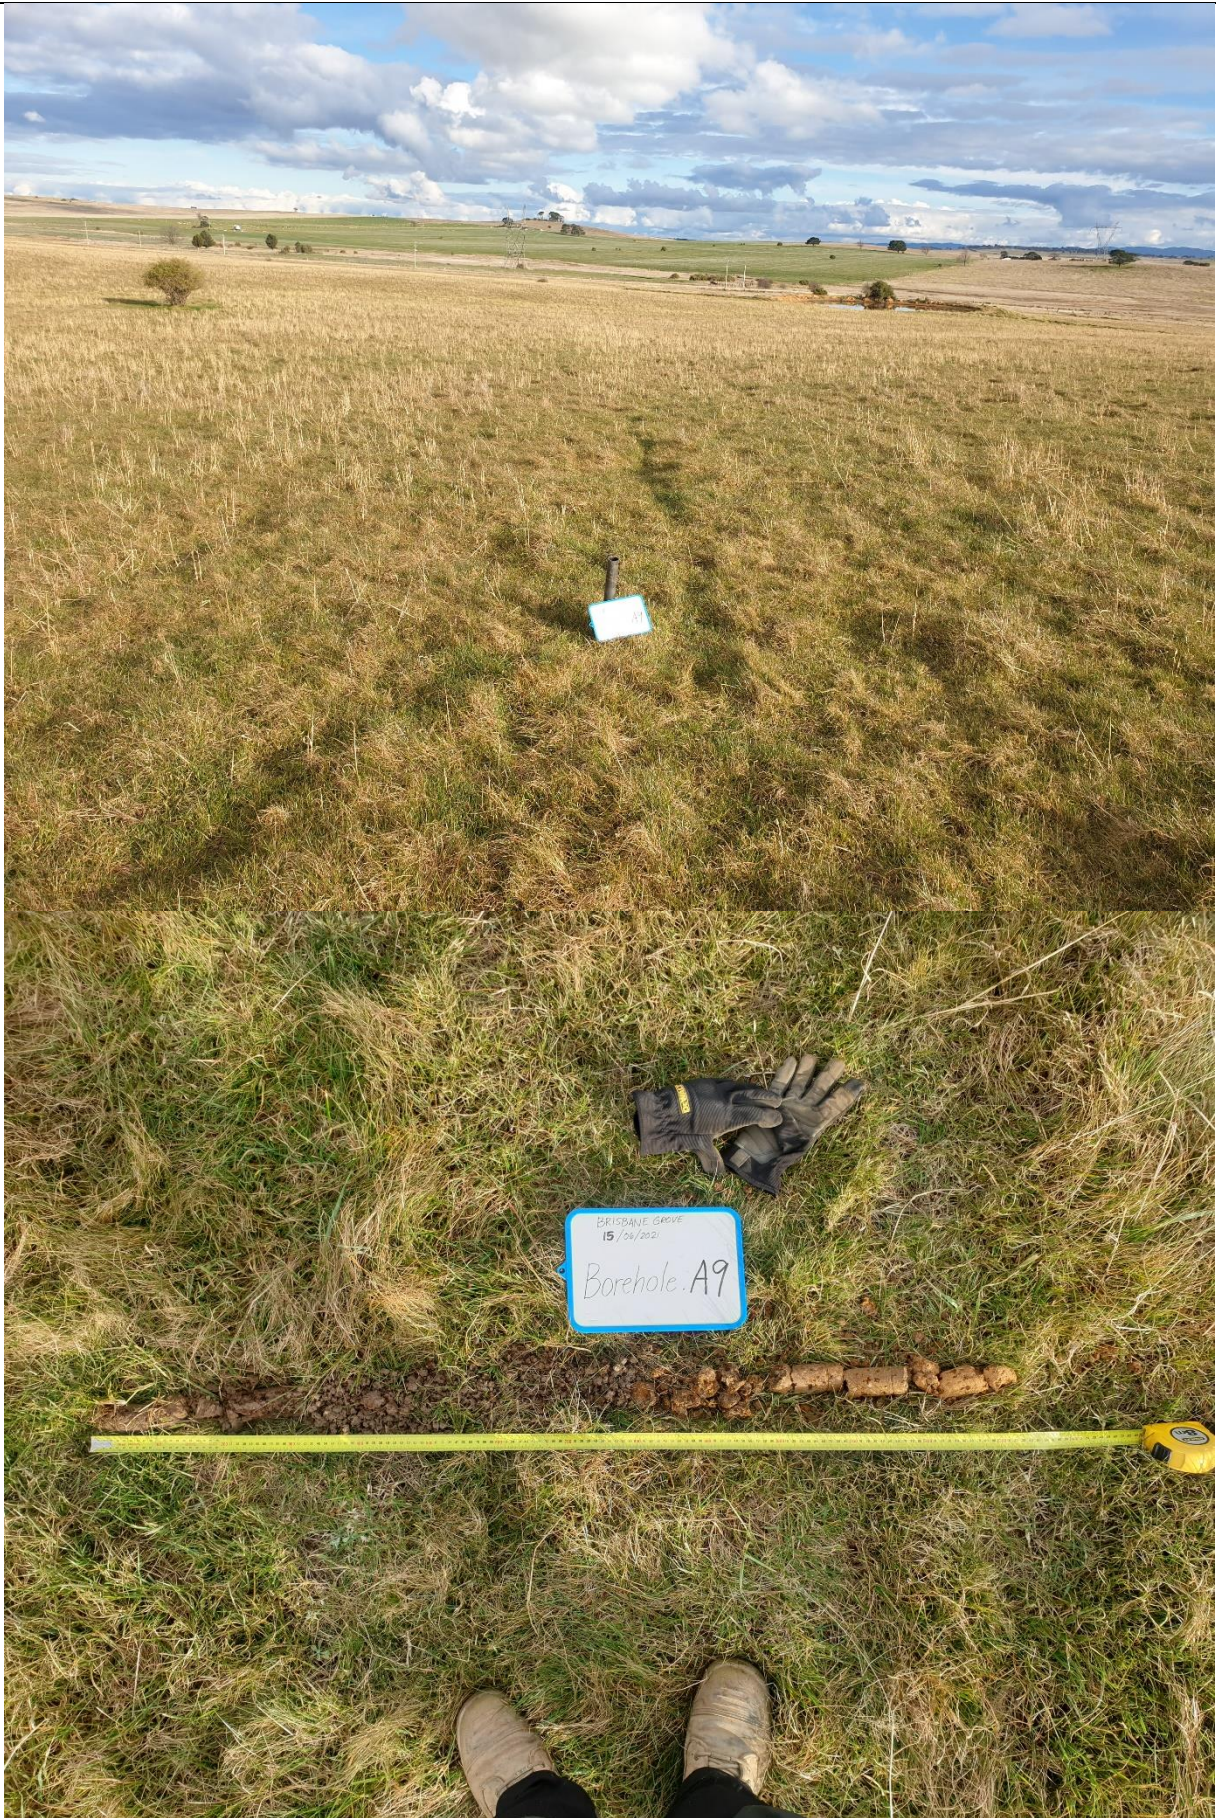
**SOUTHERN REGION LAND ENGINEERING
BRISBANE GROVE RURAL SUBDIVISION
LOCATION AND SOIL CORE PHOTOS (A9)**

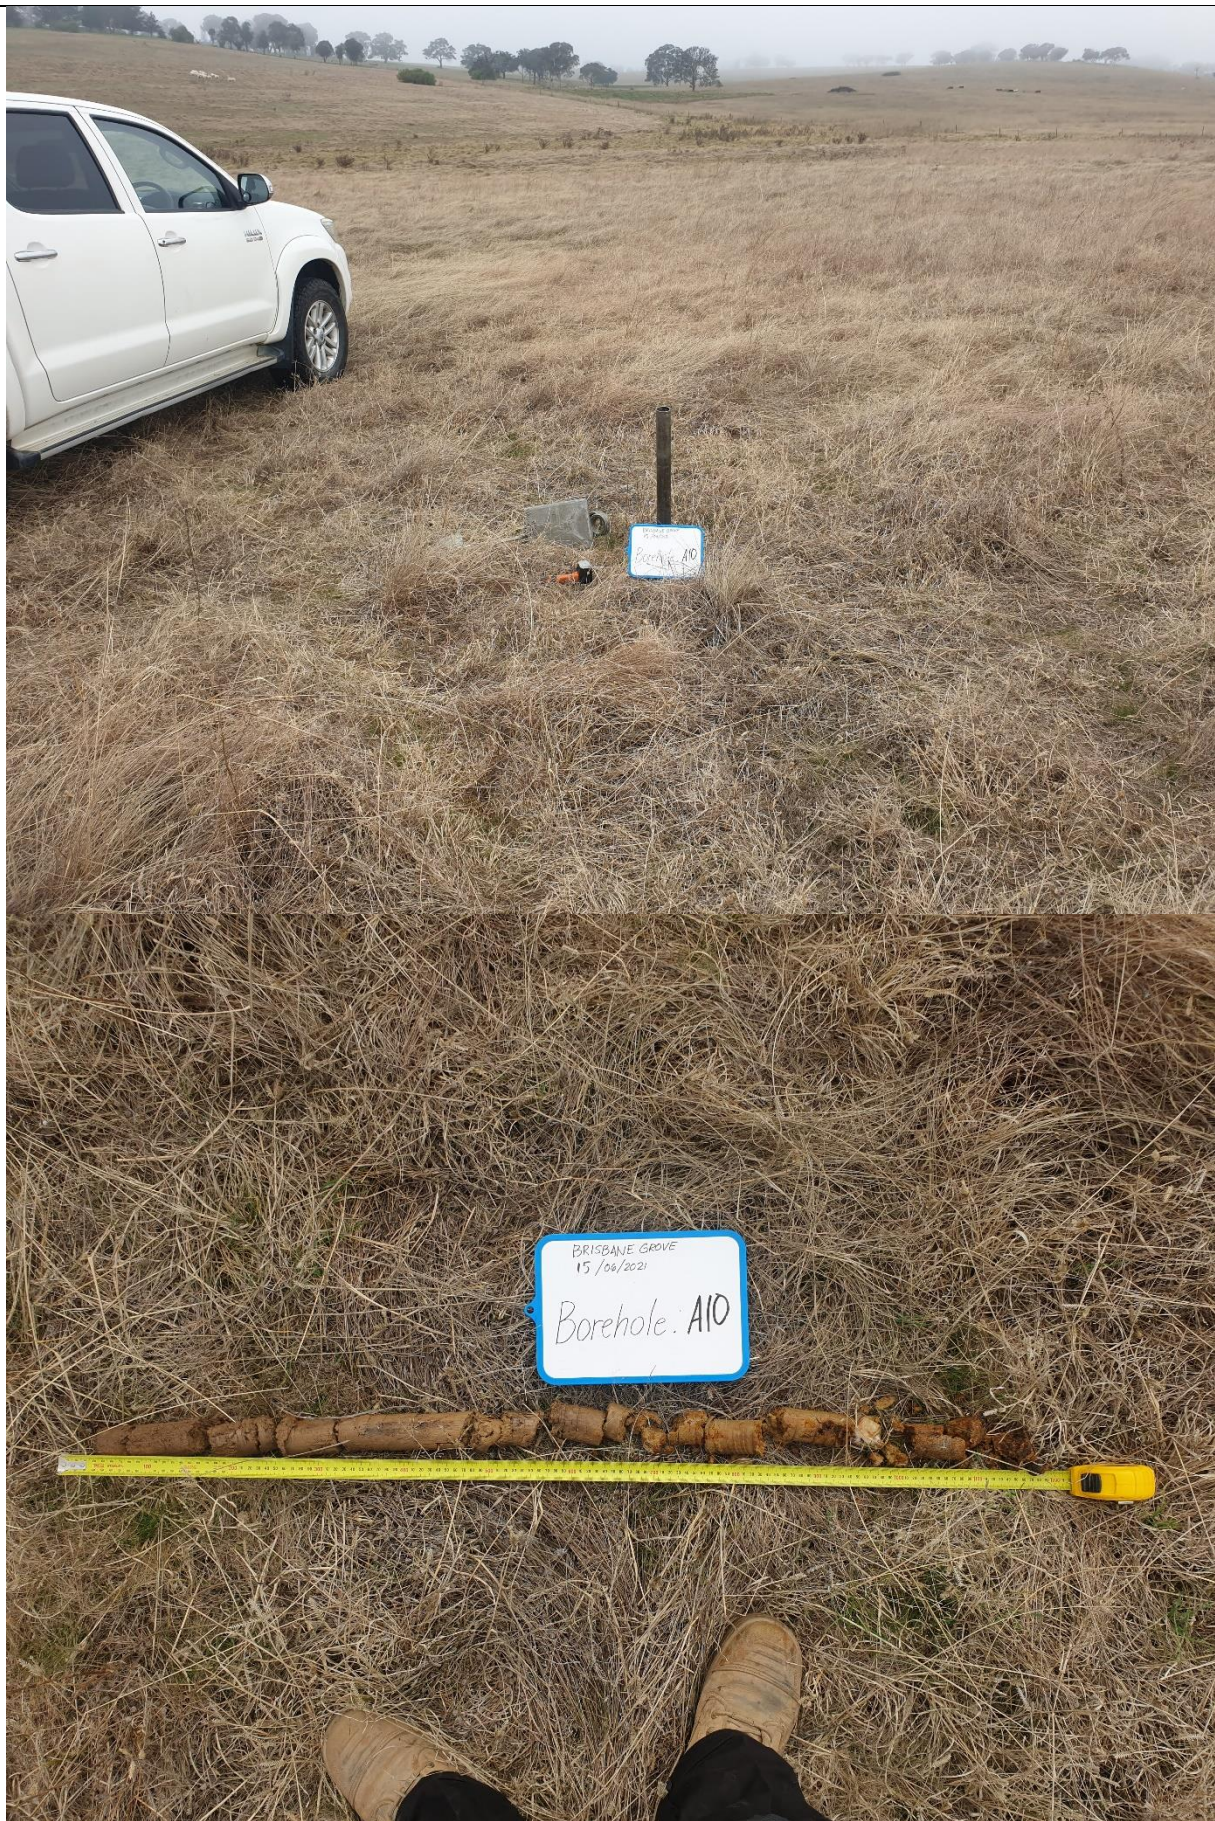
**SOUTHERN REGION LAND ENGINEERING
BRISBANE GROVE RURAL SUBDIVISION
LOCATION AND SOIL CORE PHOTOS (A10)**

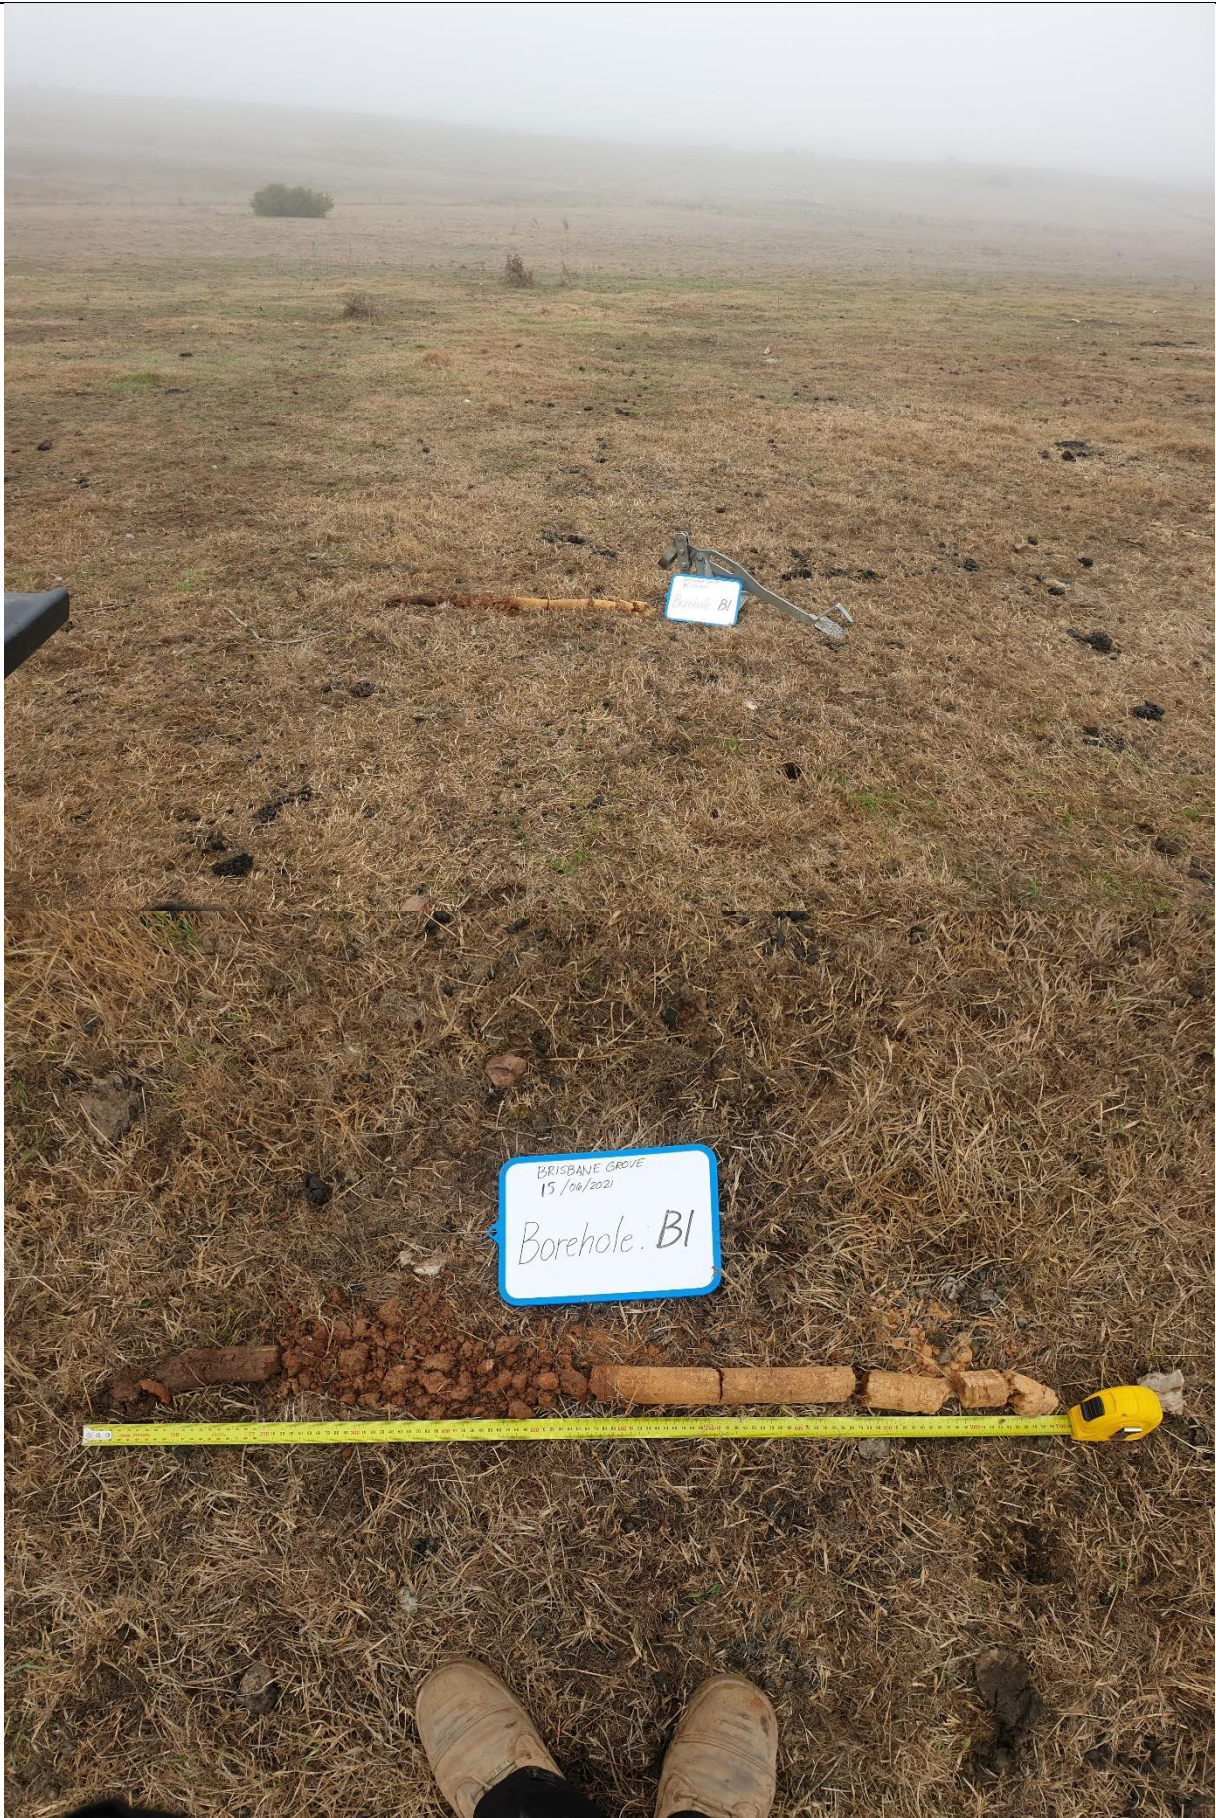
**SOUTHERN REGION LAND ENGINEERING
BRISBANE GROVE RURAL SUBDIVISION
LOCATION AND SOIL CORE PHOTOS (B1)**

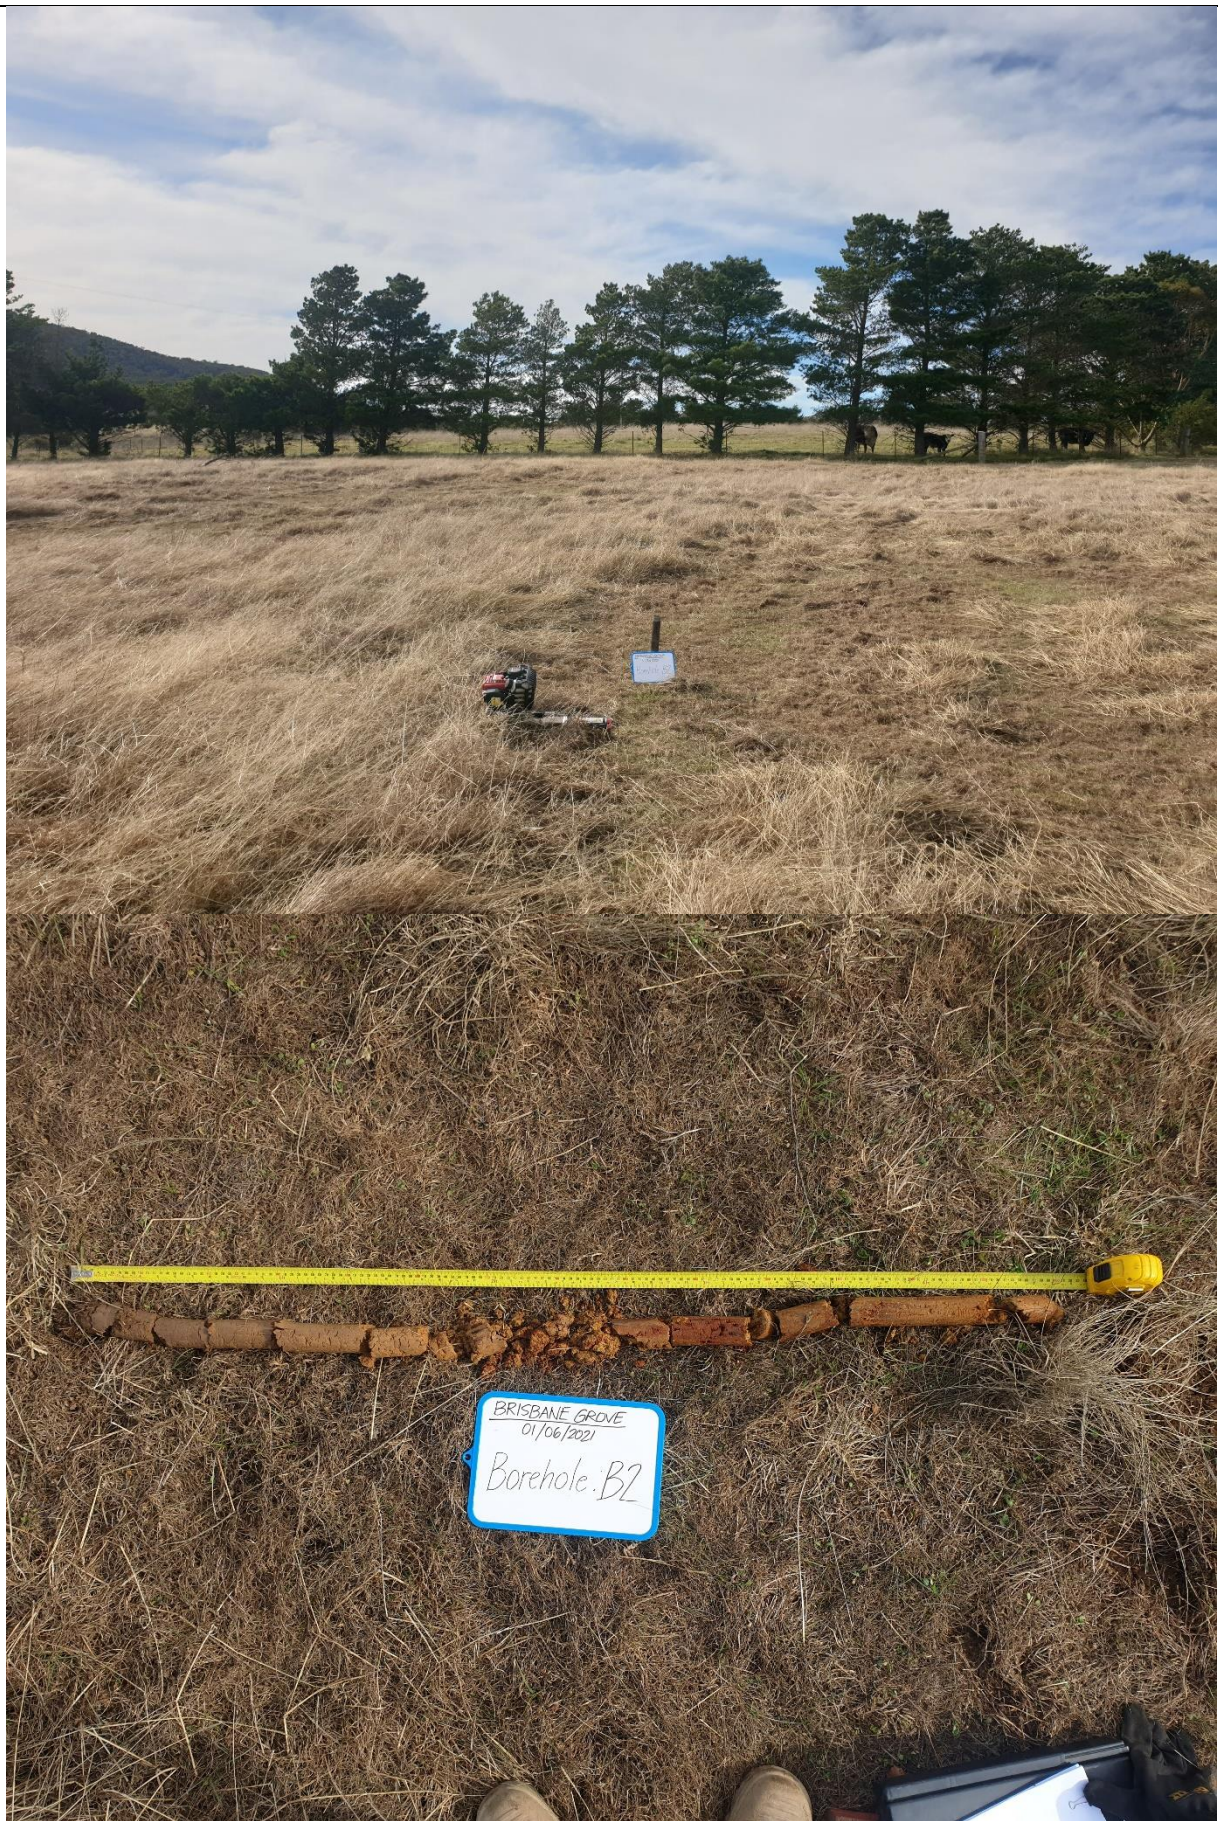
**SOUTHERN REGION LAND ENGINEERING
BRISBANE GROVE RURAL SUBDIVISION
LOCATION AND SOIL CORE PHOTOS (B2)**

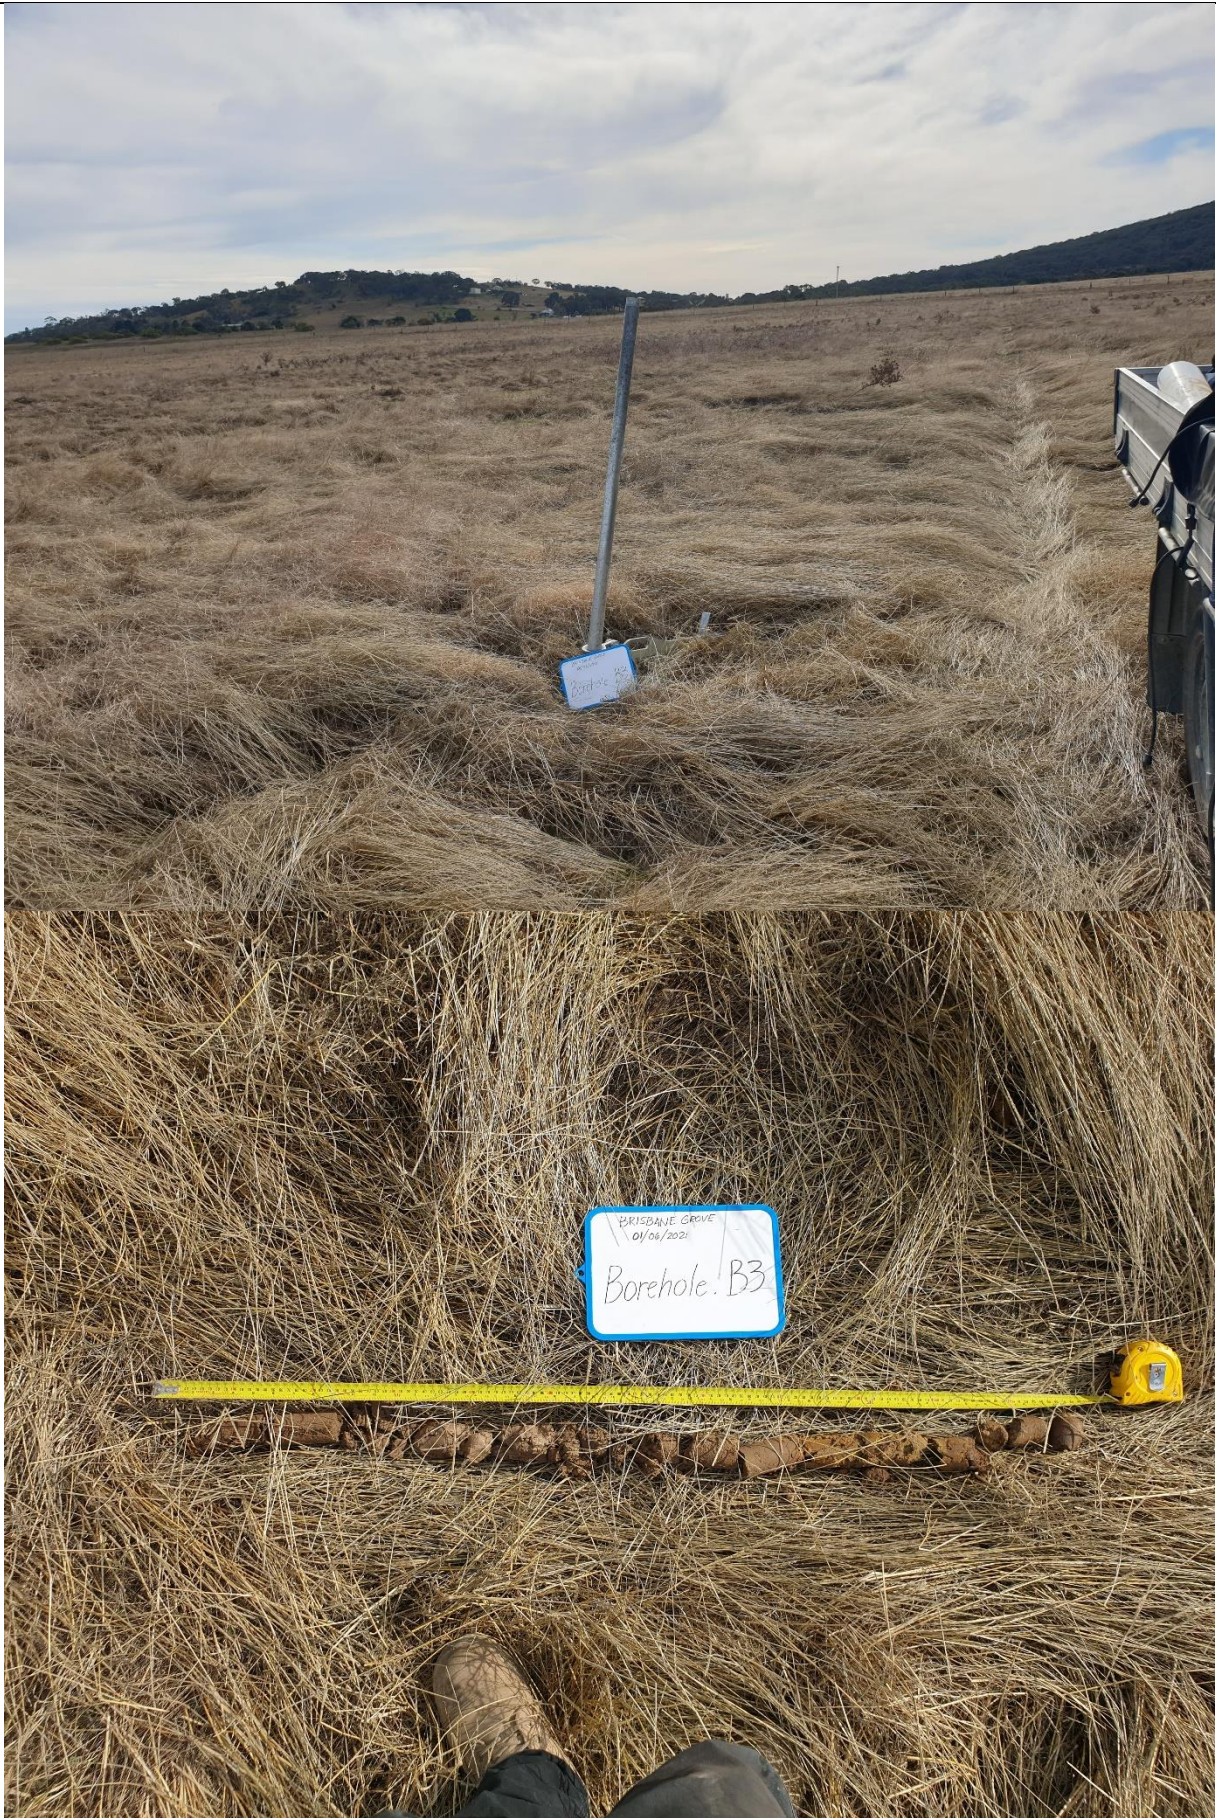
**SOUTHERN REGION LAND ENGINEERING
BRISBANE GROVE RURAL SUBDIVISION
LOCATION AND SOIL CORE PHOTOS (B3)**

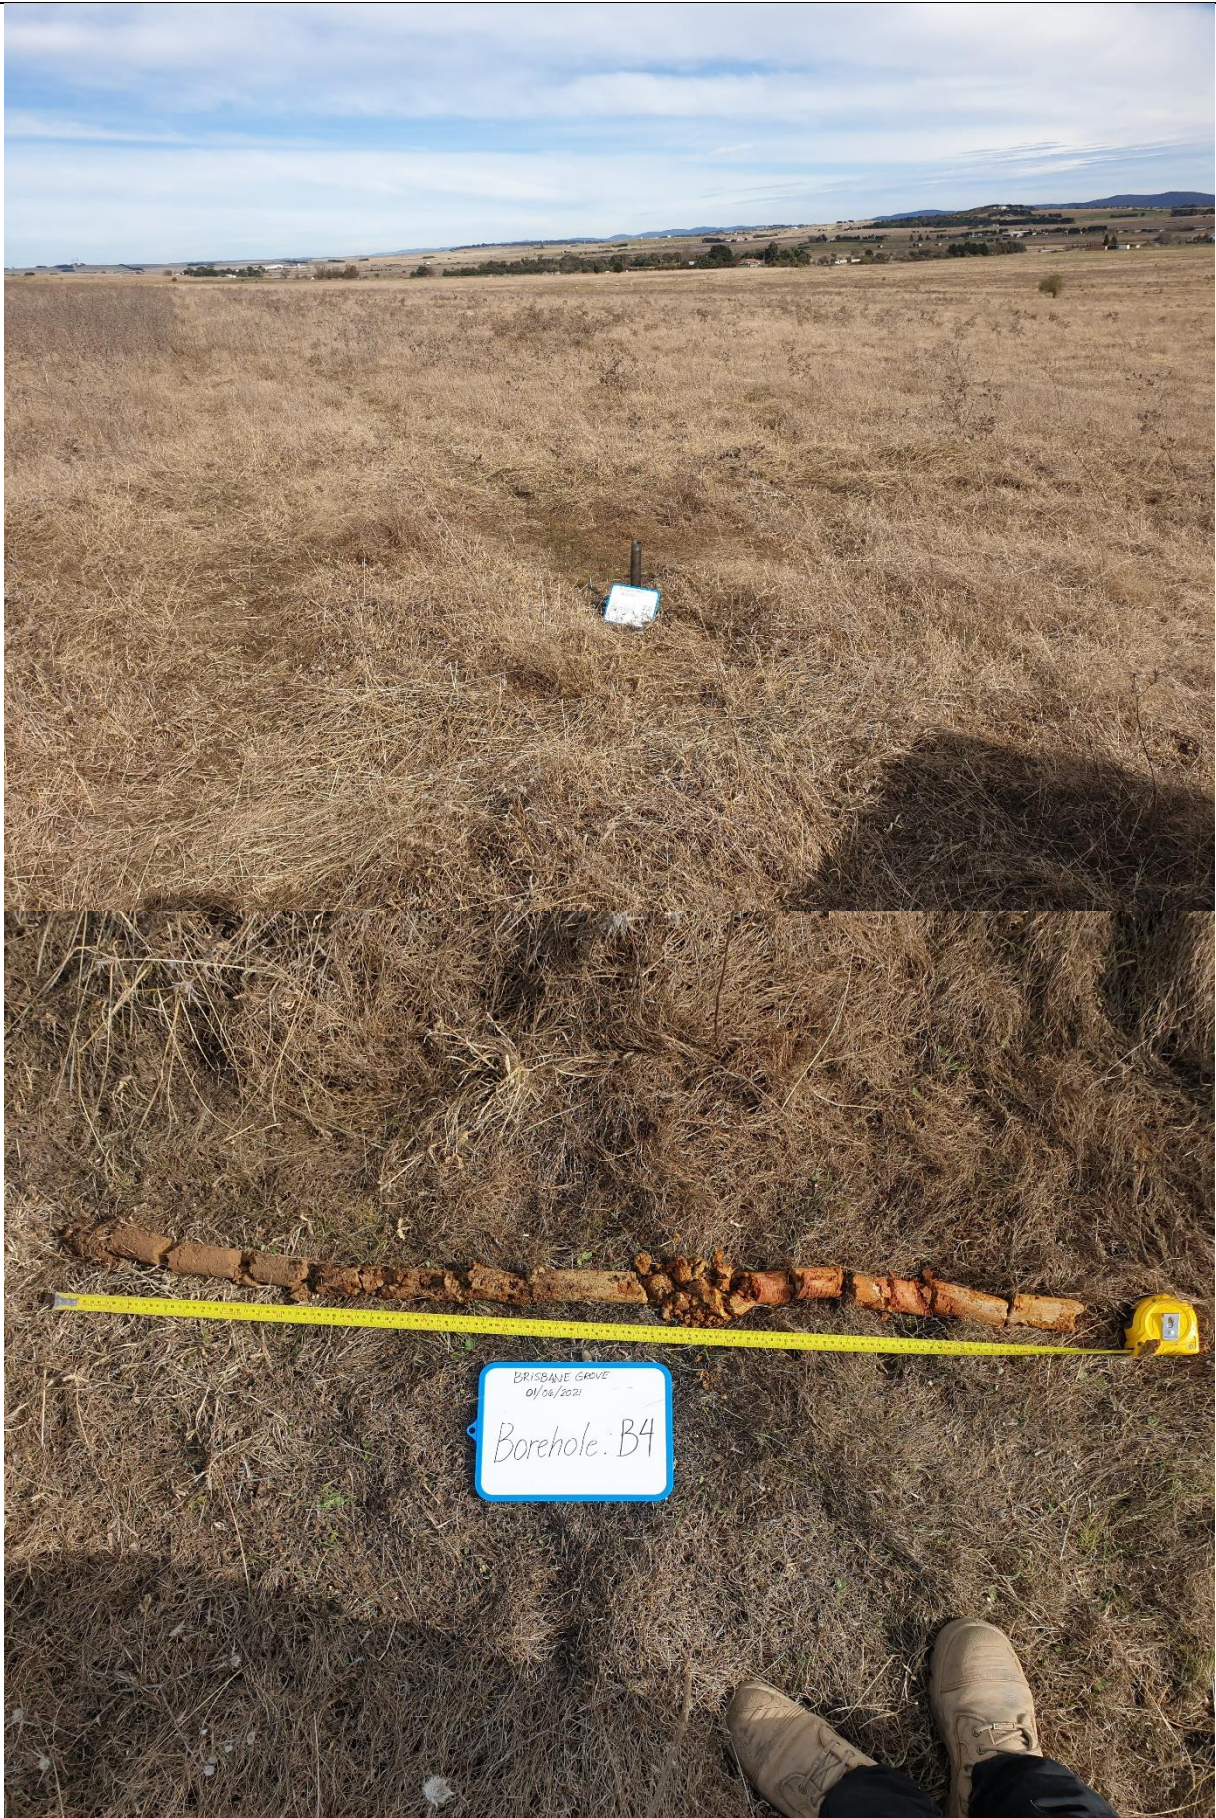
**SOUTHERN REGION LAND ENGINEERING
BRISBANE GROVE RURAL SUBDIVISION
LOCATION AND SOIL CORE PHOTOS (B4)**

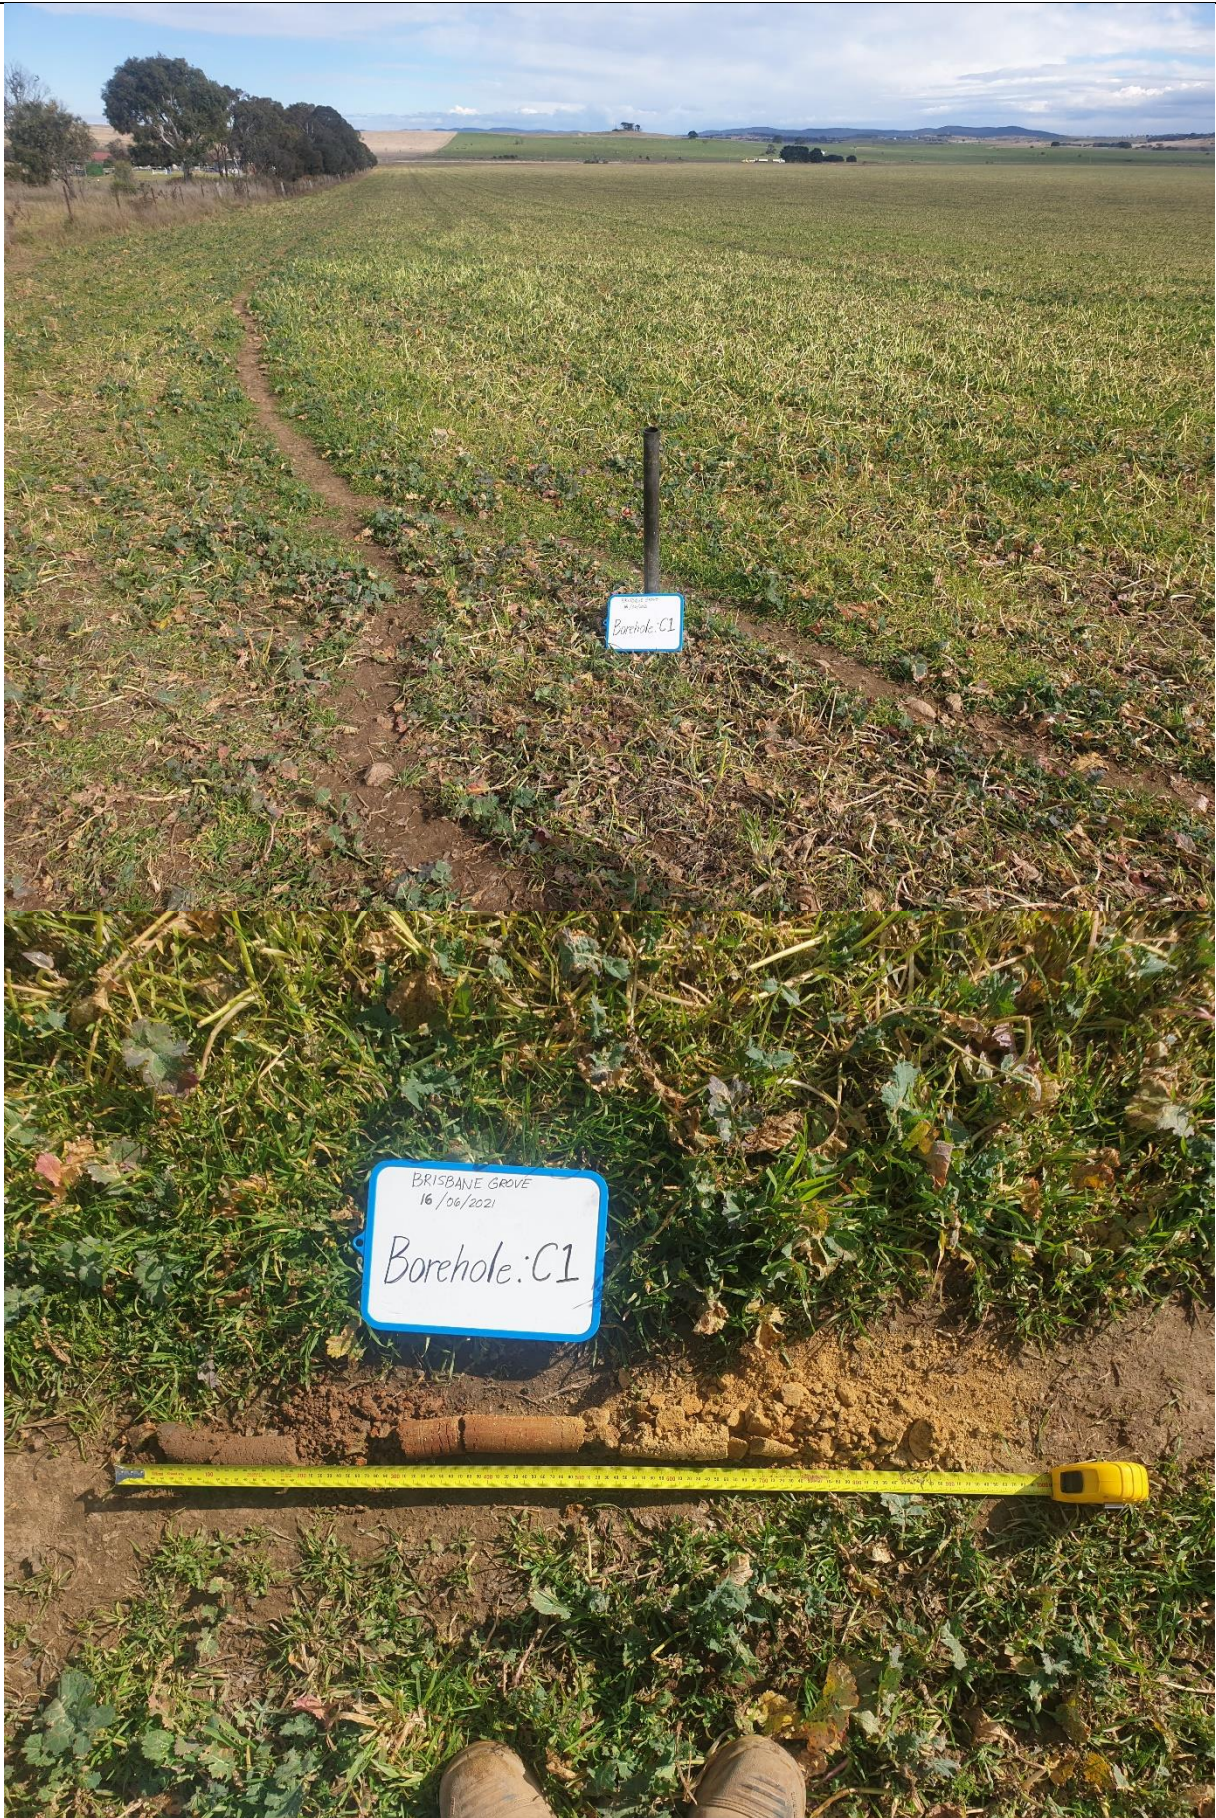
**SOUTHERN REGION LAND ENGINEERING
BRISBANE GROVE RURAL SUBDIVISION
LOCATION AND SOIL CORE PHOTOS (C1)**

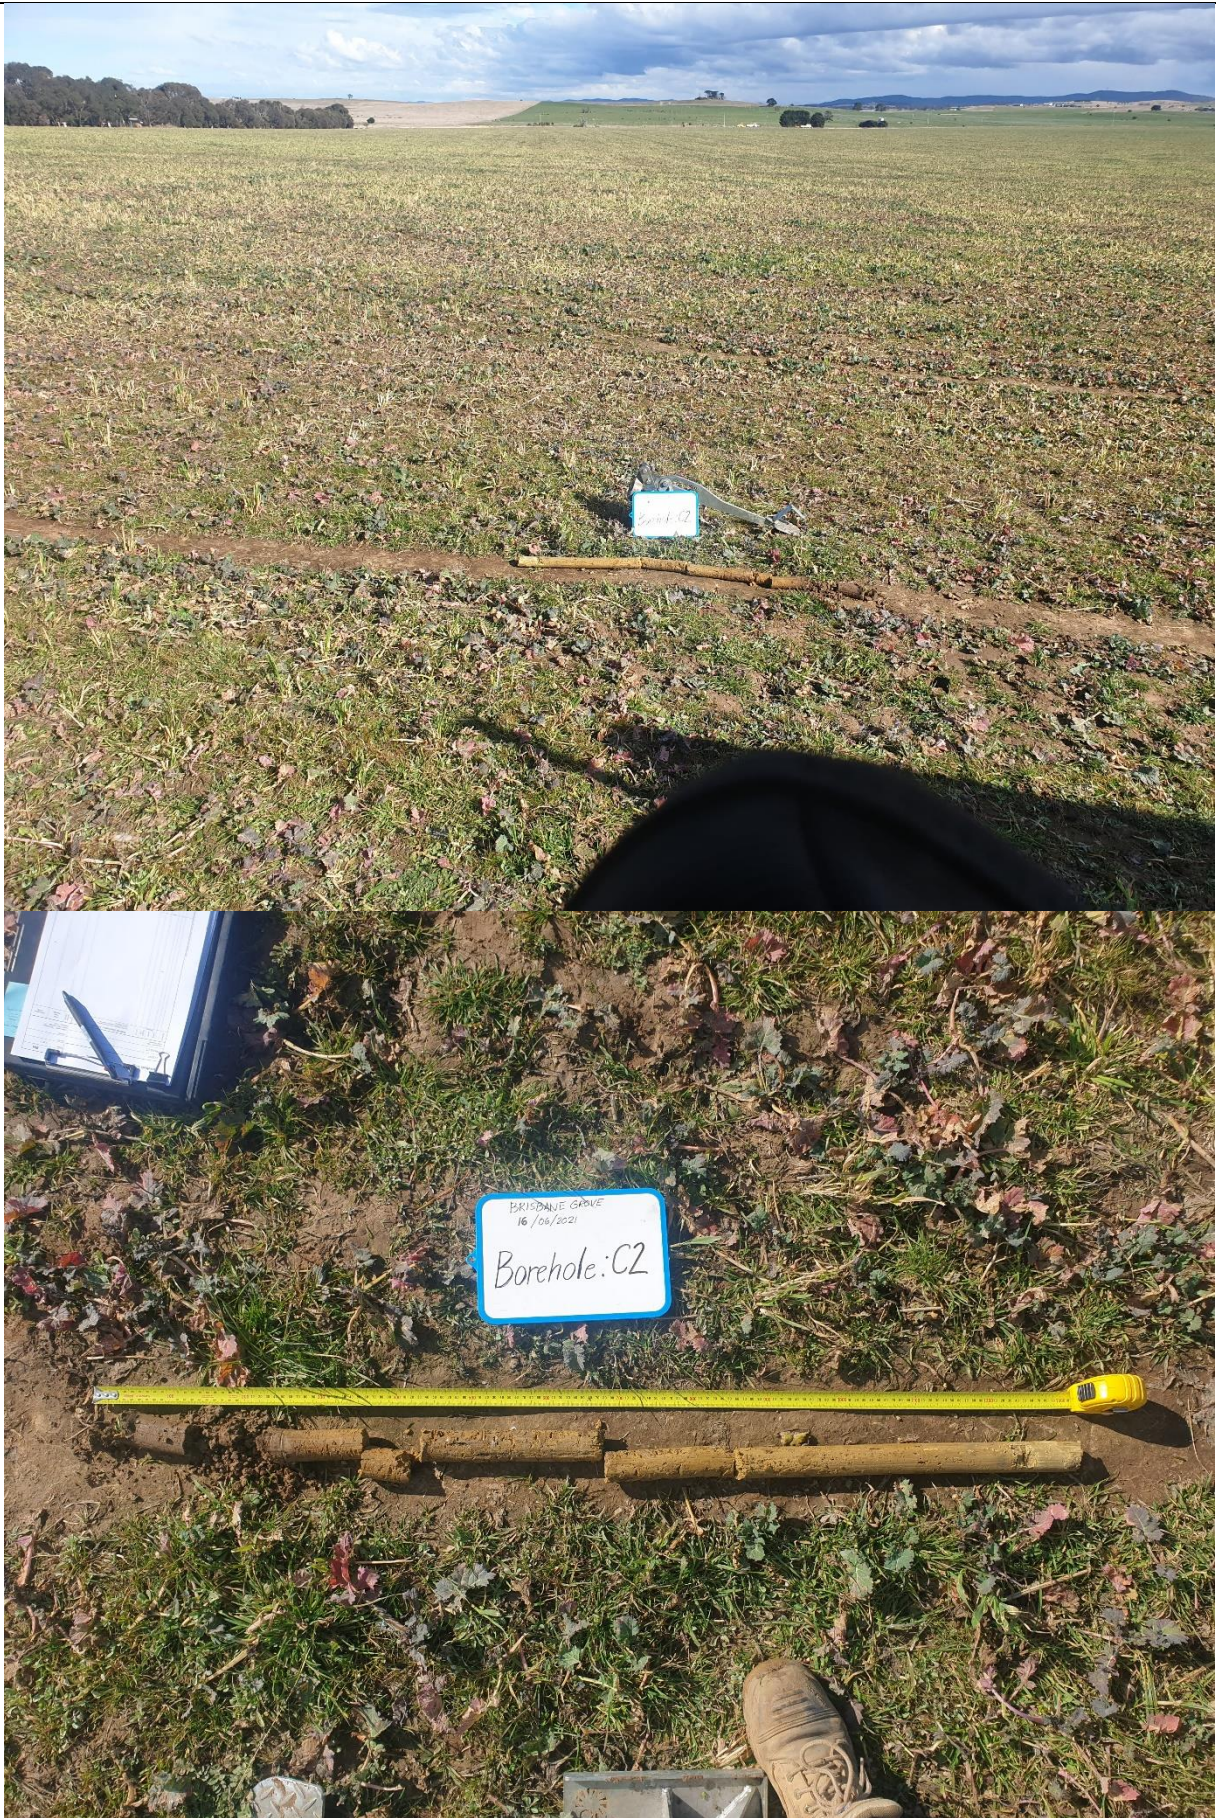
**SOUTHERN REGION LAND ENGINEERING
BRISBANE GROVE RURAL SUBDIVISION
LOCATION AND SOIL CORE PHOTOS (C2)**

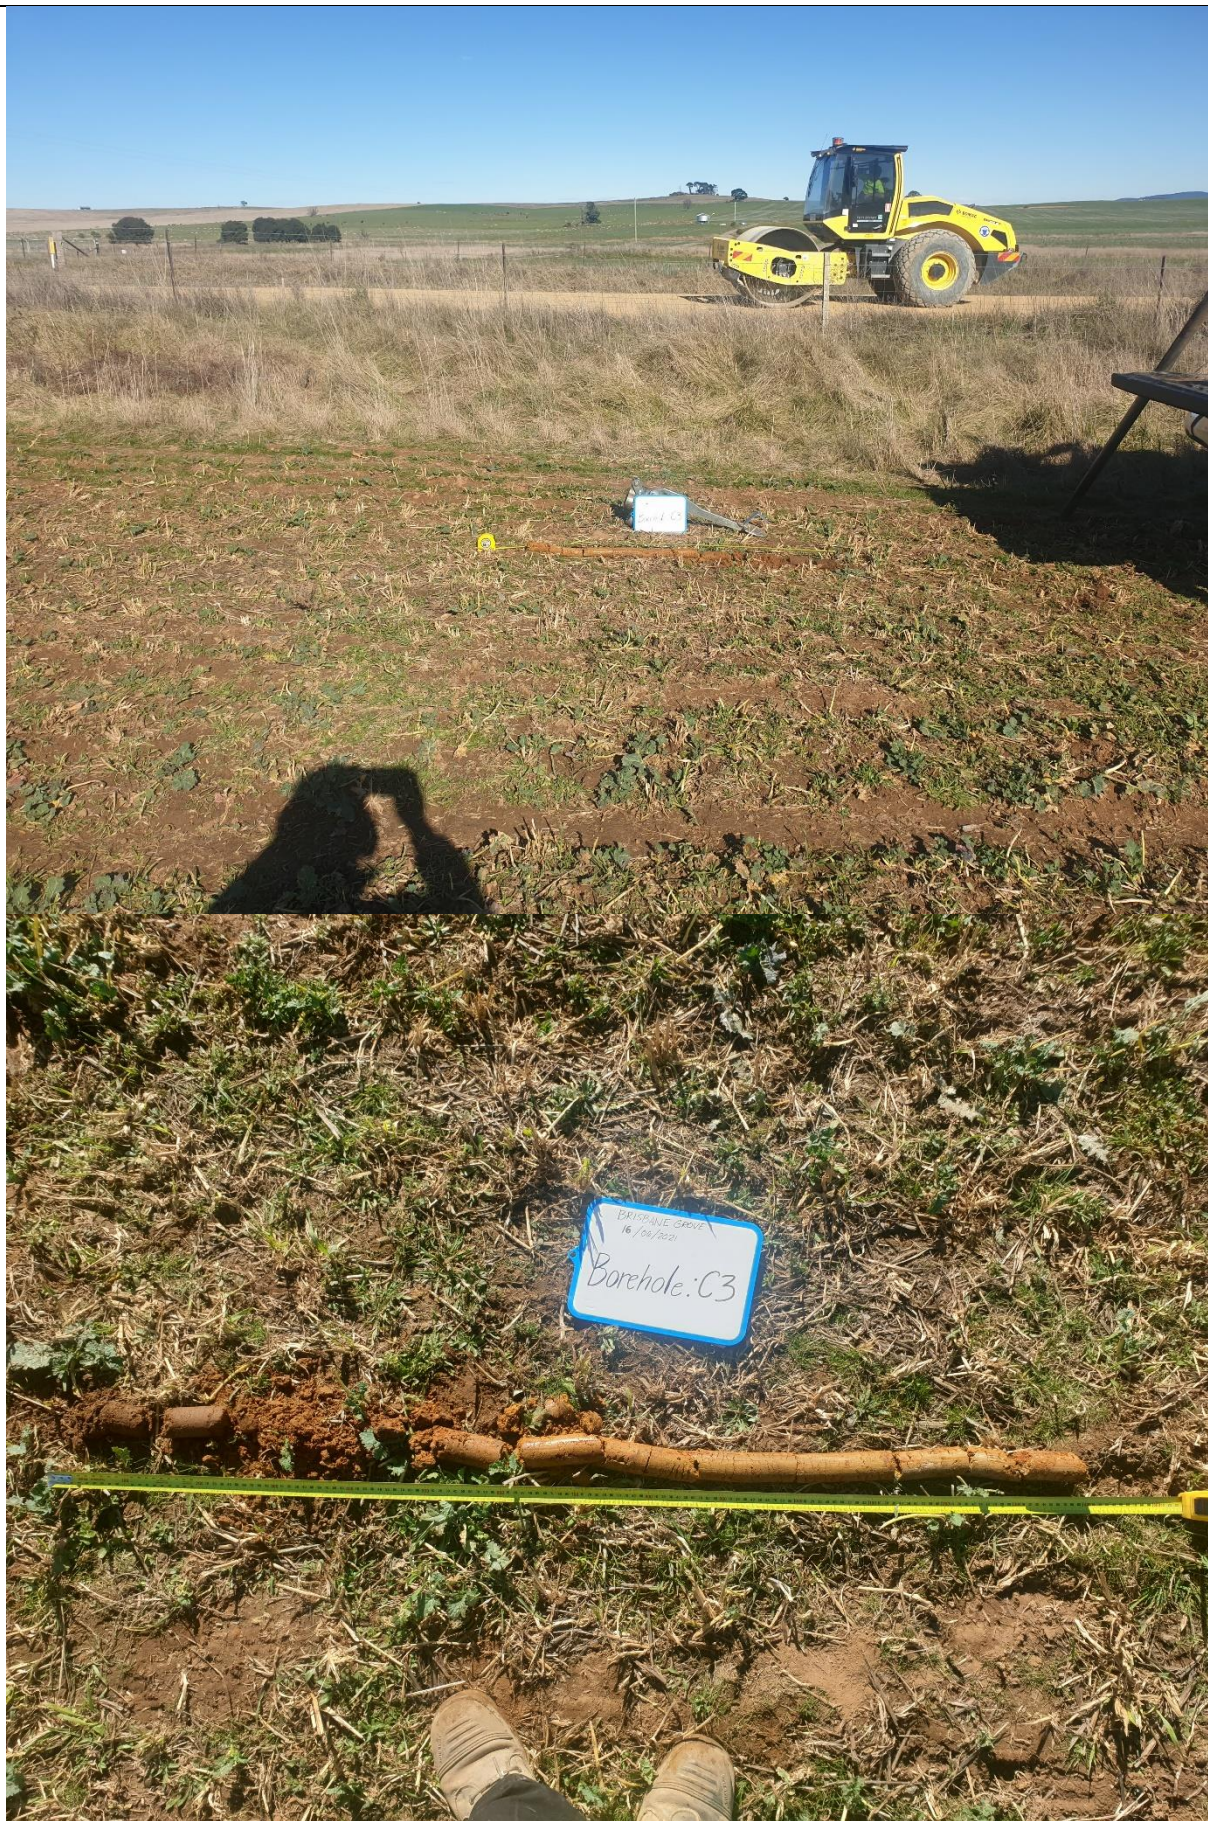
**SOUTHERN REGION LAND ENGINEERING
BRISBANE GROVE RURAL SUBDIVISION
LOCATION AND SOIL CORE PHOTOS (C3)**

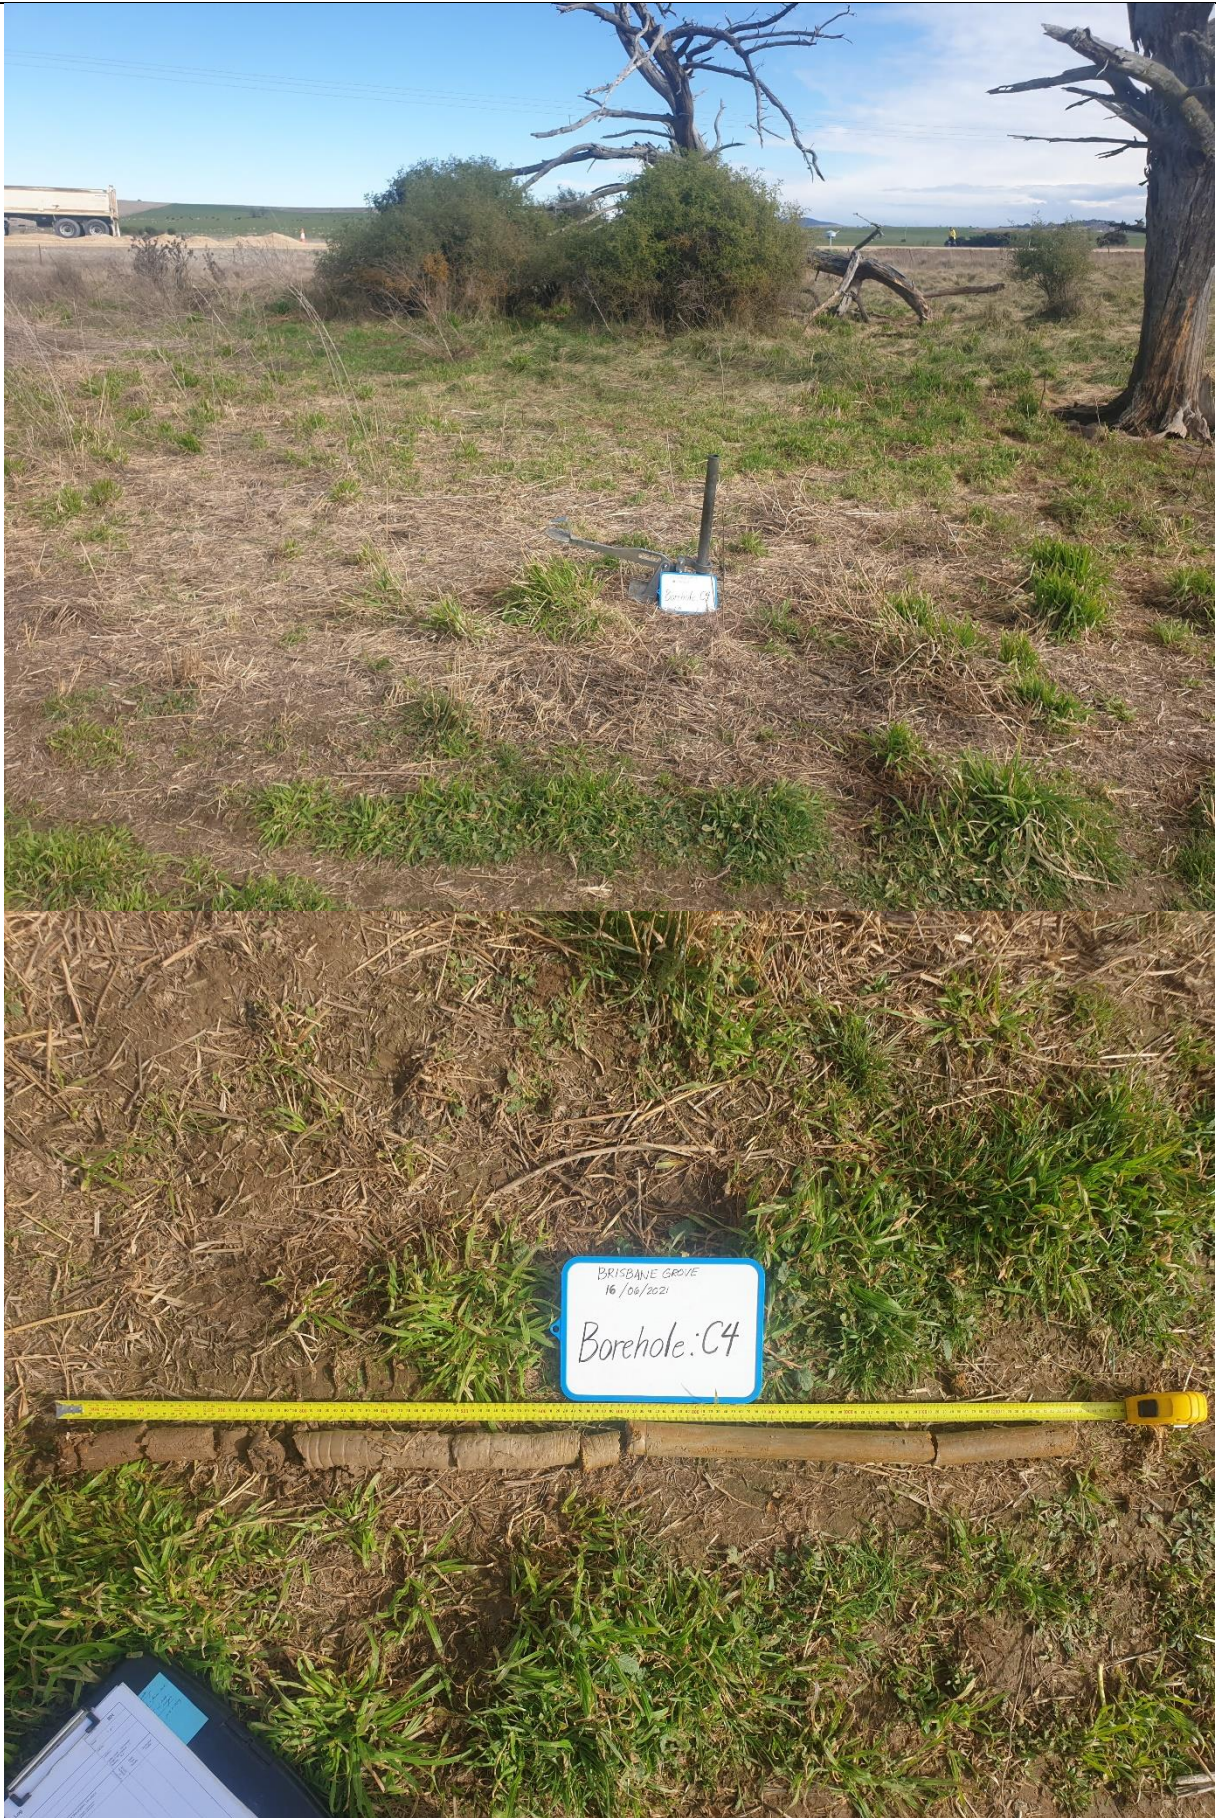
**SOUTHERN REGION LAND ENGINEERING
BRISBANE GROVE RURAL SUBDIVISION
LOCATION AND SOIL CORE PHOTOS (C4)**
