PLANNING PROPOSAL

THE HUB

MOUNTAIN ASH ROAD, GOULBURN

ENGINEERING SERVICES REPORT

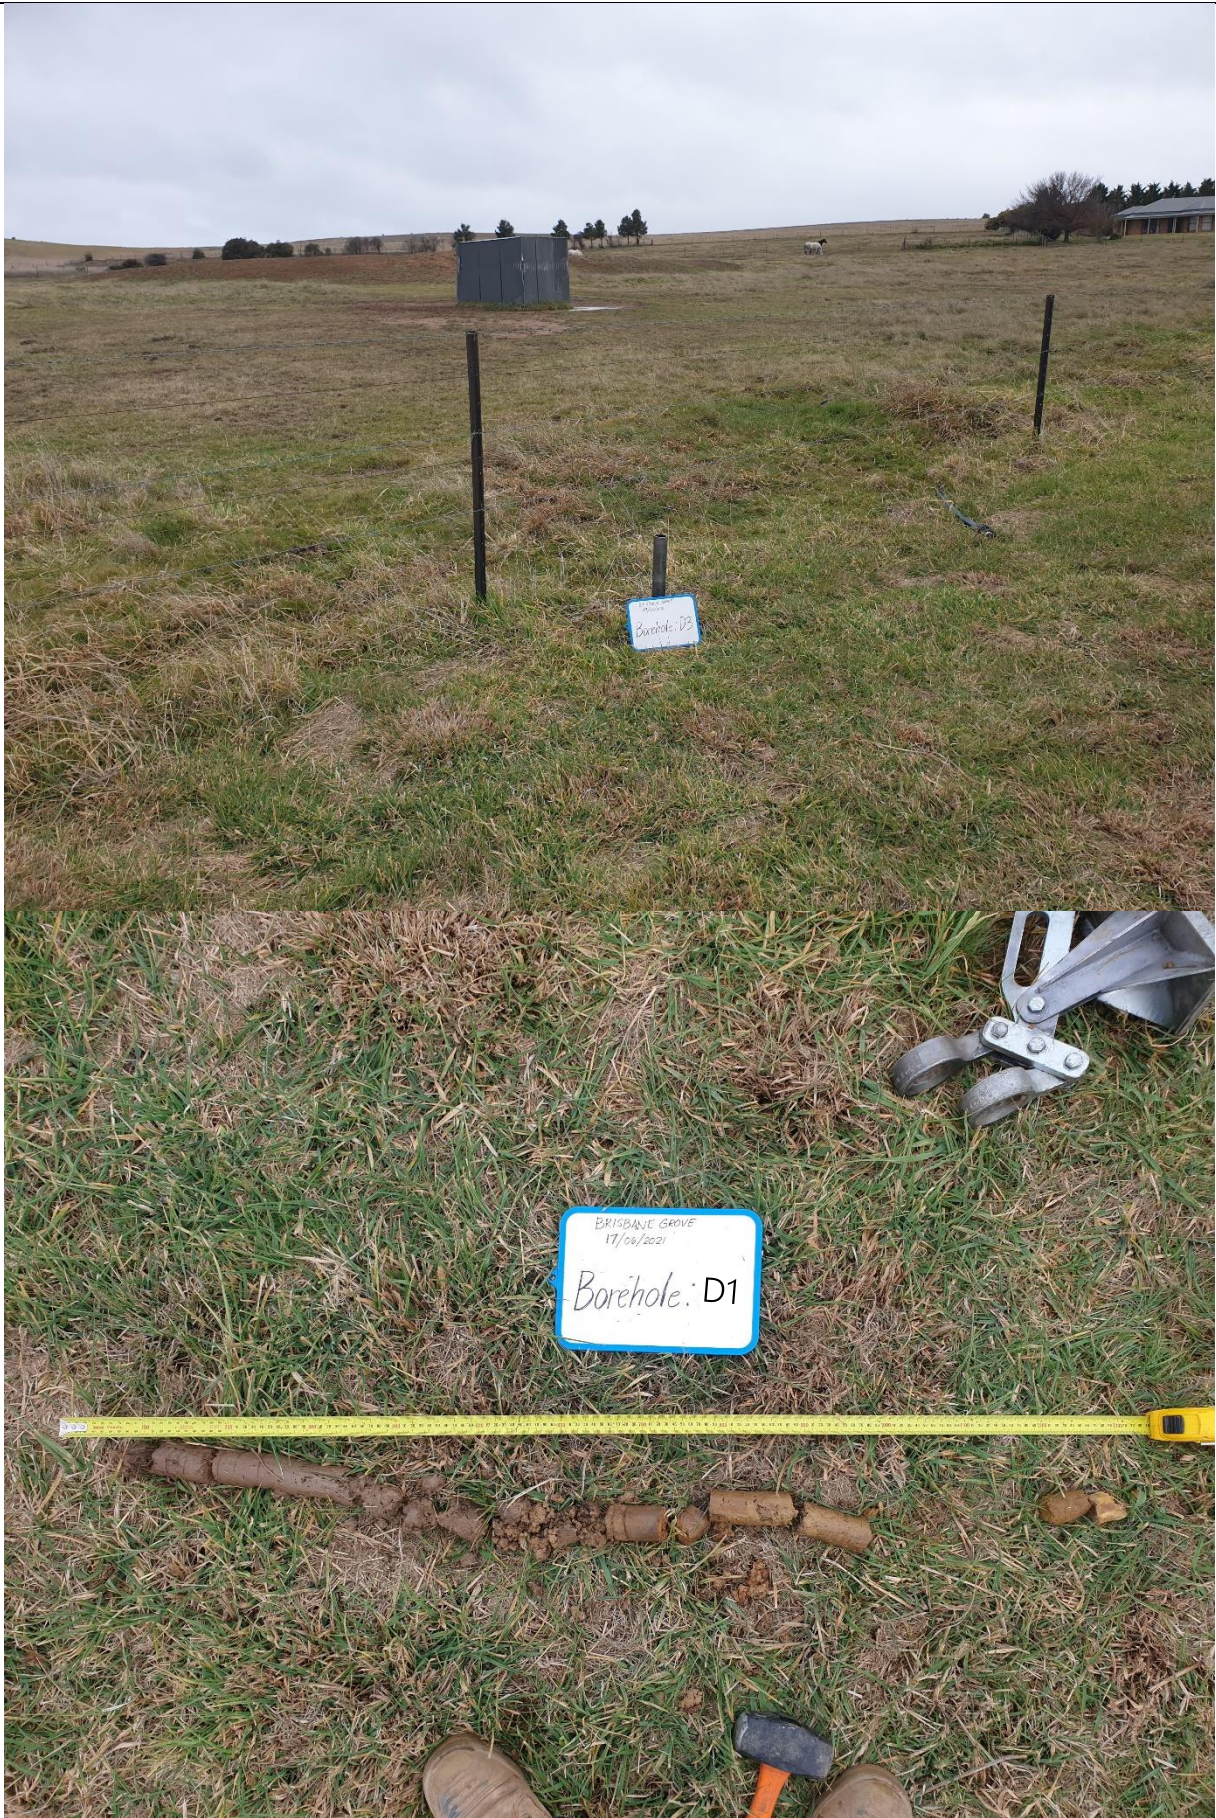
**SOUTHERN REGION LAND ENGINEERING
BRISBANE GROVE RURAL SUBDIVISION
LOCATION AND SOIL CORE PHOTOS (D1)**

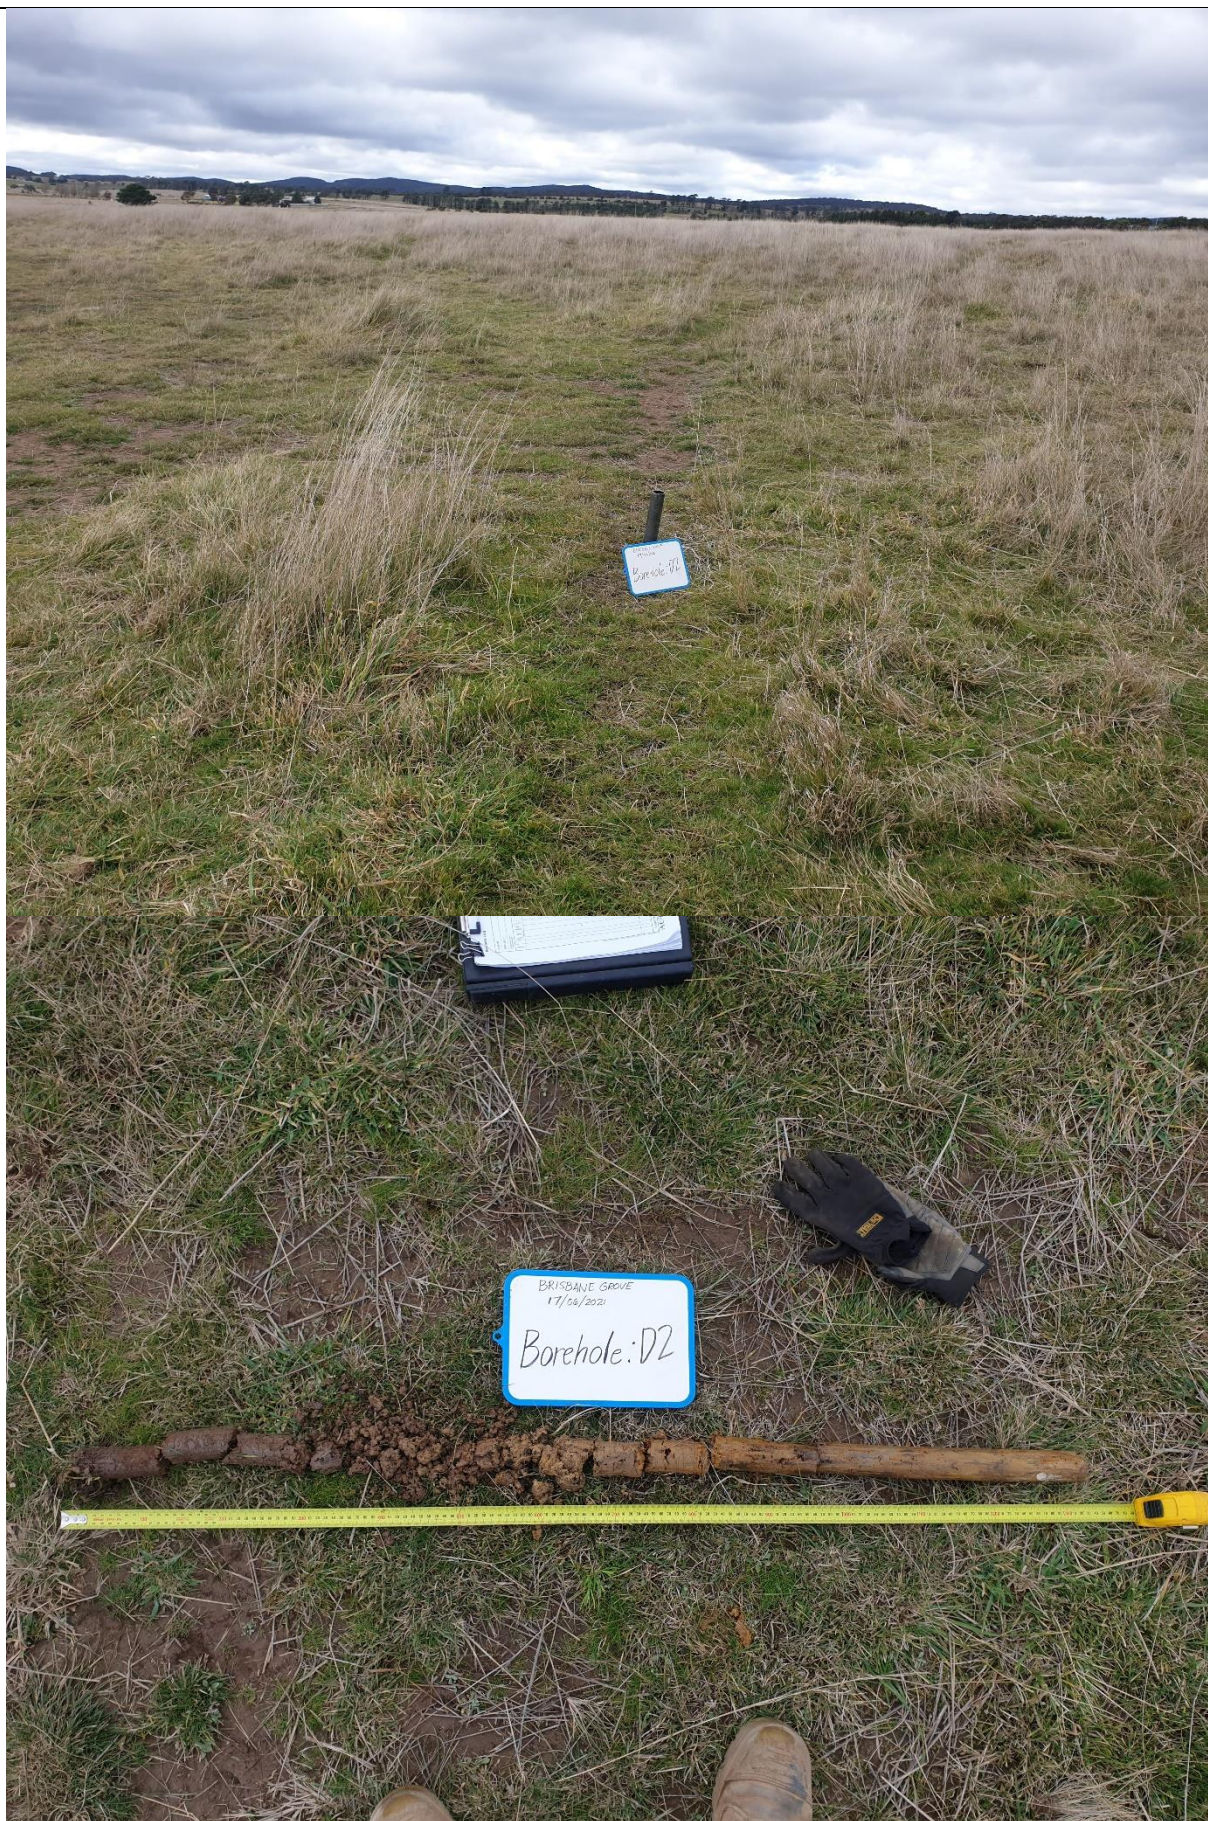
**SOUTHERN REGION LAND ENGINEERING
BRISBANE GROVE RURAL SUBDIVISION
LOCATION AND SOIL CORE PHOTOS (D2)**

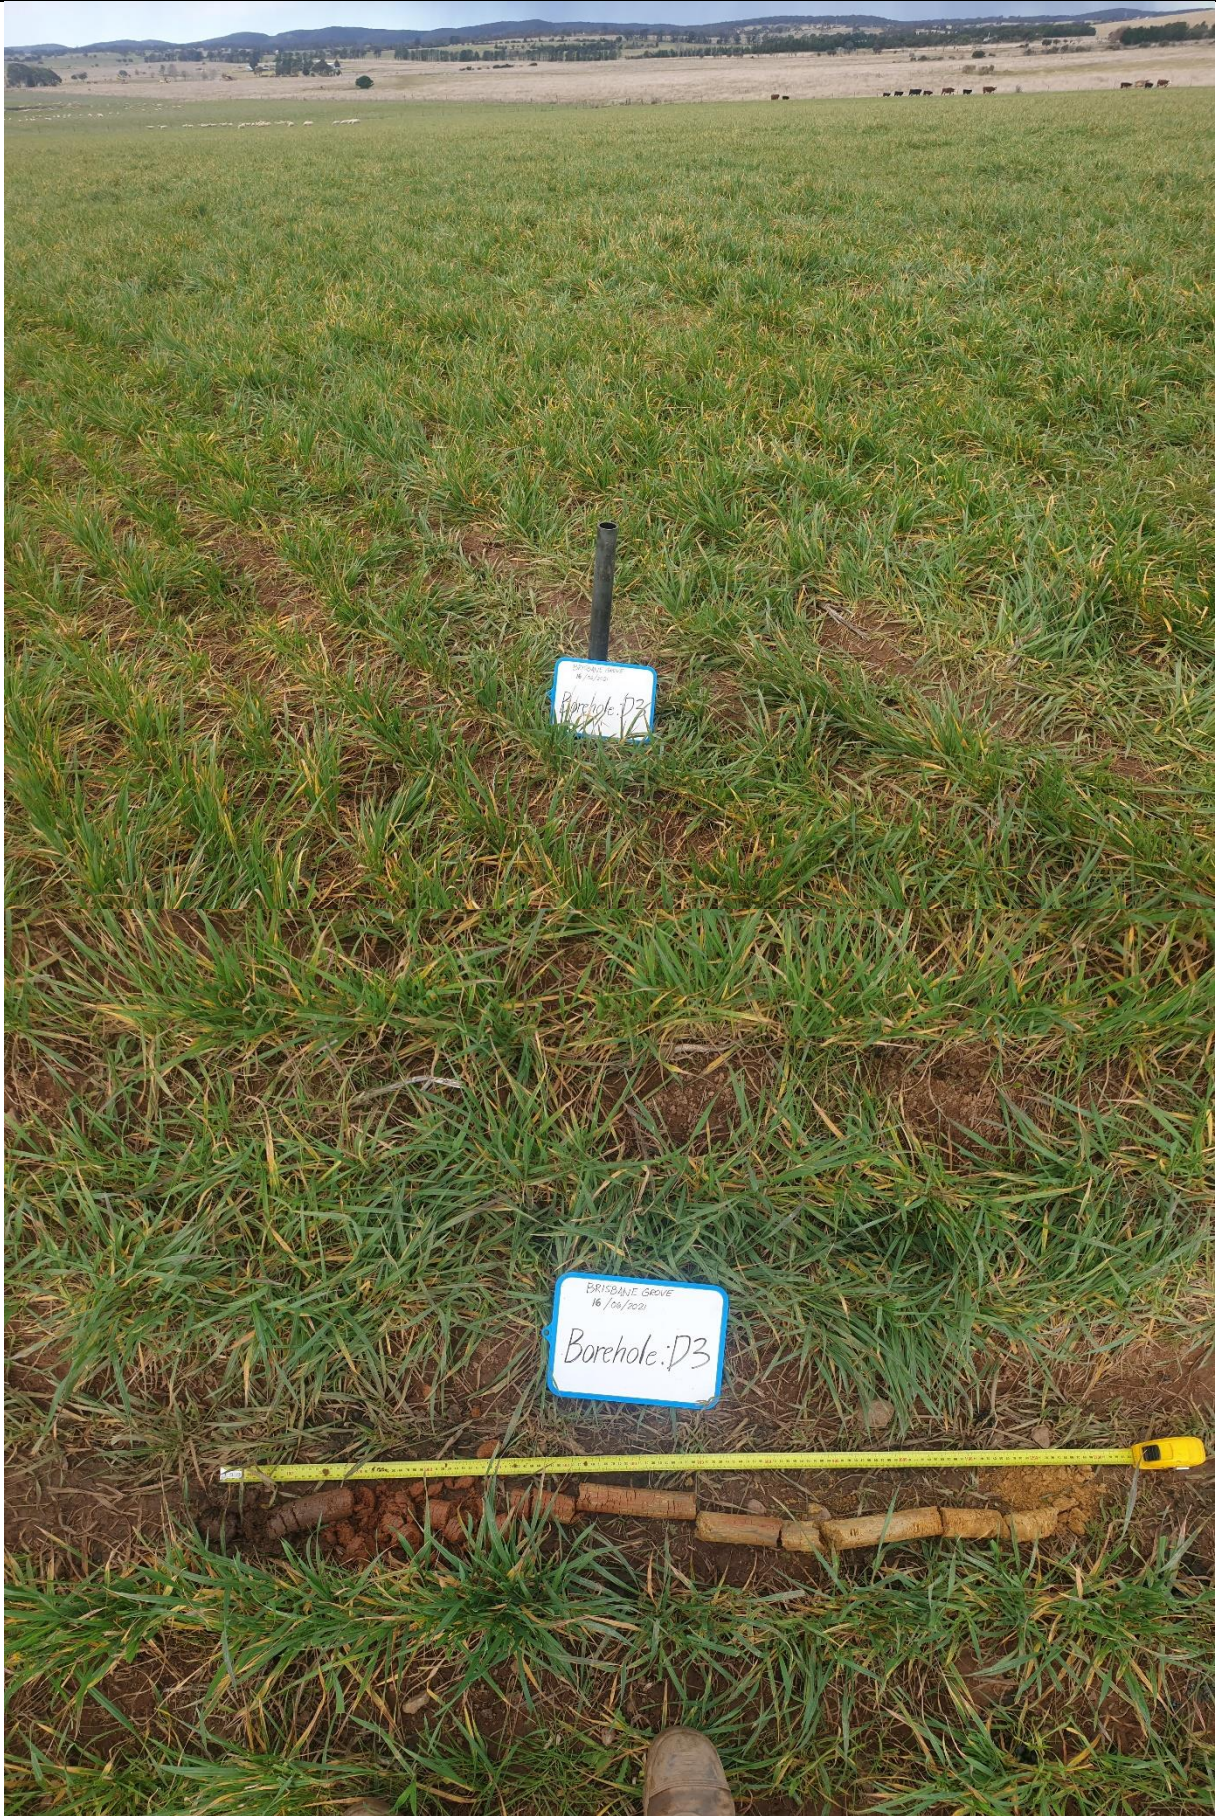
**SOUTHERN REGION LAND ENGINEERING
BRISBANE GROVE RURAL SUBDIVISION
LOCATION AND SOIL CORE PHOTOS (D3)**

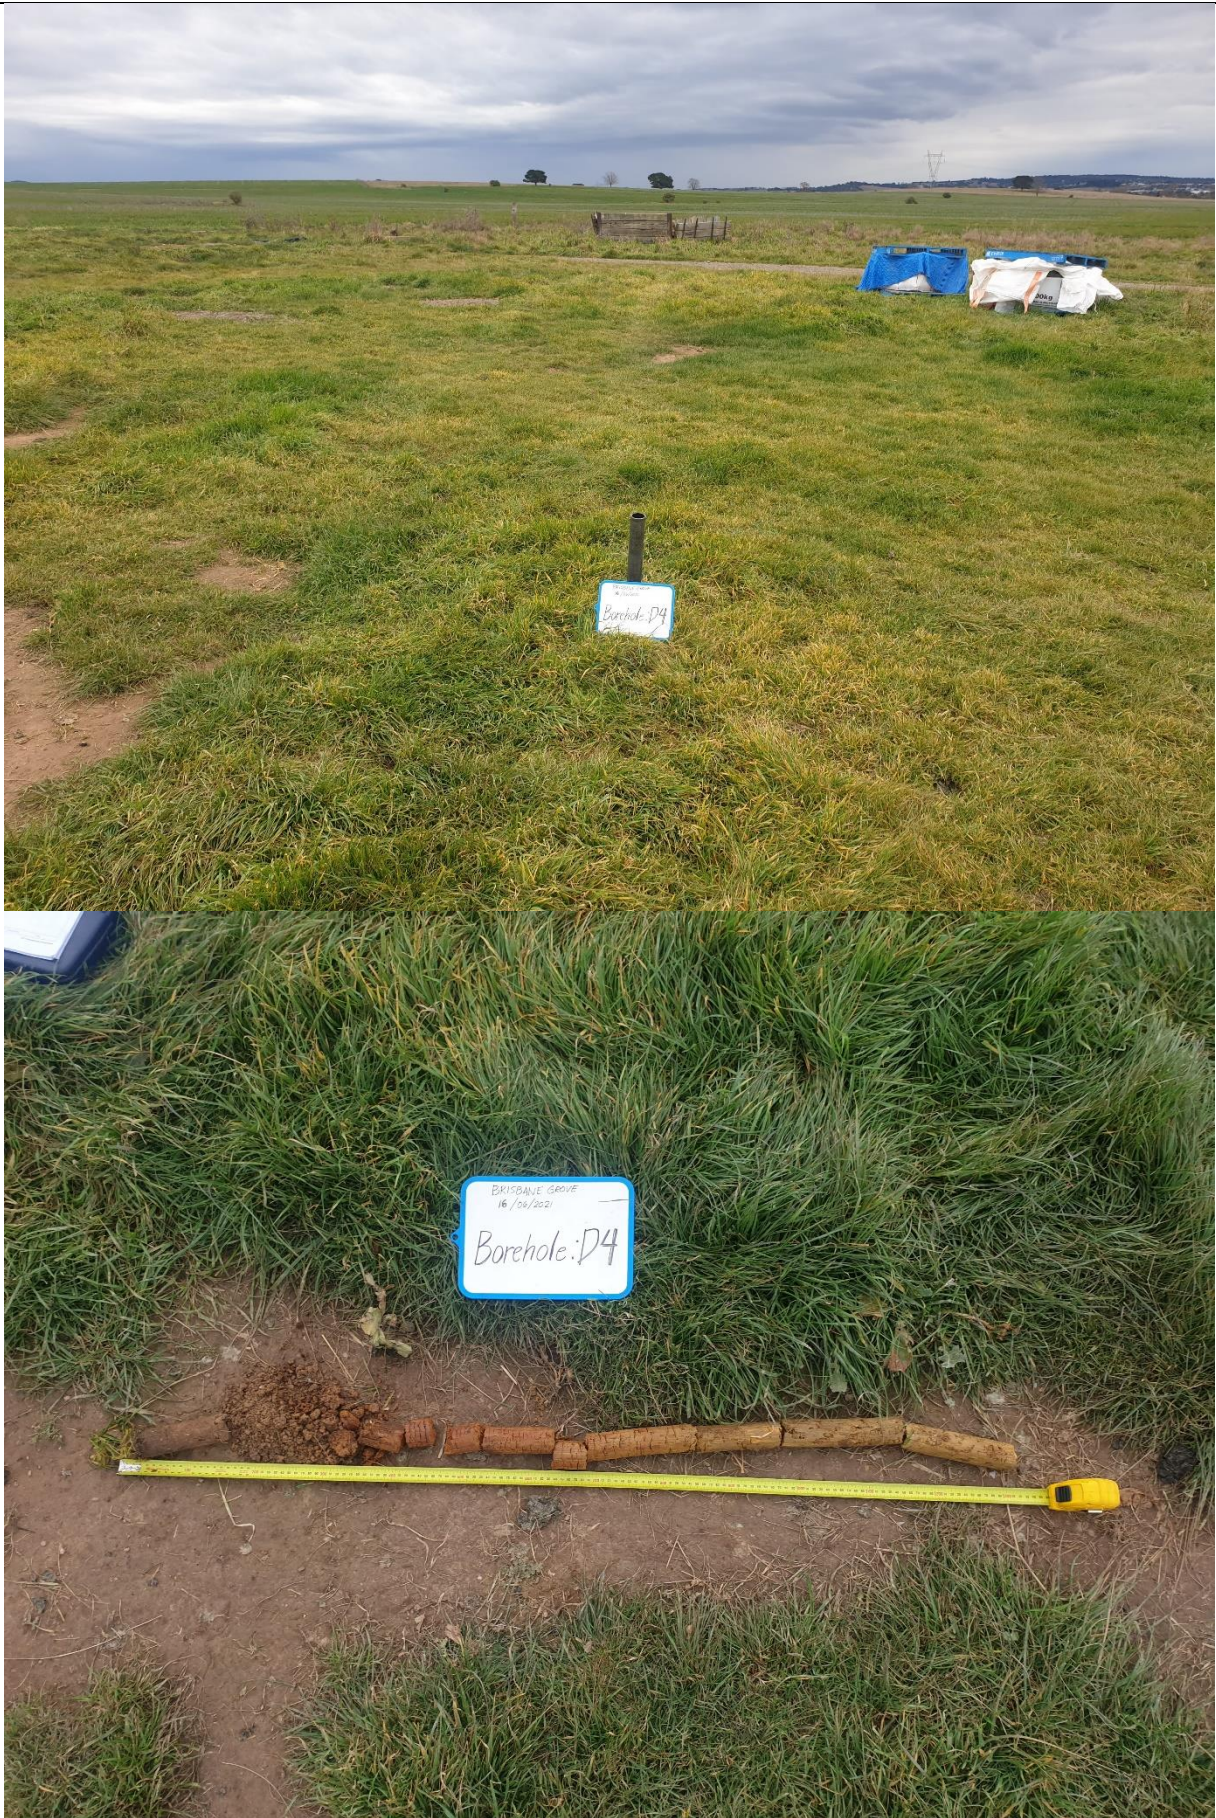
**SOUTHERN REGION LAND ENGINEERING
BRISBANE GROVE RURAL SUBDIVISION
LOCATION AND SOIL CORE PHOTOS (D4)**

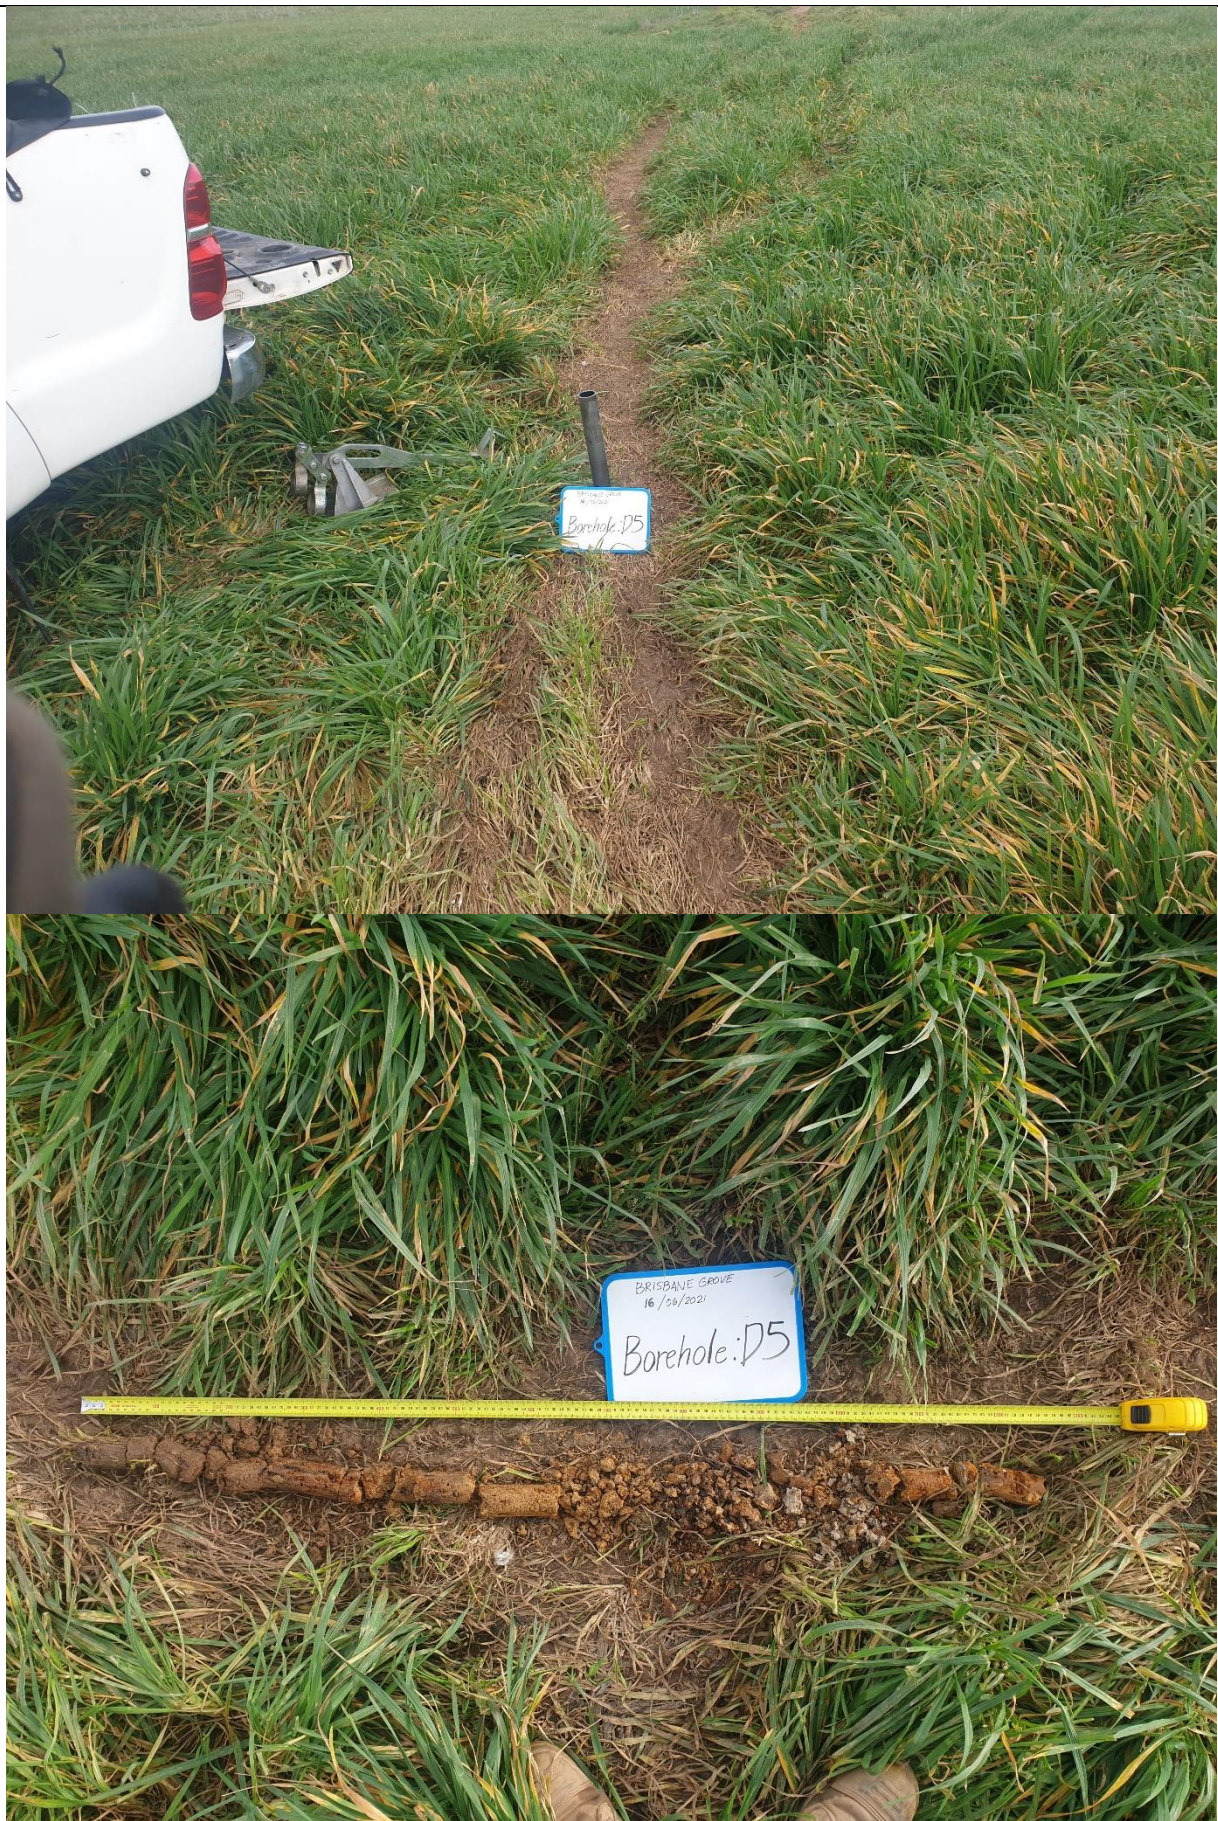
**SOUTHERN REGION LAND ENGINEERING
BRISBANE GROVE RURAL SUBDIVISION
LOCATION AND SOIL CORE PHOTOS (D5)**

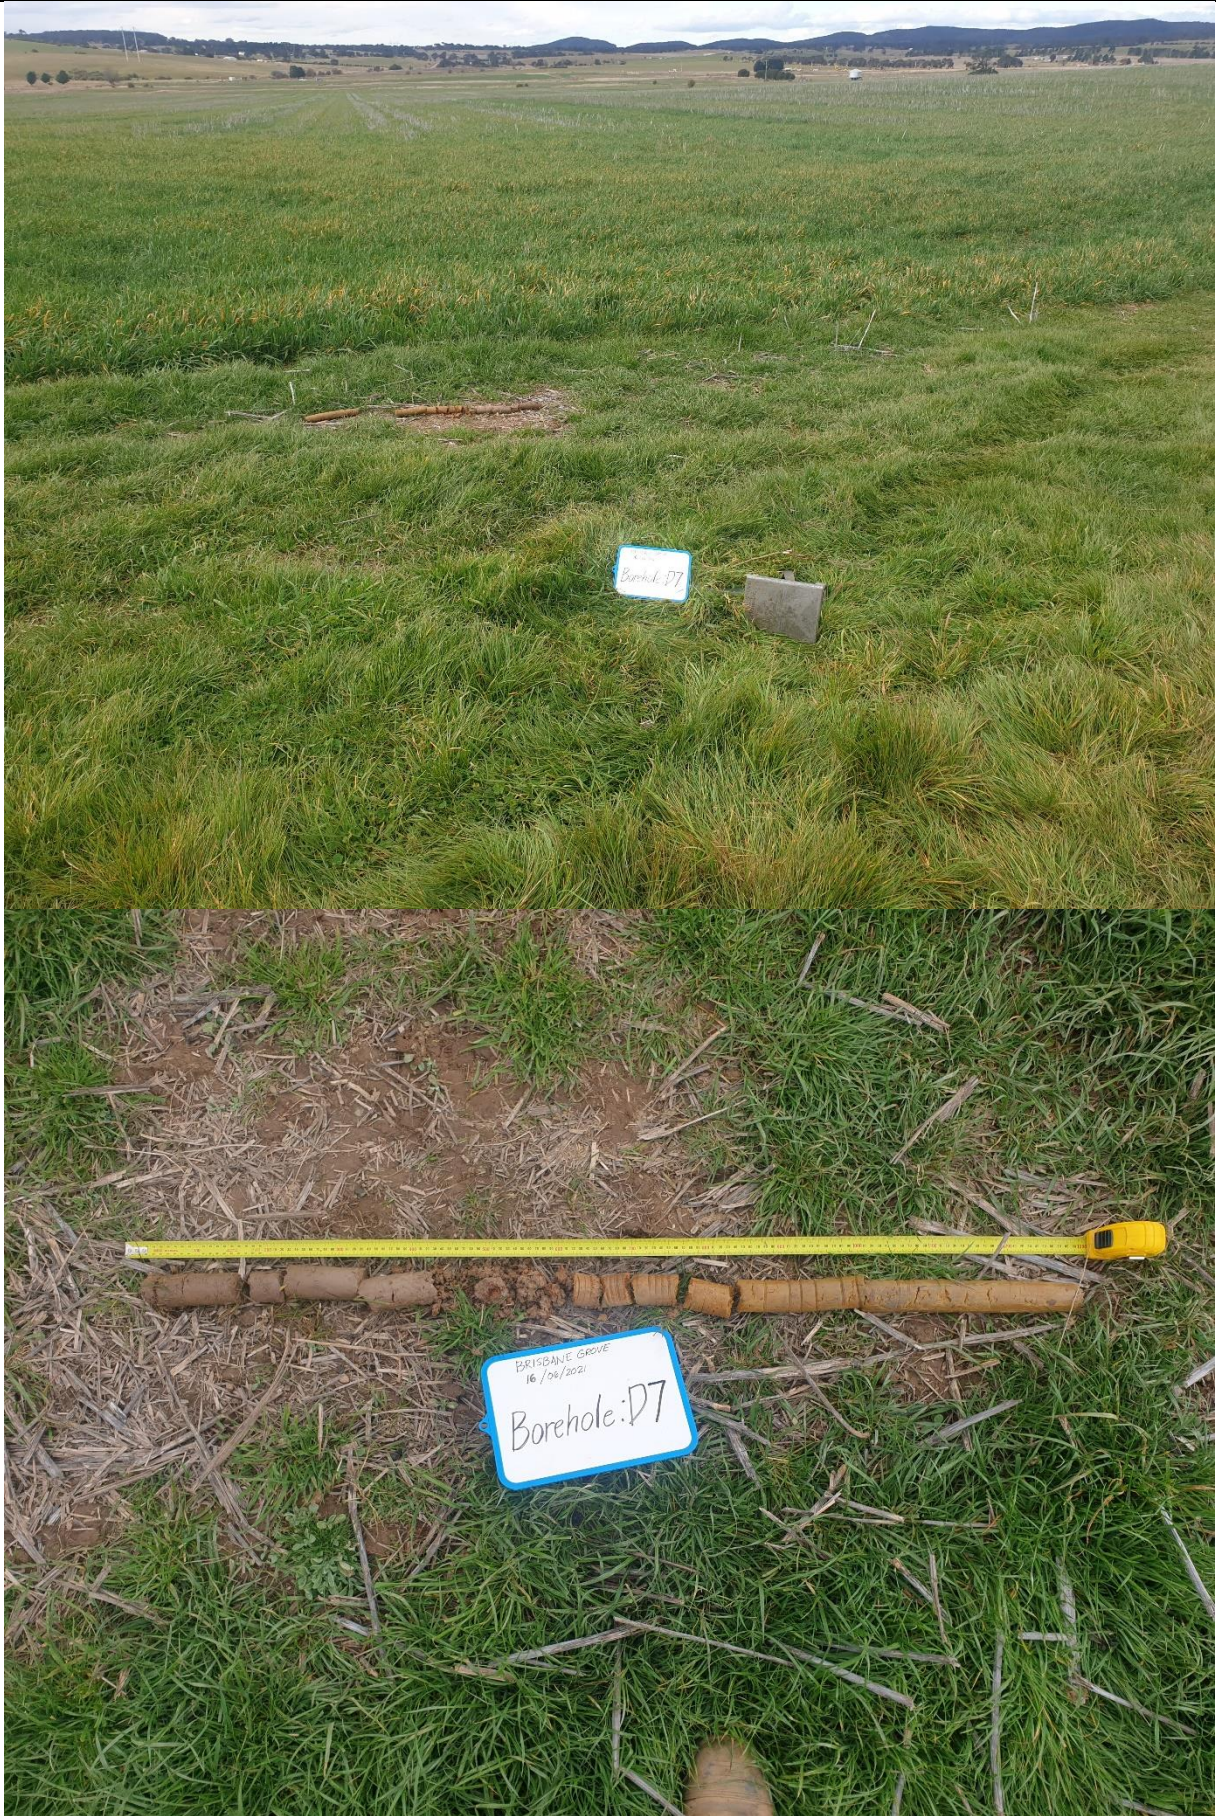
**SOUTHERN REGION LAND ENGINEERING
BRISBANE GROVE RURAL SUBDIVISION
LOCATION AND SOIL CORE PHOTOS (D7)**

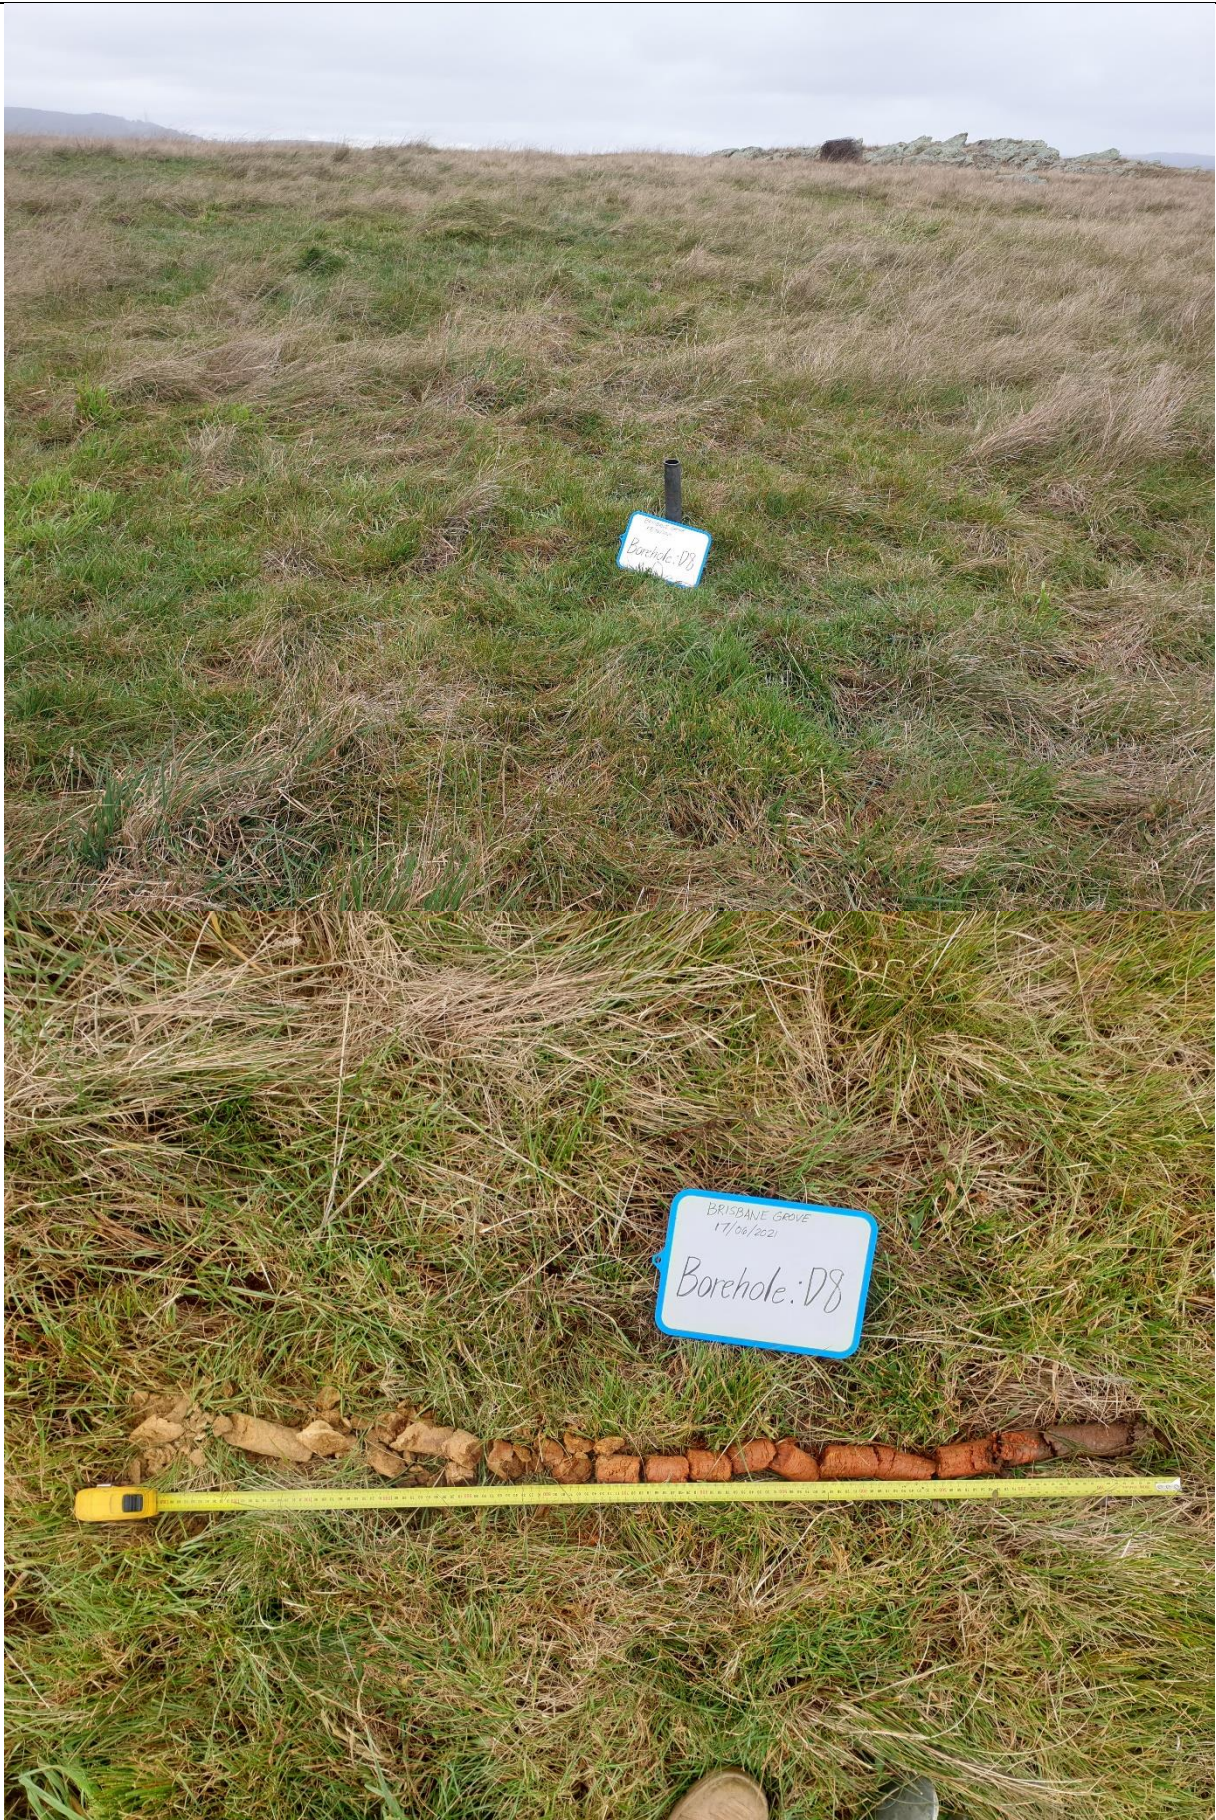
**SOUTHERN REGION LAND ENGINEERING
BRISBANE GROVE RURAL SUBDIVISION
LOCATION AND SOIL CORE PHOTOS (D8)**

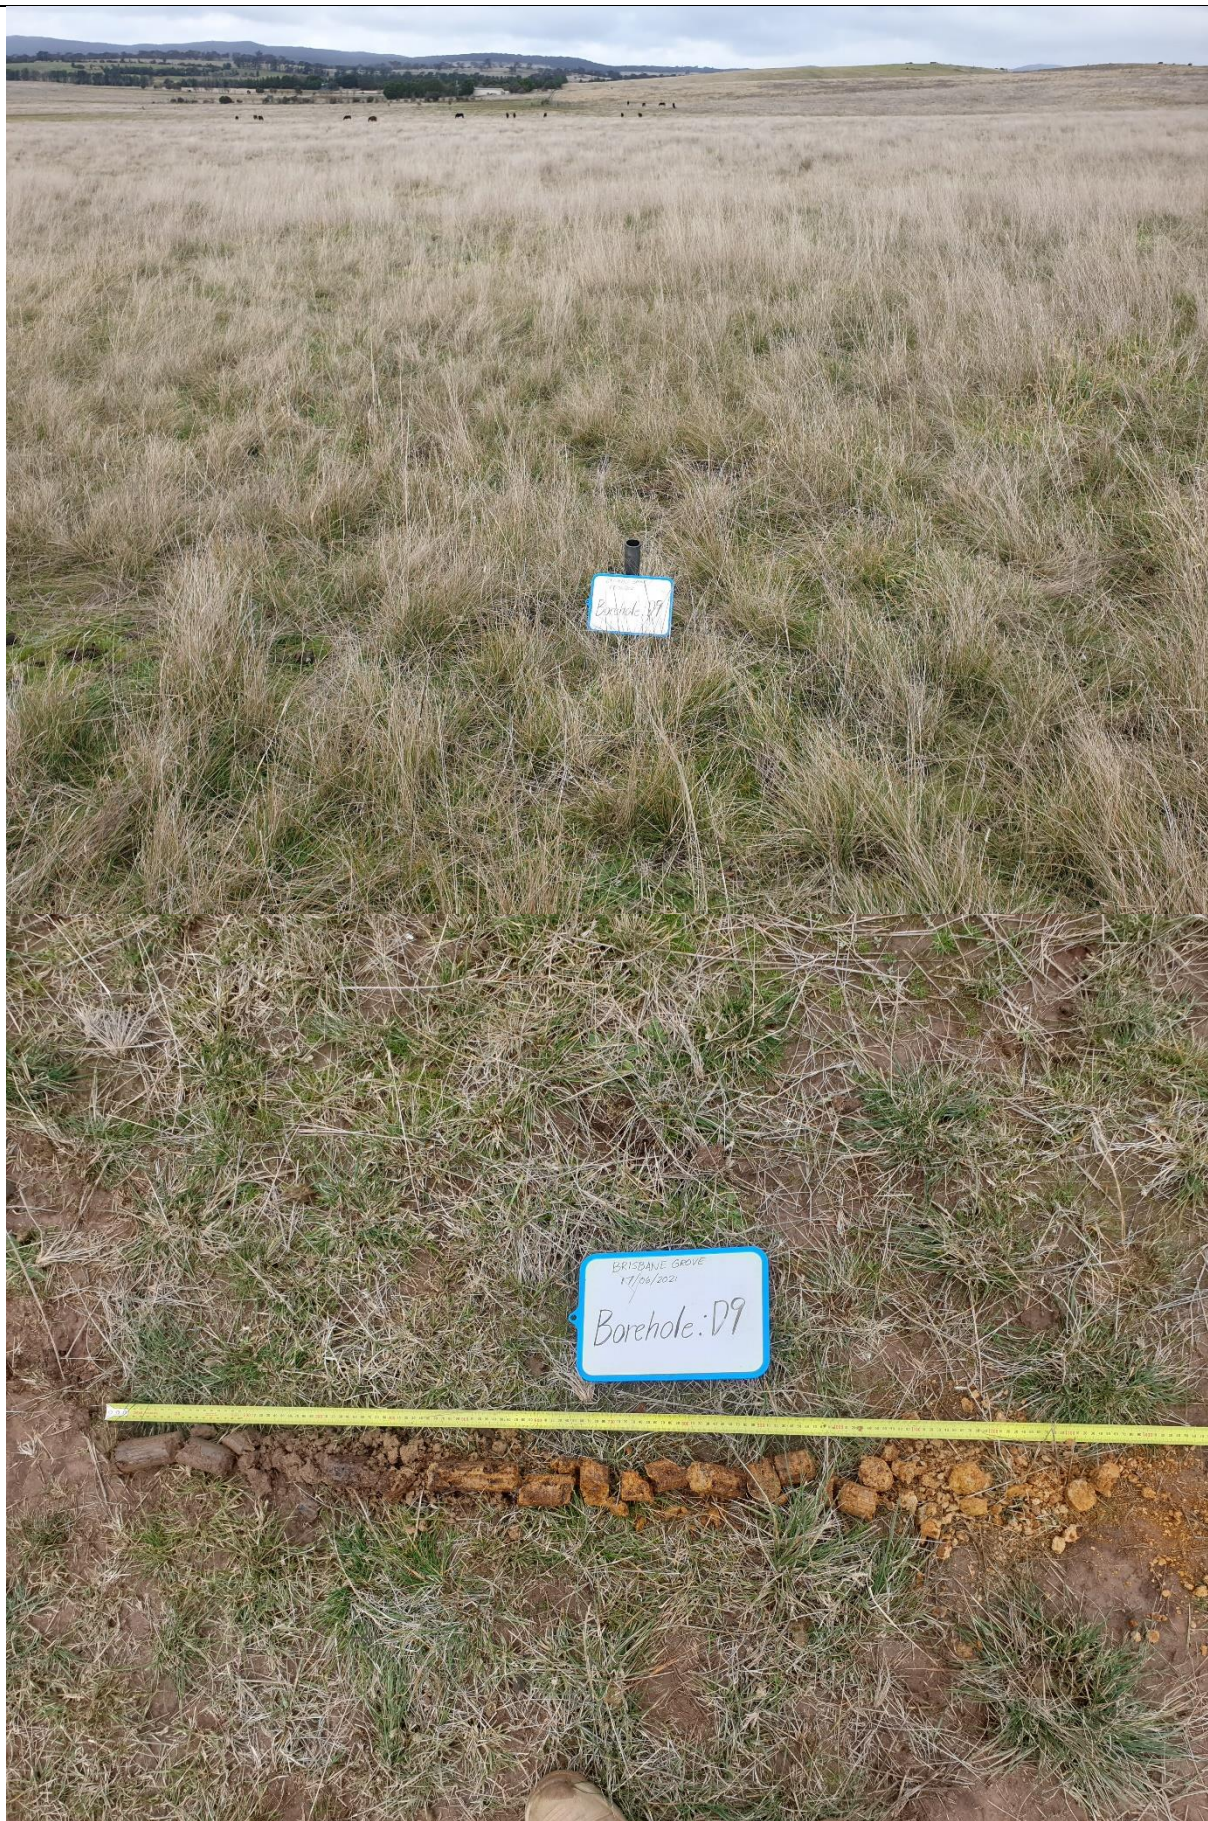
**SOUTHERN REGION LAND ENGINEERING
BRISBANE GROVE RURAL SUBDIVISION
LOCATION AND SOIL CORE PHOTOS (D9)**

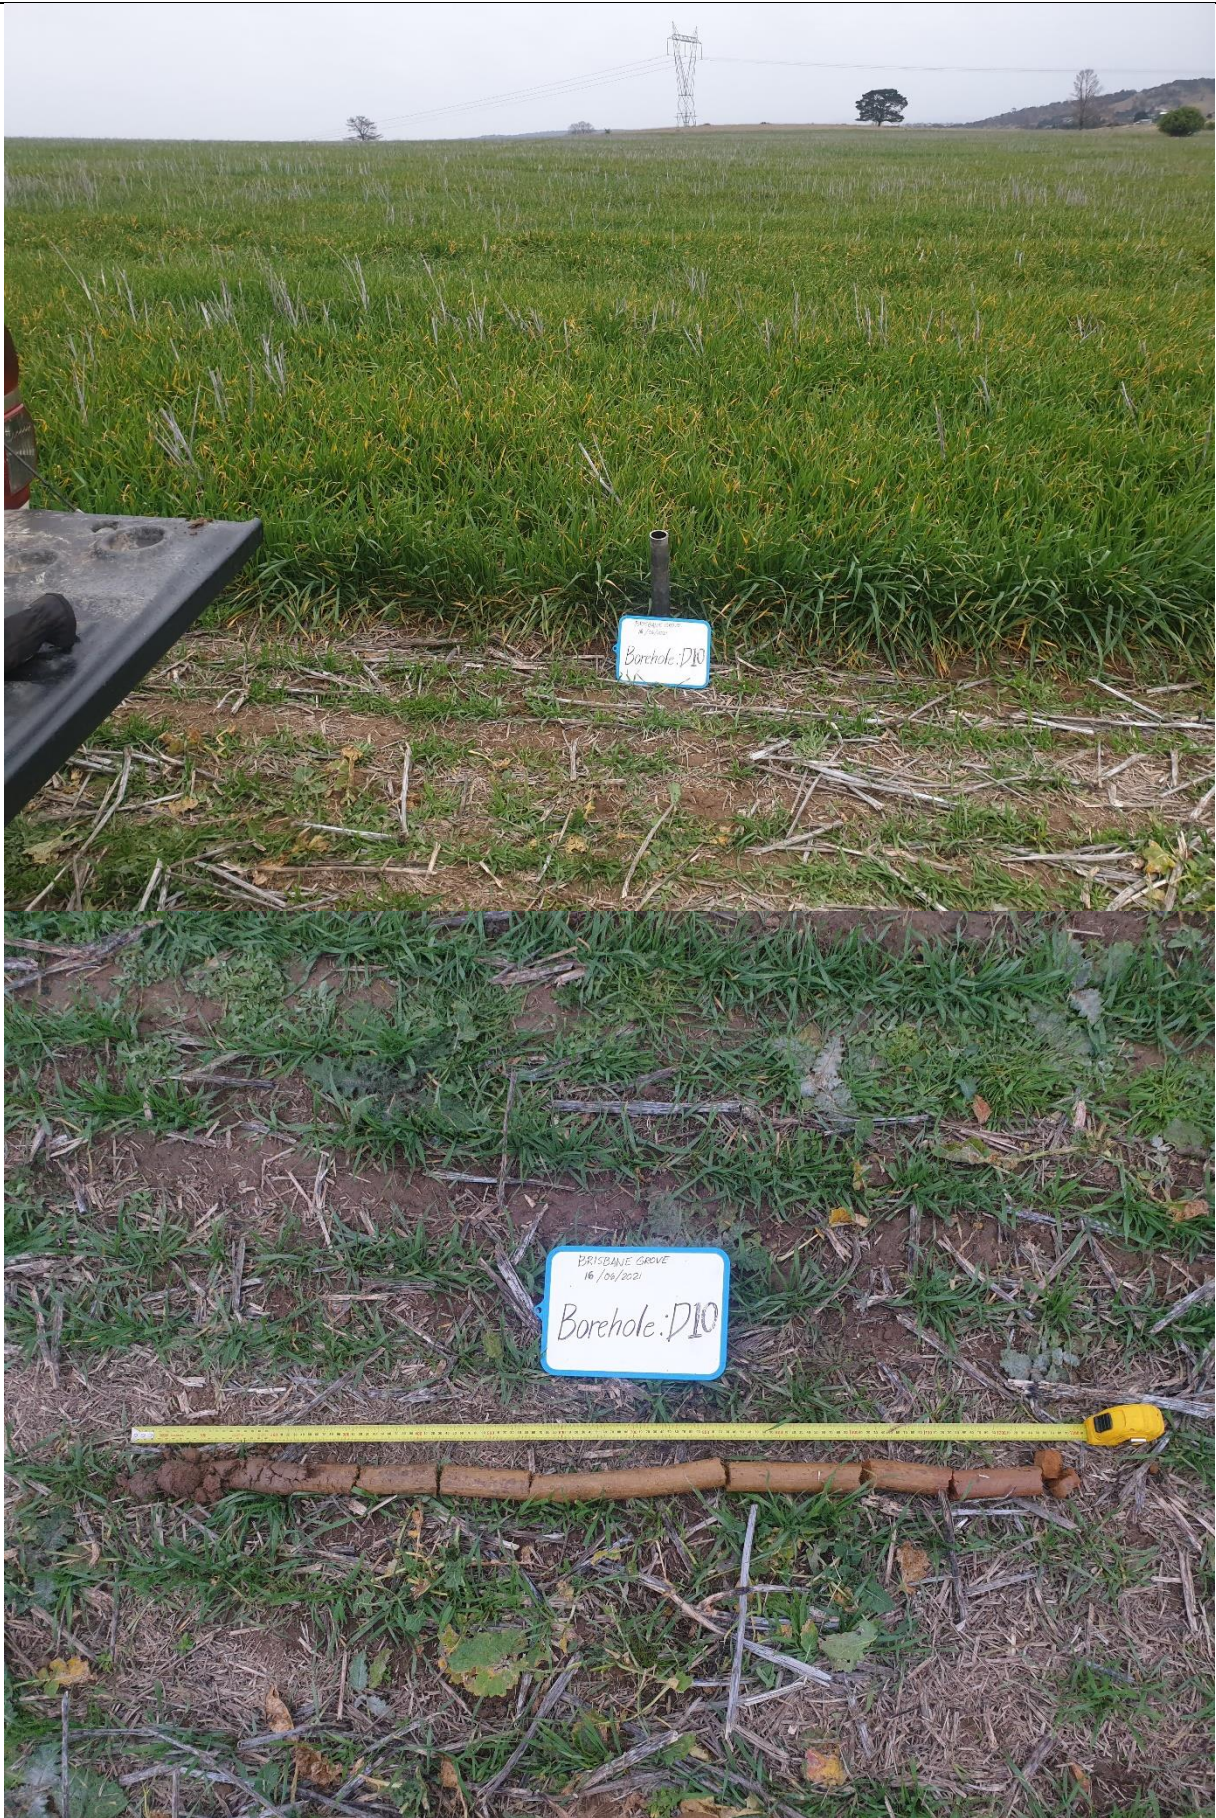
**SOUTHERN REGION LAND ENGINEERING
BRISBANE GROVE RURAL SUBDIVISION
LOCATION AND SOIL CORE PHOTOS (D10)**

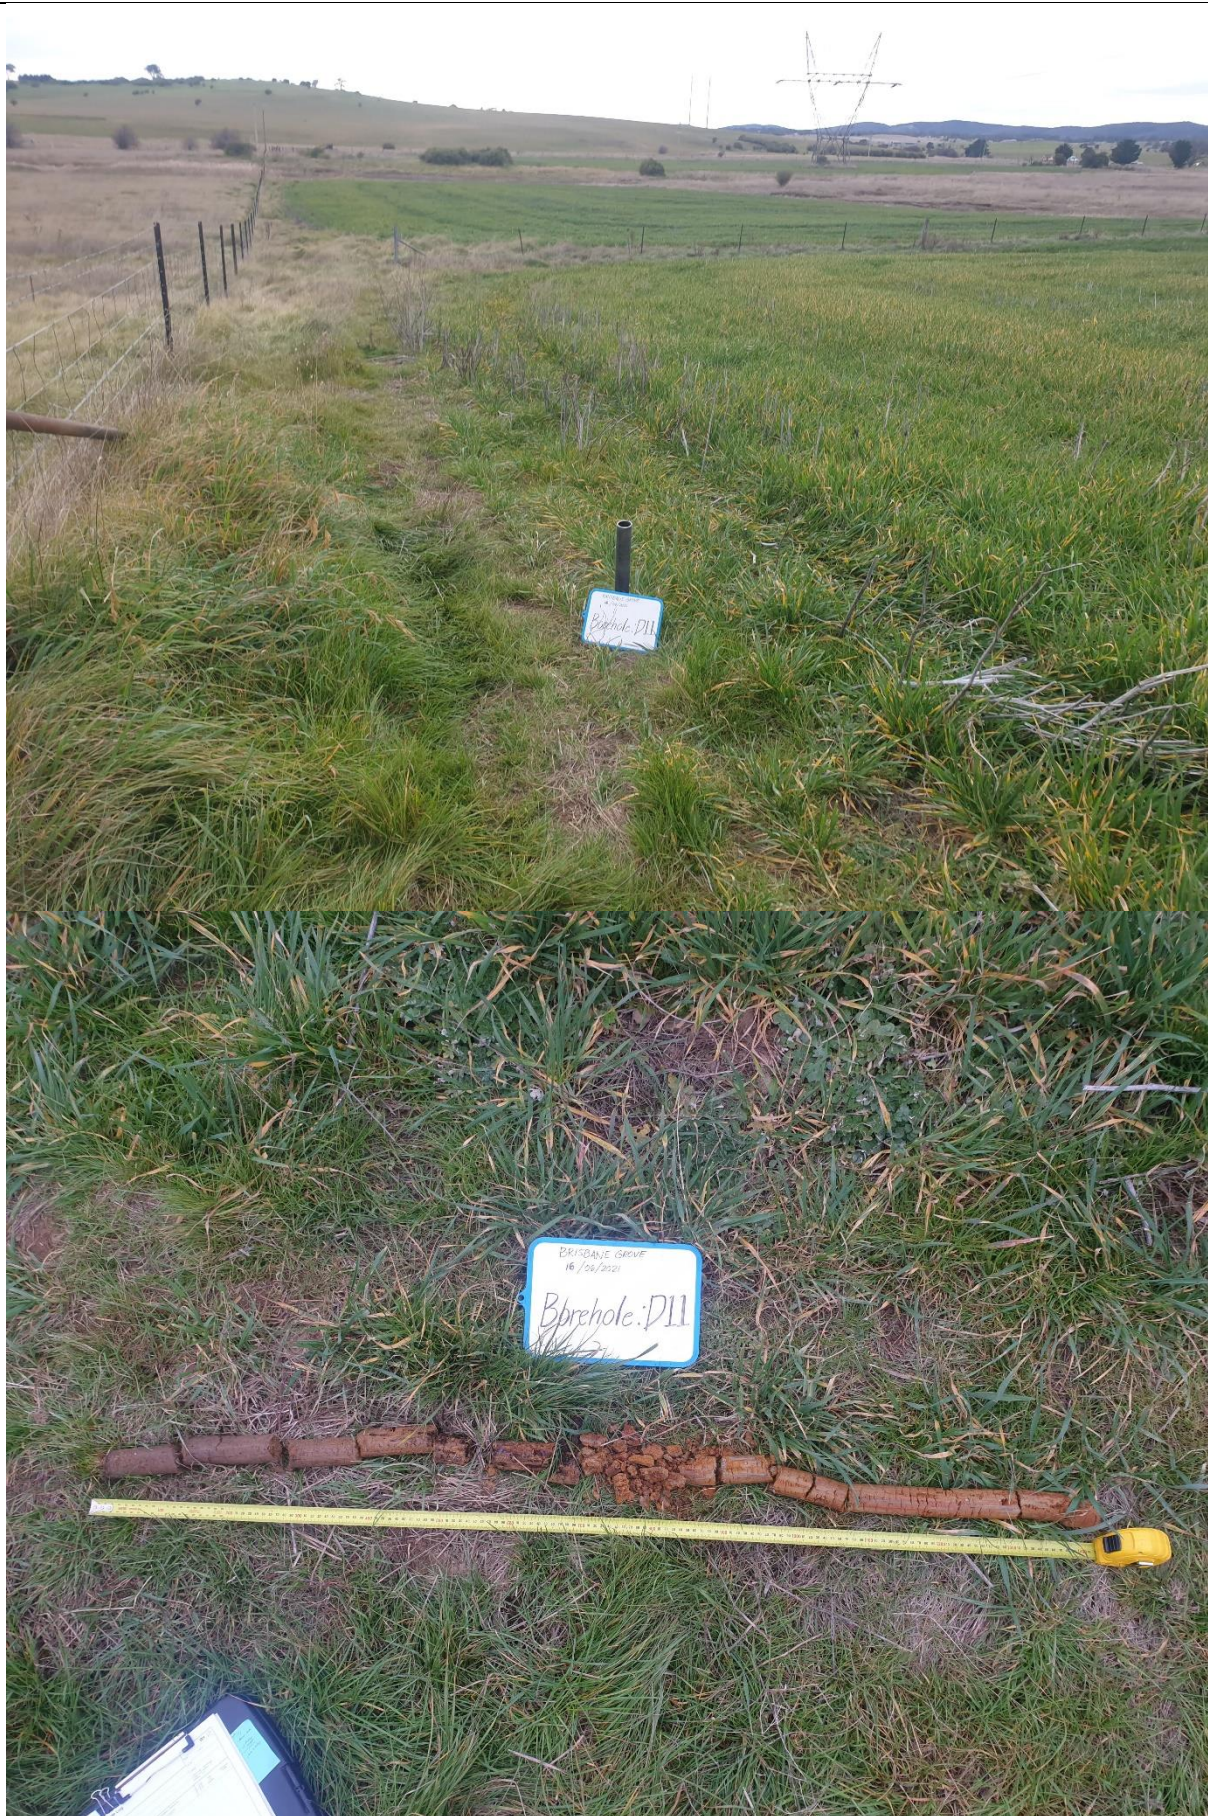
**SOUTHERN REGION LAND ENGINEERING
BRISBANE GROVE RURAL SUBDIVISION
LOCATION AND SOIL CORE PHOTOS (D11)**
