PLANNING PROPOSAL

THE HUB

MOUNTAIN ASH ROAD, GOULBURN

ENGINEERING SERVICES REPORT

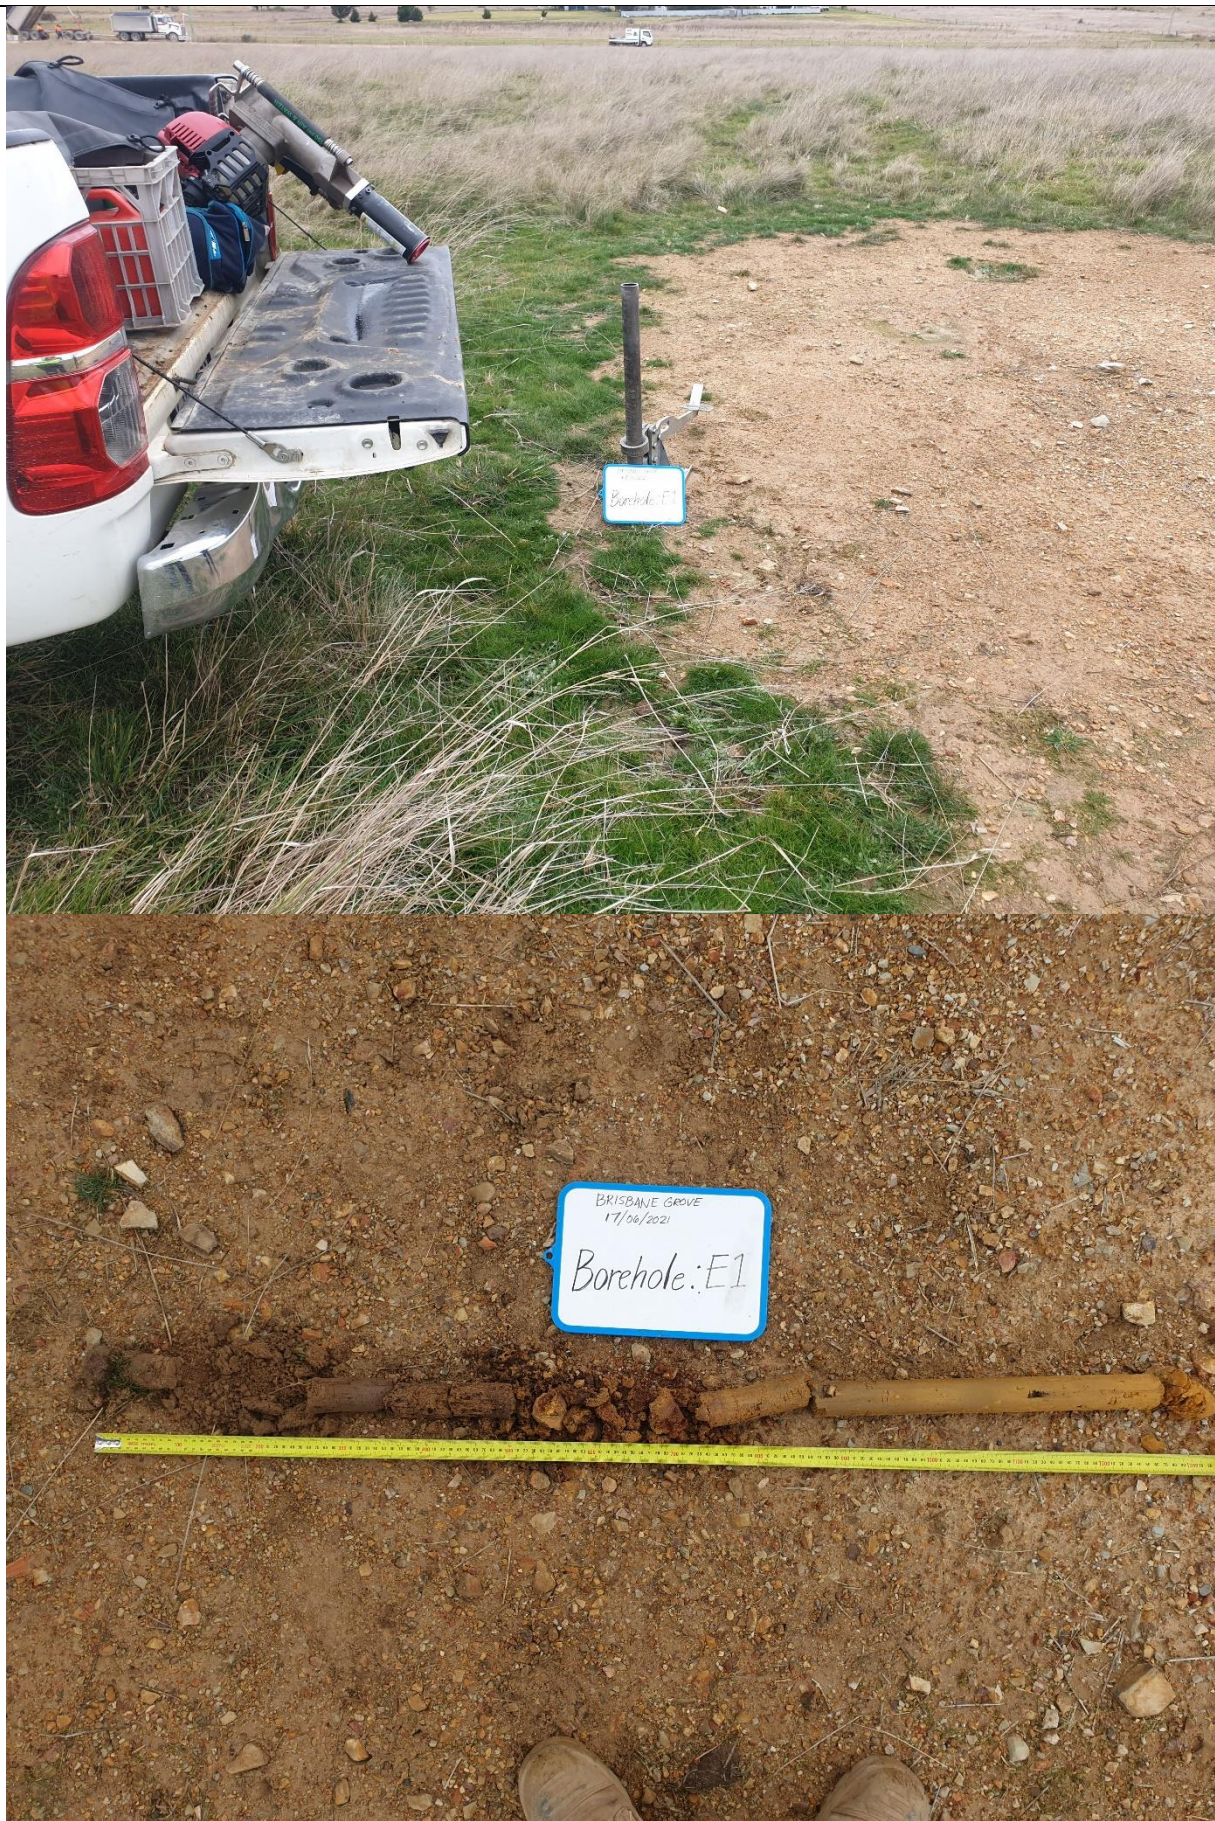
**SOUTHERN REGION LAND ENGINEERING
BRISBANE GROVE RURAL SUBDIVISION
LOCATION AND SOIL CORE PHOTOS (E1)**

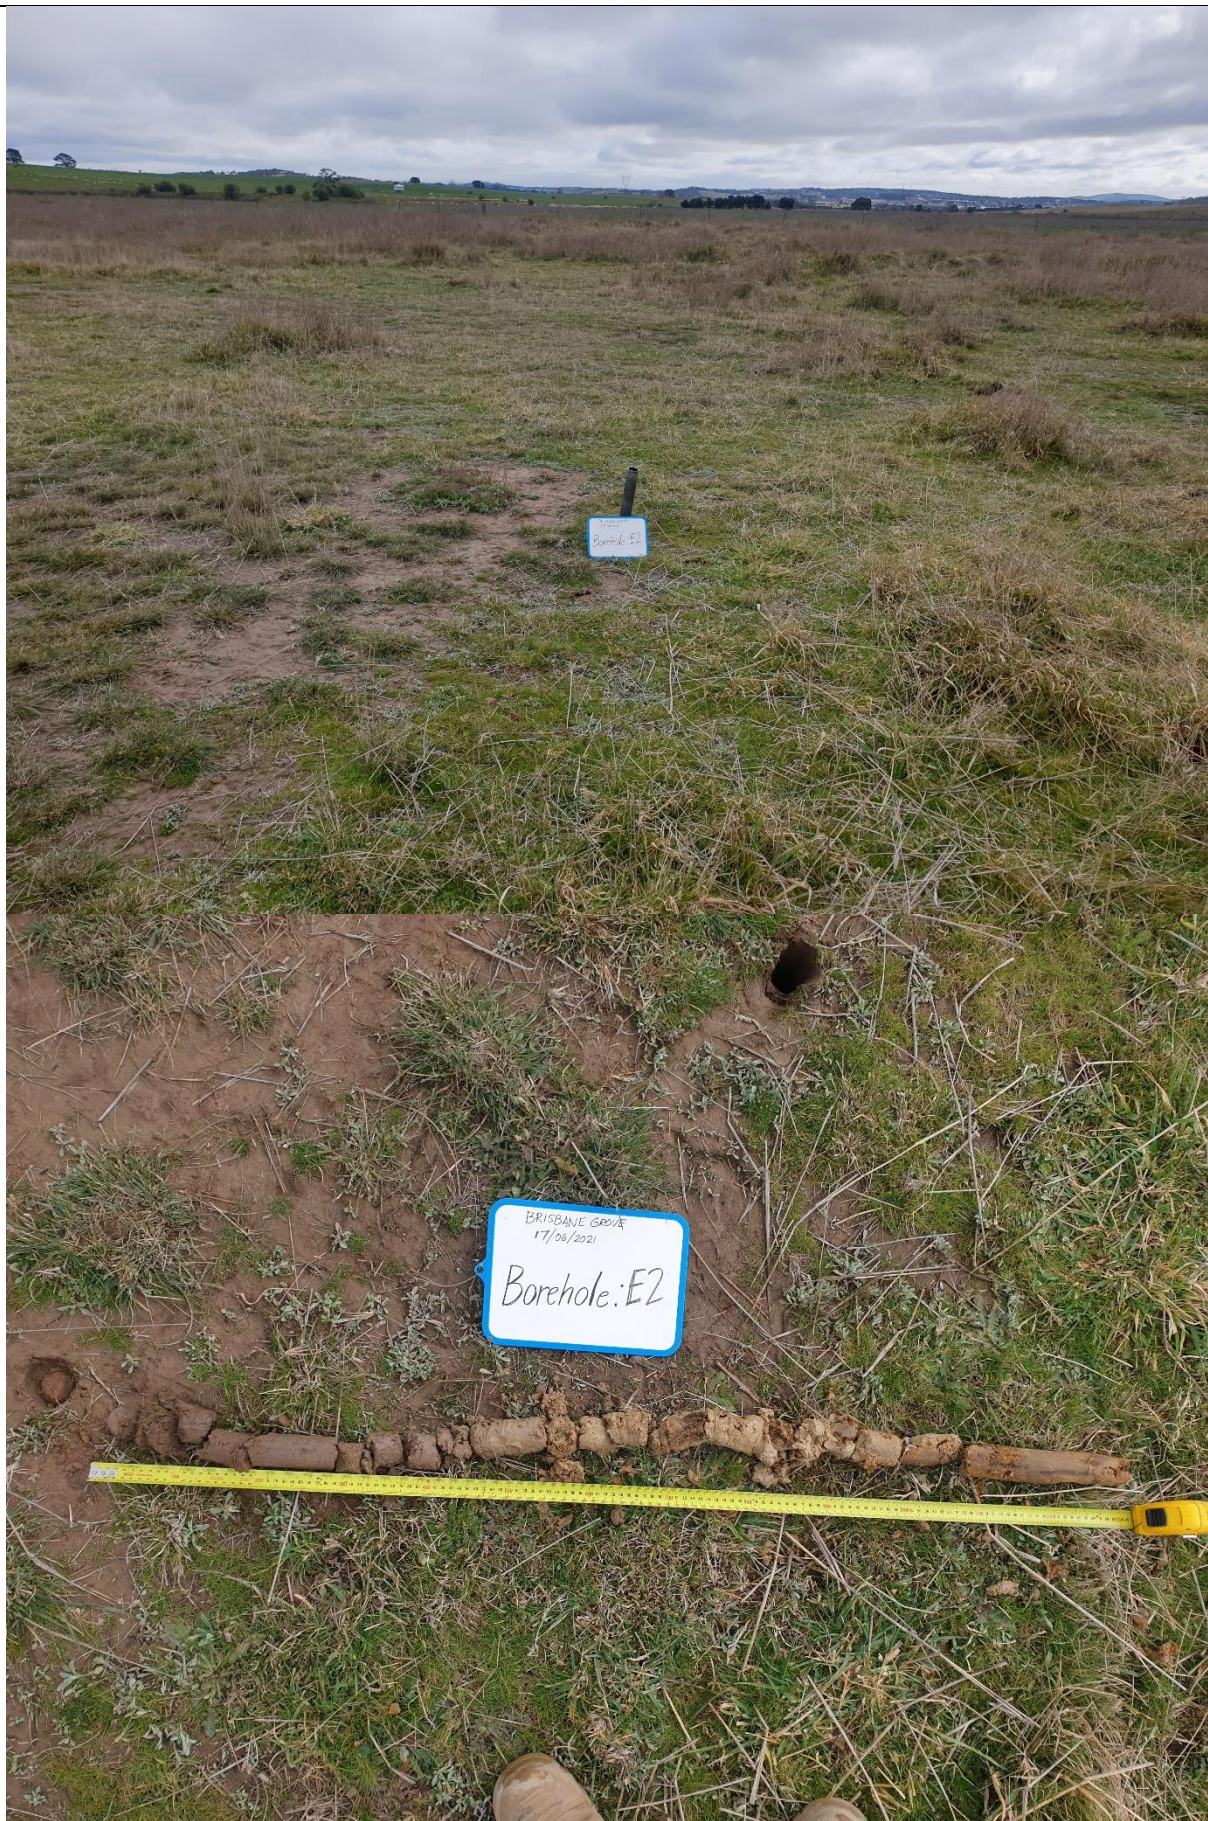
**SOUTHERN REGION LAND ENGINEERING
BRISBANE GROVE RURAL SUBDIVISION
LOCATION AND SOIL CORE PHOTOS (E2)**

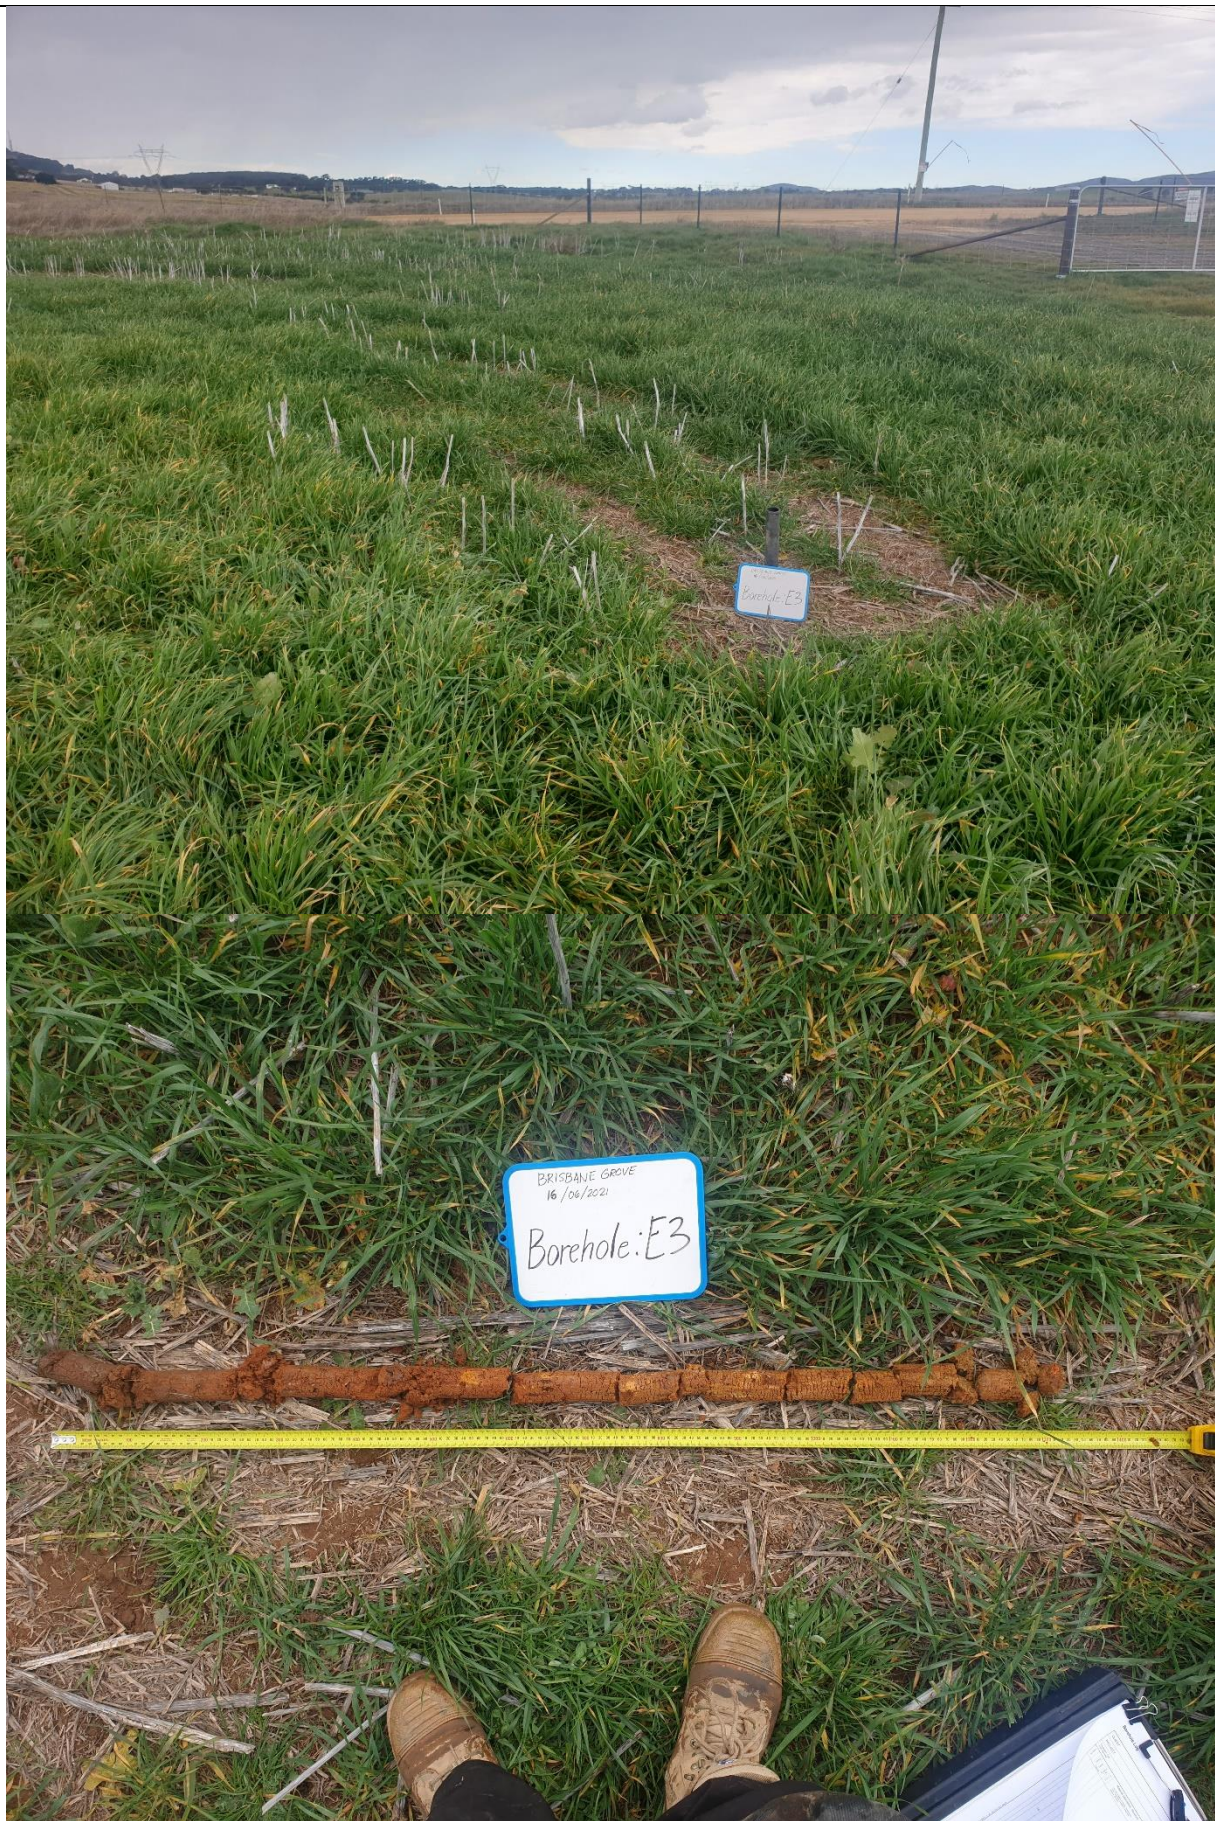
**SOUTHERN REGION LAND ENGINEERING
BRISBANE GROVE RURAL SUBDIVISION
LOCATION AND SOIL CORE PHOTOS (E3)**
