Project 92225.04  
7 December 2022  
R.002.Rev3  
LOC

**Preliminary Groundwater Investigation  
Proposed Rezoning  
621 - 705 The Northern Road, Cobbitty, NSW**

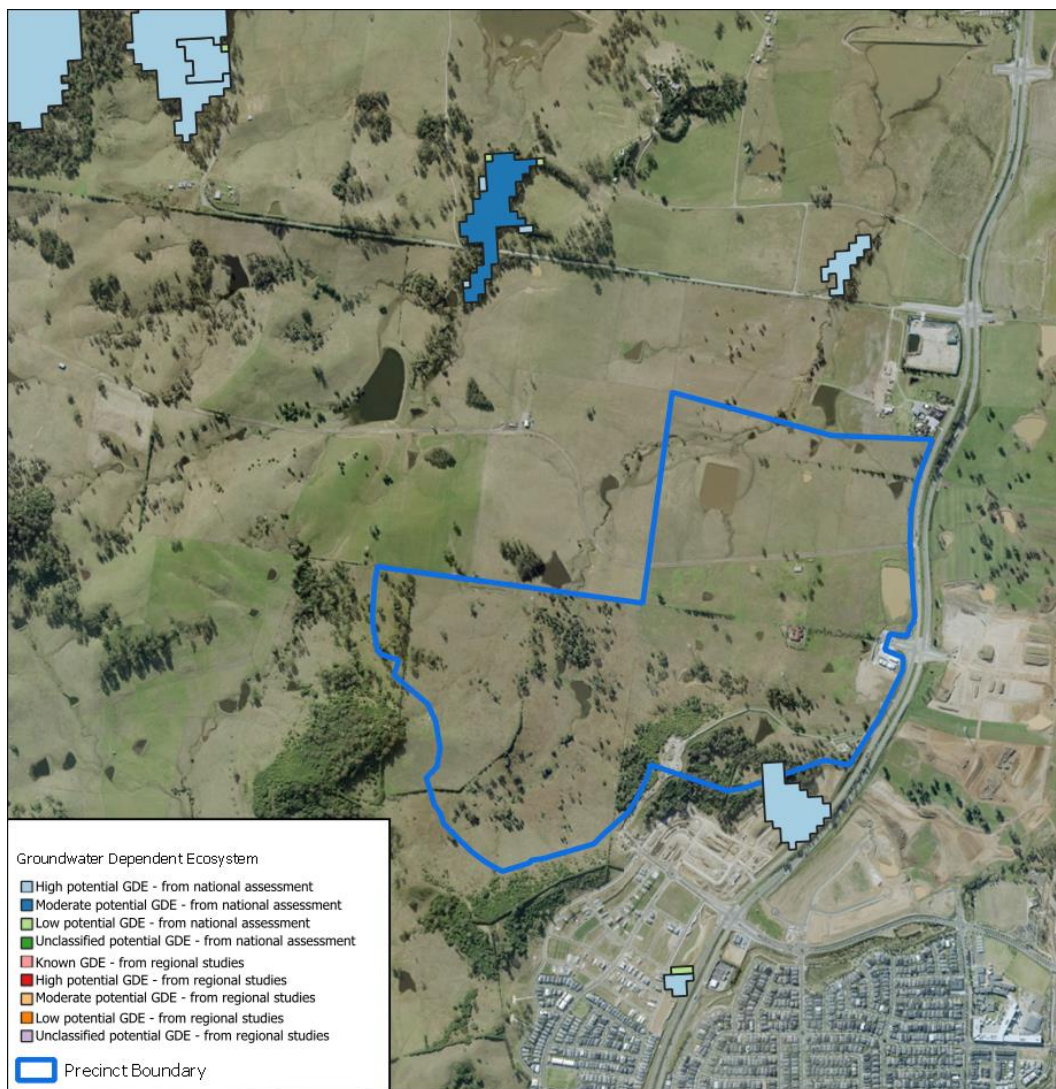
**Figure 1 GDE in proximity to the site**

Review of the *Groundwater Dependant Ecosystem Atlas* (BOM, 2020) did identify a Groundwater Dependant Ecosystem (GDE) of Cumberland Shale Hills Woodland and Cumberland River Flat Forest marginally within the southern boundary and northern boundary of the site, respectively (as shown on Figure 1 below). Groundwater at the site is inferred to generally flow towards the north, and therefore is unlikely to impact on the GDE. To the north of the site, GDEs of Cumberland Shale Hills Woodland and Cumberland River Flat Forest were identified approximately between 400 m to 900 m from the site boundary and were associated with creeks and drainage lines. As stormwater will be directed toward these areas as part of development, it is not considered likely that there will be any impact from development with suitable controls.

The GDEs to the north of the site were associated with creeks and drainage lines. As stormwater will be directed toward these areas as part of development, it is not considered likely that there will be any impact from development. The GDE to the south is inferred to be in a separate groundwater catchment to the majority of the site and is unlikely to be impacted by the current development.

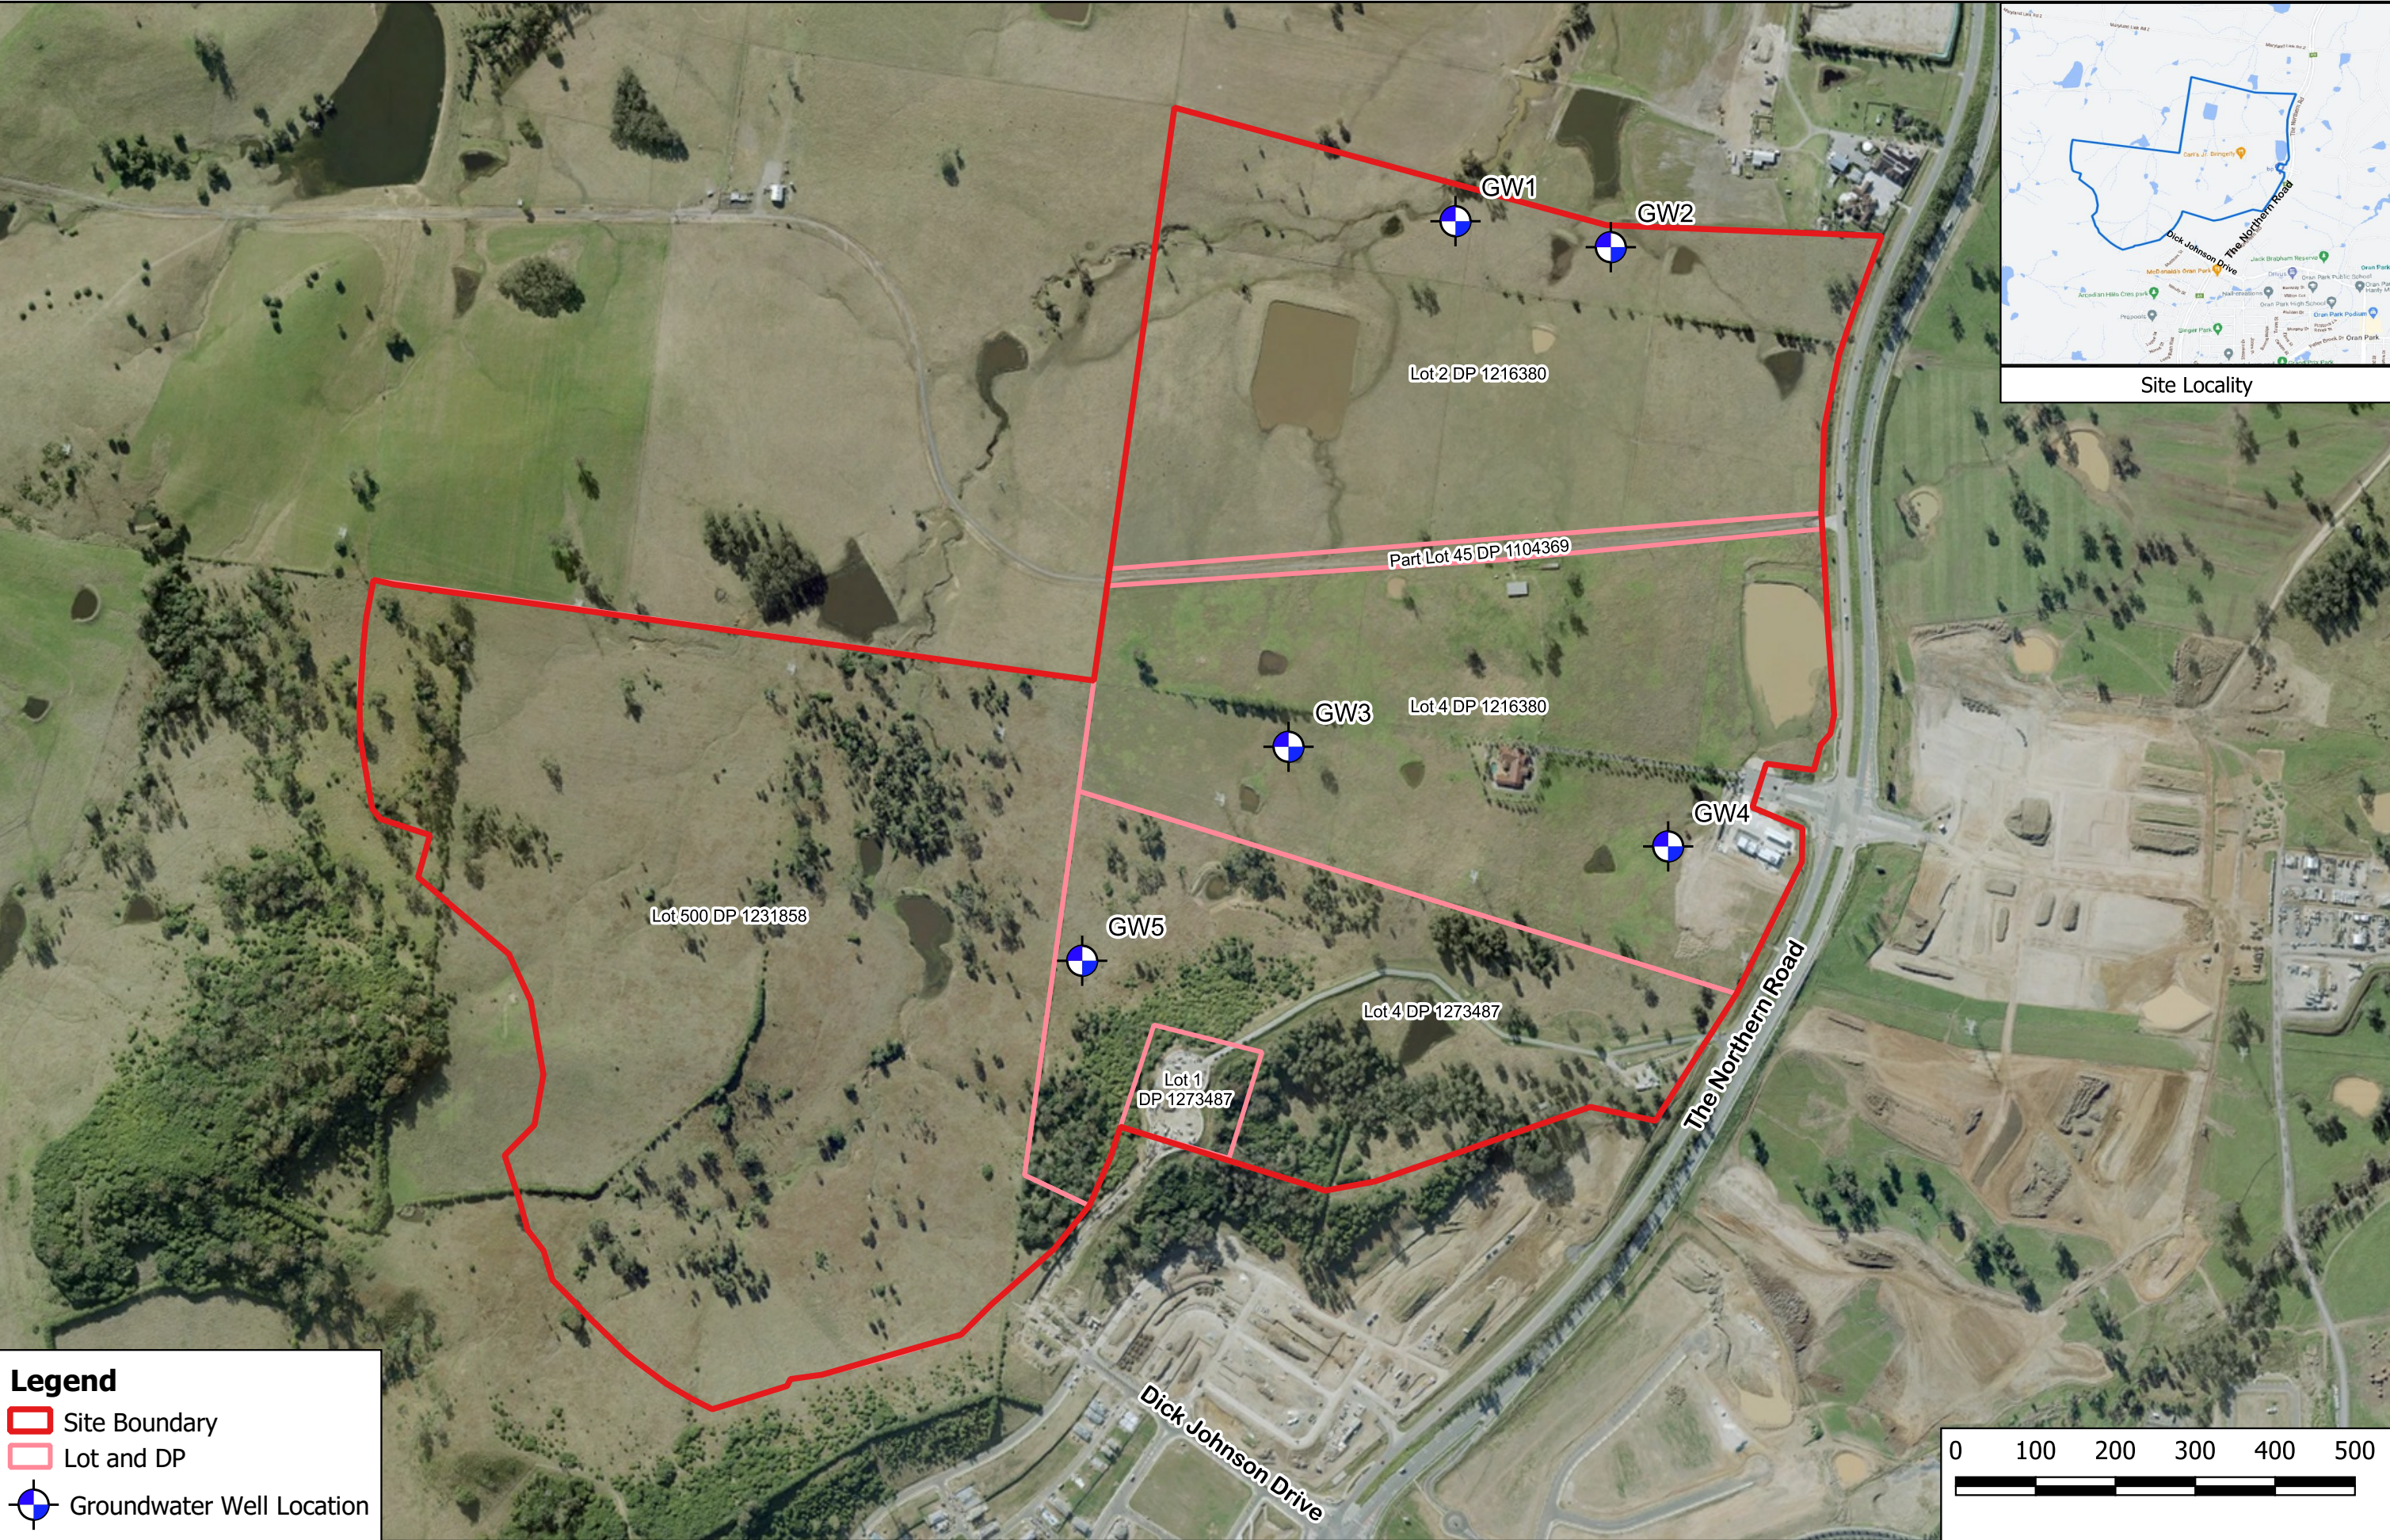
Douglas Partners Pty Ltd (DP) were commissioned by Boyuan Bringelly Pty Ltd to conduct a preliminary groundwater investigation at 621 – 705 The Northern Road, Cobbitty (the site). The site location is shown on Drawing 1, attached.

The locations of the boreholes are shown on Drawing 1, attached. The borehole logs, including the construction details of the wells, are attached, together with notes defining classification methods and descriptive terms.
