## South Creek West Precinct Riparian Assessment

**JJ Cobbitty**

This report should be cited as ‘Eco Logical Australia 2026. South Creek West Precinct Riparian Assessment. Prepared for JJ Cobbitty.’

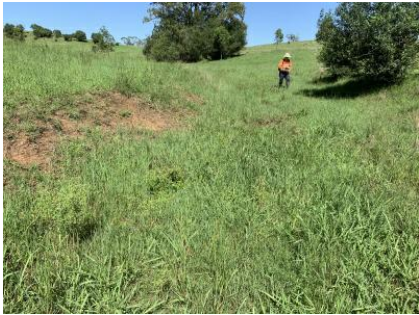
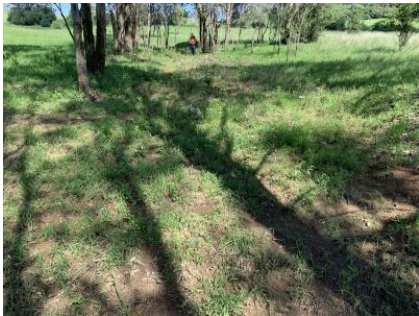
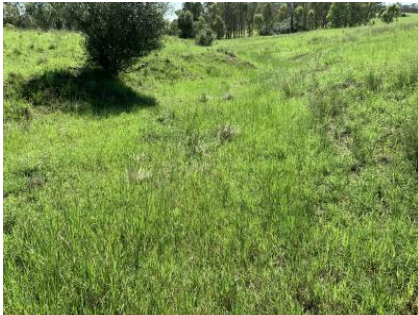
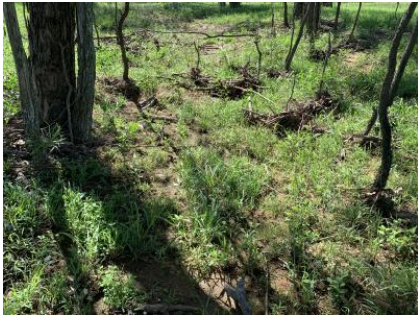
| Reach | Proposed WM Act Status<br>(pending DCCEEW –<br>Water Group approval) | Description | Condition | Photo facing upstream | Photo facing downstream |
|---|---|---|---|---|---|
| 1AA | River | The channel was defined upstream, 1 m with 0.5 high banks that were grassed and gently sloped. The riparian vegetation was mainly absent, except for pasture grasses and scattered African Olive shrubs. Moving downstream, the channel dispersed into overland flow, before becoming defined again at the start of the small patch of native vegetation predominately juvenile <i>E. tereticornis</i> . The bed was bare, with a clay silt benthic substrate. Small turbid pools were present at the low points. Flood debris was evident at the base of riparian vegetation. No aquatic vegetation was observed. | Poor | <p>Upstream section</p> <p>Channel through vegetated riparian zone</p> | <p>Upstream section – sparse riparian vegetation</p> <p>Flood debris on up sides of tree trunks</p> |

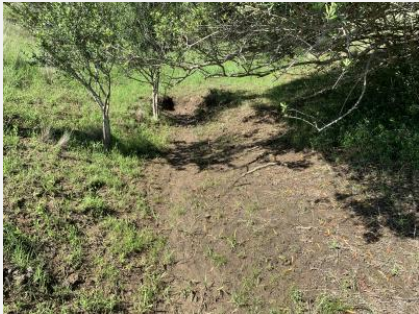
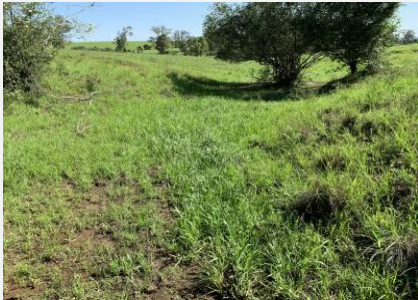
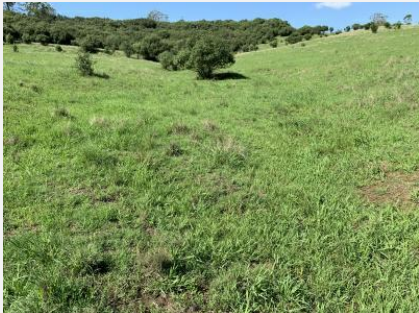
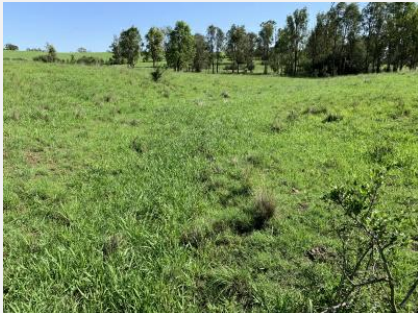
| 1AB | River | The channel began upstream with a small head cut and defined exposed channel for 40 m before becoming overland flow with no defined bed or banks. There was no aquatic vegetation present, and the bed was a coarse clay. The riparian vegetation was African Olive shrubs, and a pasture grasses. | Poor | <p>Head cut upstream</p> | <p>Channel meandering through olives</p> |
| | | | | <p>Overland flow only</p> | <p>Overland flow only</p> |

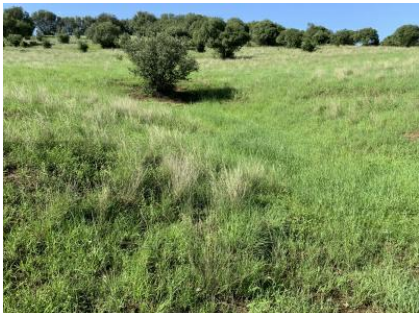
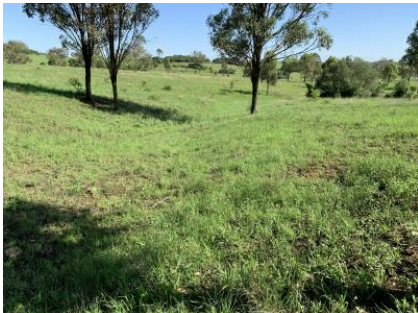
| 1AC | Not a 'river' | No defined bed or banks. Overland flow at a low point only. | Poor | | |

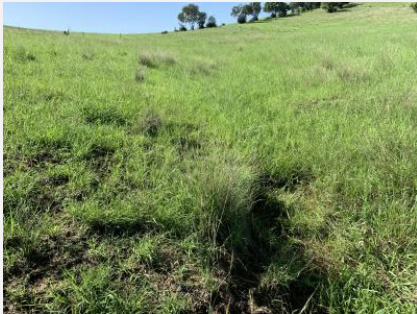
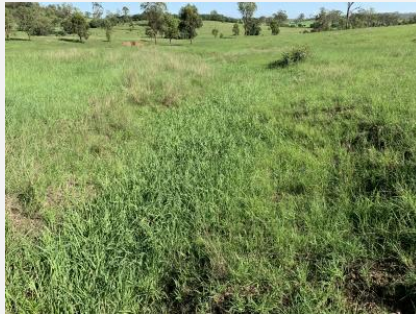
| 1AD | River | Channel 0.5 – 1 m upstream, beginning with a narrow-incised channel before widening downstream with gently sloped grassed banks. The channel was dry with no aquatic vegetation present. There was a small head cut present at the confluence with 1AC. Riparian vegetation was pasture grasses only, no shrubs or trees were present. | Poor | | |

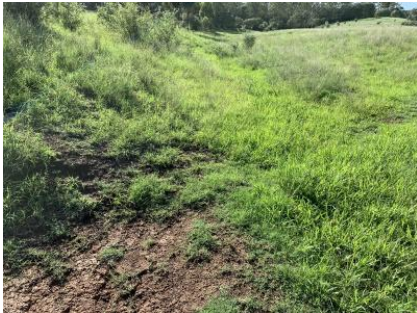
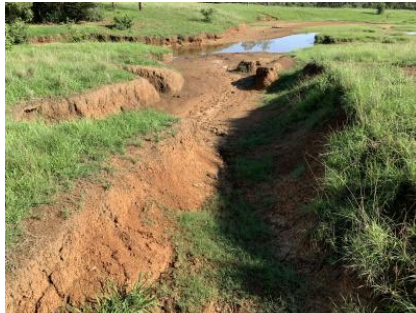
| 1AE | River | Channel varied between 0.5 – 1.5 m wide. Upstream, the channel was shallow with gently sloped banks. Water was present, in long narrow pools. No aquatic vegetation was observed. The channel was vegetated with grass and sedges. Upstream of the confluence with the dam, the channel was deeply eroded with a 1.5 m vertical head cut. One turtle was observed at the confluence. The riparian vegetation along the length of the channel was a mix of native and exotic grasses. <i>Bursaria spinosa</i> and Cotton Bush were present in the wider riparian area. | Moderate | | |

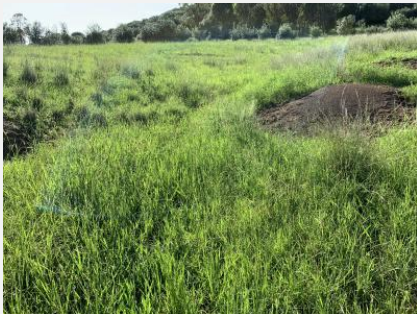
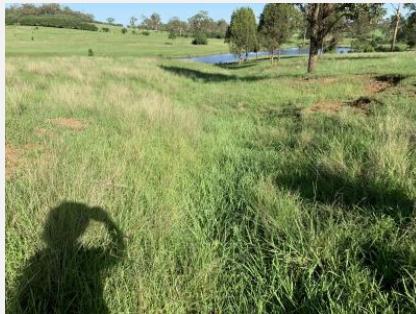
| 1AF | River | Channel approximately 0.5 m wide, with gently sloping grassed banks. Ephemeral creek, with no water at the time of survey. Riparian vegetation was pasture grass only, no trees or shrubs. Scattered <i>Eucalyptus moluccana</i> were observed in the broader riparian zone. | Poor | | |

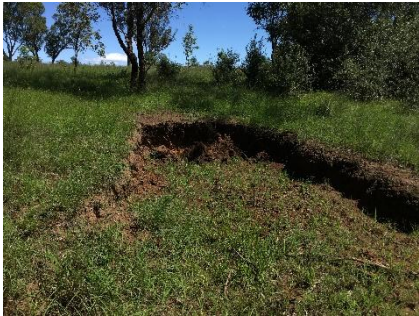
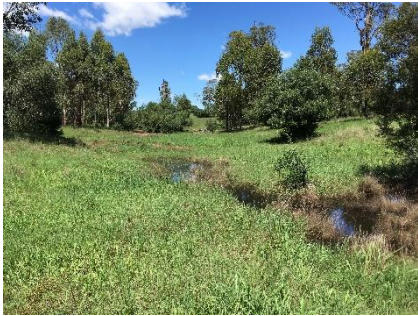
| 1AG | River | Partly dry, ephemeral channel approximately 5 m wide with eroded banks and intermittent standings of water. Some aquatic vegetation including <i>Juncus</i> sp. observed along the channel and banks. | Poor | | |

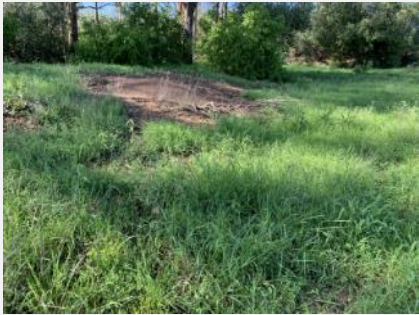
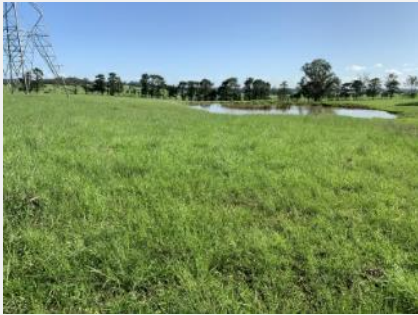
| 1AH | Not a 'river' | No defined bed or banks. Overland flow at a low point only. | Poor | | |

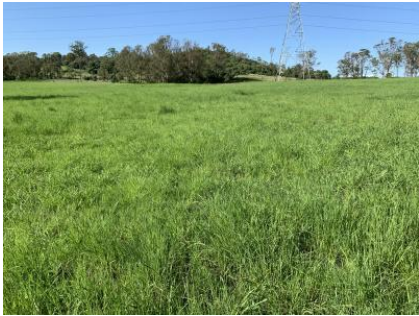
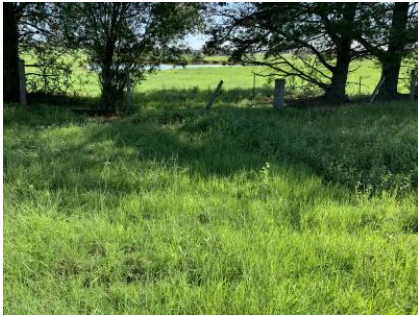
| 1AI | Not a 'river' | No defined bed or banks. Overland flow at a low point only. | Poor | | |

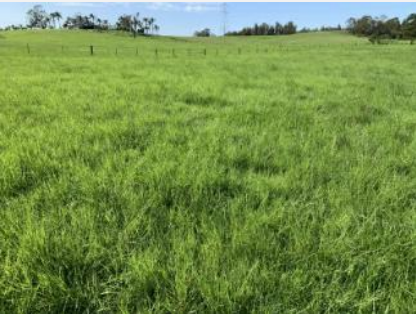
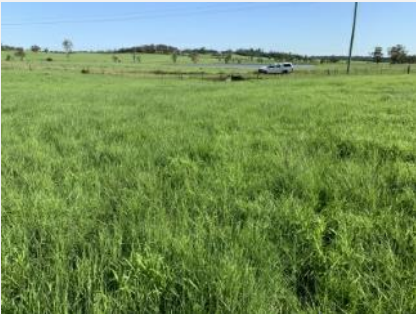
| 1AJ | Not a 'river' | No defined bed or banks. Overland flow at a low point only. | Poor | | |

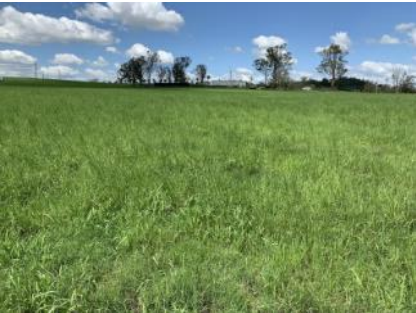
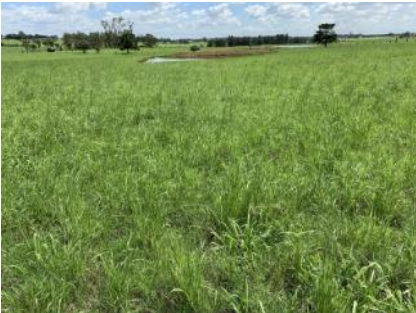
| 1AM | Not a 'river' | No defined bed or banks. Overland flow at a low point only. | Poor | | |

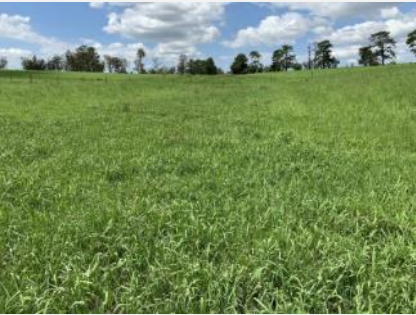
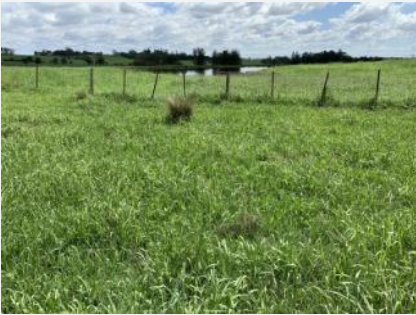
| 1AN | Not a 'river' | No defined bed or banks. Overland flow at a low point only. | Poor | | |

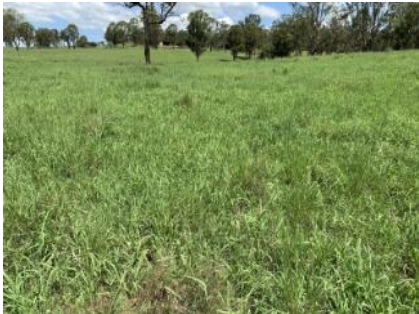
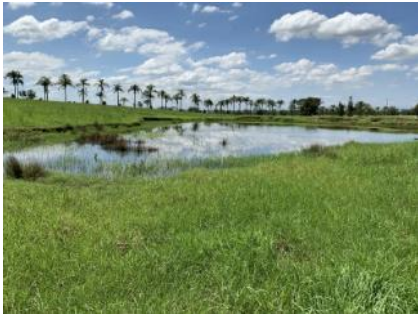
| 1AO | Not a 'river' | No defined bed or banks. Overland flow at a low point only. | Poor | | |

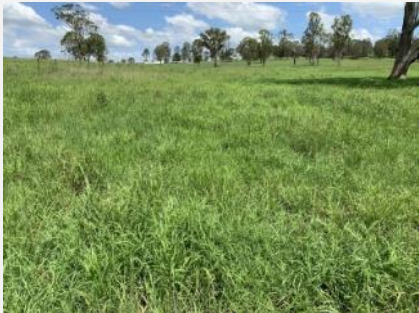
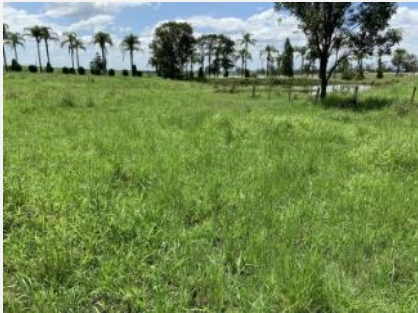
| 1AP | Not a 'river' | No defined bed or banks. Overland flow at a low point only. | Poor | | |

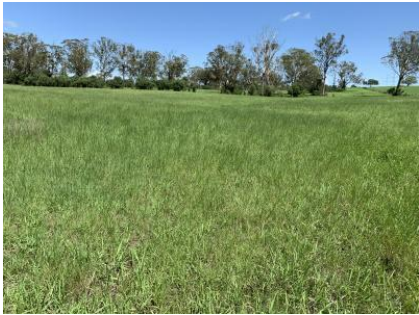
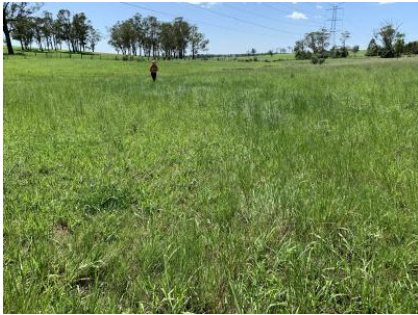
| 1V | Not a 'river' | No defined bed or banks. Overland flow at a low point only. | Poor | | |

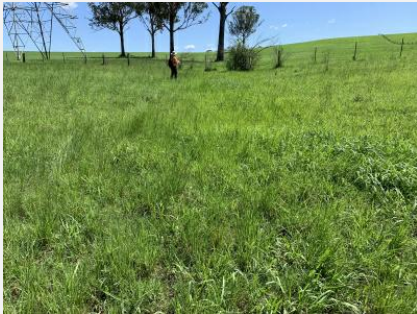
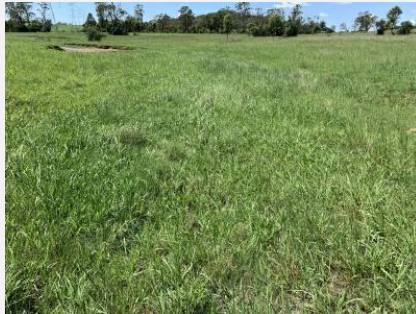
| 1W | Not a 'river' (desktop only – requires field validation) | No defined bed or banks. Overland flow at a low point only. Upstream of site boundary was not validated. | Poor | | |

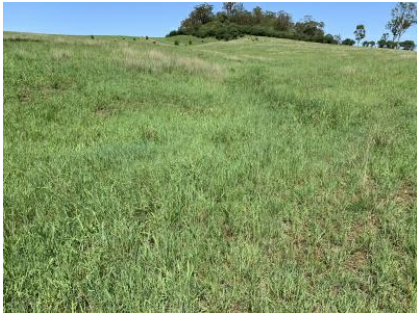
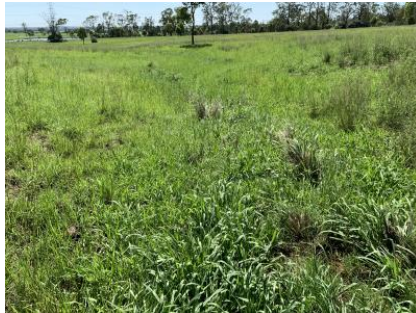
| 1X | River | Channel was defined approximately 100 m downstream from start of Strahler mapping. The banks were 0.5 m wide, with shallow pools of clear water present. The channel then dispersed downstream, becoming overland flow, until it was mapped to flow offsite. | Poor | | |

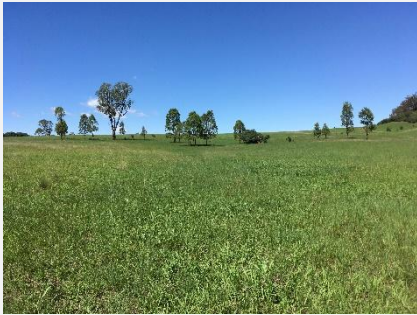
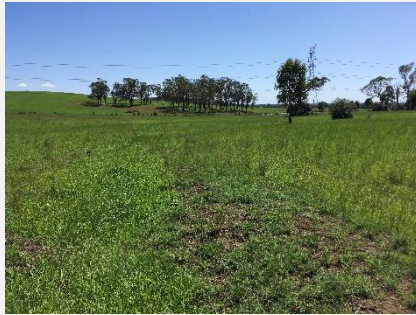
| 1Y | Not a 'river' | No defined bed or banks. Overland flow at low point only. | Poor | | |

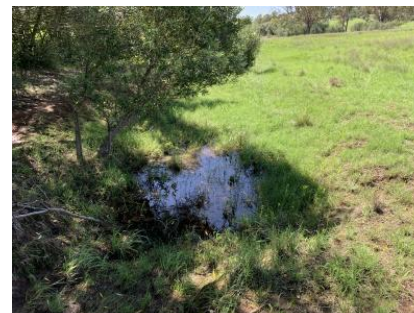
At the upstream extent of the creek, there was an eroded head cut with a small tannin stained pool of water and vegetation that differed to the surrounding pasture grasses. Downstream, the channel dispersed into overland flow, and a single turtle was observed in the grass. The channel developed definition approximately halfway to the confluence with 2F. The channel was 1 m wide, with sloped grassy beds. Water was pooled in at the low points and woody debris was scattered throughout the reach. Riparian vegetation throughout was pasture grasses, patches of African Olive and scattered *Eucalyptus* sp. The creek had some shading, where vegetation was present. One Common Eastern Froglet was heard calling.

Head cut at upstream extent

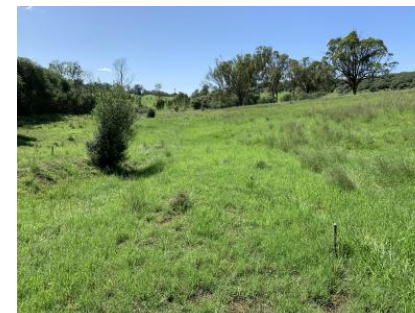
Channel disperses into overland flow

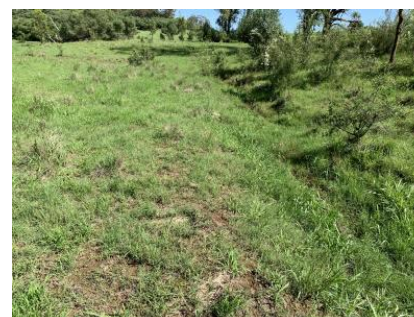
Defined channel

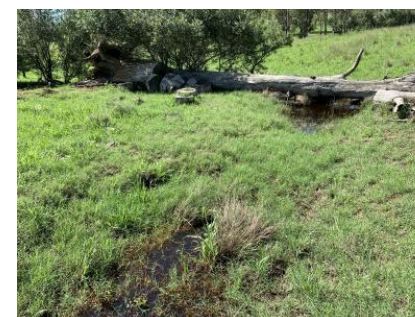
Pooling water in channel

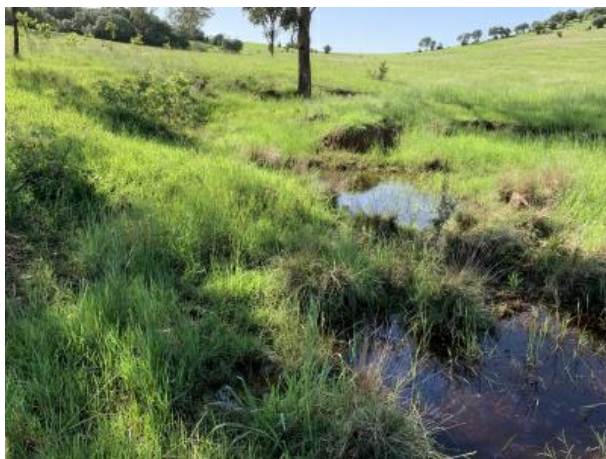
The channel began with a headcut at the confluence of 1AC and 1AD. The channel was 1 m wide, with intermittent pools of water, which had an oily sheen on the surface. No aquatic macrophytes were observed in these pools. Scattered African Olive shrubs lined the channel and the remaining riparian vegetation consisted of pasture grass with no native tree species observed. The channel stopped after 50 m, dispersing into overland flow with no defined bed or banks to direct flow. Approximately 60 m downslope, the channel became defined with a clear eroded headcut. Downstream the channel was 2 m wide, with slumping banks vegetated with grass. Water was present, in depressions in the channel. There was no difference in the vegetation in the channel to the riparian zone. No trees or shrubs were present. No frogs, fish or wader birds were observed using the watercourse. The condition of 2E was moderate.

*Upstream – pools of water with sheen*

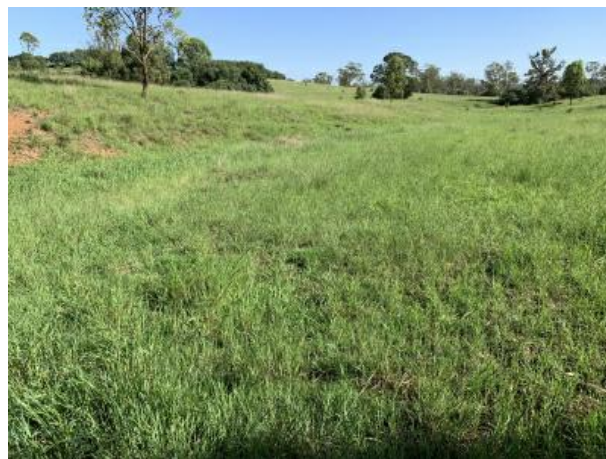
*Facing downstream – channel disappears*

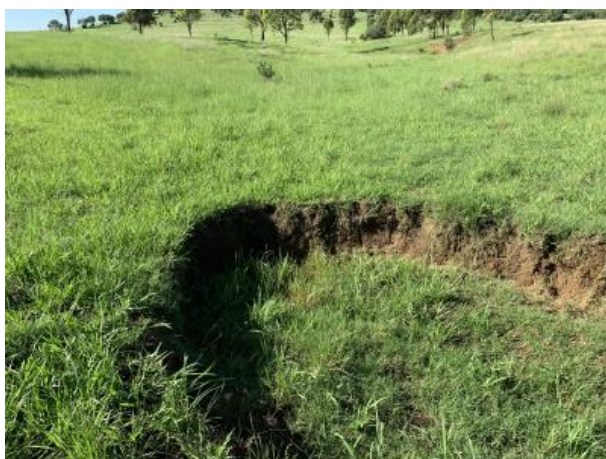
*Defined headcut that begins channel downstream*

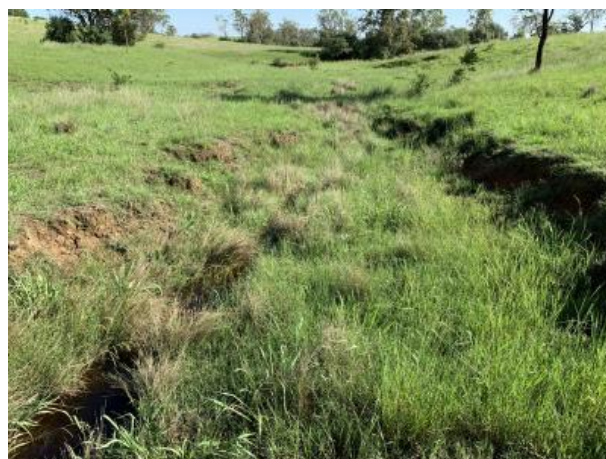
*Banks slumping with pasture in channel*

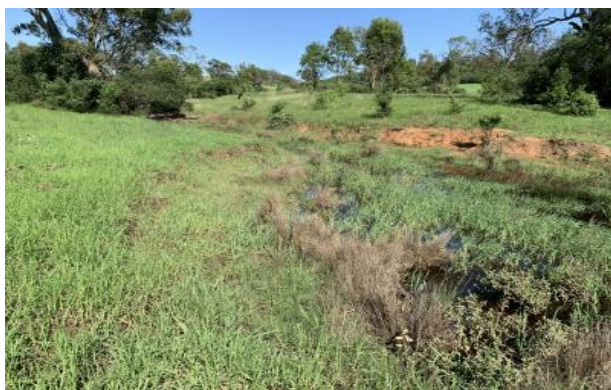
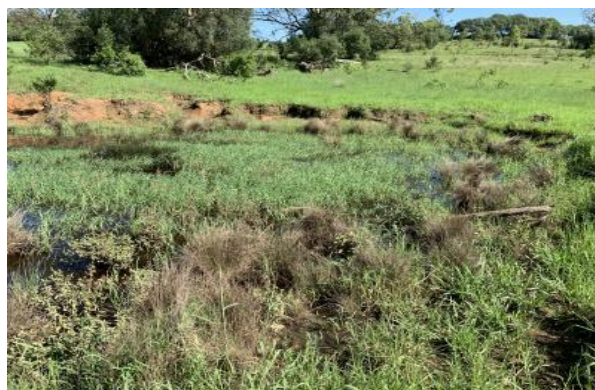
Channel began at the confluence of 1AA and 1AB, the banks were both vertical with undercutting erosion. The channel widened into a pool approximately 7 m wide and 10 m wide, with shallow clear

*Upstream pool with aquatic macrophytes, turtle and Juncus.*

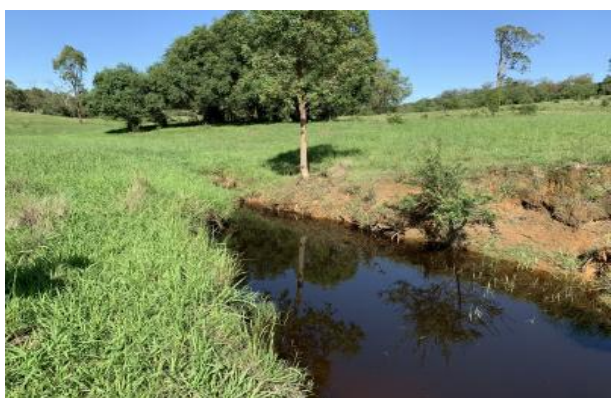
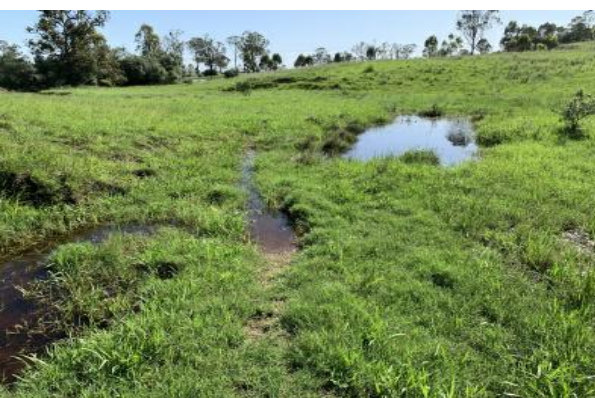
*Narrower channel with tannin-stained water*

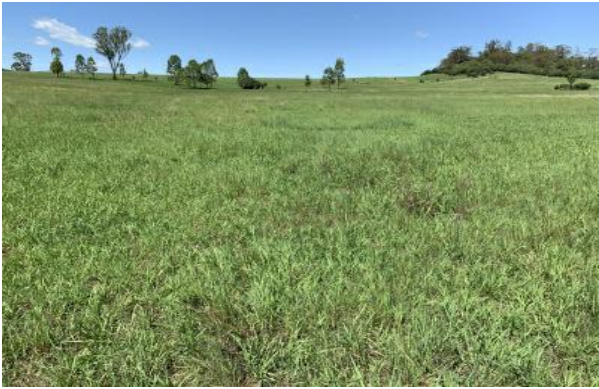
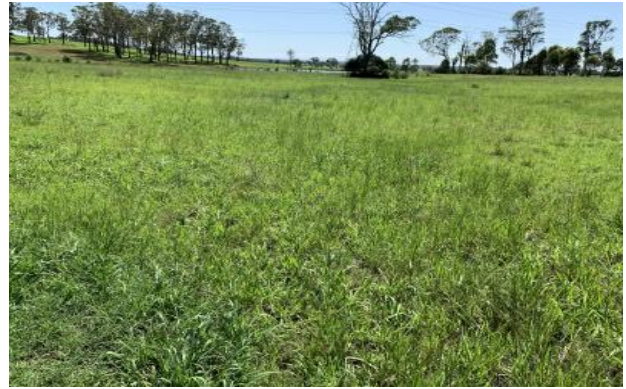
The mapped channel began at the confluence of 1X and 1Y. There was no defined channel for the extent of the reach. No defined bed or banks were observed, or geomorphic processes. The reach has been mapped as a creek however, as there was a channel defined upstream along watercourse 1X. Riparian vegetation was pasture grasses only, no shrubs or trees were present. The condition of this watercourse was poor.

*Facing upstream*

*Facing downstream*

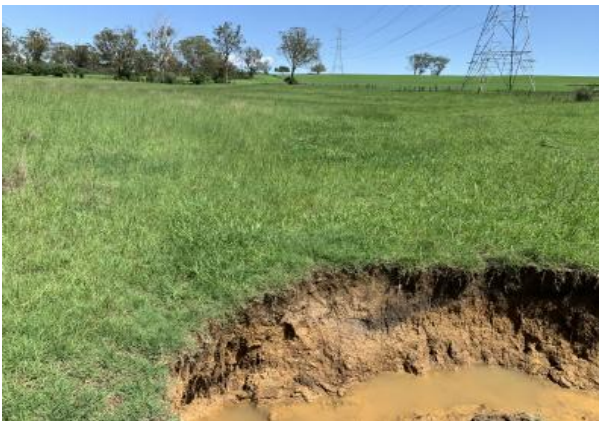
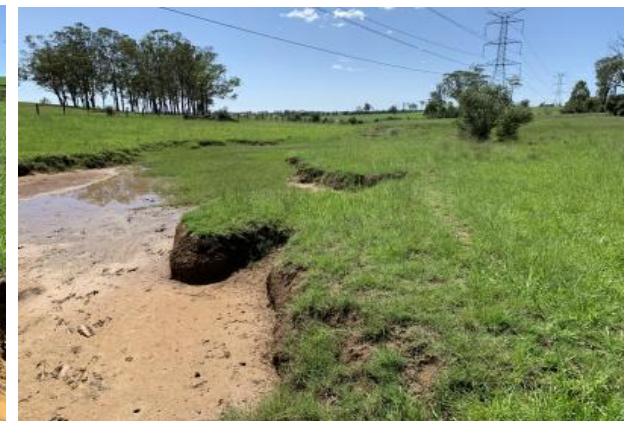
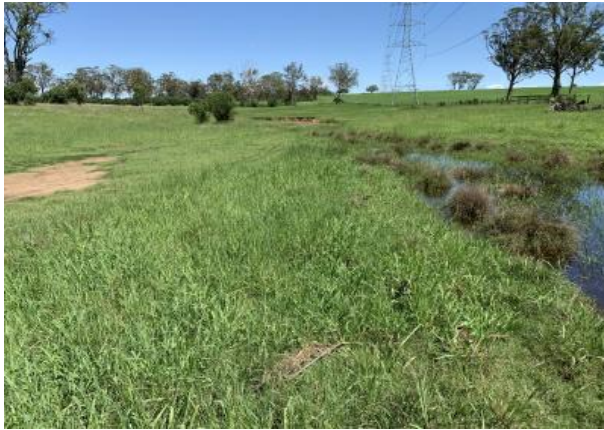
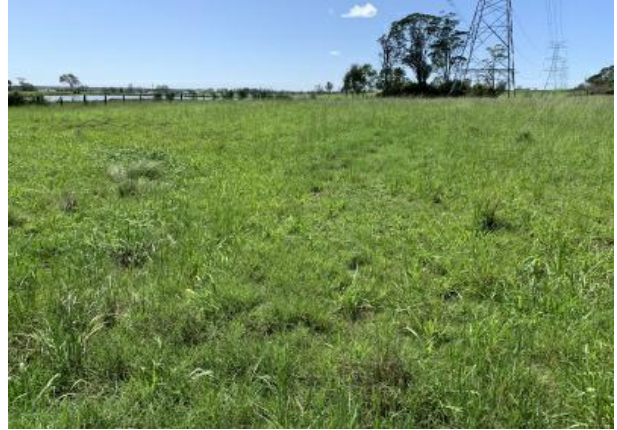
2H begins at the confluence of 1V and 1W. At the confluence of the two first-order creeks, the channel was not defined. The channel began at the top of the first dam, which was dry at the time of the survey. Scattered *Juncus* lined the dam, however, there was no aquatic vegetation present in the dam. The second dam had clear water, with submerged grass. *Juncus* lined the edge of the dam. Downstream of the dams, the channel became overland flow with no defined geomorphic processes. There was a headcut at the boundary of the site, which defined the upstream extent of the dam downstream. There was limited variation along the watercourse, with no snags or boulders present. Turbid water was present in this headcut. No aquatic vegetation was observed in the surveyed reach, no frogs were heard, and no aquatic fauna was observed. The overall condition was moderate.

*Facing upstream – confluence of first-orders*

*Facing downstream – dry dam*

*Facing upstream at second dam – clear water*

*Facing downstream – channel disperses into grass*

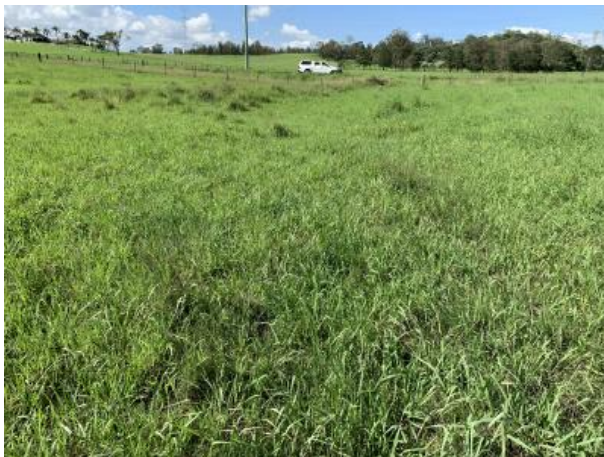
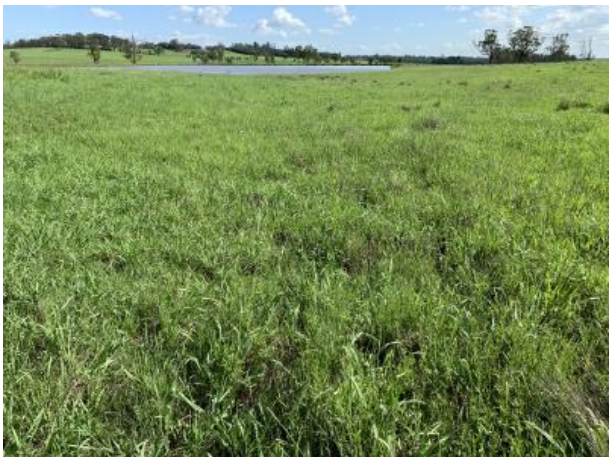
The mapped channel began at the confluence of 1AI and 1AH. There was no defined channel for the extent of the reach. No defined bed or banks were observed, or geomorphic processes. Riparian vegetation was pasture grasses only, no shrubs or trees were present. This watercourse was in poor condition.

*Representative upstream and downstream photos of overland flow*

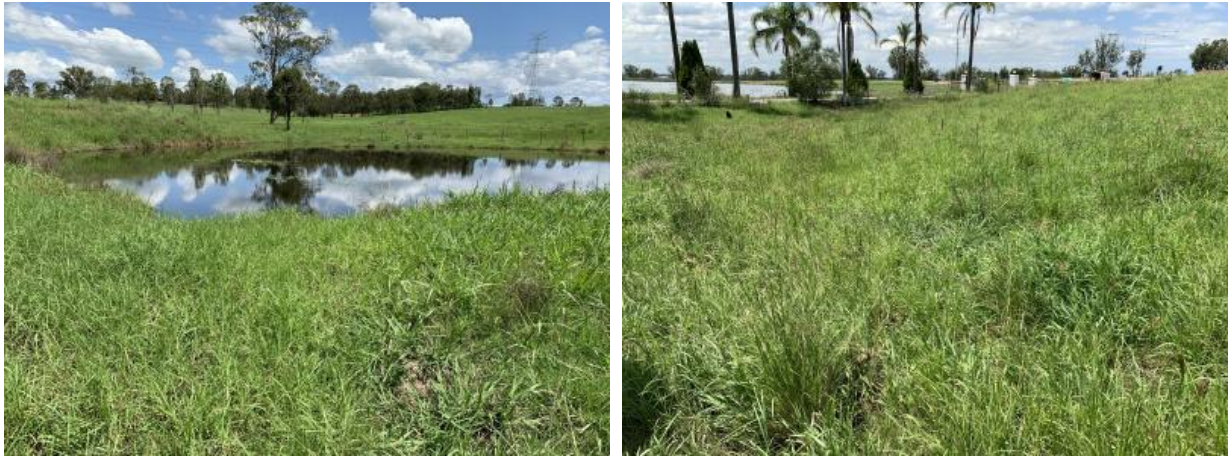
The mapped channel began at the confluence of 1AP and 1AO. There was no defined channel for the extent of the reach, only overland flow at a low point. No defined bed or banks were observed, or geomorphic processes. Riparian vegetation was pasture grasses only, no shrubs or trees were present. This watercourse was in poor condition.

*Representative upstream and downstream photos of overland flow*

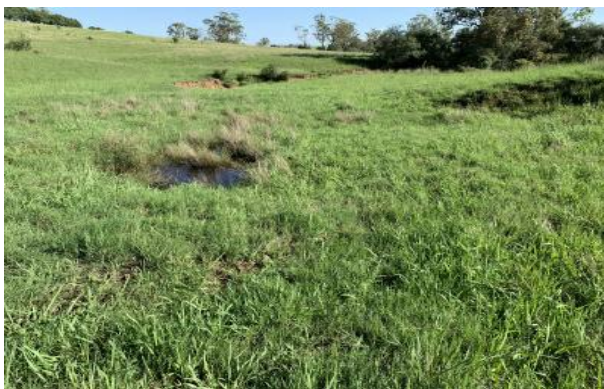
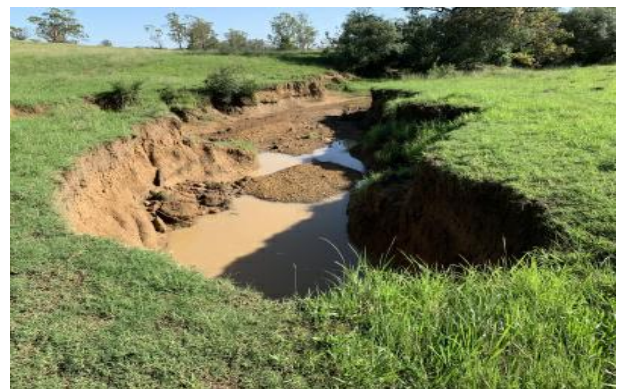
The third-order creek began at the confluence of 2E and 2F, slightly upstream of the large dam. The channel was 2 m wide with gently sloping banks and no riparian trees or shrubs, before entering the dam, at a severely eroded 2 m drop off. Downstream of the dam, the channel was up to 5 m wide and well defined with long, wide pools present throughout which had turbid water and no aquatic macrophytes. Water was also present in other low-lying depressions. Sedges including *Juncus* sp. were observed in wet areas. Banks transitioned from gently sloping with grassy vegetation upstream to bare, steep and undercut downstream. The riparian corridor downstream of the dam had a native canopy with *Eucalyptus tereticornis* and *Angophora* spp. with exotic African Olive dominating the shrub layer. Ground cover was typical pasture grasses. Although no aquatic vegetation was present, there was woody debris throughout to diversify flow after rain. Pools and runs provided habitat for fish, frogs and wader birds. The overall condition was good.

*Facing upstream to confluence of second-orders*

*Channel joins dam at large eroded feature*

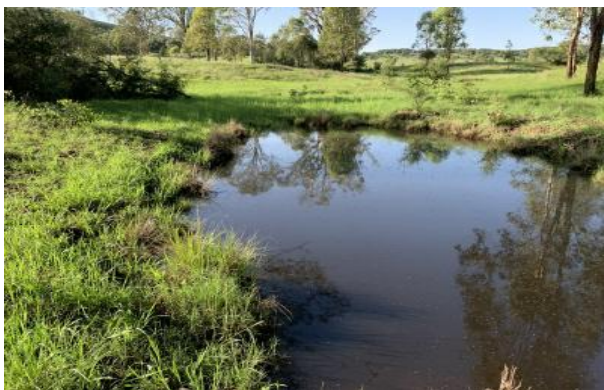
Downstream of dam – facing upstream large wide

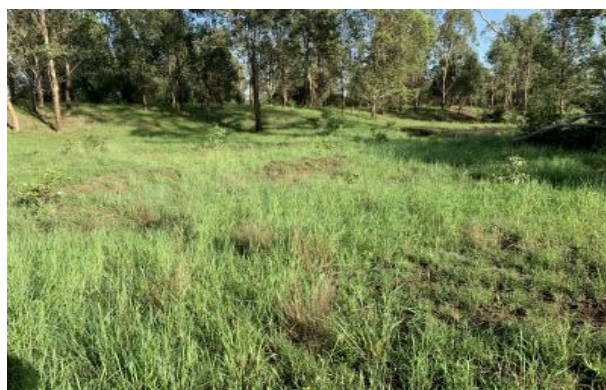
Facing downstream – gently sloped grassy banks

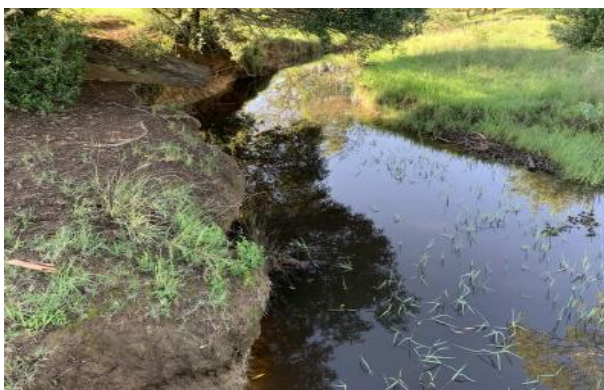
Bare banks with undercutting

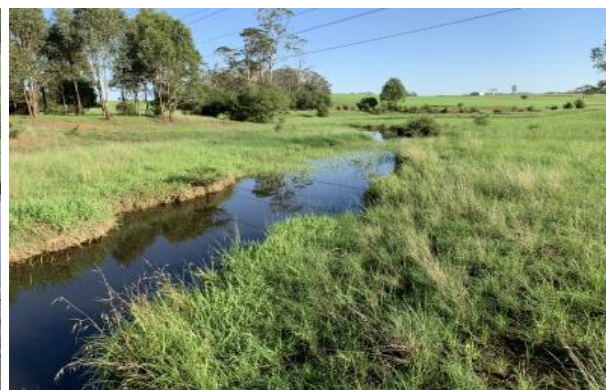
Long pool present at downstream extent of channel

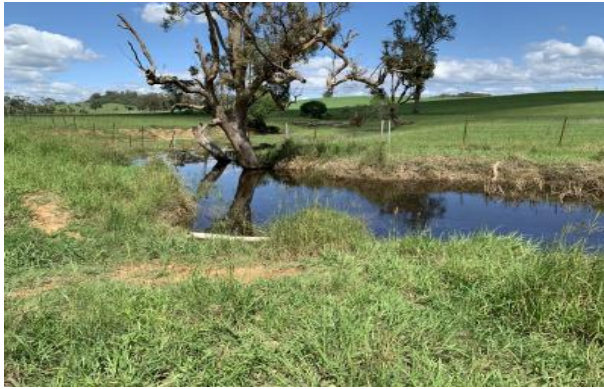
The downstream extent of this fourth order was field-validated. At the upstream extent of the surveyed reach, the channel was evident as 3 m wide and over 1 m deep. Snags and the native aquatic plants *Typha orientalis* (Cumbungi) and Slender Knotweed were present. Birds including *Anas superciliosa* (Pacific Black Duck), *Egretta novaehollandiae* (White-faced Heron) and *Egretta pacifica* (White-necked Heron) were observed using the pool. *Limnodynastes tasmaniensis* (Spotted Marsh Frog) was also heard calling. The left bank was severely eroded, near vertical and bare. The right bank had less gradient and was vegetated by grass. Riparian vegetation was mostly absent, with two large *Melaleuca styphelioides* the only trees observed. The channel meandered downstream, with narrow runs widening into larger pools and low lying saturated grassy depressions. Both banks were vegetated by grass only and were eroded on the out bends. Water in the pools was mostly stagnant with a thick oily sheen. There was evidence of cattle tracking through the creek. At the downstream extent, where the creek flowed outside the study area, was a long deep pool, with clear water. The fence line was filled with debris, damming the pool upstream. Many snags were present. The banks were high, approximately 1.5 m, and bare. There was a small, vegetated area with *Melaleuca* sp. and *Angrophora* sp. surrounding the creek. The roots of some trees were evident sticking out of the eroded banks. *Limnodynastes peronii* (Striped Marsh Frog) and Spotted Marsh Frog were heard calling along the entire reach and frog eggs were observed in many of the pools. The overall condition was good.

*Upstream where creek enters site – long clear pool*

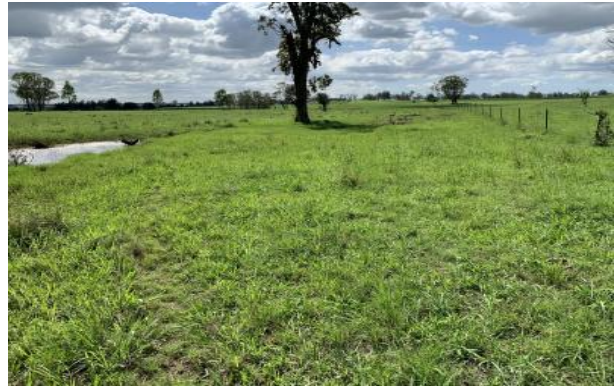
*Facing downstream – sparse riparian vegetation*

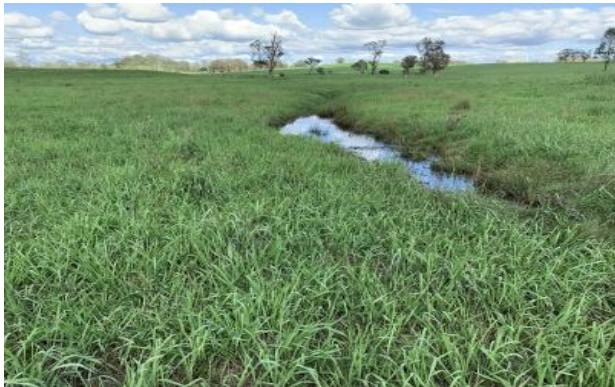
*Centre of surveyed reach – run of shallow water*

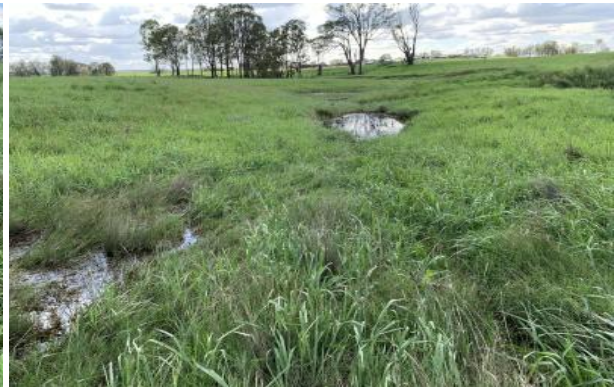
*Runs flowing into pools with stagnant water*

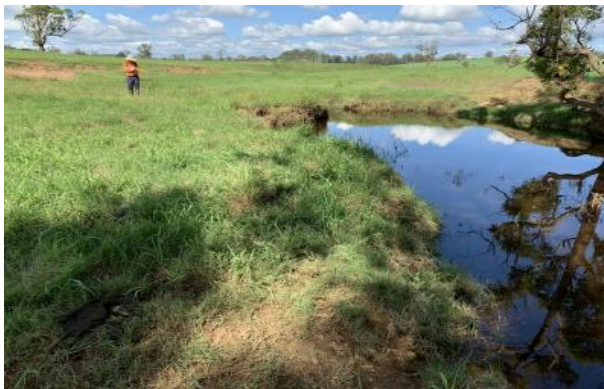
*Downstream pool with debris along the fence line of property*

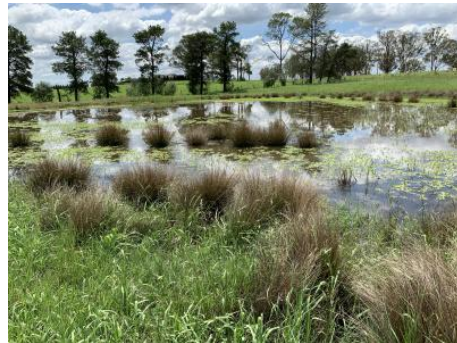
| Reach | Dam Number* | Description | Aquatic Fauna Observed | Aquatic Flora Observed | Representative Photo |
|---|---|---|---|---|---|
| 1AN | 1 | Dam nearing capacity, fringing vegetation was good frog habitat. | <i>Crinia signifera</i> (Common Eastern Froglet), <i>Tachybaptus novaehollandiae</i> (Australasian Grebe) | <i>Ludwigia peploides</i> (Water Primrose), <i>Ottelia ovalifolia</i> (Swamp Lily), <i>Juncus</i> | |

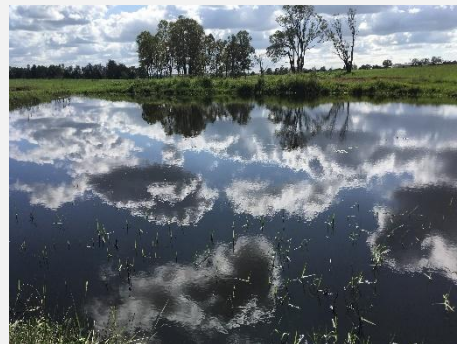
| Reach | Dam Number* | Description | Aquatic Fauna Observed | Aquatic Flora Observed | Representative Photo |
|---|---|---|---|---|---|
| 1AN | 2 | Dam nearing capacity, fringing vegetation, water was clear and shallow. | No fauna observed | Scattered <i>Juncus</i> | |

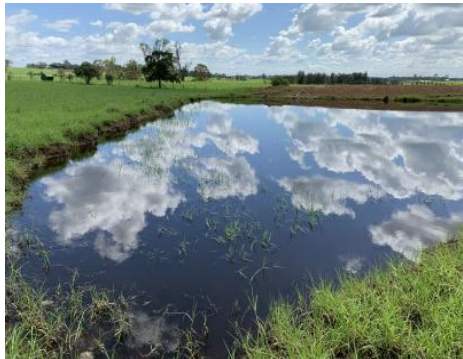
| Reach | Dam Number* | Description | Aquatic Fauna Observed | Aquatic Flora Observed | Representative Photo |
|---|---|---|---|---|---|
| 1AM | 1 | Dam nearing capacity, eroded bank, water was clear with tannins. | 2 turtles | Scattered Juncus | |

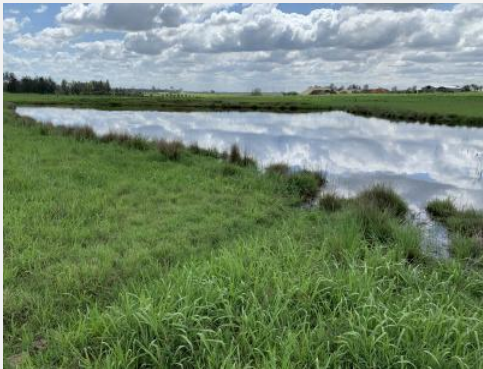
| Reach | Dam Number* | Description | Aquatic Fauna Observed | Aquatic Flora Observed | Representative Photo |
|---|---|---|---|---|---|
| 1AM | 2 | Dam nearing capacity, eroded bank, water was clear with tannins. | 2 turtles | Fringing Juncus | |

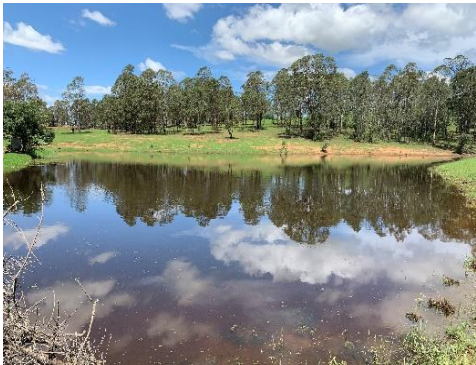
| Reach | Dam Number* | Description | Aquatic Fauna Observed | Aquatic Flora Observed | Representative Photo |
|---|---|---|---|---|---|
| 1AO | 1 | Clear deep water, dam was full with submerged terrestrial vegetation. | 4 turtles, Australasian Grebe, White-faced Heron, <i>Chenonetta jubata</i> (Australian Wood Duck) | Fringing Juncus | |

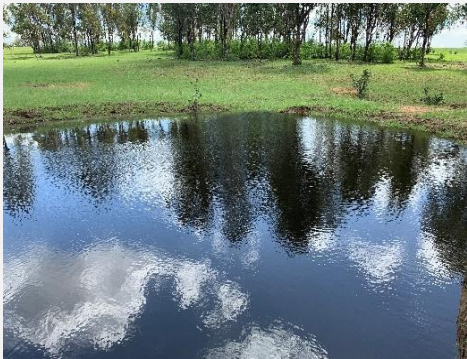
| Reach | Dam Number* | Description | Aquatic Fauna Observed | Aquatic Flora Observed | Representative Photo |
|---|---|---|---|---|---|
| 1AO | 2 | Clear, shallow water. Dam was nearing capacity with submerged terrestrial vegetation. | No fauna observed | No flora observed | |

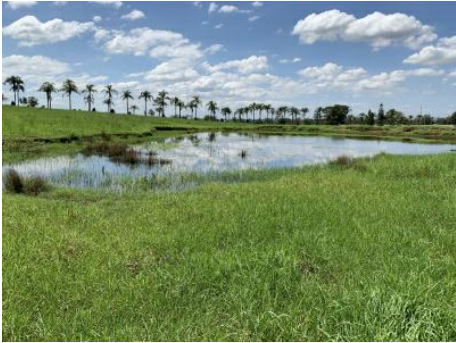
| Reach | Dam Number* | Description | Aquatic Fauna Observed | Aquatic Flora Observed | Representative Photo |
|---|---|---|---|---|---|
| 1AO | 3 | Dam was deep with turbid water and grassy banks. | No fauna observed | Water Primrose, <i>Eleocharis</i> sp. (Bulrush), Juncus, Swamp Lily | |

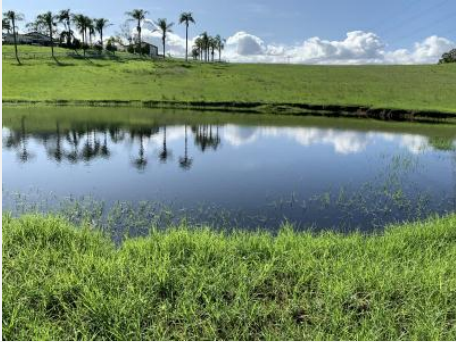
| Reach | Dam Number* | Description | Aquatic Fauna Observed | Aquatic Flora Observed | Representative Photo |
|---|---|---|---|---|---|
| 1AJ | 1 | Water was clear and dam was nearing capacity. | 3 Turtles, 1 Common Eastern Froglet | Fringing Juncus | |

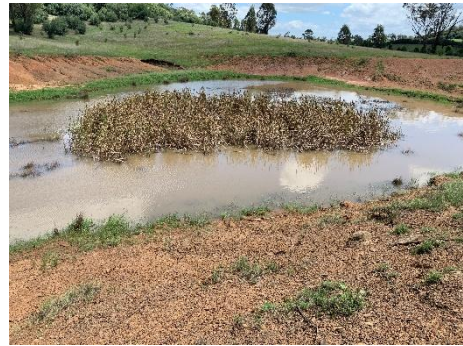
| Reach | Dam Number* | Description | Aquatic Fauna Observed | Aquatic Flora Observed | Representative Photo |
|---|---|---|---|---|---|
| 1AH | 1 | Water was shallow and extremely turbid. A large tunnel had eroded through the dam wall and there were big rills eroding on the upstream side. | 5 Turtles, Australasian Grebe, White-faced Heron, Striped Marsh Frog | Cumbungi in centre of dam, fringing Juncus. | |

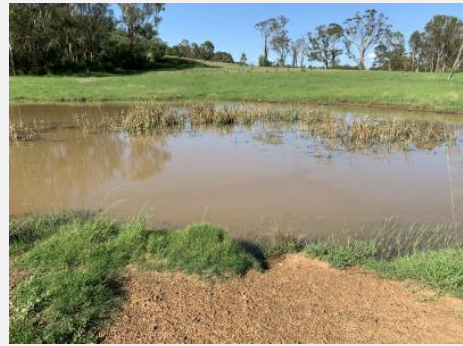
| Reach | Dam Number* | Description | Aquatic Fauna Observed | Aquatic Flora Observed | Representative Photo |
|---|---|---|---|---|---|
| 2I | 1 | Water was turbid, with grass the only fringing vegetation. | Australian Wood Duck, Australasian Grebe, 2 Turtles | Cumbungi | |

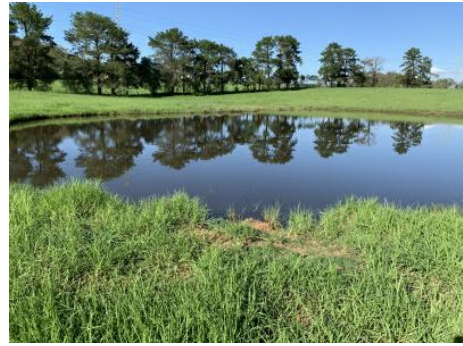
| Reach | Dam Number* | Description | Aquatic Fauna Observed | Aquatic Flora Observed | Representative Photo |
|---|---|---|---|---|---|
| 2I | 2 | Water was less turbid than dam 1, grass only fringing vegetation. | No fauna observed | No flora observed | |

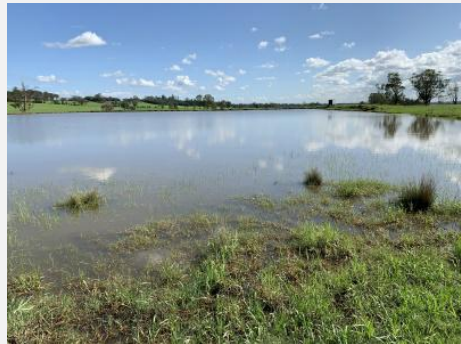
| Reach | Dam Number* | Description | Aquatic Fauna Observed | Aquatic Flora Observed | Representative Photo |
|---|---|---|---|---|---|
| 2I | 3 | Very large dam, reaching capacity. Water was turbid and submerging terrestrial vegetation. | Australian Wood Ducks, Australasian Grebe, Pacific Black Duck, White-faced Heron, 3 Turtles | No flora observed | |

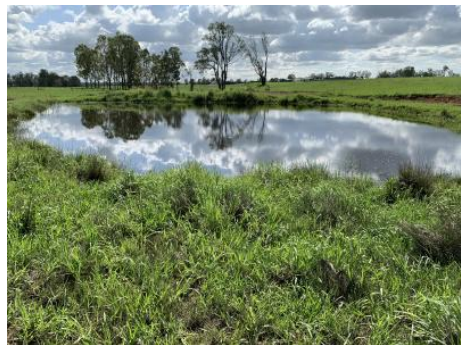
| Reach | Dam Number* | Description | Aquatic Fauna Observed | Aquatic Flora Observed | Representative Photo |
|---|---|---|---|---|---|
| 2I | 4 | Dam walls were very steep, with dam almost at capacity with clear water. Grass was only fringing vegetation. | 3 Turtles | No flora observed | |

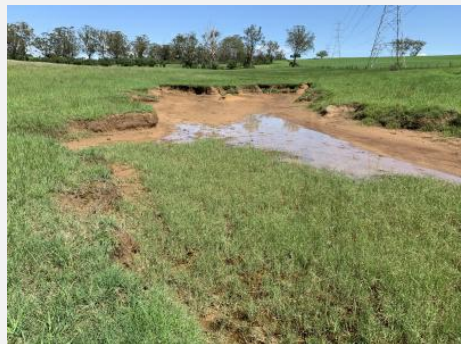
| Reach | Dam Number* | Description | Aquatic Fauna Observed | Aquatic Flora Observed | Representative Photo |
|---|---|---|---|---|---|
| 2H | 1 | Dam was almost dry, with a clay capped silty benthic substrate. | No fauna observed | No flora observed | |

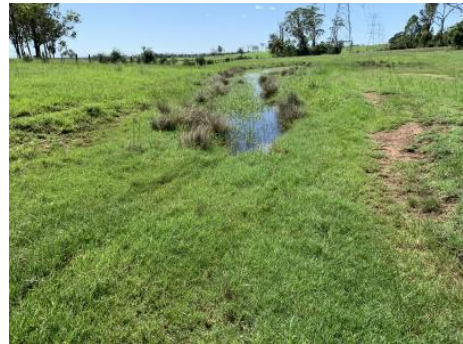
| Reach | Dam Number* | Description | Aquatic Fauna Observed | Aquatic Flora Observed | Representative Photo |
|---|---|---|---|---|---|
| 2H | 2 | Dam had clear, shallow water. Terrestrial grass was submerged. | No fauna observed | No flora observed | |

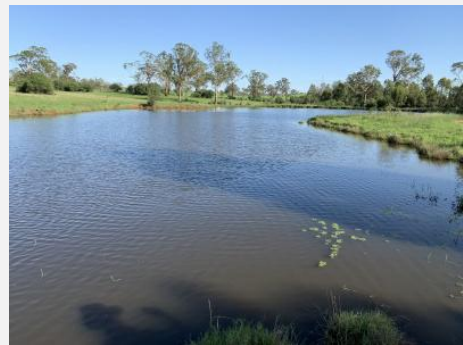
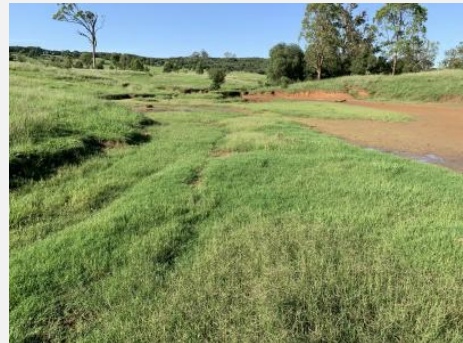
| Reach | Dam Number* | Description | Aquatic Fauna Observed | Aquatic Flora Observed | Representative Photo |
|---|---|---|---|---|---|
| 3D | 1 | Very large dam, with a narrow eroding upstream extent that was dry. The wide downstream extent had turbid water with submerged terrestrial vegetation. | 1 Turtle, White-faced Heron | Sparse Swamp Lily, Fringing Juncus | |
