Report on  
Preliminary Geotechnical and Salinity Assessment

Proposed Rezoning  
Sub Precinct 5, South Creek West, NSW

Prepared for  
Boyuan Bringelly Pty Ltd

Project 92225.02  
December 2022

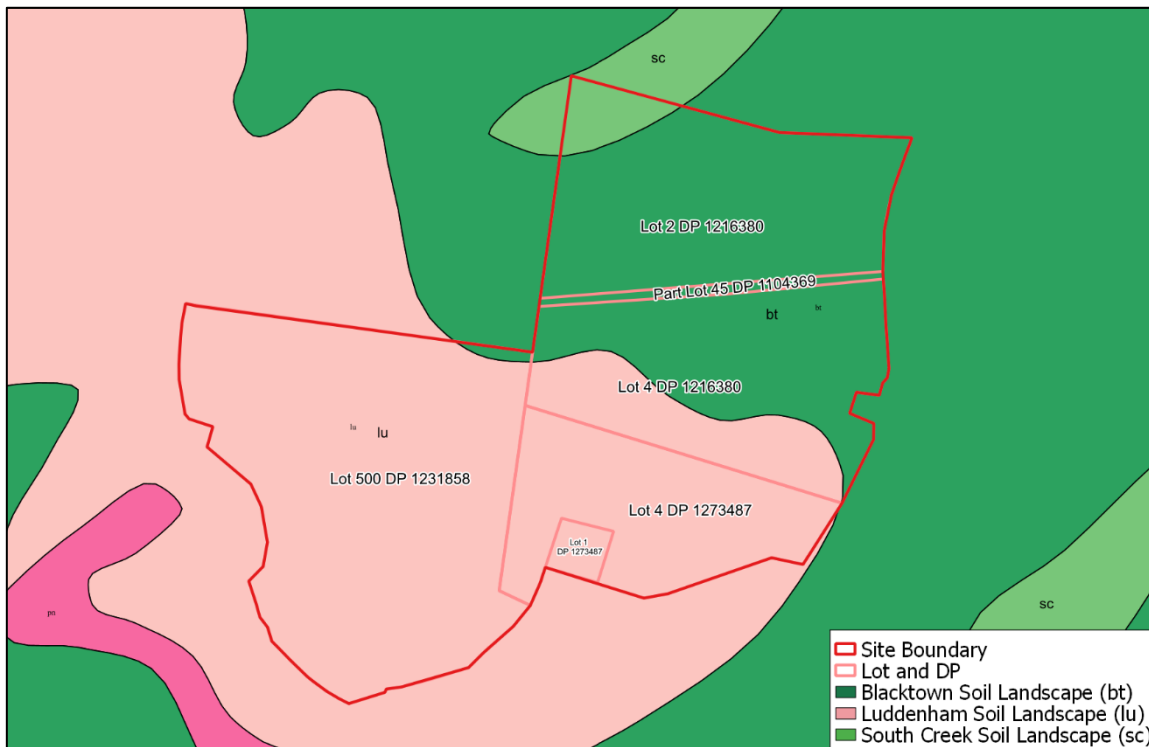
**Figure 1 Penrith 1:100 000 Soils Landscape Sheet, with the site boundary for the revised ILP.**

The Luddenham erosional soil landscape is characterised by undulating to rolling low hills on Wianamatta Group shales, with slope grades usually 5 - 20% and local relief of 50 - 80 m. Soils within this landscape are typically described as moderately reactive with a high erosion hazard. On crests and upper slopes (which is consistent with the observed topographic features within the southern and western portions of this site), these soils are typically described as dark brown or red podzolic soils, shallow to moderately deep (<1.0 m thick). On lower slopes and within drainage lines, these soils are typically described as yellow podzolic soils, moderately deep (<1.5 m thick).

The Blacktown residual soil landscape is characterised by gently undulating rises on Wianamatta Group shales, with slopes usually <5% and local relief to 30 m. Soils within this landscape are typically described as moderately reactive with low fertility, poor soil drainage and highly plastic subsoil. On crests, upper slopes and well drained areas, these soils are typically described as red and brown, shallow to moderately deep podzolic soils (<1.0 m thick). Elsewhere, on lower slopes and in areas of poor drainage, these soils are typically described as yellow, deep podzolic soils and soloths (1.5 - 3.0 m thick: which is consistent with the observed topographic features within the northern portions of this site).

The South Creek alluvial soil landscape is characterised by floodplains, valley flats and drainage depressions within channels across the Cumberland Plain, and are usually relatively flat with incised channels. Soils are often very deep and layered, overlying bedrock or relict residual soils (red and yellow podzolic soils). Soils within this landscape are typically described as being subject to erosion (hazard) and frequent flooding.

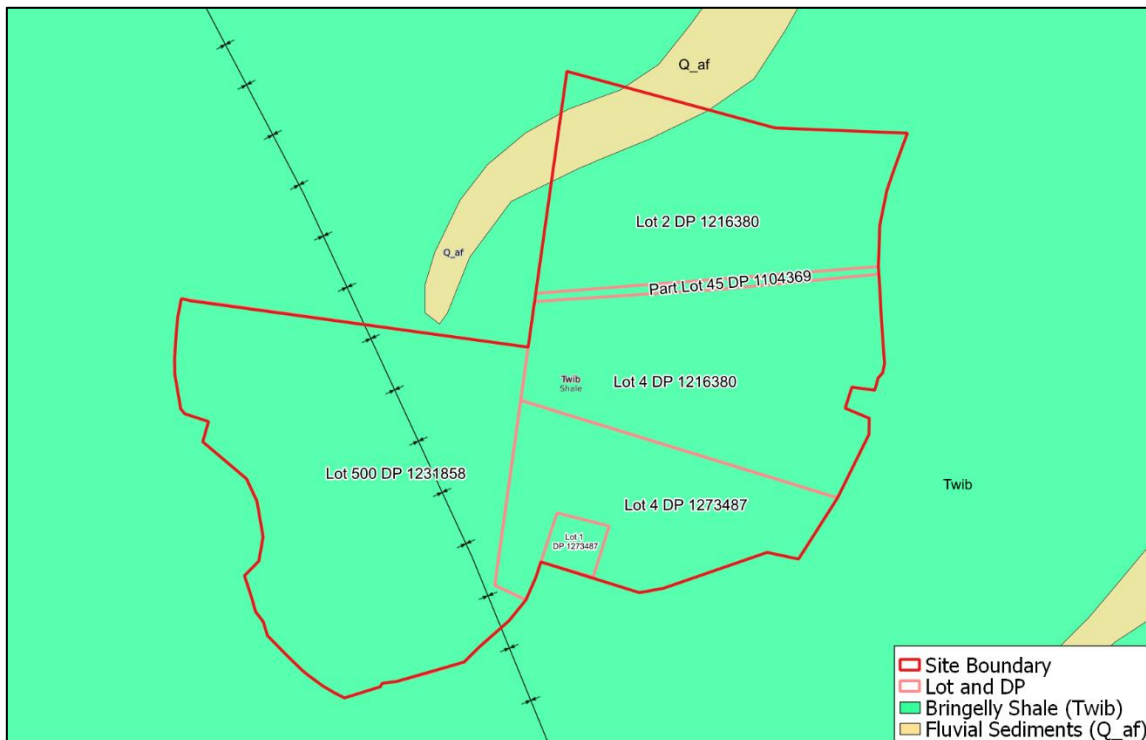
**Figure 2 Penrith 1:100,000 Geological Sheet, with the site boundary for the revised ILP.**

Reference to the Penrith 1:100 000 Geological Sheet (Herbert & Smith, 1991) indicates that the site is underlain by both Bringelly Shale (mapping unit Twib) of the Wianamatta Group of Triassic age and Fluvial Sediments (mapping unit Q\_af) of Quaternary age. The Bringelly Shale formation typically comprises shale, carbonaceous claystone, claystone, laminite, fine to medium-grained lithic sandstone, rare coal and tuff. The Fluvial Sediments formation typically comprises fine-grained sand, silt and clay. Un-named sandstone members within the Bringelly Shale are present within the southern parts of the site, forming elongated ridgelines.

The NSW Seamless geology dataset (Colquhoun, et al., 2019) indicates that a broad, north-west striking synclinal fold structure is present within the western part of the site, with another synclinal fold structure present about 5 km to the north-east. This data indicates that Lot 4 in DP1273487 is on the eastern limb of the syncline, that most of Lot 500 in DP1231858 is on the western limb of the syncline, and that an anticline (or a series of more than one smaller anticlines) is likely to be present within the eastern part of the site. Therefore, bedding within the rock on the western side of the ridgeline is likely to be dipping towards the south-west, and bedding within the rock on the eastern side of the ridgeline could be dipping towards the north-east.

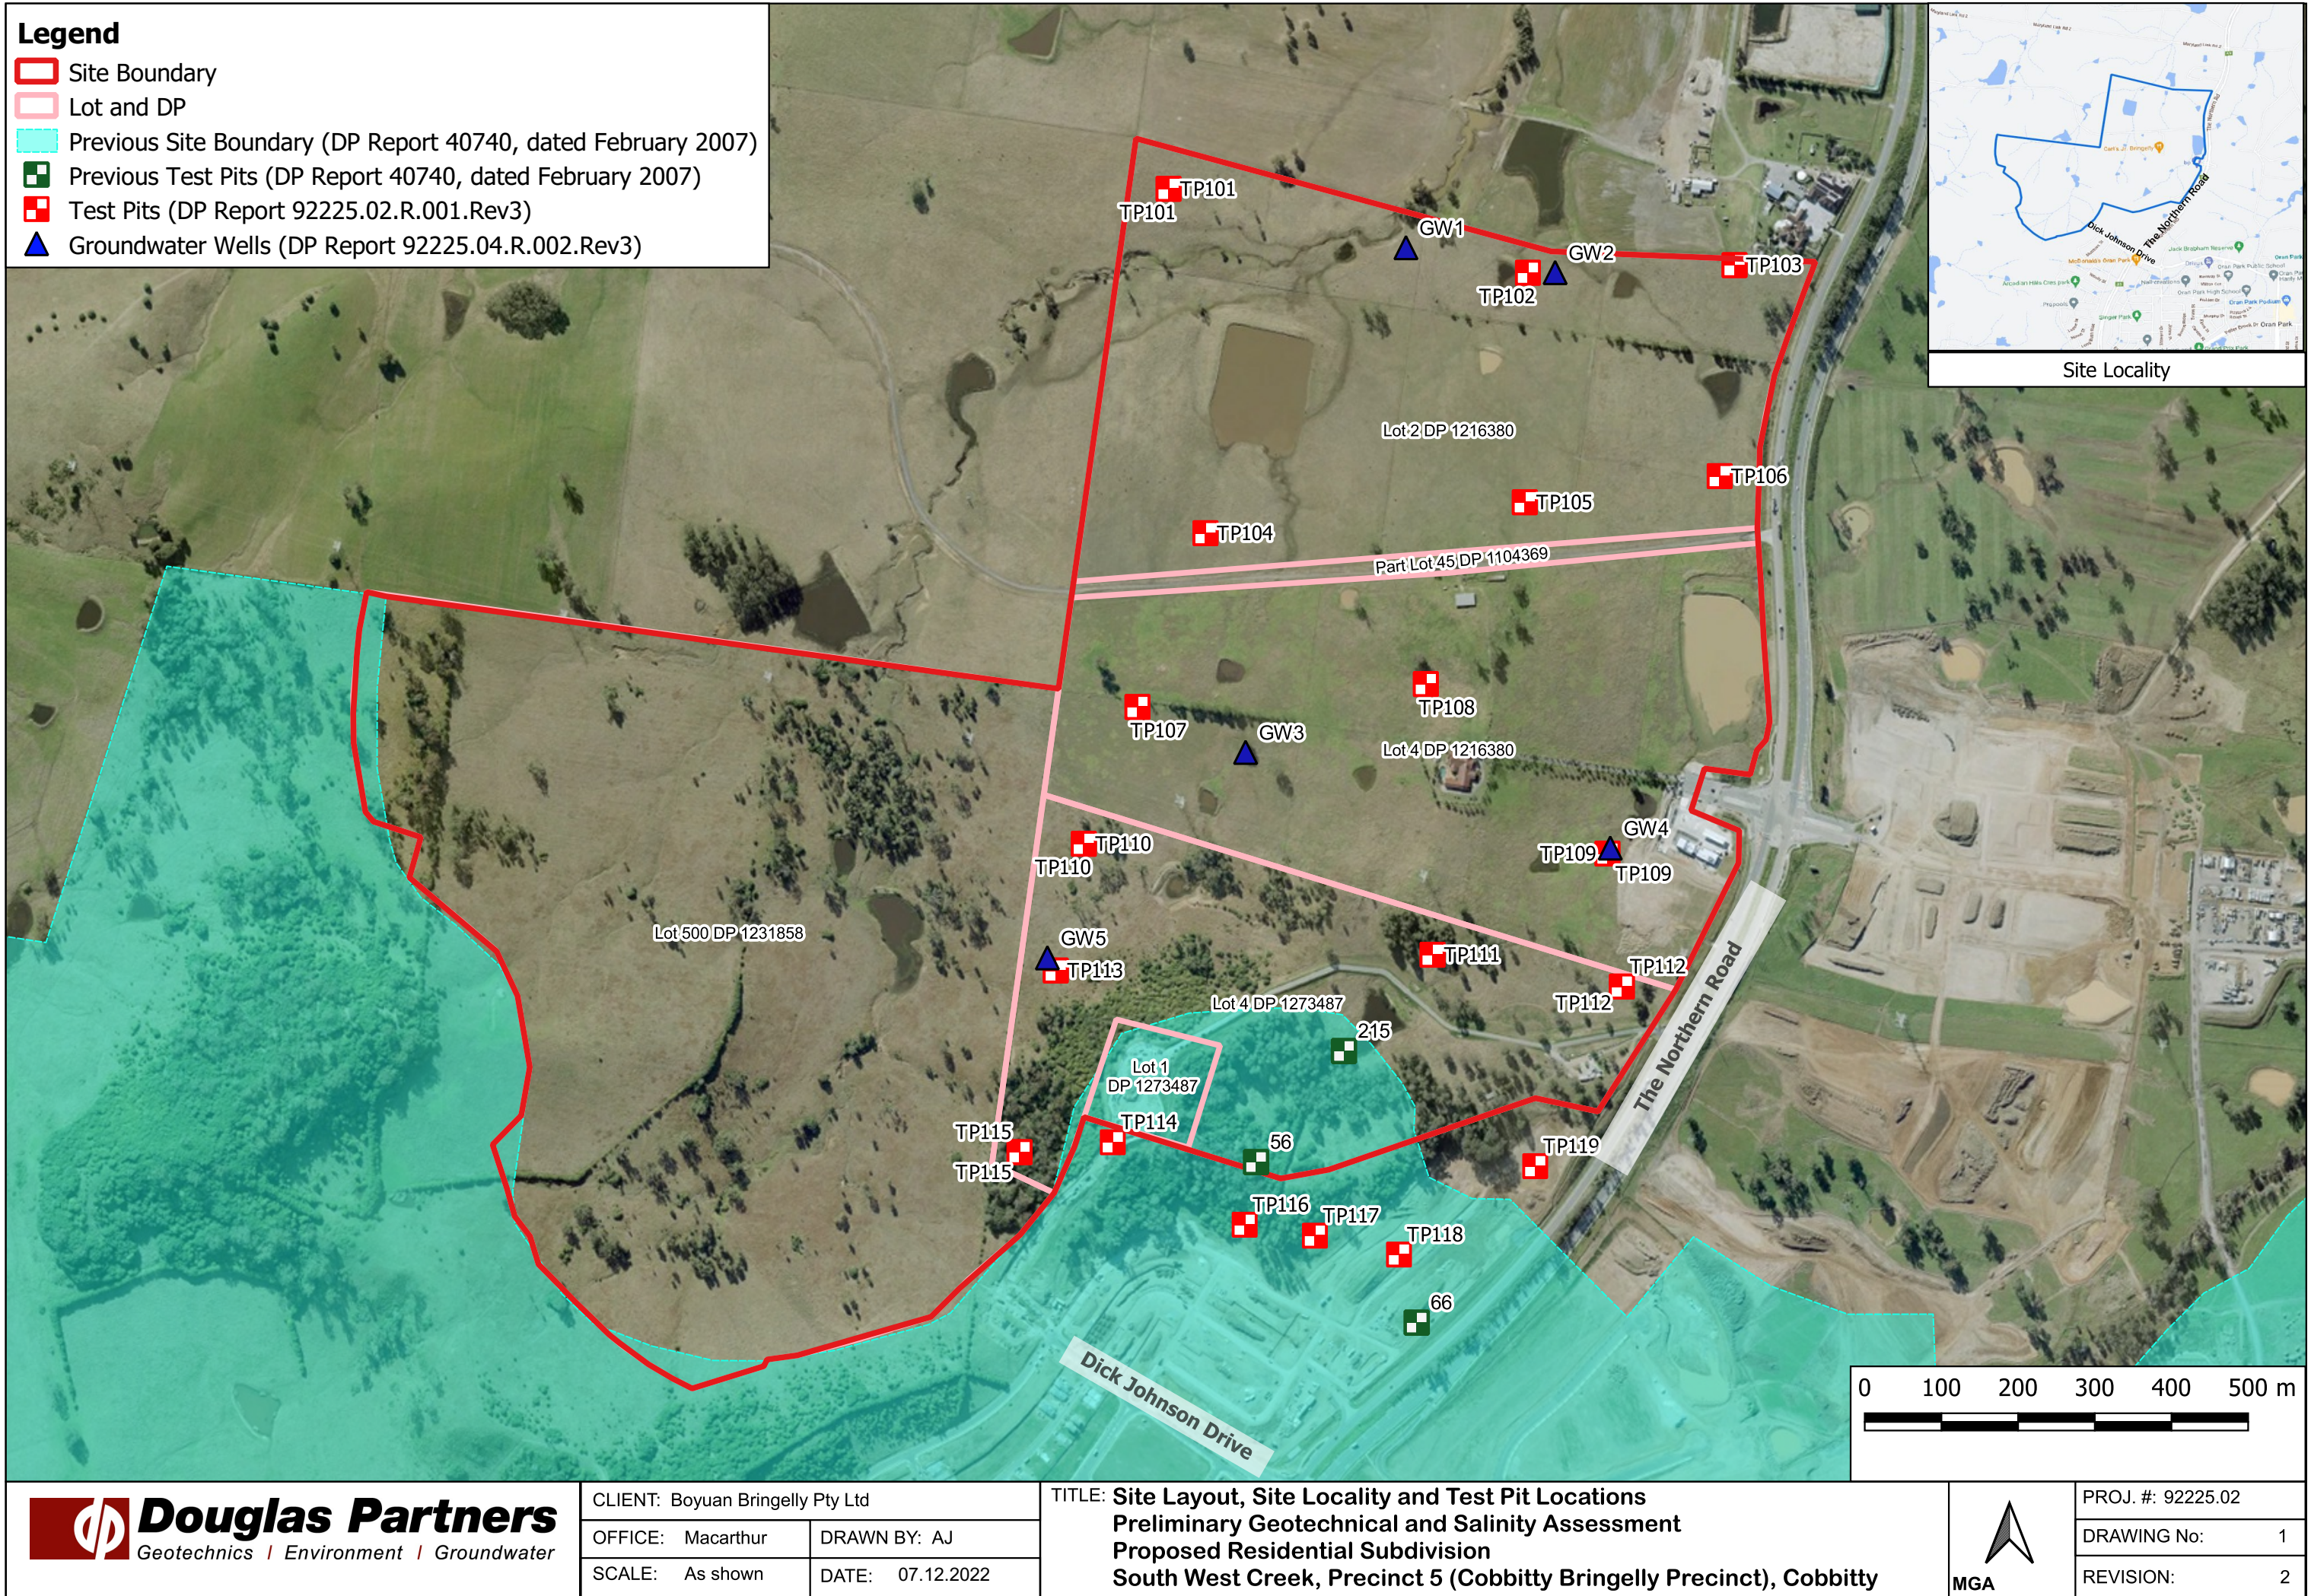
Areas where soil, geology, topography and groundwater conditions predispose a site to salinity. These conditions are similar to areas of known salinity (see above). These areas are most common in lower slopes and drainage systems where water accumulation is high (i.e. high relative wetness index).

Areas on Wianamatta Group Shales and Tertiary Alluvial Terraces. Scattered areas of scalding and indicator vegetation have been noted but no concentrations have been mapped. Saline areas may occur in this zone, which have not yet been identified or may occur if risk factors change adversely.

Areas where salinity processes do not operate or are of minor significance. Soils are rapidly drained and underlying strata (Hawkesbury/Narrabeen Sandstone) are highly permeable, resulting in continual flushing and removal of salts in the landscape. No salinity has been observed in these areas and is not expected to occur.
