CLEVELAND HOUSE 273-275 CLEVELAND ROAD CLEVELAND NEW SOUTH WALES

CONSERVATION MANAGEMENT STRATEGY

DRAFT REPORT

Project:	Cleveland House
Services required:	Conservation Management Strategy
Client:	Newquest Property Pty Ltd
Prepared by:	Chris Carter
Project number:	21092

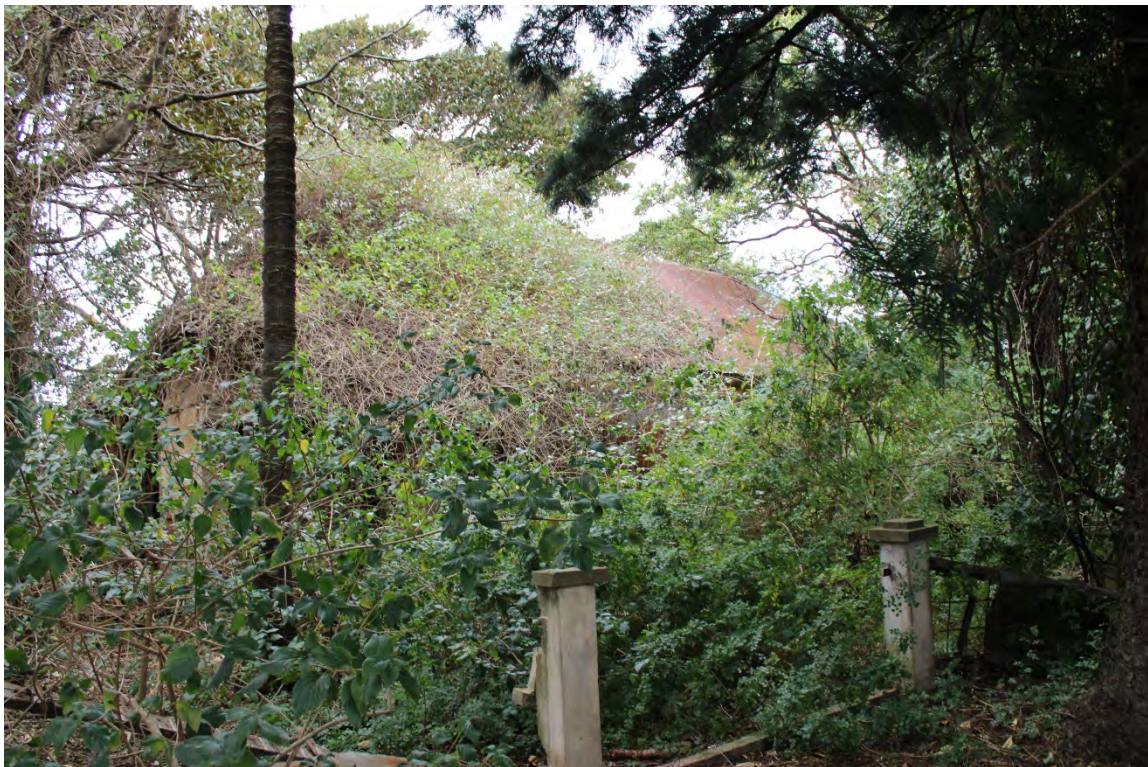
Figure 4.1 View of Cleveland House from the north-east (rear).

The site inspection confirmed that Cleveland House is largely overgrown, particularly by an invasive species of vine (lantana) that has caused significant damage to both the building and grounds (Figure 4.1).

The deterioration of the building results from several factors including invasive vegetation, natural deterioration, lack of maintenance, and structural damage due to ground movement or failing foundations. However, the most significant issue relates to pilfering and vandalism, as several elements of the building have been removed. Early descriptions indicate that doors, windows and joinery were made of Australian cedar – a material that has some value on the open market. All original doors appear to have been removed along with jambs and frames. Most windows have also been removed. One remaining window has a double hung frame. Timber mouldings including skirting, architraves and picture rails have been removed along with timber mantles above open fireplaces. It appears that the removal of these elements was done without care and, in several cases, resulted in considerable damage to the adjoining fabric. One section of external brick wall and at least 2 internal dividing walls have been removed. Not only have many of the bricks been taken away, but these walls gave structural support to the roof and, as a result, sections of the roof are in danger of collapse. Structural damage is obvious with cracks appearing in several walls.

Cleveland House is currently overgrown with lantana which is, in turn, causing damage to the fabric of the house. In the first instance, the vegetation that is impacting on the building should be removed. Other vegetation growing within 3 metres of the house should be removed unless it is determined that such vegetation forms part of an early garden or planting.

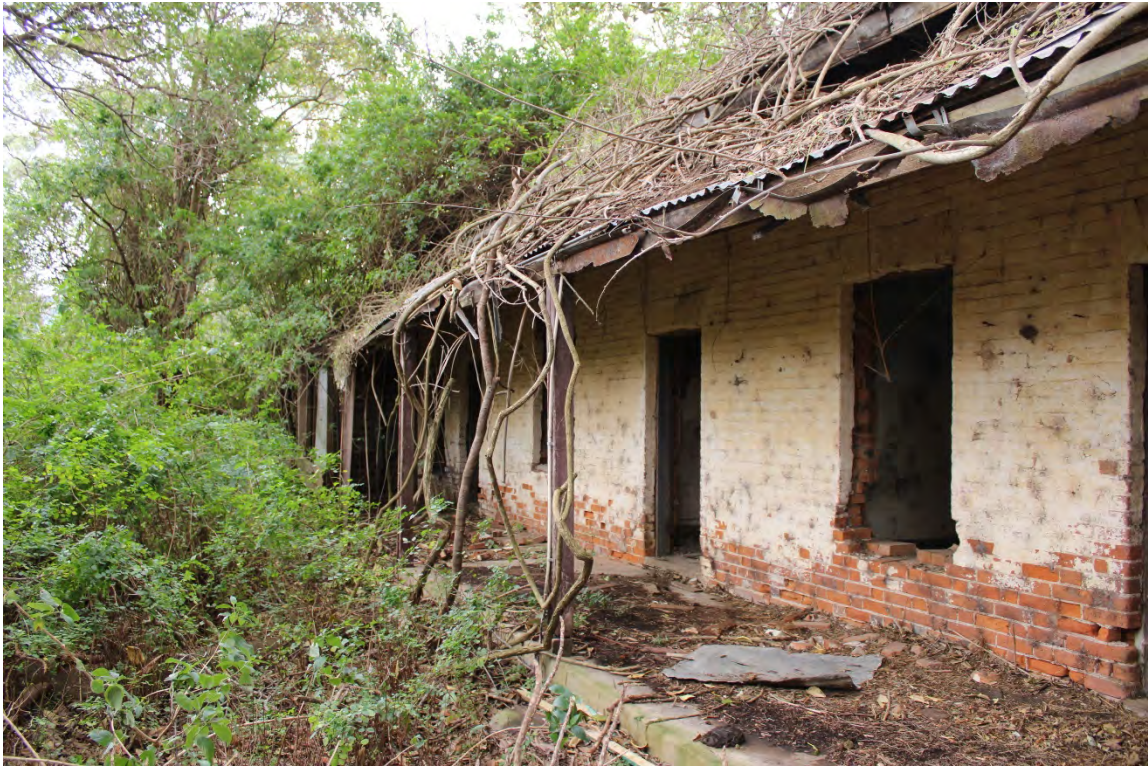
Figure 4.2 Cleveland House from south-east.

The house appears oriented to have the ‘front’ face the south, toward Mullet Creek. The ‘rear’ of the house would have been used for access from the north, or from Cleveland Road in more modern times. This location would afford views from French doors and windows across the verandah down the slope toward the creek, over what was a formalised garden. The house can be described as a brick cottage with a hipped roof clad with corrugated metal sheeting. The bricks were laid in a mixture of Flemish and stretcher bond. External walls are 390 millimetres thick. Internal walls are 270 millimetres thick, rendered and finished with a plaster coat. External walls were rendered and painted. The render coat on several sections of walls has dislodged from the wall. Bricks laid in flat arches spanned over external door and window frames.

The hipped roof was framed with sawn timber. The roof battens are spaced in such a way to suggest that the roof was originally clad with timber or slate shingles and the corrugated metal roof installed later. The ceiling was lined with timber matchboards. It appears that much of the ceiling has been removed (or fallen down) and termite infestation is apparent in several areas. The floor frame used sawn timber overlaid with timber floor-boards, with several areas missing boards.

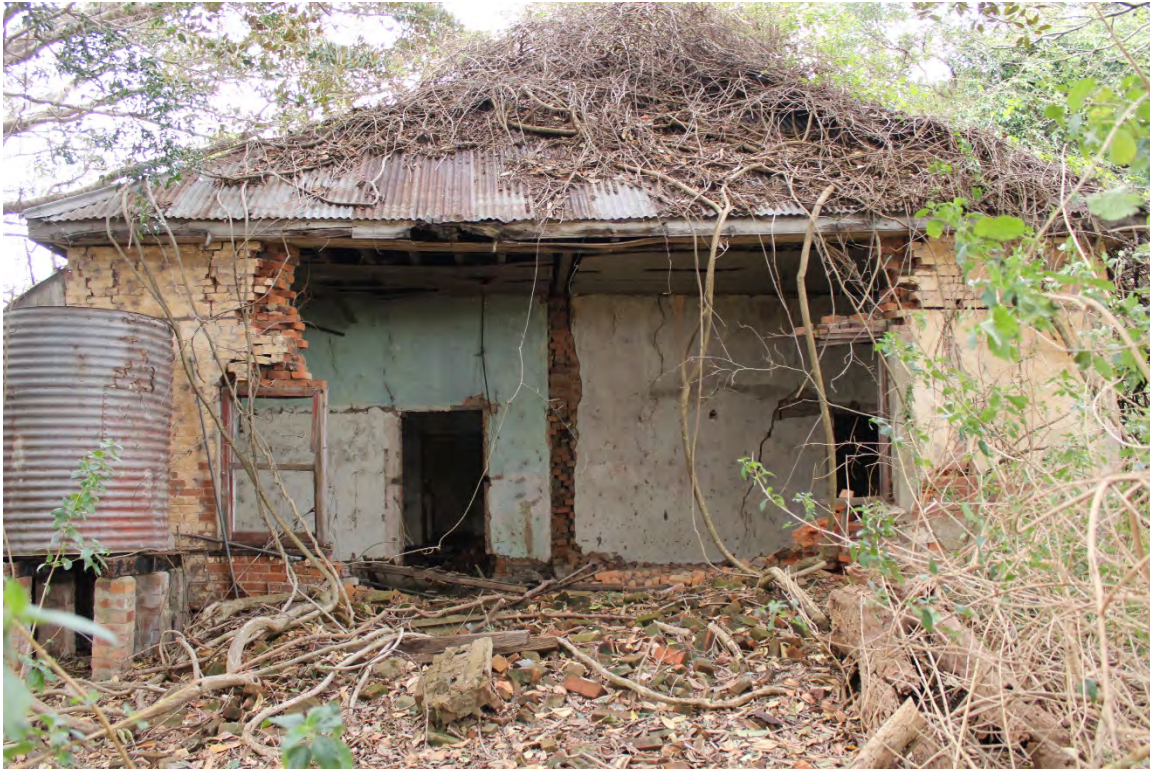
Figure 4.3 Cleveland House - east elevation.

The deterioration of the roof covering and guttering in some areas has allowed water damage to impact on elements including fascia boards.

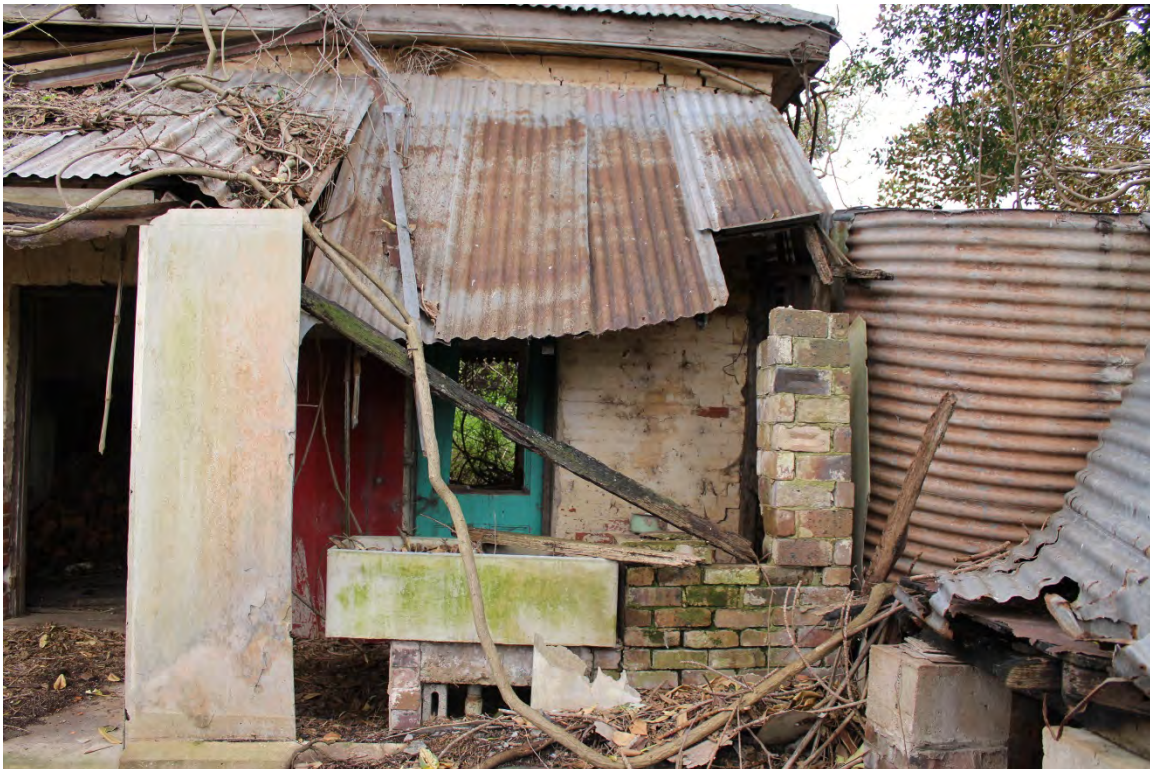
Figure 4.4 Detail of south-east corner of building.

The remains of 3 round, corrugated metal tanks are located on brick stands adjacent to the south-west corner of the house. The tanks are in poor condition and have collapsed.

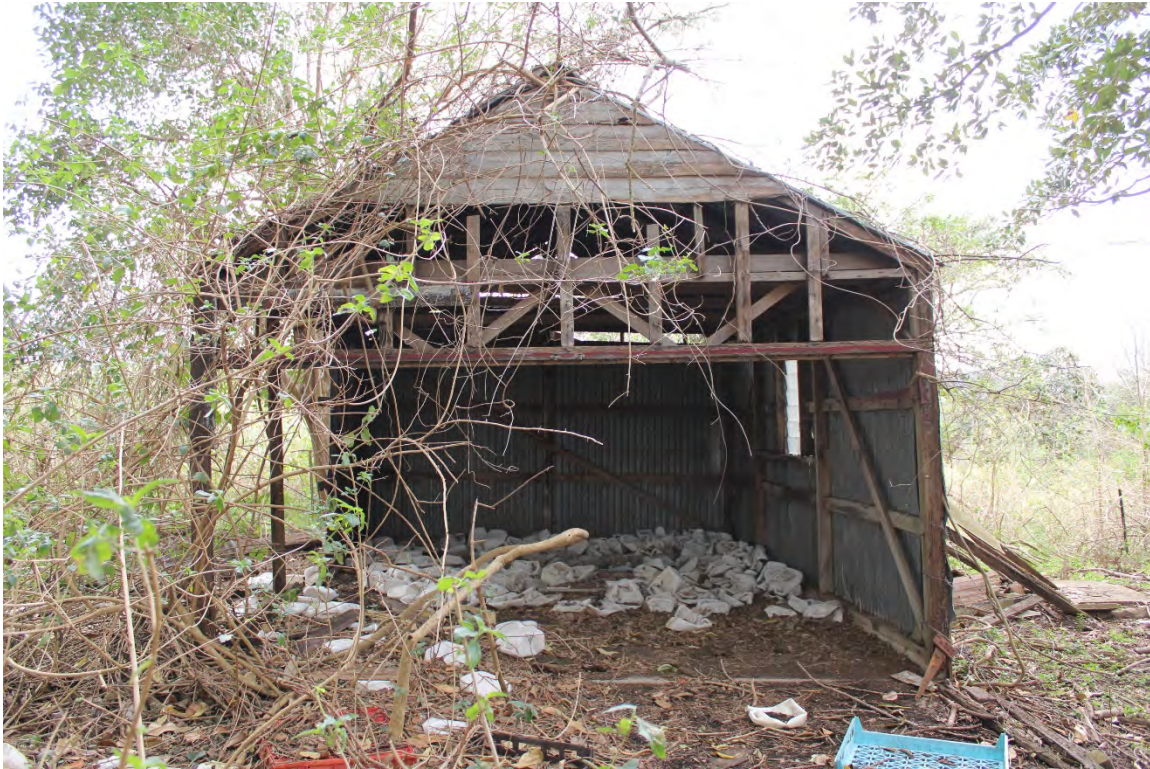
Figure 4.9 Structure located south-east of house.

A timber-framed shed with gable roof and clad with corrugated metal sheeting is located several metres to the south-east of the house. The floor is paved with concrete. This building is not intact and part of the eastern wall cladding is missing along with sections of timber weatherboards on the northern gable. This building appears to have been constructed in the 20th century and may have been used as a garage as there is an area clear of trees between the shed and a gate located in a fence line to the north of the house.

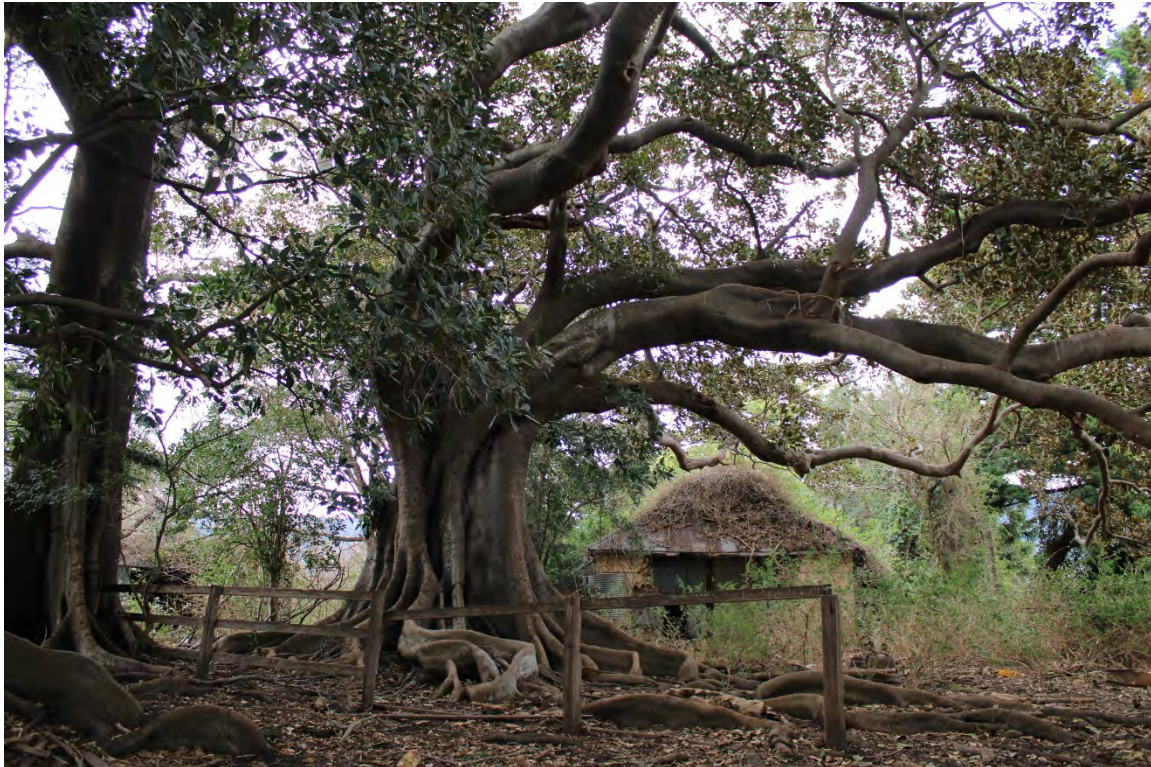
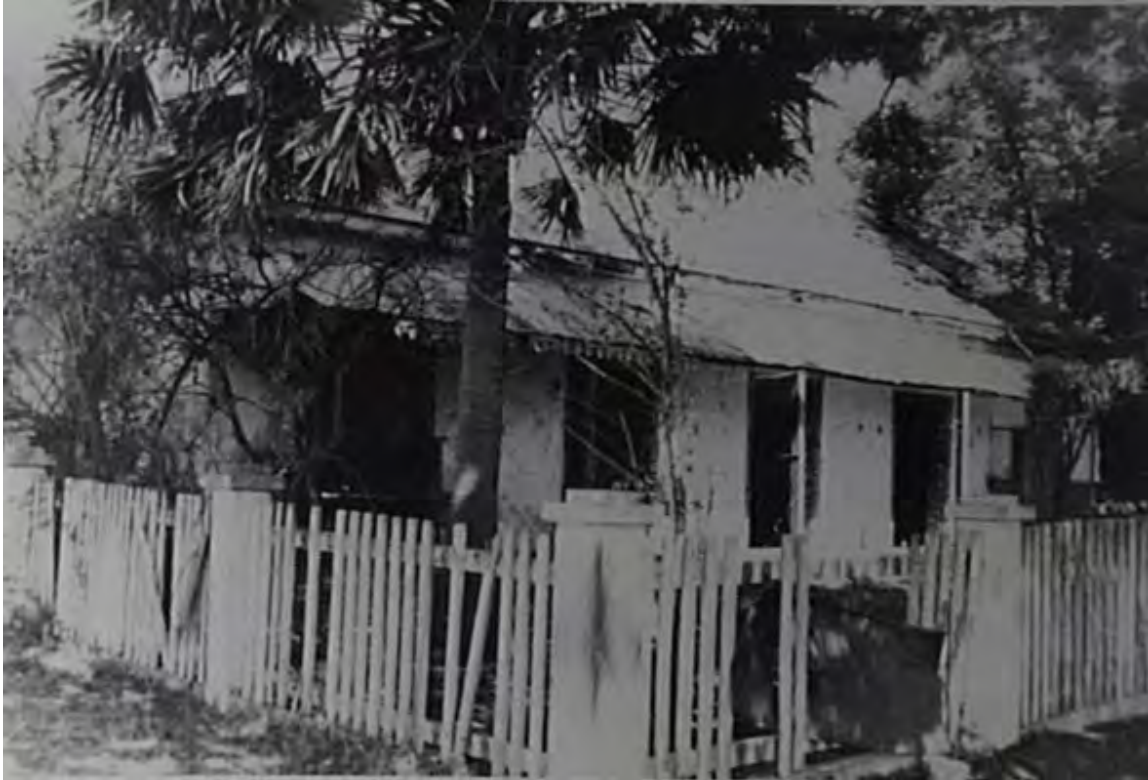
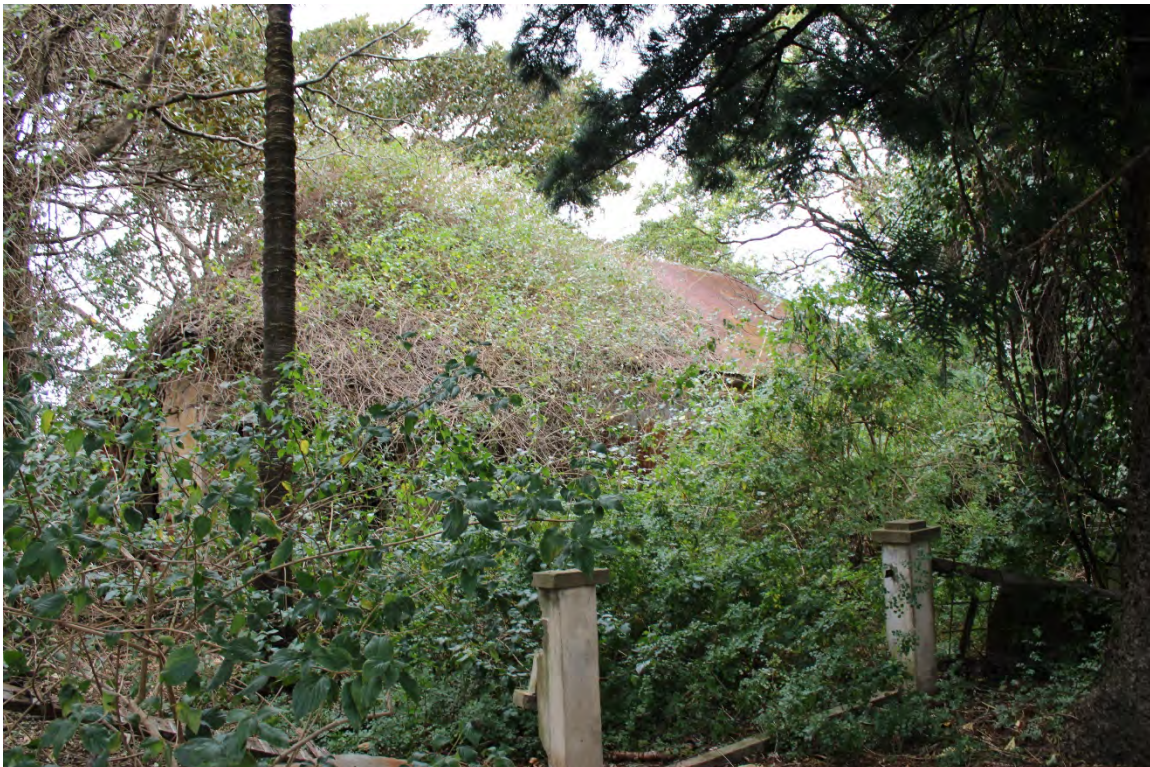
The only evidence of a formalised garden consisted of several ceramic garden border tiles that remain *in situ* in an area close to the south-west corner of the house. Much of the area that may have formed the formal and/or kitchen gardens are overgrown with lantana and could not be inspected closely.

Figure 4.11 to Figure 4.13 provide a view of the current condition of the garden. Figure 4.12 and Figure 4.13 are photographs taken from roughly the same position. Note the palm that is visible in both images. The aerial image in Figure 3.5 shows the basic layout of the garden to the south of Cleveland House.

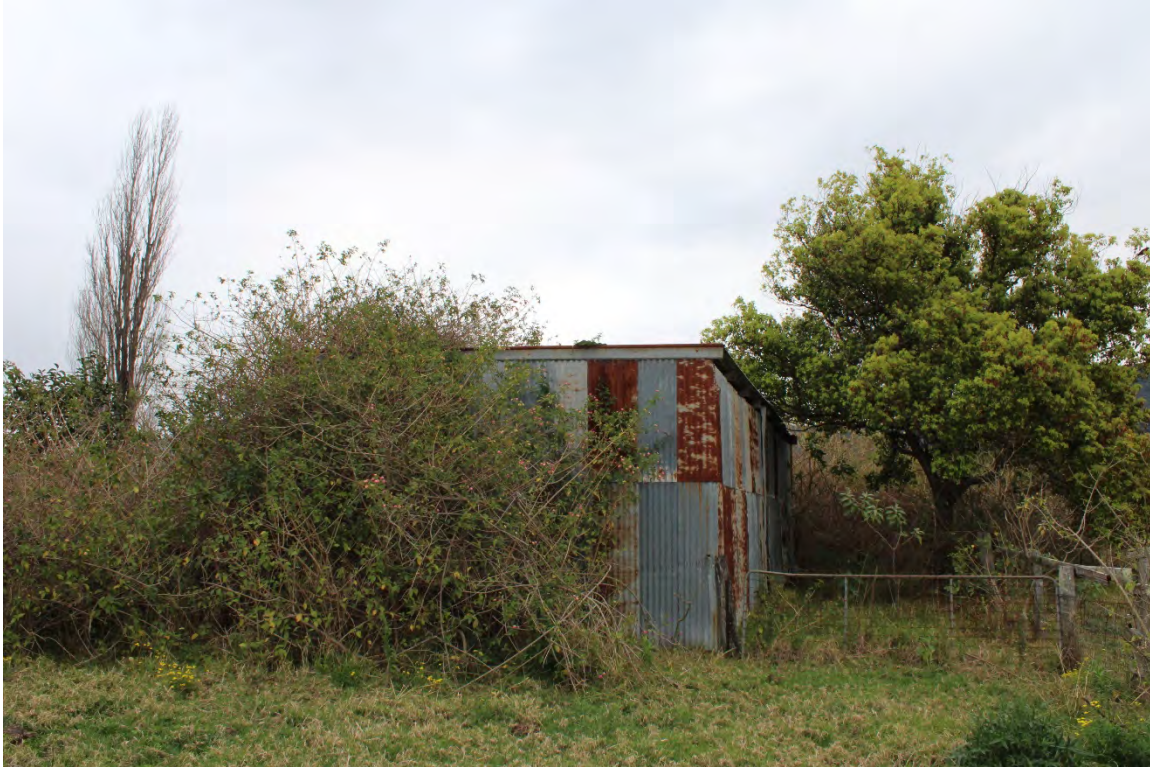
Figure 4.14 Dairy complex - northern structure from the east.

The first structure, the northern-most, could not be inspected closely as it was overgrown with lantana. It is basic, timber framed structure clad with corrugated metal sheeting (Figure 4.14).

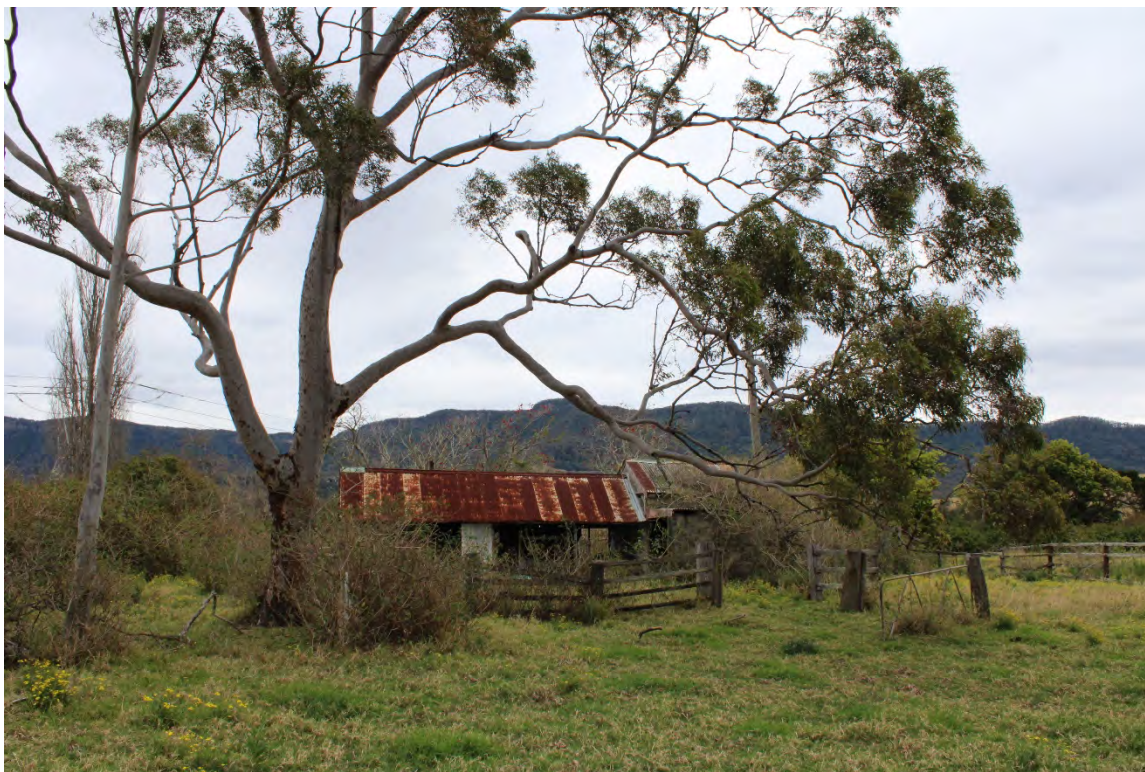
Figure 4.15 Dairy complex - central structure, view from east.

The central structure appears to be the oldest extant structure and consists of a narrow rectangular building with a gable roof clad with corrugated metal sheeting (Figure 4.15). The building is divided into at least 3 sections. It has a concrete floor with a base wall of concrete and timber frames continuing to the roof line. A part of the northern end has walls built of concrete blocks. The southern end wall had a concrete wall to a height of about 1 metre, topped with a timber frame and gable clad with timber weatherboards. A set of yards with post and rail fencing is located adjacent to and to the east of this building. The use of concrete and concrete blocks indicate that this section of the building was built early in the 19th century.

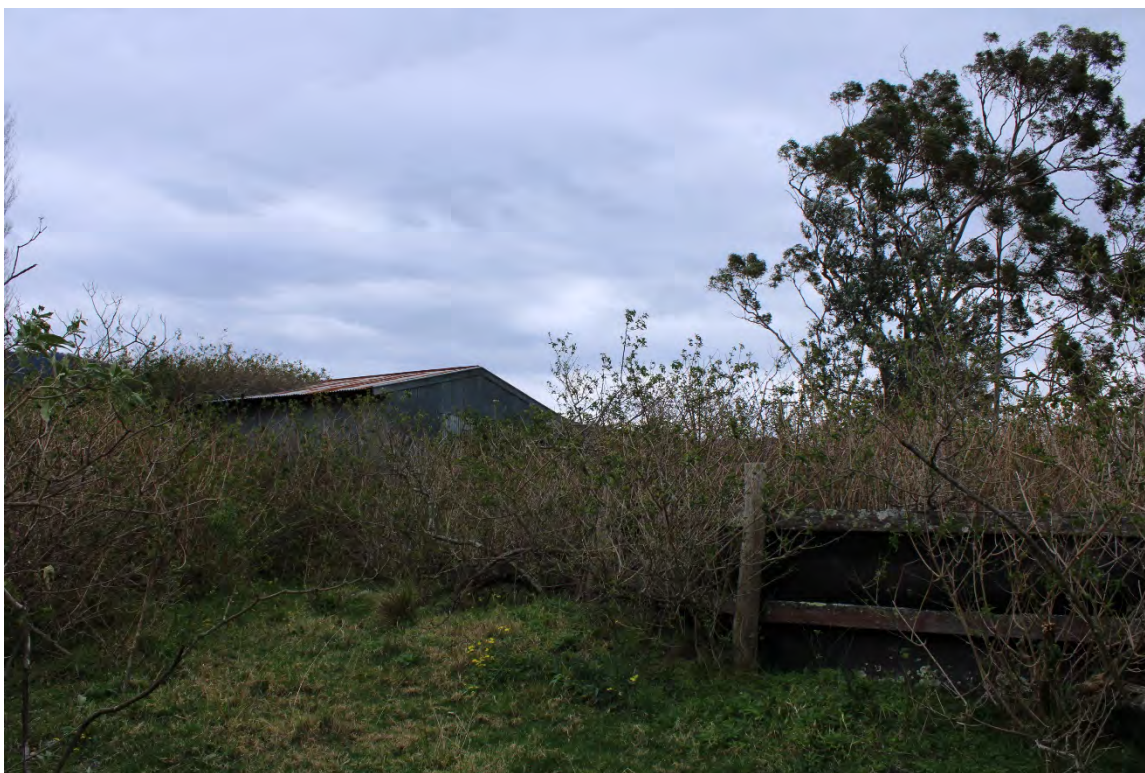
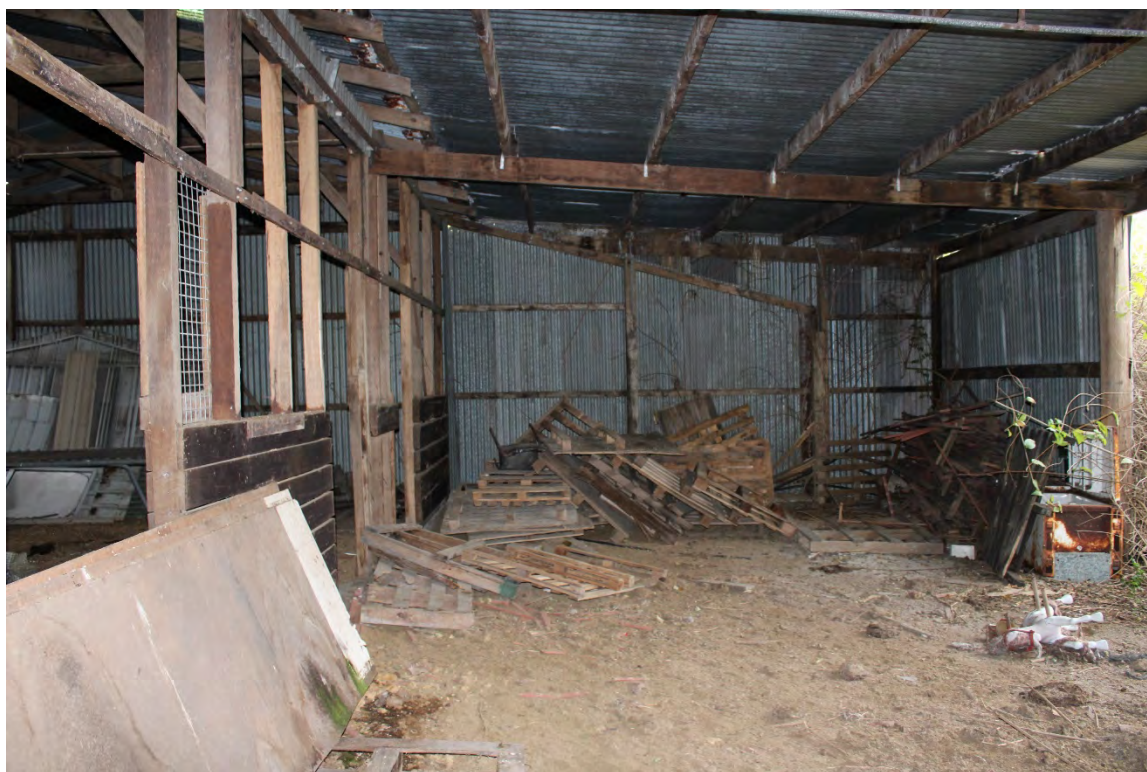
The southern structure is a timber framed shed clad with corrugated metal sheeting (Figure 4.16 and Figure 4.17). This building appears to have been built in at least 3 stages. The first stage consisted of a rectangular, gable ended shed; the second stage had the shed extended approximately 4.2 metres to the north with the addition of a 'lean-to' roof; finally this 'lean-to' roof was later extended another 1.8 metres.

The remains of a round set of yards is located to the south-west of the southern-most building. These yards consist of post and rail perimeter fence and line with a thick rubber matting. This feature is overgrown with lantana and difficult to define. These yards are visible in Figure 4.16.
