Cleveland Road, West Dapto - Riparian Assessment

Newquest Property Pty Ltd

Project Name	Cleveland Road, West Dapto - Riparian Assessment
Project Number	19WOL-15040
Project Manager	Bethany Lavers
Prepared by	Emily Messer and Claire Wheeler
Reviewed by	Ian Dixon
Approved by	Bethany Lavers
Status	Final
Version Number	4
Last saved on	16 October 2020

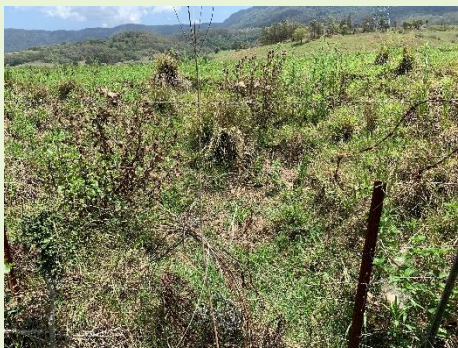
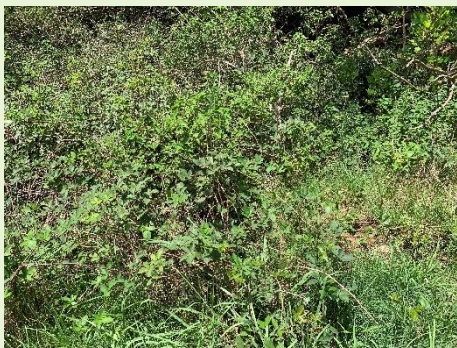
Reach	Strahler	WCC category	Result	Photo facing upstream	Photo facing downstream
1F	-	3	Desktop assessment only. Not a 'river' under the WM Act. Unlikely to have defined bed, banks or geomorphic processes.	-	-
1G	1	-	Not a 'river' under the WM Act. No defined bed, banks or geomorphic processes.

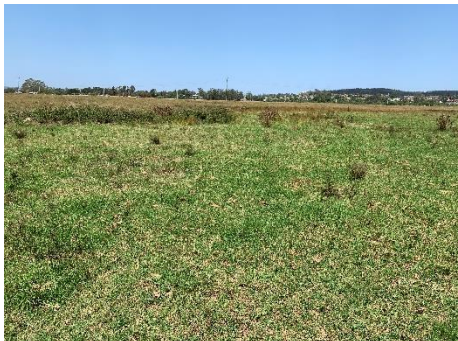
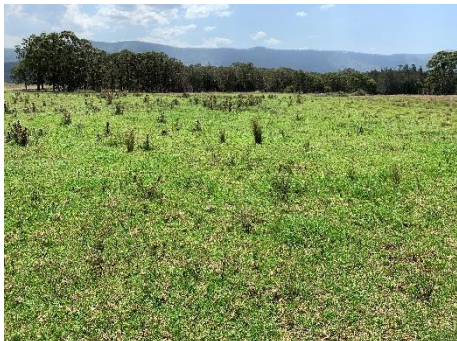
1H	1	3	Desktop assessment only. Not a 'river' under the WM Act. Unlikely to have defined bed, banks or geomorphic processes.	-	-
1I	1	-	Desktop assessment only. Defined channel from aerial imagery. Unlikely to provide habitat for fauna. Riparian habitat was pasture grass with scattered paddock trees.	-	-
1K	1	3	Not a 'river' under the WM Act. No defined bed, banks or geomorphic processes.

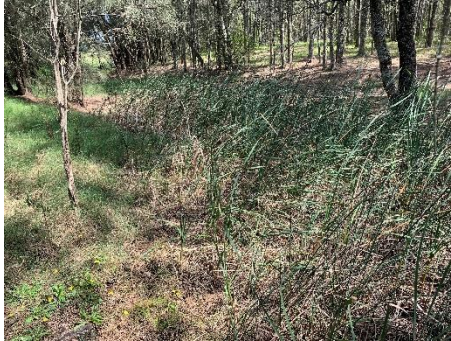
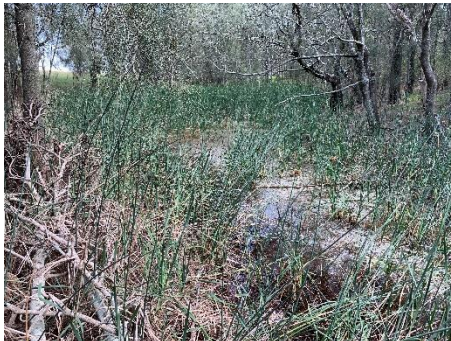
Reach	Strahler	WCC category	Result	Photo facing upstream	Photo facing downstream
10	1		Desktop assessment only. Examination of contours and aerial photos indicate defined channel present.		
2D	2	-	Desktop assessment only. Not a 'river' under the WM Act. Unlikely to have defined bed, banks or geomorphic processes.	-	-
2E	2	3	<p>The first 150 m had no defined bed or bank and has been mapped as not a 'river'. The channel began downstream of the pipe culvert. Moving downstream the channel defined by the extent of dense <i>Typha orientalis</i>. There was shallow (<10 cm), stagnant water present with an oily sheen and foam. No aquatic fauna was observed. Riparian habitat was Coastal Swamp Oak Forest.</p>

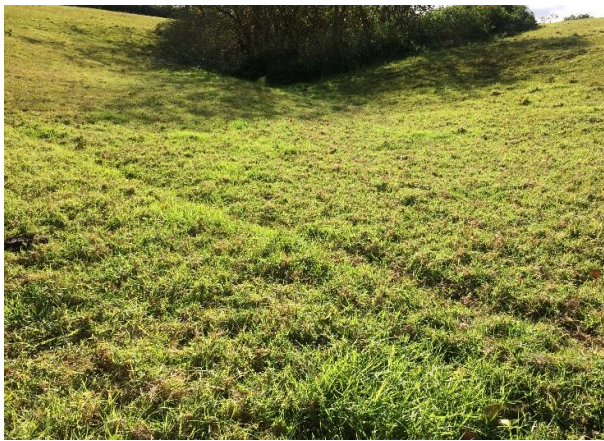
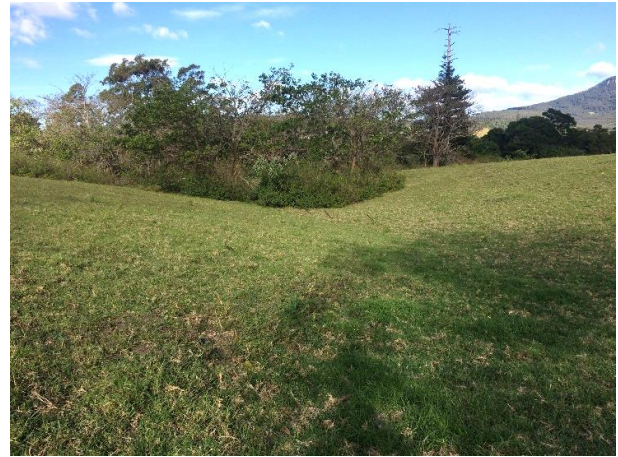
Reach 1A: Classed as Category 3 as per WCC and 1st order under WM Act. The upper 175 m of this reach did not have a defined bed, banks or geomorphic processes. It was a grassy depression between dense patches of exotic vegetation. Where the channel began, it was straight, highly incised, with steep banks and a predominately silty bed. Moving downstream, the channel widened (1 – 2 m) and meandered throughout the vegetation. The channel was dry at the time of the survey and no aquatic flora or fauna occurred. The riparian zone was dominated by dense weeds including *Erythrina x sykesii* (Coral Tree), *Lantana camara* (Lantana), *Rubus fruticosus* (Blackberry) and *Urtica dioica* (Stinging Nettle). The channel was filled with Coral Tree leaf litter and woody debris. At the time of the survey there was no habitat for fish, frogs or wading birds.

Facing upstream – no defined channel

Facing downstream – no defined channel

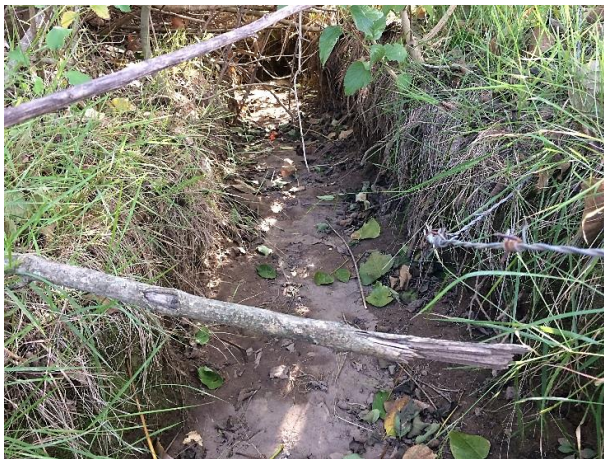
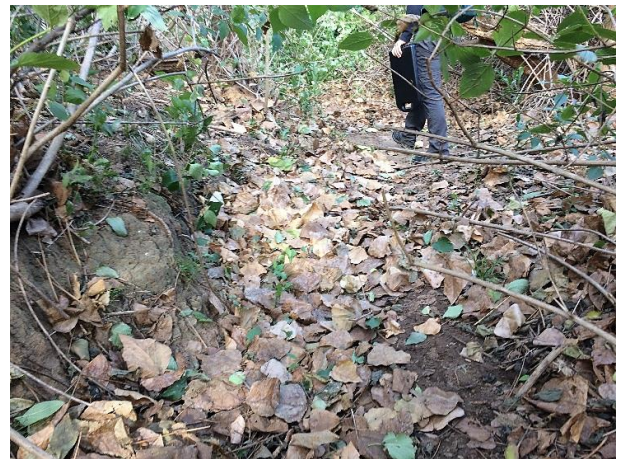
Facing upstream – start of channel

Facing downstream

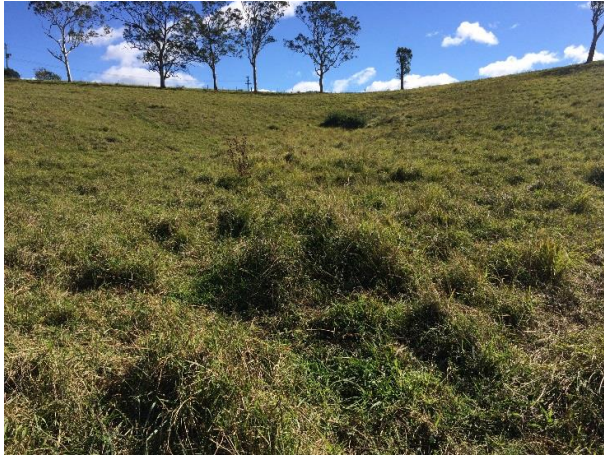
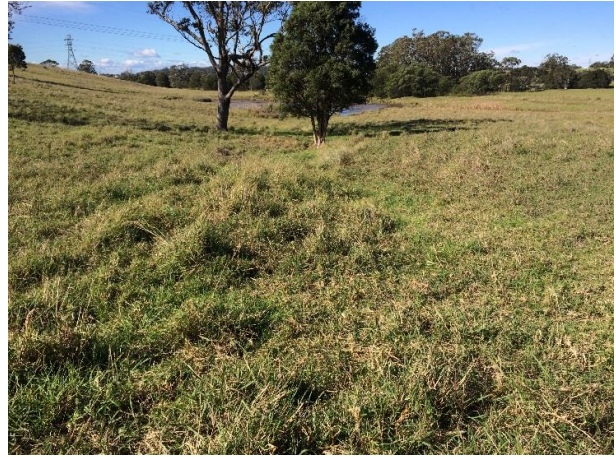
Reach 1B: Classed as Category 3 as per WCC and 1st order under WM Act. This creek had no defined bed, banks or geomorphic processes until approximately 80 m downstream of the dam. Until this point the stream was a cleared grassy depression that may flow during heavy rainfall. The riparian zone was cleared pasture with scattered Blackberry. Downstream of the dam the channel was wide with gently-sloping banks. The benthic sediment was predominately silt. The water was shallow, stagnant and turbid. No fish or frogs were observed. A single *Ardea pacifica* (White-necked Heron) was observed wading in the water. The riparian zone in this downstream stretch was vegetated with scattered native

Facing upstream – no defined channel

Facing downstream – no defined channel

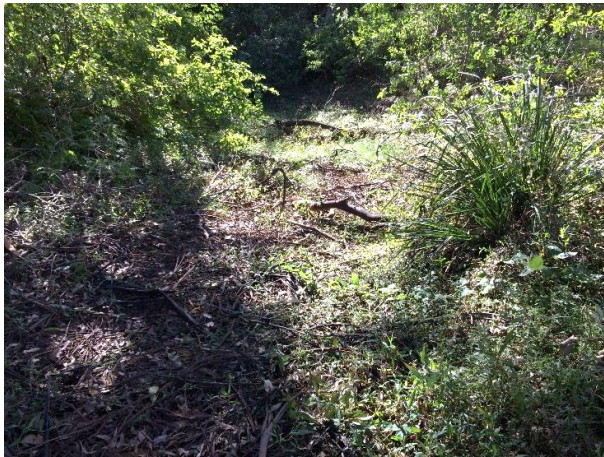
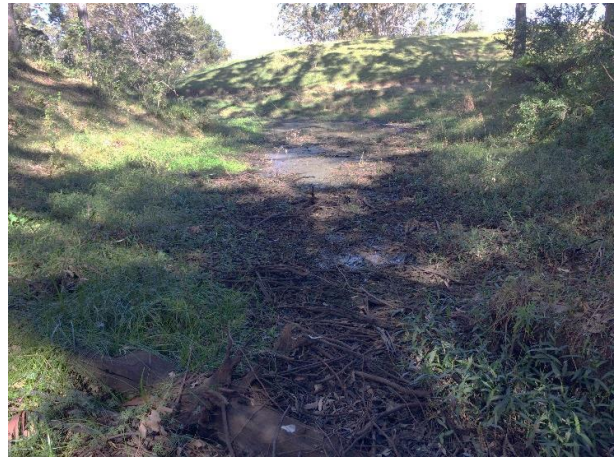
Facing upstream – dry channel

Facing downstream – wide channel with pools

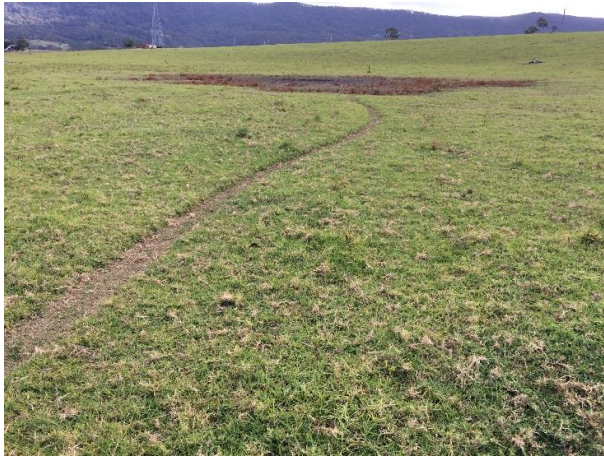
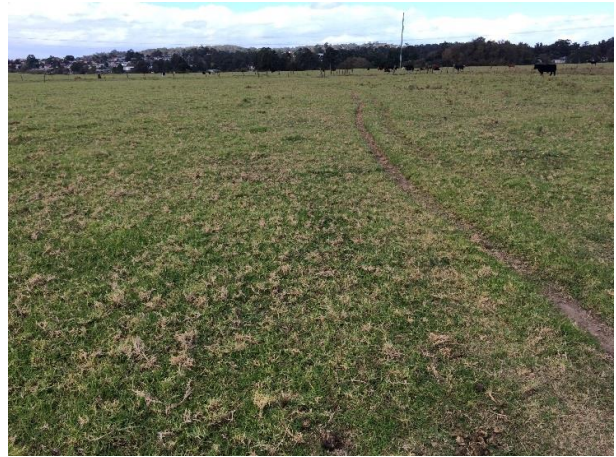
Reach 1C: Classed as Category 3 as per WCC and 1st order under WM Act. This creek had no defined bed, banks or geomorphic processes for the upper 800 m. The creek was a grassy depression that may convey flows in times of heavy rainfall through the cleared pasture. The channel began downstream of a pipe culvert. The channel width was approximately 2 – 3 m wide and meandered through the grassy paddock. There was evidence of trampling by livestock in both the channel and on the banks. There was no aquatic vegetation, or habitat for fish, frogs or birds at the time of the survey.

Facing upstream – no defined channel

Facing downstream – no defined channel

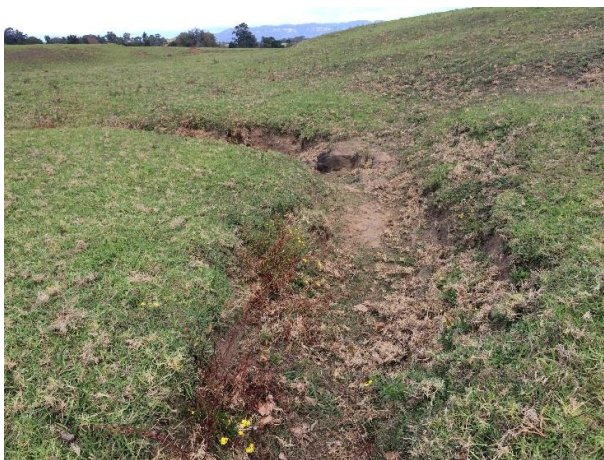
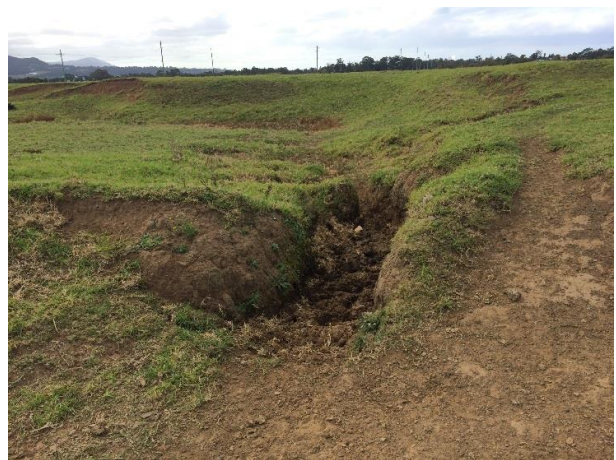
Facing upstream – defined channel

Facing downstream – channel eroded by cattle

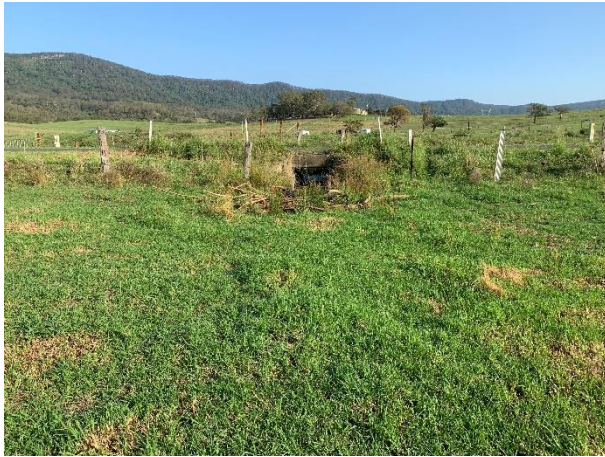
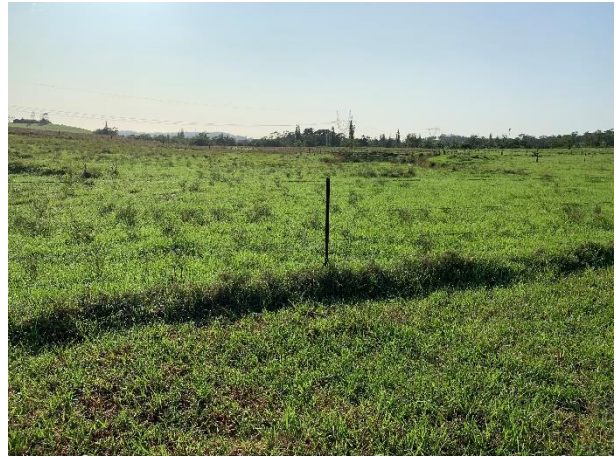
Reach 1E: Classed as Category 3 as per WCC and 1st order under WM Act. The upper 70 m of this reach did not have a defined bed, banks or geomorphic processes. It was a grassy depression between the road and the dam. The channel has been mapped from the western side of the first dam, where aquatic habitat was present. There was a defined channel between the first and second dam. The channel, excluding the dams, was dry at the time of the survey and no aquatic flora was observed in the creek. Both dams provided aquatic habitat with water and aquatic vegetation including *Ludwigia peploides* (Water Primrose), *Eleocharis* sp., *Azolla pinnata* (Azolla) and *Typha orientalis* present. There were two *Porphyrio porphyrio* (Purple Swamphen) using the *Typha orientalis* as habitat. The riparian vegetation either side of the creek was pasture.

Facing upstream – no defined channel

Facing downstream – no defined channel

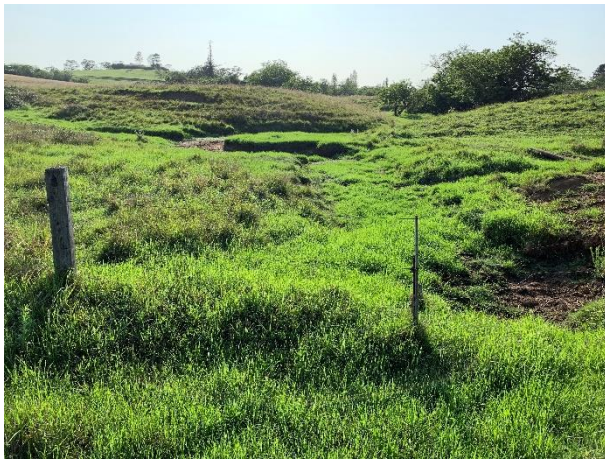
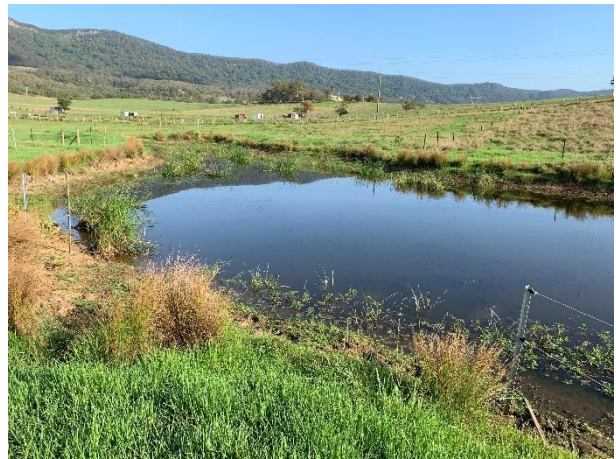
Facing downstream of dam –channel defined

Dam providing habitat

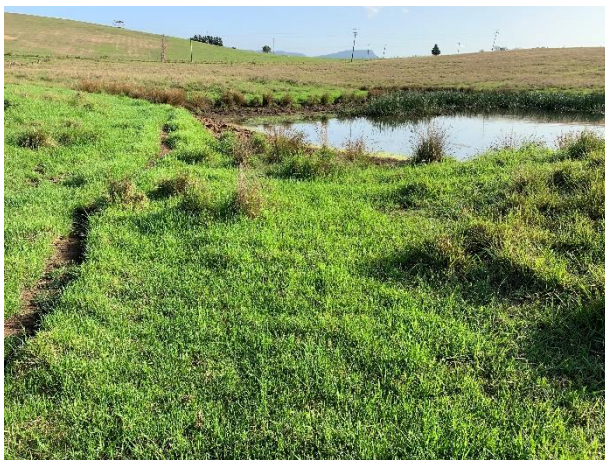
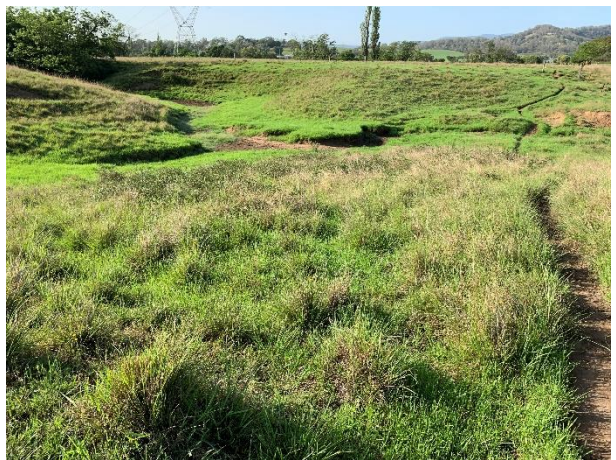
Reach 1F: Not mapped as a watercourse under WCC mapping and 1st order under WM Act. This creek is mapped to flow south from a dam and join with 1E. At the time of the survey, there was no defined bed, banks or geomorphic processes.

Facing upstream – no defined channel

Facing downstream – no defined channel

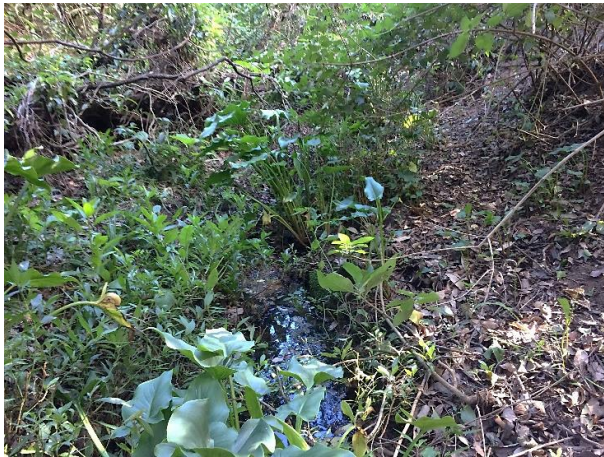
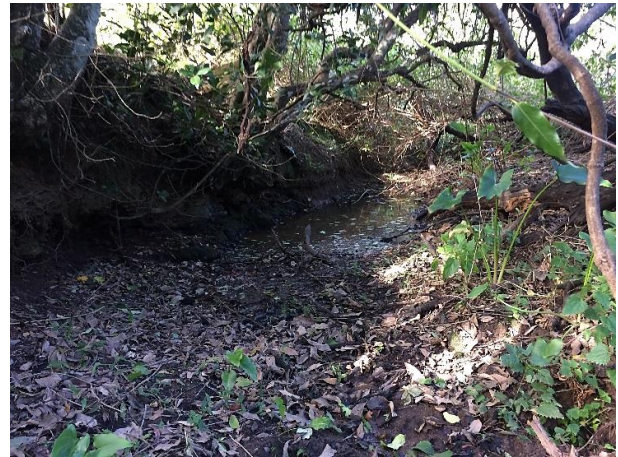
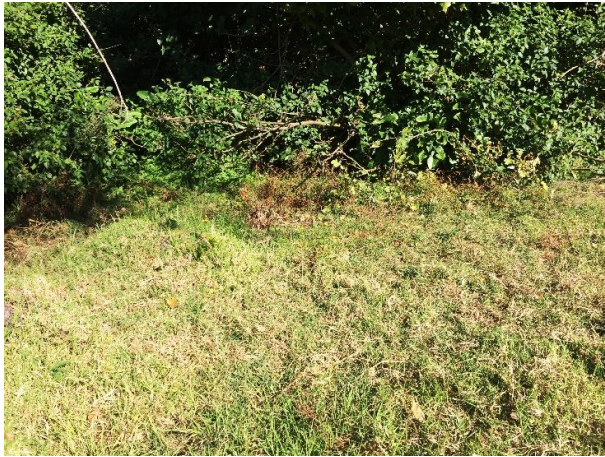
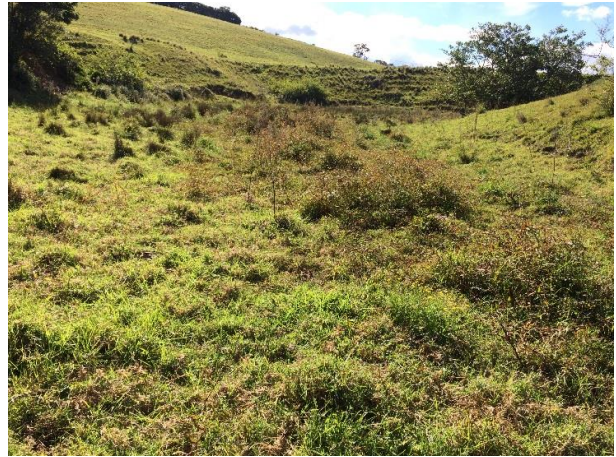
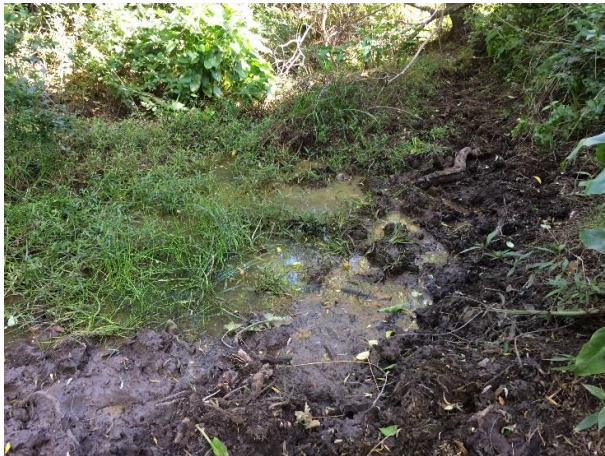
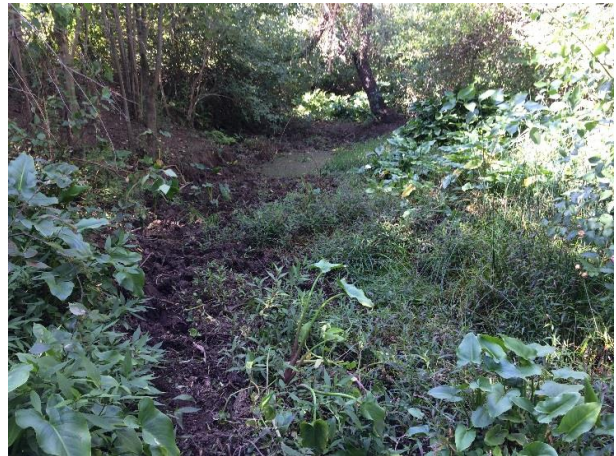
Reach 2A: Classed as Category 3 as per WCC and 2nd order under WM Act. The channel in the upstream section was on average 1 – 2 m wide, with a few shallow (10 cm) turbid pools. Aquatic vegetation present in pools was mostly dense *Spirodela polyrhiza* (Duckweed) and scattered *Zantedeschia aethiopica* (Arum Lily). The banks were predominately lined with vegetation and sloped gently. On the outer bends the banks were steeper and undercut. The benthic substrate was predominately silt. Riparian vegetation was mostly exotic, with species such as Coral Tree, Lantana, Blackberry and Stinging Nettle growing in dense patches. Downstream of where 1A joined the creek, the channel was wide with small shallow pools. The channel was smothered by Coral Trees and their dead branches. The banks were lined with dense Lantana. Downstream of this vegetation the channel became less defined, flowing into an open grassy swale where the water would disperse overland. There were no defined bed or banks throughout this section of the creek. Clumps of native *Juncus usitatus*, *Juncus subsecundus* and exotic *Juncus acutus* (Sharp Rush) were scattered throughout this area. Further downstream, the channel became defined again with a broad bed and gently-sloping banks through a dense patch of vegetation. From here, the channel had an average width of 4 – 5 m, with predominately exotic vegetation including *Salix babylonica* (Willow), Lantana, Blackberry and Coral Trees lining the banks. Native *Casuarina cunninghamiana* (She-oak) and Eucalypt trees were also scattered throughout the riparian zone. A *Pseudechis porphyriacus* (Red-bellied Black Snake) was observed in this vegetation. There were a few small, stagnant narrow pools throughout the reach. All had evidence of trampling by cattle. No fish, frogs or wading birds were observed during the field survey, although there was potential habitat for all three in times of flow.

Facing upstream

Facing downstream – small shallow pool

Facing upstream – channel stops after vegetation

Facing downstream – grassy swale

Facing upstream – channel impacted by livestock

Facing downstream – shallow turbid pool

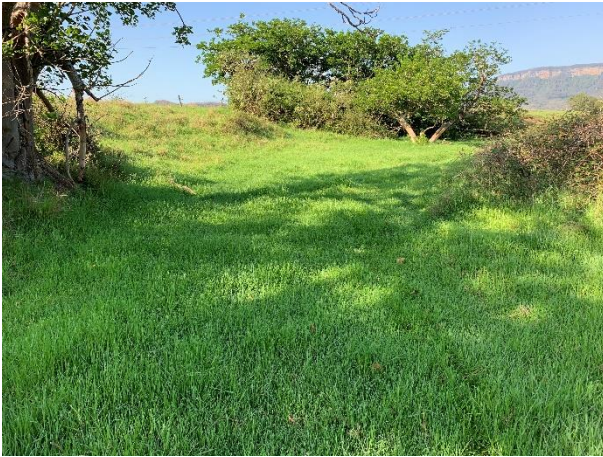
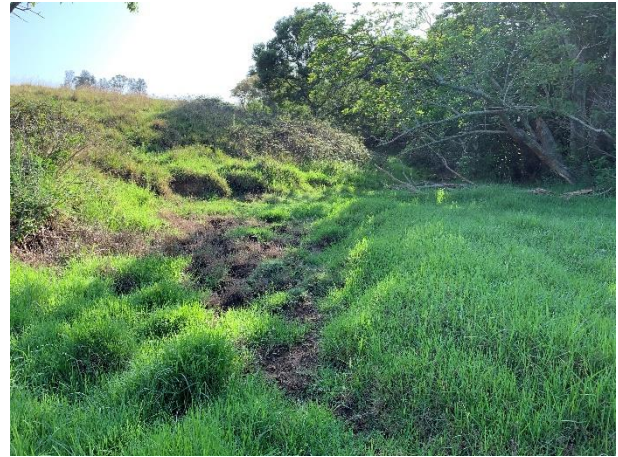
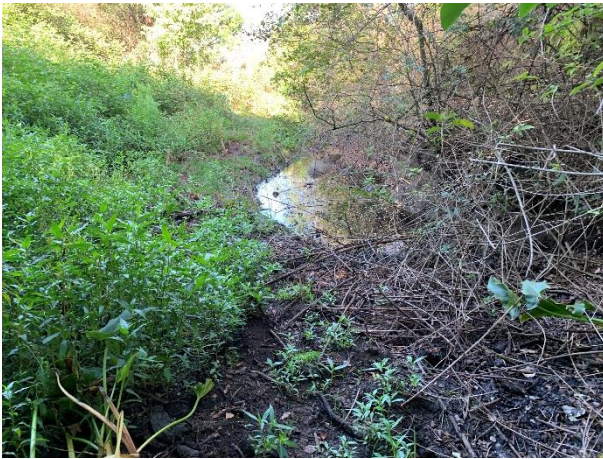
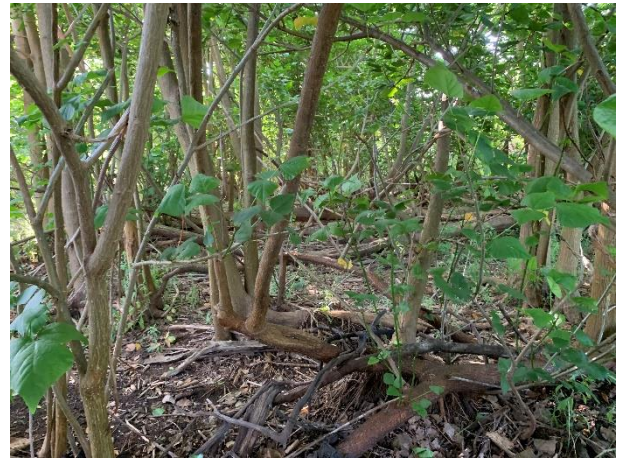
Reach 2A (cont'd): The channel in the upstream section was on average 3 – 4 m wide and dry. The banks sloped gently and were vegetated with pasture and patches of dense *Rubus fruticosus*. There was evidence of cattle being in the creek with trampling observed in the bed. Downstream, the channel width narrowed to 1 – 2 m. A long shallow pool was present adjacent to the left bank, the water was stagnant with an oily sheen. Adjacent to the pool along the right bank, the native macrophyte *Persicaria decipiens* (Slender Knotweed) dominated the groundcover and beyond this was extremely dense Blackberry, *Erigeron bonariensis* (Flaxleaf Fleabane), *Ageratina adenophora* (Crofton Weed), and *Lantana camara* (Lantana). The left bank was vertical with overhanging Lantana. A *Pseudechis porphyriacus* (Red-bellied Black Snake) was observed slithering into the Lantana. Where the channel entered the adjacent lot, *Erythrina x sykesii* (Coral Trees) were growing in the bed. The roots would disperse the water in times of flow. No fish, frogs or wading birds were observed during the field survey, although there was potential habitat for all three in times of flow.

Facing upstream – grassed bed with blackberry

Facing downstream – cattle trampling evident

Facing upstream – shallow pool with dense weeds

Facing downstream – dense Coral Trees

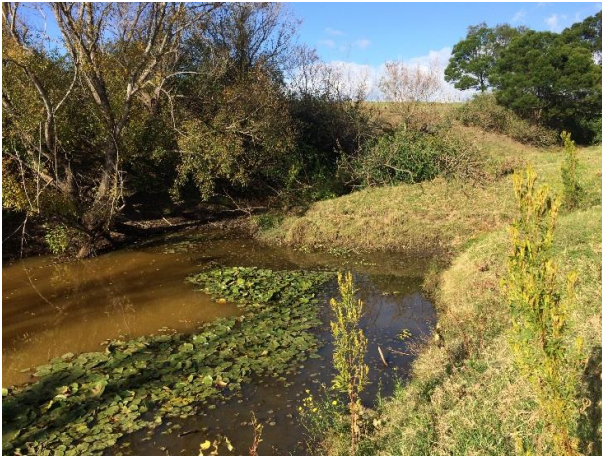
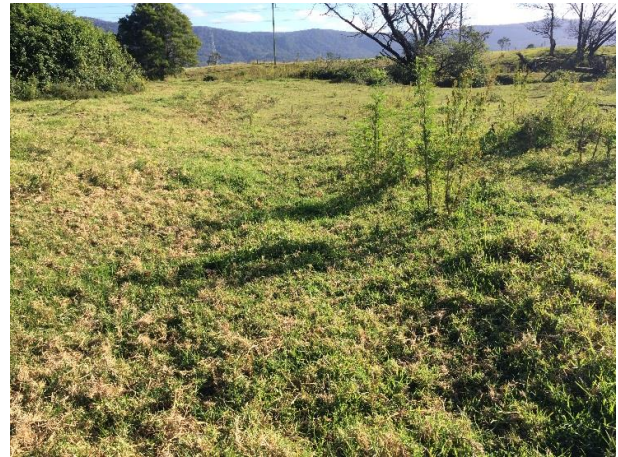
Reach 2B: Classed as Category 2 as per WCC and 2nd order under WM Act. This stream joins Mullet Creek on the southern boundary of the site. Upstream the channel was defined, with a narrow run that flowed into a large wide pool. The pool was lined with Willows and exotic grasses. *Typha orientalis* was present in the pool, as was the exotic lily *Nymphaea mexicana* (Yellow Waterlily). There was no defined channel between this pool and the fourth order creek. Here it was a grassy overland depression that would flow in times of heavy rain but had no defined channel or banks.

Facing upstream – large deep, turbid pool

Facing downstream – no defined channel

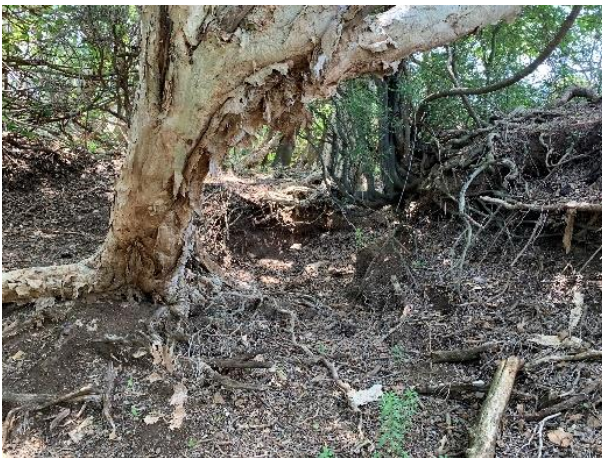
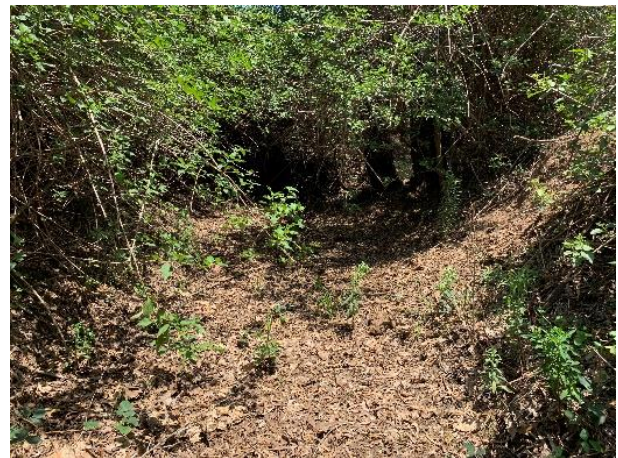
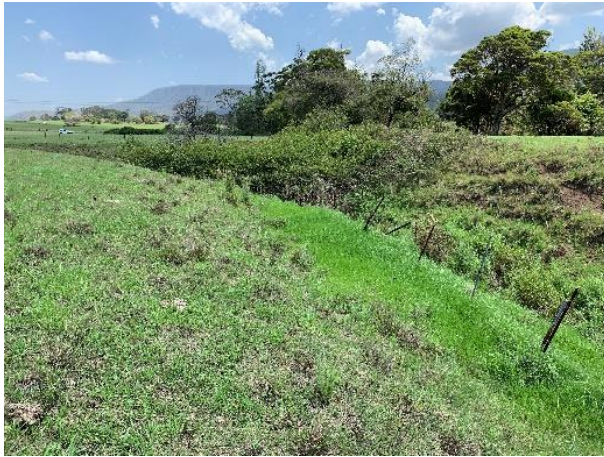
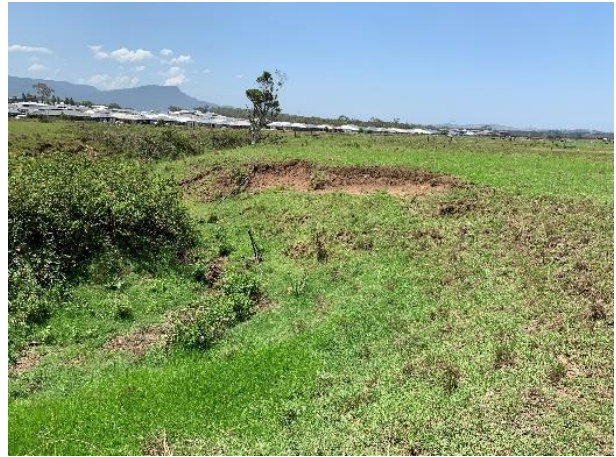
Reach 3A: Classed as Category 2 as per WCC, 3rd order under WM Act and 'key fish habitat' as per DPI Fisheries mapping. This creek had defined bed and banks. The surveyed upstream portion of the creek had deeply incised banks over 2 m high. The bed was heavily shaded by the exotic species *Lantana camara* (Lantana), *Rubus fruticosus* (Blackberry) and *Ligustrum sinense* (Privet). Mature native *Melaleuca styphelioides*, *Eucalyptus* sp. and *Angophora floribunda* were scattered between the weeds. No aquatic flora or fauna was observed. Moving downstream the banks increased in slope. Blackberry was present in the channel and the riparian vegetation was predominately pasture. Typha was present at the eastern extent of the reach.

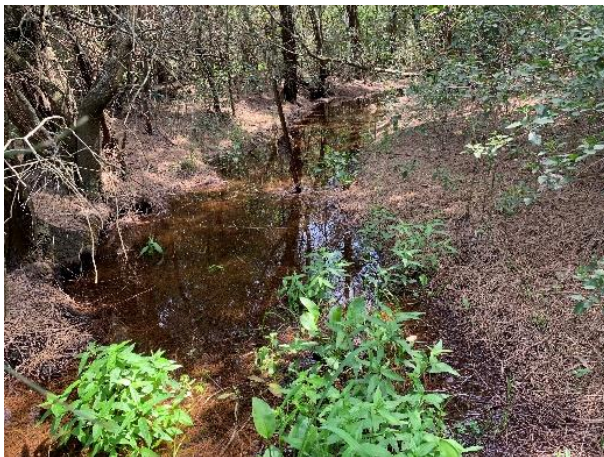
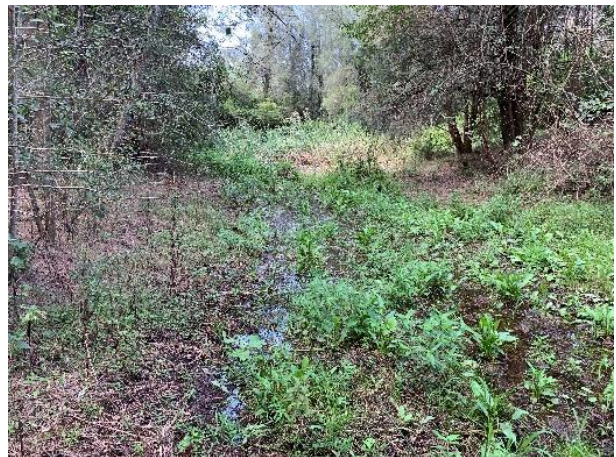
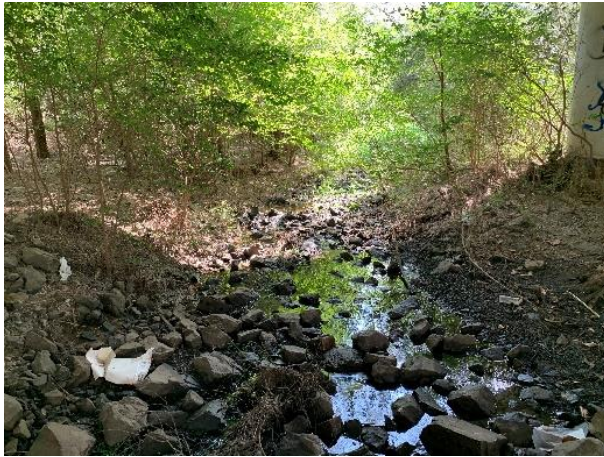
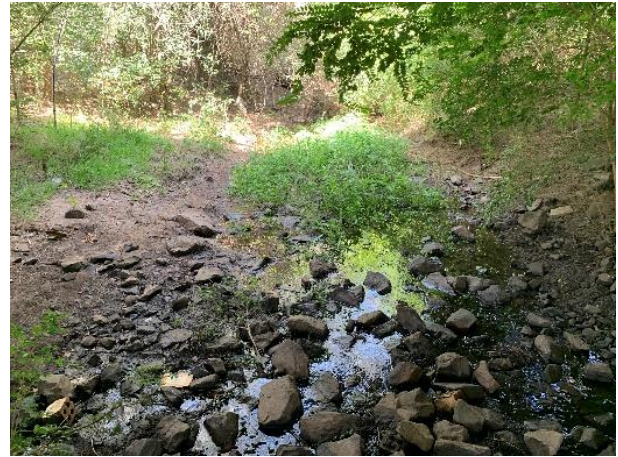
Reach 3A (cont'd): The eastern portion of the creek was relatively inaccessible. The portion that was surveyed had shallow, clear water. *Persicaria decipiens* (Slender Knotweed) was present throughout the reach. The riparian vegetation within this area of the site was validated as Plant Community Type 1232 *Swamp Oak floodplain swamp forest, Sydney Basin Bioregion and South East Corner Bioregion* during field surveys by ELA as part of the Flora and Fauna Assessment completed for the site in 2020 (ELA, 2020a).

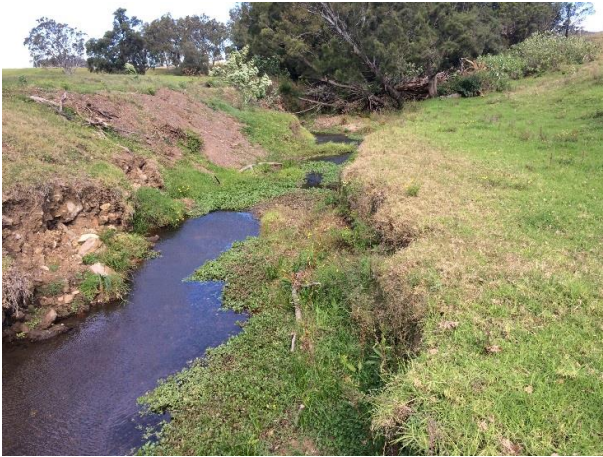
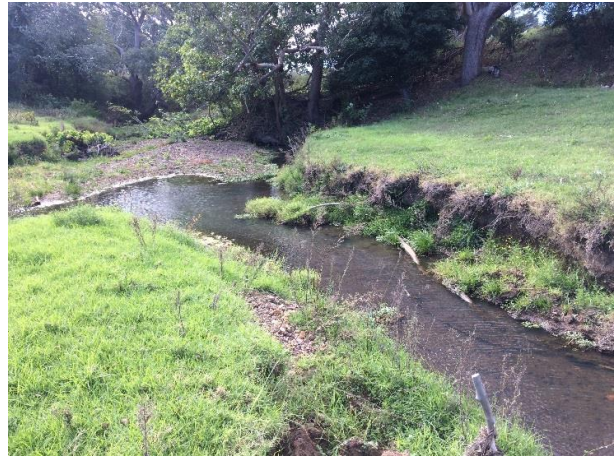
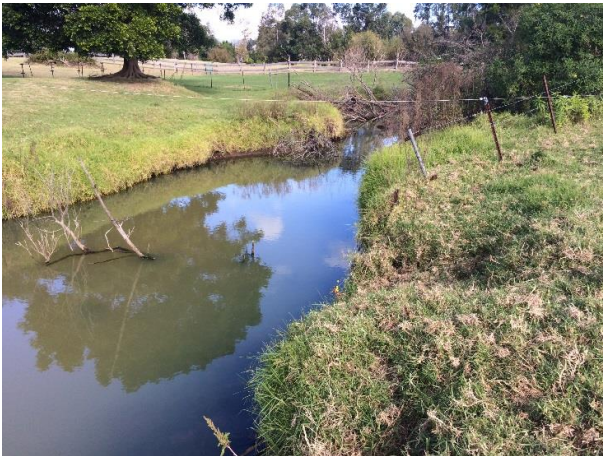
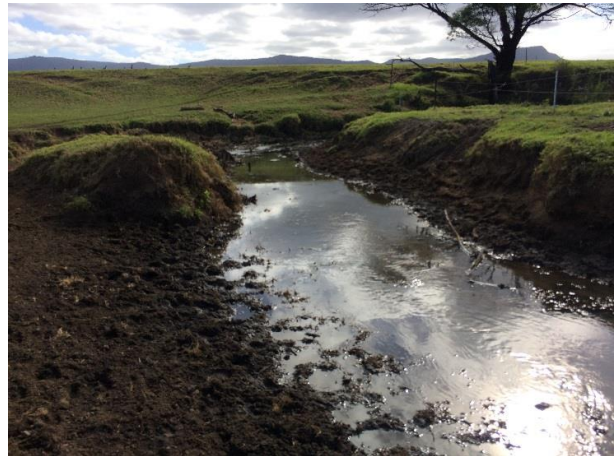
Reach 4A: Classed as Category 1 as per WCC, 4th order under WM Act and 'key fish habitat' as per DPI Fisheries mapping. Mullet Creek runs along the southern boundary of the site. The creek had an average width of 6 – 8 m with some wider braided sections where Willows had diverted the water. The bed consisted of predominately fine sediment with gravel, cobbles and occasionally instream woody debris. In the upstream reach the water was clear and flowing slowly. Aquatic plants were common including filamentous algae and *Azolla pinnata*. The flow alternated between narrow runs and wide pools. There were no riffles present in the creek. The banks were steep on the outer bends, up to 2 m high and undercut. The inner bends had a lower gradient, with accumulations of sediment in the channel. Both banks were dominated by weed species. Moving downstream, after the first order tributary 1B joined the creek, the channel narrowed with an average width of 4 – 6 m. The water became turbid and there was evidence of erosion from cattle. Cattle were observed crossing the creek at numerous points during the survey. The banks were slumped either side of these crossings. Downstream of where reach 2B joined, a long stretch of Cumbungi was present. The water flowing through the Cumbungi was clear. Approximately 200 m downstream, *Eichhornia crassipes* (Water Hyacinth), a weed of national significance was observed. Initially it was scattered throughout the channel, but moving downstream the weed became very dense, and blocked the entire channel for over 100 m.

Along the entire reach the banks were dominated by exotic species including *Bidens pilosa* (Cobblers Peg), Coral Trees, Lantana, *Onopordum acanthium* (Scotch Thistle), Blackberry, Stinging Nettle and Willows. The vegetation alternated between extremely dense sections and open pasture. There were mature native trees scattered throughout the riparian zone also, including included She-oaks, Eucalypts and Tea Trees.

Facing upstream – slow flowing, turbid water

Facing downstream – livestock crossing

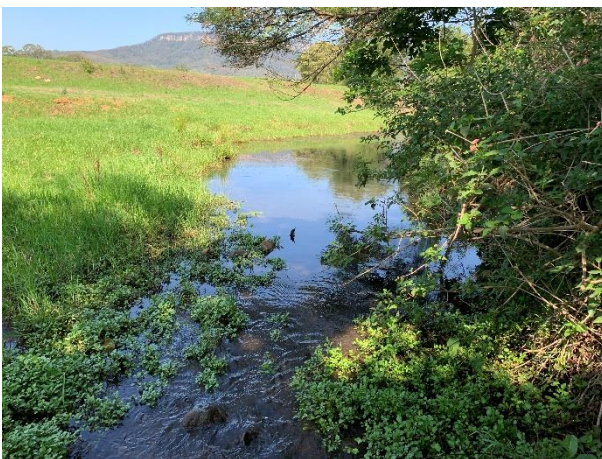
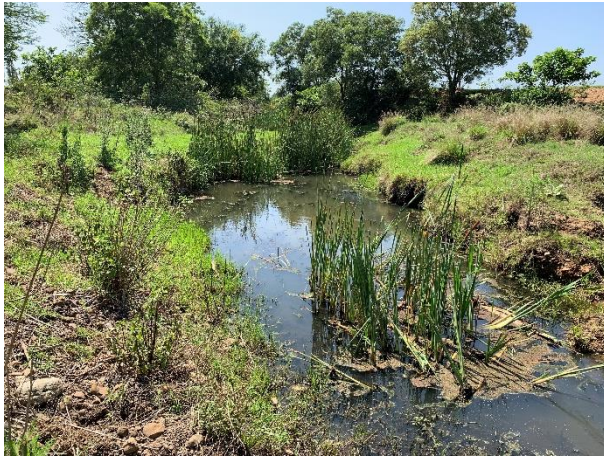
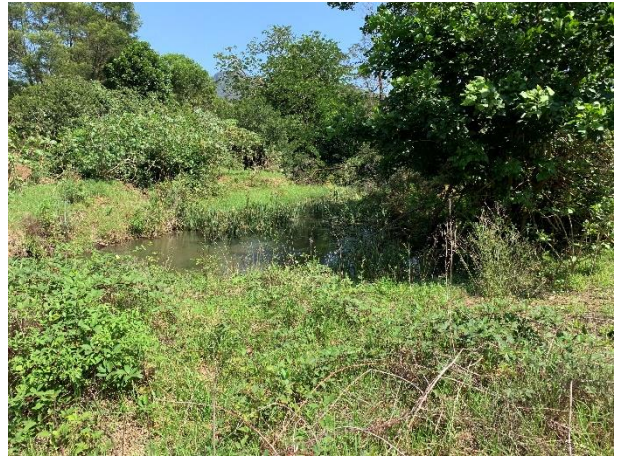
Reach 4A (cont'd): The water throughout the reach was clear and flowing, alternating between narrow runs and wider pools. No riffles were present. The benthic habitat was gravel and cobbles with fine sediment. Native aquatic vegetation was present throughout the reach, with *Azolla*, *Potamogeton crispus* (Crispy Pondweed), *Typha*, *Lemna disperma* (Duckweed), Slender Knotweed and *Nasturtium officinale* (Watercress) consistently observed. The left bank along the reach was steep and up to 3 m high. The outer bends were eroded and vertical. The inner bends had a gentler slope, with accumulations of sediment. Riparian vegetation along the reach was predominately weed species including Coral Trees, Lantana, Blackberry, Flaxleaf Fleabane and pasture grasses. Native trees and shrubs, such as *Acacia longifolia* (Wattle), *Hibiscus heterophyllus* (Hibiscus), *Melaleuca styphelioides* (Prickly-leaved Paperbark) were scattered amongst the weeds. The vegetation alternated between extremely dense sections and open pasture, where cattle had accessed the creek. Native aquatic fauna observed included two *Chelodina longicollis* (Eastern Long-necked Turtle) and three *Anguilla australis* (Short-finned Eel). The exotic fish, *Gambusia holbrooki* (Mosquitofish) were observed in each pool.

Facing upstream – slow flowing, turbid water

Facing downstream – livestock crossing
