**Site Audit Report  
Stage 1 & 2, Little Bay Cove  
Development, Anzac Parade,  
Little Bay**

Prepared for:  
**CHOF5 Little Bay Pty Ltd**

Prepared by:  
**ENVIRON Australia Pty Ltd**

Date:  
**September 2012**

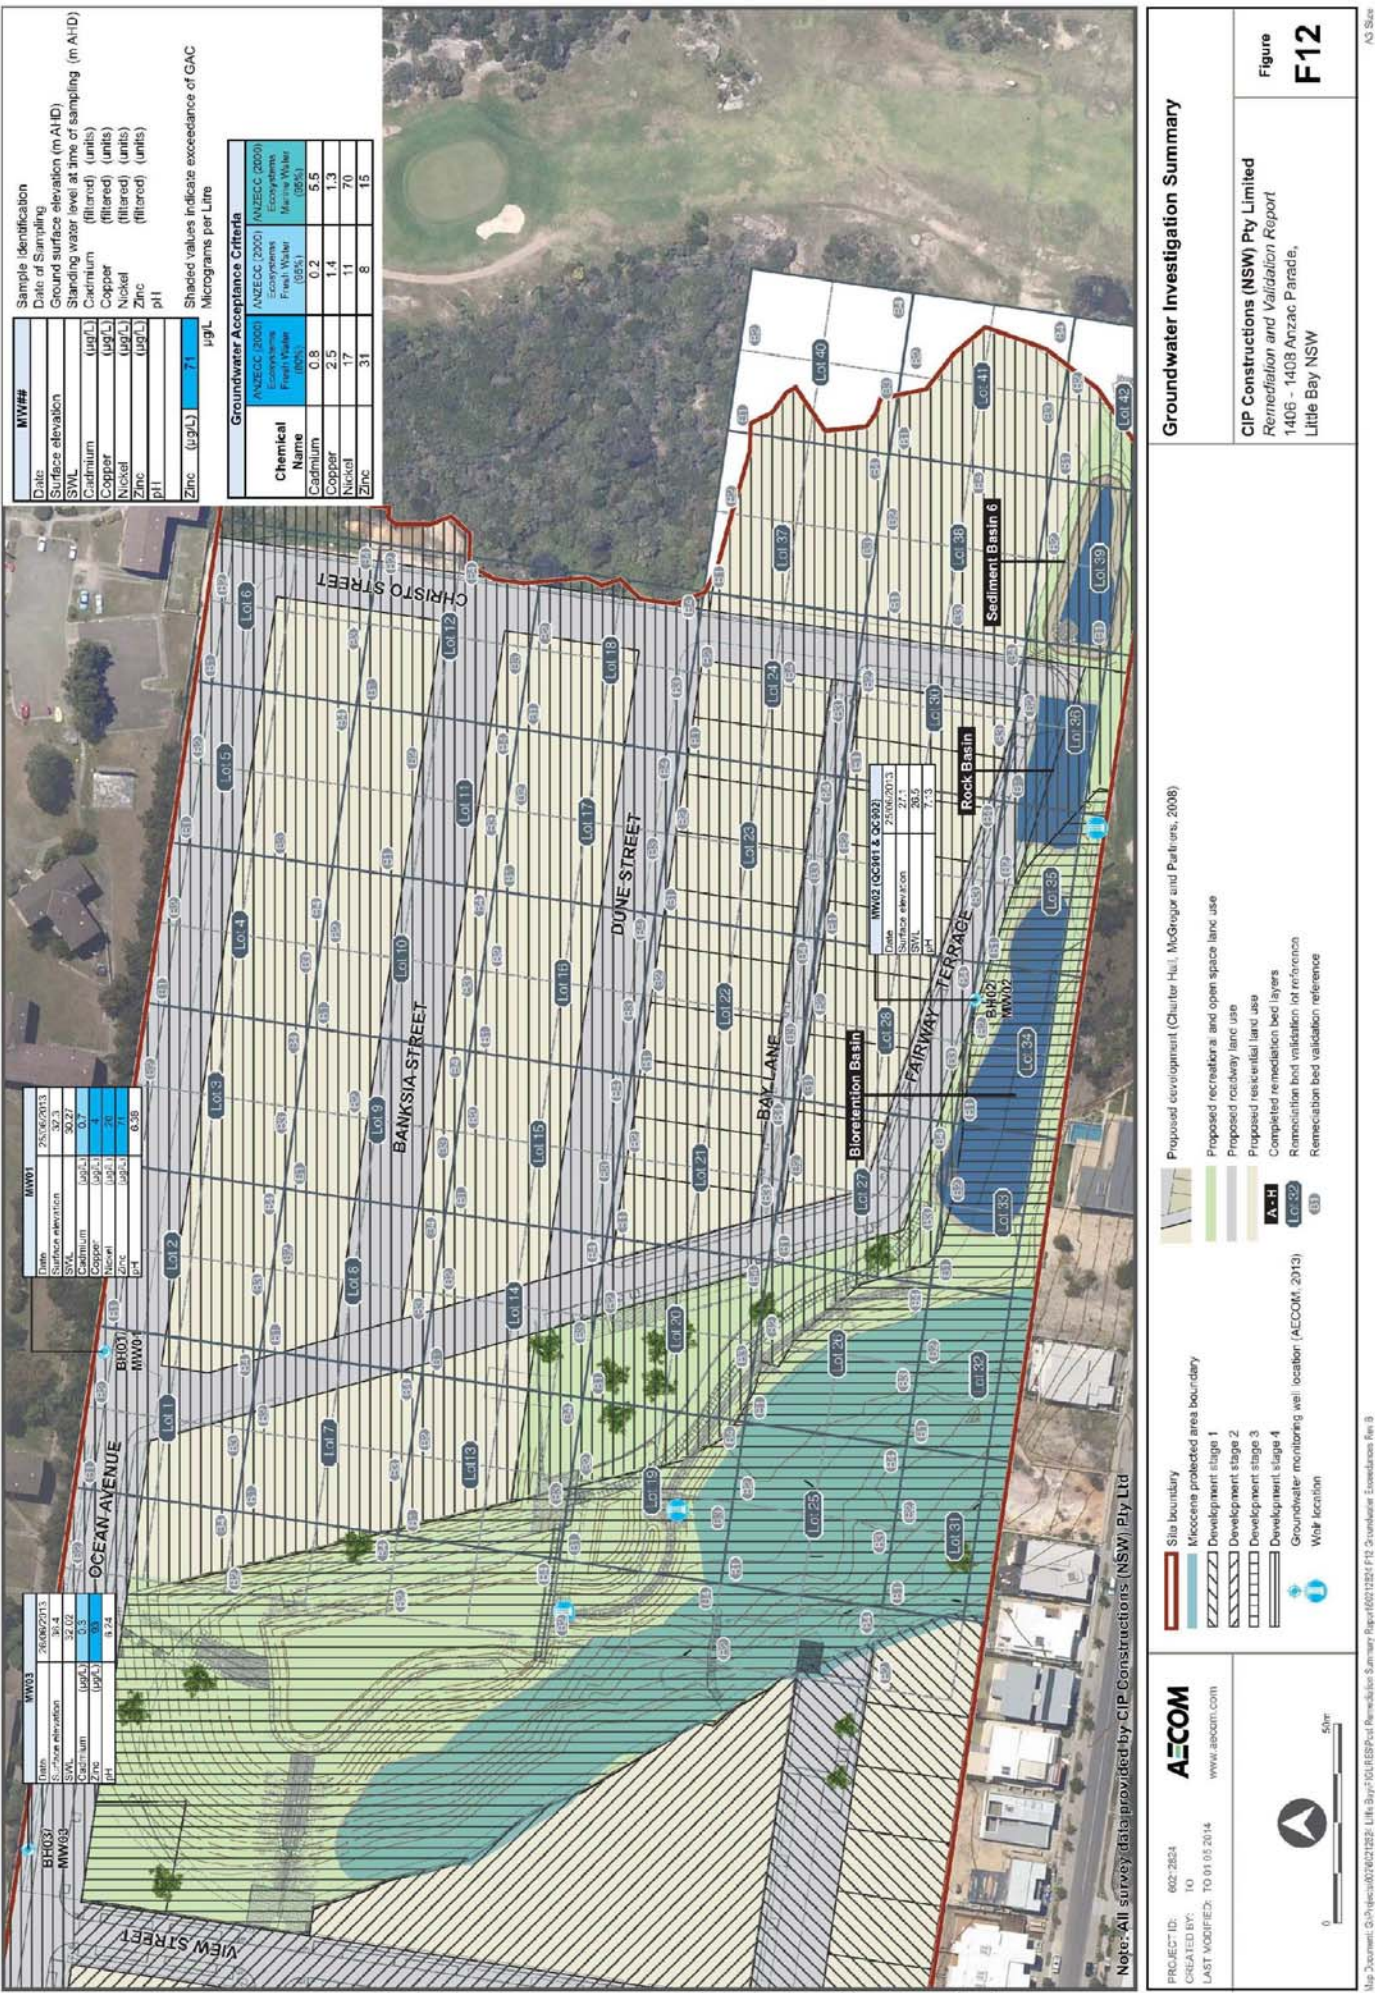
Figure  
F12

Groundwater Investigation Summary

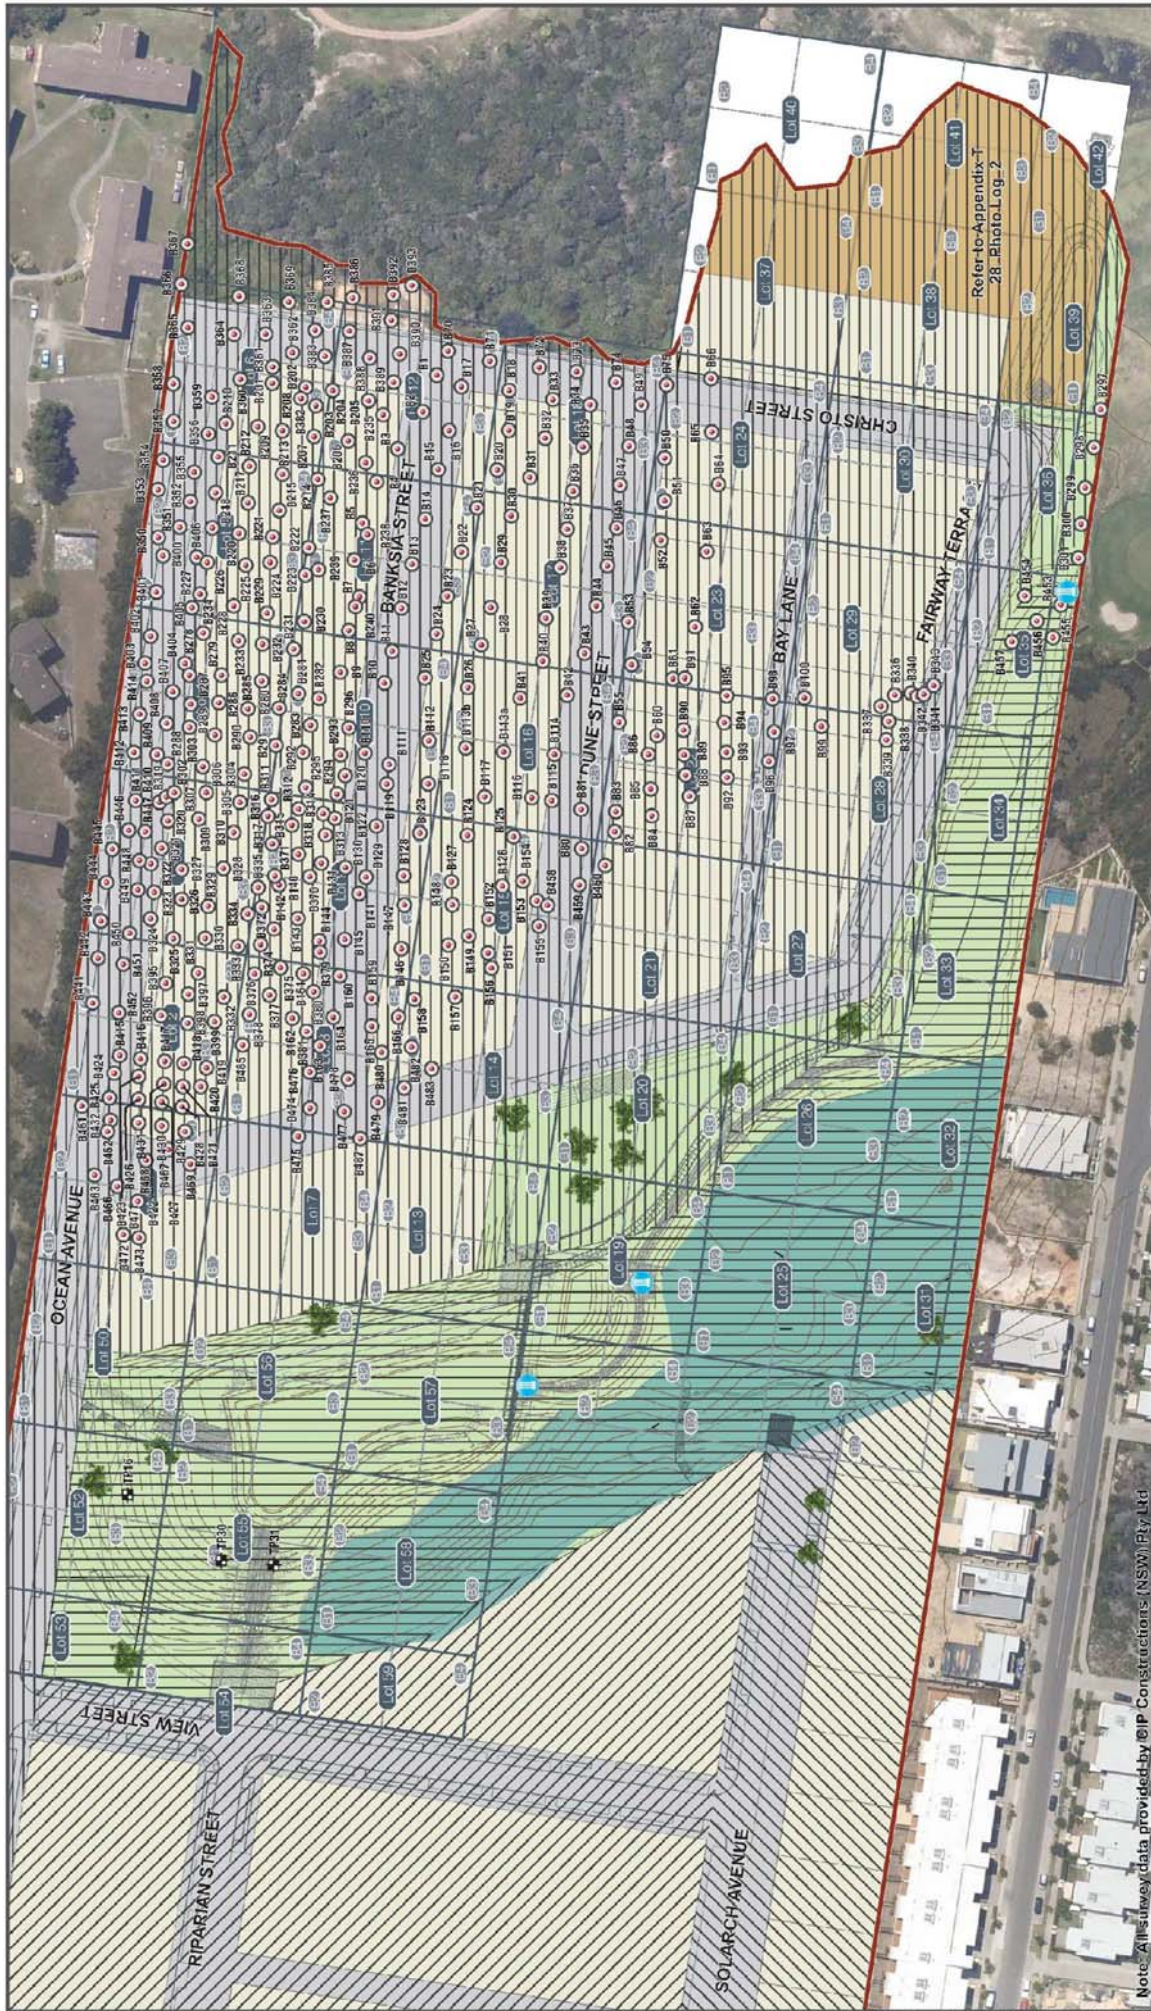
PROJECT ID: 6072624 CREATED BY: TO LAST MODIFIED: 10/05/2024 www.aecom.com		<b>AECOM</b>	
Proposed development (Chatter Hall, McGregor and Partners, 2006)		<b>Base of Excavation Validation - Bedrock</b>	
Proposed recreational and open space land use Proposed roadway land use Proposed residential land use Remediation and validation lot reference Remediation and validation reference		CIP Constructions (NSW) Pty Limited Remediation and Validation Report 1406 - 1408 Anzac Parade, Little Bay NSW	
Site boundary Maccorma privatised area boundary Development stage 1 Development stage 2 Development stage 3 Development stage 4 Bedrock validation location Test pit location Well location		Figure <b>F5</b>
