<u>Subject: Planning Proposal for the Rezoning of</u> Lots 411 – 413 DP 1063902, Medowie Road, Medowie

PLANNING PROPOSAL

PROPOSED REZONING

Lots 411-413, DP 10633902

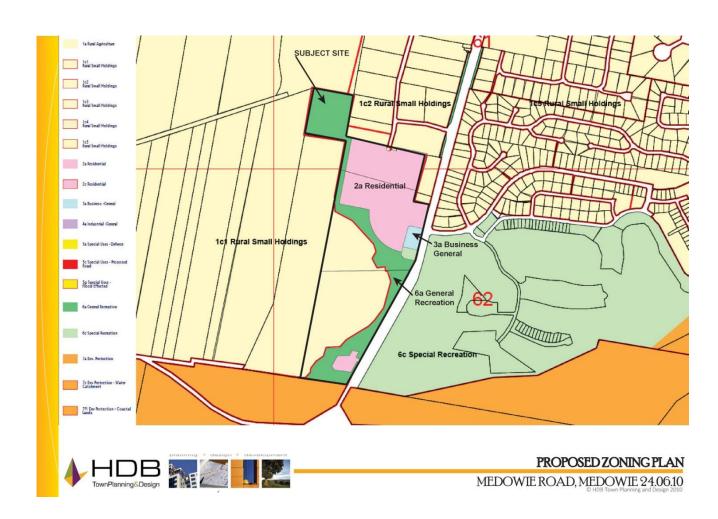
Figure 2 - Proposed Zoning Map Amendments

The objectives or intended outcomes are to be achieved by way of amendment to the Port Stephens LEP 2000 Land Zoning Map as shown in *Figure 2* below.

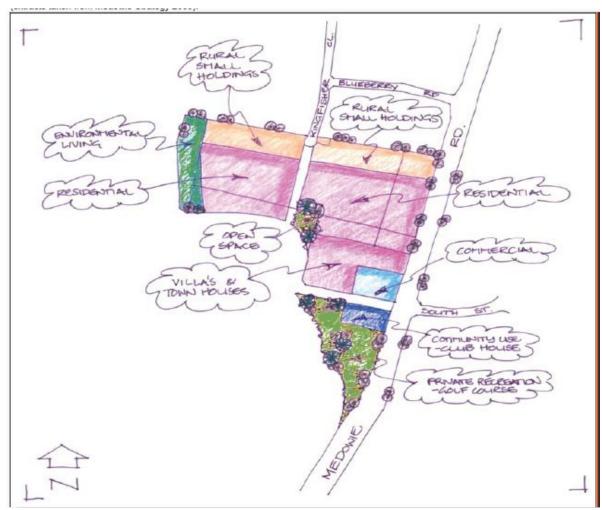
The Port Stephens Council Medowie Strategy 2009 indicates that the site is appropriate for Rural Small Holdings, Environmental Living, Residential, Town houses and Villas, Commercial, Community Use, Open Space and Private Recreational uses. Proposed typical land uses for the site as extracted from the Medowie Strategy are shown in *Figure 3* below.

Figure 3 – Extract from Medowie Strategy – Proposed Zones

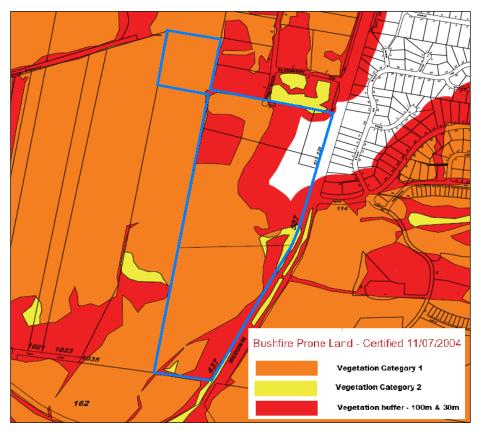
Figure 5 - Bushfire Prone Land Map

Part of the site is identified as being Bushfire Prone by Port Stephens Council's Bushfire Prone Land Map (See *Figure 5* below).

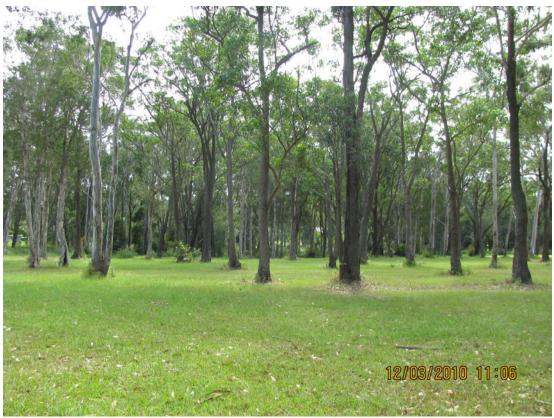
Figure 3: Photo from northwest of site looking east showing strip of trees between the two racetracks on site.

A large portion of the site consists of a parkscape currently managed by regular mowing. A large wetland is located in the west of the site and two small wetlands isolated by a figure eight racetrack are located in the north west of the site. A bitumen racetrack is also located in the north of the site with a strip of large trees dominated by *Eucalyptus robusta* (Swamp Mahogany) and *Eucalyptus tereticornis* (Forest Red Gum) extending between the two racetracks from the northern boundary to the large wetland on site. A number of very large *Pinus sp.* were also located to the south of the bitumen racetrack. A site map is shown in Figure 2. Photos showing the vegetation present on site are shown in Figures 3 and 4.

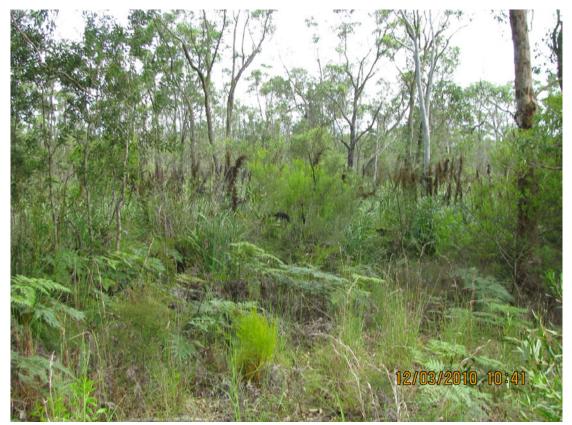
Figure 4: Photo from southern portion of site looking west towards the large wetland on site.

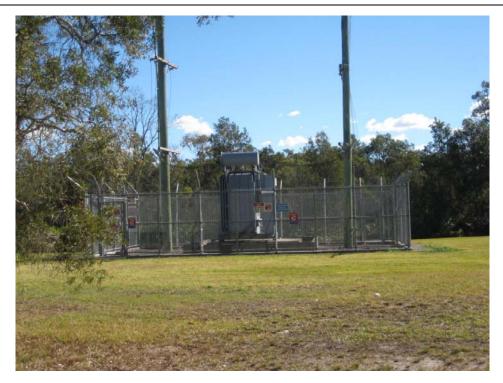
PHOTOGRAPH 1: The electrical substation (transformer yard) located near the middle of the site

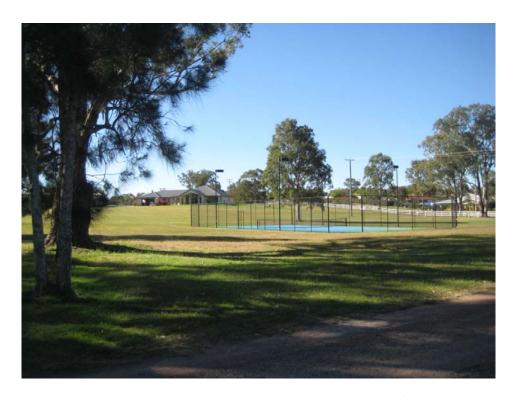
PHOTOGRAPH 2: Looking towards the tennis court near the gravel driveway (shown in the foreground) near the middle of the site

- A gravel driveway was observed leading to the northern residence (Photograph 2). A tennis court
 was observed near this gravel driveway.
- The small creek / drain that cuts through the middle of the site was observed to be partially filled with water (Photograph 3). Two small bridges (suitable for vehicular traffic) were observed to cross over this drain / creek.

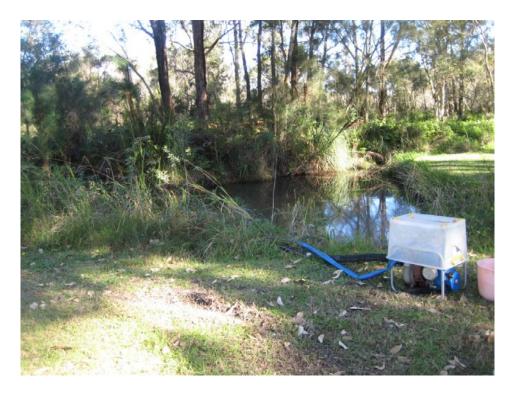
PHOTOGRAPH 3: Looking at the small drain that cuts east to west across the middle of the site

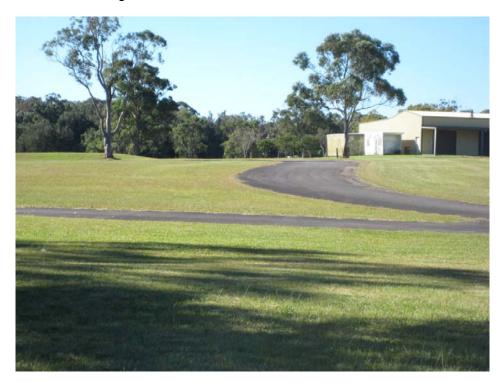
PHOTOGRAPH 4: The bitumen-paved racing track located near the northern residence on the site

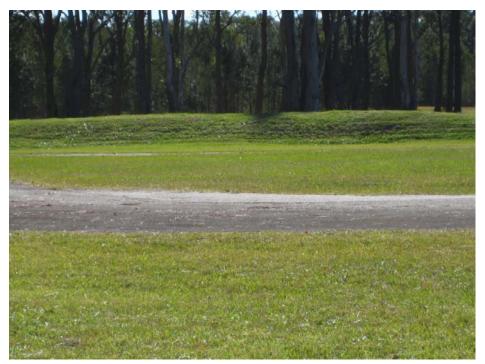
PHOTOGRAPH 5: Looking at one of the two fill mounds that act as buffers around the racing track. This fill mound is located along the south-western section of the track

The assessment concludes that the likelihood for significant contamination to be present in the existing fill on the site is considered to be low and is suitable for reuse on site. The report also recommends that a Phase 2 Environmental Site Assessment (ESA) be carried out at the Development Application Stage when detailed design is finalised. The PCA is attached, (See Appendix B – Preliminary Contamination Assessment).

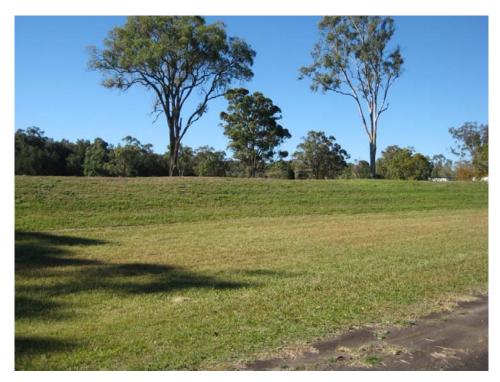
PHOTOGRAPH 6: Looking at the two fill mounds located around the racing track. This fill mound is located along the northern side of the track

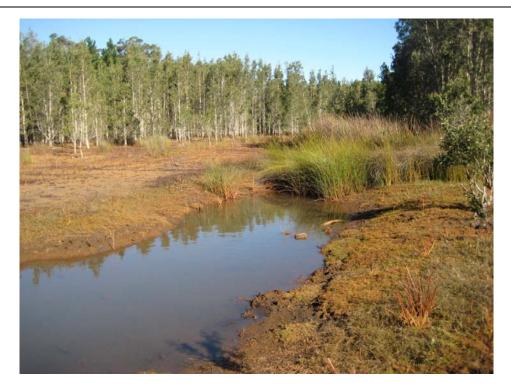
PHOTOGRAPH 7: Looking at the swamp / marsh area adjacent to the north-western section of the site.

- A swamp / marsh area was observed adjacent to the north-western section of the site (Photograph 7). This section was observed to consist of a filled area with two small circular sections in the centre containing water. Concrete slabs were also identified in this area.

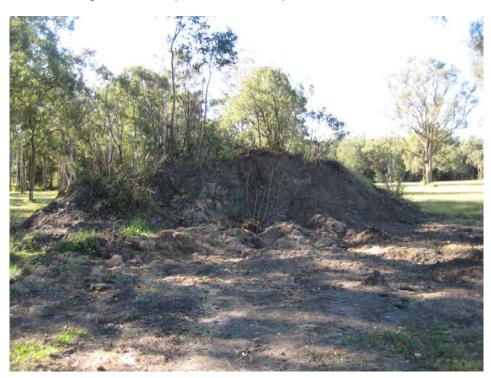
PHOTOGRAPH 8: A stockpile of predominantly sandy soil near the racing track. This stockpile is inferred to have been created from soil excavated elsewhere on site

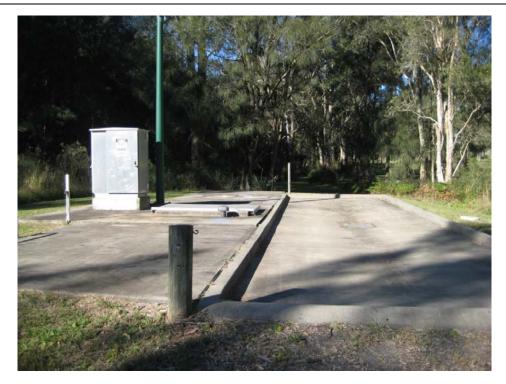
PHOTOGRAPH 9: The Medowie Wastewater Pumping Station, located along the northern boundary of the site

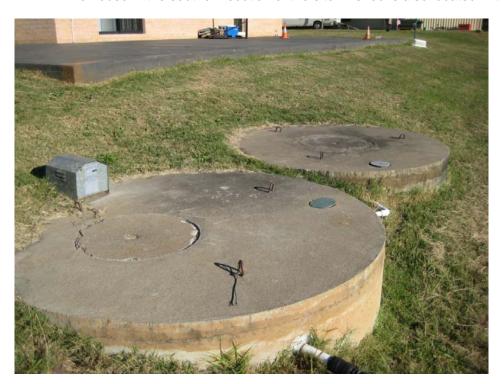
PHOTOGRAPH 12: Septic tanks located near the southernmost house

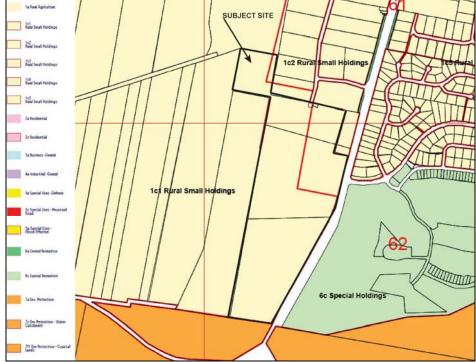
The existing zoning of the site (1(c1) Rural Small Holdings) is shown in the following figure.

Figure 3 - Current Zoning.

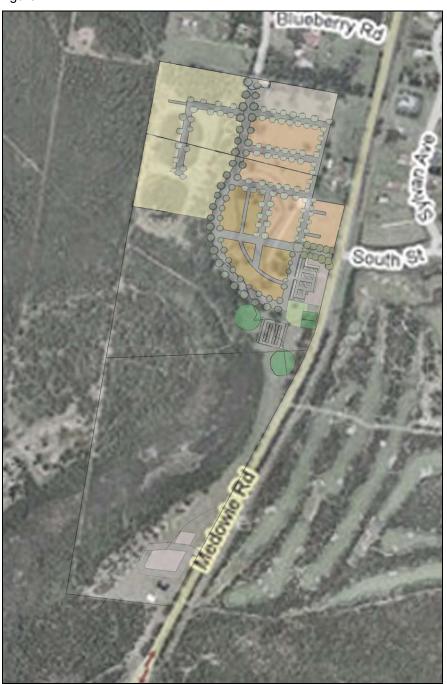
In order to demonstrate the feasibility of the proposed rezoning, a concept masterplan has been prepared. It contains Residential, Seniors Living, Commercial/Business and Open Spaces land uses which the rezoned site could accommodate. Reference is made to the following Figure.

Figure 5 - Concept Site Layout.

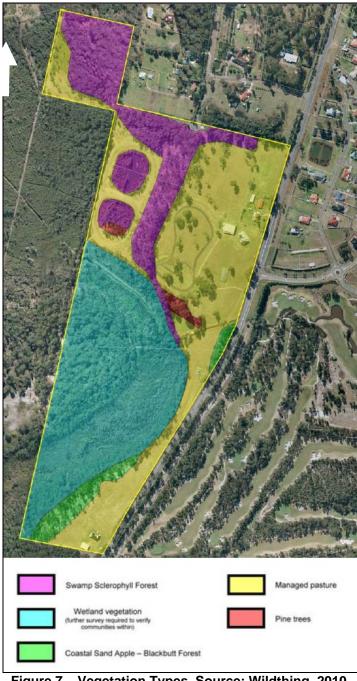
An analysis of the vegetation communities present on the site was undertaken by ecological consultants Wildthing P/L as part of their ecological site assessment prepared in support of the rezoning. The following figure details vegetation types/communities present on the subject site.

Figure 7 – Vegetation Types. Source: Wildthing, 2010.

Based on this information, and a separate analysis based on the methodology contained within PBP 2006, the vegetation that influences bushfire behavior within 140m of the proposed zones was undertaken. This assessment found three distinct vegetation classifications as listed below:

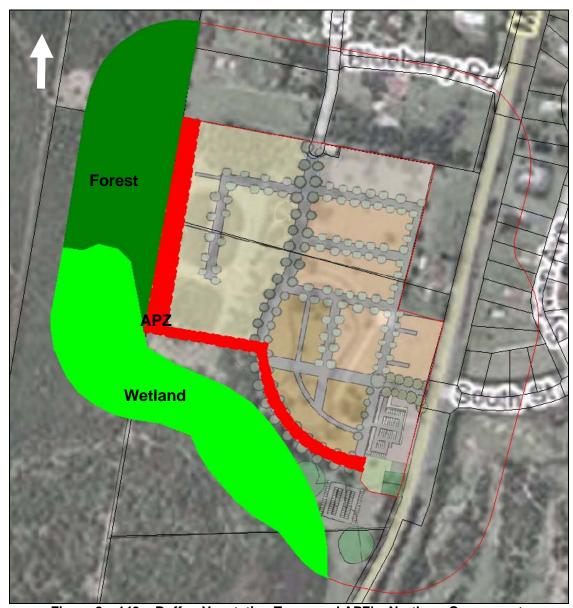
Figure 8 – 140m Buffer, Vegetation Types and APZ's, Northern Component.

Direction from proposed building line	Vegetation:	Effective Slope:	Required setback	OPZ	
Environmental Living					
North	Managed Land	Flat	NA	NA	
South	Wetlands	>0 ° to 5°	10	NA	
East	Managed Land	Upslope	NA	NA	
West	Forest	>0 ° to 5°	25		
Residential / Villa / Townhouses / Commercial / Club					
Northeast	Residential	Upslope	NA	NA	
Southeast	Residential	Flat	NA	NA	
Southwest	Wetland	>0 ° to 5°	10	NA	
Northwest	Residential	Flat	NA	NA

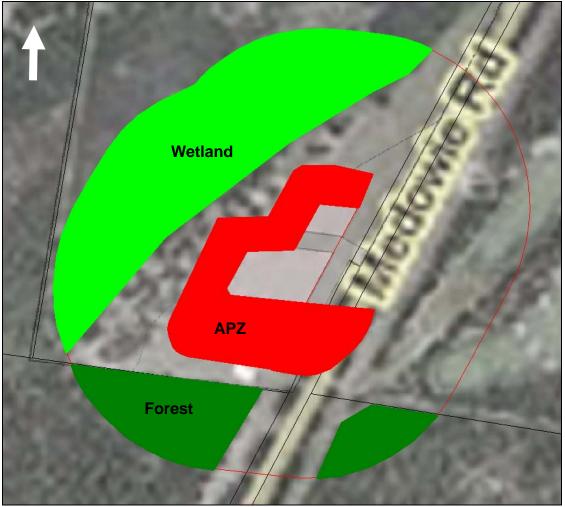
Figure 9 – 140m Buffer, Vegetation Types and APZ's for Seniors Living Special Fire Protection Purpose

Direction from Building Envelope	Vegetation:	Effective Slope:	Required setback	OPZ
SEPP Seniors Living				
North	Managed Land	Upslope	NA	NA
South	Forest	Flat	60	10
East	Managed Land	Flat	NA	NA
West	Wetlands	>0 ° to 5°	35	NA
