DHA Fort Wallace Stockton Beach Coastal Engineering Assessment

November 2017

Prepared for: Department of Housing Australia

Prepared by: BMT WBM Pty Ltd (Member of the BMT group of companies)

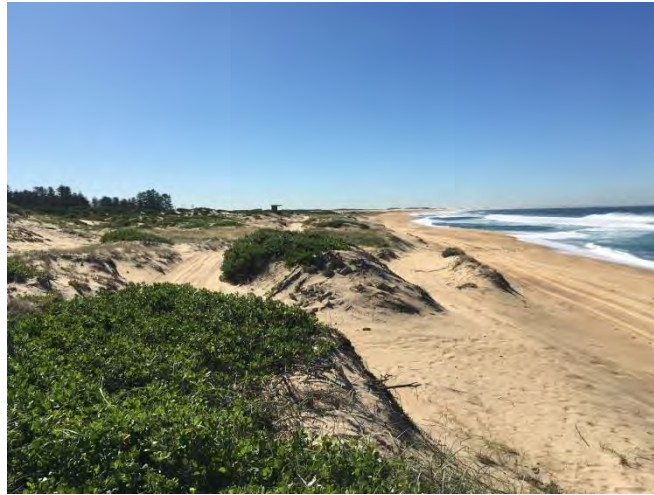
Figure 2-3 Beach along Northern Half of Fort Wallace, erosion not evident

extends along the southern half or more of the site, before disappearing and being replaced by a stable to accreted dune and beach (Figure 2-3). It is possible the erosion escarpment was created during the June 2016 storms. That event arrived from a more north easterly direction, and so more heavily impacted the southern end of Stockton Beach. For this reason, the Fort Wallace site and adjacent beach to the north was barely (if at all) impacted by the June 2016 storms. In general, the site does not presently appear to be greatly affected by ongoing recession due to the harbour breakwaters, unlike the southern part of Stockton Beach (see Section 2.1.4).

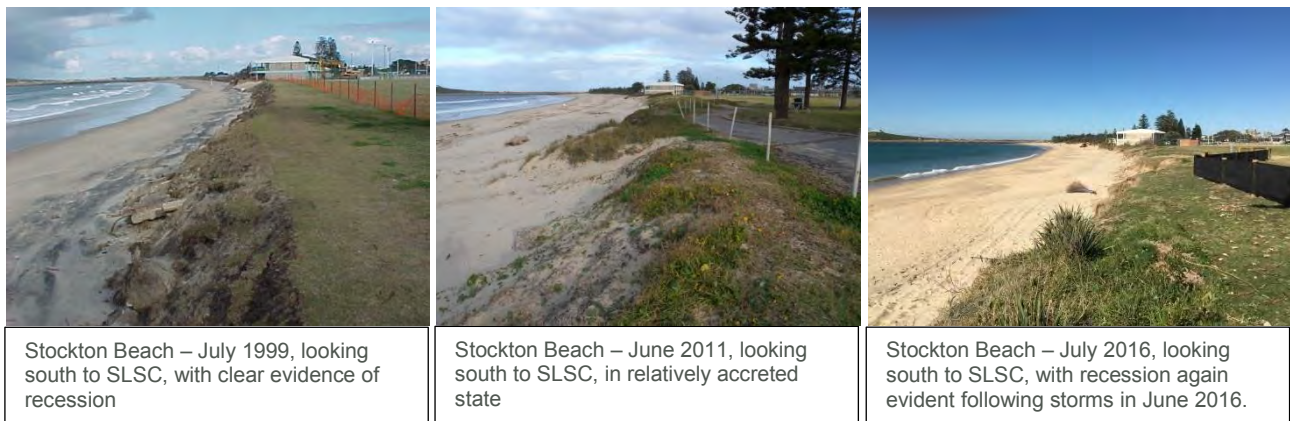
Figure 2-4 Stockton Beach Key Area of Recession over time

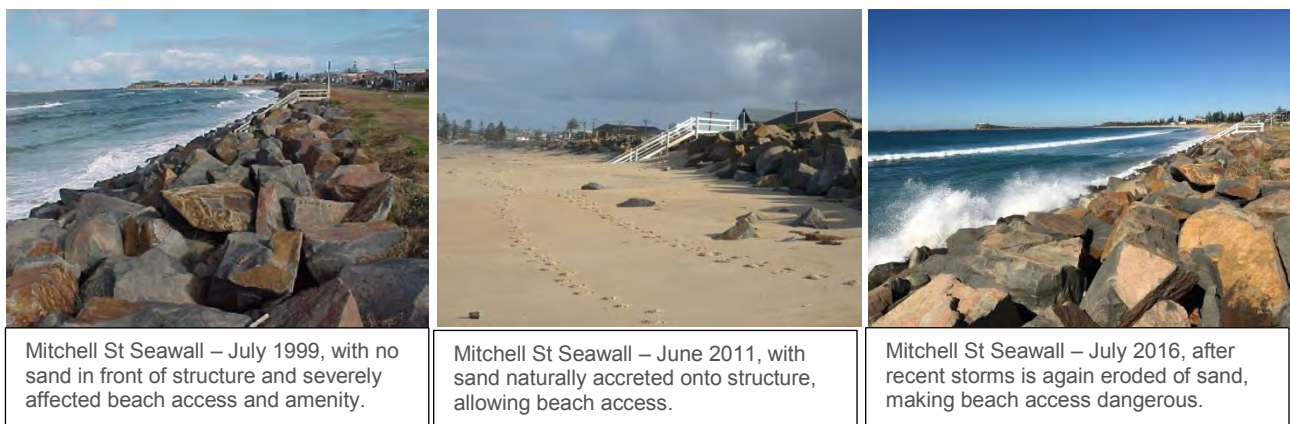
Figure 2-5 Stockton Beach Mitchell St Seawall and Recession over time

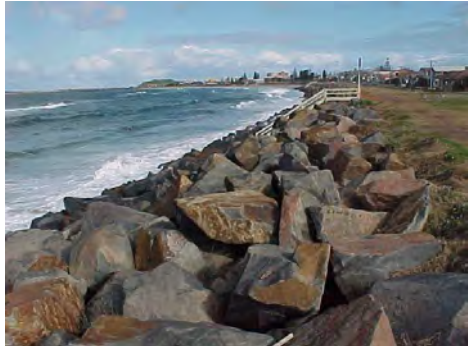
Option, <i>Ball-park cost</i>	Positives	Negatives	Recommendation for use at Fort Wallace
<p>Rock revetment (seawall)</p> <p>Construction of a rock revetment along the seaward boundary of the property(s) (see picture)</p> <p>Cost: ~ \$10,000 / linear metre of seawall, plus maintenance costs (which may include beach nourishment).</p> <p>Caution: seawalls <u>are not permissible</u> to be built on an individual property basis, due to their impact on adjacent land (see “negatives”).</p>	<p>Retains the shoreline in its current position, to maintain the buildings and assets behind the shoreline.</p> <p><i>In the case of Fort Wallace, the seawall would not be constructed now, but be required to be implemented in the future when a specific erosion trigger is reached, or an assessment of the property(s) identifies that a revetment is required to restore structural stability.</i></p>	<p>On receding beaches such as Stockton, the seawall results in a loss of beach and beach amenity in front of the structure (see picture below of Mitchell St seawall). Erosion at the ends of the structure also occurs.</p> <p>Revetments can “lock away” sand reserves that would otherwise be eroded and supply the coastal system. This is particularly so at Fort Wallace given the volume of sand within the existing dunes.</p> <p>Under existing coastal legislation, amelioration of offsite impacts such as erosion in front and at the ends of the structure is required. This typically means ongoing beach nourishment, additional to the cost and maintenance of the seawall structure alone. Given that property owners at Fort Wallace would be the sole beneficiary of the revetment, existing coastal legislation allows the entire cost burden (construction, maintenance and remediation works) to be placed upon these property owners.</p>

<p>No, not recommended, due to the existing recession hazard at Stockton Beach, that would place an unreasonable financial burden on future property owners to build and maintain the structure, including beach nourishment</p>
