Preliminary Contamination Investigation Report

Lot 711 DP 1128593.

Greigs Flat NSW

A.F. Legler & Associates PTY LTD

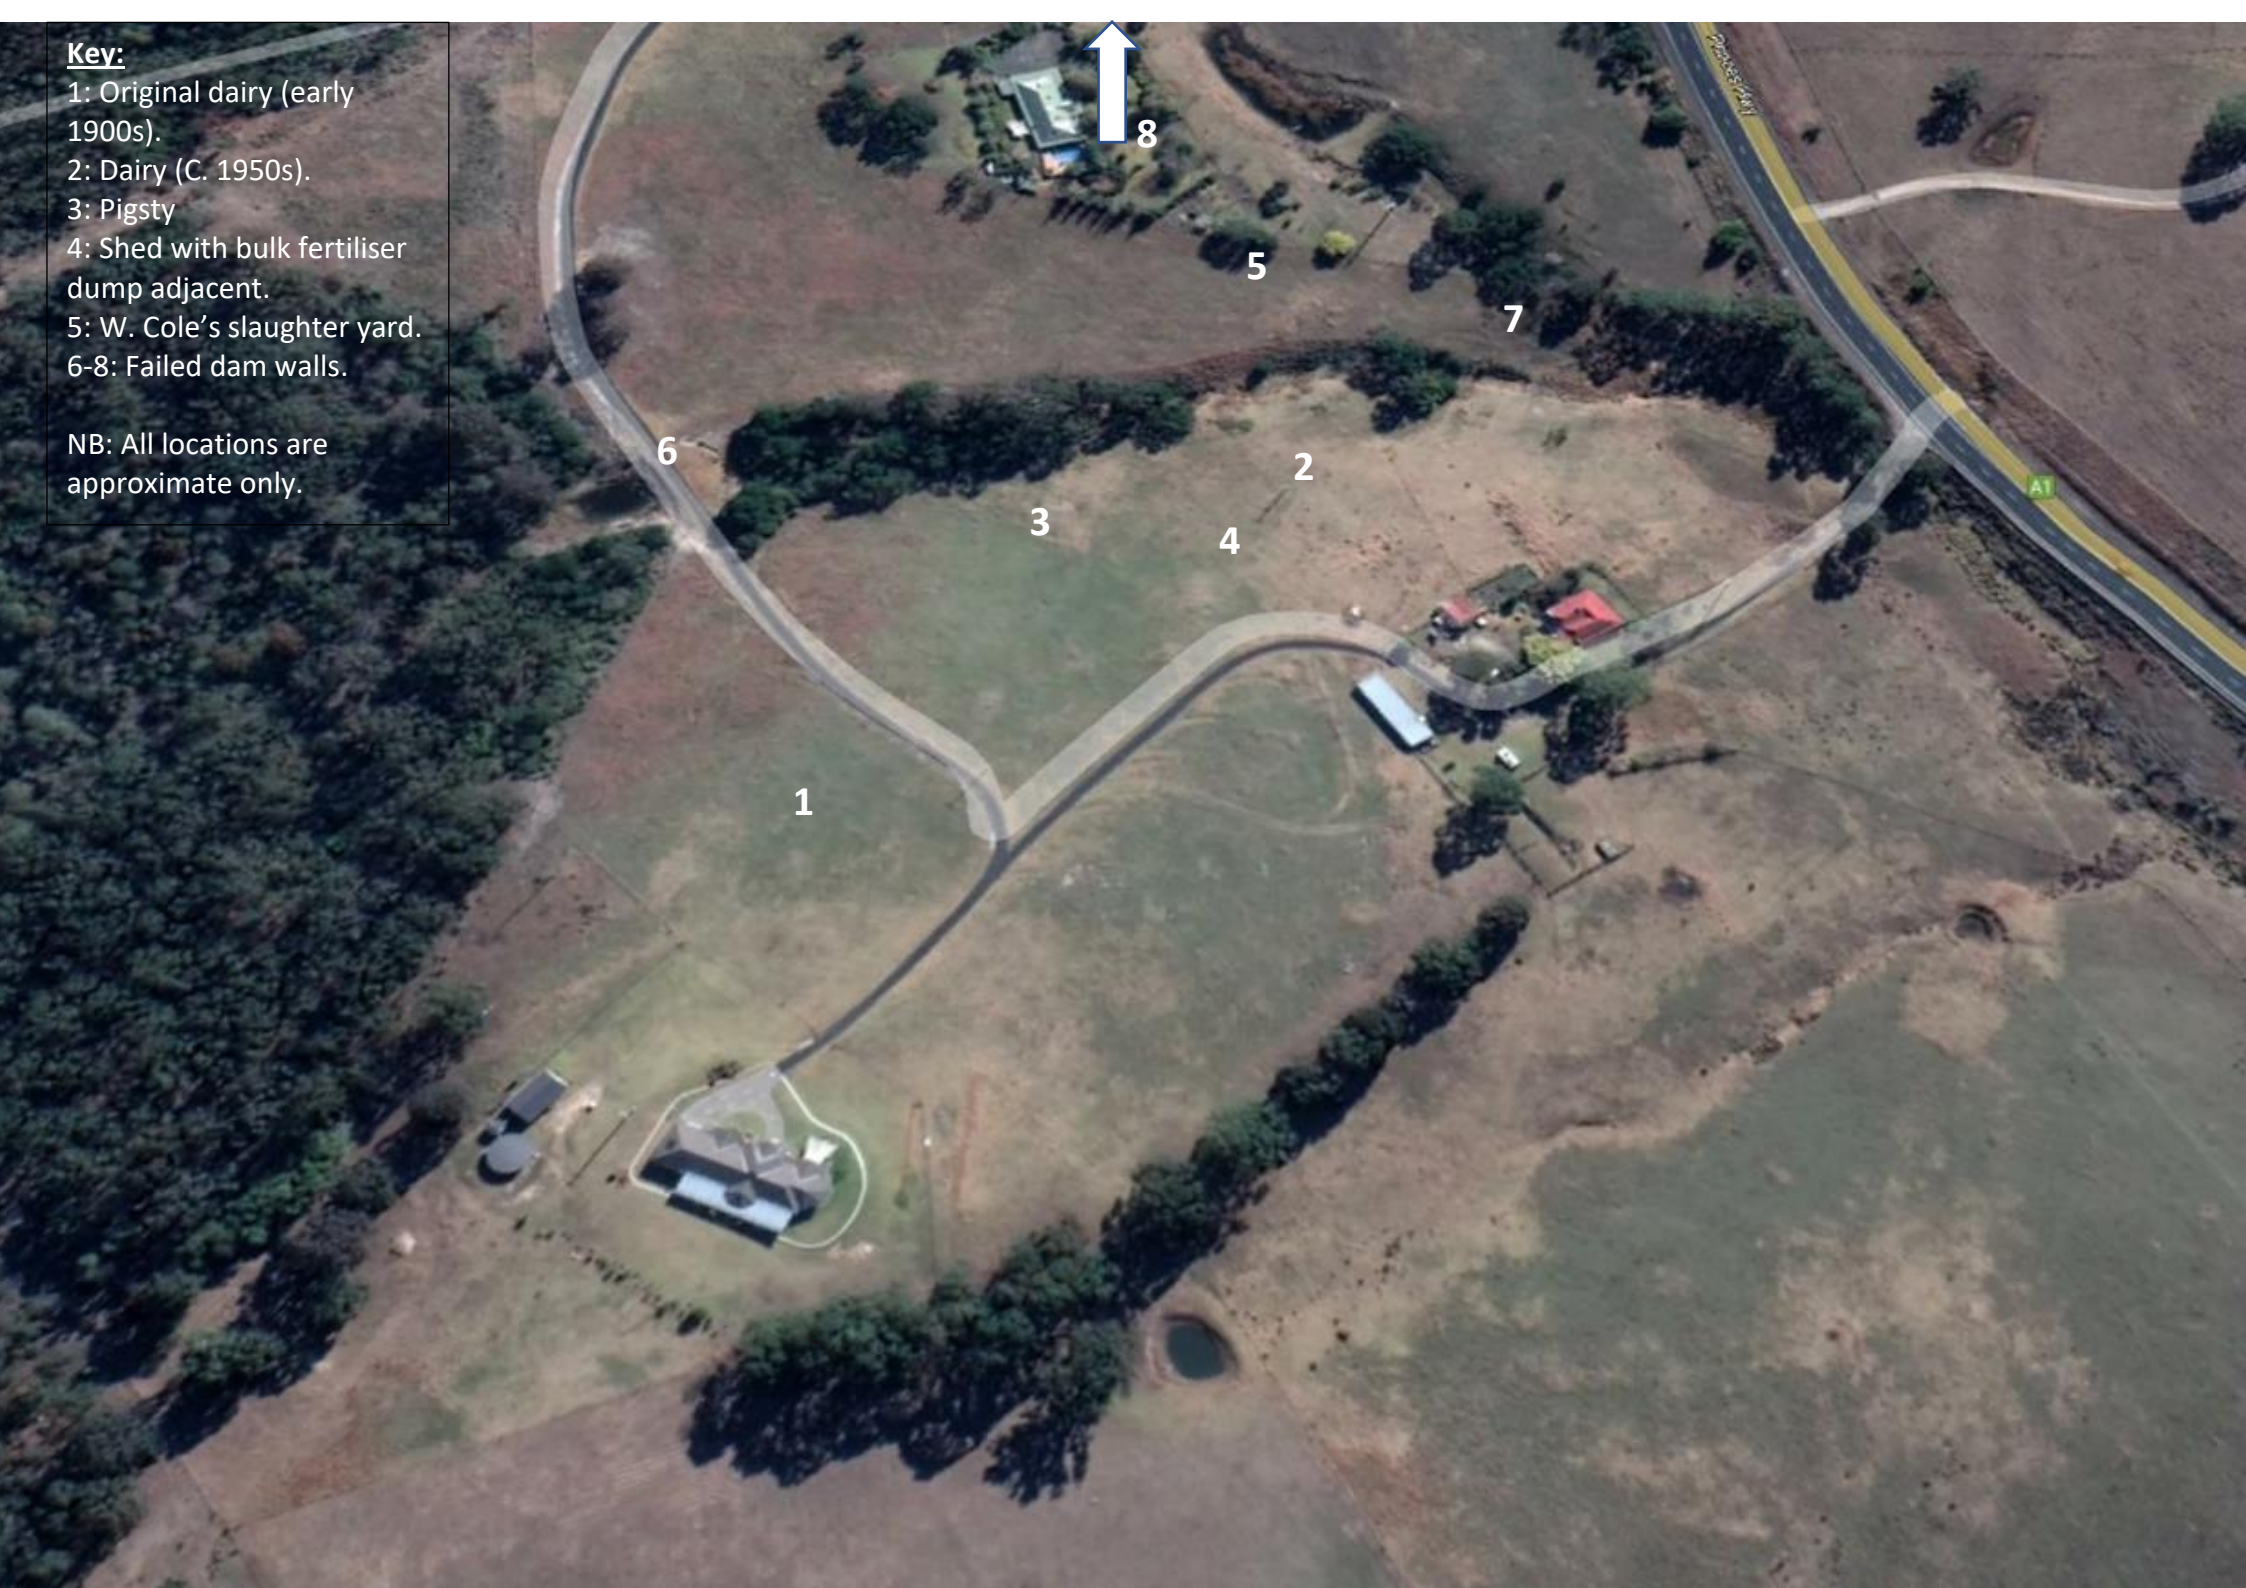
- 1: Original dairy (early 1900s).
- 2: Dairy (C. 1950s).
- 3: Pigsty
- 4: Shed with bulk fertiliser dump adjacent.
- 5: W. Cole's slaughter yard.
- 6-8: Failed dam walls.

NB: All locations are approximate only.

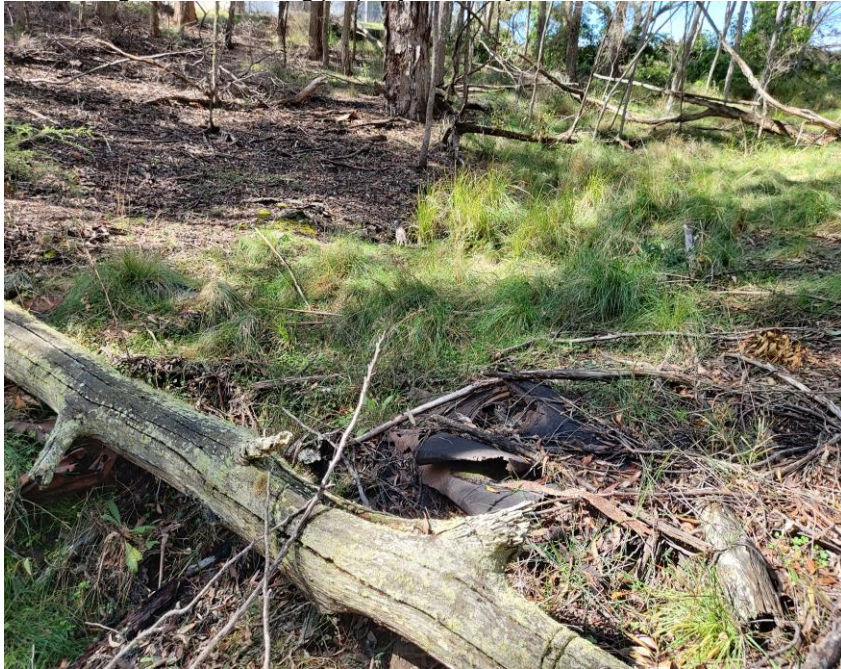
Minor amounts of debris including the remains of boiler and several tires and wheels were identified in the northwest corner of the property.

P2: Debris in gully

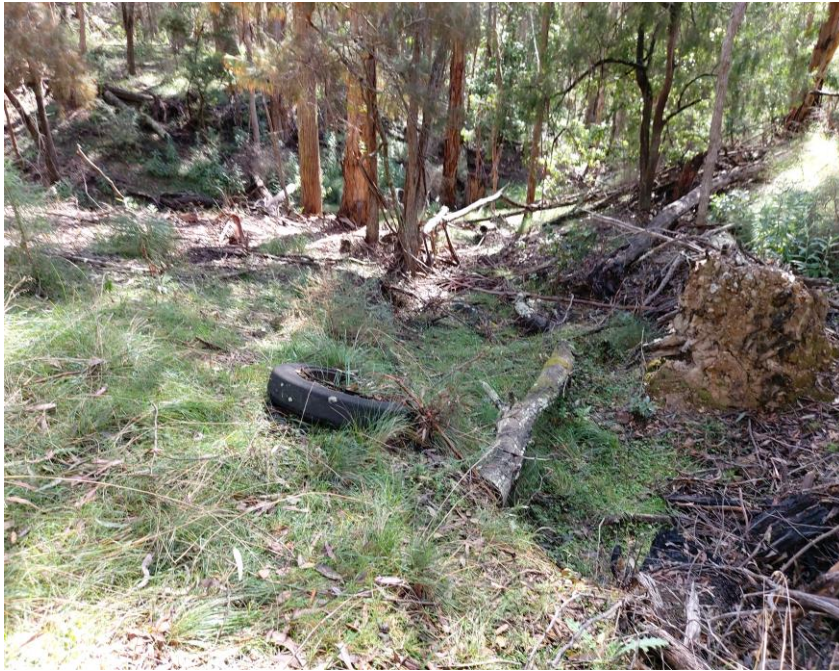
P3: Debris In gully

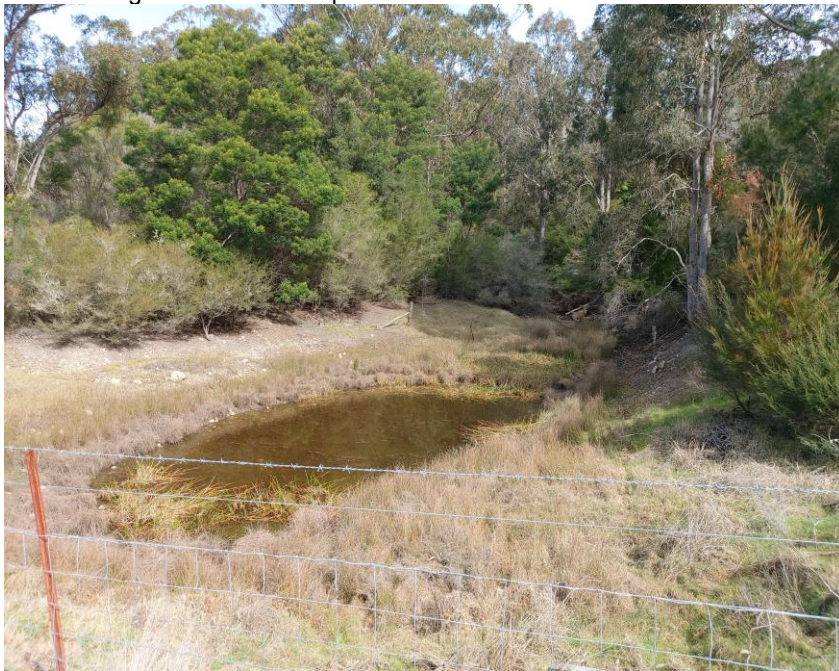
P15: Small dam located on Proposed Lot 1

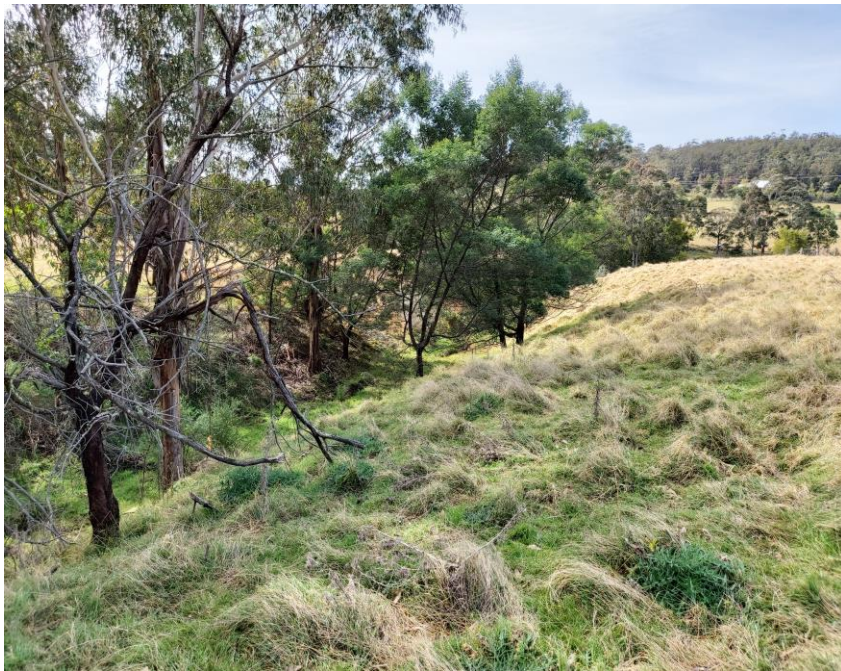
Based on the Review of Site History buried demolition waste may be present on proposed Lot 3. The potential for rubbish dumps has also been identified. Based on the site inspection no evidence of rubbish dumping was noted in the gullies and ravines which are the most likely locations. Further, a detailed inspection of proposed Lot 3 revealed no evidence of unusual soil mounding, surface depressions or debris. The property owner has also indicated that mowing activities have never identified debris in this area.

P18: Gully Proposed Lot 3 looking NE

Based on the above, additional assessment may be warranted regarding potential buried demolition waste on Proposed Lot 3, otherwise no additional assessment is recommended.

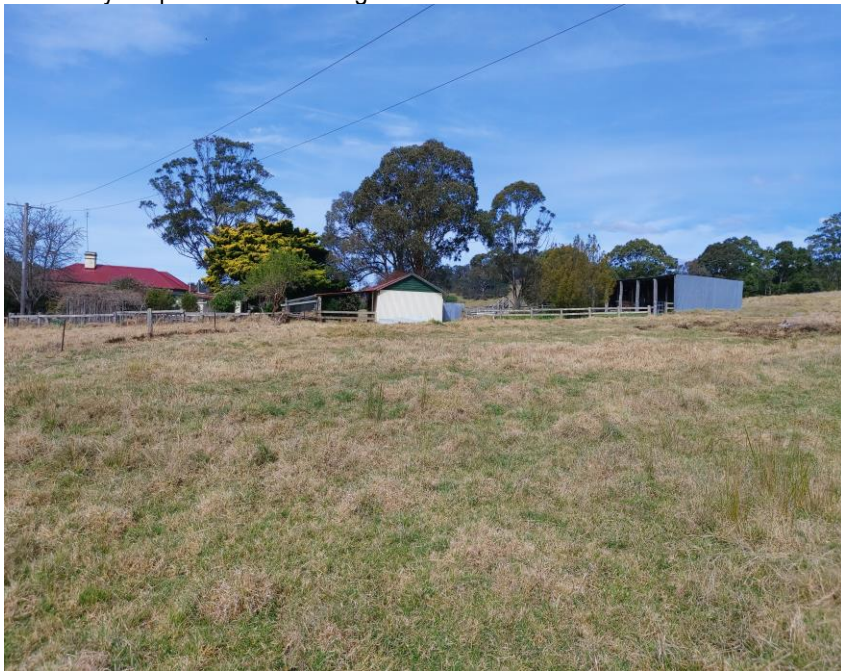
The area of proposed Lots 3 and 5 which were previously occupied by the Rose Hill Farm dairy and cattle yards was inspected in detail. With the exception of concrete foundation materials, no evidence of the previous structures was noted.

P19: Site of former yards & dairy, Rose Hill Cottage & out buildings in background
