Wastewater Land Capability
Assessment:
Lot 711, DP1128593, South Pambula,
NSW

P1404330JR02V02
February 2022

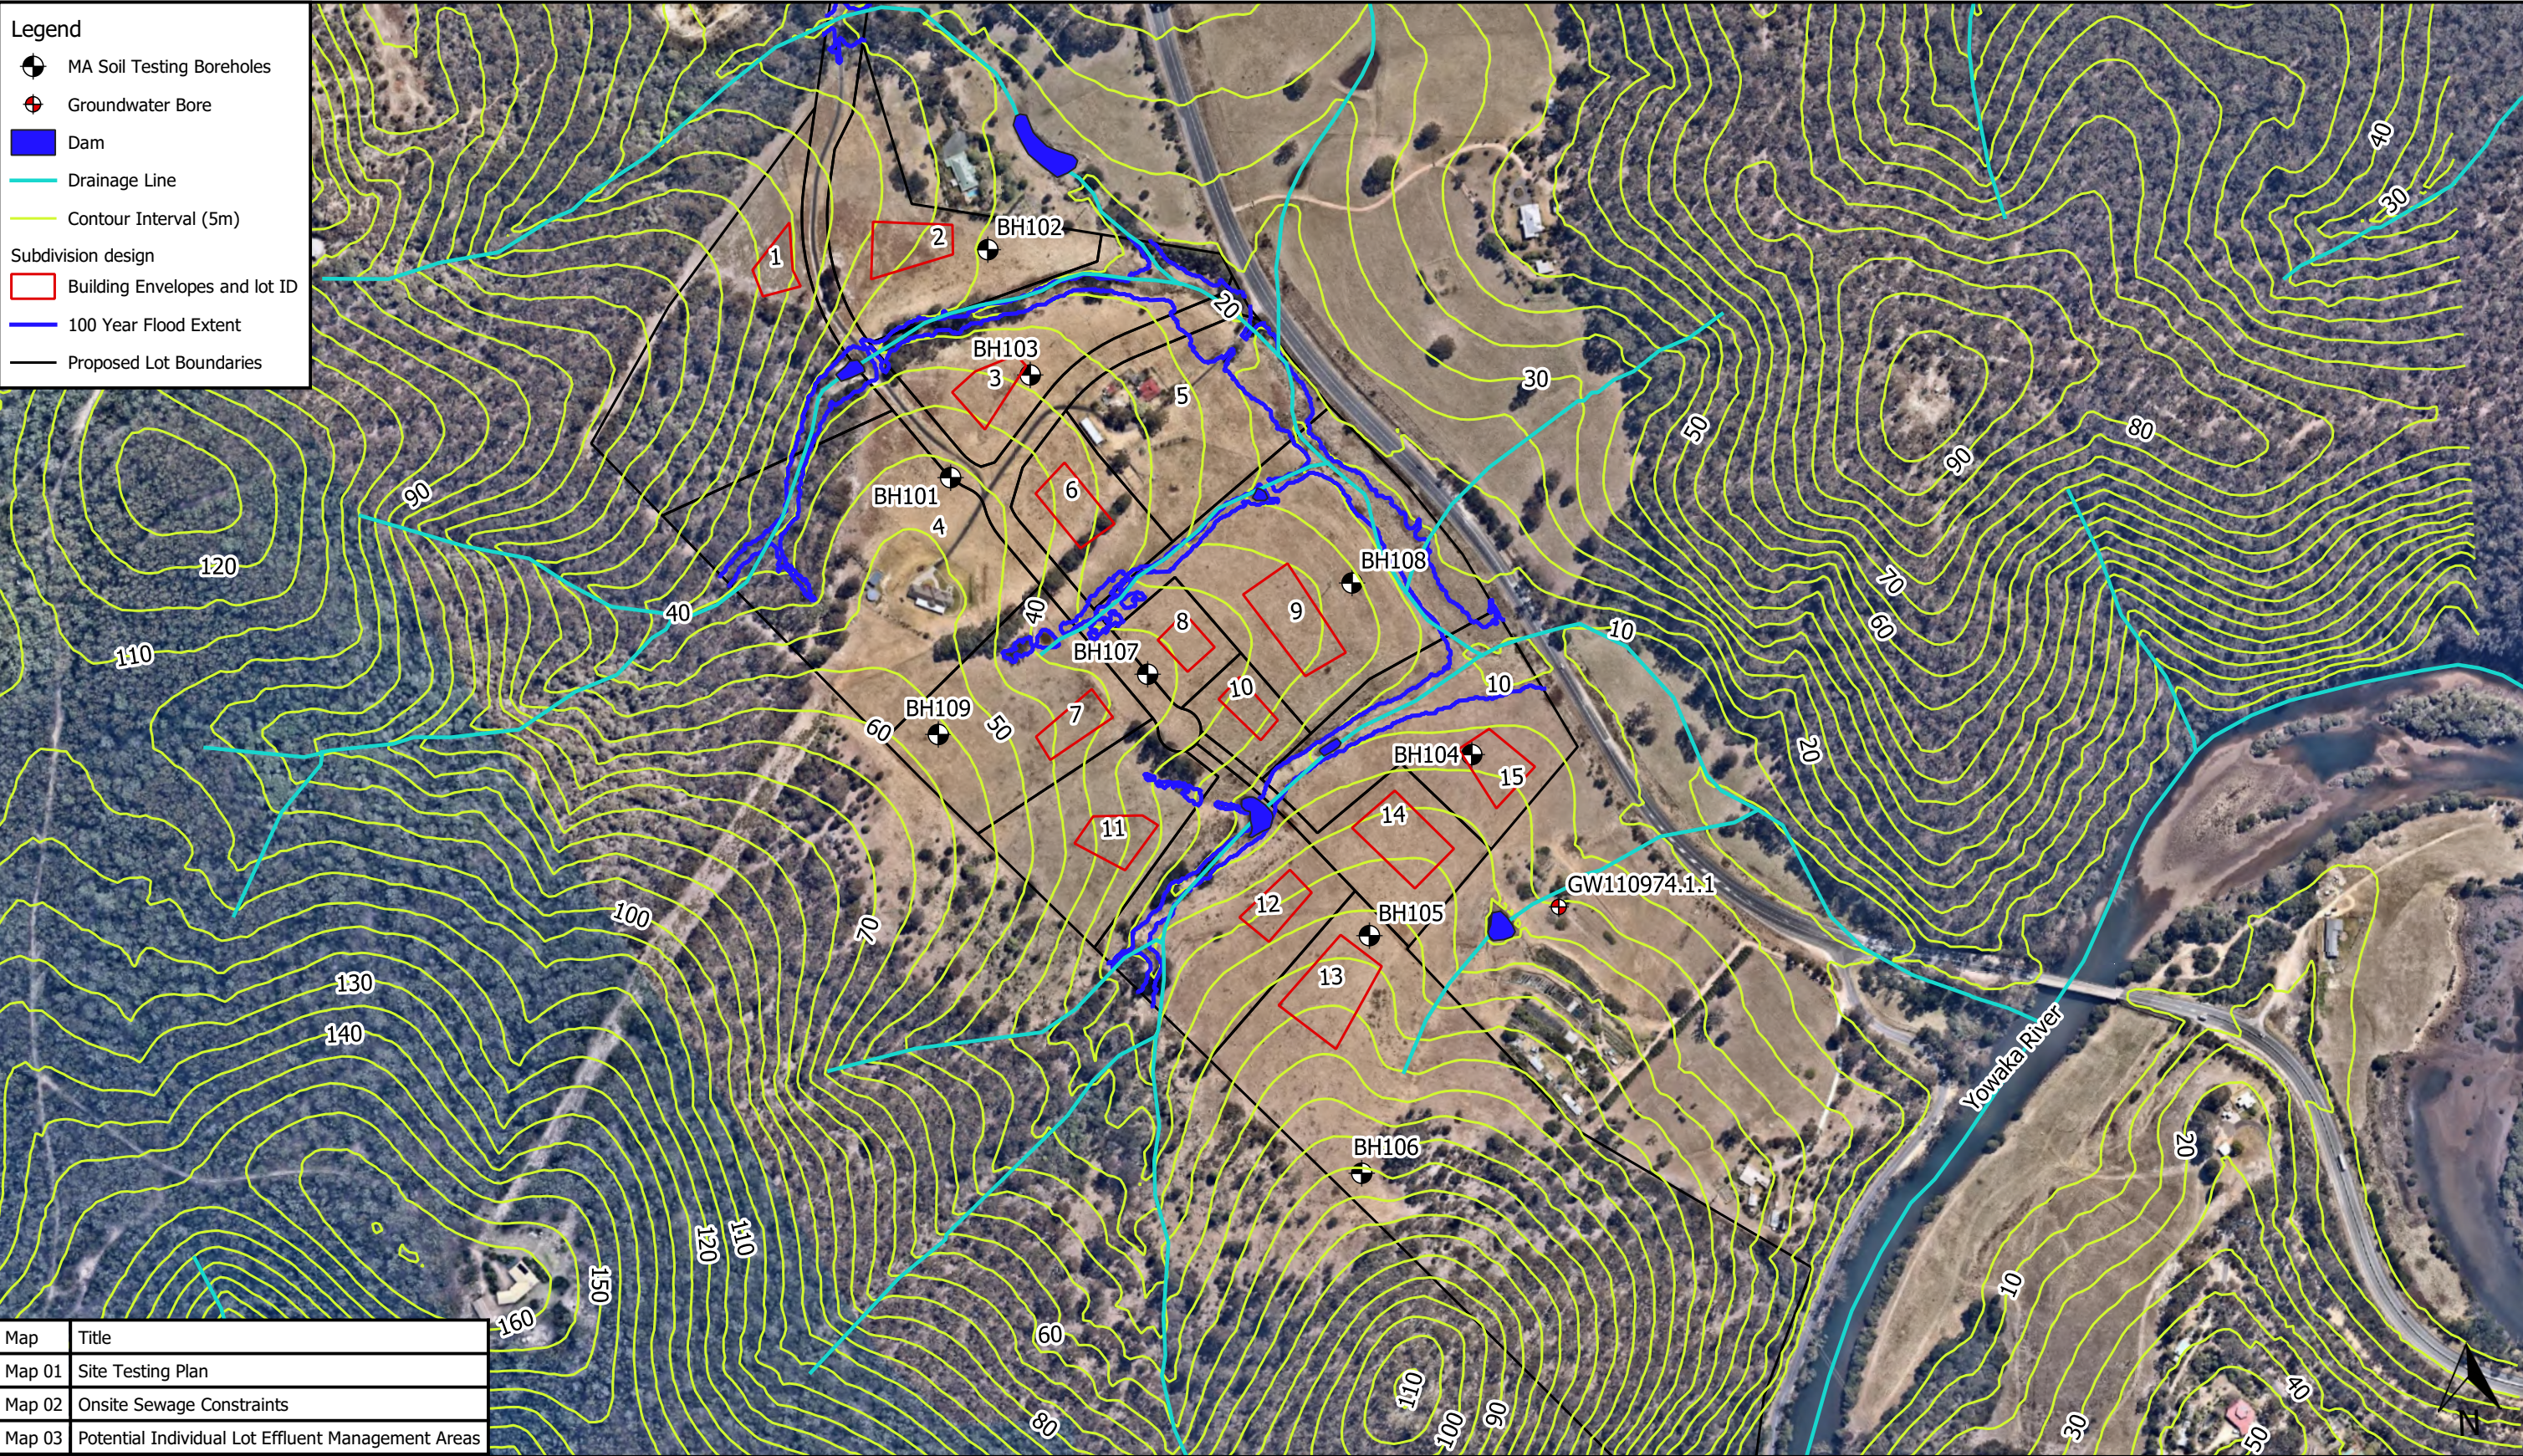
Sources:
Aerial Image Source: Nearmap (2021);
Flooding information from Southeast (2021) Planning Proposal Lot 711 DP1128593: Flood Risk Assessment and Surface Water Assessment;
Lot layout and building pads provided by OCRE (2021); Waterways from SixMaps; Contours from ELVIS Lidar.

Subsurface Slope Analysis (%)

> 20

Site description is provided in Table 1 with a site plan provided in Map 01 (Attachment A).

Borehole testing locations are shown in Map 01 (Attachment A) and borehole logs are provided in Attachment B.

Land capability assessment indicates a moderate slope limitation. The area for major slope limitations (i.e. > 20%) for both irrigation and absorption is shown in Map 02 (Attachment A). All other soil features indicate minor limitations. A plan detailing appropriate effluent management areas (EMA)s for the proposed lots is shown in Map 03 (Attachment A).

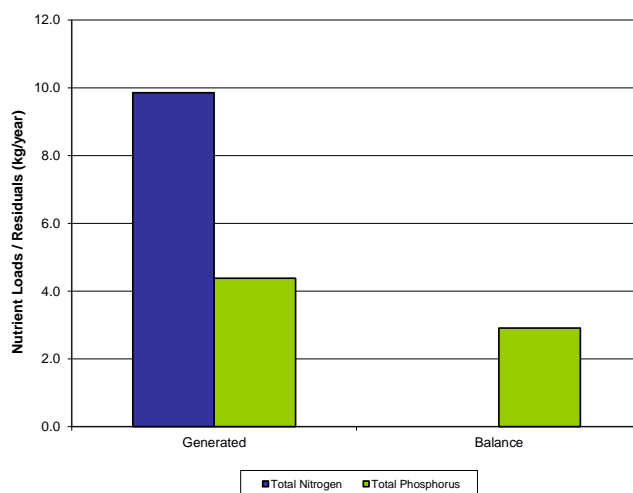
NITROGEN BUDGET FOR RE-USE FIELD			
N generated	9.86	kg/year	
N consumed	9.86	kg/year	
N balance	0.00	kg/year	
Min Area	428	m ²	
PHOSPHORUS BUDGET FOR RE-USE FIELD			
P generated	4.38	kg/year	
P consumed	1.47	kg/year	
P balance	2.91	kg/year	
P sorption	145.4	kg P/design soil depth	
Field life (for P)	50.0	Years	
Min Area	491	m ²	
MINIMUM NUTRIENT ASSIMILATION AREA			
Minimum Area	491	m ²
