## **URBAN CAPABILITY PLANNING PROPOSAL AREA WITHIN SOUTH JERRABOMBERRA NSW**

**PRELIMINARY GEOTECHNICAL INVESTIGATION REPORT**

**OCTOBER 2014**

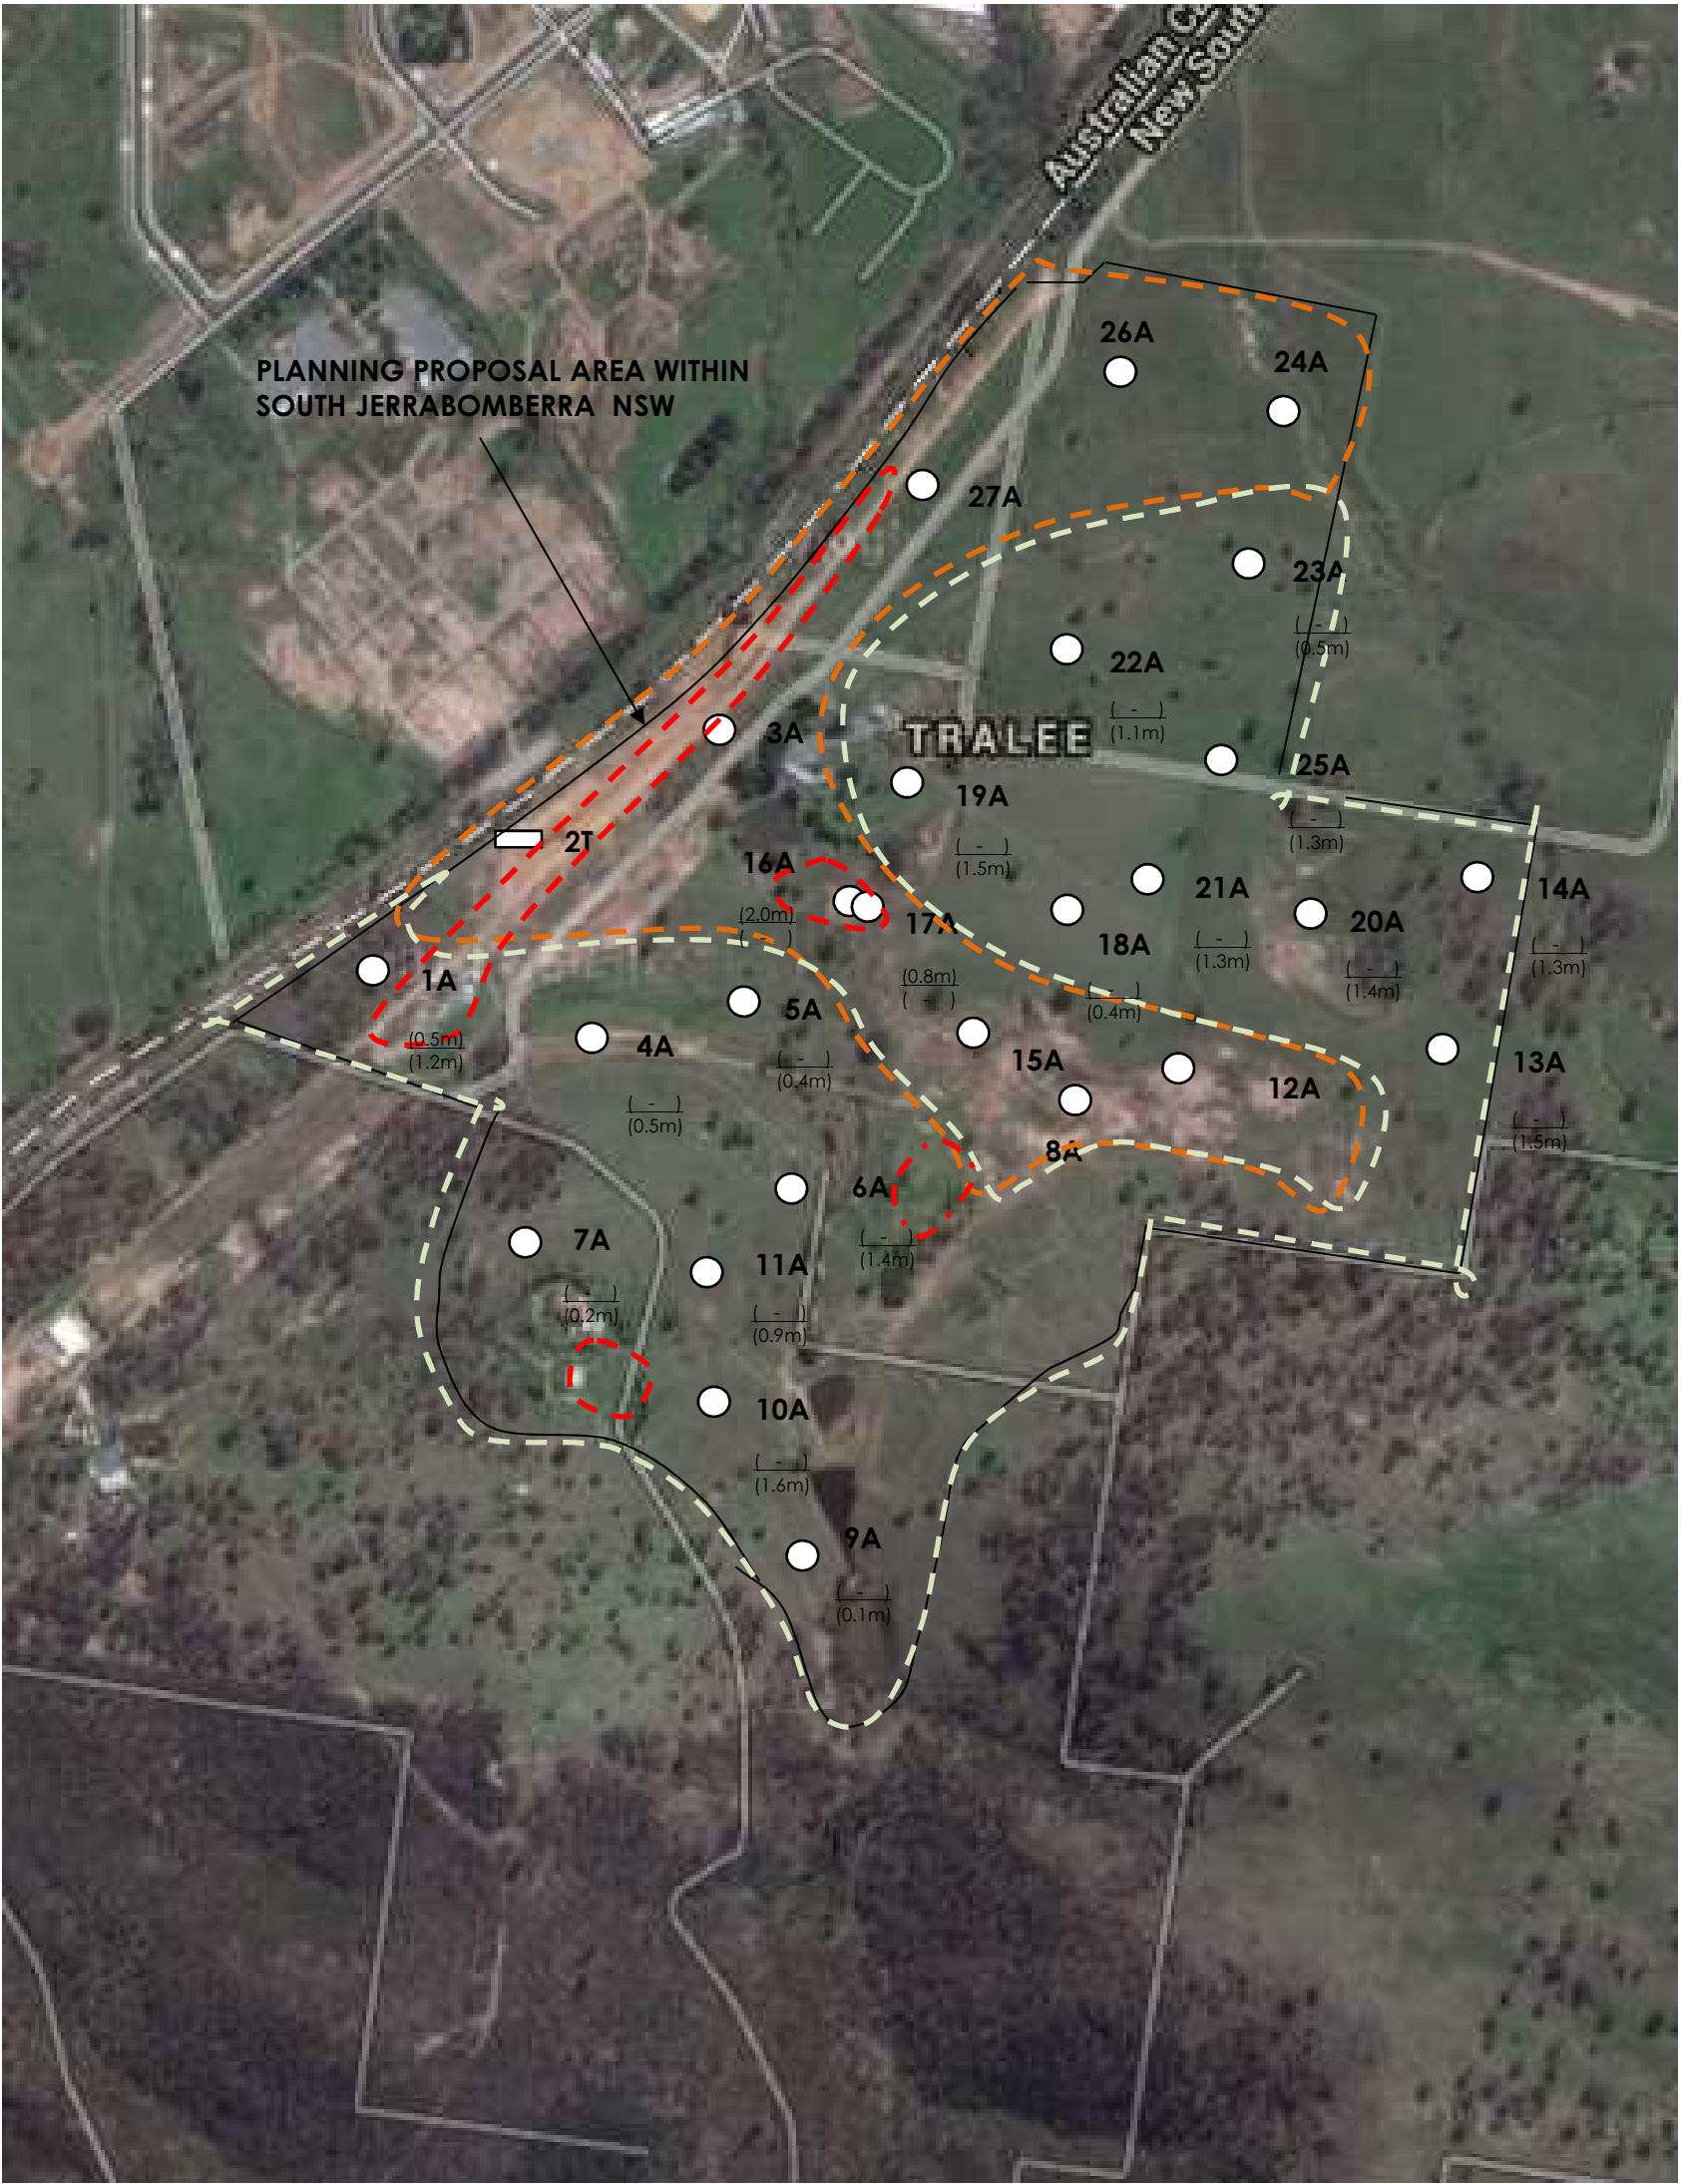
**PANNING PROPOSAL AREA WITHIN SOUTH JERRABOMBERRA NSW  
RECENT AERIAL PHOTOGRAPH & LOCATION OF BOREHOLES AND TEST PIT**

The site is presently undeveloped greenfield, although an incomplete airfield runway is present on the site. There are large stockpiles of uncontrolled fill present on the site, these are roughly outlined in Figure 3 and photographs of some of these are attached to this report, more stockpiles may be present on site. Uncontrolled fill is fill that has not been placed and compacted in accordance with AS3798 "Guidelines on Earthworks for Commercial & Residential Developments" (Reference 1) and is therefore not suitable as a foundation for structures. Figure 3 is a recent aerial photograph that shows the present site layout and the location of the auger holes and test pit.

There are numerous stockpiles of soil present on the site, the approximate locations of which are shown in Figure 3, denoted as Area 3. Structures and roads cannot be founded on these stockpiles, however, assuming contaminants are not present, these soils could be used in required earthworks in subdivision/road construction.

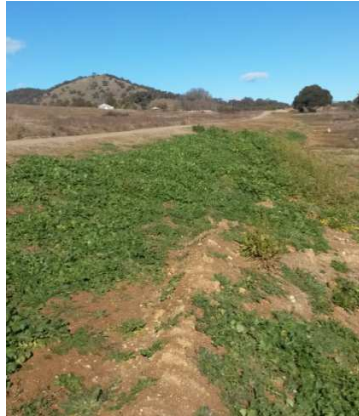
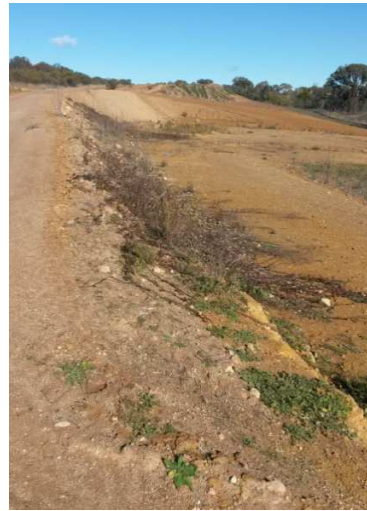
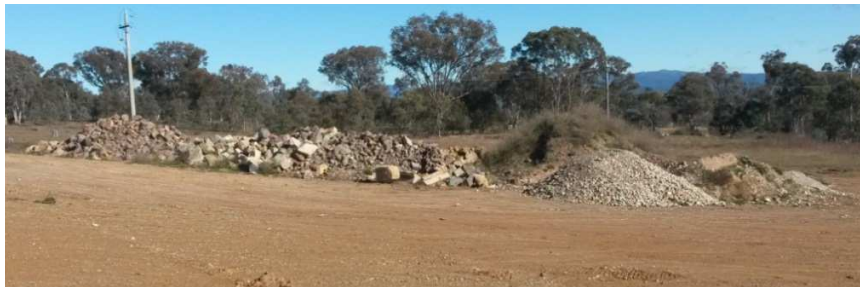
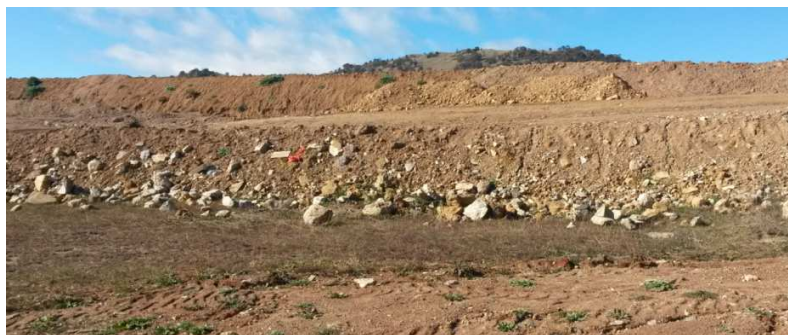
**Photos 1 to 4 (above)** – 18/7/14 – View of road fill and fill stockpiles on north-western side of the site.

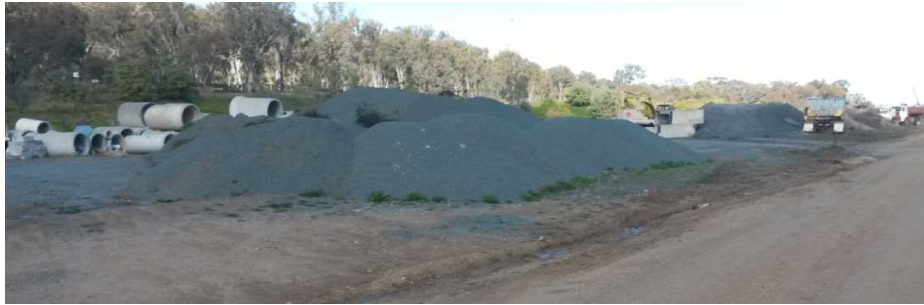
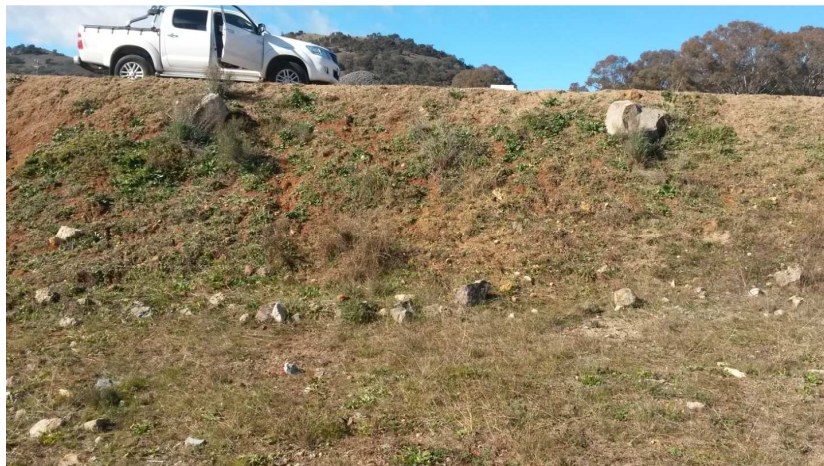
**Photos 5 to 6 (above)** – 18/7/14 – View of road fill and fill stockpiles on north-western side of the site.

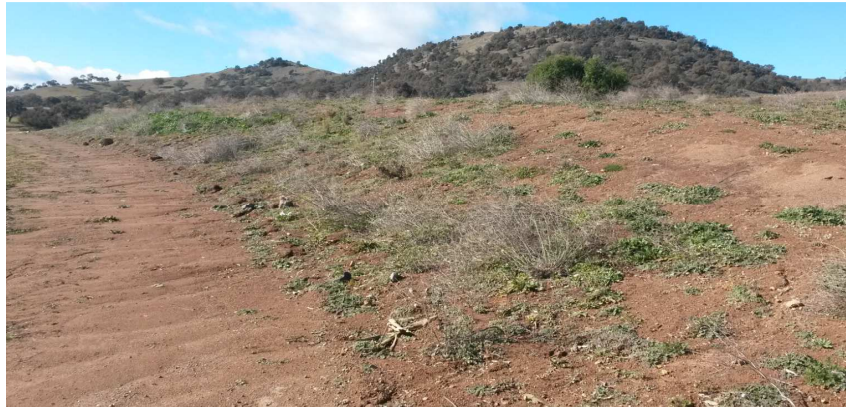
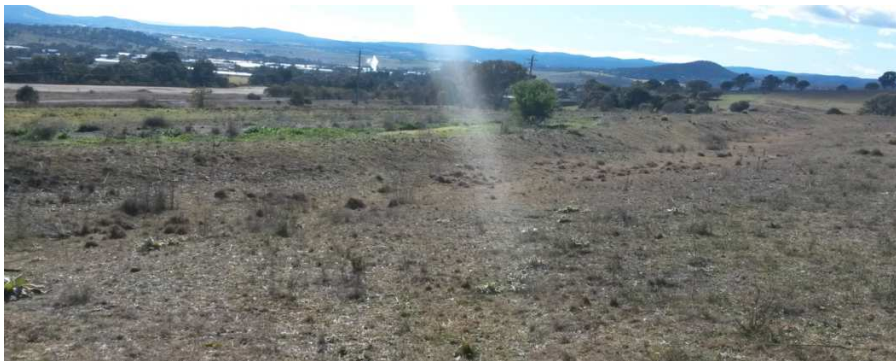
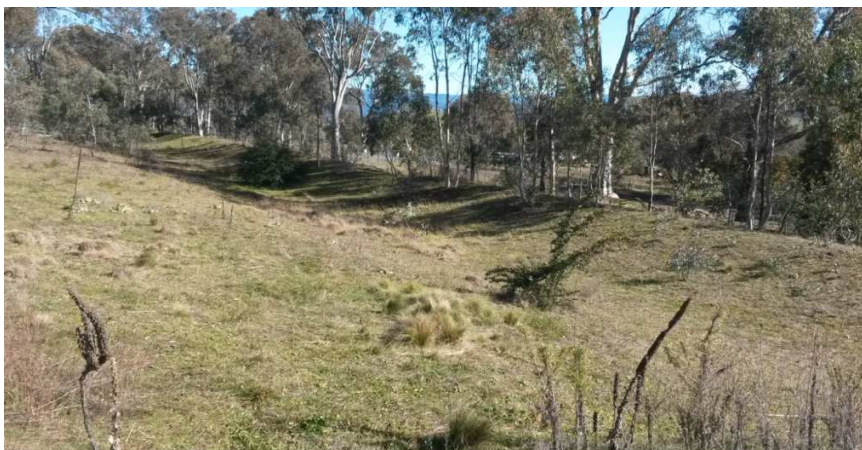
**Photos 7 to 9 (above)** – 18/7/14 – View of cut-to-fill berms near the residence in the south-western corner of the site.

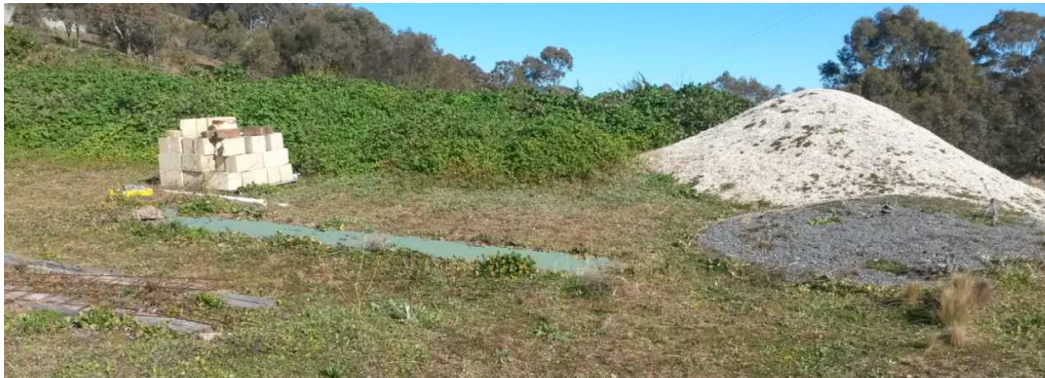
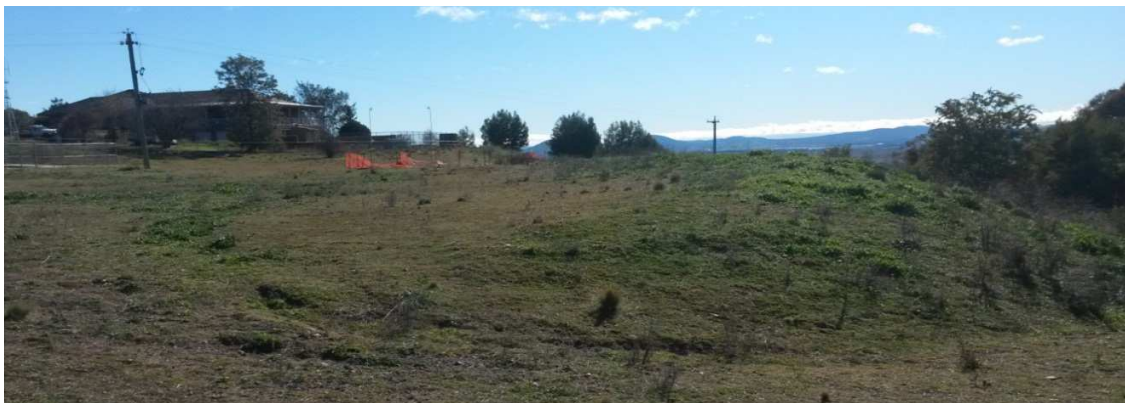
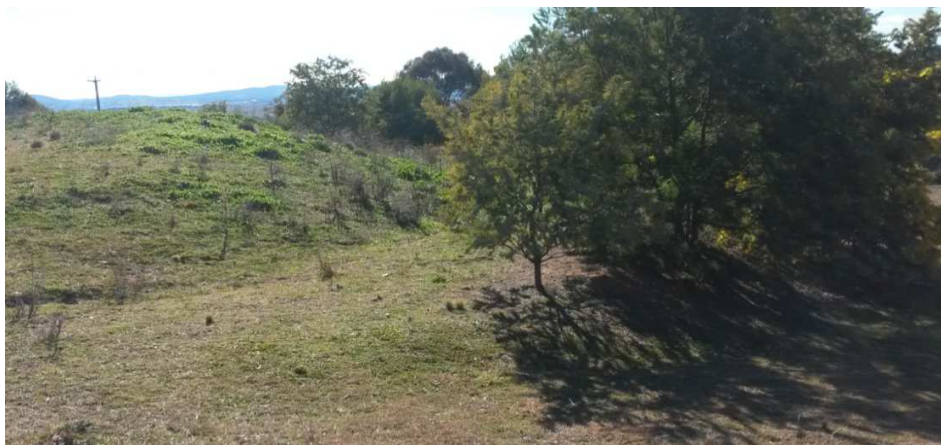
**Photos 10 to 12 (above)** – 18/7/14 – View of fill stockpiles near the residence in the south-western corner of the site.

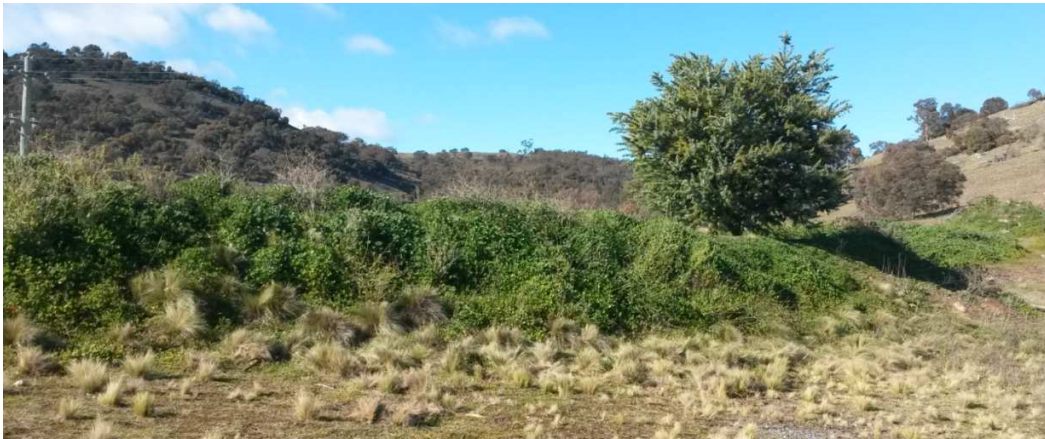
**Photo 13 (above)** – 18/7/14 – View of fill stockpiles near the residence in the south-western corner of the site.

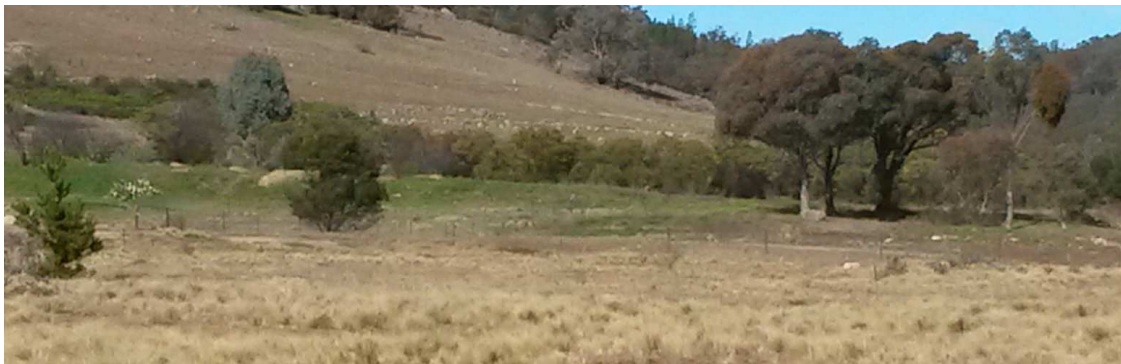
**Photo 14 (above)** – 18/7/14 – View of possible fill stockpiles east of borehole 6A.

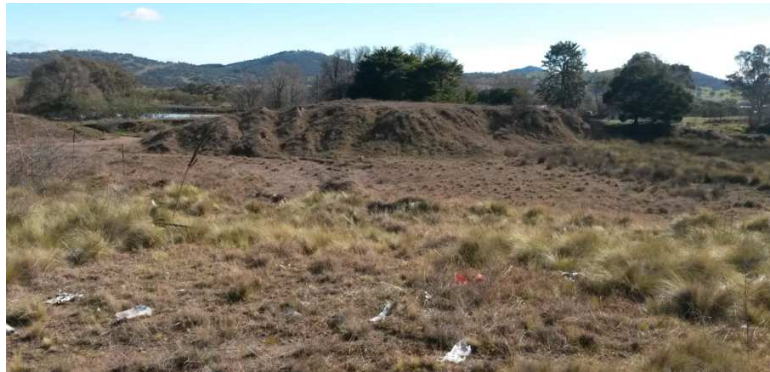
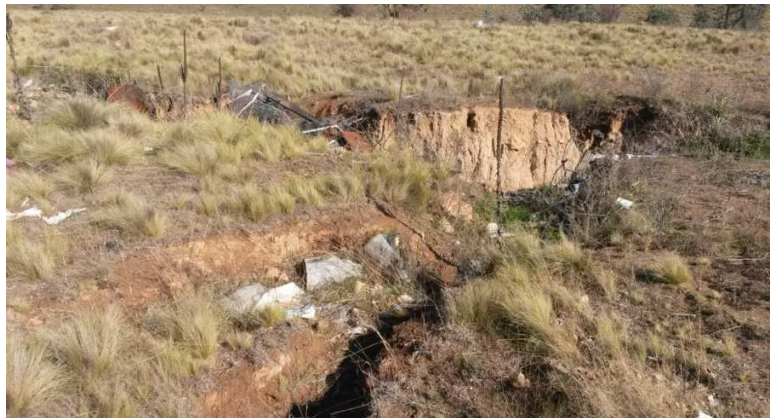
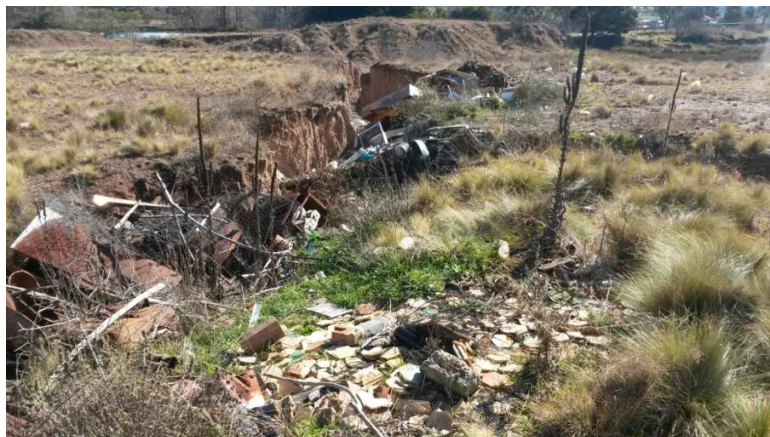
**Photos 15 to 17 (above)** – 18/7/14 – View of fill stockpiles and waste near the residence at the mid-western side of the site.

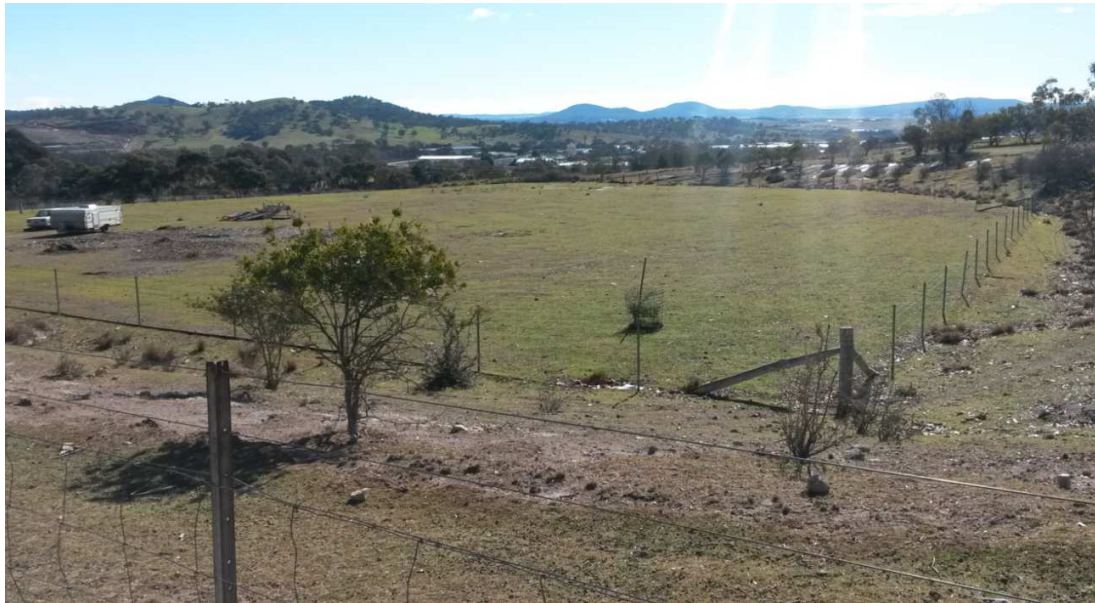
**Photo 18 (above)** – 18/7/14 – View of cut-to-fill platform north-east of the residence at the mid-western side of the site.
