Phase 2 Environmental Site Assessment, Parcel 16

Prepared for:
Hydro Aluminium Kurri Kurri Pty Ltd

Prepared by:
ENVIRON Australia Pty Ltd

Project Number:
AS130348

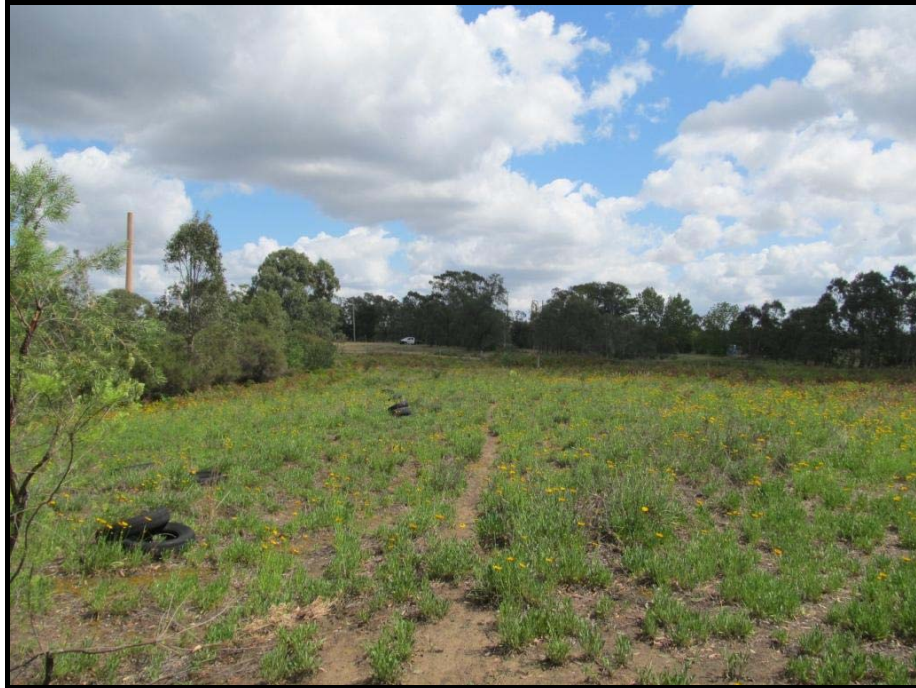
Hummocky ground, disturbed ground and a small soil stockpile was identified in the northern portion of Lots 423, 424 and 425 at the location of former dwellings. No evidence of construction debris was identified on the surface of Lots 423, 425 or 426. Some small fragments of iron waste identified the former house footprint on Lot 424. (**Figure 3**). Hummocky ground was also identified in the northern portion of Lot 426, although historical photos show no development on this part of the Lot. Several discarded tyres were observed in the northern portion of Lot 423.

Photo 1: Photograph showing flat northern portion of Lot 423, facing north. Note the discarded tyres.

- For aesthetic reasons, the discarded tyres should be collected and disposed of appropriately.

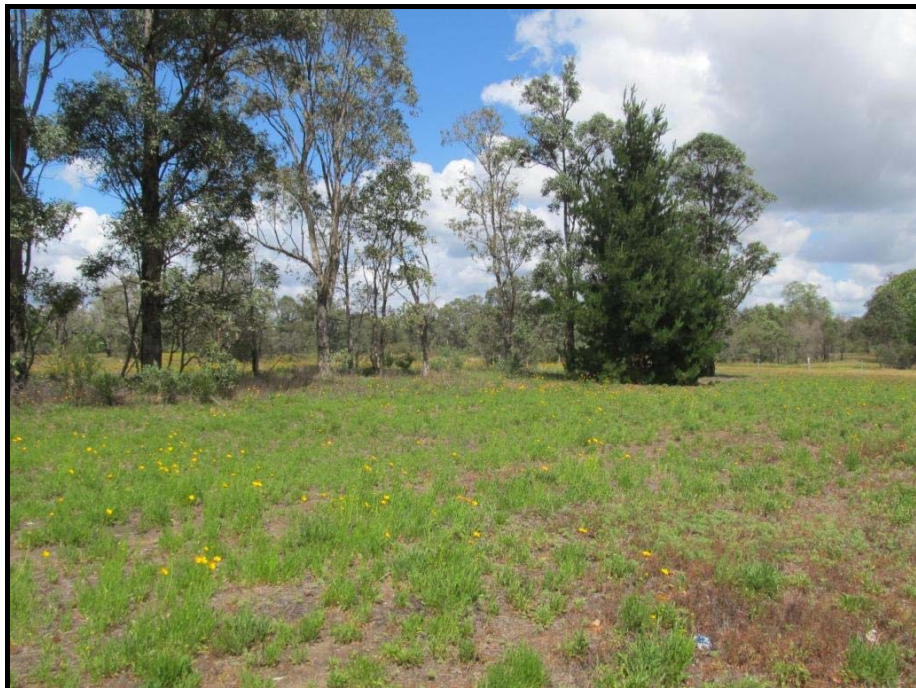
Photo 4: Photograph of the northern portion of Lot 424 at the location of the former dwelling.

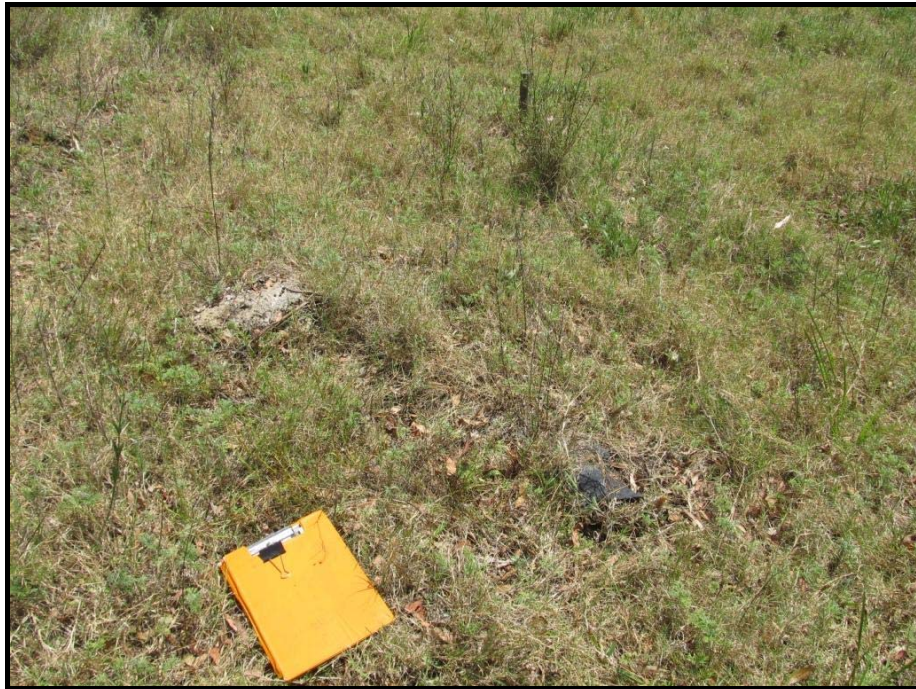
Parcel 16 previously contained three houses near the Dickson Road frontage. The houses were constructed in the early 1960s and were demolished in the early 1990s. Little evidence of the construction debris associated with the houses was identified during the site walkover apart from some small scraps of iron waste. Excavations into the three house footprints did not identify buried demolition wastes. Some discarded car tyres were noted on the eastern boundary of Lot 423.

Photo 5: Photograph of minor construction debris associated with the former dwelling on Lot 424.
