Phase 2 Environmental Site Assessment, Parcel 11

Prepared for:
Hydro Aluminium Kurri Kurri Pty Ltd

Prepared by:
ENVIRON Australia Pty Ltd

Project Number:
AS130348

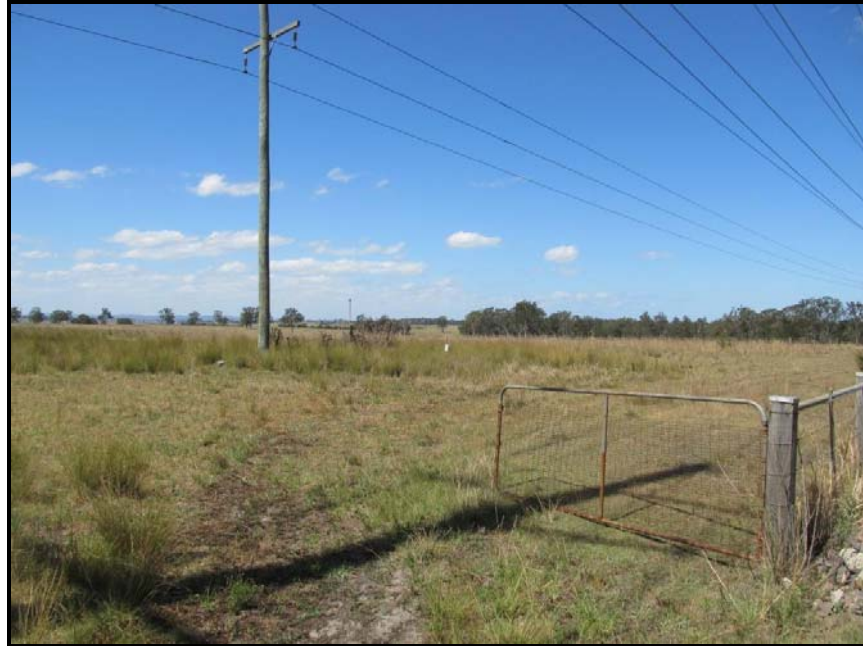
Photo 1: Photograph showing the grassed farmland on Lot 1, facing north east.

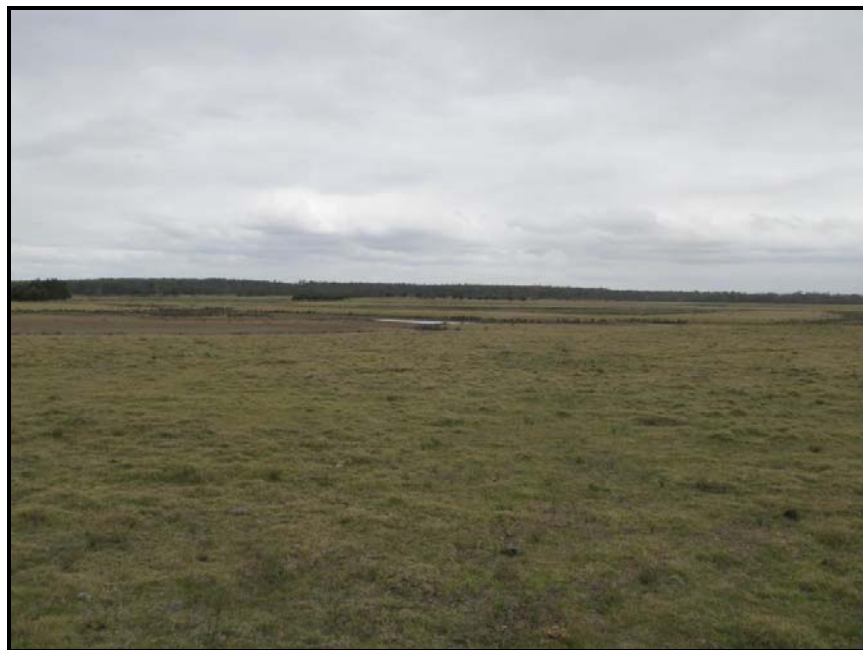
Photo 2: General view of farmland on Lot 1, facing north.

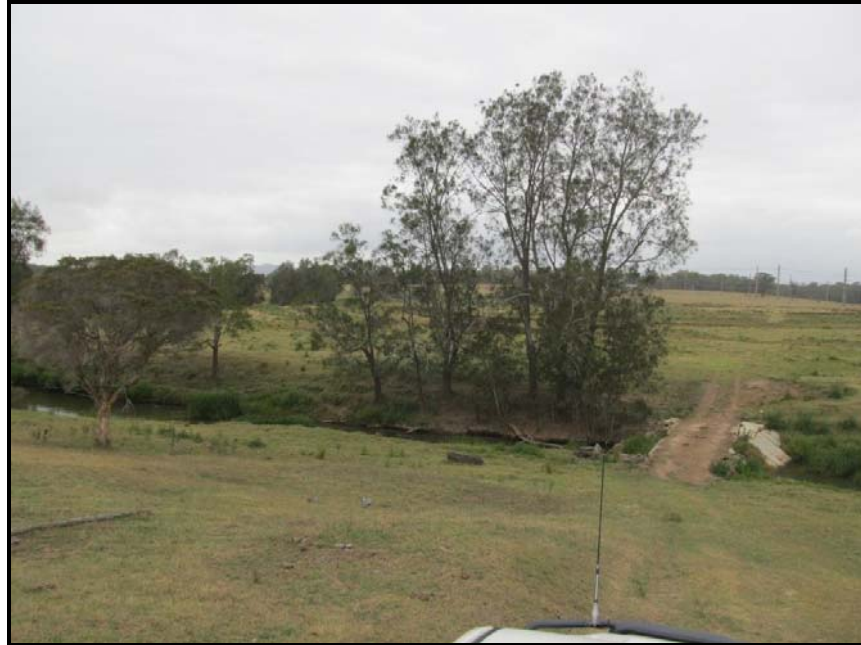
Photo 3: Photograph of the bridge over Swamp Creek on Lot 3, facing south.

No signs of disturbed land or of land filling were observed during the walkover, except as described above for the construction of a bridge.

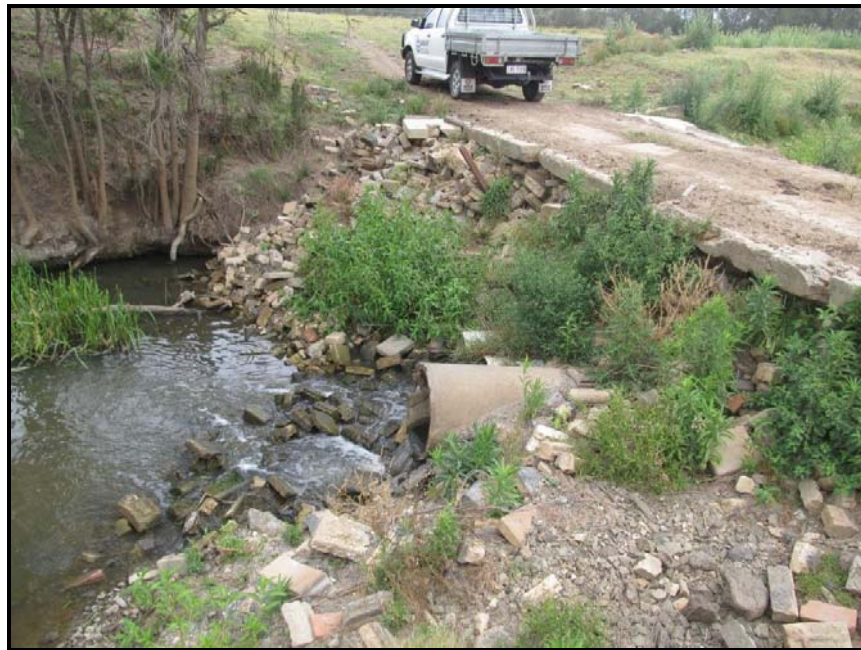
Photo 4: Close-up of the bridge, showing its construction from refractory brick.

Bake furnace refractory brick has been used with the Hydro buffer zone to create accessible tracks and create causeways across the creeks. Bake furnace refractory bricks are used as an insulating material to line the bake furnace for baking of anodes and are a by-product of aluminium smelting.

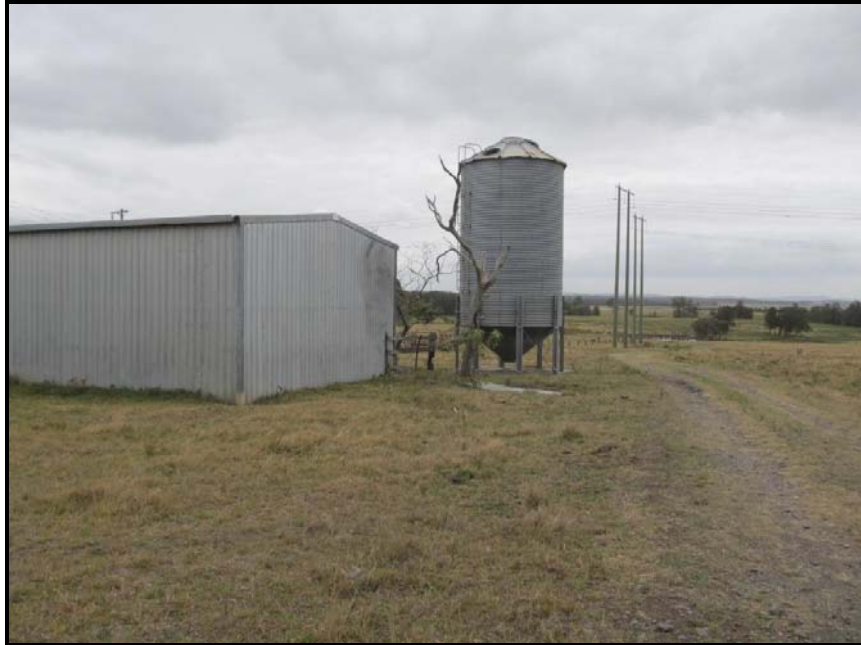
Photo 5: Photograph showing the aluminium shed on Lot 3, facing north. Note the high voltage power lines in the background.

The aluminium shed, tank and silo were the subject of an Audit conducted by ENVIRON in 2014. The Audit comprised an inspection of the external building construction materials. These materials were aluminium and timber and based on the inspection it is unlikely that hazardous materials are present.

The aluminium shed was the subject of a Hazardous Materials Audit completed by ENVIRON in 2014. The audit did not identify any hazardous building materials.

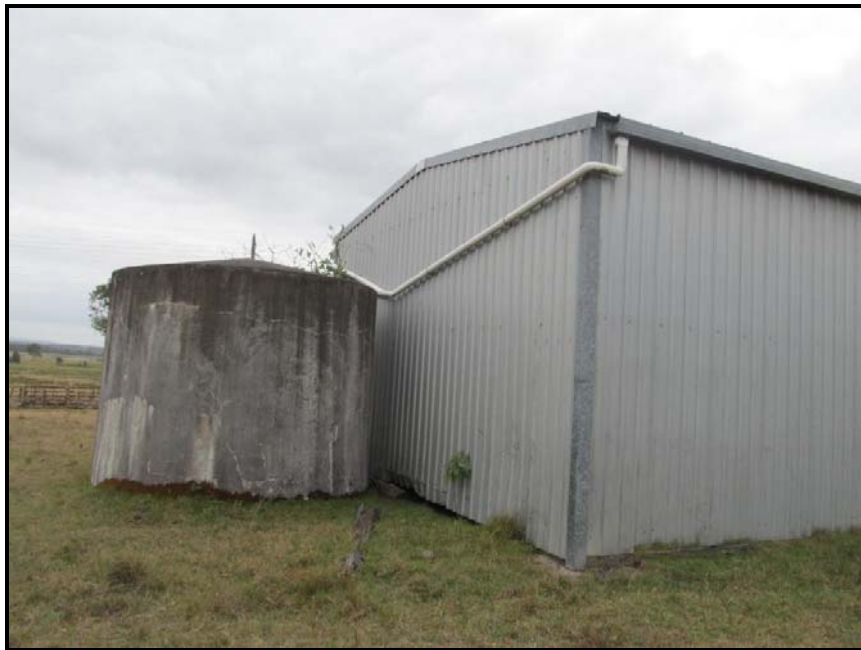
Photo 6: Photograph of the concrete water tank adjacent to the shed.
