Phase 2 Environmental Site Assessment, Parcel 6

Prepared for:
Hydro Aluminium Kurri Kurri Pty Ltd

Prepared by:
ENVIRON Australia Pty Ltd

Date:
April 2015

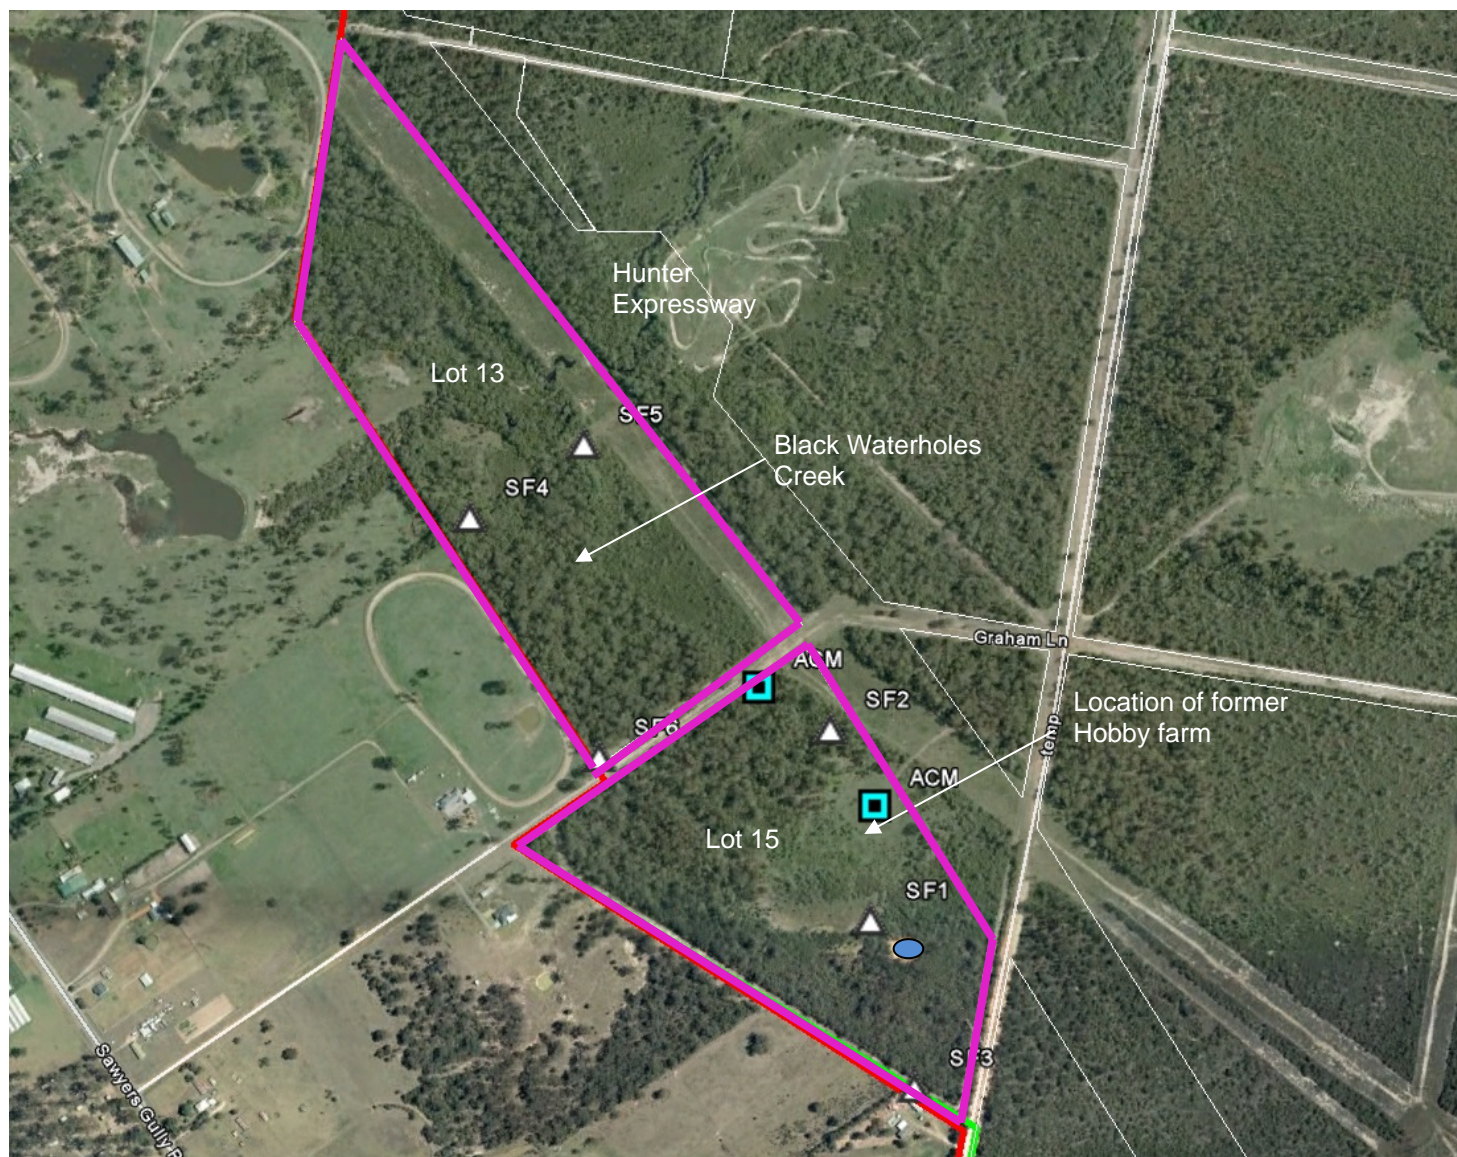
Figure 3: Site Layout and Surface Soil Sampling Locations

A site plan showing the location of the hobby farm is included in **Figure 3**.

A small mound of soil and ACM fragments were observed on Grahams Lane, indicating that accessible areas of Parcel 6 are susceptible to illegal dumping brought from off site. The approximate location of the ACM waste is shown in **Figure 3**.

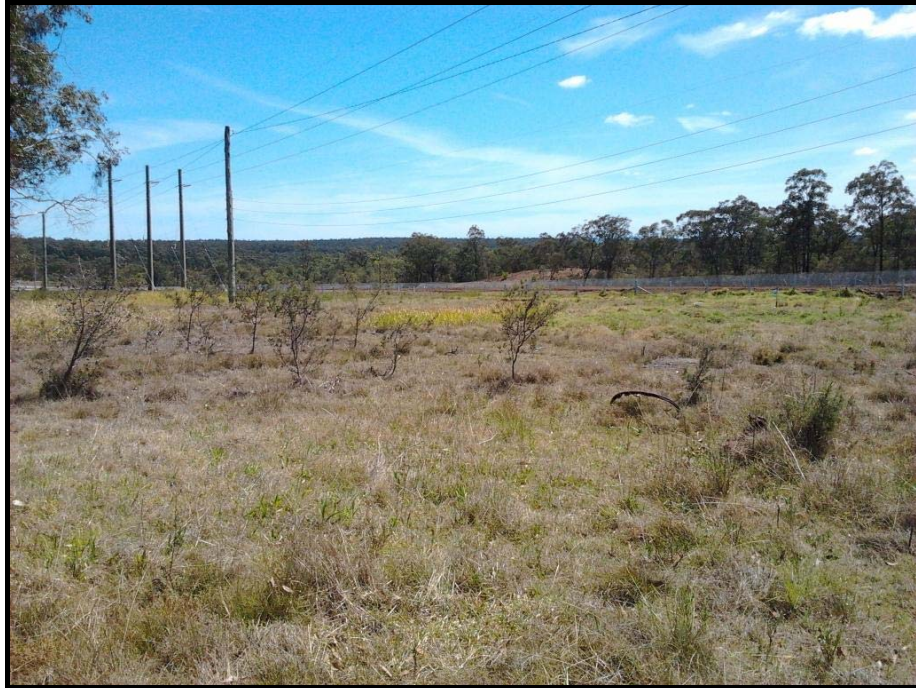
The south eastern portion of Parcel 6 (Lot 15) comprised of a large circular cleared area surrounded by bushland which is the location of the former hobby farm. Hummocky ground and several fill mounds were observed in the cleared area with anthropogenic material such as metal scrap, concrete rubble and ACM fragments at the surface of the mounds.

Photo 1: Photograph of the cleared area at the location of the former hobby farm on Lot 15, facing north west.

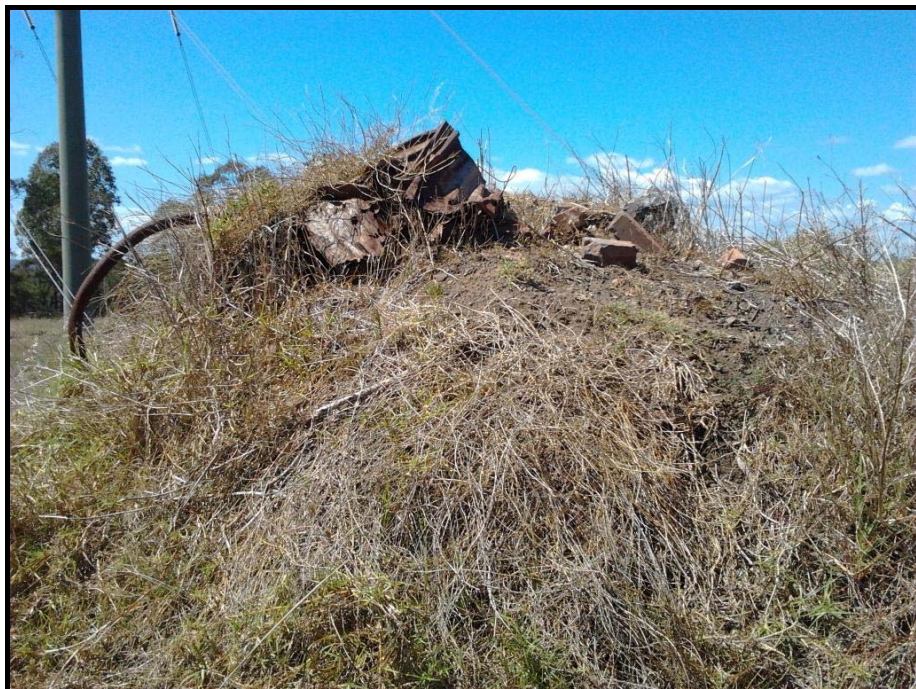
Photo 2: Photograph of hummocky ground with surface metal scrap on Lot 15.

- It is noted that Parcel 6 contains numerous small stockpiles of soil with construction waste such as concrete and metal scrap. This material should be removed for aesthetic reasons.

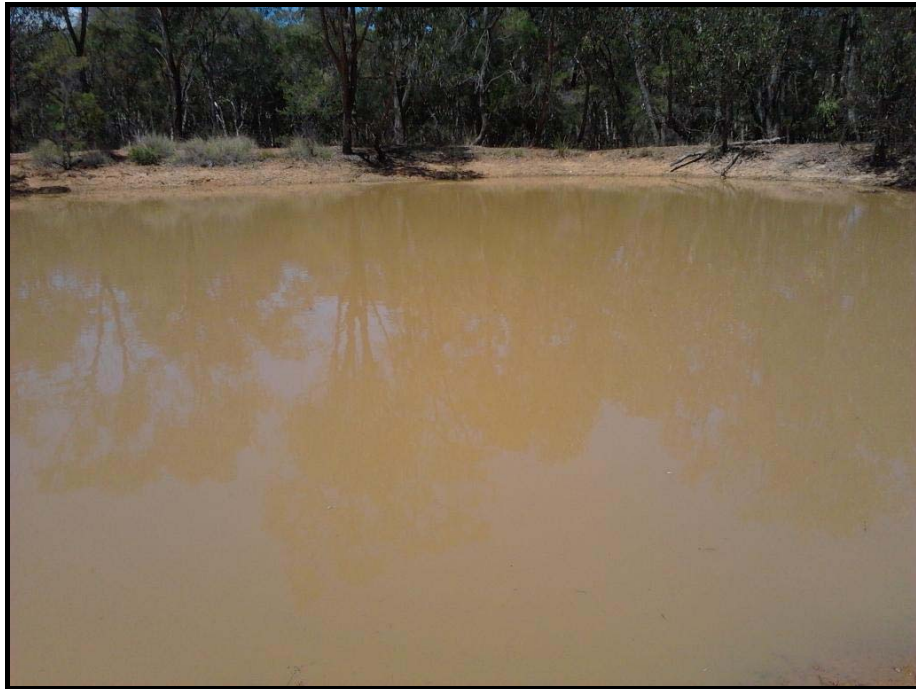
A dam associated with the former hobby farm was observed to the south east of the former hobby farm location. A fill mound near the dam comprised metal scrap on the surface.

Photo 3: Photograph of the dam in the south eastern corner of Lot 15.

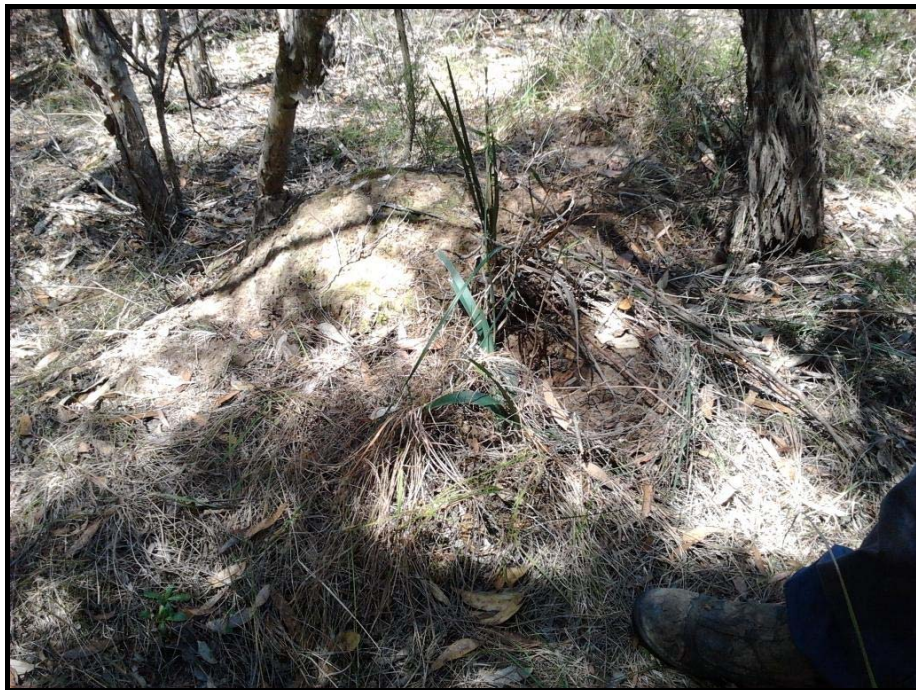
Photo 4: Photograph of hummocky ground on Lot 13.

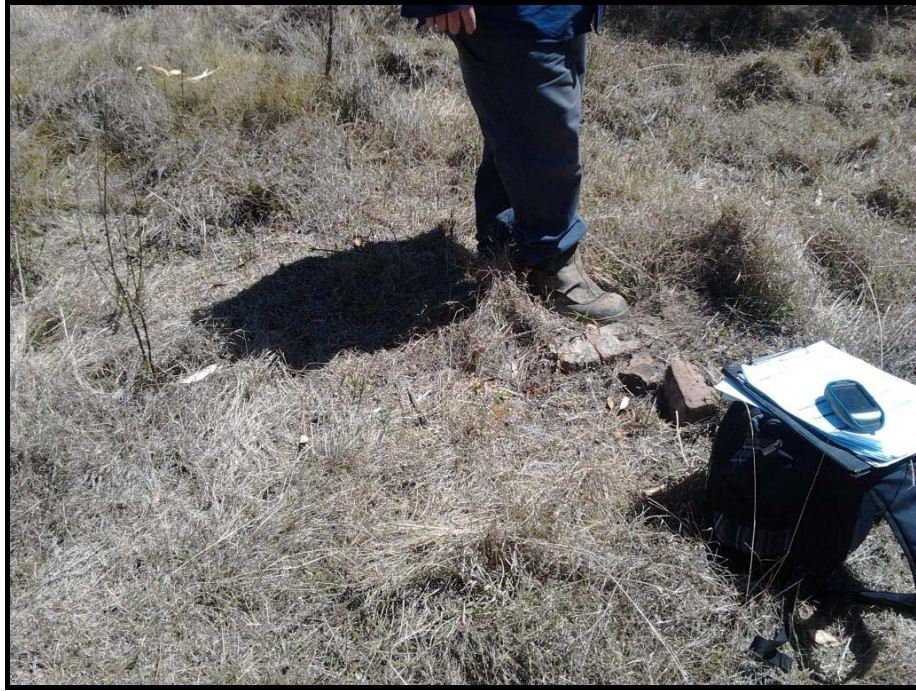
The north western portion of Parcel 6 (Lot 13) comprised of predominantly dense bushland with two cleared areas near the south western boundary. The cleared areas were overgrown with weeds and grasses and house bricks were observed on the surface at the southern cleared area.

Photo 5: Photograph of bricks on the surface of Lot 15.
