## Phase 2 Environmental Site Assessment, Parcel 8

Prepared for:  
**Hydro Aluminium Kurri Kurri Pty Ltd**

Prepared by:  
**ENVIRON Australia Pty Ltd**

Date:  
**April 2015**

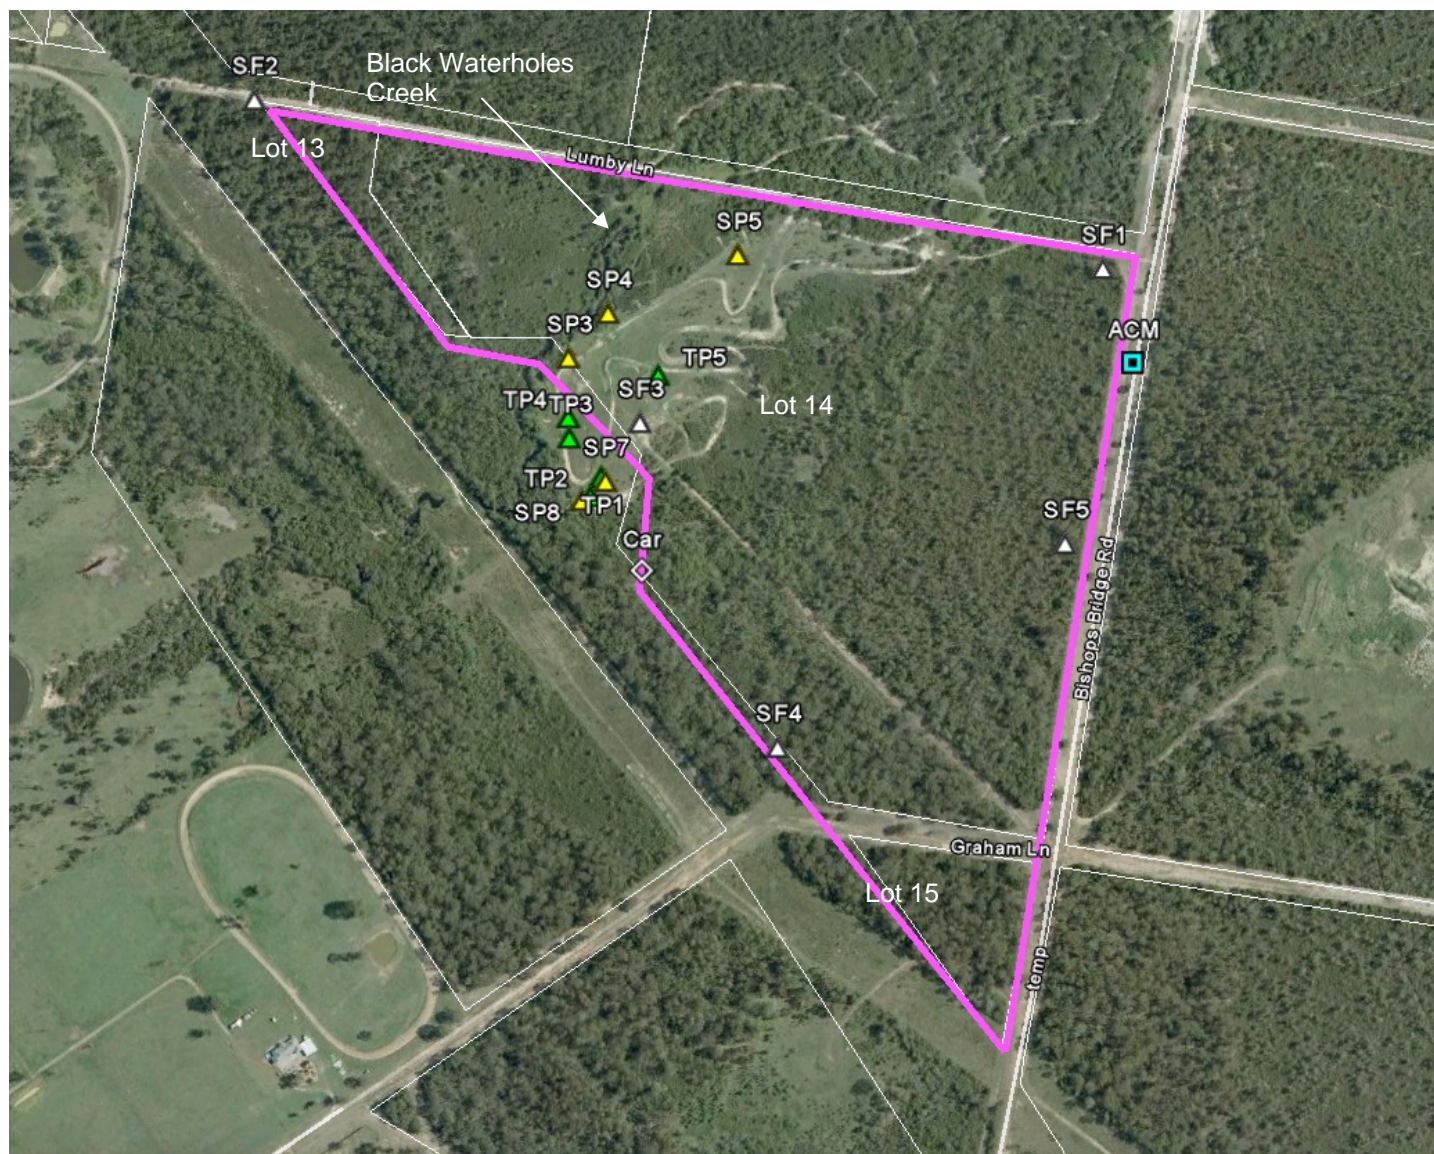
- Site Boundary
- △ SF Soil Sample for Fluoride Analysis
- △ SP Stockpile Sample
- △ TP Test Pits
- ACM ACM Stockpile
- ◇ Car body

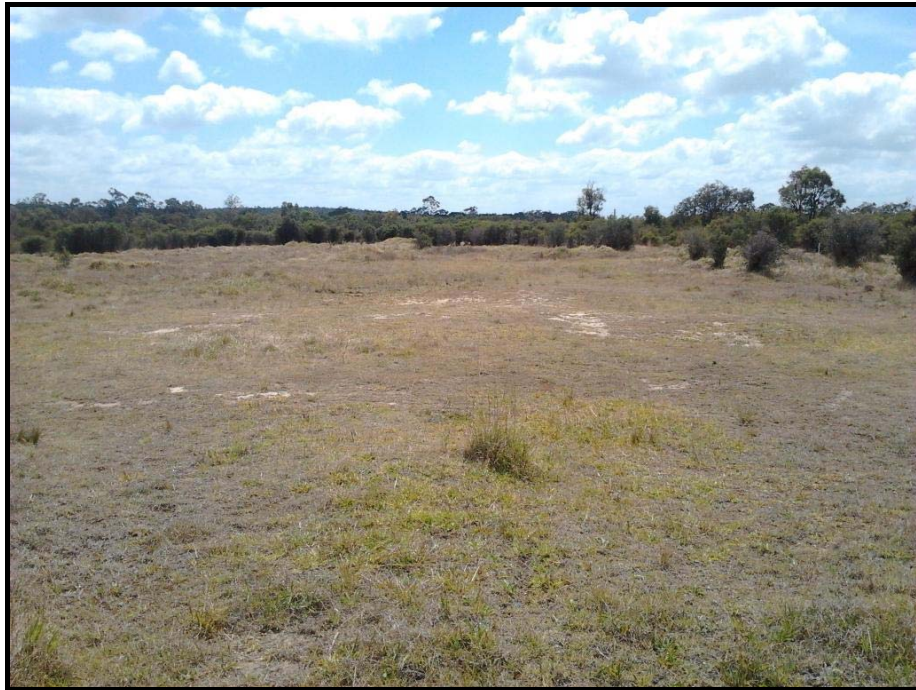
**Photo 1:** Photograph of the cleared area at the location of the former hobby farm on Lot 14.

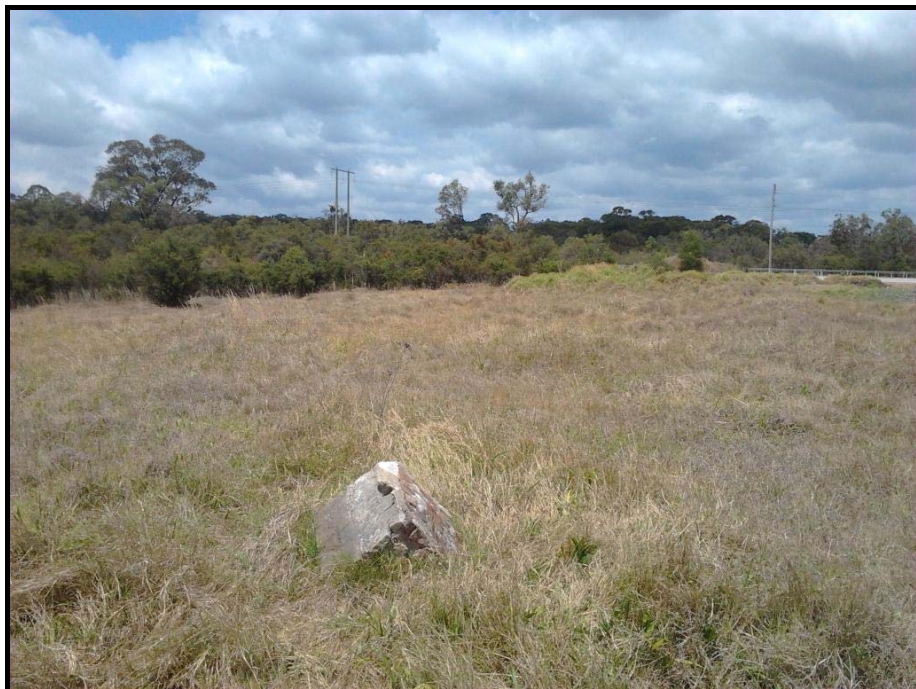
**Photo 2:** Photograph of the remnant footing on Lot 14.

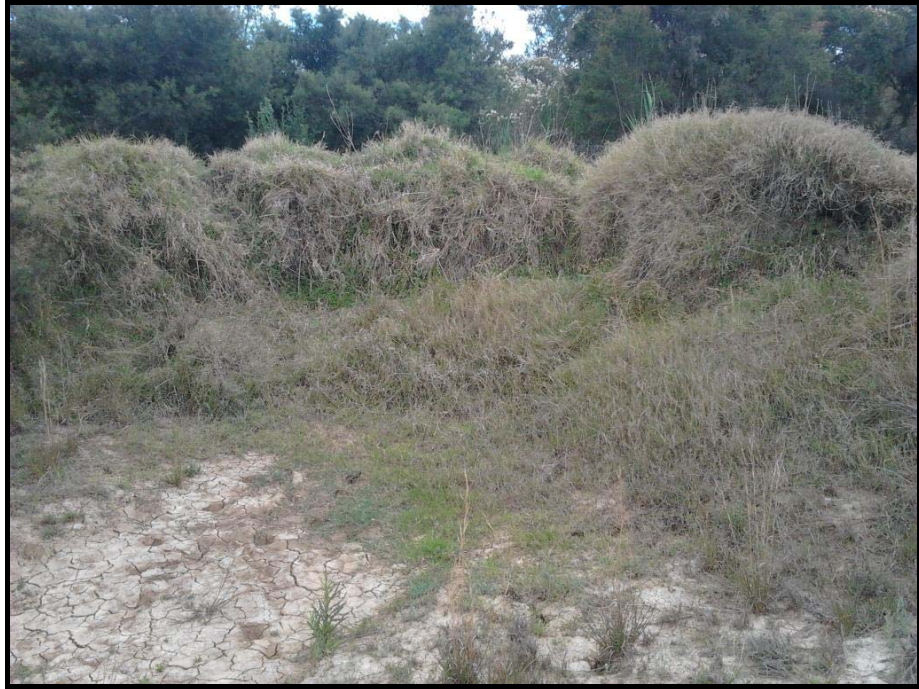
into five separate stockpiles and soils samples were collected from a range of depths up to 1.3m. Four samples were analysed for asbestos, heavy metals, total petroleum hydrocarbons (TPH), benzene, toluene, ethyl benzene and xylene (BTEX), polycyclic aromatic hydrocarbons (PAHs), organochlorine pesticides (OCPs) and organophosphorous pesticides (OPPs). The soil stockpiles were observed to comprise disturbed topsoil, generally brown silty sand, underlain by yellow/ brown clay.

**Photo 3:** Photograph of grassed soil stockpiles near the dirt bike track on Lot 14.

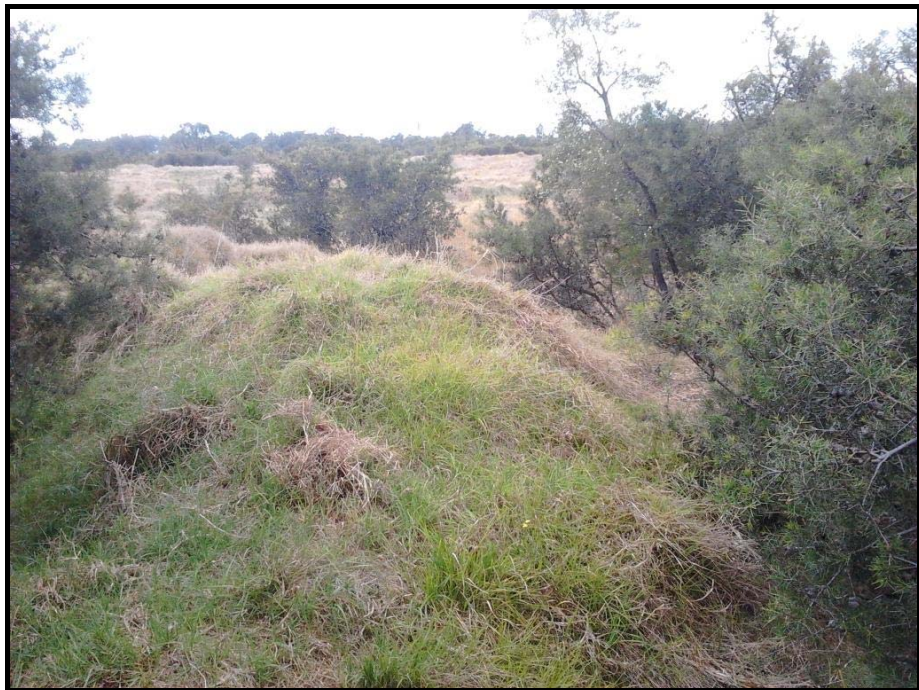
**Photo 4:** Photograph of hummocky ground near the dirt bike track on Lot 14.

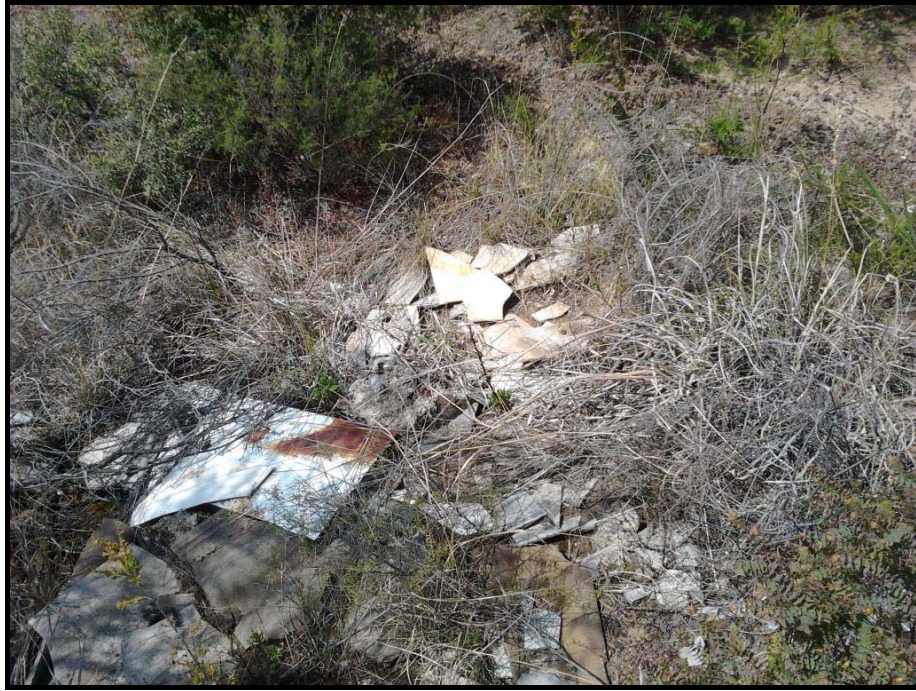
The identification of an old, rusted car body on the south western boundary close to the Hunter Expressway and a small stockpile of dumped building waste, including tiles, house bricks, concrete pieces and ACM fragments, near the north eastern corner of Parcel 8 adjacent to Bishops Bridge Road, indicate that accessible areas of Parcel 8 are susceptible to illegal dumping. It is noted that the ACM fragments were not analysed for asbestos. However, based on the results of asbestos analysis of similar materials from other parcels in the Buffer Zone, the fragments are considered to contain asbestos.

**Photo 5:** Photograph of building waste, including ACM fragments, near Bishops Bridge Road.

- An appropriately licensed asbestos removal contractor be engaged to remove and dispose of the asbestos waste. Validation of the area following removal should be undertaken by an appropriately qualified consultant and documented.
- For aesthetic reasons, the car body should be removed from the site and recycled as appropriate.

The ACM fragments observed in a small stockpile of building waste on Bishops Bridge Road classify as Asbestos Waste. The ACM fragments should be collected by an appropriately licenced contractor and appropriately managed or disposed. Other wastes should be disposed of or recycled where appropriate. Alternatively, planning permission could be sought for emplacement of the waste building materials in a containment cell within the Hydro site.
