Phase 2 Environmental Site Assessment, Smelter Site, Additional Investigations

Prepared for:
Hydro Aluminium Kurri Kurri Pty Ltd

Prepared by:
ENVIRON Australia Pty Ltd

Date:
May 2015

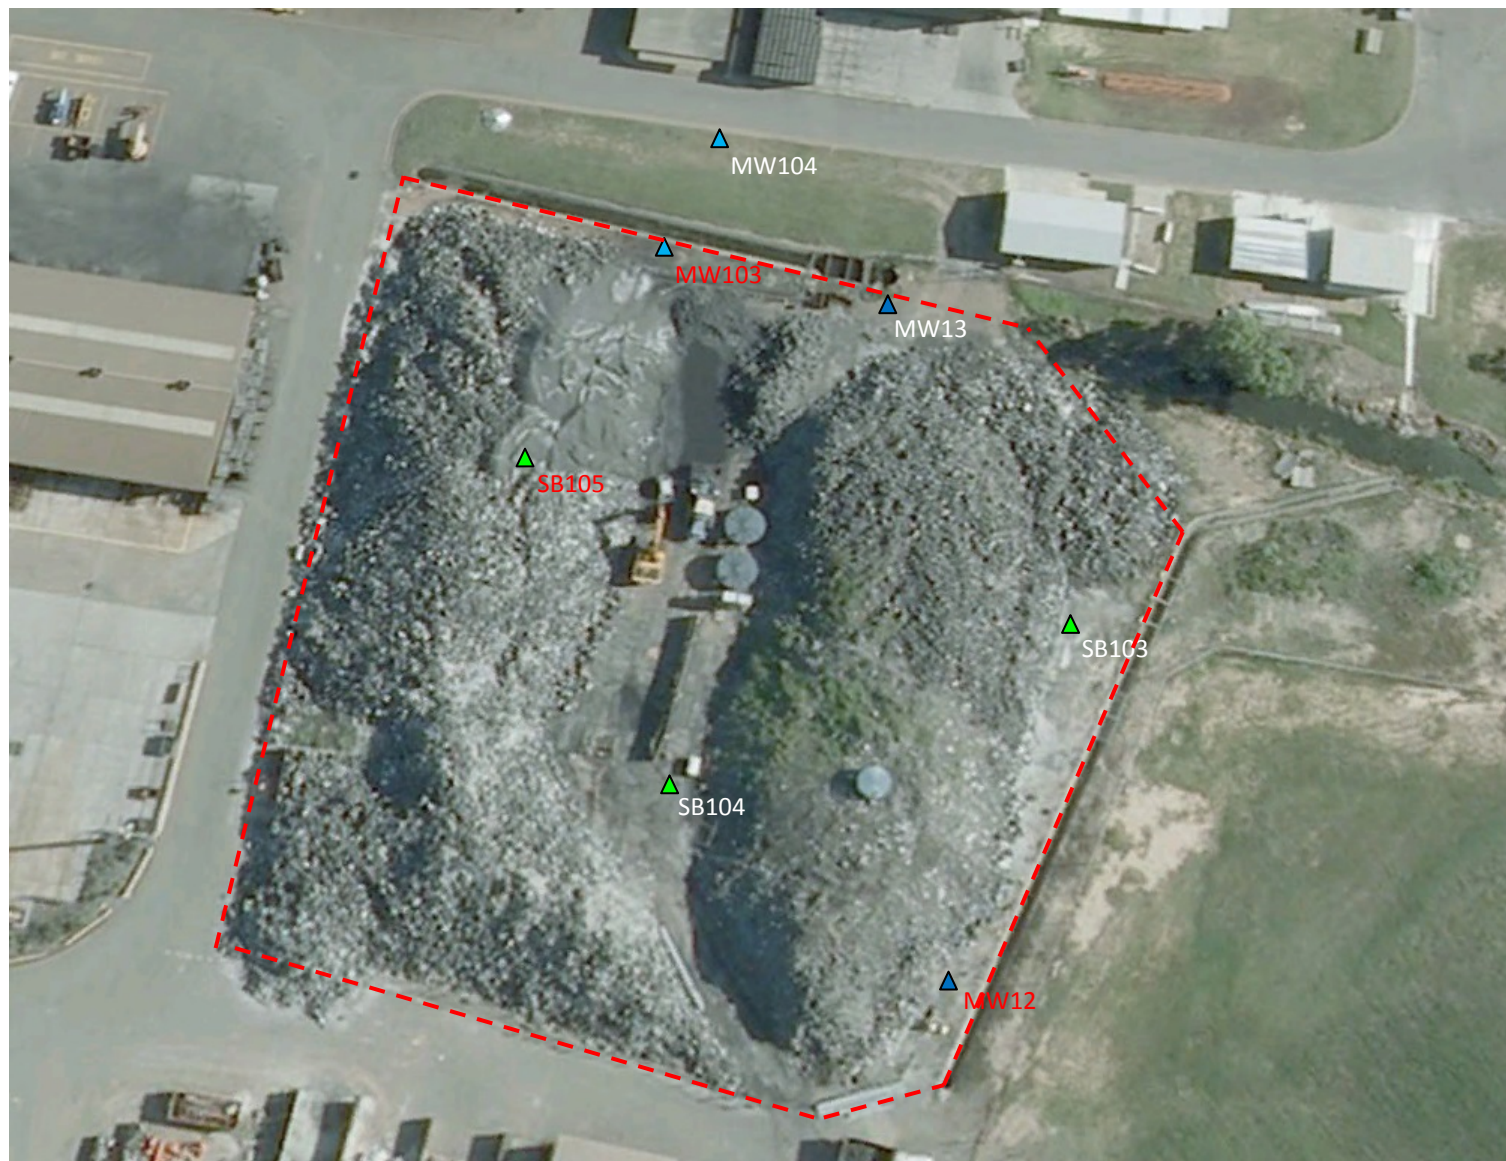
- ▲ 2014 groundwater well locations
 - ▲ 2014 soil sampling locations
 - ▲ 2012 groundwater well and soil sampling locations
 - MW103 Soil sampling locations with PAHs > guidelines
 - - - Approximate extent of soil contamination
- Approximate Scale 1cm:5m

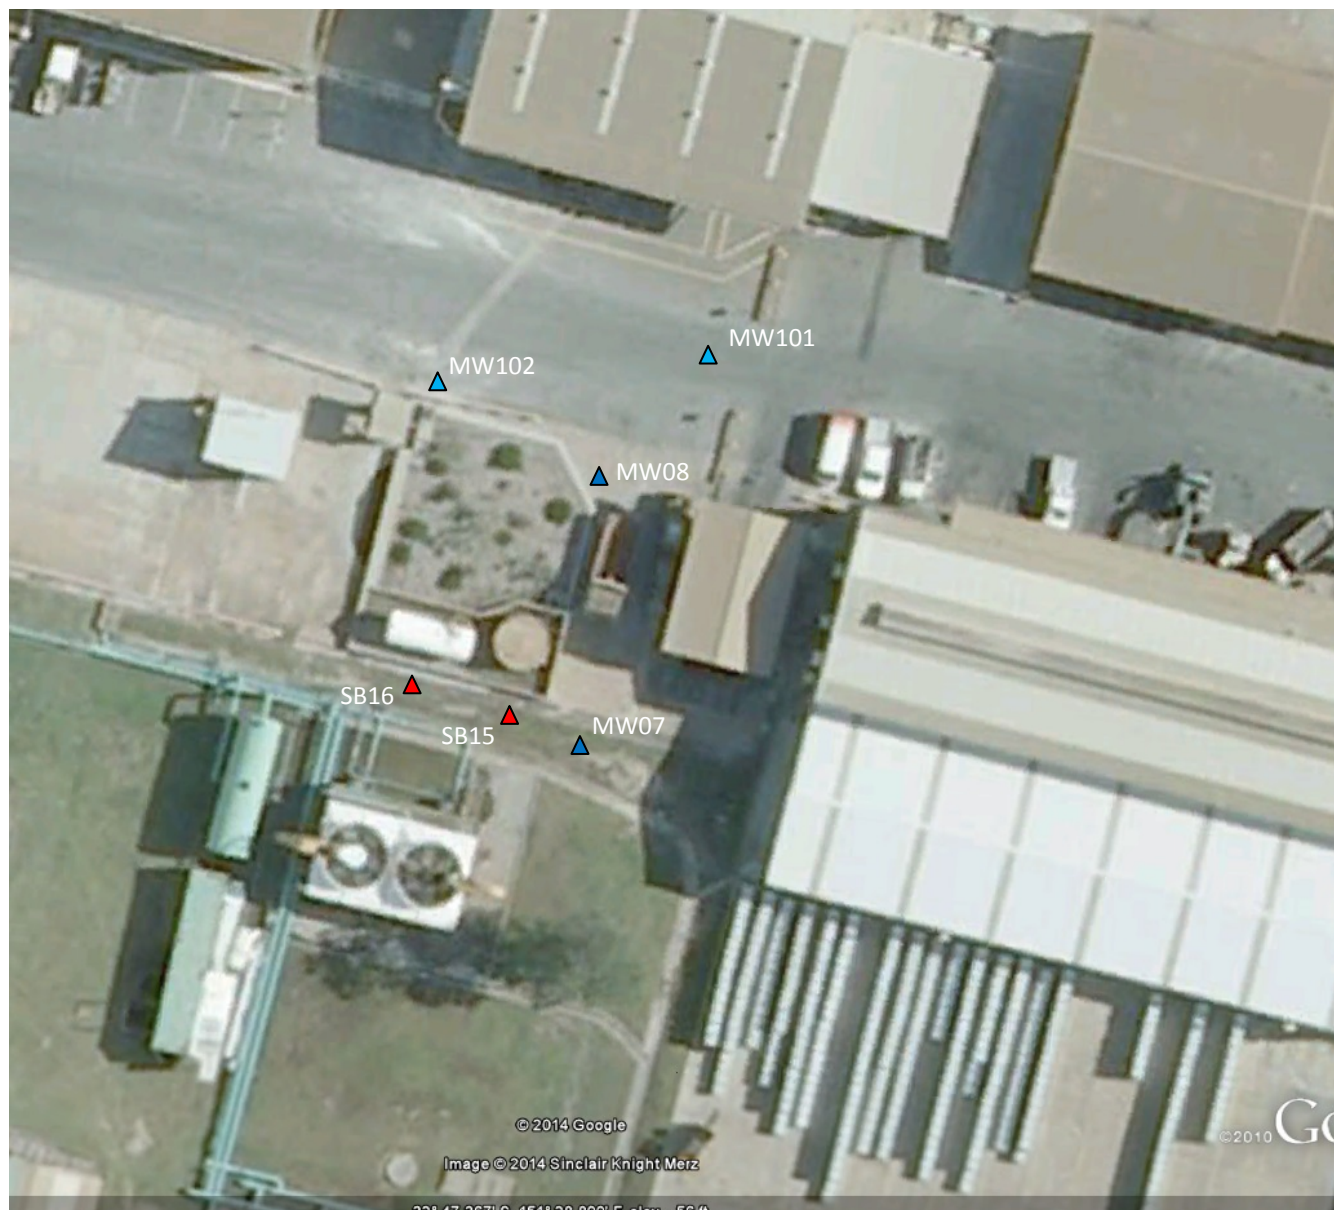
- ▲ 2014 groundwater well locations
- ▲ 2012 groundwater well and soil sampling locations
- ▲ 2012 soil sampling locations

Approximate Scale is 1cm:2m

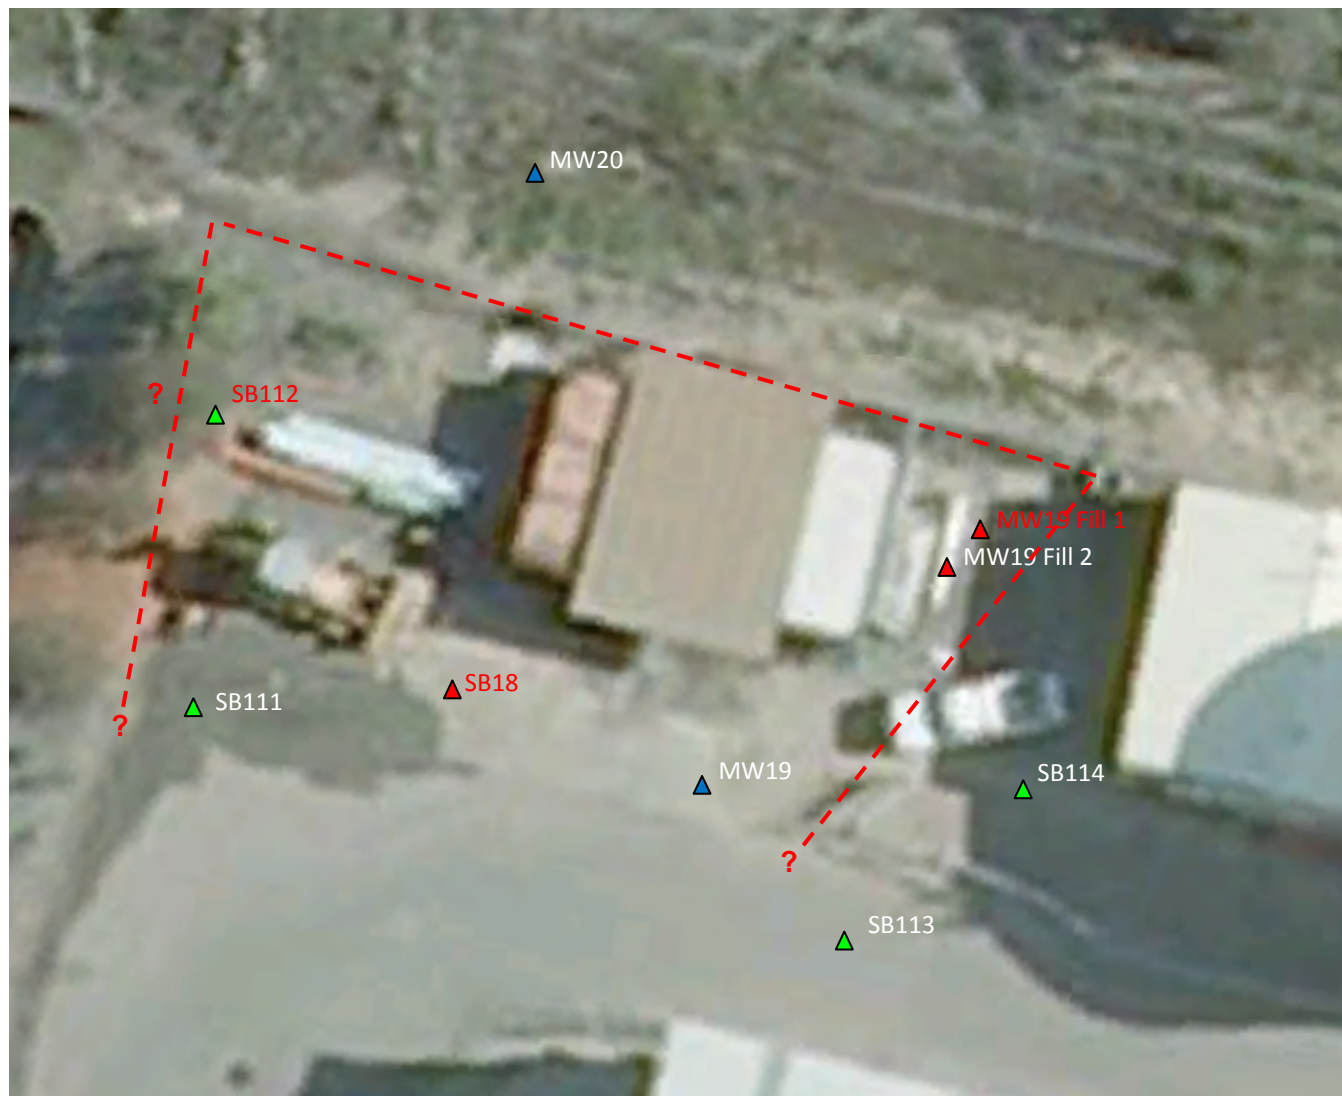
AEC 3 – Refuelling Area

- ▲ 2014 soil sampling locations
 - ▲ 2012 groundwater well locations
 - ▲ 2012 soil sampling locations
 - MW19 Fill 1 Soil sampling locations with PAHs > guidelines
 - Likely extent of soil contamination
- Approximate Scale is 1cm:1.5m

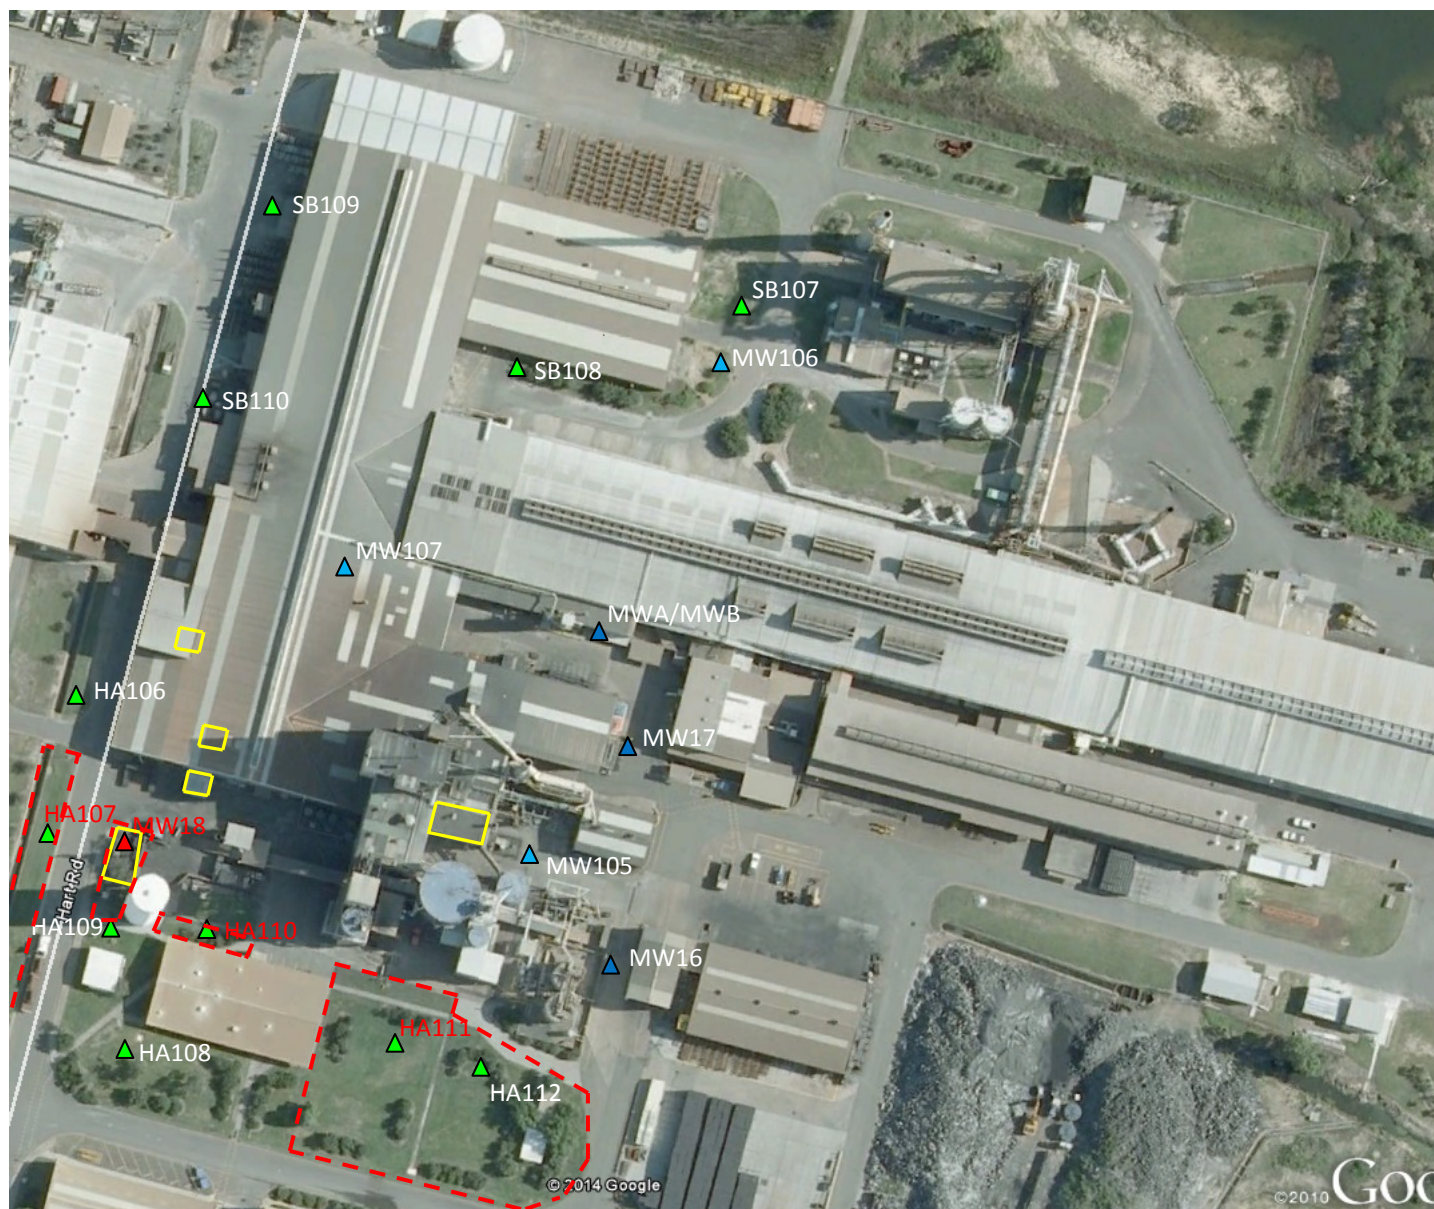
- ▲ 2014 groundwater well locations
 - ▲ 2014 soil sampling locations
 - ▲ 2012 groundwater well locations
 - ▲ 2012 soil sampling locations
 - HA111 Soil sampling locations with PAHs > guidelines
 - Areas of visible staining
 - Approximate extent of shallow soil contamination
- Approximate Scale 1cm:12m

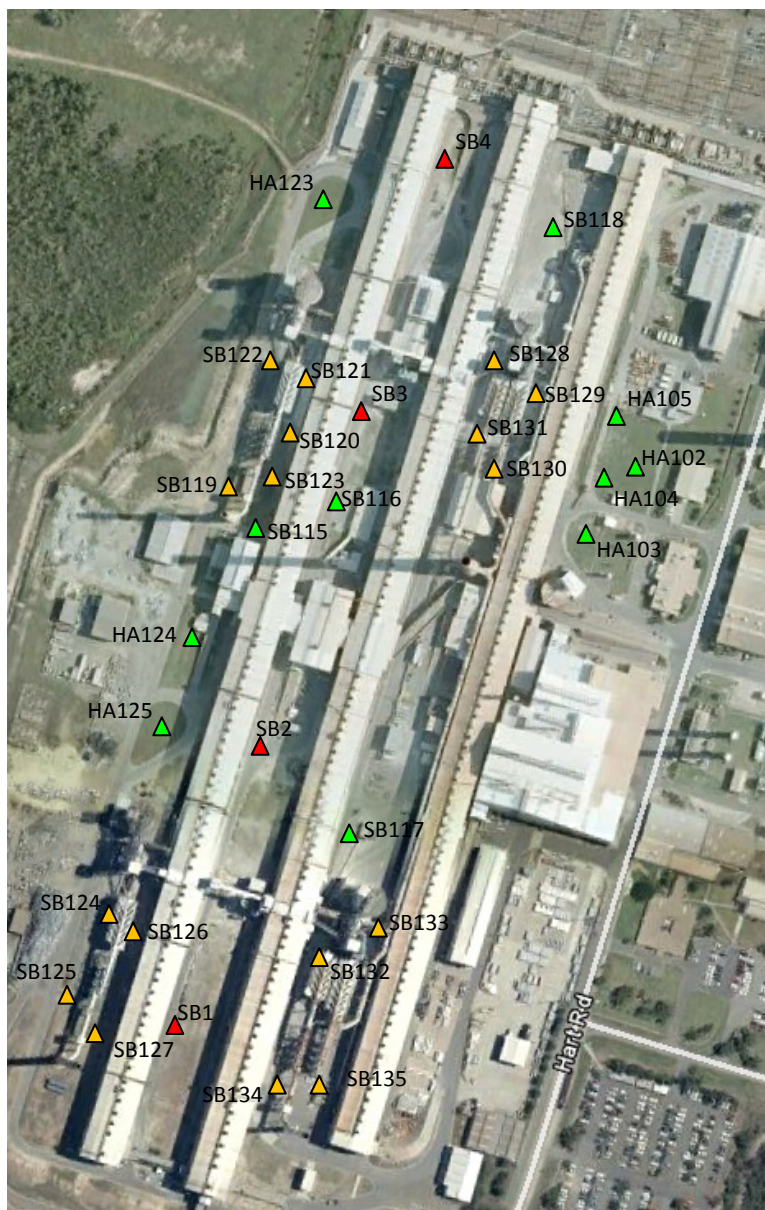
- ▲ 2014 soil sampling locations – AEC 25
- ▲ 2014 soil sampling locations – AEC 12
- ▲ 2012 soil sampling locations

Approximate Scale 1cm:53m

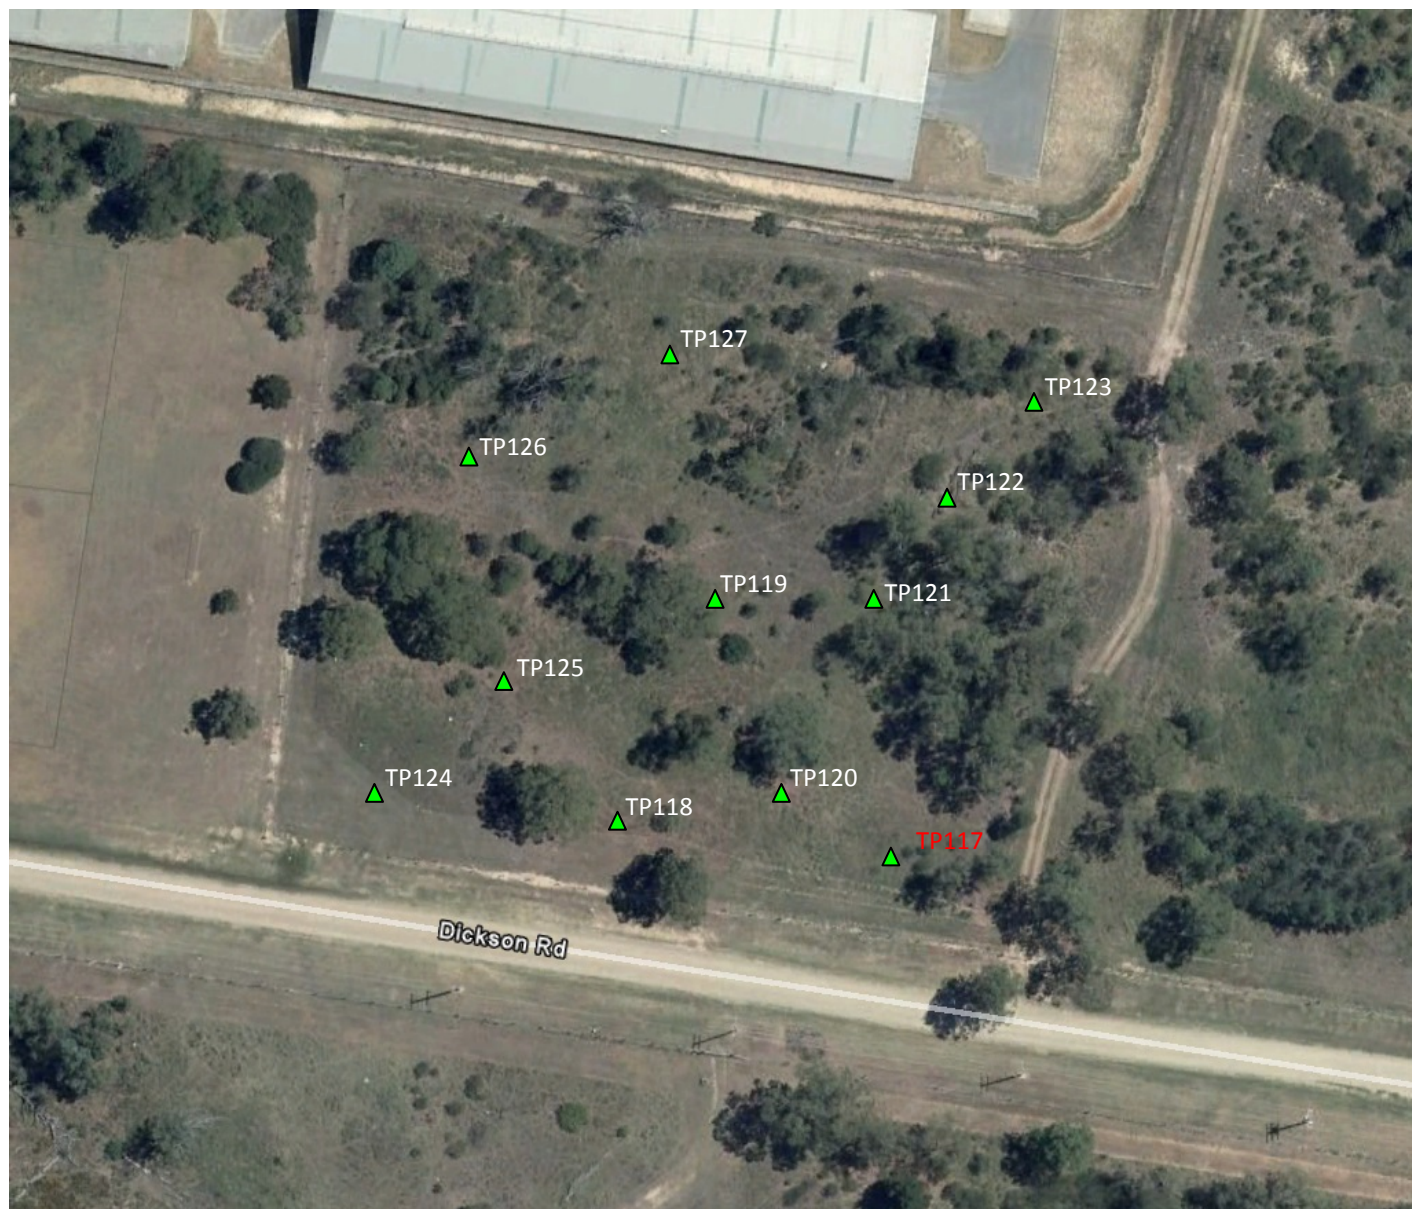
▲ 2014 soil sampling locations

TP117 Soil sampling location
with PAHs > guidelines
