# **Limited Geotechnical Investigation**

**Various Lots, Sections A to V DP 1596  
off Saddlers Way, Wyee Point**

**RPS HSO**

**17 November 2009  
BH Ref: 90343**

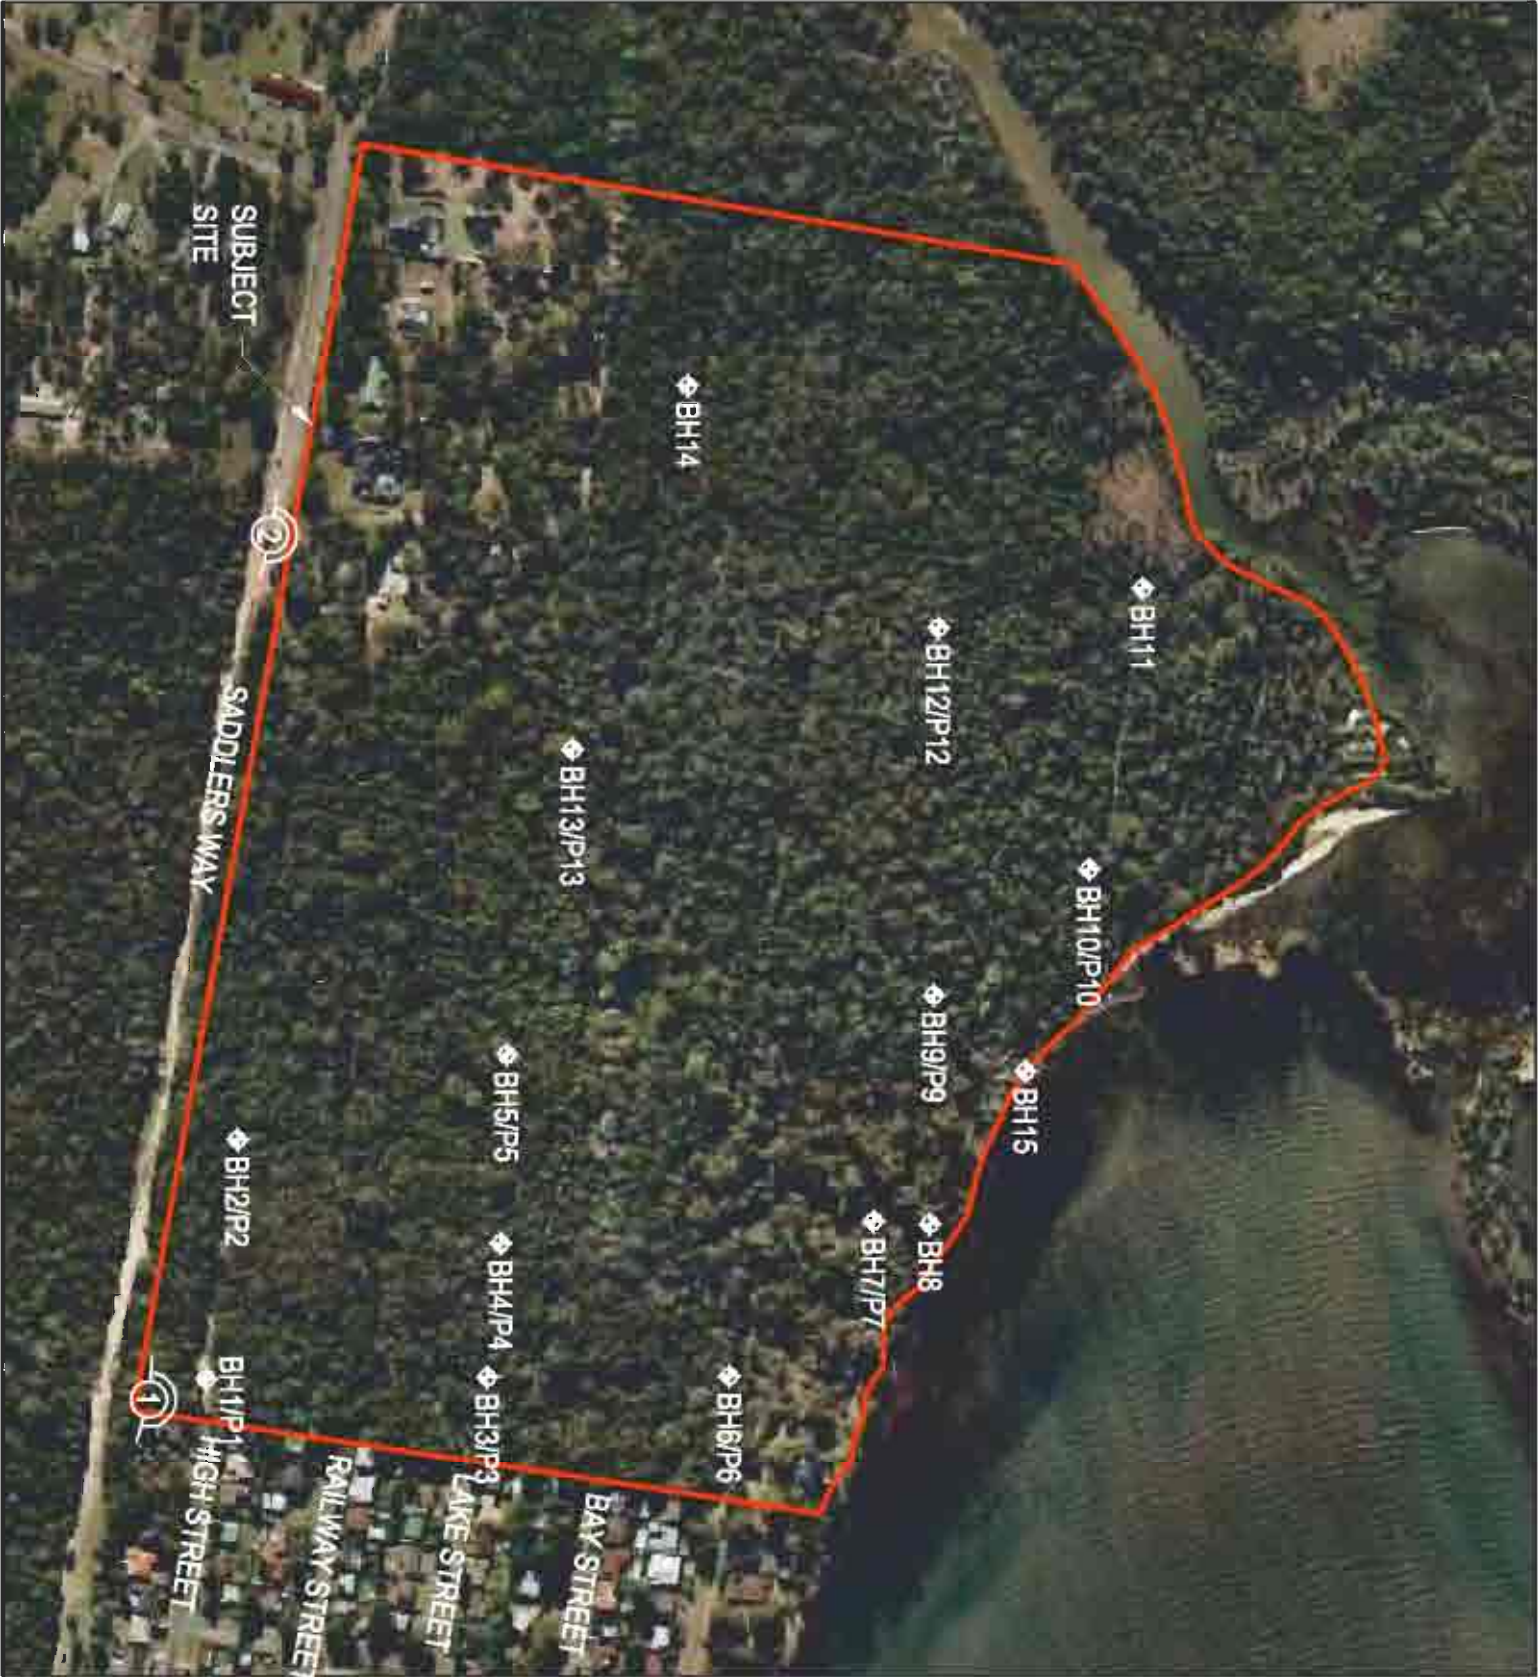
LOCALITY PLAN  
N.T.S.

- LEGEND**
- ◆ BH1/P1 - APPROXIMATE BOREHOLE/FALLING WEIGHT PENETROMETER PROBE LOCATION
  - ① - PHOTOGRAPH LOCATION AND DIRECTION

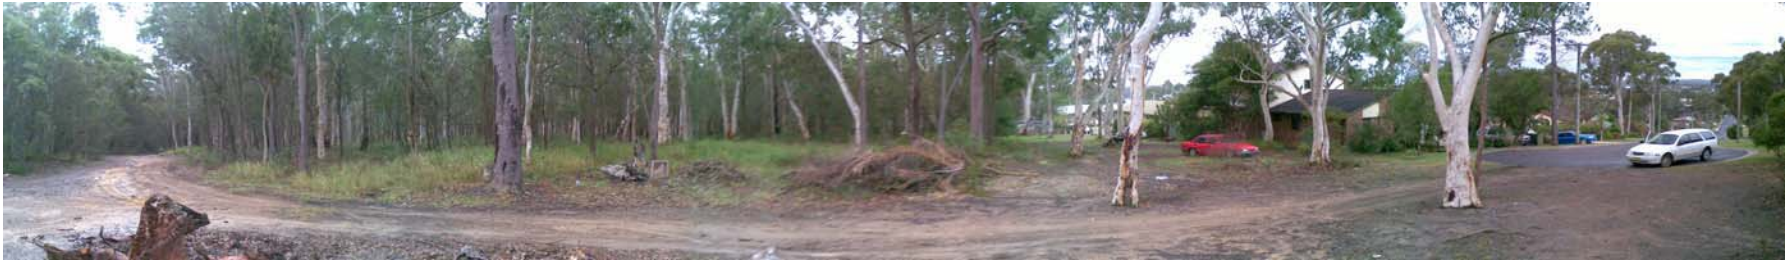
Photograph 1 – Taken in the southeastern portion of the site looking west through north to the east

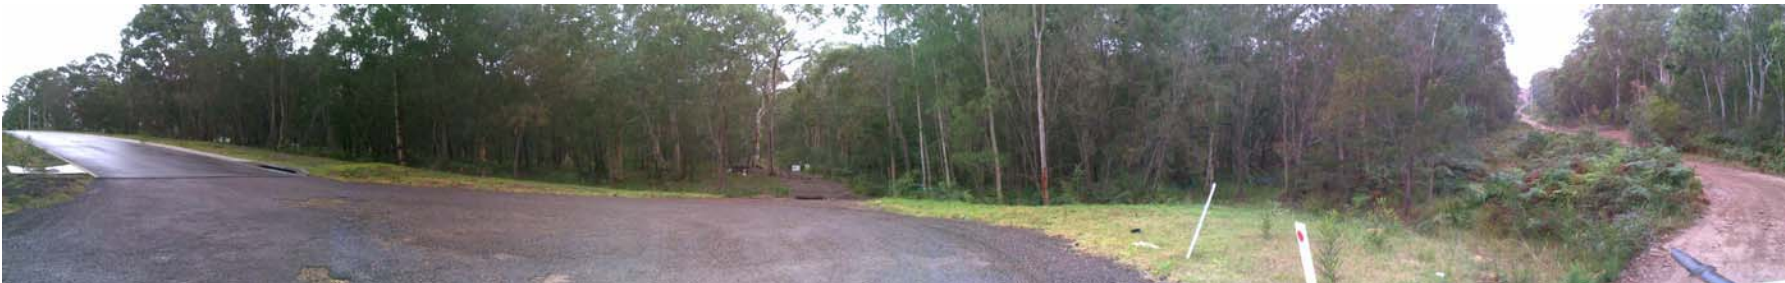
Photograph 2 - Taken on the southern side of the site in looking west through north to the east

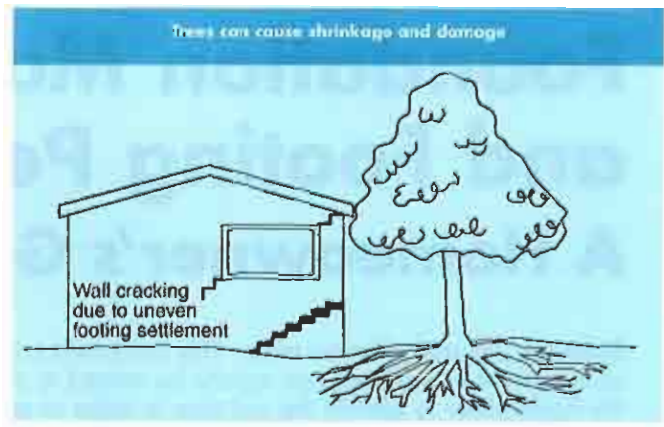
As the moisture absorption process completes its journey to the innermost areas of the building, the internal footings will rise. If the spread of moisture is roughly even, it may be that the symptoms will temporarily disappear, but it is more likely that swelling will be uneven, creating a difference rather than a disappearance in symptoms. In buildings with timber flooring supported by bearers and joists, the isolated piers will rise more easily than the strip footings or piers under walls, creating noticeable doming of flooring.

As the weather pattern changes and the soil begins to dry out, the external footings will be first affected, beginning with the locations where the sun's effect is strongest. This has the effect of lowering the external footings. The doming is accentuated and cracking reduces or disappears where it occurred because of dishing, but other cracks open up. The roof lines may become convex.
