PRELIMINARY STORMWATER MANAGEMENT PLAN

For
PROPOSED REZONING AND SUBDIVISION

At
LOT 1 DP873220
71 BRANXTON STREET, GRETA

PRELIMINARY BUSHFIRE THREAT ASSESSMENT

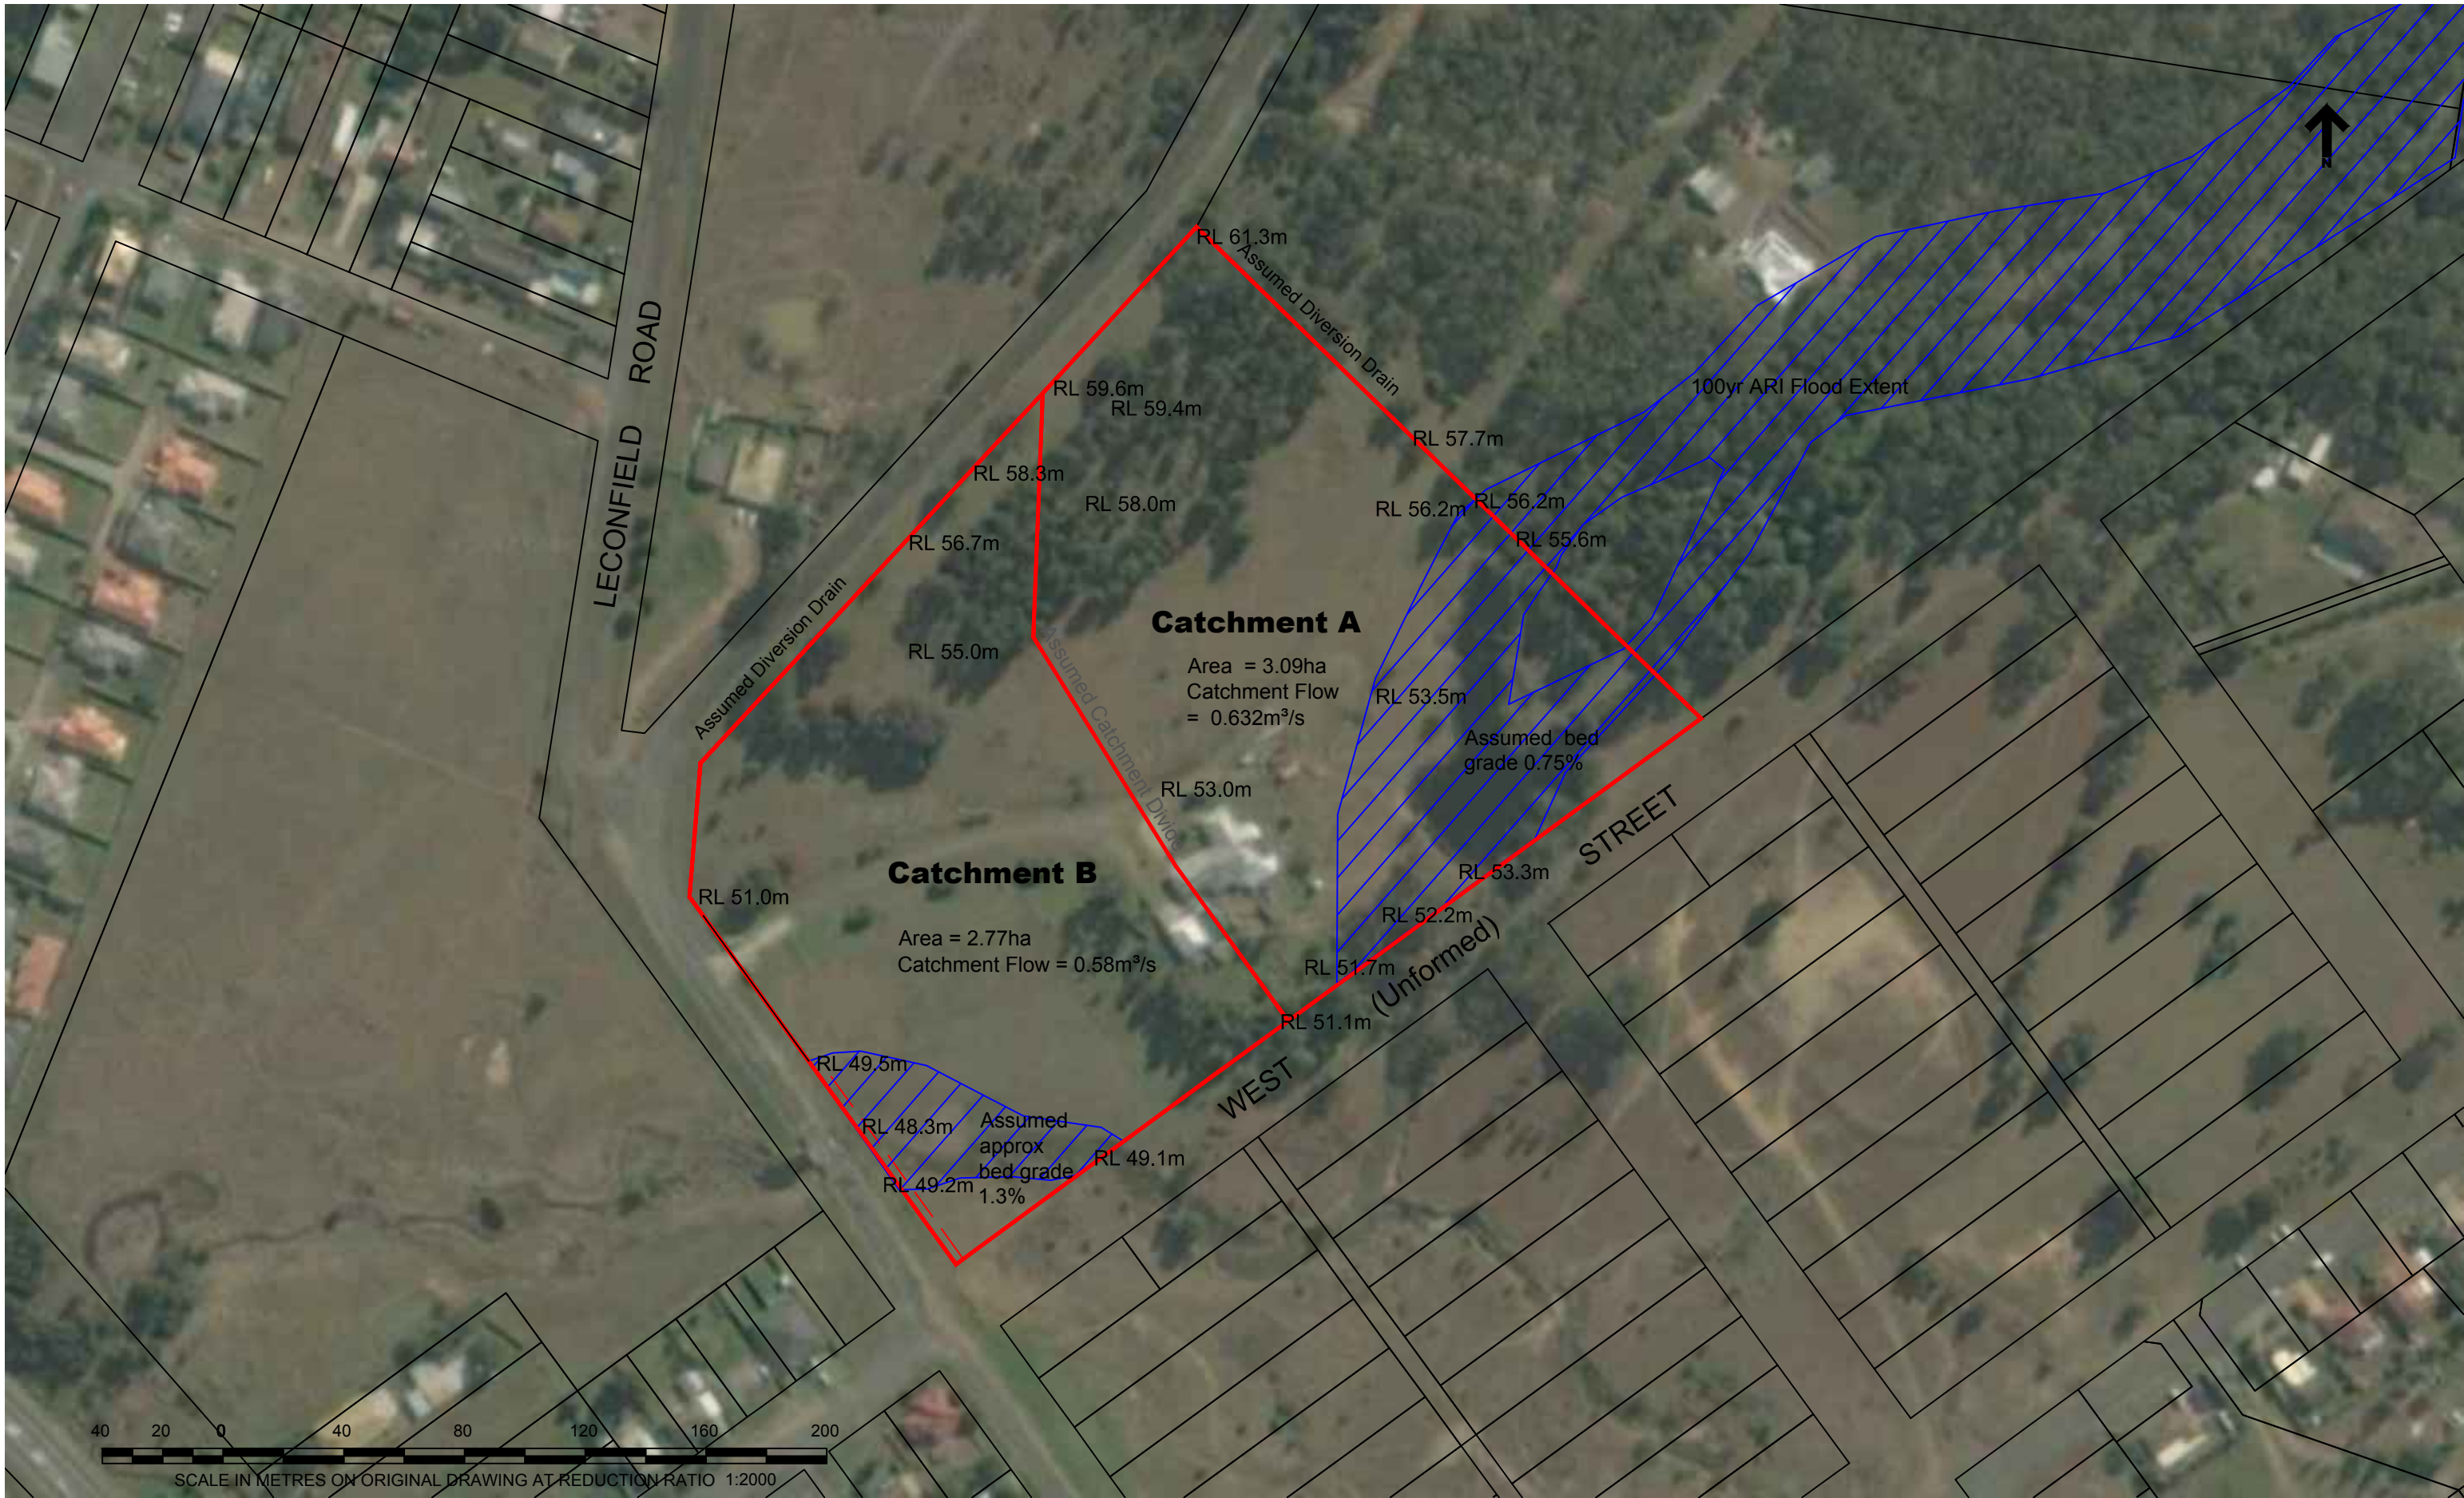
Figure 1

Existing Catchments

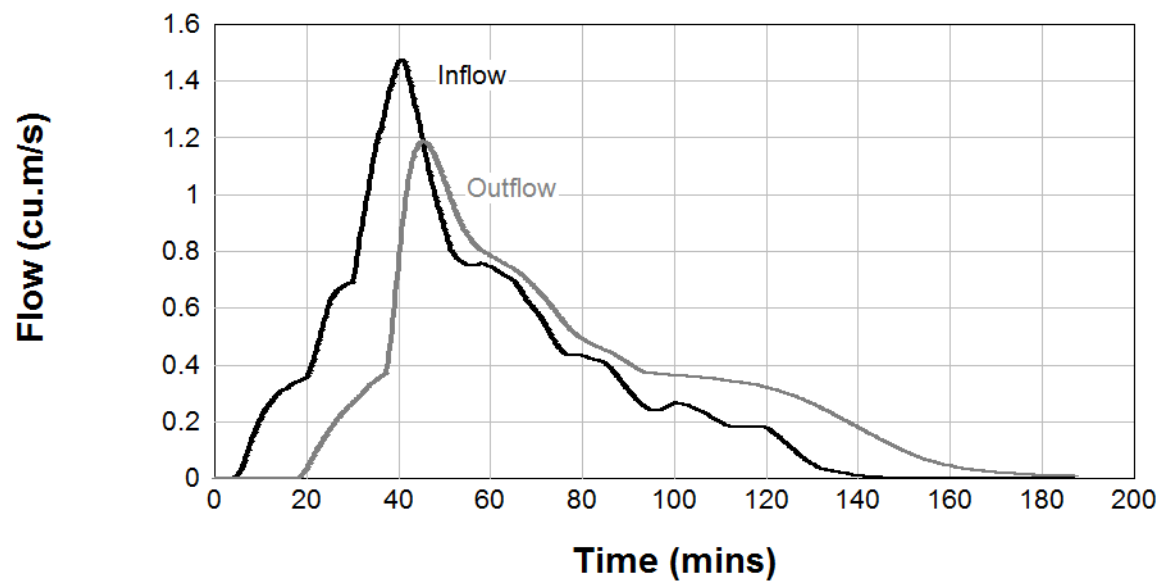
Appendix C

Basin Inflow / Outflow Hydrographs

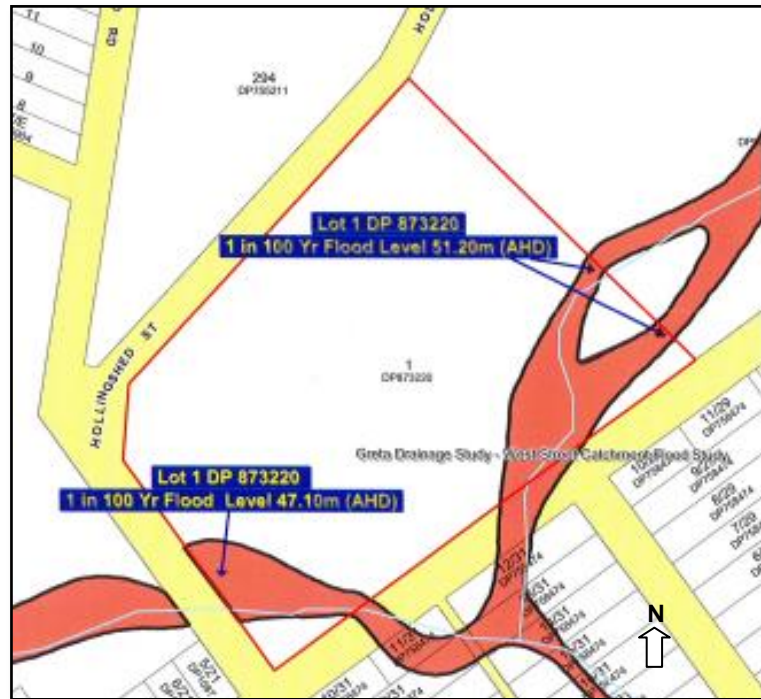
Council's flood mapping indicates that the north-east and south-east sections of the site are affected by the 1 in 100 year Average Recurrence Interval (ARI) flood event.

Figure 5: Flood map

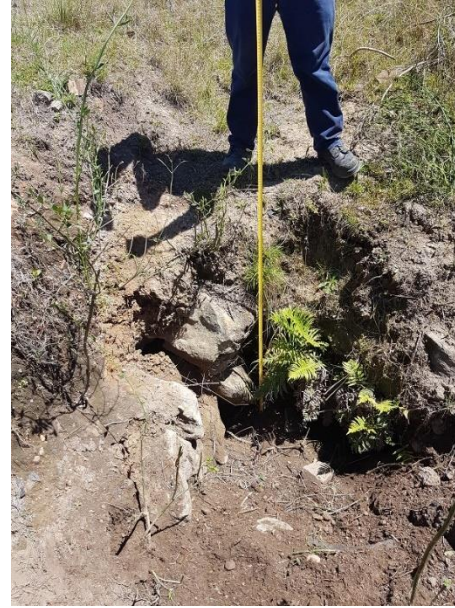
Photograph 10: Showing a pothole in west-south-western portion of site, probably related to mine subsidence.

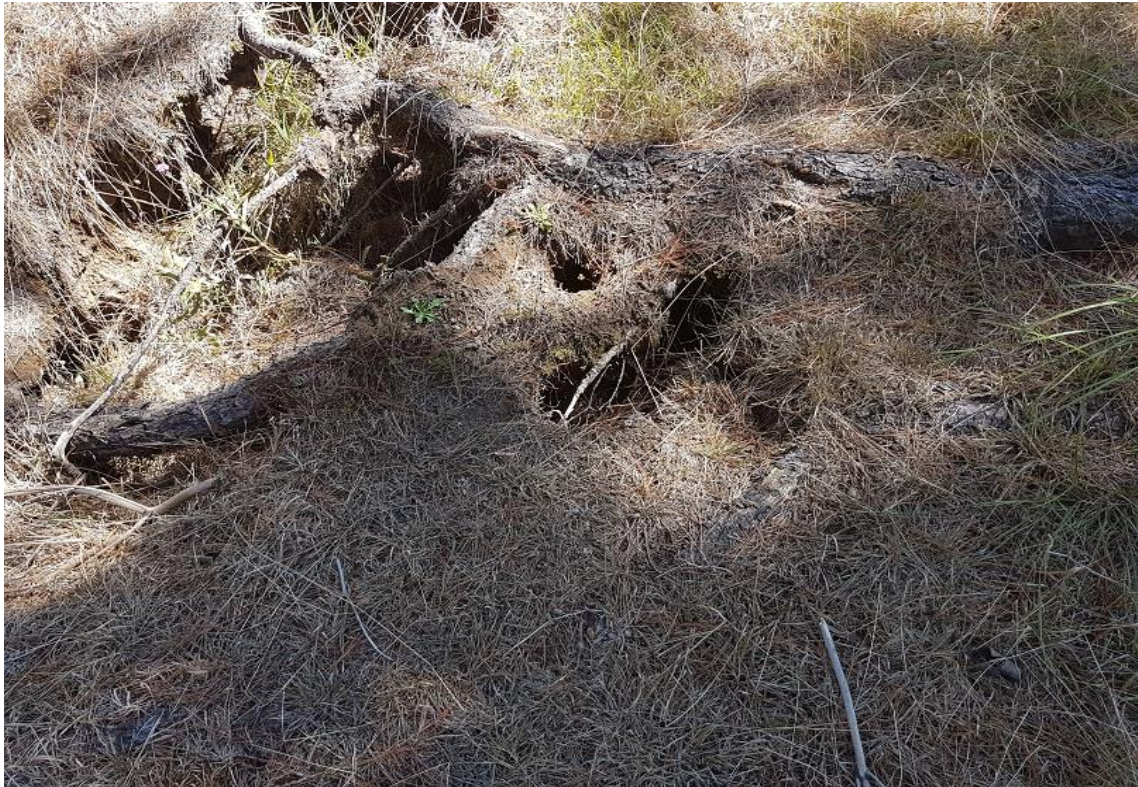
Photograph 9 - Example of pothole from mine subsidence in northwestern portion of the site.

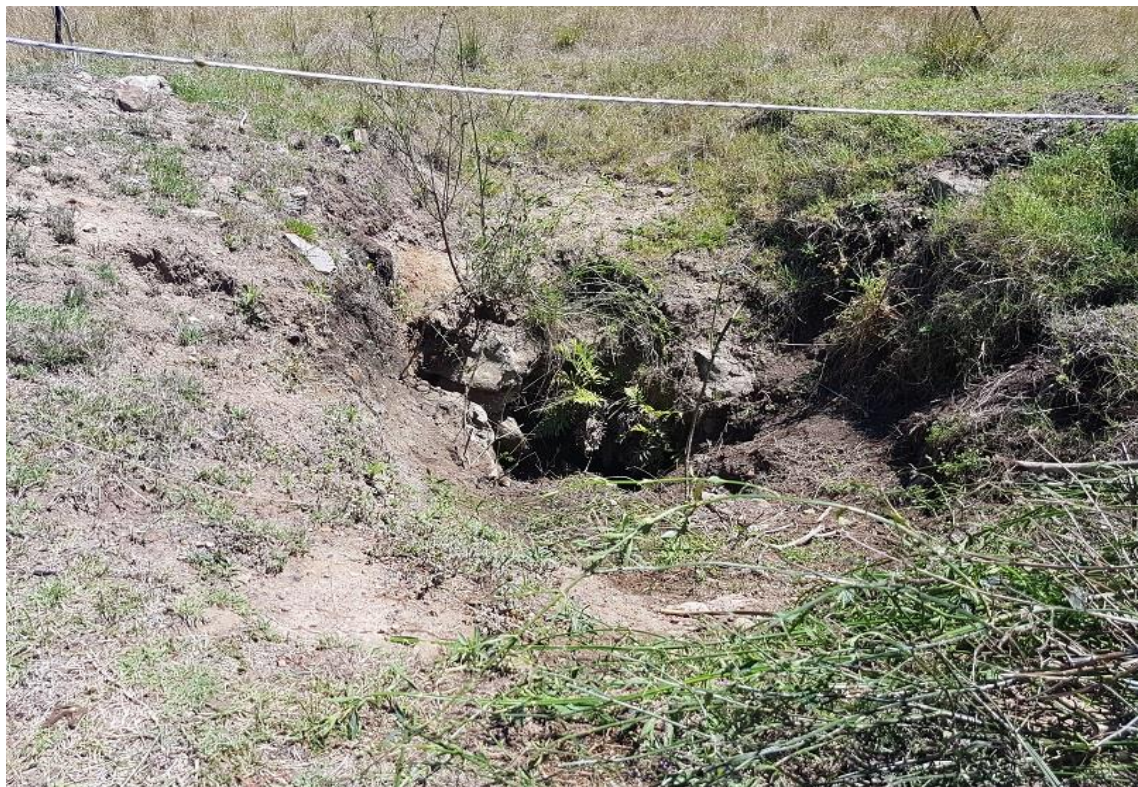
Photograph 10 - Pothole in southern portion of the site, infilled with fill including boulders.

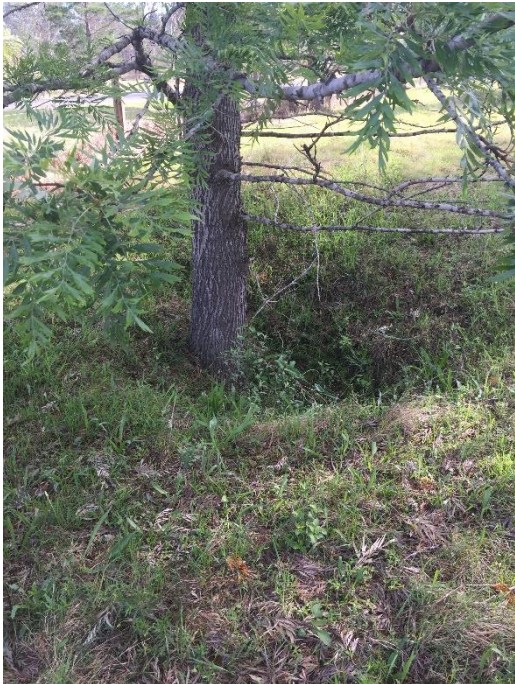
Photos of the area showing evidence of mine subsidence are presented in Plate 2.

Pothole formation
near a tree on the
northwestern side
of the site

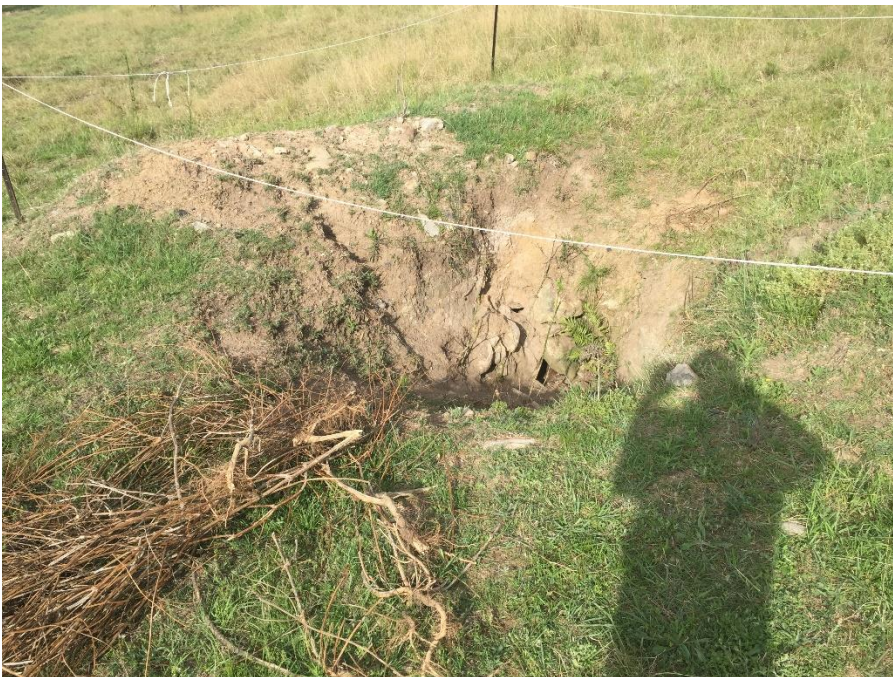
Pothole
formation on
the
northwestern
side of the site.
Note the area
being roped off.

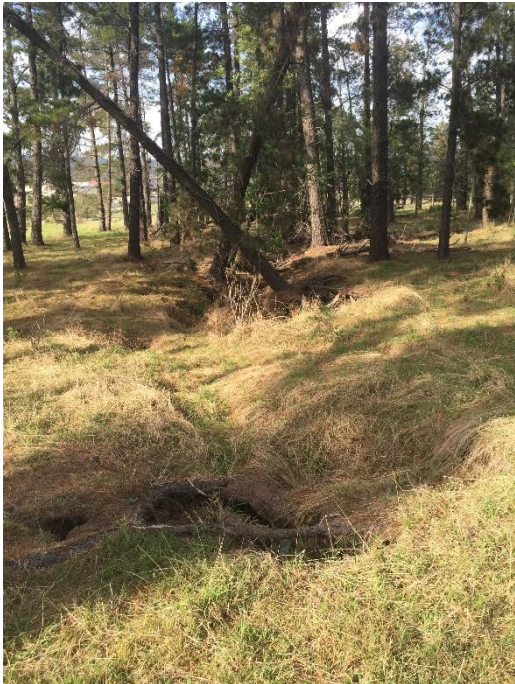
Photo of a collapsed drift on the northwestern side of the site. Note the trees collapsing on both sides into the drift

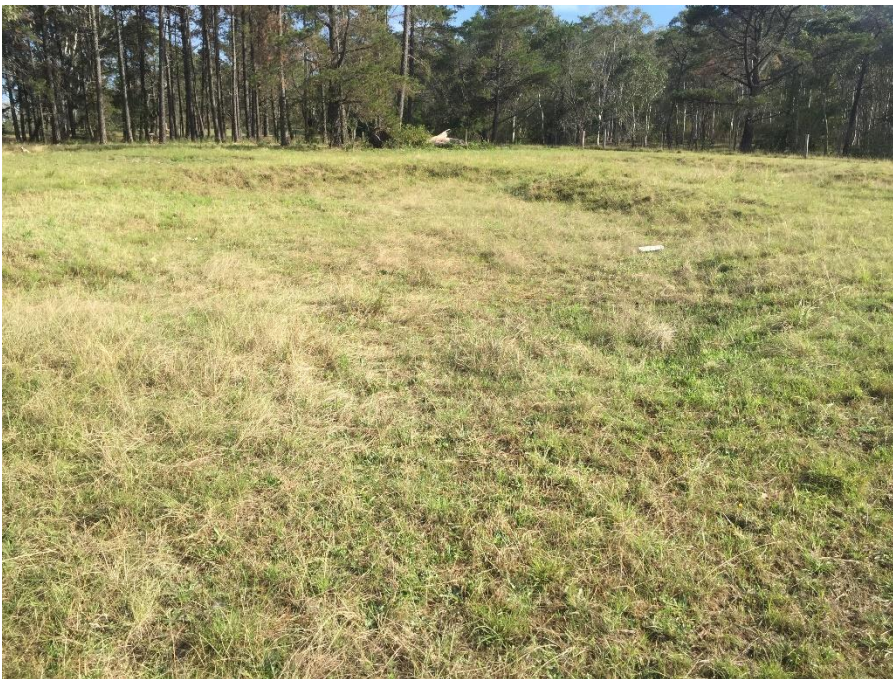
Photo of large depression northeastern side of the site. Depressions do not appear to be a features associated with pothole subsidence as observed in other areas of site
