ELA Ref/Job No: 18CAN 9899

RE: Aboriginal Heritage Due Diligence Assessment – Lot 5 DP838497

Eco Logical Australia (ELA) has been engaged by Canberra Town Planning to conduct an Aboriginal Heritage Due Diligence Assessment for the proposed sub-division of Lot 5 DP838497 Sutton Road, Sutton.

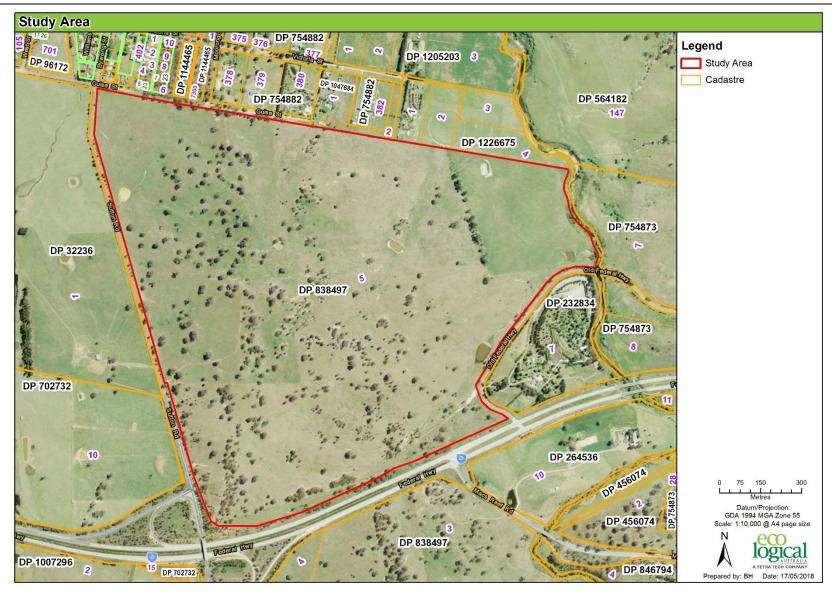
Figure 1: Study Area

The study area (**Figure 1**) is located on Sutton Road, Sutton. It is immediately south of the village of Sutton and covers approximately 183ha. The property falls within the Yass Valley Council (YVC).

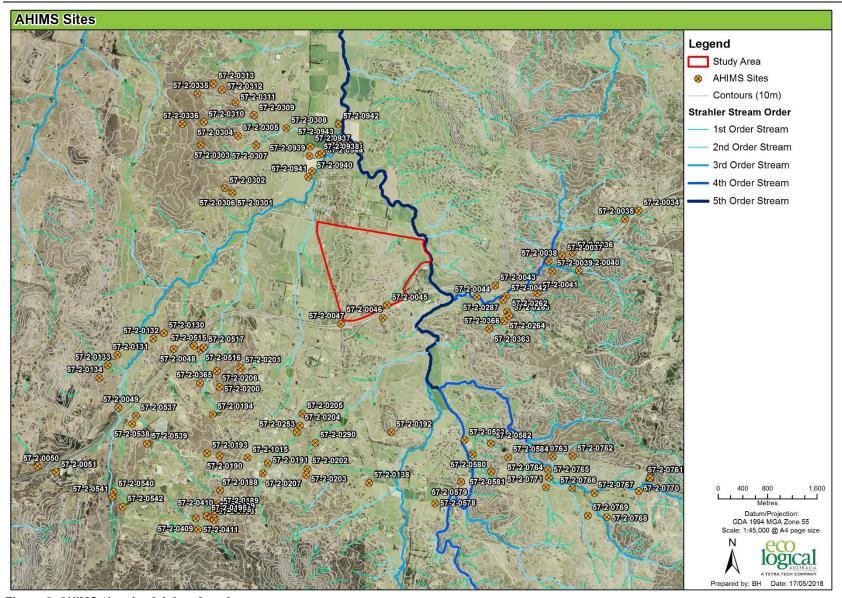
Figure 2: AHIMS sites in vicinity of study area

There are no registered AHIMS sites located within the study area boundary. Two sites (57-2-0046 and 57-2-0047) are located outside the southern boundary of the property. All three sites were recorded by Margrit Koettig in 1981. Site 57-2-0046 is located on the southern side of the Federal Highway. Site 57-2-0047 is located near the intersection of the Federal Highway and Sutton Road outside the south western corner of Lot 5 DP838497.

The study area is surrounded by several streams and tributaries which flow into the Yass River which forms the eastern boundary of Lot 5 DP838497. There are two un-named first order Strahler streams that drain the eastern facing slopes to the Yass River (**Figure 2**.).

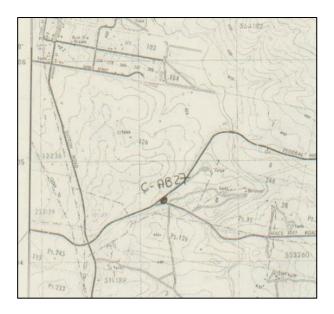
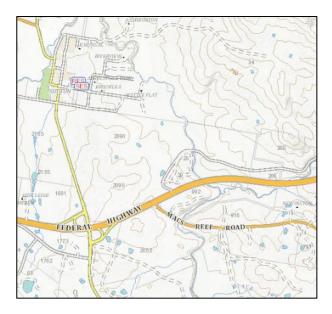
No new Aboriginal sites or objects were identified within Lot 5 DP838497 during the site-based assessment. The previously recorded site on the southern boundary of the property – 57-50045 – could not be relocated. The site card associated with the original recording describes the condition of the site in 1981 as being: *Poor – totally disturbed by clearing, ploughing, laying of coaxial cable* (AHIMS site record 57-2-0045). A thorough visual inspection of the area that was once near the junction of the former Federal Highway and Mac's Reef Road and is now on the boundary of the Lot 5 DP838497 and the road easement for the Federal Highway could not relocate any Aboriginal stone artefacts. The degree of disturbance at this location was very high and associated with:

Figure 3: AHIMS site 57-5-0045. AHIMS site record (left) and an extract from Six Maps (right) showing the changed alignment of the Federal Highway and Macs Reef Road since 1981.

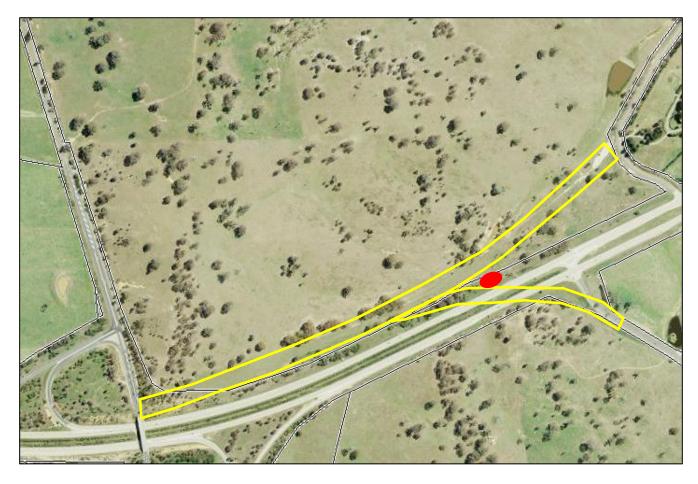
Figure 4: Suggested location for AHIMS site 57-5-0045 (red) based on the site card prepared by Koettig. The old alignment of the Federal Highway and Macs Reef Road is shown in yellow as they would have been 1981.

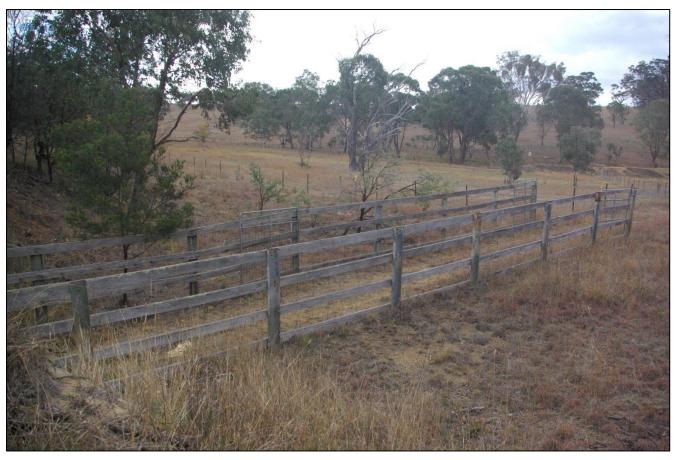
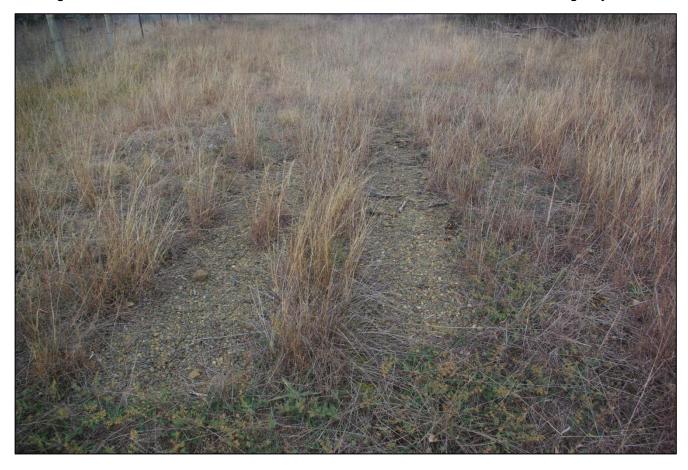
- The mechanical removal of bitumen and concrete associated with the original intersection of the Federal Highway and Macs Reef Road and the landscaping of disturbed areas;
- Earthworks associated with the construction of the new Federal Highway; and
- Works associated with the construction of a livestock tunnel beneath the Federal Highway and associated yards.

This assessment concludes that site 57-50045 has been irreversibly impacted upon by past pastoral activities, the laying of a coaxial telecommunications cable and the removal of the old Federal Highway – Macs Reef Road intersection and the construction of the northbound lanes of the new Federal Highway.

Figure 5 (above): The location of site 57-5-0045 has sustained considerable disturbance. Figure 6 (Bleow): Roadbase gravels either from the old Macs Reef Road or from the construction of the new Federal Highway.

The AHIMS site 57-2-0045 no longer exists. Nevertheless, activities that would result in ground disturbance near the boundary fence and cattle yards at its recorded location must be avoided until advice can be sought from the Office of the Environment and Heritage on whether or not the AHIMS site record can be amended to reflect that it no longer exists or whether an Aboriginal Heritage Impact Permit is required before works can occur at that location.
