**HIGHWAY SERVICE CENTRE  
BOWNING, NSW**

**Aboriginal Heritage Due Diligence Assessment**

Prepared for Waters Consultancy Pty Ltd  
for Bowning Pty Ltd

March 2017

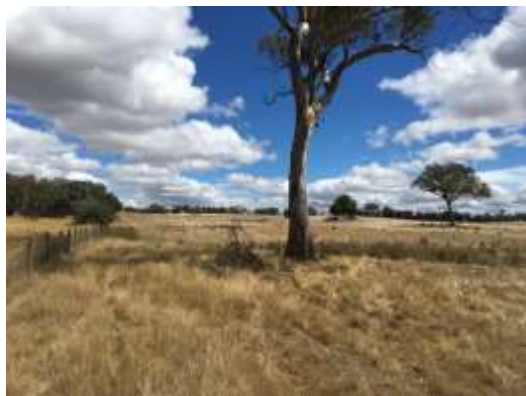
**Plate 1. View facing west showing study area and extensive grass cover.**

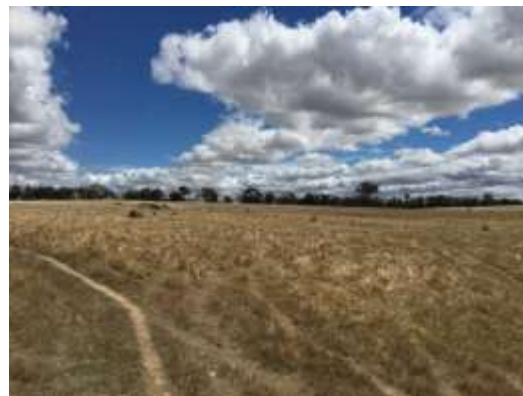
**Plate 2. View across the study area from southeast boundary. Photo shows gentle sloping across the study area and vehicle track disturbance.**

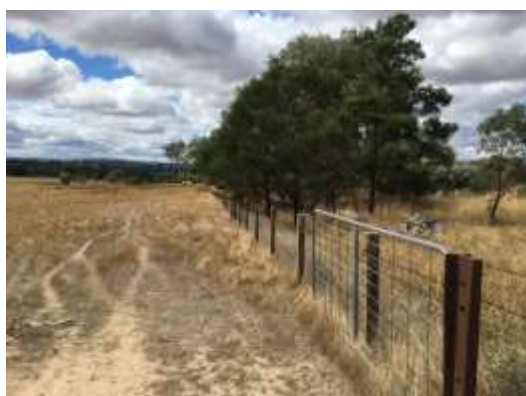
**Plate 3. View facing east showing the proposed slip lane route. Vehicle track erosion present in foreground.**

The route of the proposed slip lane was also inspected. Due to the extensive cut and fill works associated with the construction of the Hume Highway, this corridor was determined to be highly disturbed.

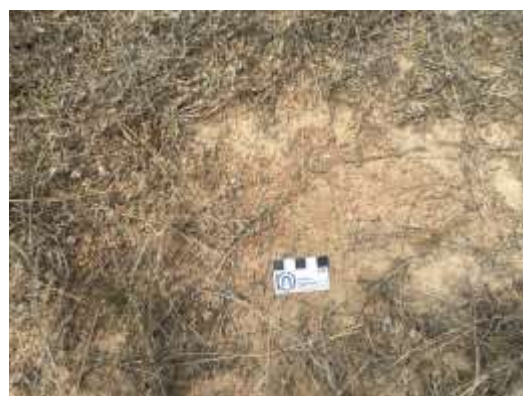
**Plate 4. Example of exposed ground, demonstrating soil erosion.**

Observed soils in exposed areas, predominantly along vehicle tracks or at the gate entrance, were eroded across the study area. Exposed bedrock was present across the landscape in the form of large rock boulders and had been subject to erosional processes. Exposed areas where the grass has been removed due to disturbance demonstrate an eroded soil profile, with the majority consisting of clay material. These exposed areas were inspected for Aboriginal objects. No artefacts or areas of potential archaeological deposit were identified.

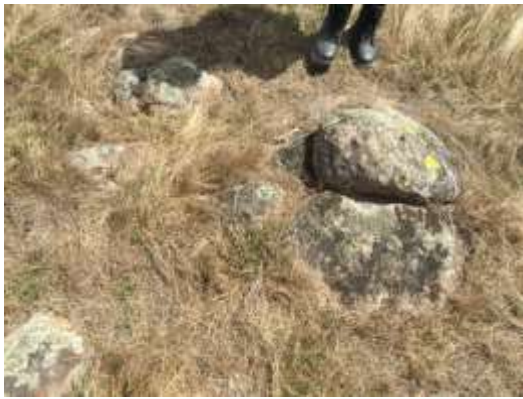
**Plate 5. Example of rock boulders present across the site.**

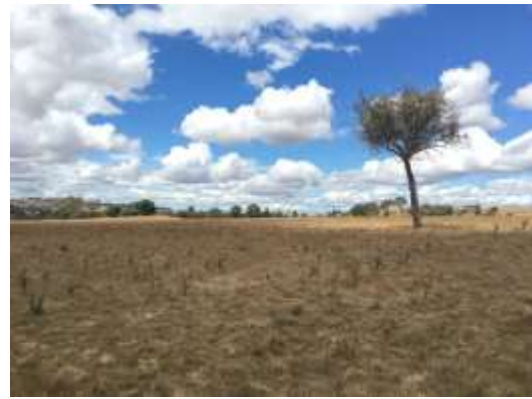
**Plate 6. View facing south across entire study area, with the Hume Highway on the horizon.**

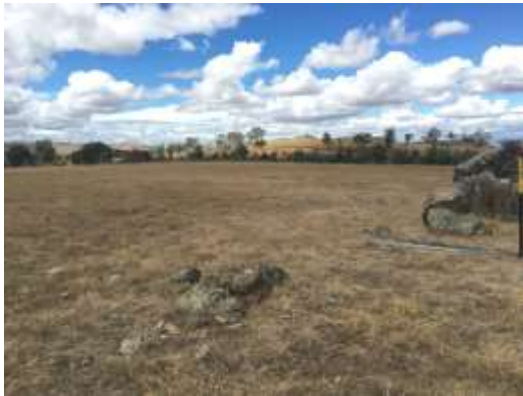
**Plate 7. View to the south showing rock boulders with the cut and fill works associated with the Hume Highway in the background.**

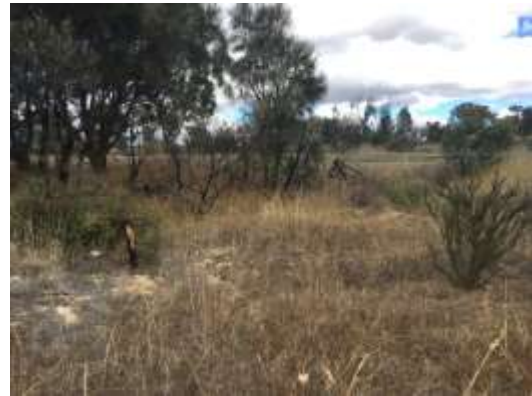
**Plate 8. View of the road corridor showing the fill in the front left corner and the cut in the back right corner, associated with the Hume Highway construction.**
