Geotechnical Investigation

71-89 Chandos Street, St Leonards, NSW

Report No: E25094.G03_Rev2

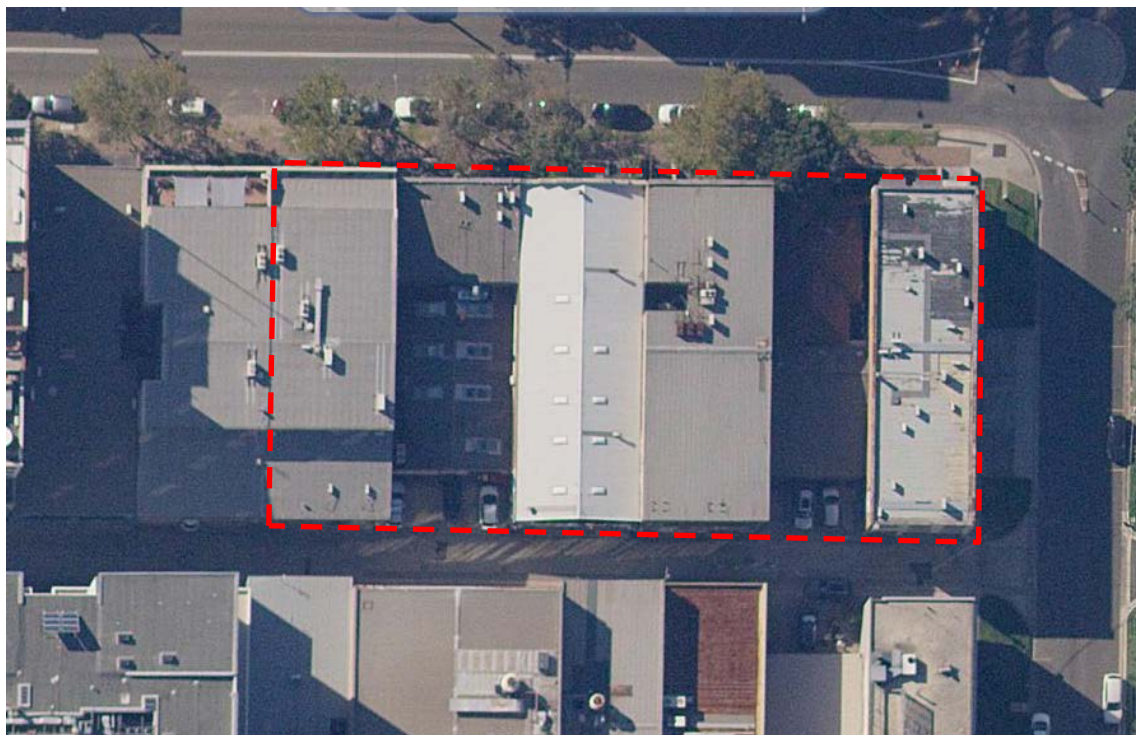
Plate 1: Aerial photograph of the site (source: sixmaps, accessed 26 May 2021)

The site identification details and associated information are presented in **Table 2-1** below while the site locality is shown on **Figure 1**. An aerial photograph of the site is presented in **Plate 1** below.

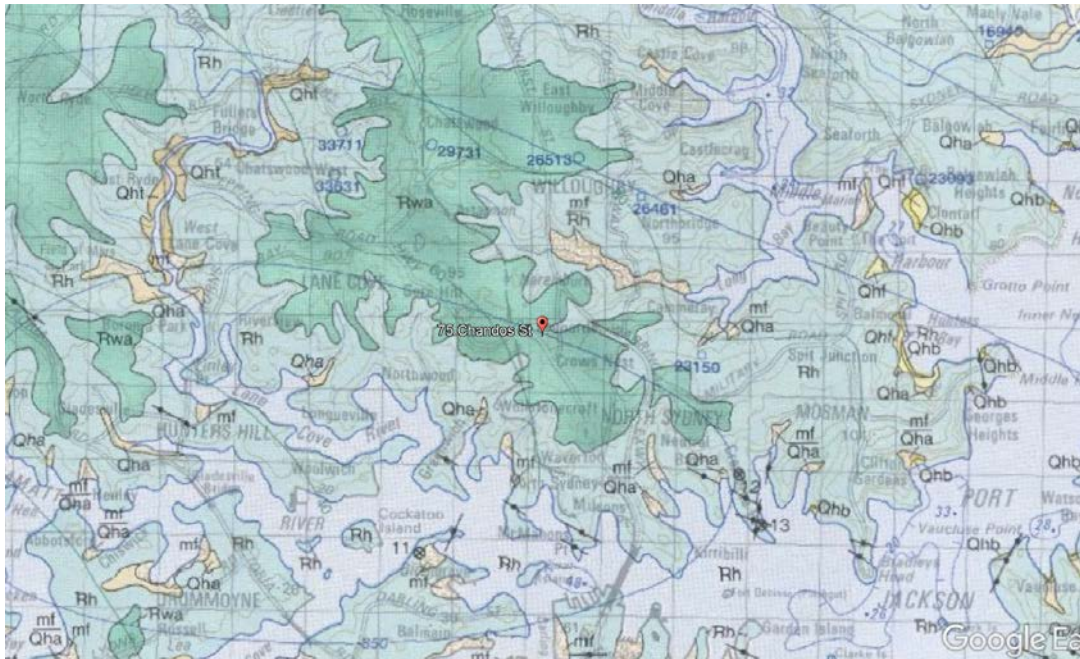
Plate 2: Excerpt of geological map showing location of site.

Attribute	Description
Topography	The site is located on the high south side of Chandos Street within gently (0-5°) dipping topography towards the west with site levels varying from R.L. 86.0m at the north-eastern corner to R.L. 89.5m at the south-western corner.
Regional Geology	Information on regional sub-surface conditions, referenced from the Department of Mineral Resources Geological Map Sydney 1:100,000 Geological Series Sheet 9130 (DMR 1983) indicates the site to be underlain by Ashfield Shale (Rwa), which consists of black to dark grey shale and laminite.

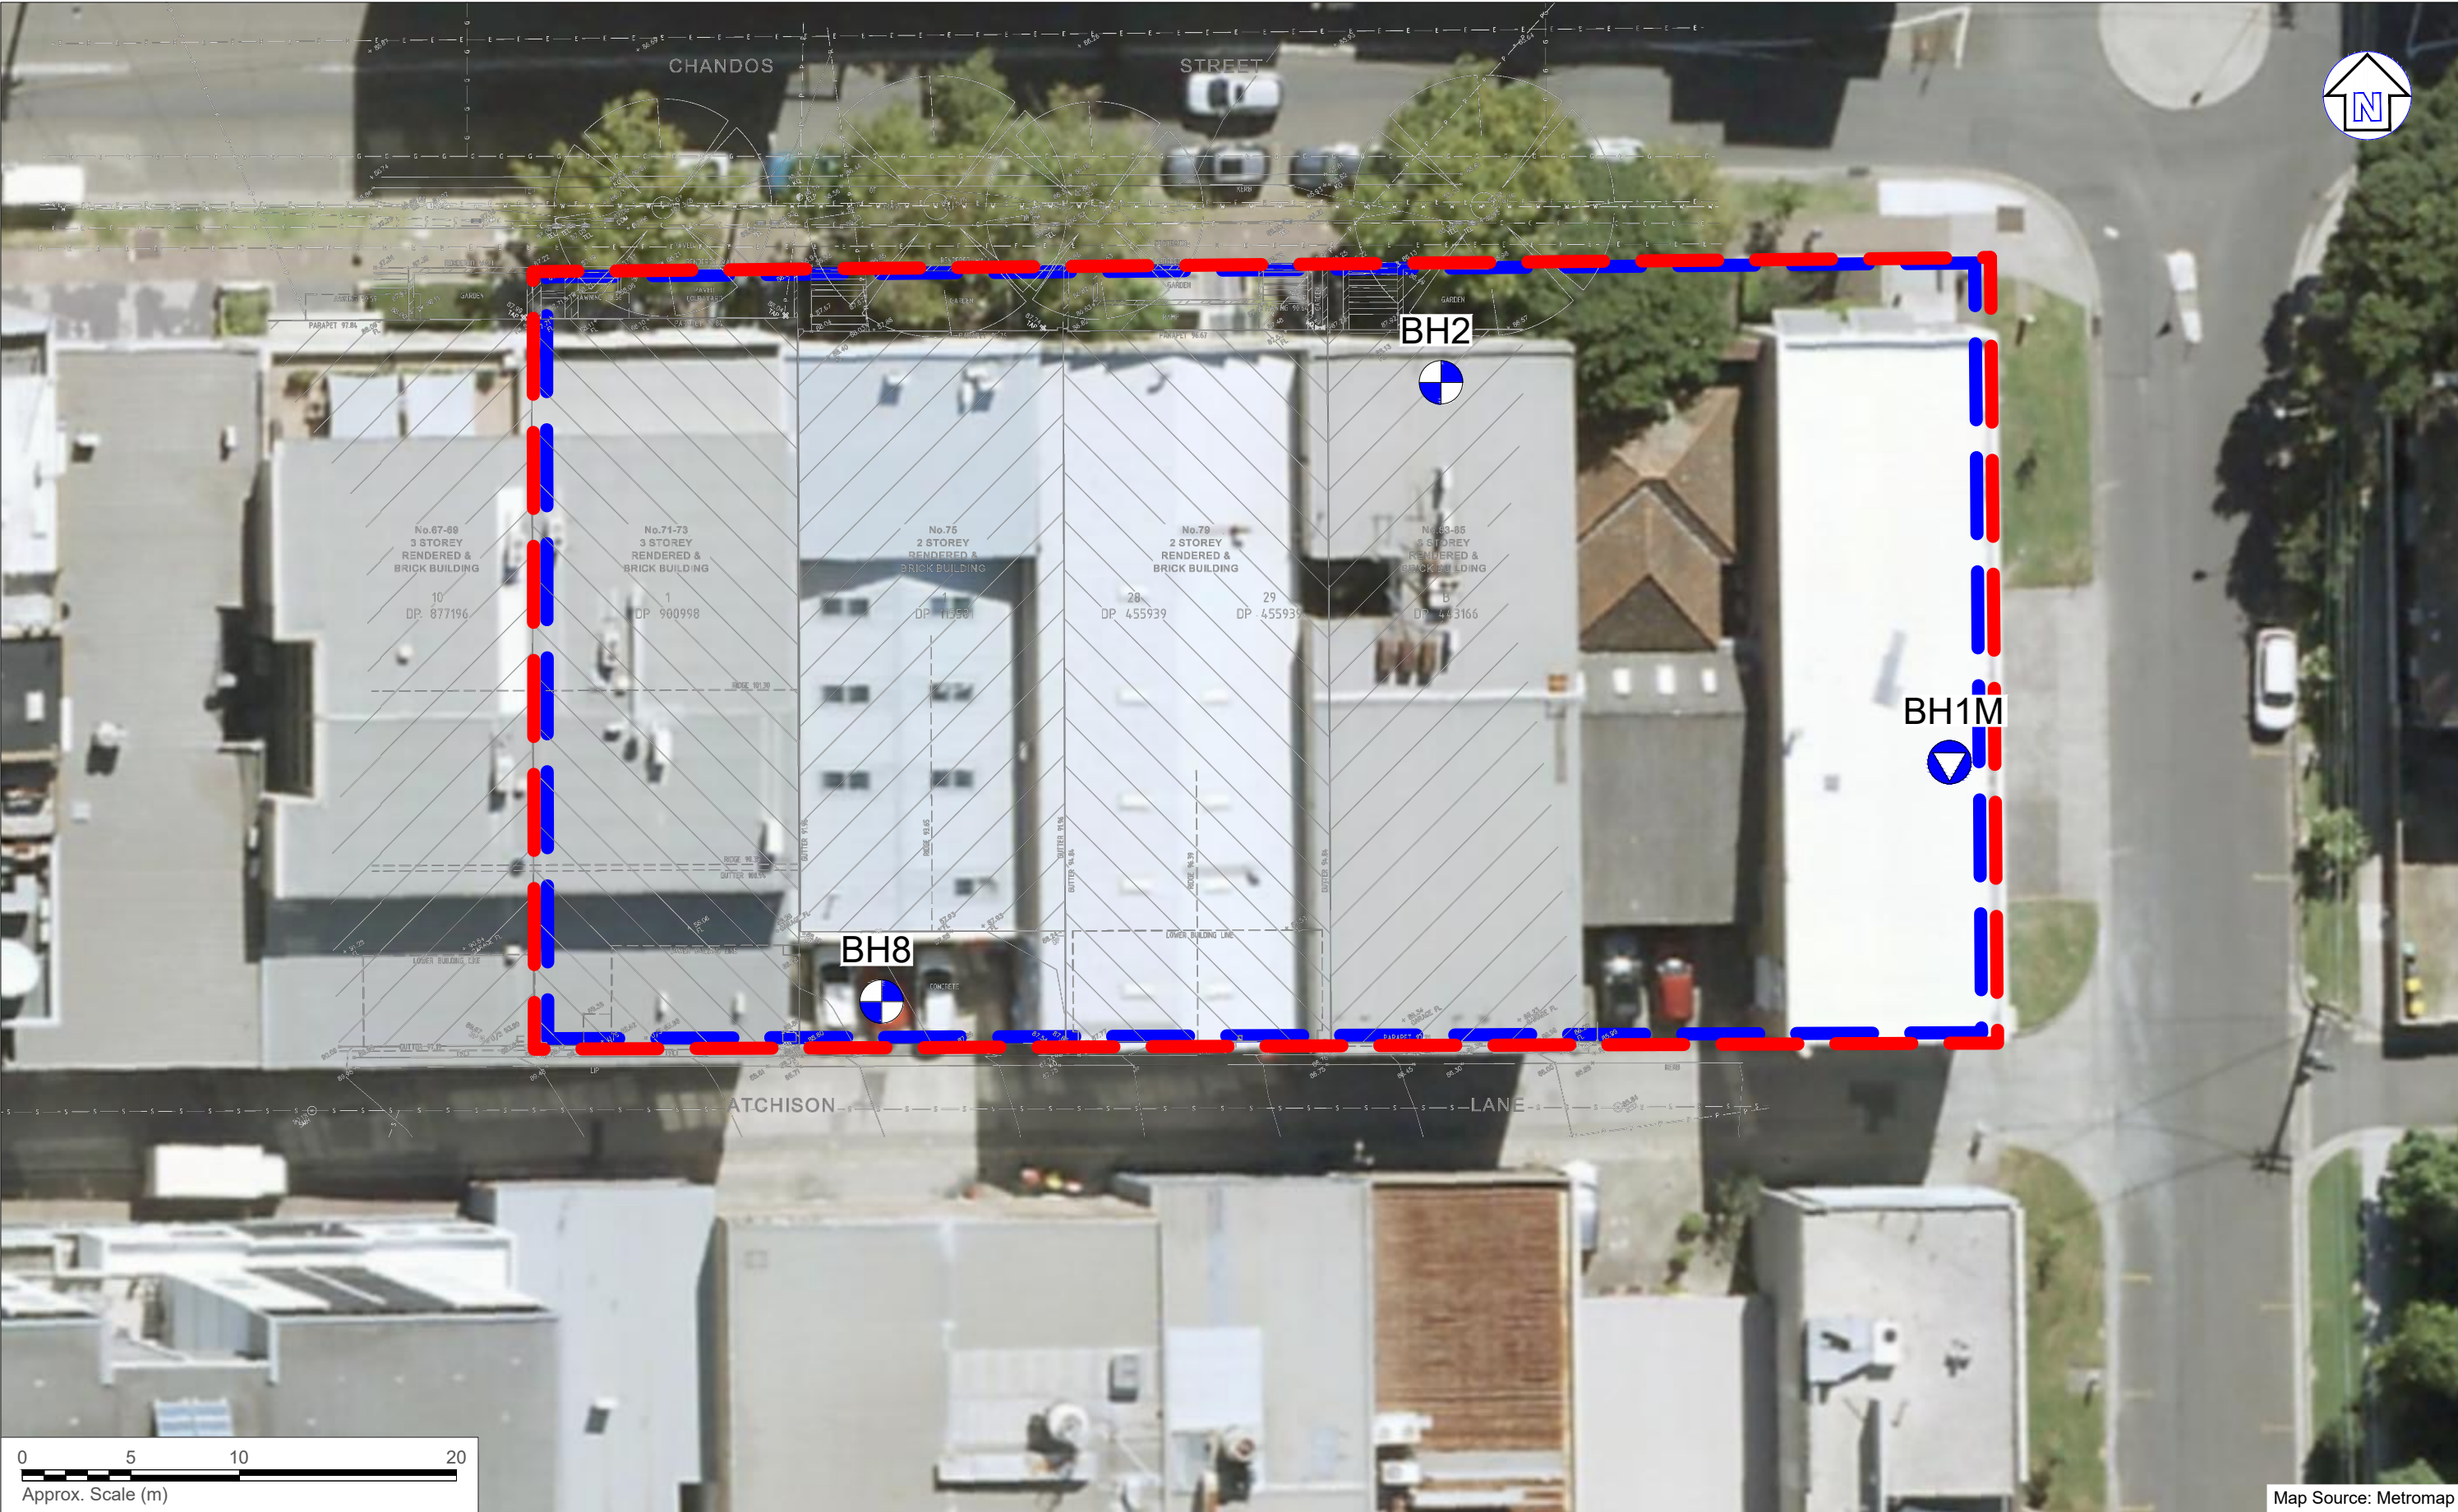
Figure 2 Borehole Location Plan

- Approximate site boundary
- Approximate basement boundary
- Approximate borehole/dcp location
- Approximate borehole/monitoring well location

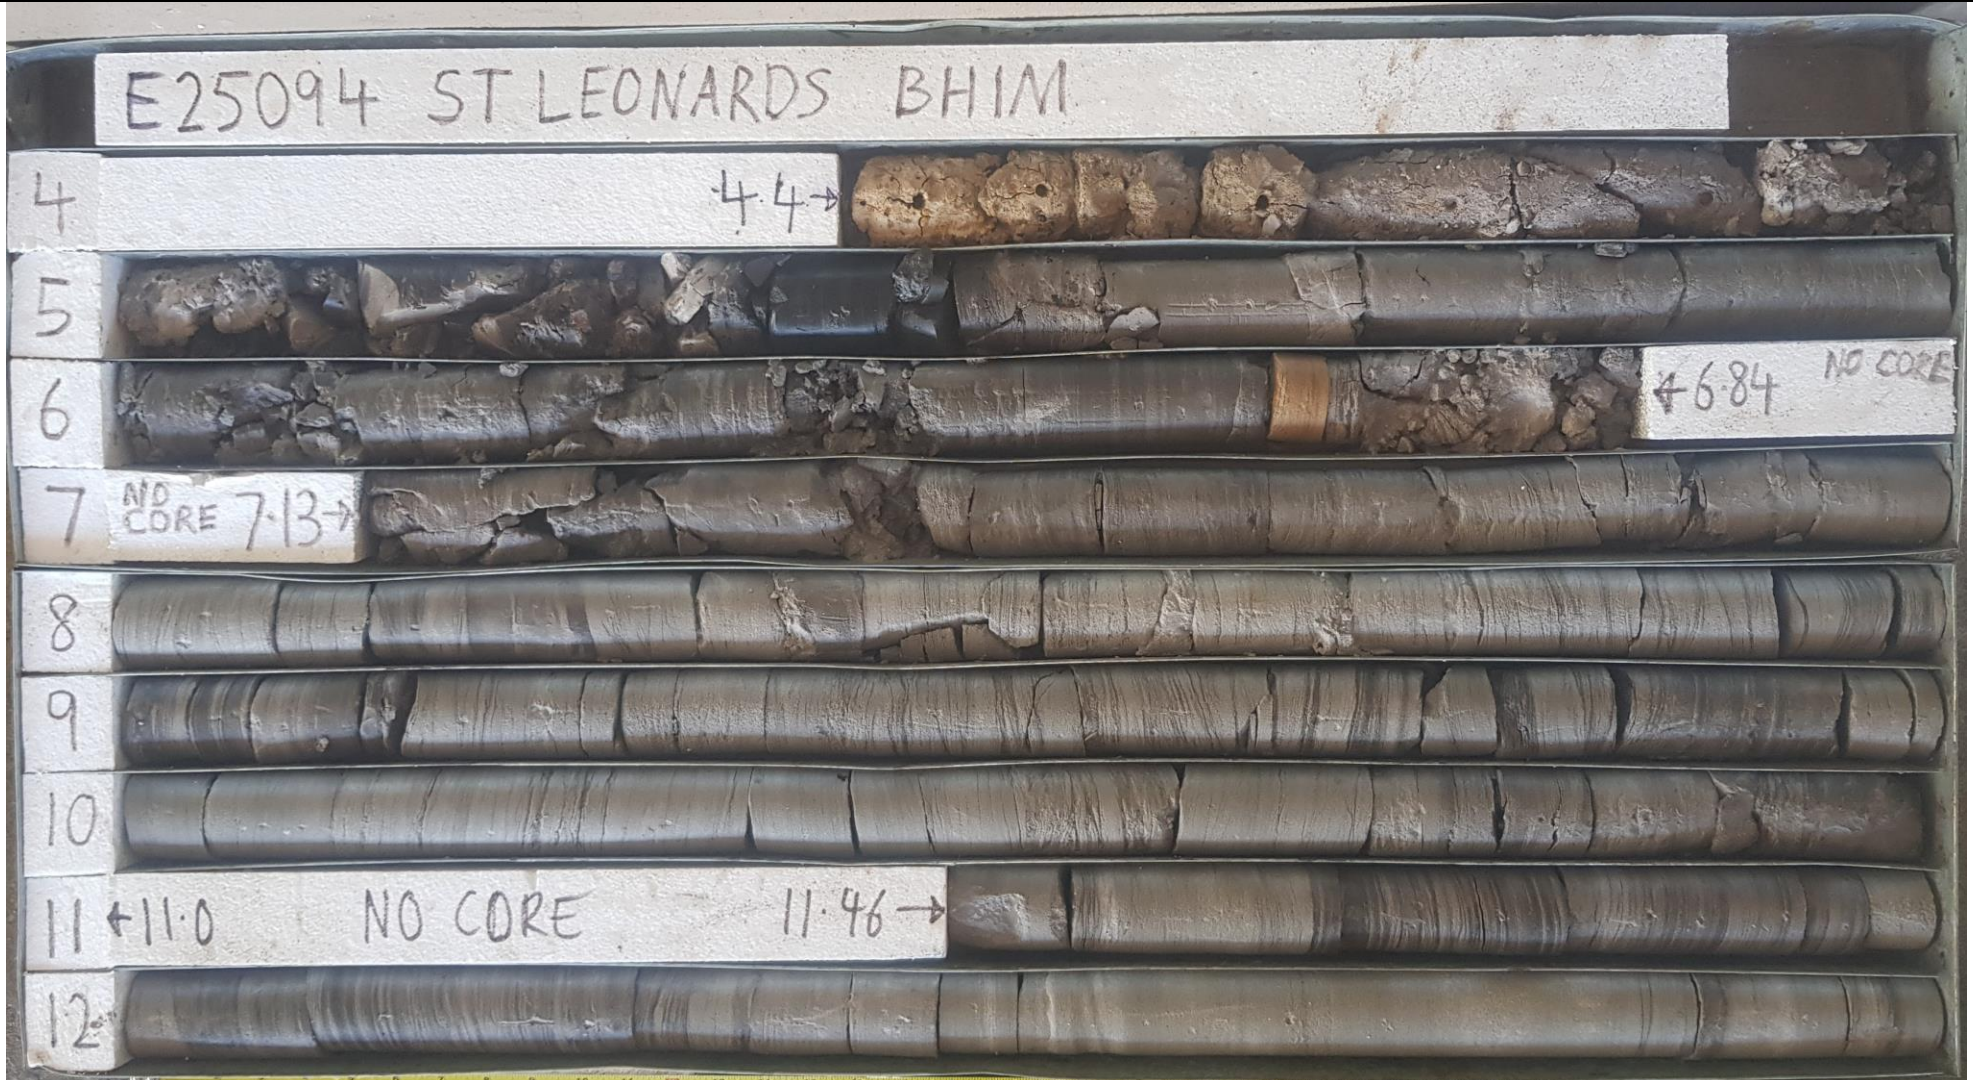
CORE PHOTOGRAPH OF BOREHOLE: BH1M

Project	Proposed Mixed-Use Development	Depth Range	4.4m to 13.0m BEGL	
Location	71-89 Chandos Street & 58-64 Atchison Street, St Leonards	Contractor	BG Drilling	
Position	See Figure 2	Drill Rig	Tight-Access Rig	
Job No.	E25094.G03	Logged	DS	Date 07 / 04 / 2021
Client	Alton Property Group Pty Ltd	Box	1-2 of 3	Checked SK Date 28 / 05 / 2021
		Surface RL	≈ 84.4m	
		Inclination	-90°

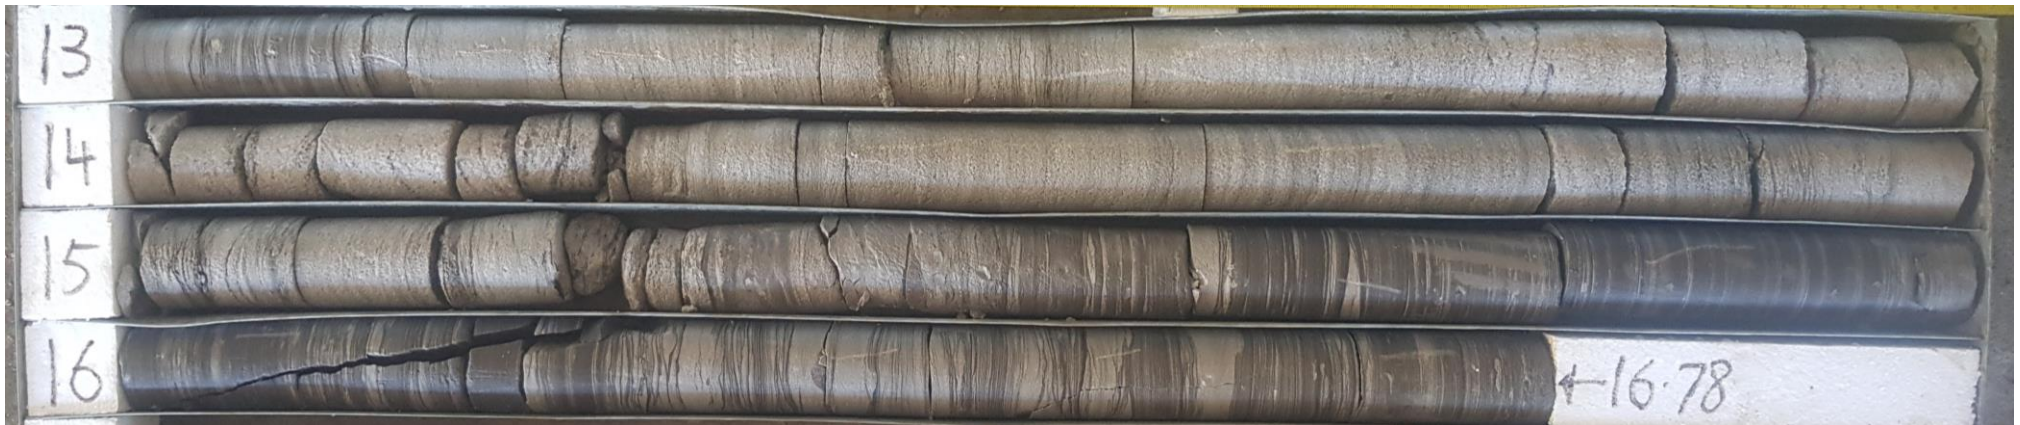
CORE PHOTOGRAPH OF BOREHOLE: BH1M

Project	Proposed Mixed-Use Development	Depth Range	13.0m to 16.78m BEGL	
Location	71-89 Chandos Street & 58-64 Atchison Street, St Leonards	Contractor	BG Drilling	
Position	See Figure 2	Drill Rig	Tight-Access Rig	
Job No.	E25094.G03	Logged	DS	Date 08 / 04 / 2021
Client	Alton Property Group Pty Ltd	Inclination	-90°	Date 28 / 05 / 2021
		Box	3 of 3

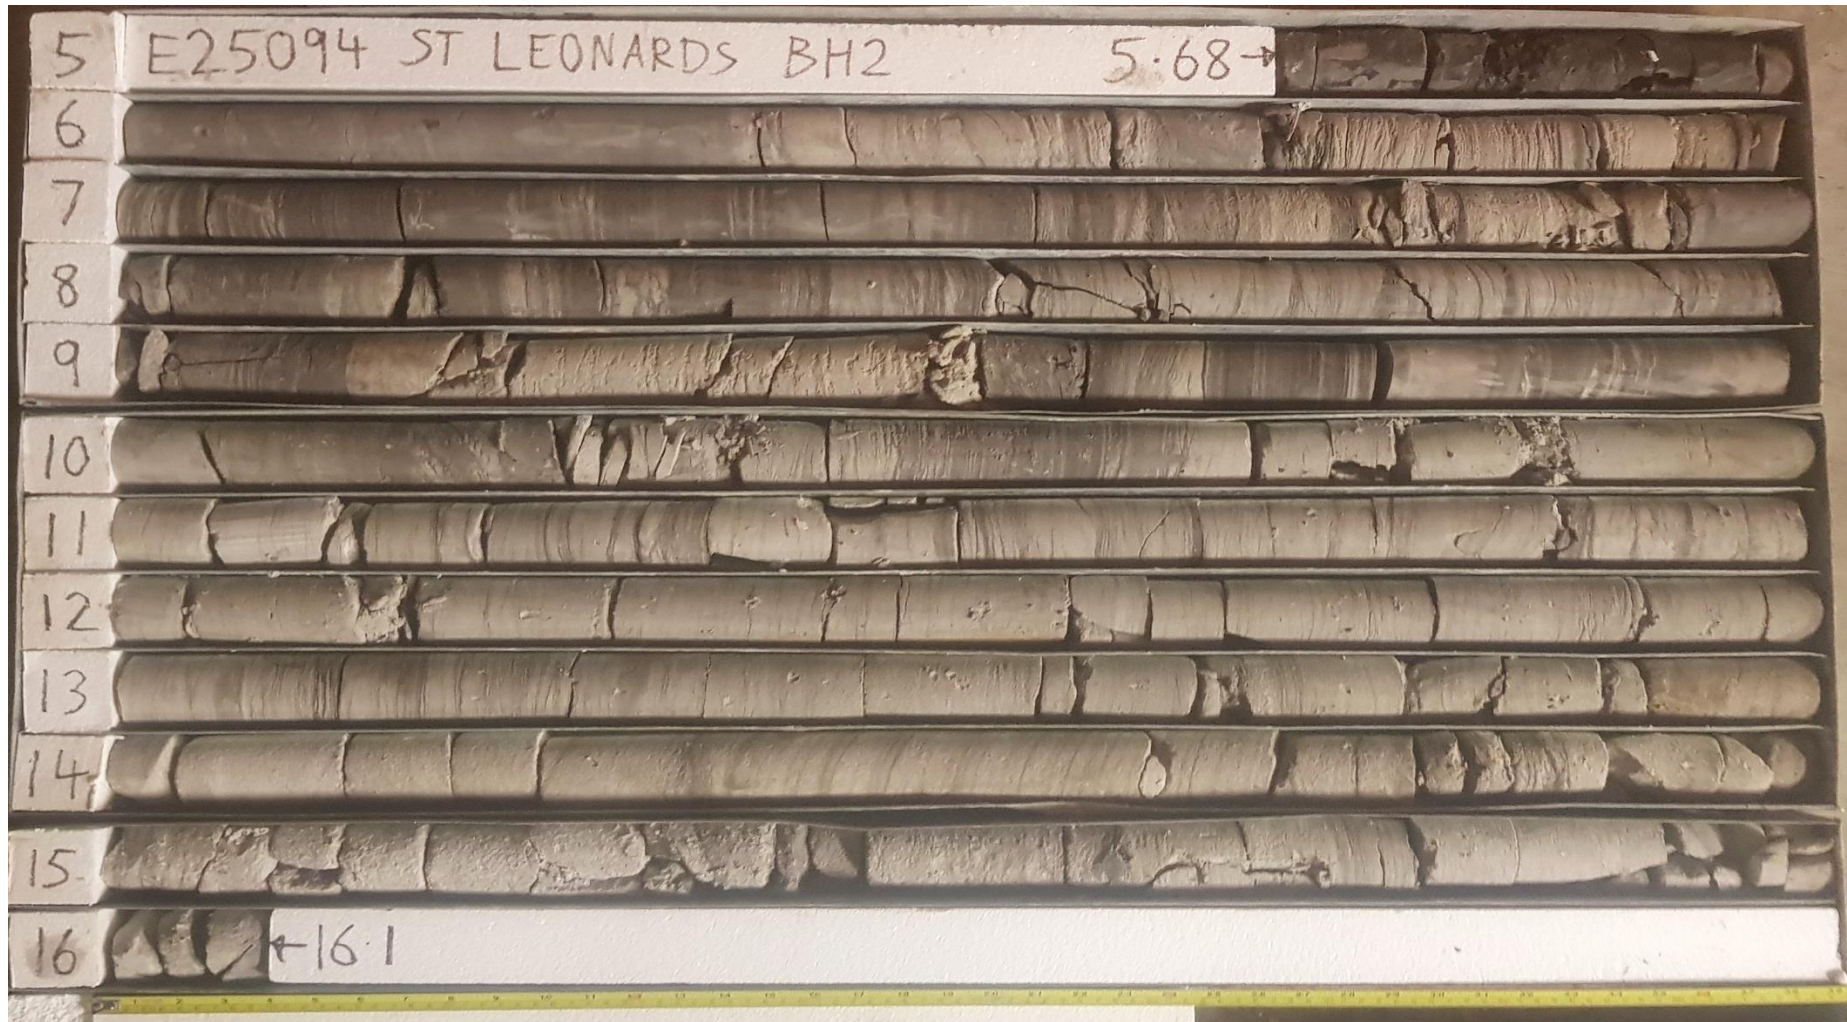
CORE PHOTOGRAPH OF BOREHOLE: BH2

Project	Proposed Mixed-Use Development	Depth Range	5.68m to 16.1m BEGL	
Location	71-89 Chandos Street & 58-64 Atchison Street, St Leonards	Contractor	BG Drilling	
Position	See Figure 2	Drill Rig	Tight-Access Rig	
Job No.	E25094.G03	Logged	DS	Date 09 / 04 / 2021
Client	Alton Property Group Pty Ltd	Box	1-3 of 3	Checked SK Date 28 / 05 / 2021
		Surface RL	≈ 85.6m	
		Inclination	-90°

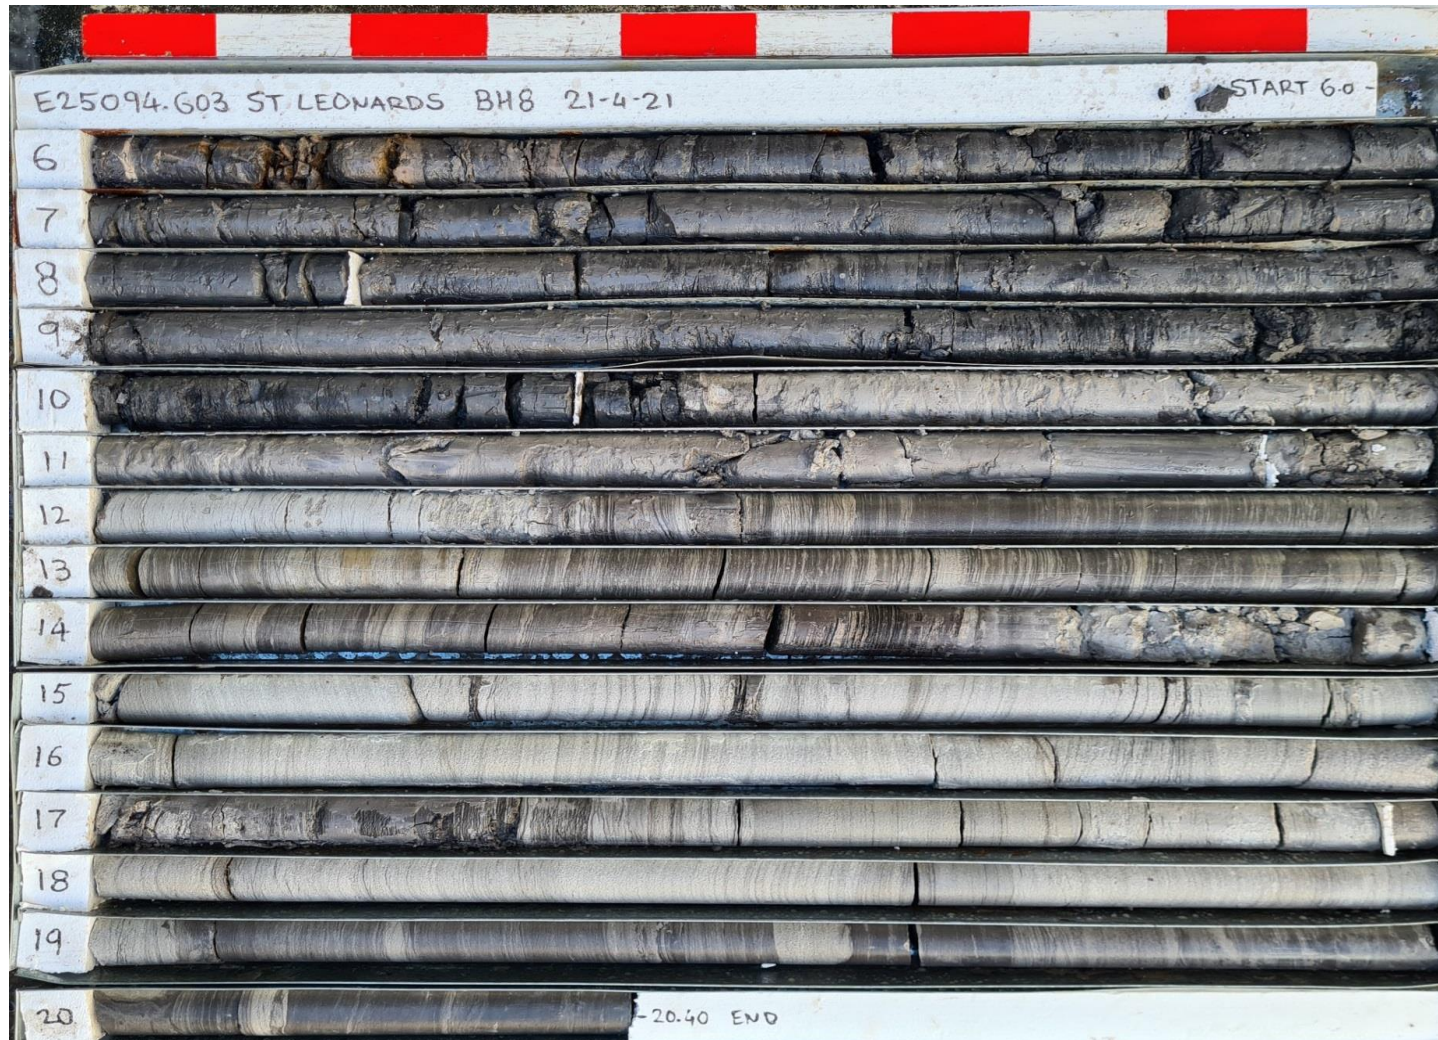
CORE PHOTOGRAPH OF BOREHOLE: BH8

Project	Proposed Mixed-Use Development	Depth Range	6.0m to 20.4m BEGL	
Location	71-89 Chandos Street & 58-64 Atchison Street, St Leonards	Contractor	Geosense Drilling	
Position	See Figure 2	Drill Rig	Hanjin DB8	
Job No.	E25094.G03	Logged	BY	Date 22 / 04 / 2021
Client	Alton Property Group Pty Ltd	Box	1-4 of 4	Checked SK Date 28 / 05 / 2021
		Surface RL	≈ 87.90m	
		Inclination	-90°

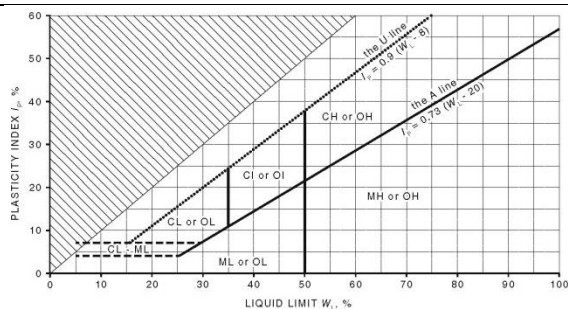
PLASTICITY PROPERTIES

Moisture content of cohesive soils shall be described in relation to plastic limit (PL) or liquid limit (LL) for soils with higher moisture content as follows: Moist, dry of plastic limit ($w < PL$); Moist, near plastic limit ($w \approx PL$); Moist, wet of plastic limit ($w < PL$); Wet, near liquid limit ($w \approx LL$); Wet, wet of liquid limit ($w > LL$).
