Preliminary Acid Sulfate Soil Assessment at 28 and 35 Sugarmill Road, Sapphire Beach

3 November 2021

For: Mr Keiran Grimley and Dr Ian Martyn

Ref	Ver	Date	Distribution
2021-165-04	A	3/11/21	Client, Planner

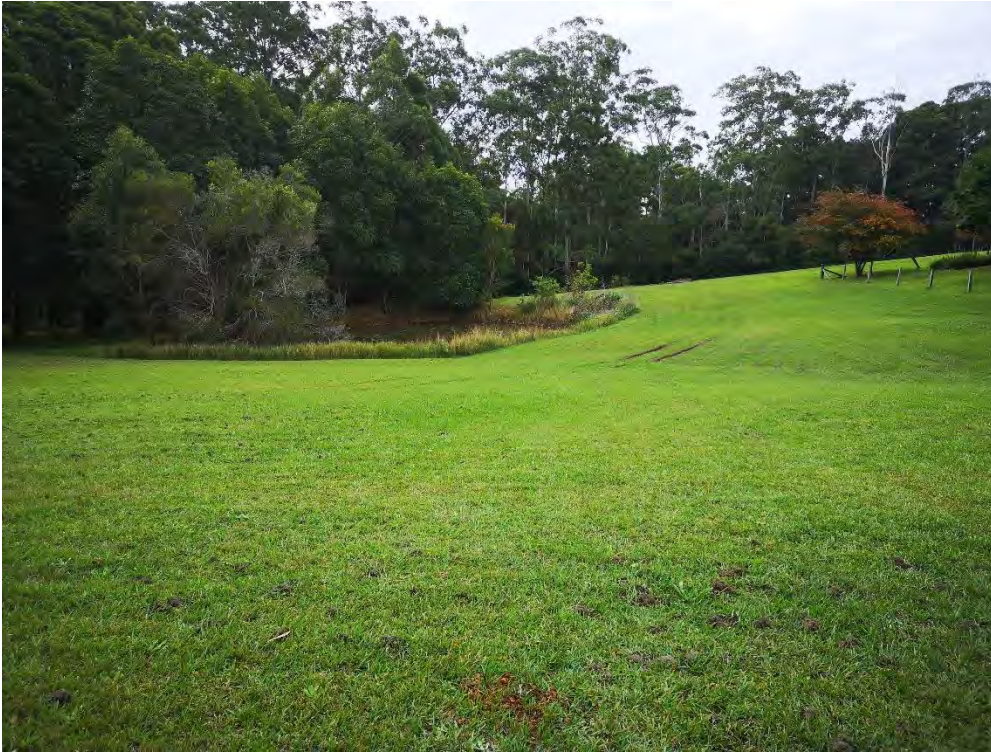
Photograph 1 No. 28-
Looking north across the
proposed Lot 121
building envelope.

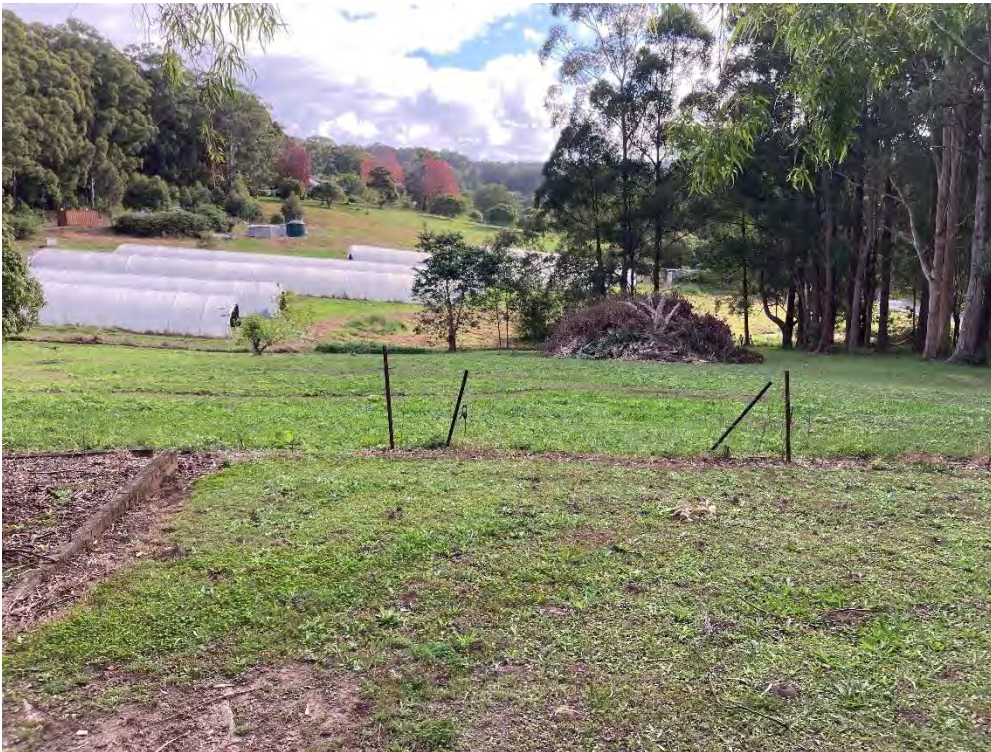
Photograph 2 No. 35 -
Looking west across
proposed Lot 911 with
an existing vegetation
patch downslope of the
of the proposed building
envelope.

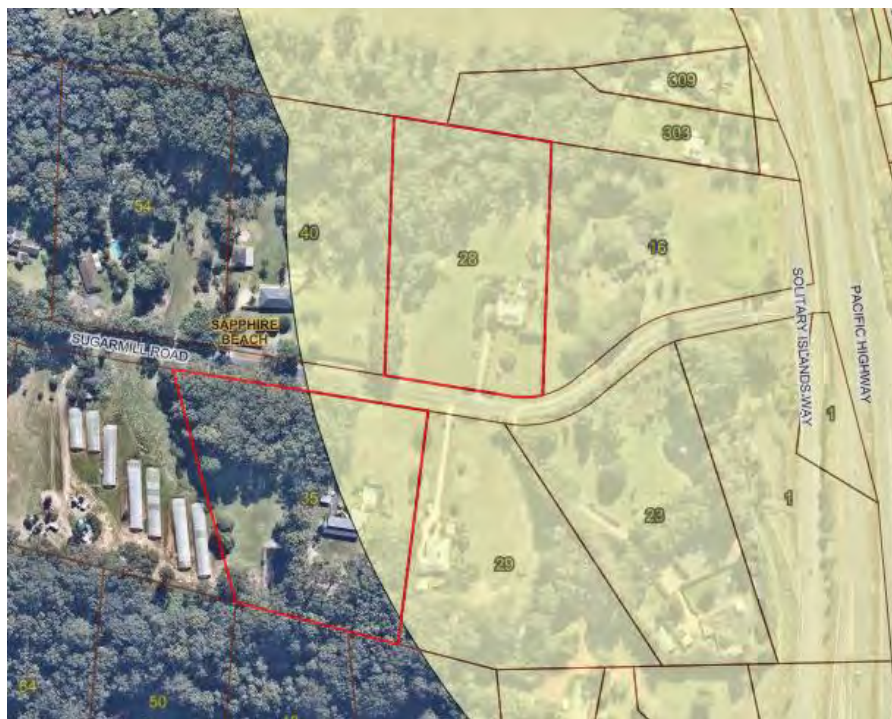
Photograph 4. Mapped ASS risk and subject properties location (pink).

Coffs Harbour City Council Local Environmental Plan (LEP, 2013) and Coffs Harbour City Council Planning and Environment Spatial Maps- ASS layers that are derived from the published ASS risk mapping, indicates that the Site is underlain by mapped “Class 5” ASS risk. No.28 is completely underlain and No. 35 is partially underlain.

Class 5 denotes areas where acid sulfate soils are not typically found but is a 500m wide buffer zone created around mapped ASS risk soils. As such, a low probability of ASS exists at the Site and the PASS investigation is precautionary only.

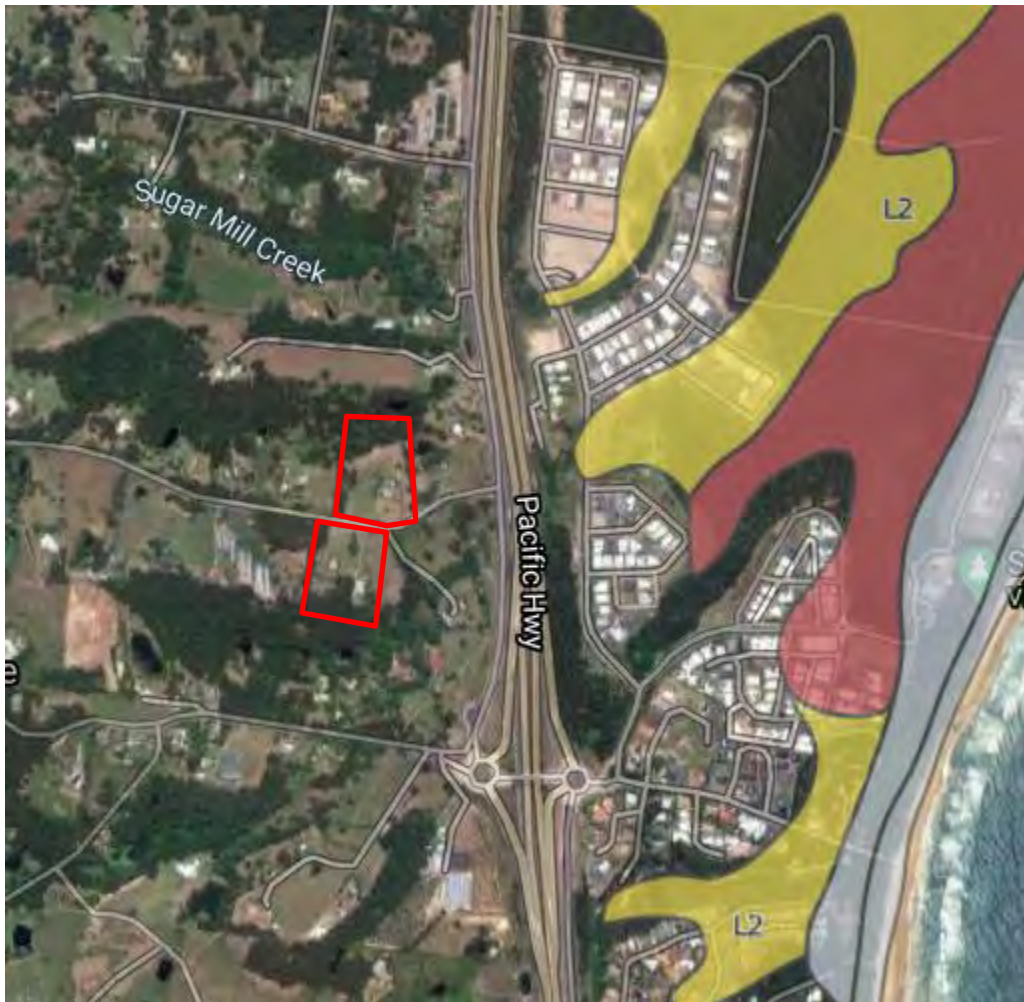
Photograph 5.

Published ASS probability mapping. Subject property's locations red outline.

Mapped ASS probability mapping provided on eSpade 2.1m indicates that mapped low and high probably ASS soils are present east of the Pacific Highway only. The high probably pf ASS is at <1m below the groundsurface and low probability at 1-3m below the groundsurface.

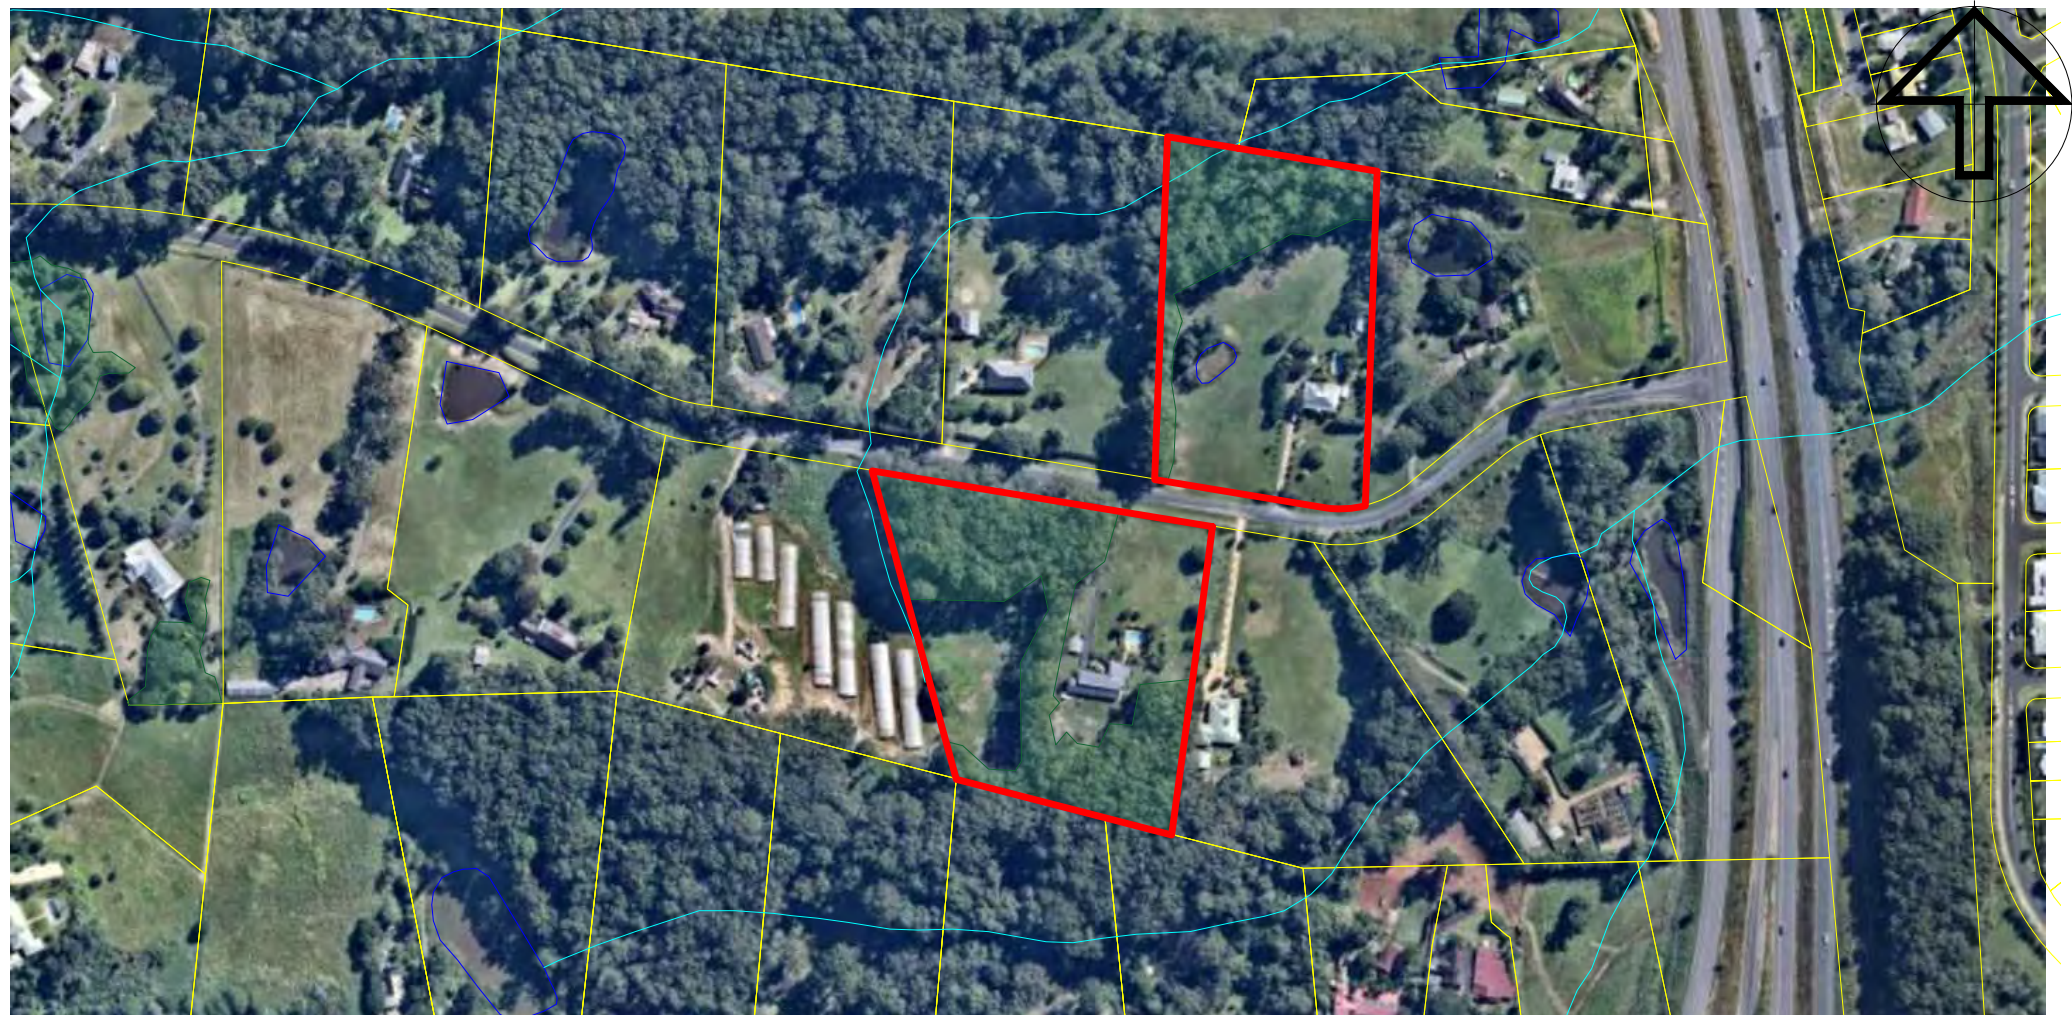
Appendix 10 - Preliminary Acid Sulphate Soils Assessment

Site soils were observed by drilling three (3) boreholes (BH1-BH3) to a maximum depth of 1.2m using a powered auger. The location of the boreholes are shown in Figure 2 and a copy of the borehole logs are presented in Appendix A.
