# Preliminary Site Investigation Report

Project  
**Proposed Site Rezoning**  
**130 Killeaton Street, St Ives NSW**

Report No  
**14772-ER-1-1**

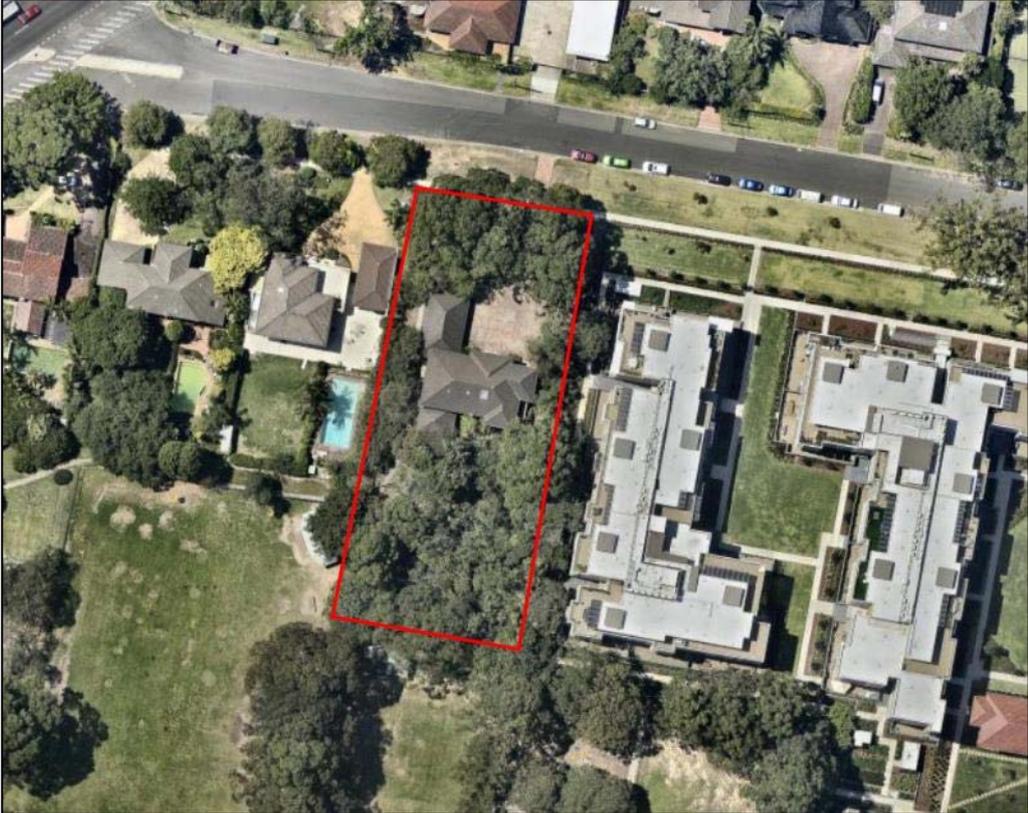
Image 5.2.7 Aerial Photograph - 2014

2014	No significant change since previous image.	A large commercial precinct has been constructed to the immediate east of the site.
2021	No significant change since previous image.	Low density residential dwellings have been demolished to the west of the site, and have been replaced by a multi-storey residential structure.

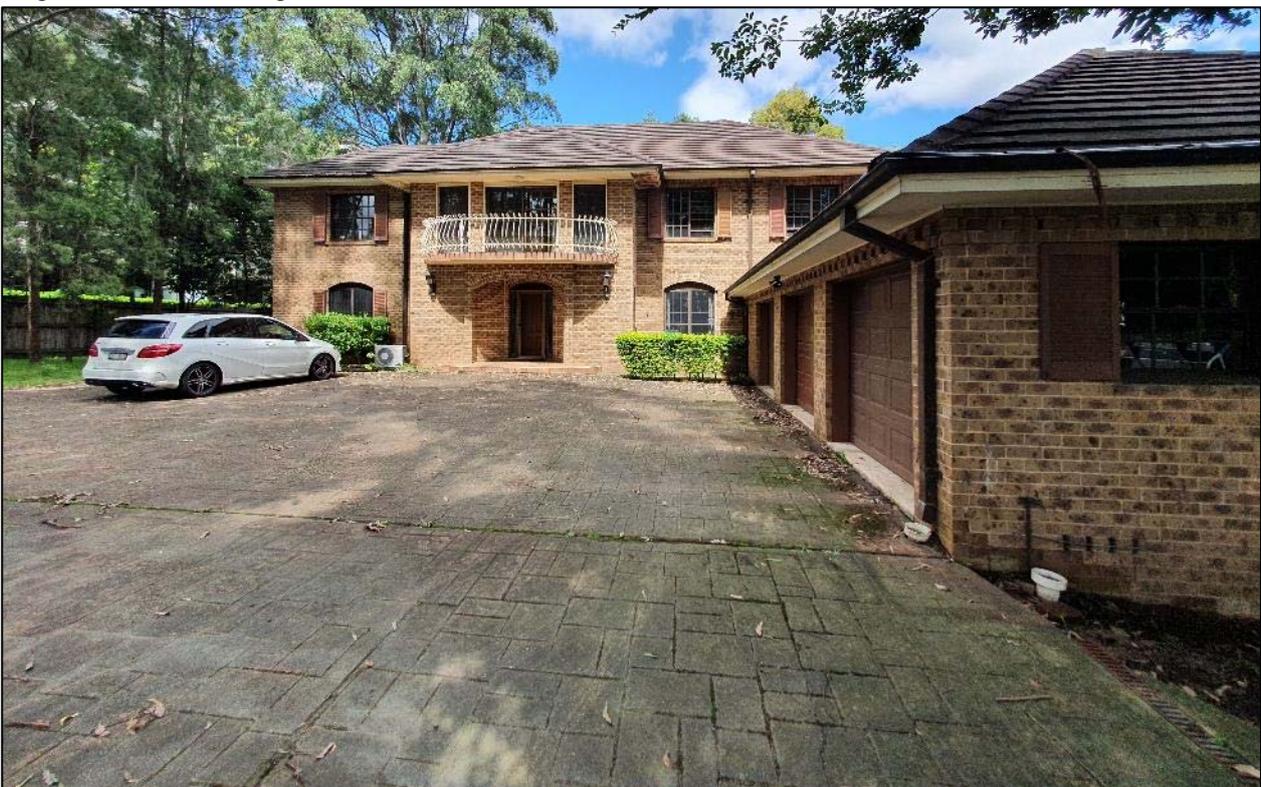
Image 6.1.1 View of dwelling in centre of site

The land use scenario at the time of the walkover appeared to be low-density residential, comprising a dwelling in the centre of the site, surrounded by trees.

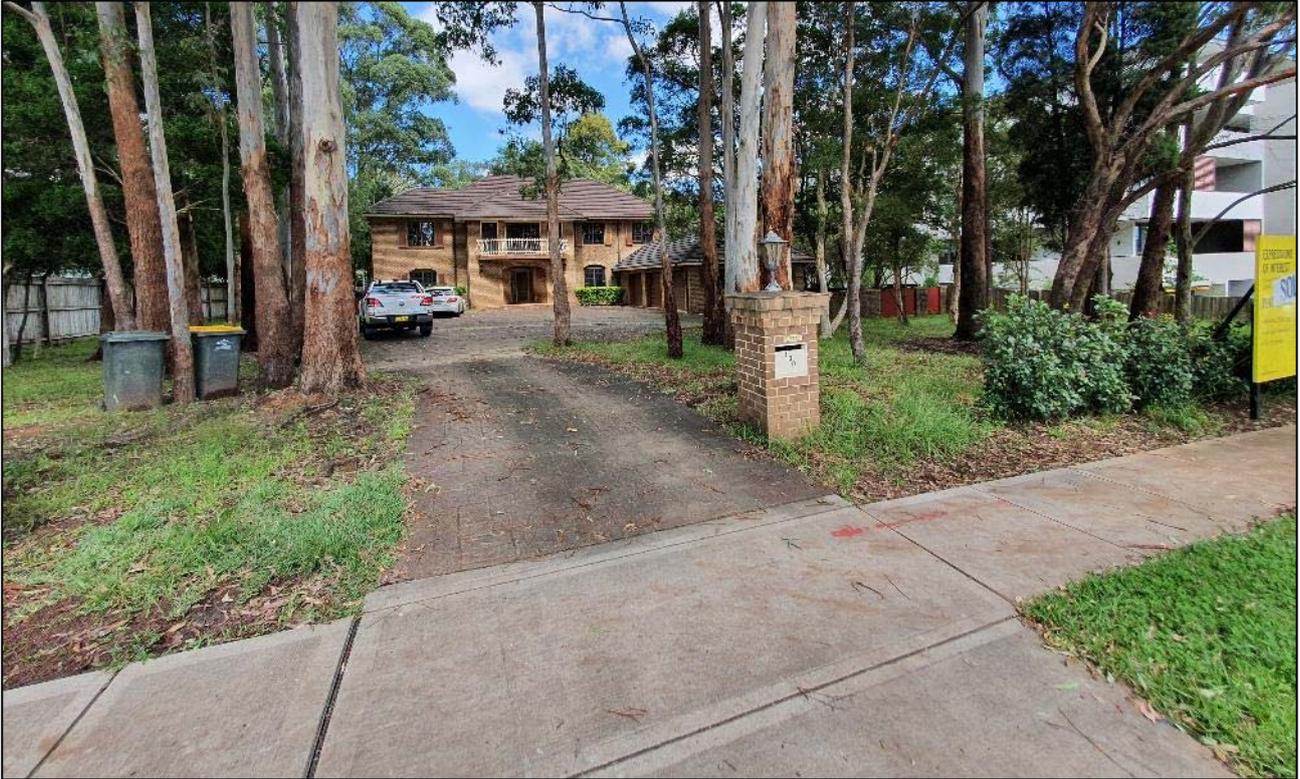
Image 6.2.1 View of frontage, facing south

The western, eastern and southern site boundaries were fenced, with the exception of a walkway through to Mona Vale Road on the western boundary. The northern boundary was not fenced.

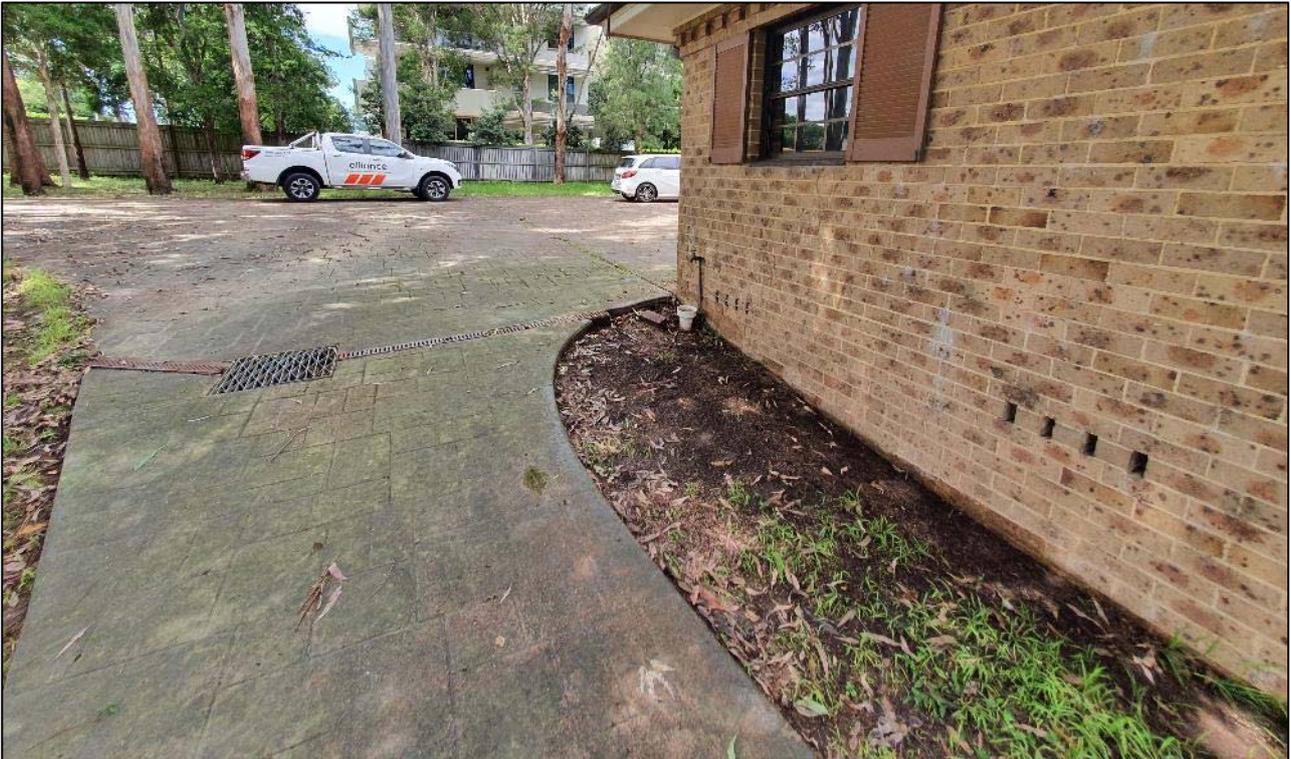
Image 6.3.1 View of concrete driveway

- The central northern portion of the site was covered by a concrete pavement driveway, that was in fair condition, with some cracking observed.
- The curtilage of the site on the western, eastern and southern boundaries was unsealed and vegetated with grass and established large trees.

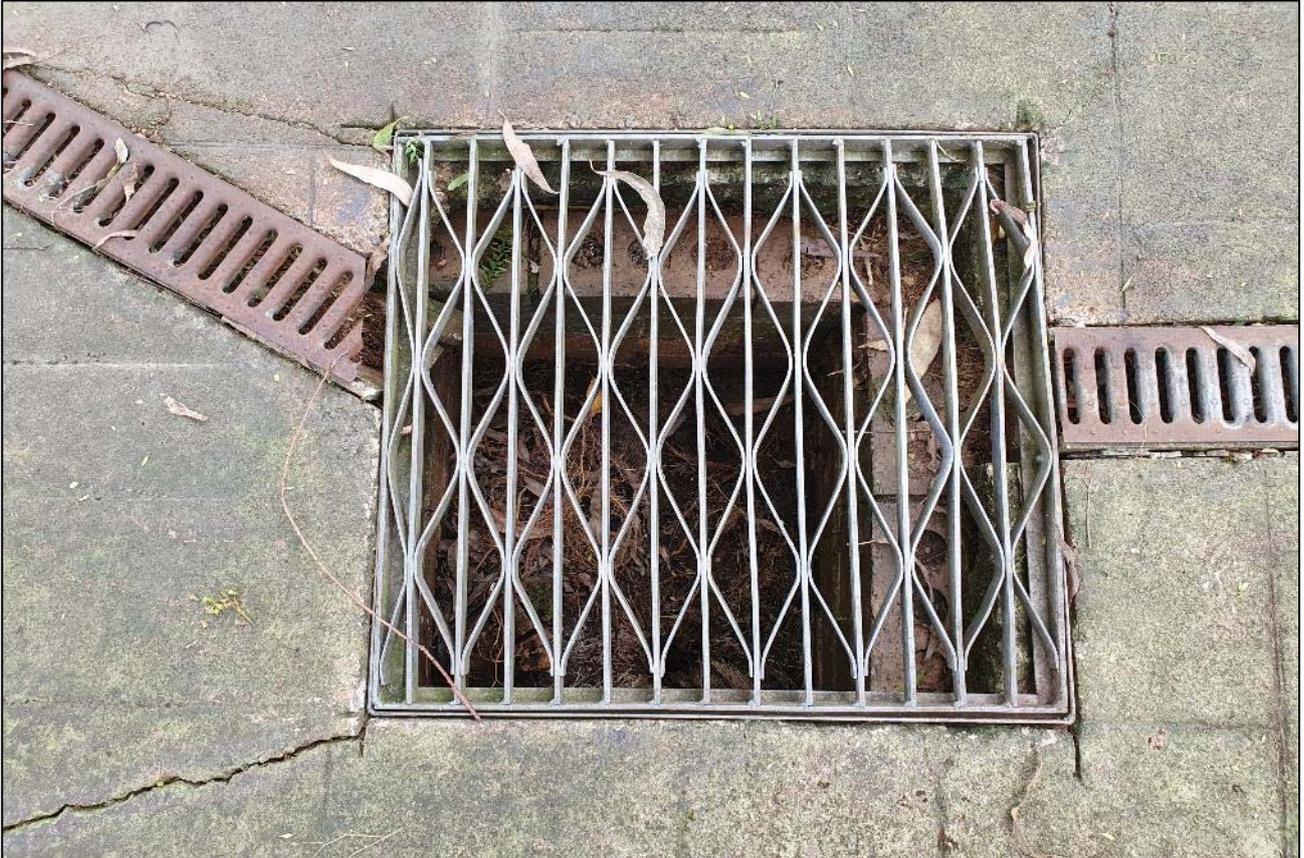
Image 6.4.1 View of the drainage pit

- Concrete entry / exit driveway adjacent to the northern boundary, with a surface water strip drains at the entrance, draining to a concrete lined pit in the north western corner of the site;

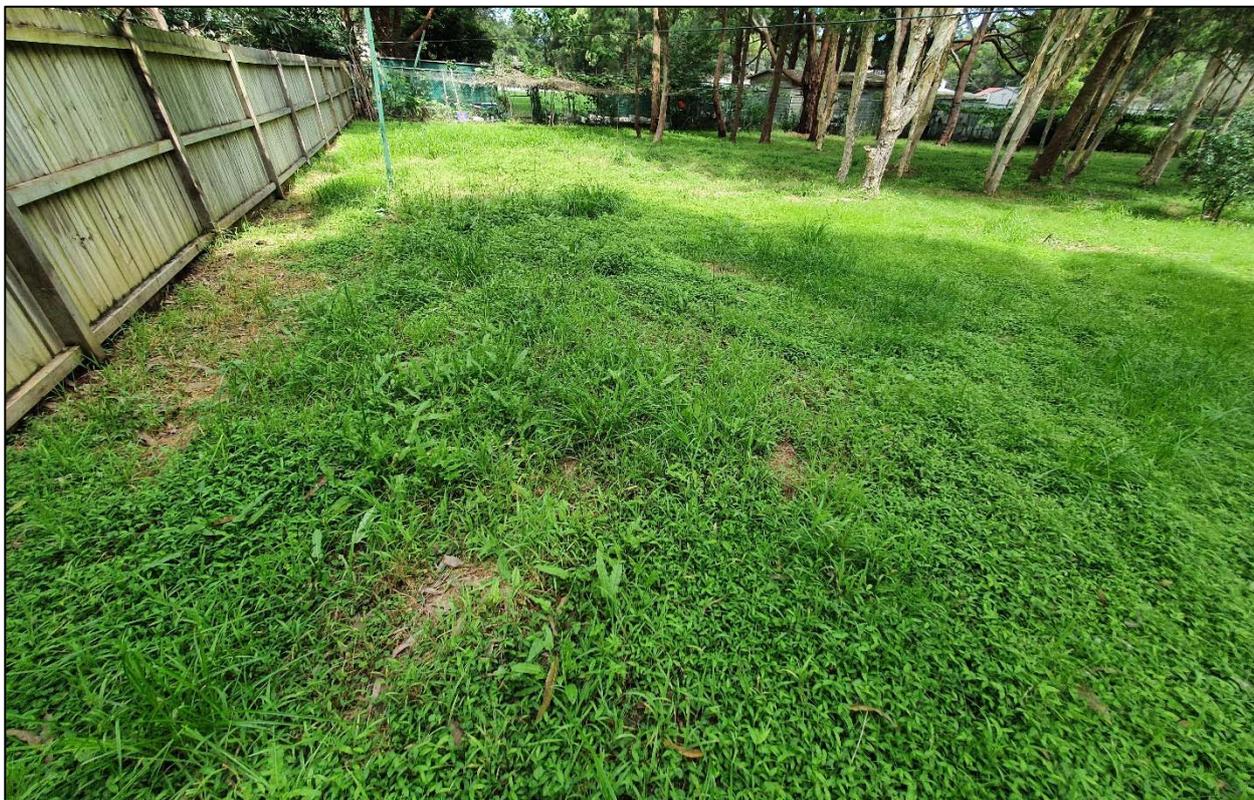
Image 6.11.1 View of undulating rear yard

There was no visual evidence observed to suggest widespread or significant filling observed at the site, with the exception of the rear yard, which appeared to undulate in and around the trees, where is likely that fill material exists.

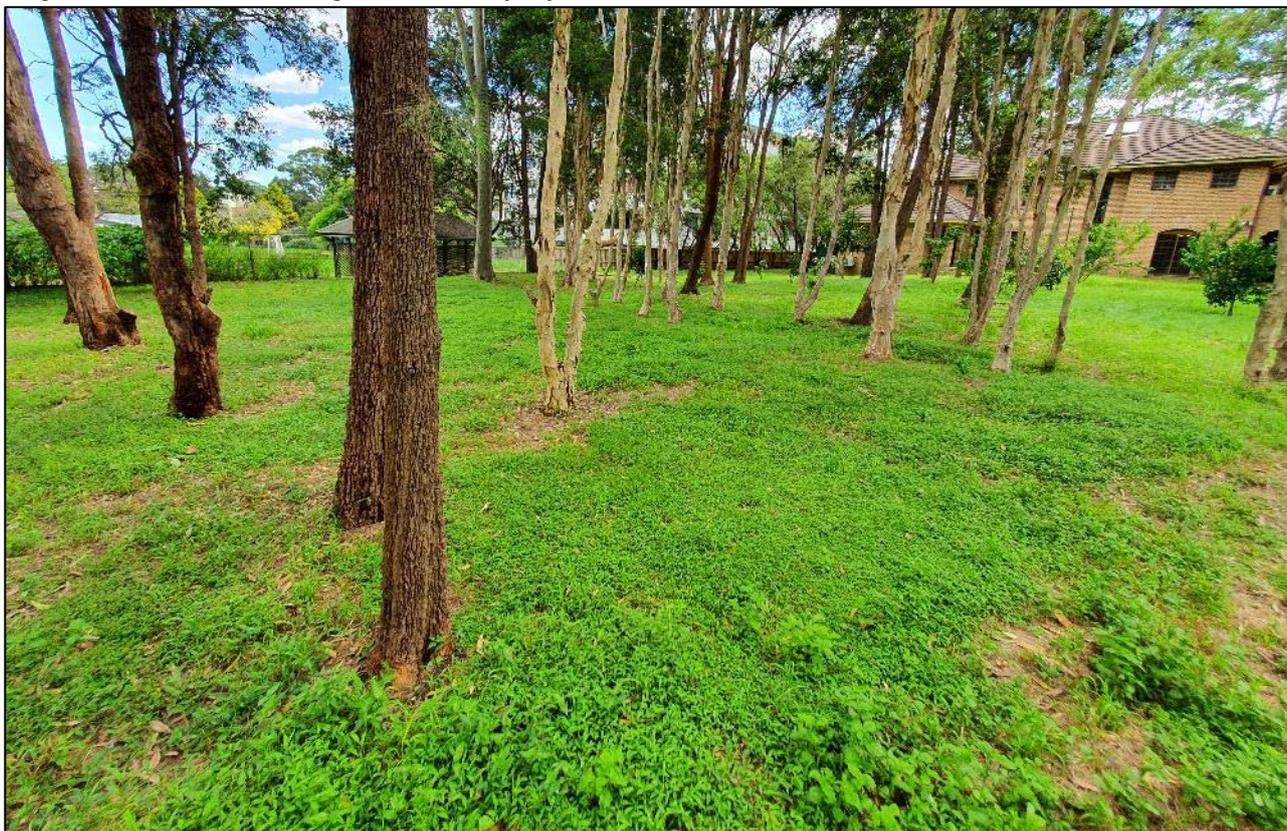
Image 6.13.1 View of tree coverage across the majority of the site

There was no visual evidence observed to suggest widespread or significant phytotoxic impact in the form of plant stress and/or dieback in vegetation present on the site. Similar observations were made of vegetation on land immediately beyond the site boundaries.

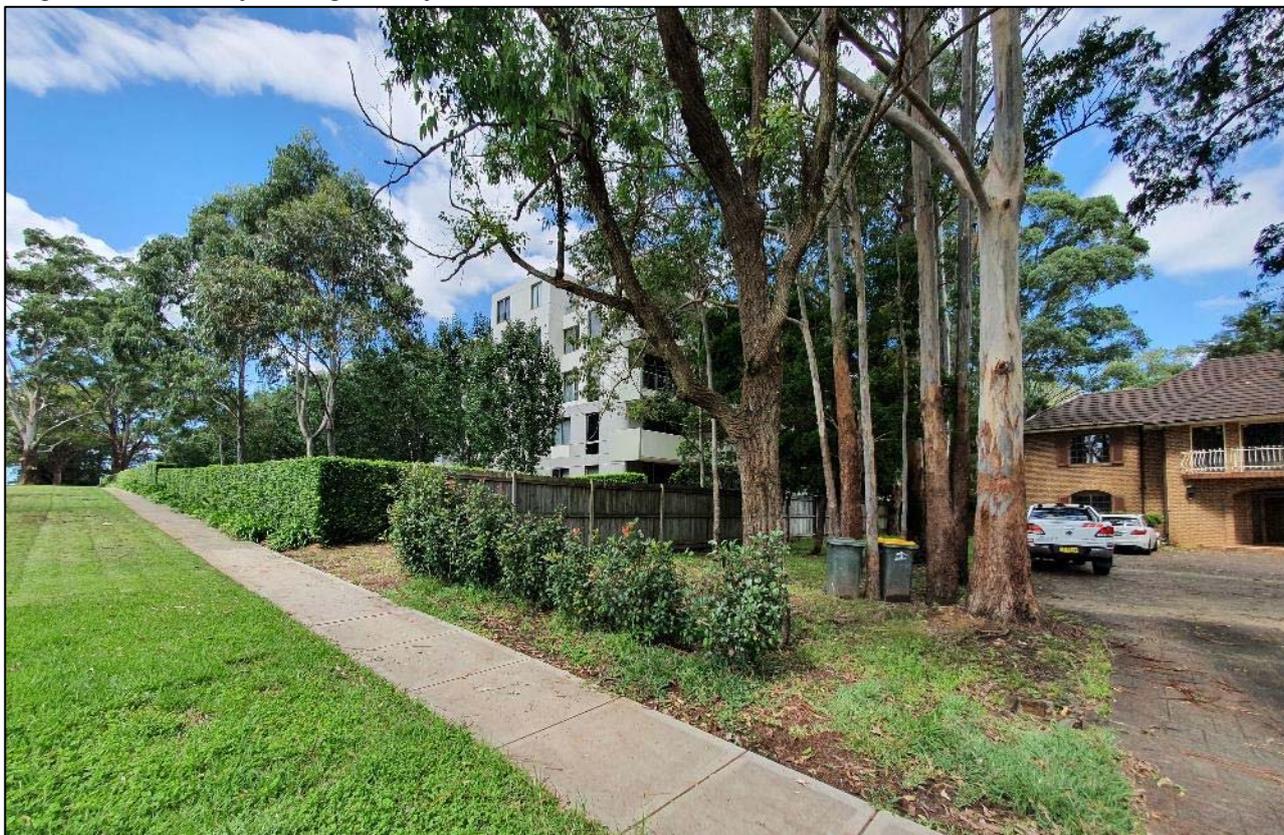
Image 6.14.1 View of adjacent high density residential land use to the east

- North – Killeaton Road, with low density residential beyond;
- East – high density residential;
- West – high density residential and school oval; and
- South – Catholic Primary School.
