STAGE 1 AND STAGE 2 ENVIRONMENTAL SITE ASSESSMENT

307 - 311 Bexley Road & 88 - 96 New Illawarra Road, Bexley North NSW

> PREPARED FOR TONY SOUEID REPORT ID: E16016BN-R03F

Date: 1st November 2017 Revision No.: 0.2

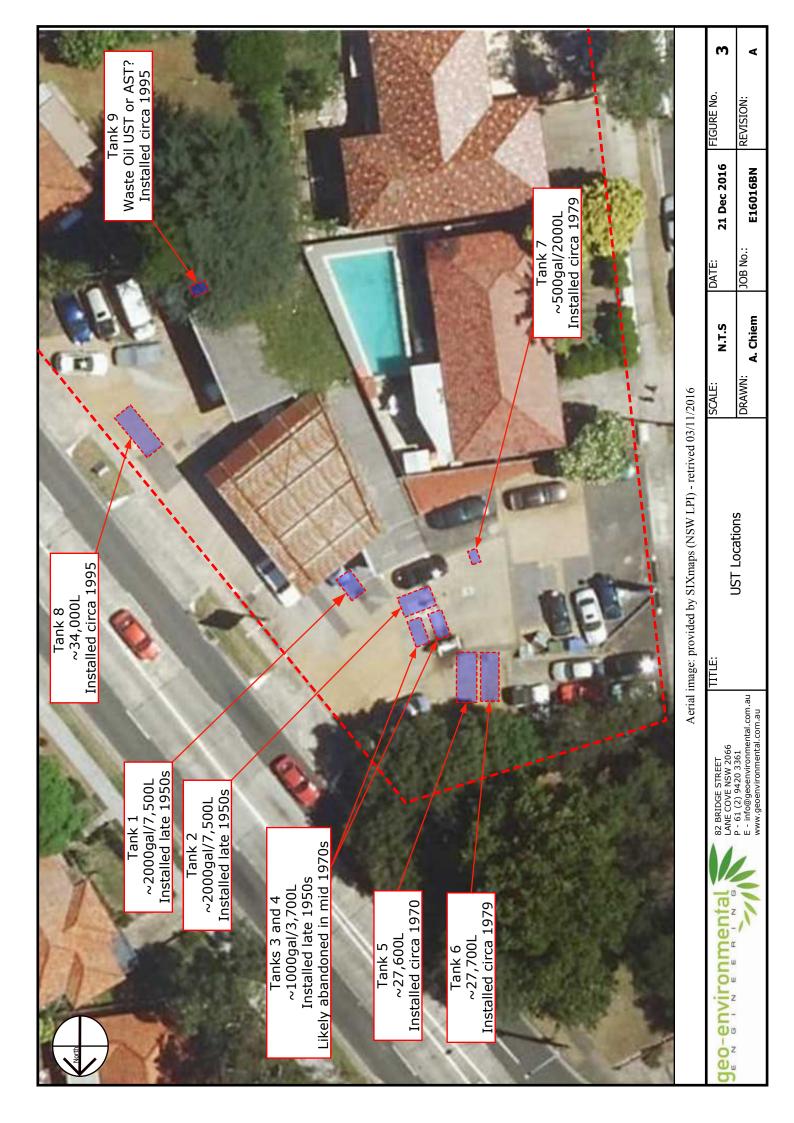
1 – Site Location Map
 2 – Site Plan
 3 – UST Locations

The USTs and any associated infrastructure has the potential to cause significant soil and groundwater contamination if leakage occurs. There is also the potential
