# Remediation Action Plan

445-459 Canterbury Road, Campsie  
NSW

NE30028

13 May 2021

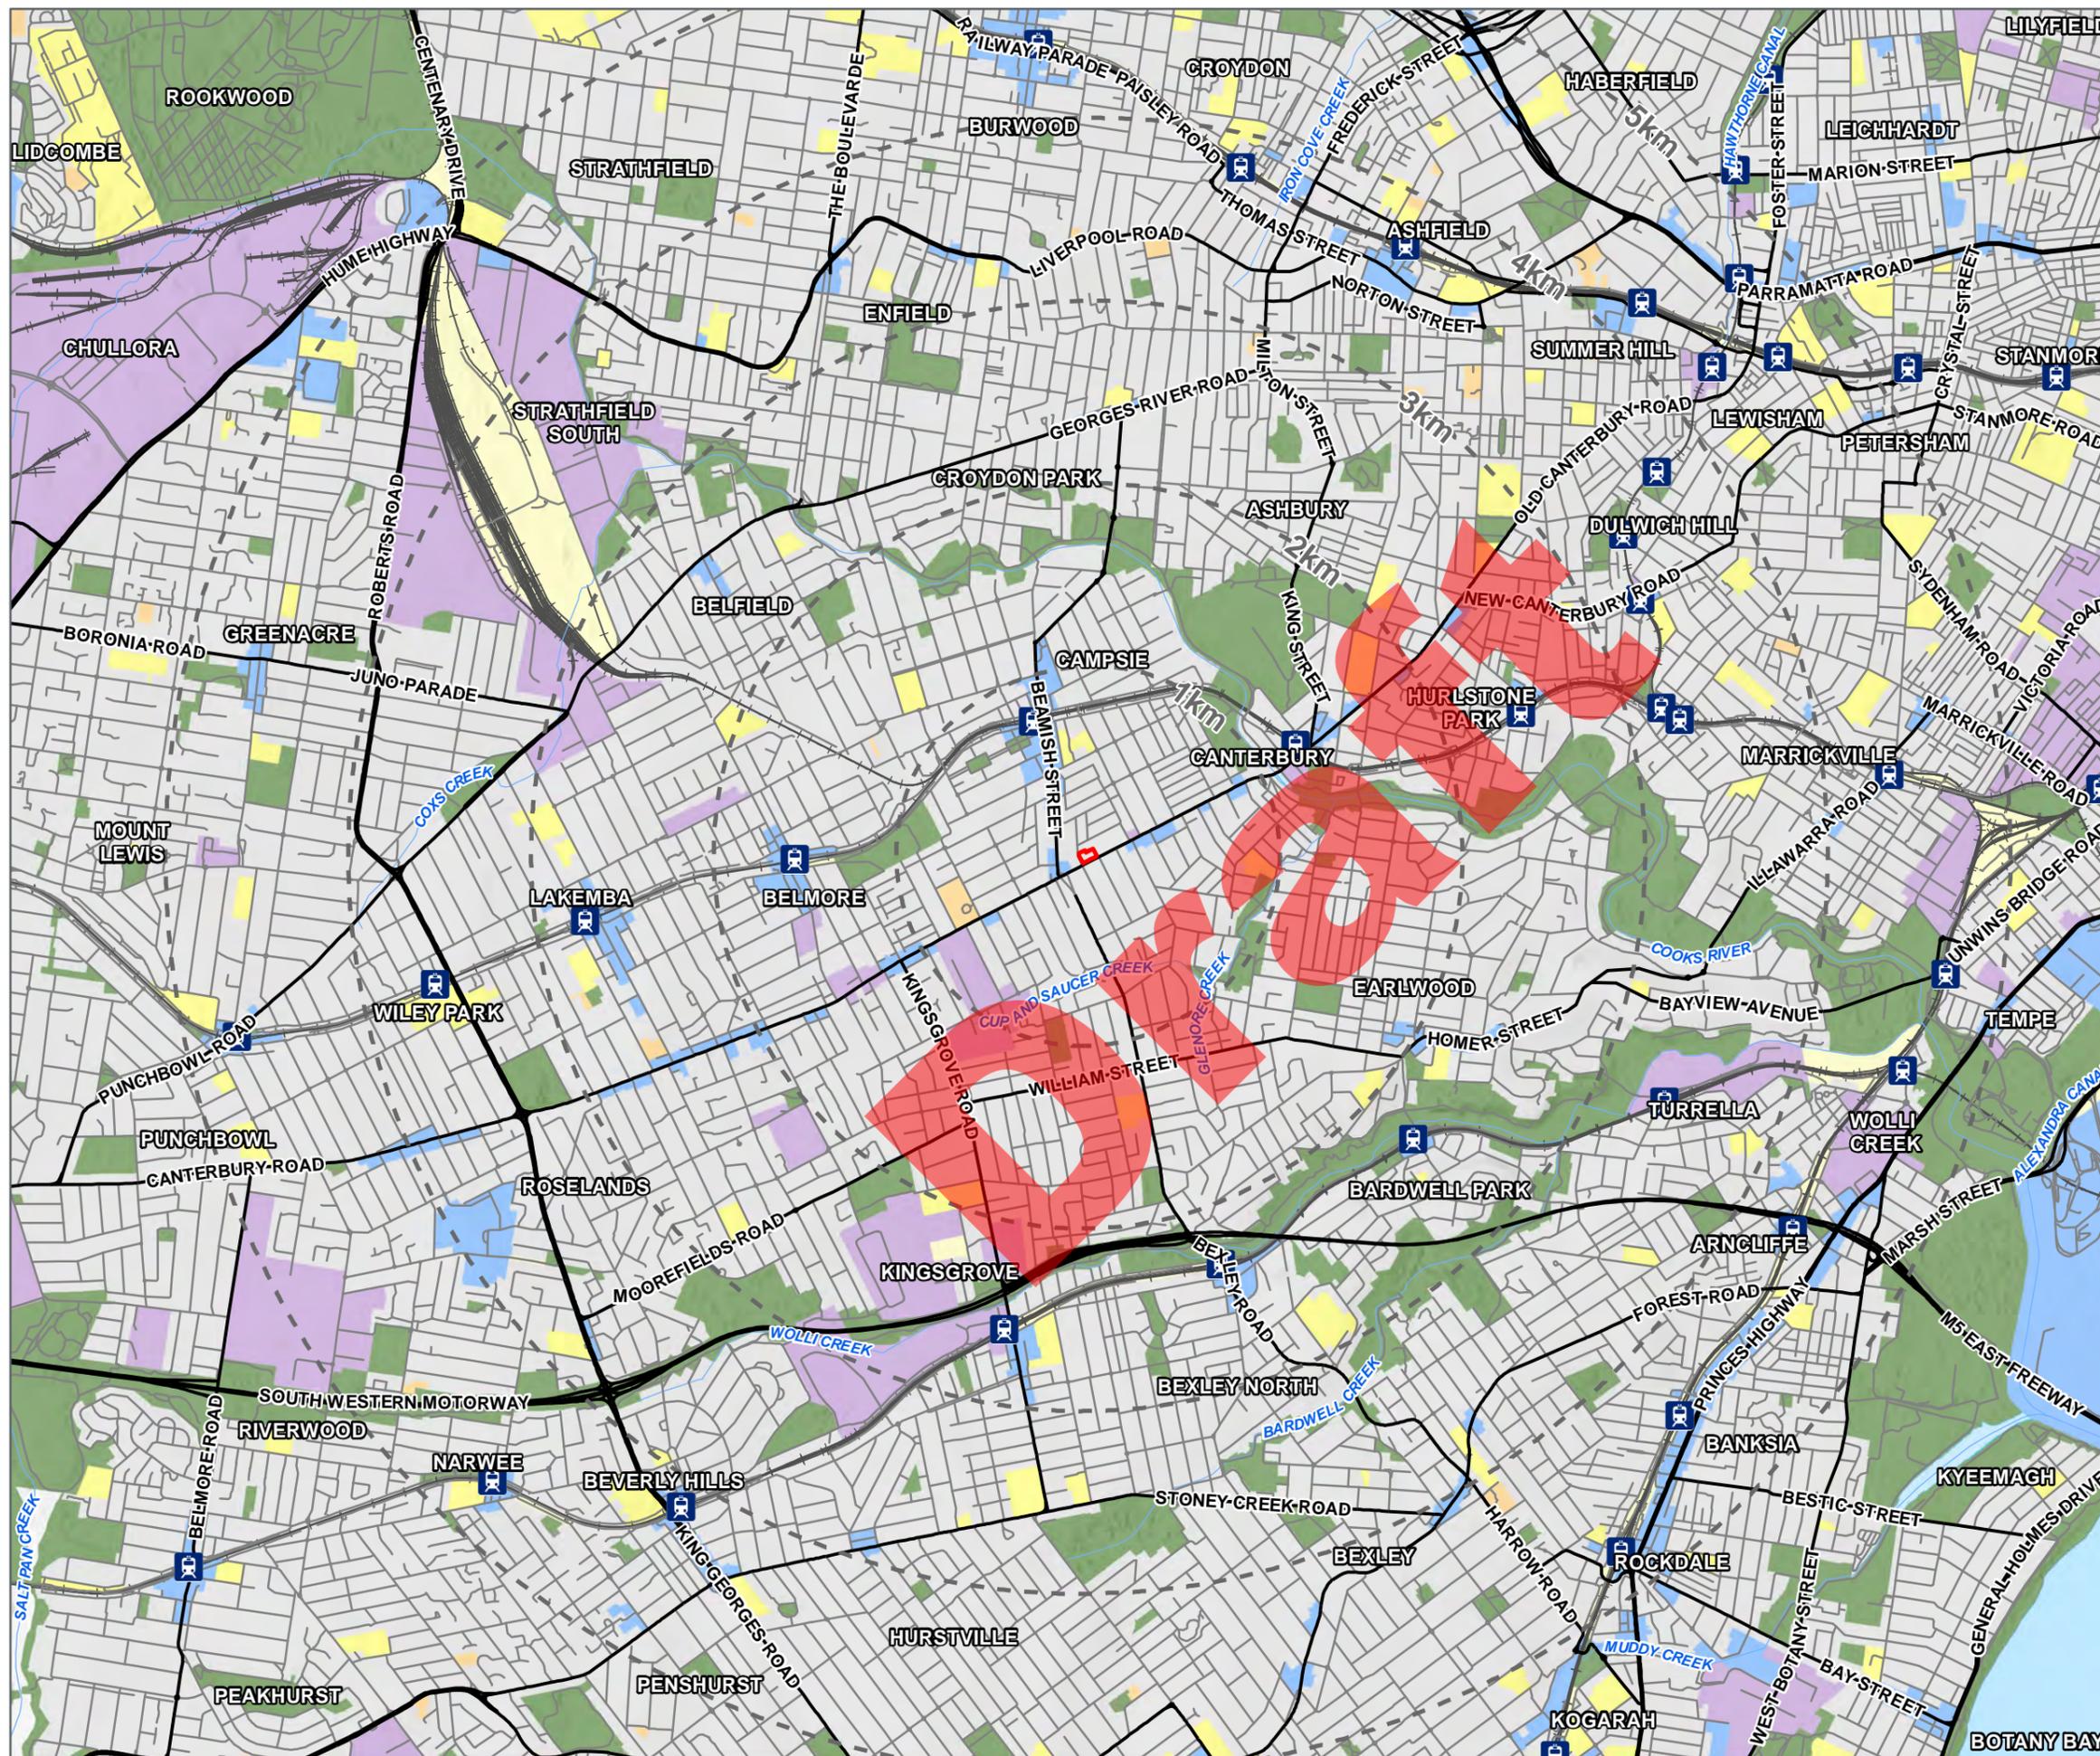
**Site Plan**

- Site Boundary
- Groundwater Contours (mAHD)
- ➔ Inferred Groundwater Flow Direction
- 1m Contours (LPI LiDAR, 2013)
- Potential Waste Oil UST
- Approximate Area of UST Impact
- Basement Excavation Footprint
- Cadastre (NSW SS, 2019)

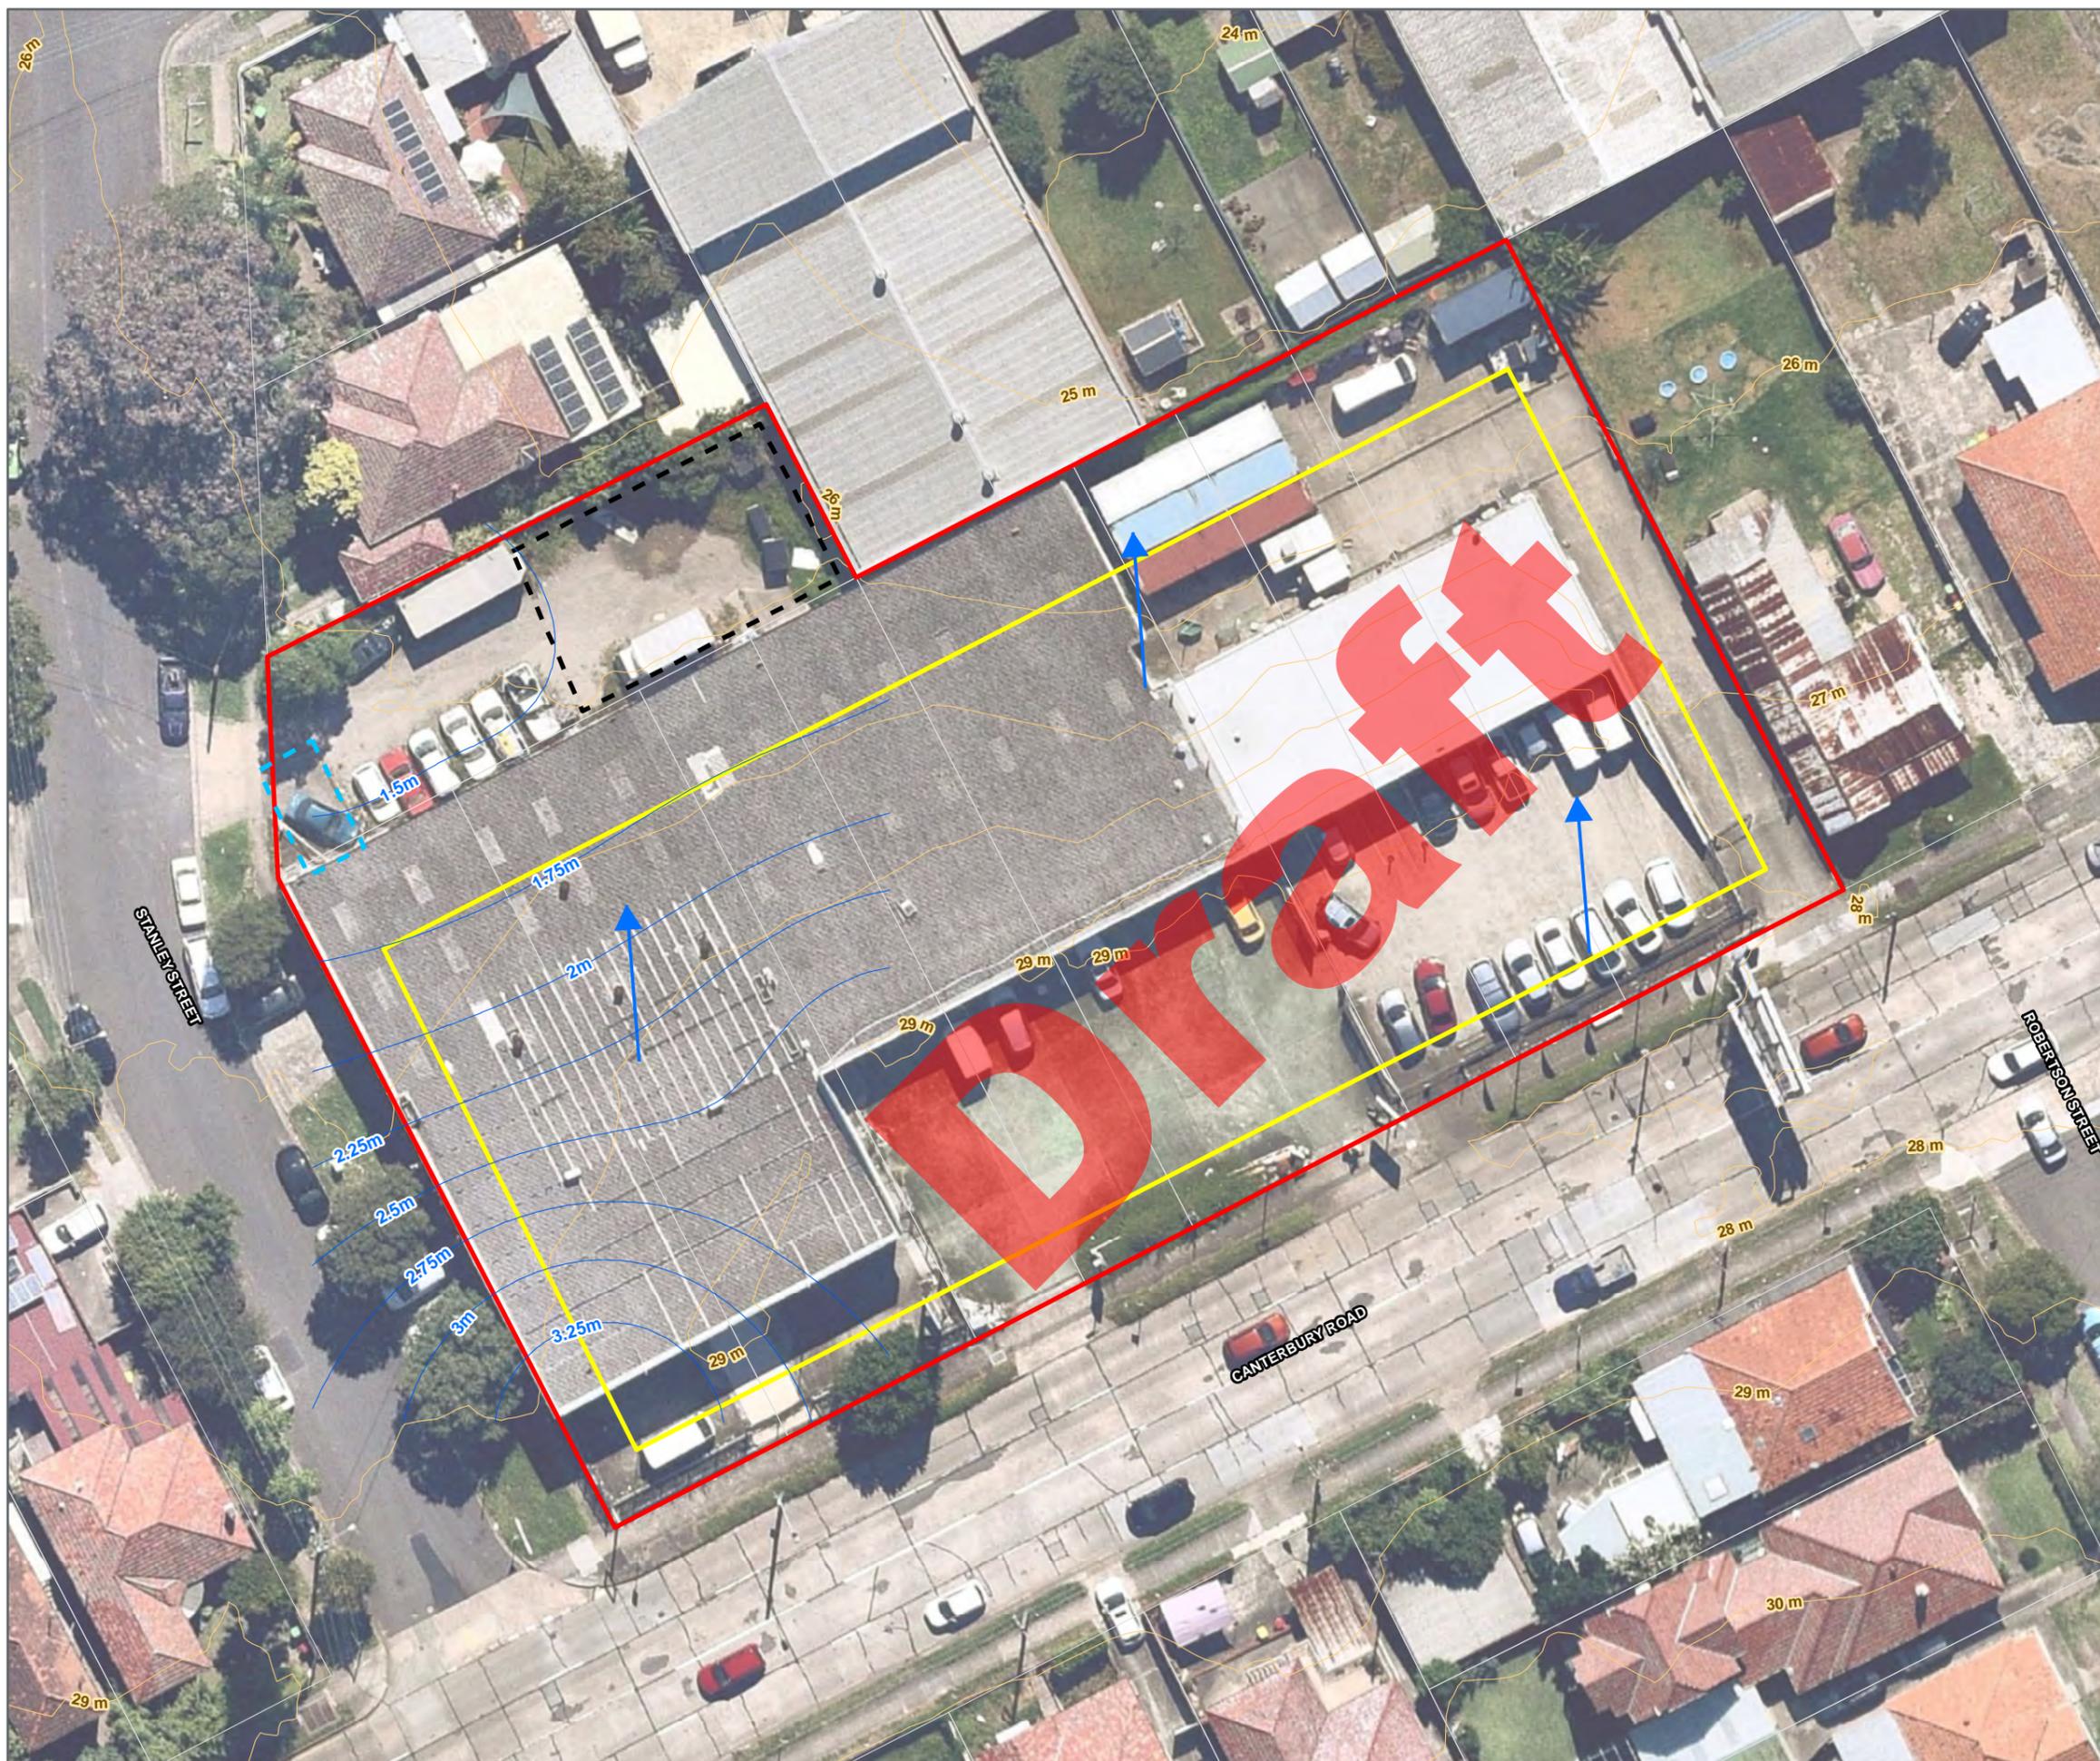
**FIGURE 2**

- Site Boundary
  - + Proposed Test Pit
  - Groundwater Monitoring Wells (Cardno, 2017 & 2020)
  - Approximate Area of UST Impact
  - Potential Waste Oil UST
  - Basement Excavation Footprint
  - Cadastre (NSW SS, 2019)
- Existing Sample Locations (Cardno, 2017 & 2020)**
- + Bore Sample Location
  - + Soil Bore to be Reassessed as Test pit

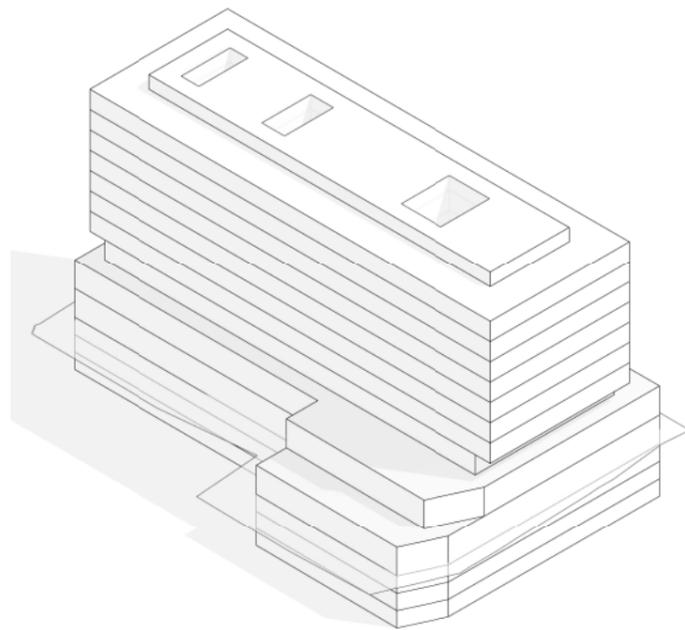
**OPTION 1**

Site: 4414m<sup>2</sup>

3 Levels of Basement Parking  
1 Ground Floor  
9 Levels above ground with plant

- No rear laneway
- Lower height
- Larger floor plates allows for larger medical unit/services across one level
- Larger floor plates reduces opportunities for natural light to penetrate
- Reduced connectivity for public through site

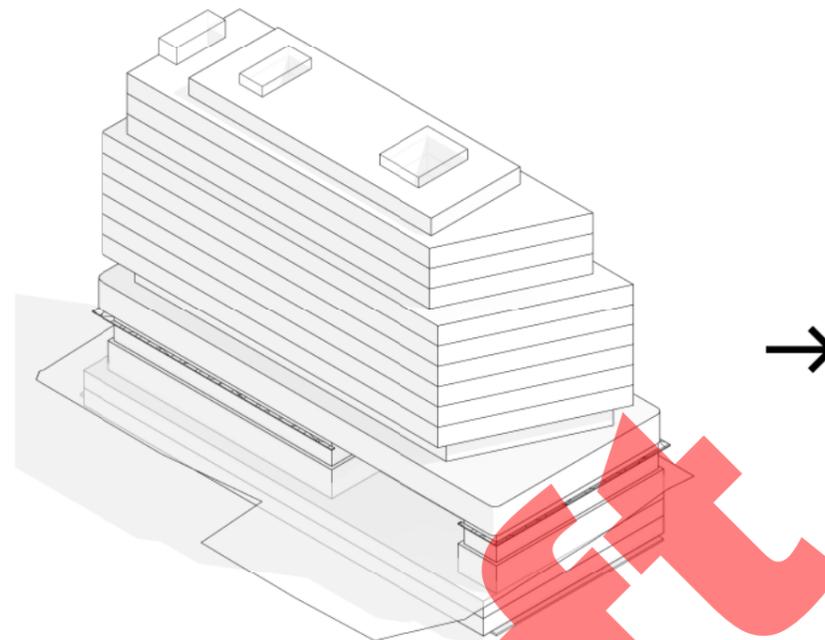
**OPTION 2**

Site: 4414m<sup>2</sup>

2 Levels of Basement Parking  
2 Ground Floor levels, Upper and Lower  
11 Levels above ground with plant

- New back laneway to Stanley St
- Increased public connectivity across site
- Narrow floor plate allows for better access to natural light across floor
- Increased setbacks in the North
- Reduced building bulk
- Floor plate size provides efficient staffing

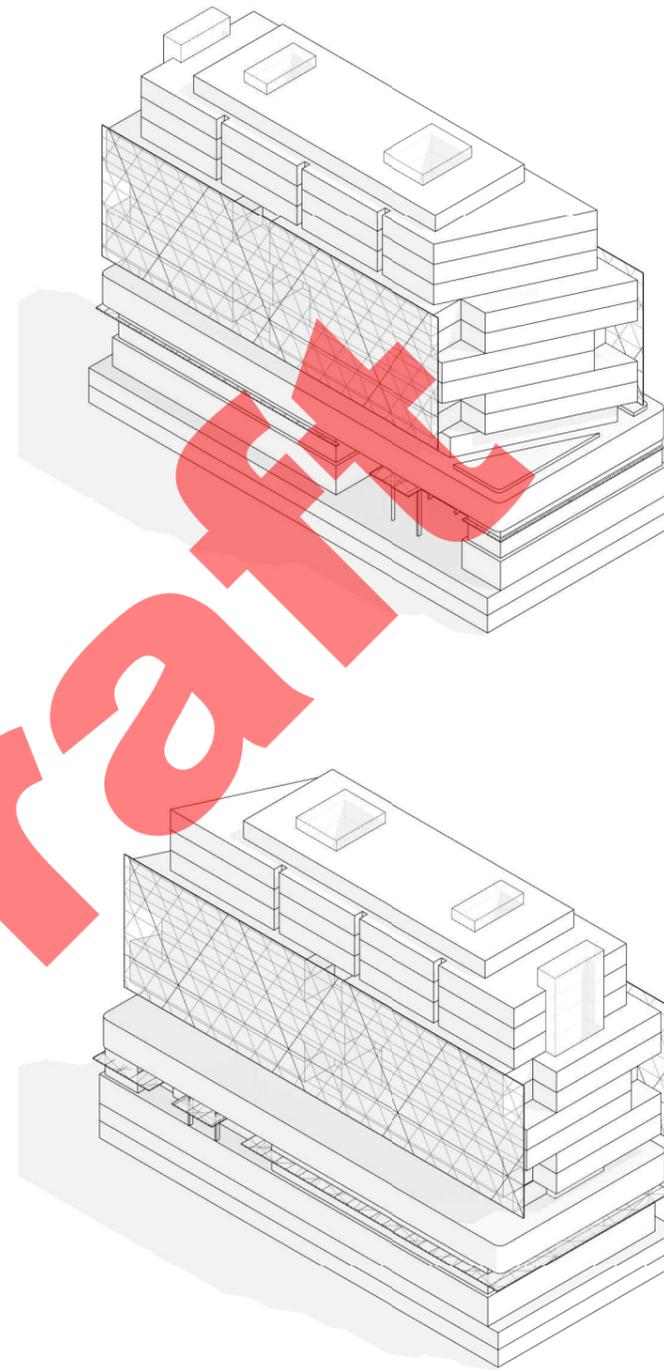
**DEPARTMENTS:**

- Site: 4414m<sup>2</sup>
- Basement 1 – Parking
- Basement 2 – Parking
- Ground lower – Loading Dock, Store & Retail
- Ground upper – Allied Health, Amb. Care & Medical Retail
- Level 1 – Theatres & Recovery, CSSD, Sterile Stock
- Level 2 – Theatre Lounge & Plant
- Level 3 – In-patient Unit
- Level 4 – In-patient Unit
- Level 5 – In-patient Unit
- Level 6 – In-patient Unit
- Level 7 – In-patient Unit
- Level 8 – In-patient Unit
- Level 9 – Consult or Education Suites
- Level 10 – Consult or Education Suites
- Level 11 – Consult or Education Suites
- Plant

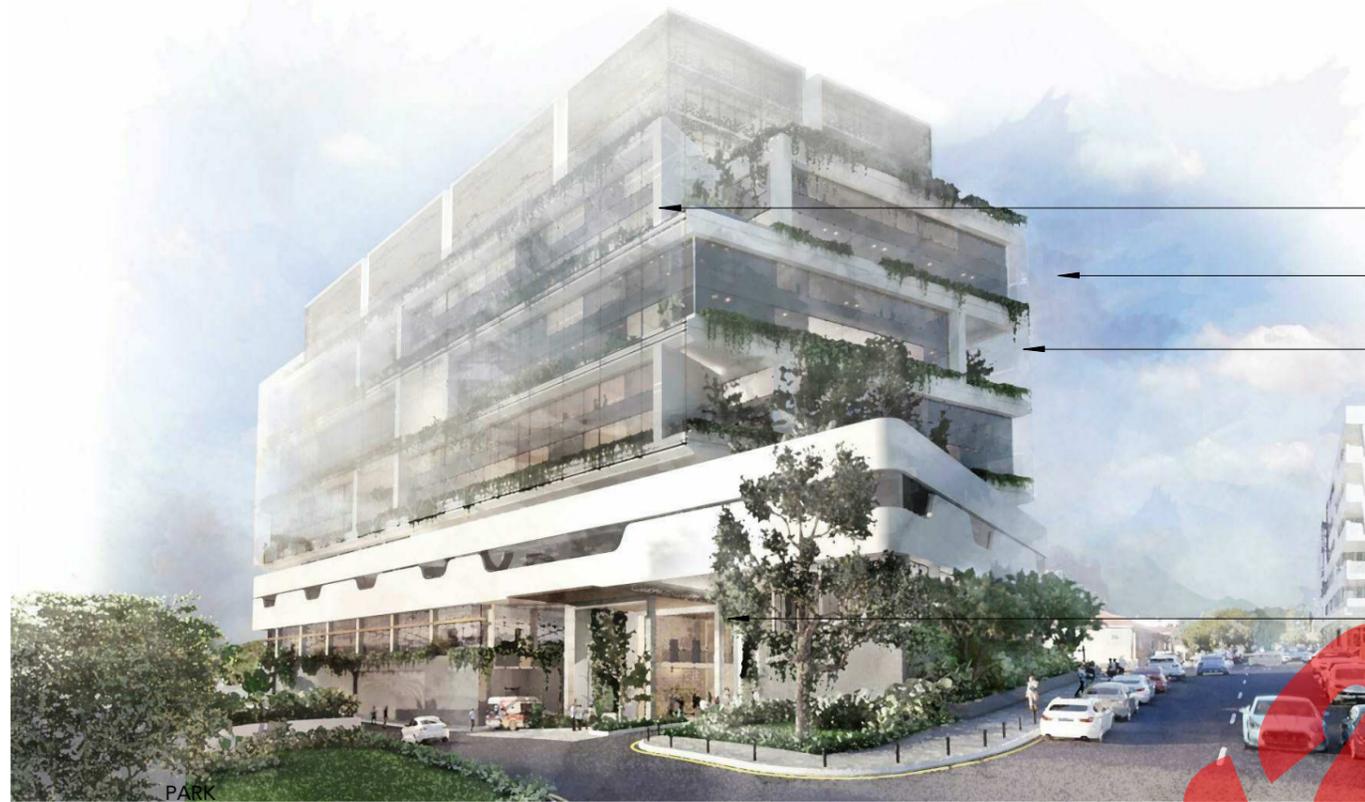
SOLAR CONTROL

ACOUSTIC SCREEN

SKY GARDENS

PUBLIC INTERFACE  
CANTERBURY RD TO STANLEY  
STREET LINK THROUGH  
DOUBLE HEIGHT ATRIUM
